# 2013 Inspection and Status Report for the Former Boiling Nuclear Superheater (BONUS) Reactor Facility, Rincón, Puerto Rico

## Summary

The Former Boiling Nuclear Superheater (BONUS) Reactor Facility, located on the west coast of Puerto Rico in the town of Rincón, was inspected on August 28, 2013. The inspection included confirming the integrity of the entombed reactor system, the containment building, site security, general housekeeping, and condition of the surrounding land. The site was found to be in good condition. No cause for a follow-up inspection was identified.

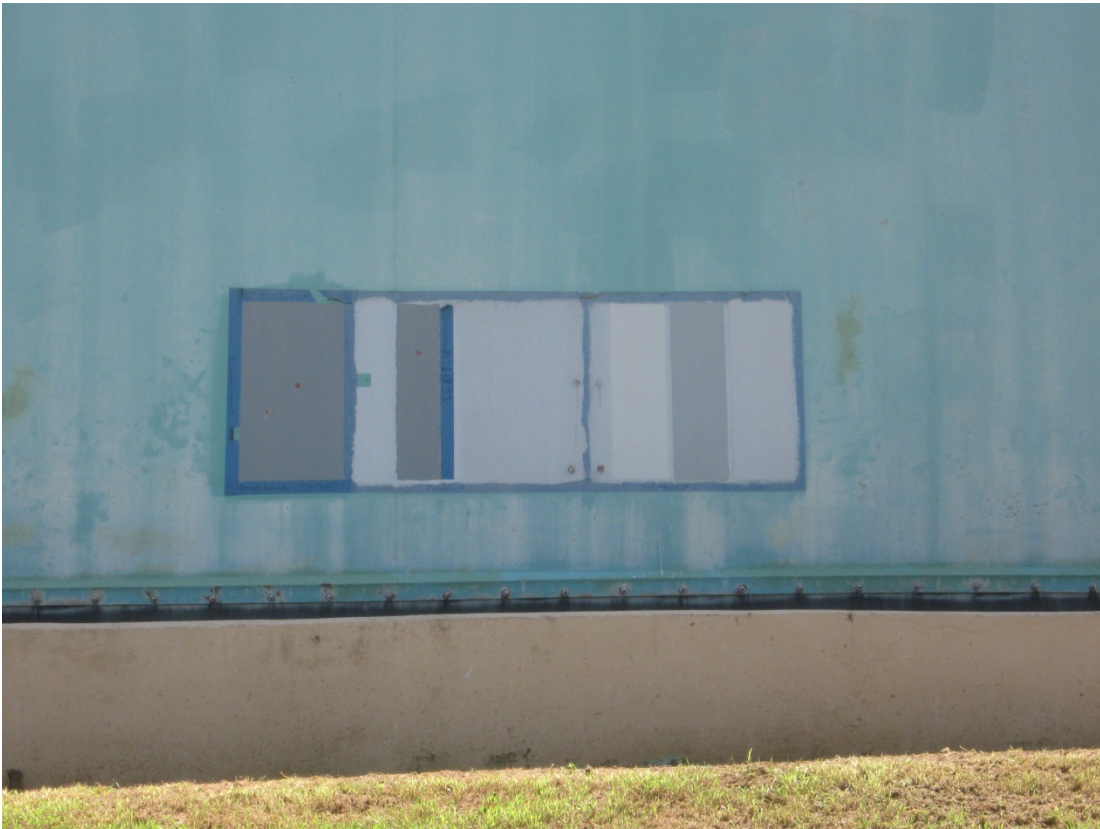
The Containment Dome houses the entombed reactor system. The outer surface of the dome was in the process of being painted. The work observed appeared to be of high quality with an emphasis on safety. Paint color was tested prior to beginning the work (PL-1). The color on the far left, in PL-1, is the color that was selected. A portable lift is being used to get people and supplies to the top of the dome (PL-2). During the inspection supplies were being staged on top of the dome (PL-3). Painting is scheduled to be complete in December 2013.

BON 8/2013. PL-1. Test paint – outside surface of containment dome.

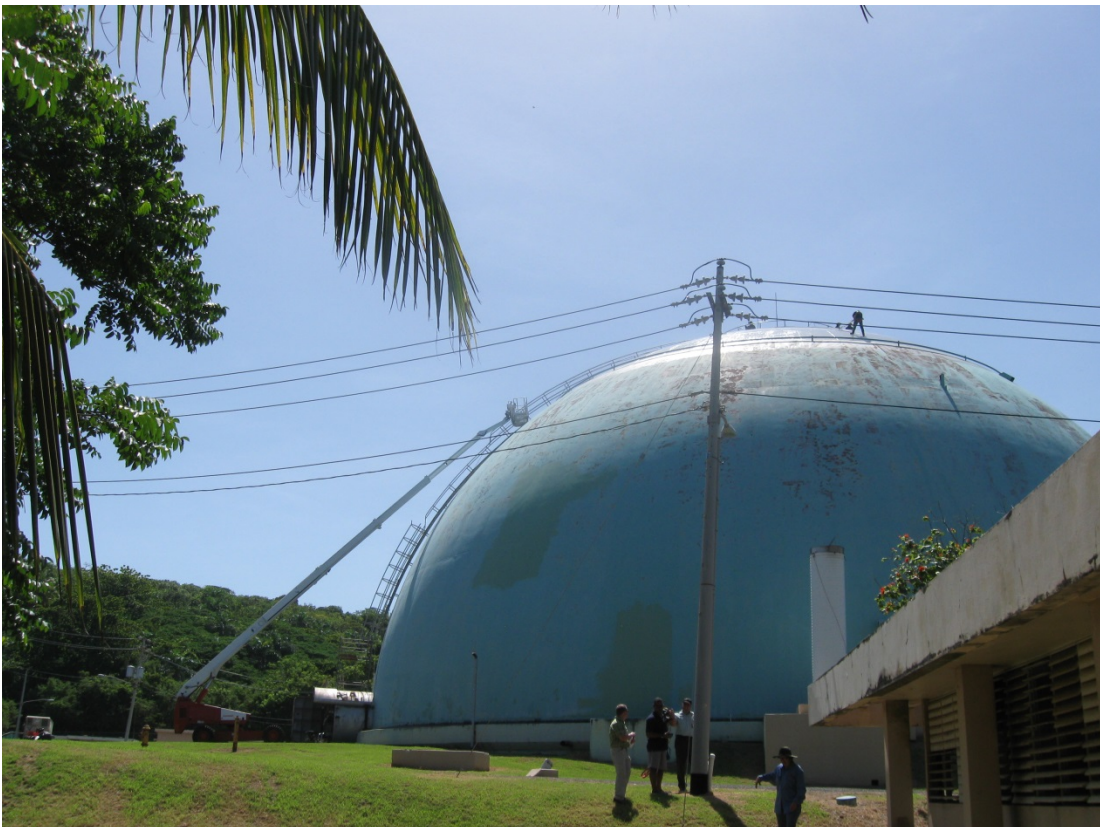
BON 8/2013. PL-2. Extended bucket lift to top of containment dome.

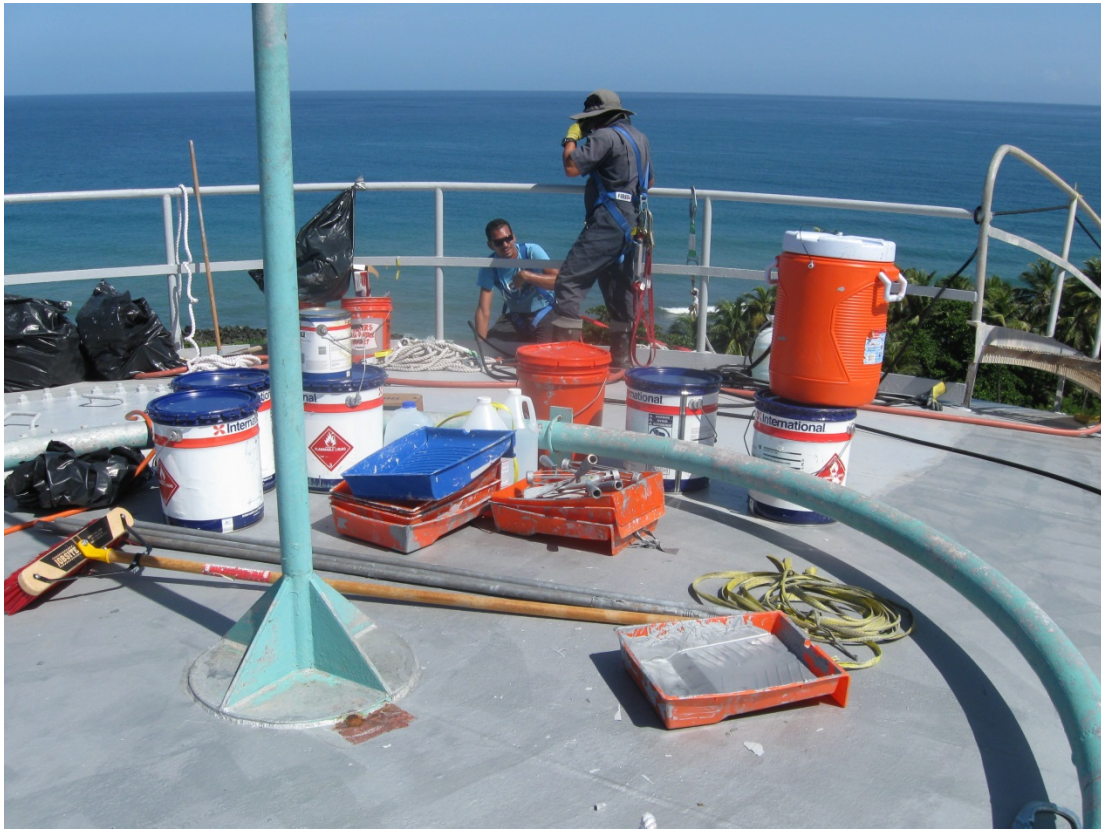
BON 8/2013. PL-3. Top of dome, paint supplies.

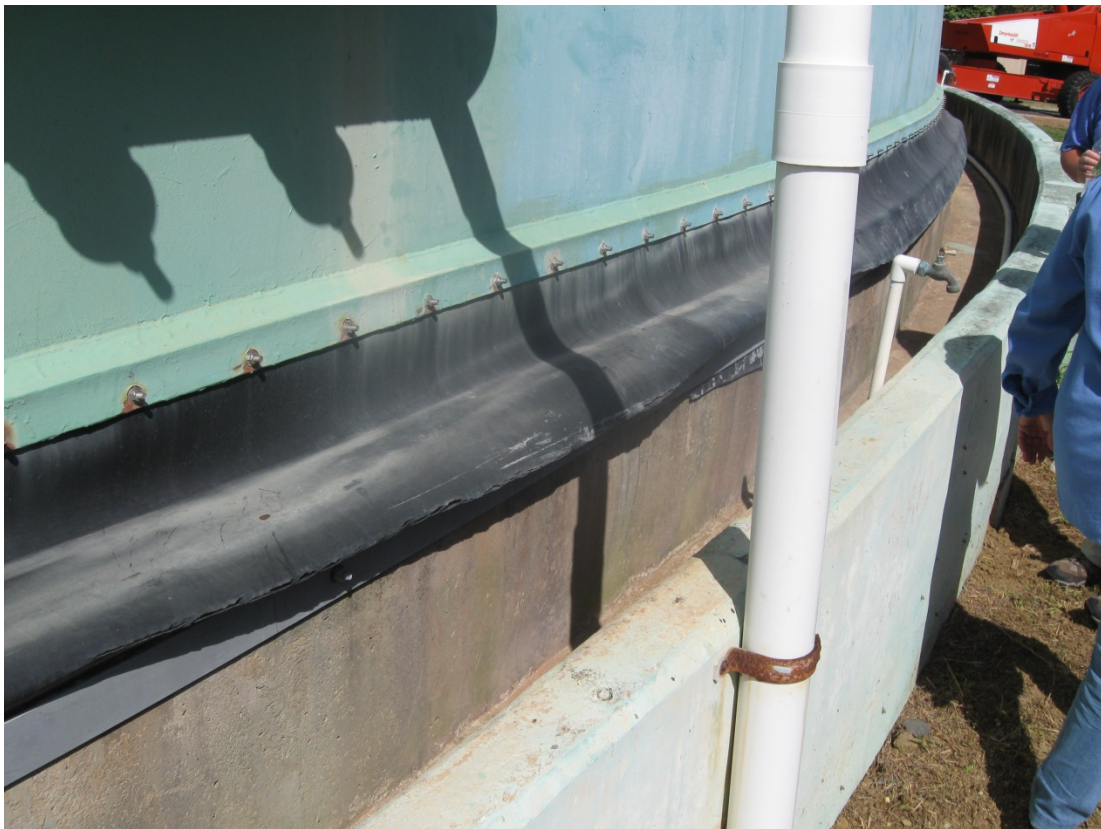
Around the base of the containment dome is a rubber seal/gasket that serves to direct water away from the base of the outer curved surface of the dome. The dome has a diameter of approximately 160 feet, and a corresponding circumference of approximately 502.4 feet. In 2010, the rubber seal was observed to be in bad condition. It was cracked, ripped, and missing in some locations. Since 2010, PREPA personnel have installed a secondary seal over the damaged seal (PL-4 and PL-5). The secondary seal serves to carry water away from the underlying damaged primary seal.

BON 8/2013. PL-4. Repairs to seal around base of dome.

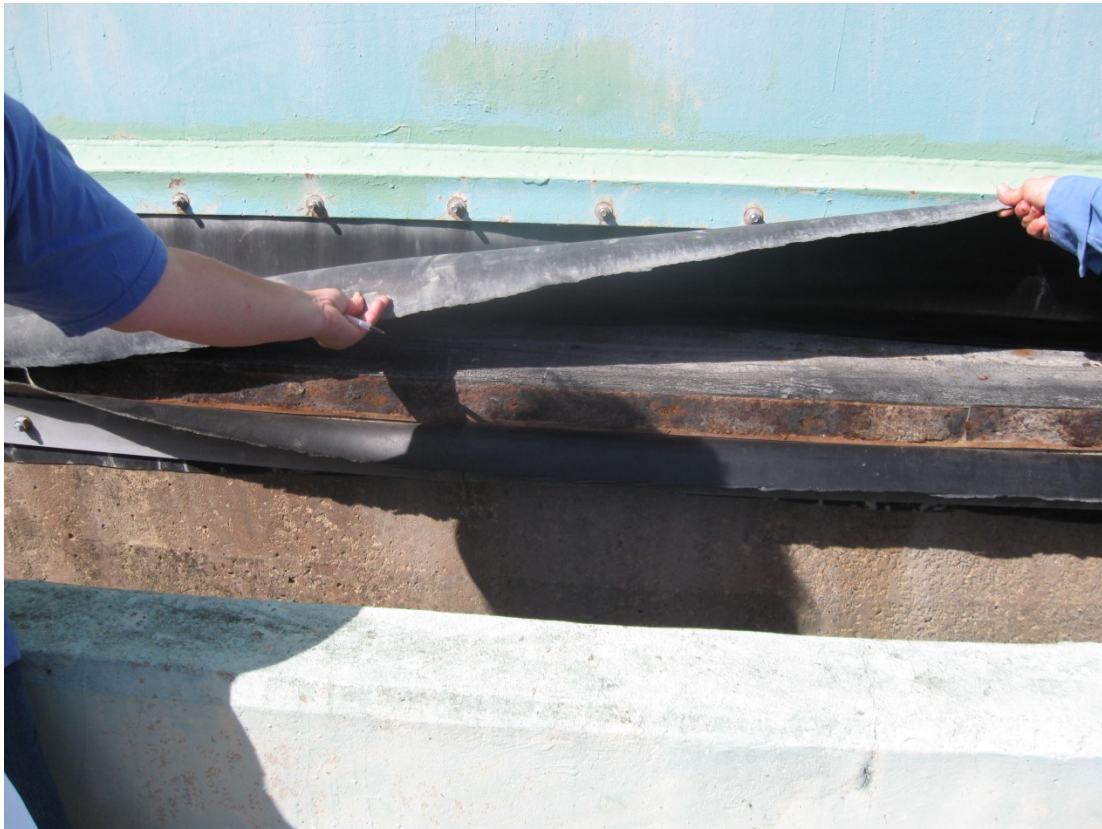
BON 8/2013. PL-5. Repairs to seal around base of dome.

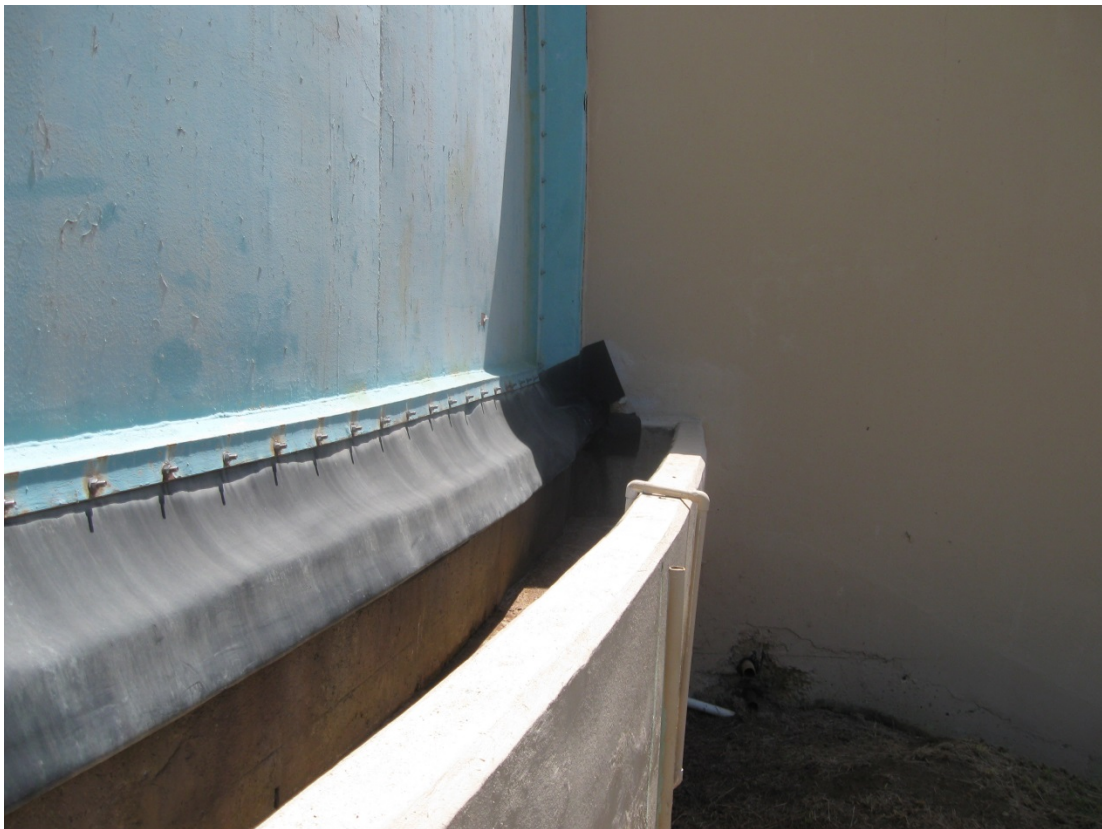
In 2010 inspectors found that the flashing near the administrative offices at the base of the dome was bent away from the dome creating a large void for water to enter the building. Inspectors found that this flashing had been properly repaired (PL-6).

BON 8/2013. PL-6. Flashing repair along base of dome.

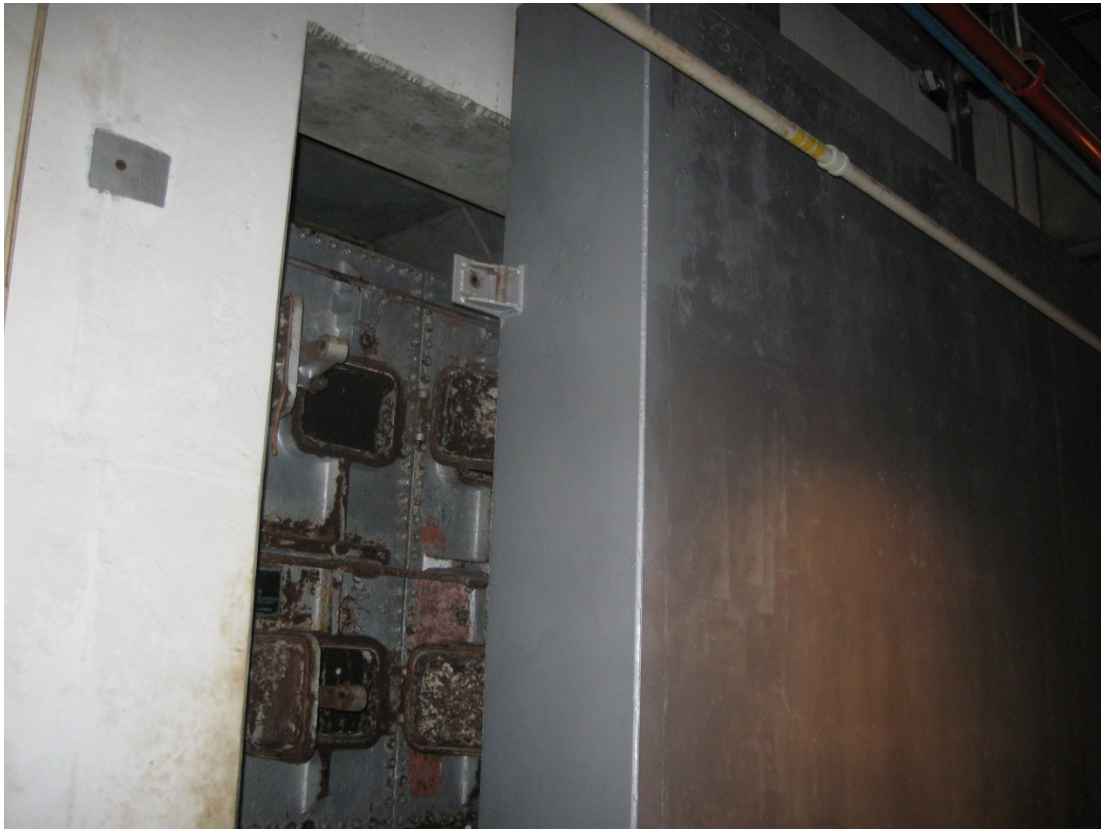
In 2010 inspectors recommended that peeling paint on painted surfaces in the basement of the facility be tested for lead. A test was conducted and one area was found to have paint that contained small amounts of lead. The lead-contaminated area was painted over to provide additional protection against potential lead exposure (PL-7).

BON 8/2013. PL-7. Repainted surface to address underlying lead paint.

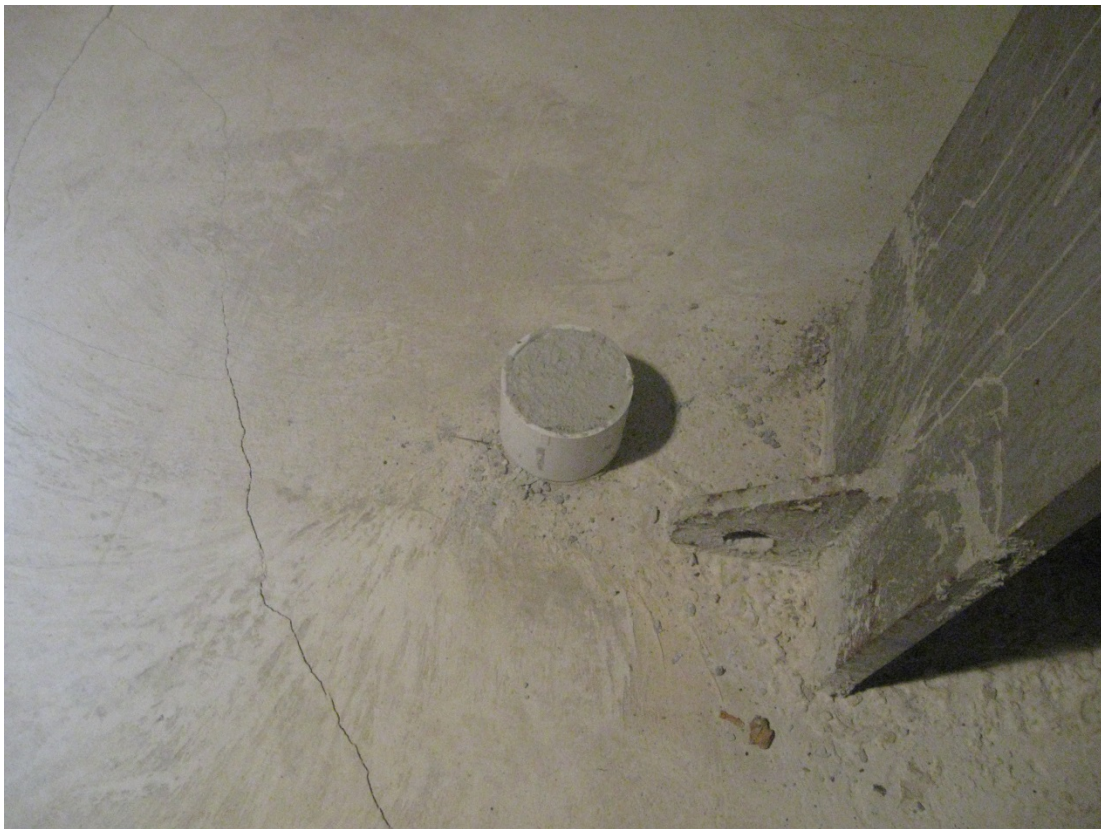
A few inches of concrete have been added to the basement floor of the containment building since Hurricane Georges to provide shielding for some isolated and discrete areas of fixed radioactive contamination on the basement floor. Floor drains in the basement floor were filled in with concrete raising the question of how will water drain from the facility should it flood again (PL-8). It was recommended in 2010 that PREPA provide DOE the plans that will be followed to address future flooding events at the facility. Plans were prepared and made available to the DOE.

BON 8/2013. PL-8. Floor drain filled with cement.

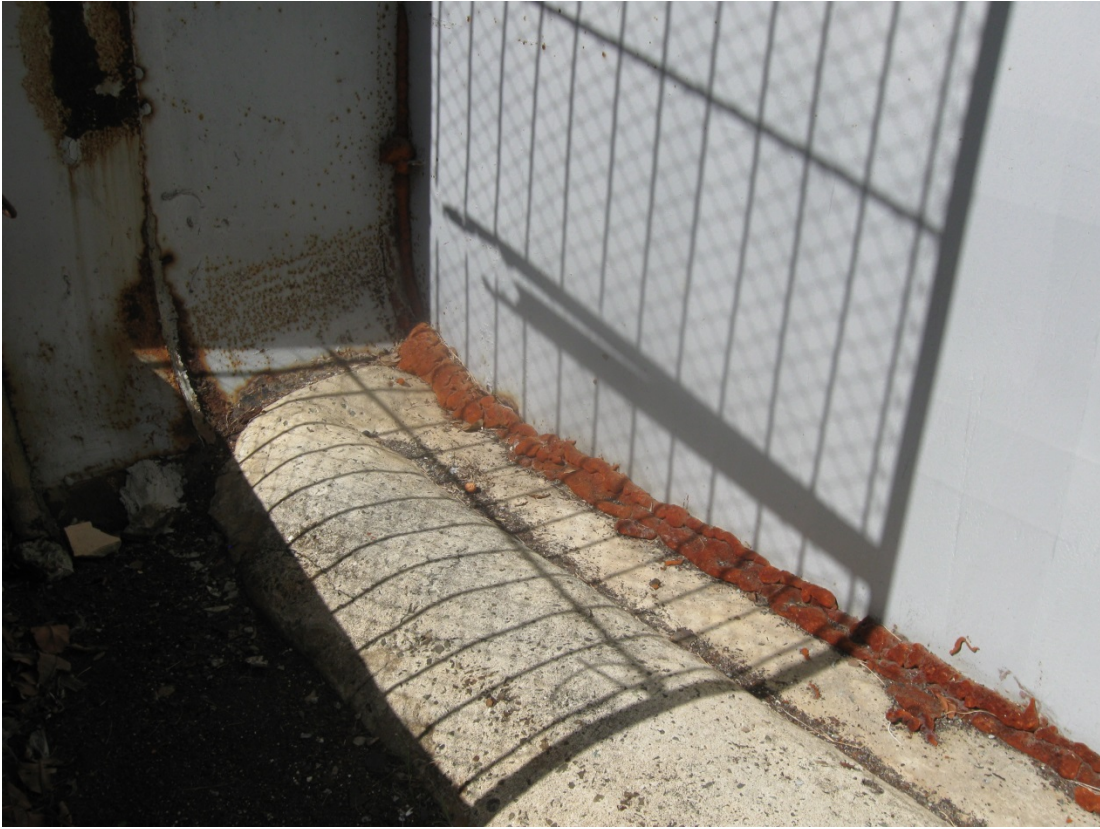
In 2010, inspectors observed the freight door on the east side of the containment building, leading to the basement was sealed shut with scale. Metal flashing in front of the freight door had large holes in it due to corrosion of the metal. These large holes had the potential to allow water to enter the basement should the entry way to the freight door flood as it did during Hurricane Georges in 1998. In 2010 inspectors recommended that the corroded flashing around the freight door be repaired, the door be opened, and the door seal cleaned, inspected, and replaced if deemed appropriate. Inspectors in 2013 found that PREPA had carried out the recommendation. The door was sealed shut (PL-9), and corroded metal in front of the door had been repaired with a layer of concrete (PL-10).

BON 8/2013. PL-9. Freight door, east side of containment building.

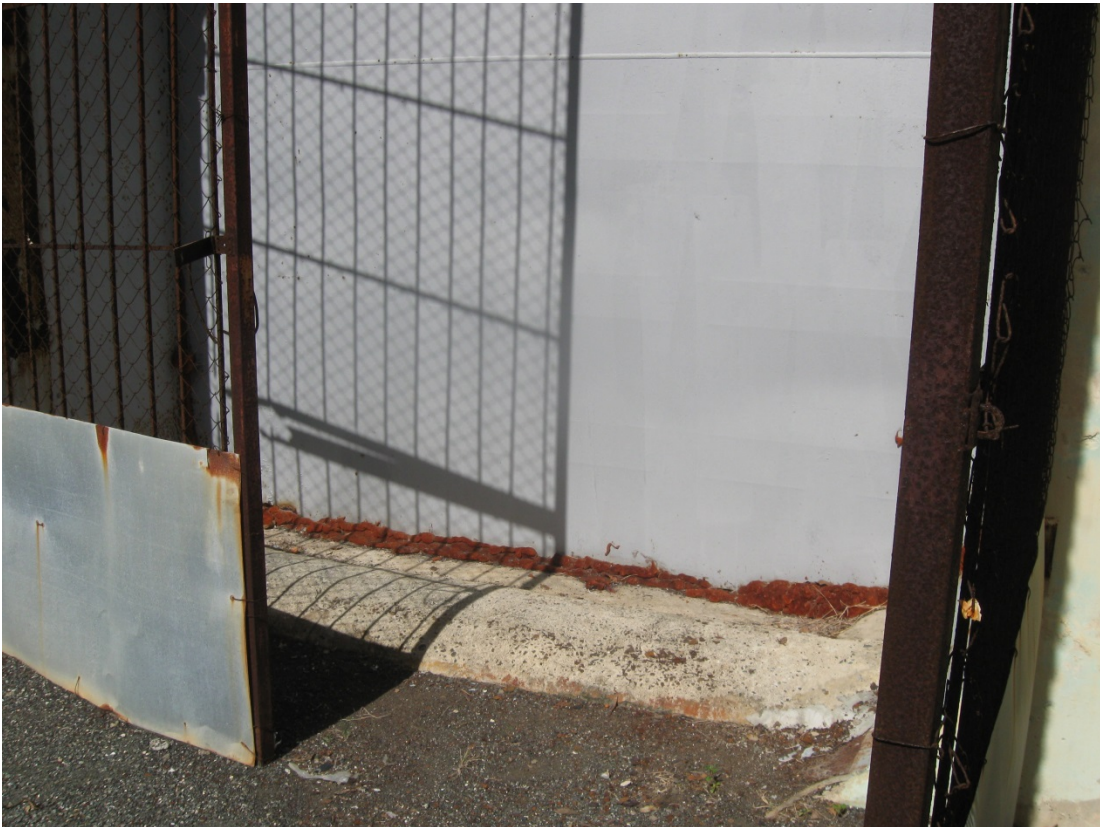
BON 8/2013. PL-10. Freight door, east side of containment building.

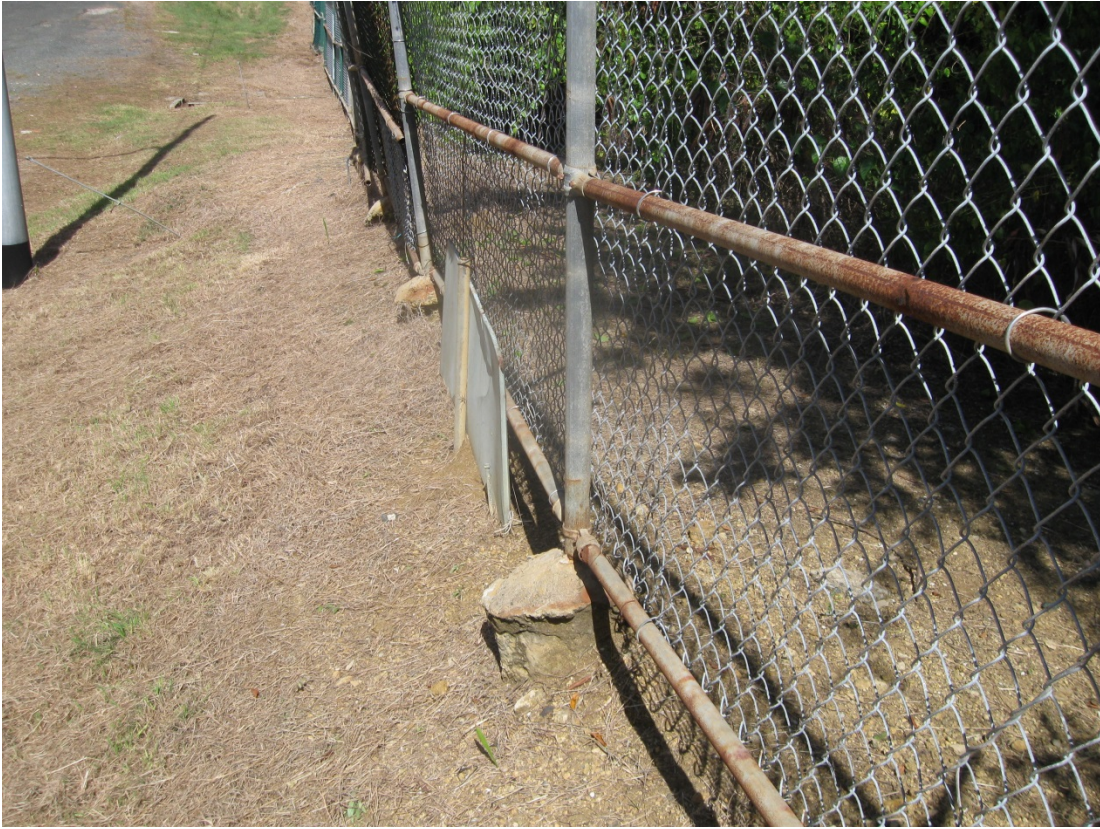
In 2010, the fence was in poor condition. The barbed wire along much of the top of the fence was missing. Several holes, large enough for people to pass through, were cut in the fence. In several areas the fence was overgrown with vegetation. Inspectors in 2013 noted the fence to be in good condition. Although the barbed wire along much of the top of the fence was still missing, all holes had been repaired, and vegetation had been cleared from most of the fence (PL-11).

BON 8/2013. PL-11. Looking west down north fence line.

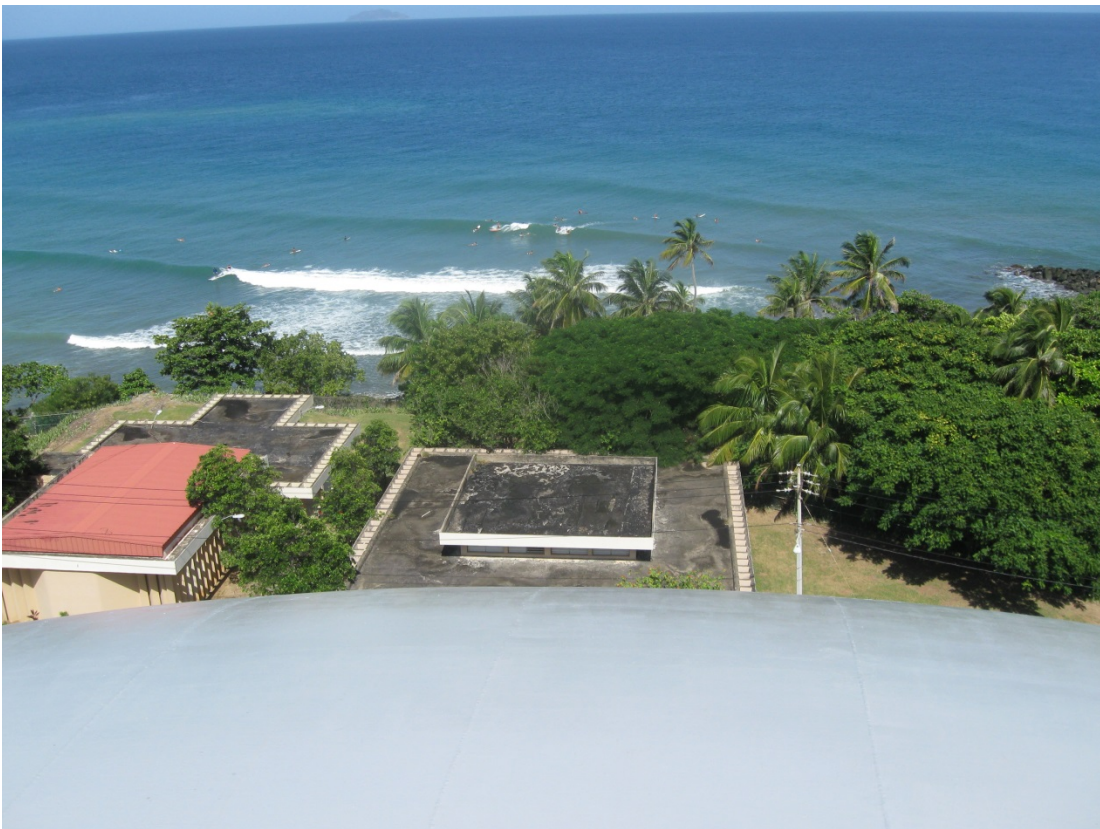
No changes to the surrounding area were noted during the inspection. The retaining wall on the west side of the facility, near the beach, remains broken due to a close-growing palm tree, but remains serviceable (PL-12, through PL-16).

BON 8/2013. PL-12. Top of dome, looking west.

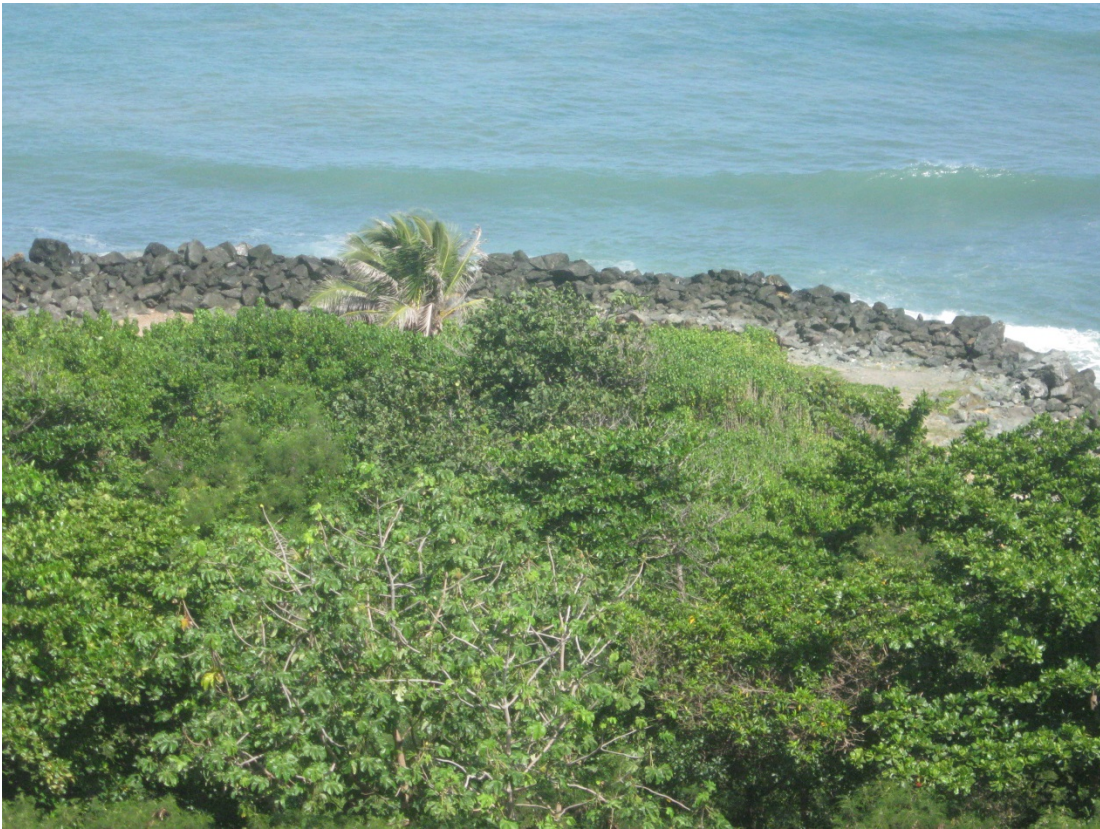
BON 8/2013. PL-13. Top of dome, looking northwest.

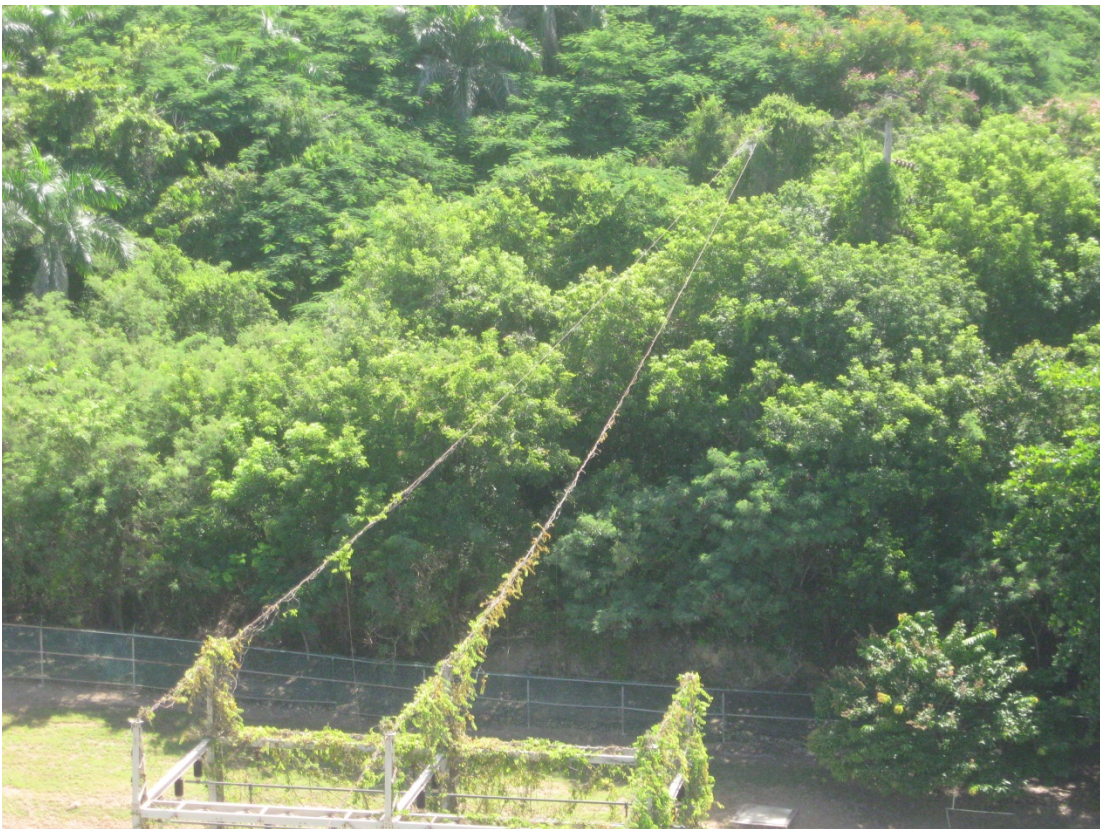
BON 8/2013. PL-14. Top of dome, looking northeast.

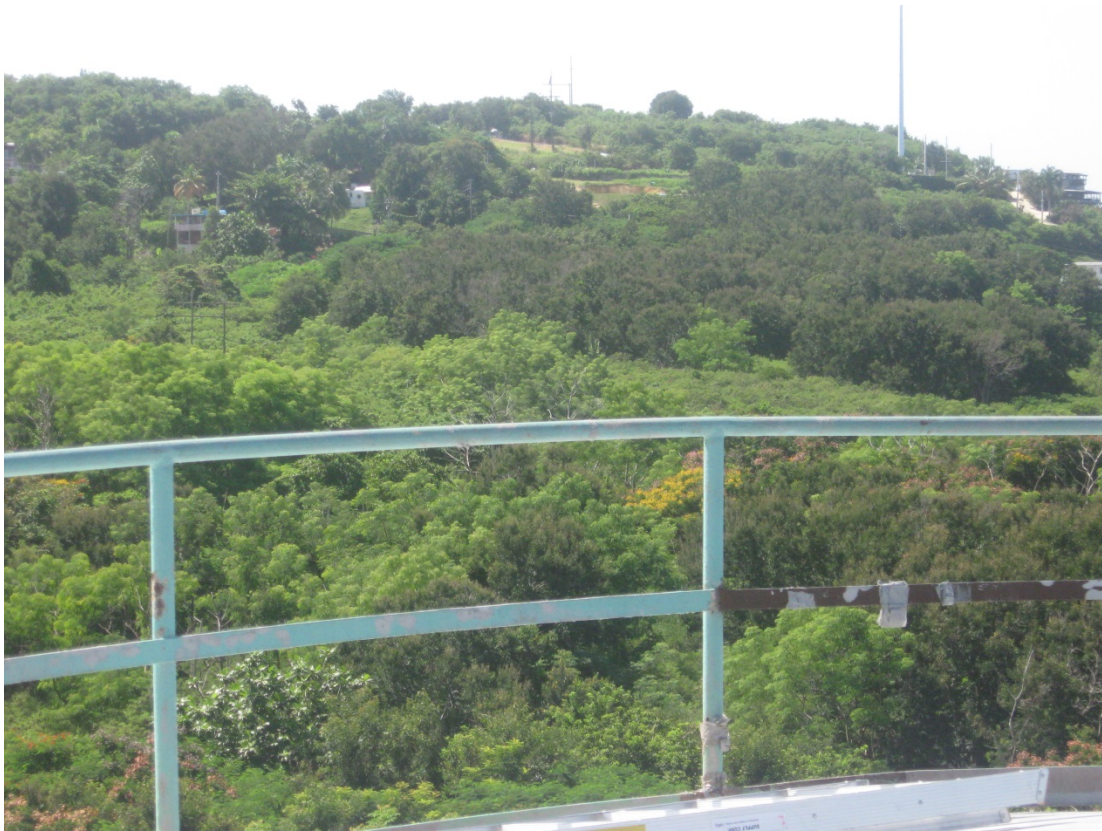
BON 8/2013. PL-15. Top of dome, looking southeast.

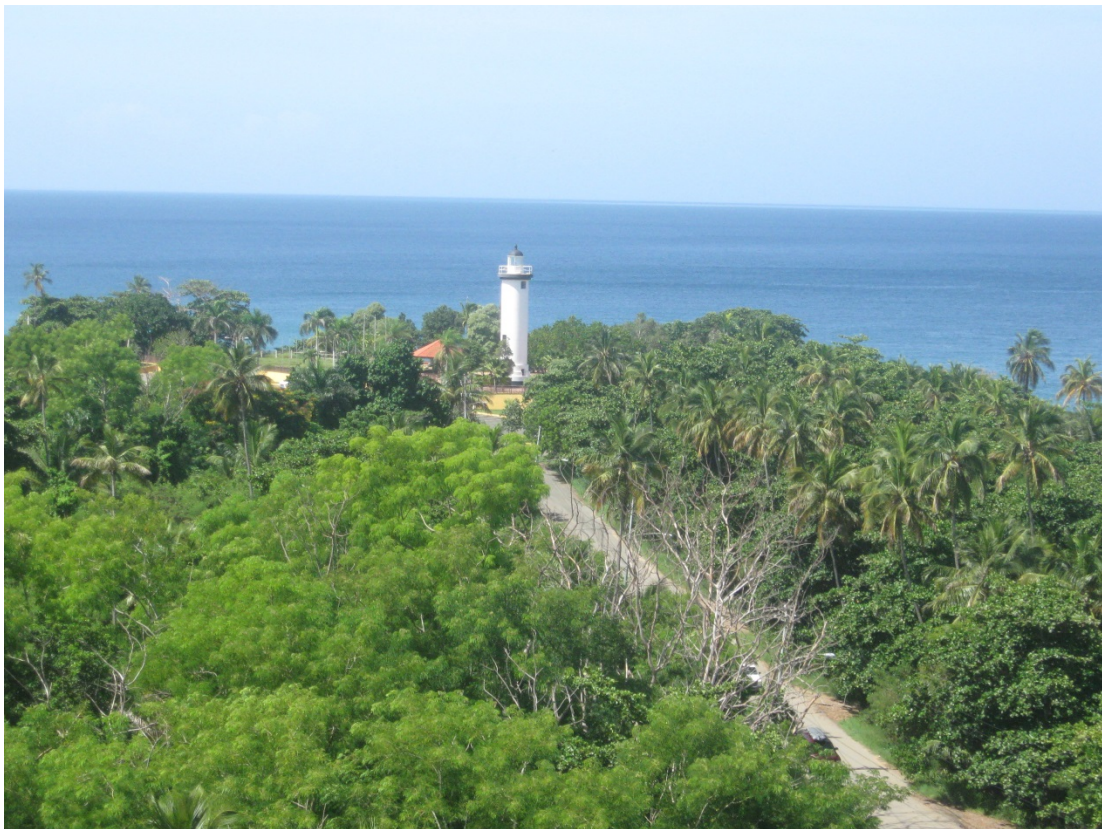
BON 8/2013. PL-16. Top of dome, looking southwest.
