**2019 Inspection and  
Status Report for the Boiling  
Nuclear Superheater  
(BONUS) Decommissioned  
Reactor Site,  
Rincón, Puerto Rico**

**July 2019**

U.S. DEPARTMENT OF  
**ENERGY**

Legacy  
Management

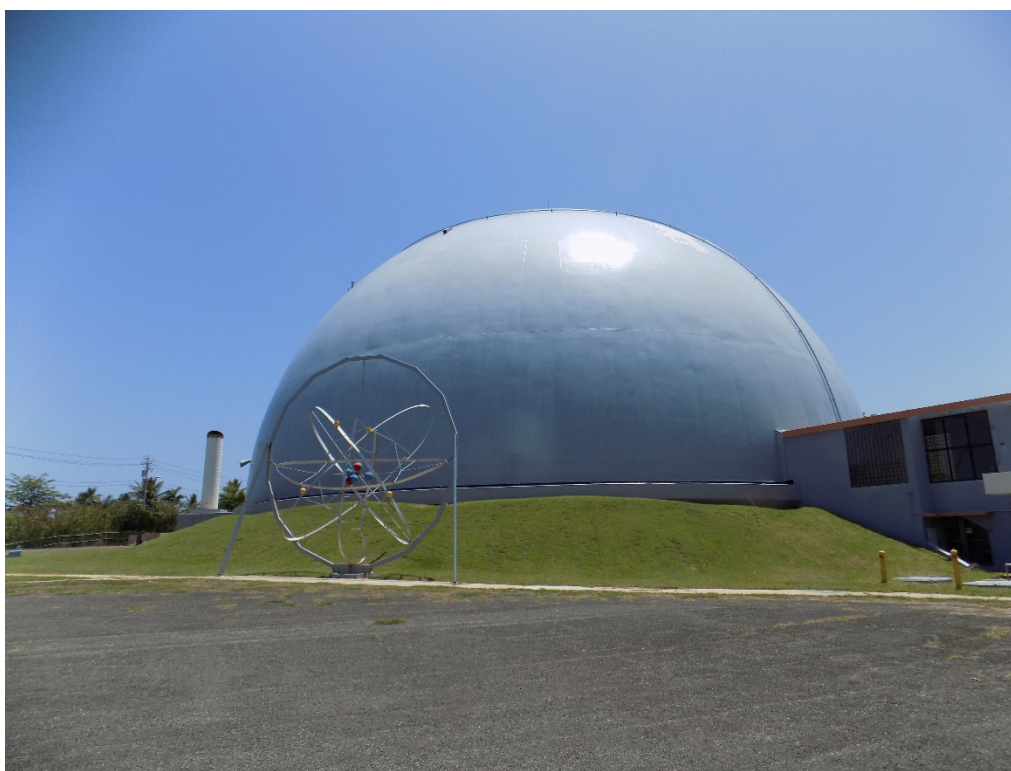
The outer surface of the dome was reconditioned and painted in 2013 (PL-1). Paint in one area of the dome was damaged during the hurricane, and it needs to be repainted as soon as possible (PL-2). The freight door (on the east side of the containment dome) is sealed shut, but an opening above the door had become the home for a wasp infestation. The wasps need to be

*PL-1. Containment dome*

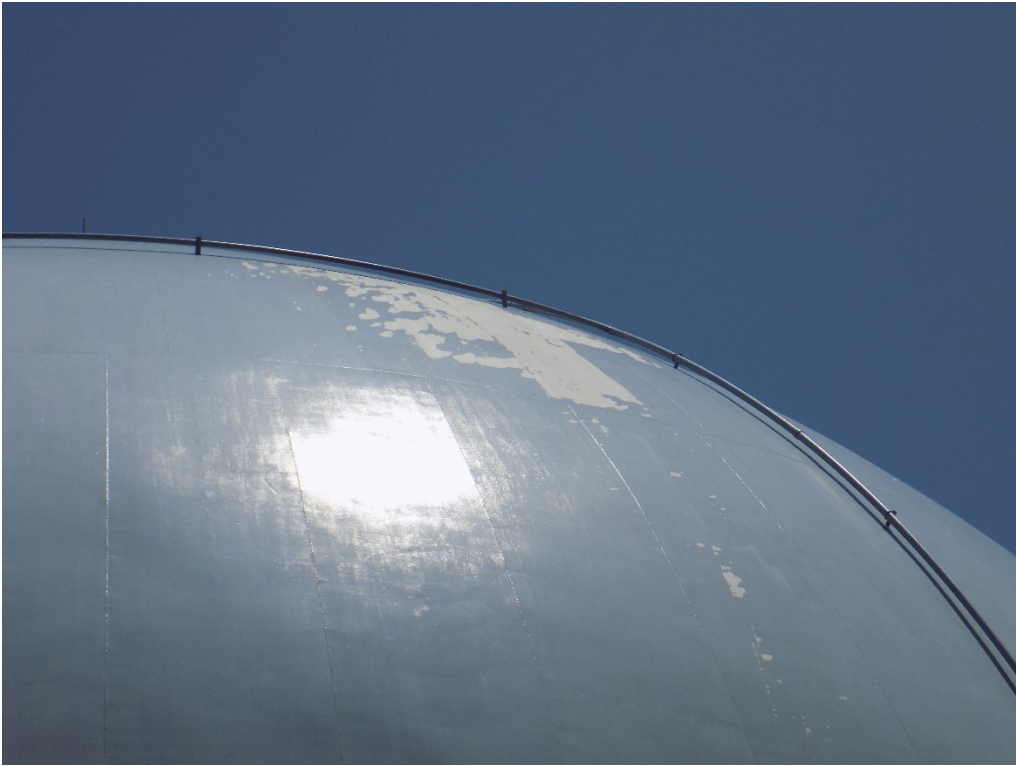
*PL-2. Missing paint on dome*

One small area of the dome should be repainted as soon as possible to help protect the dome from corrosion.

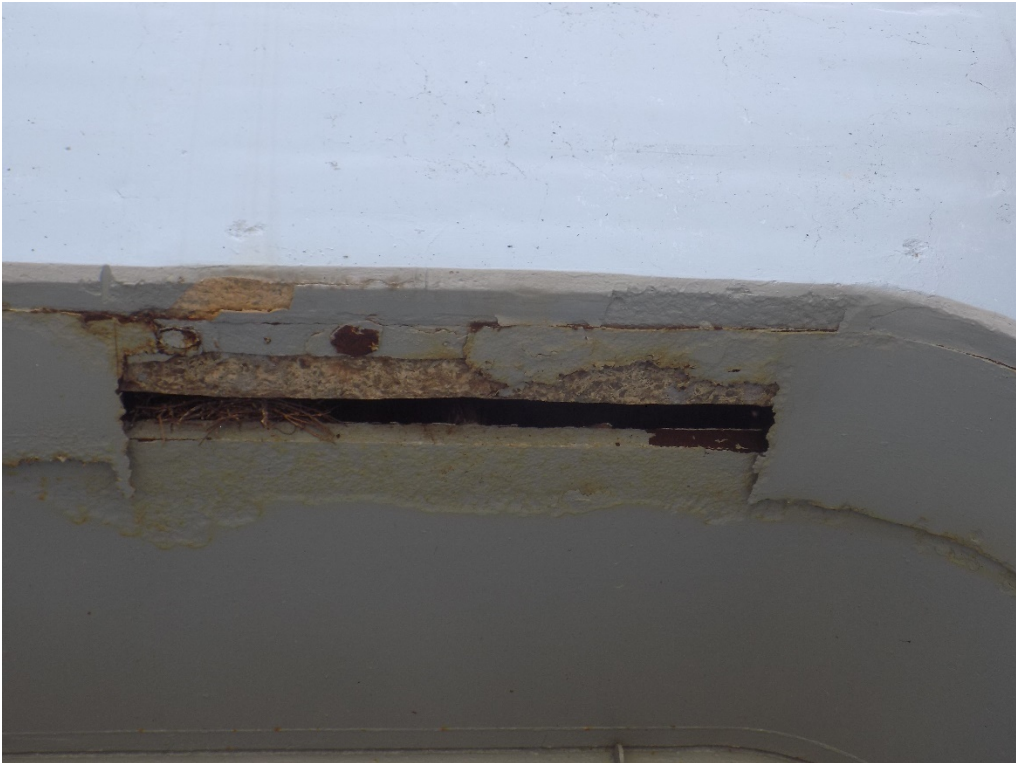
removed and the opening needs to be sealed as soon as possible to prevent the infestation from getting worse (PL-3).

*PL-3. East freight door with wasp infestation*

An area of wasp infestation located along the top of the east freight door should be cleaned of wasps and sealed to prevent future insect infestations.

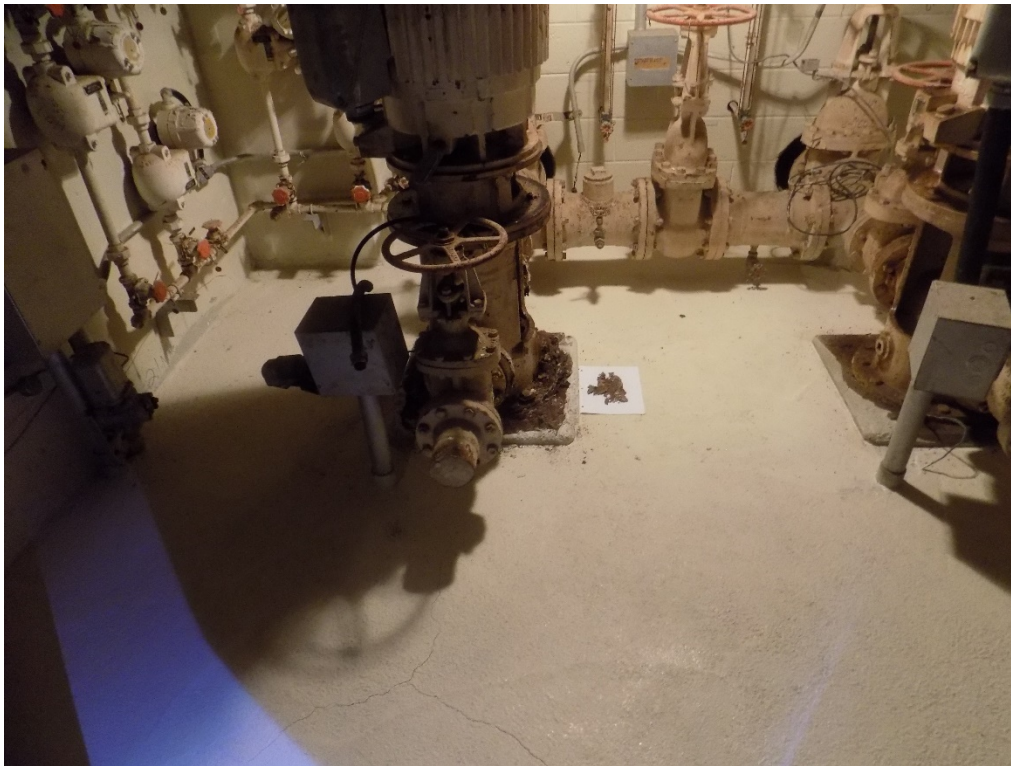
In November 2018, PREPA conducted a radiation survey that discovered removable contamination in the basement, at the base of a condensation pump in the Condensate Pump Room. The contamination consisted of approximately two handfuls of rust debris stained with oil (PL-4 and PL-5). It is believed that the presence of the rust material is somehow connected to the two hurricane storm events of 2017. Inspectors observed that access to the area is being properly controlled. The path forward that was discussed is to (1) leave contamination in place and (2) develop a Radiological Work Plan for the area for those times when the area needs to be accessed for sampling.

*PL-4. Contaminated oil-stained rust at base of condensate pump in basement of containment building*

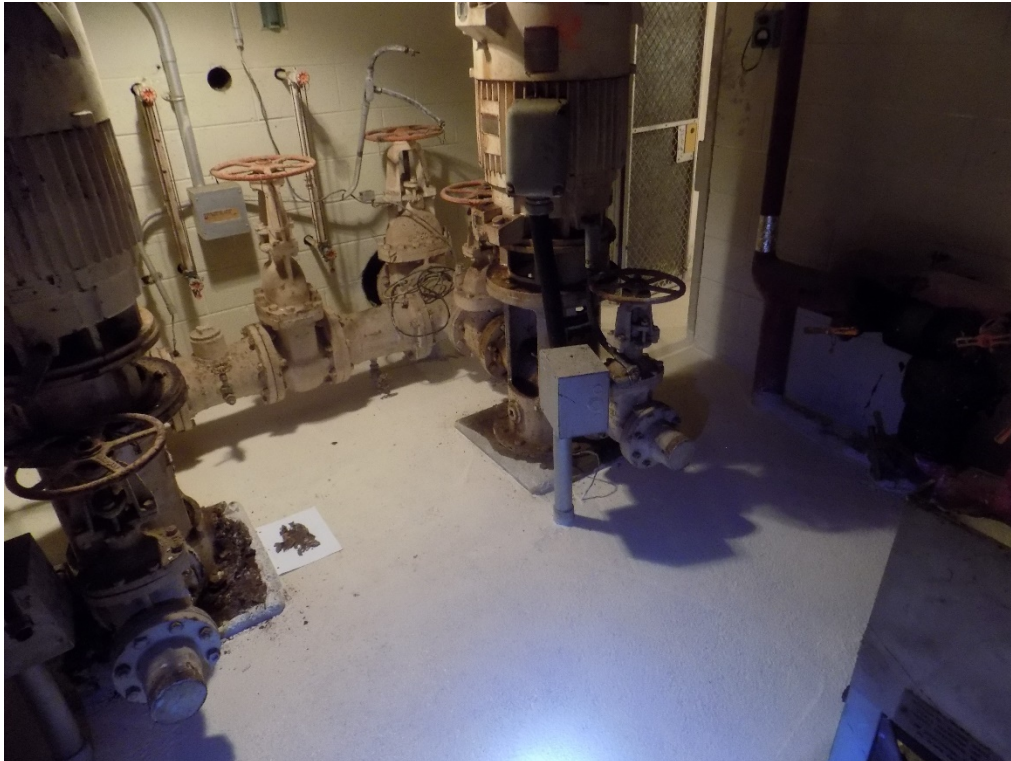
*PL-5. Contaminated oil-stained rust at base of condensate pump in basement of containment building*

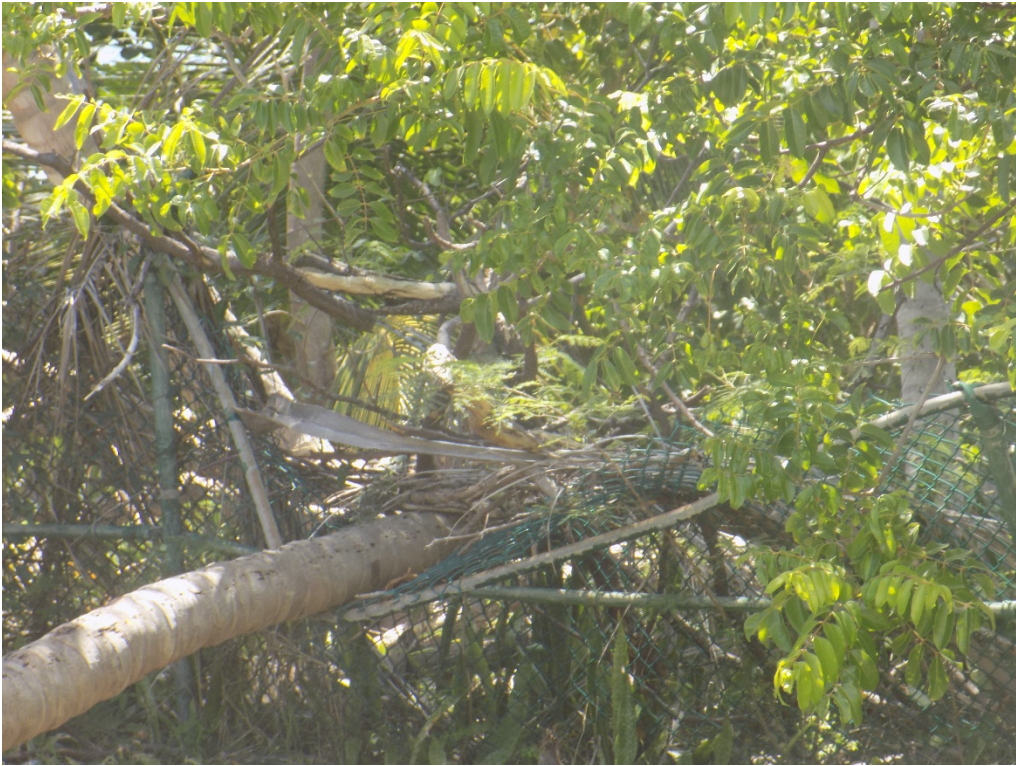
Upon arrival, the security guard was present and the gate was closed and locked. The on-duty security guard allowed the inspection team to enter the grounds. The perimeter security fence was found to be in poor condition. Numerous downed trees resulting from the 2017 hurricanes damaged the fence in several areas (PL-6, PL-7, PL-8). The fence is entirely down in some areas (PL-9). For security purposes, the fence needs to be repaired as soon as possible.

*PL-6. Downed tree on security fence*

Hurricane damage to the perimeter fence and the retaining wall along the beach need to be repaired.

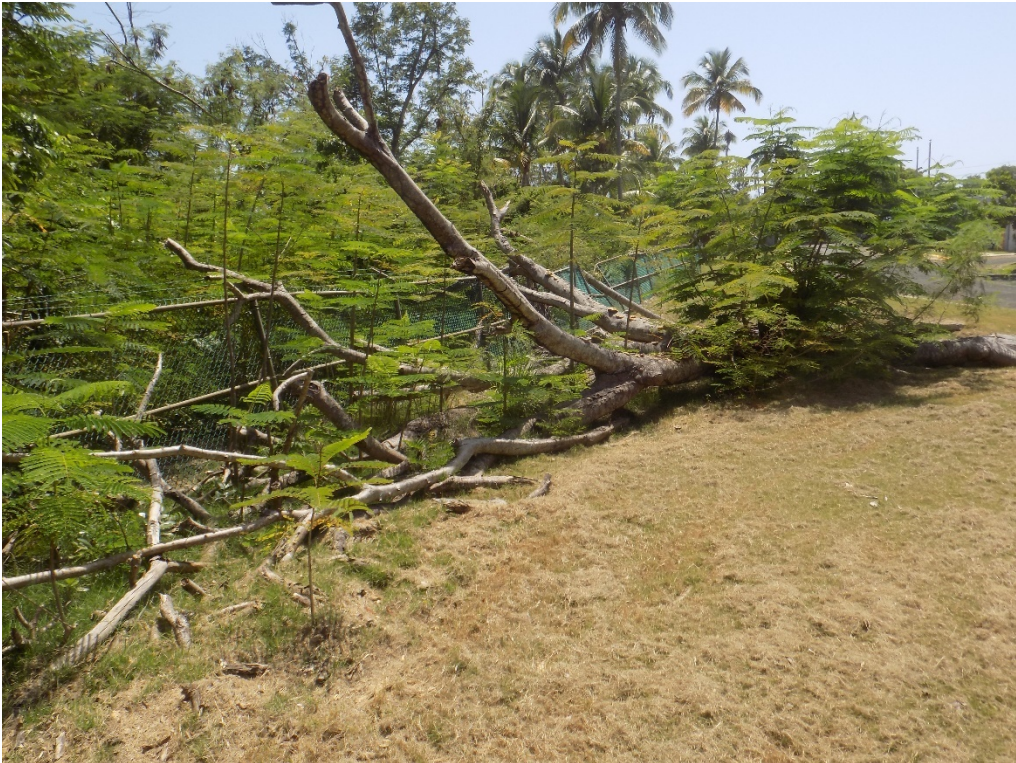
*PL-7. Downed tree on security fence*

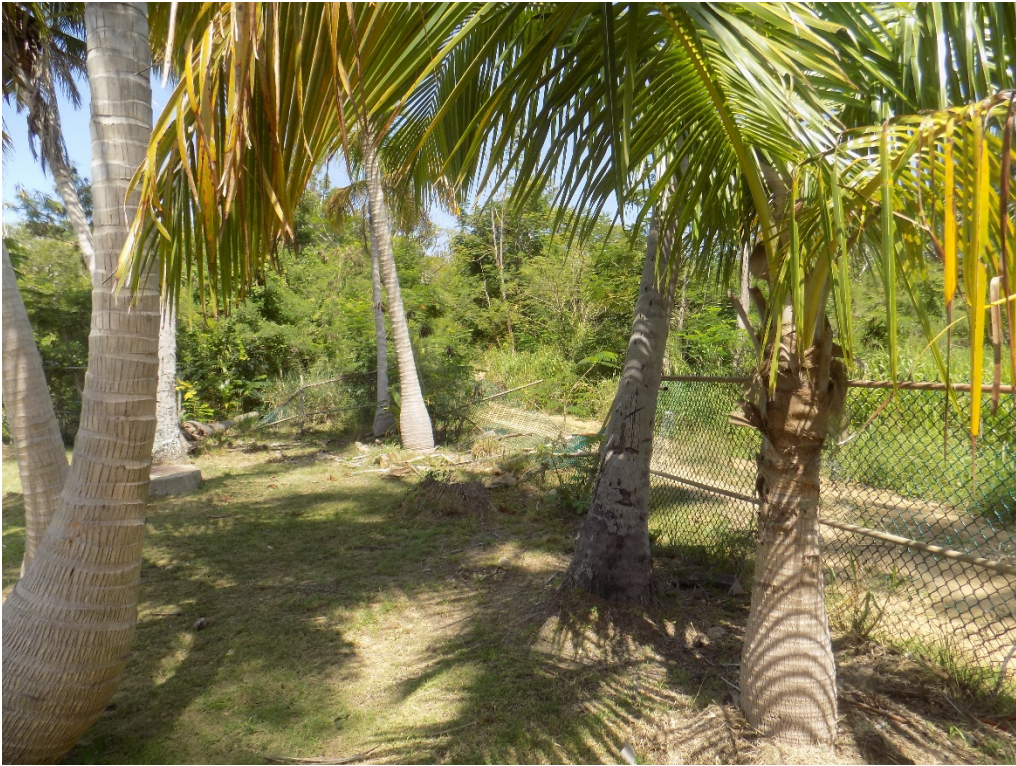
*PL-8. Downed tree on security fence*

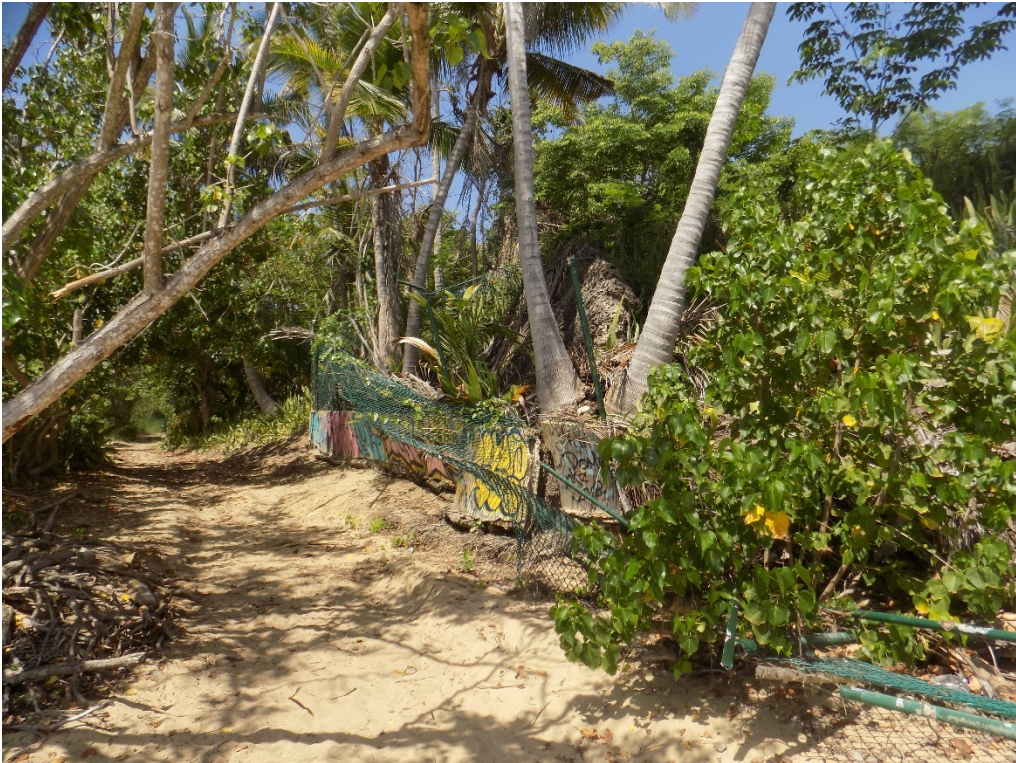
*PL-9. Damaged security fence*

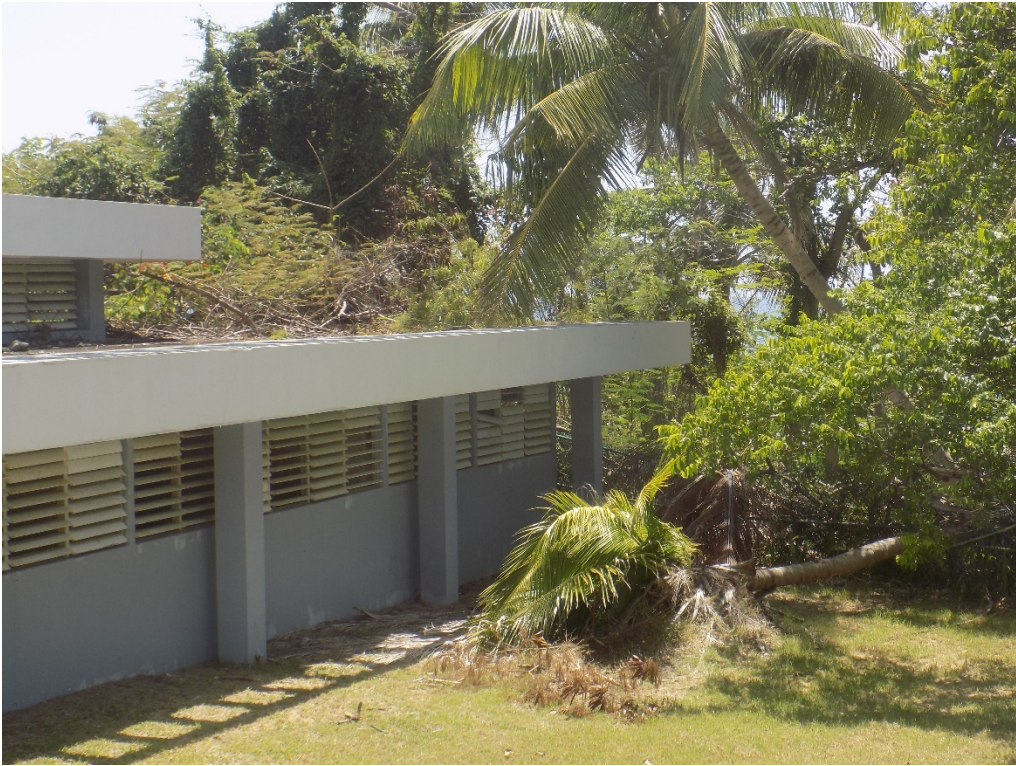
The auditorium was in good condition and was being used by PREPA. It consists of a stage area with seating for approximately 100. The patio area is located just outside of the auditorium. It was in good condition and was also being used by PREPA on an as-needed basis. The training center was not being used. For safety reasons, the inspection team did not go inside the training center. Downed trees were present on the roof of the training center (PL-10).

*PL-10. Downed tree on roof of training center*

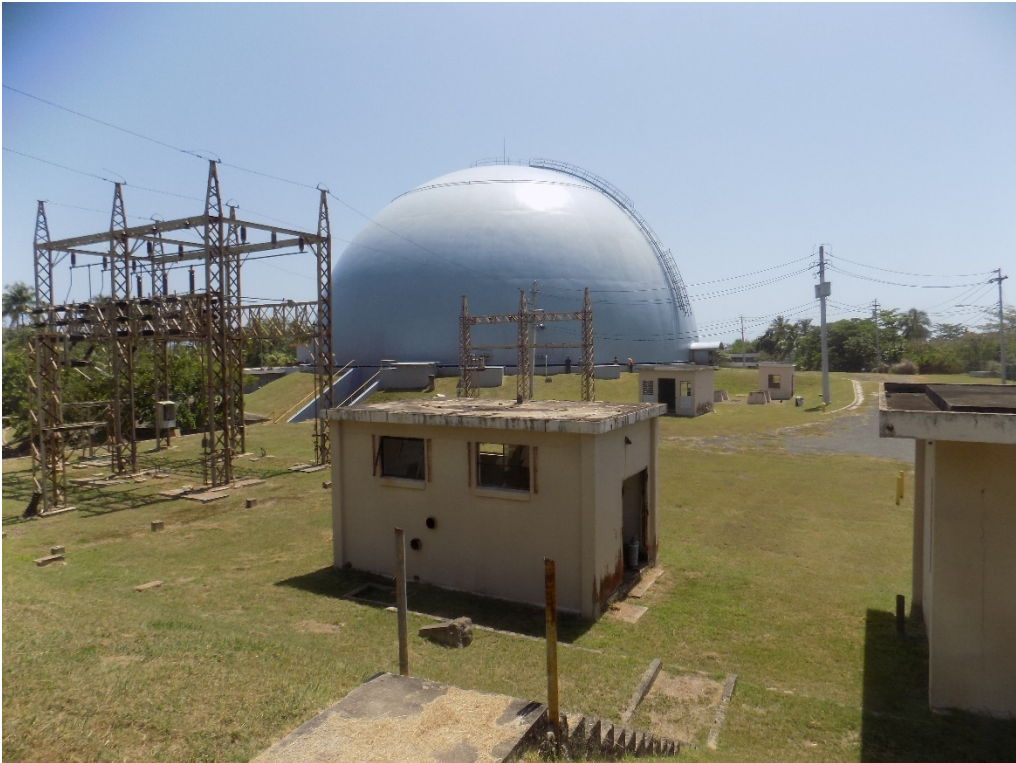
General housekeeping around the site was excellent. Areas between buildings and along the fence line were free of trash. Except for vegetation damage from the 2017 hurricanes, the landscaping was well maintained (PL-11 and PL-12).

*PL-11. Containment dome*

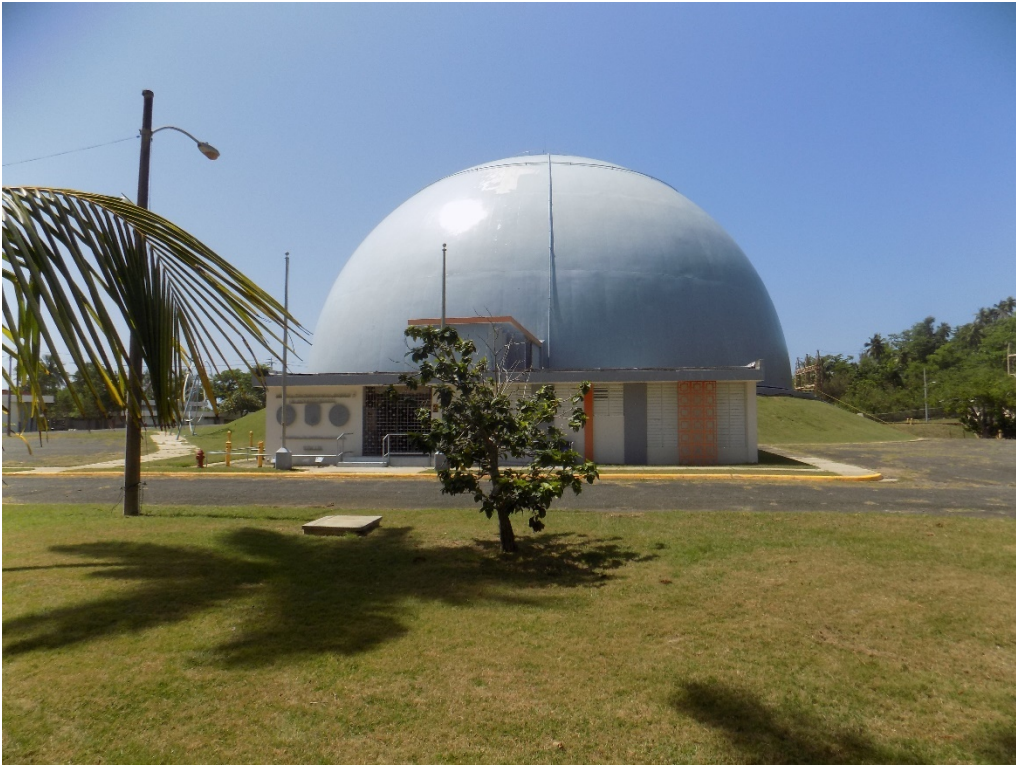
*PL-12. Containment dome*

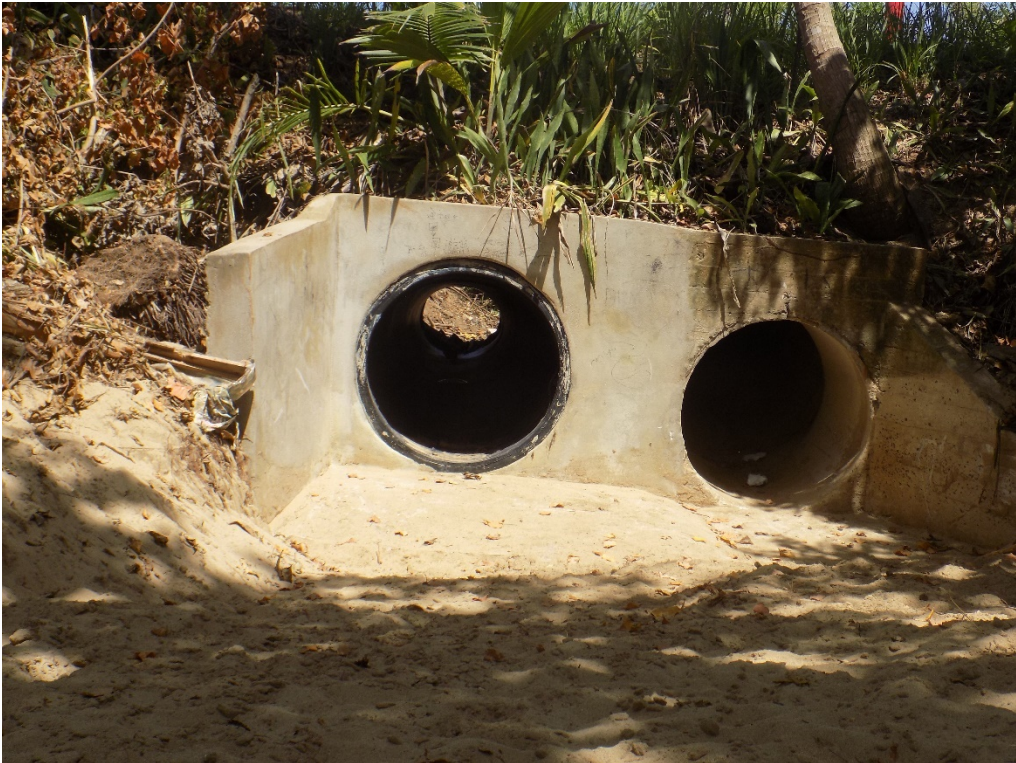
The retaining wall on the west side of the facility, near the beach, was severely damaged by the 2017 hurricanes and was in need of repair. Storm drains leading from the site were found to be clear and free of debris (PL-13).

*PL-13. Drain culverts*
