# **2025 Inspection and Status Report for the Boiling Nuclear Superheater (BONUS) Decommissioned Reactor Site, Rincón, Puerto Rico**

**August 2025**

Legacy  
Management

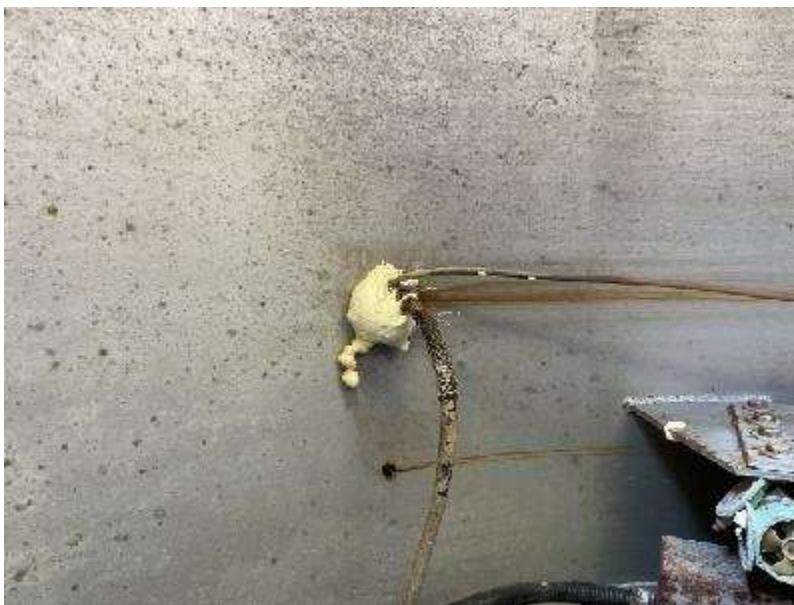
During the 2024 inspection, inspectors observed an opening in the side of Airlock 2 with what appeared to be an electric cord running through it. This opening was found to be properly sealed during this year's inspection (PL-1).

*PL-1. Hole in Airlock 2 Sealed*

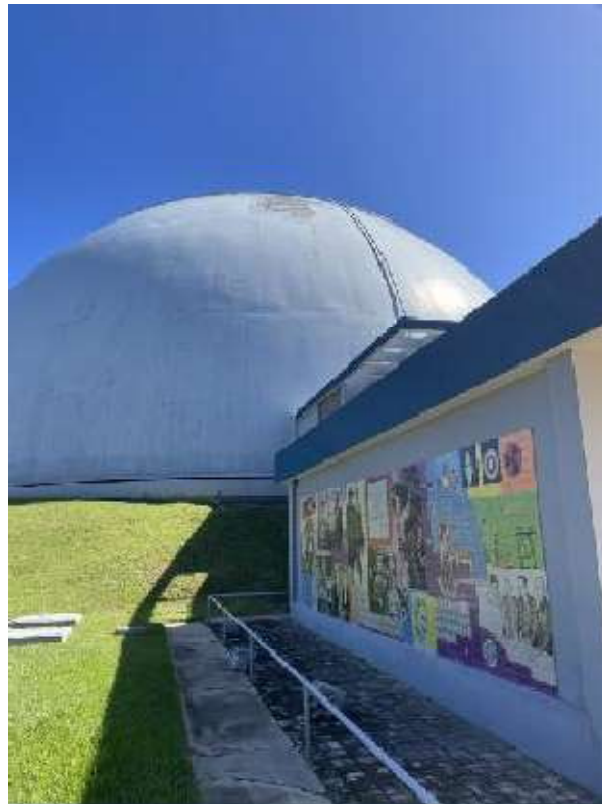
The outer surface of the dome was reconditioned and painted in 2013. Paint in a few areas of the dome was damaged during the 2017 hurricanes and needs to be repainted (PL-2).

*PL-2. Paint on Dome Damaged*

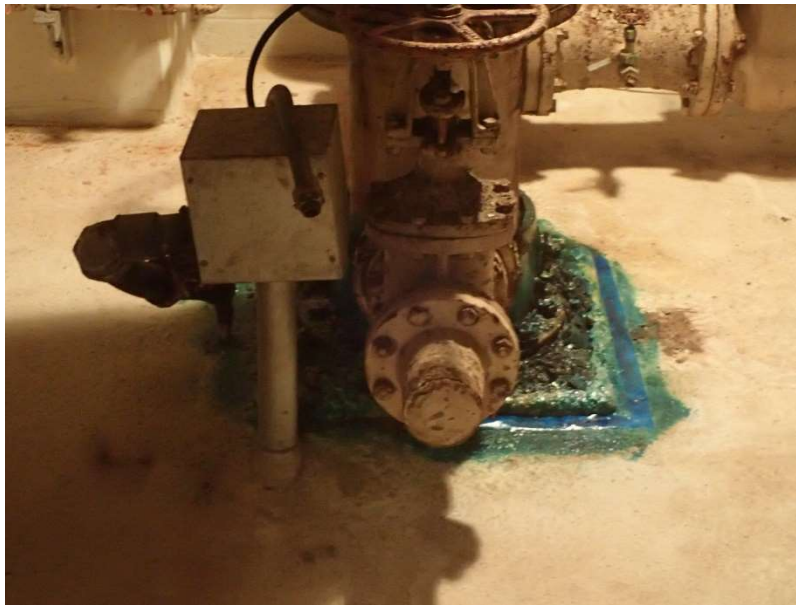
In November 2018, PREPA conducted a radiation survey and discovered removable contamination in the basement at the base of a condensation pump in the Condensate Pump Room. The contamination consisted of approximately two handfuls of rust debris stained with oil. It is believed that the presence of the rust material is likely connected to the two hurricane storm events in 2017. The rust debris has been safely encapsulated (sealed) in an epoxy material, which was observed to be intact and undisturbed (PL-4). No additional debris was observed.

*PL-4. Encapsulated Material*

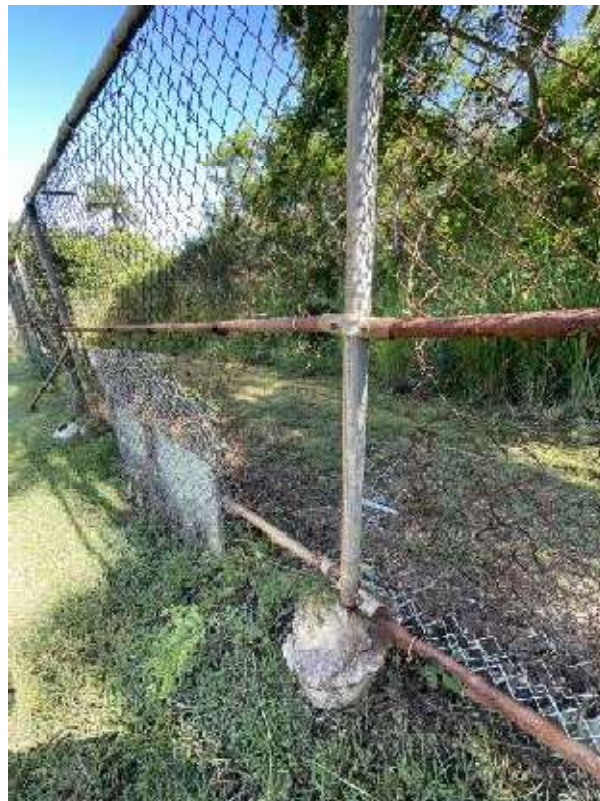
Upon arrival, the security guard was present, and the gate was closed and locked. The on-duty security guard allowed the inspection team to enter the grounds. The perimeter security fence was found to be in poor condition and compromised in several areas as evidenced by recent graffiti found on an outbuilding (PL-5 and PL-6). The top rail of the perimeter fence was bent or damaged in many areas. Barbed wire was missing along most of the fence (PL-7). It is recommended that the fence be further repaired if funding becomes available.

*PL-5. Hole in Fence near Old Zeolite Treatment Plant*

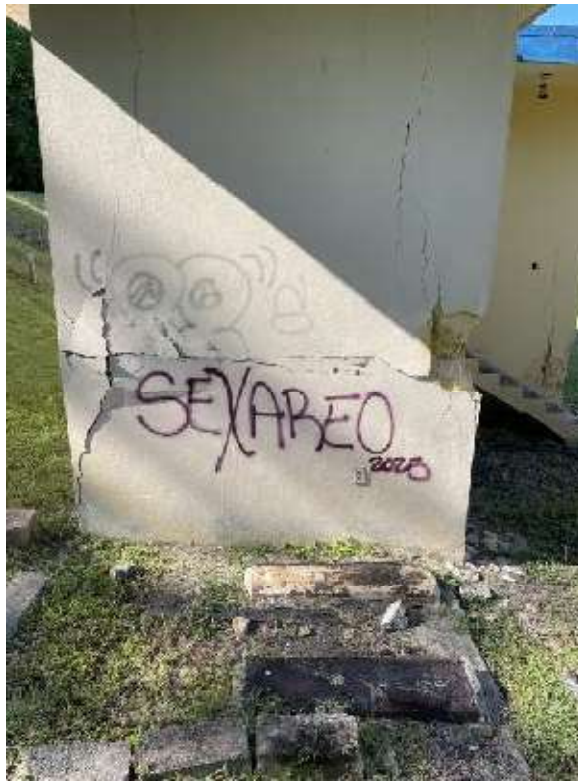
*PL-6. Dated Graffiti on Outside Wall of Old Zeolite Treatment Plant*

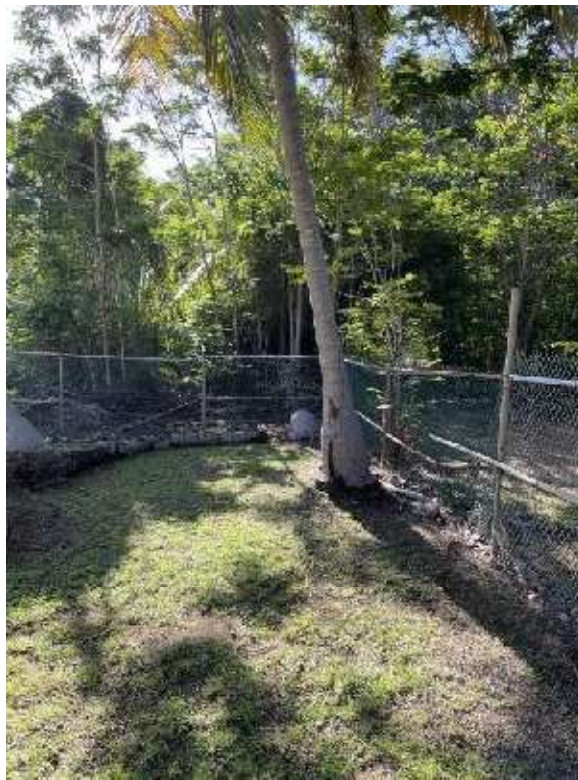
*PL-7. Barbed Wire Missing*

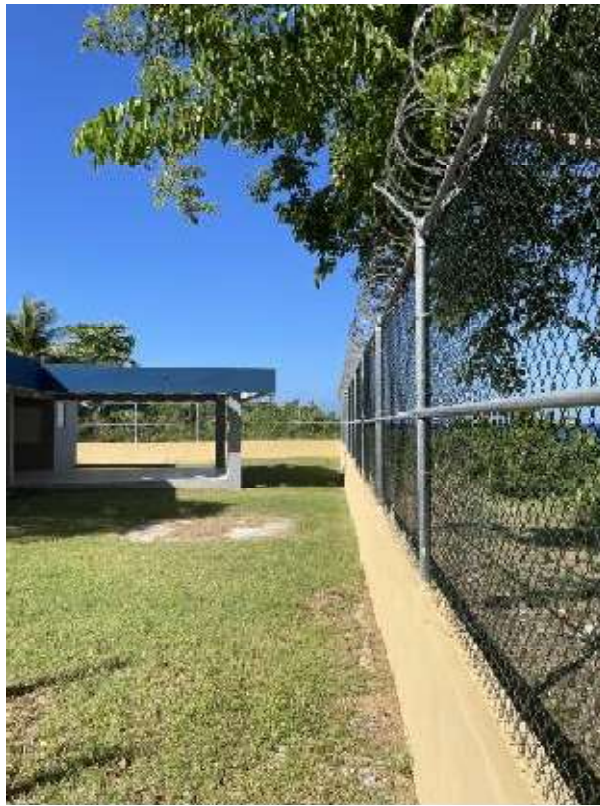
The new retaining wall with security fence atop was installed just west of the support facilities in 2024. It was found to be in great condition (PL-8).

*PL-8. New Retaining Wall and Fence*

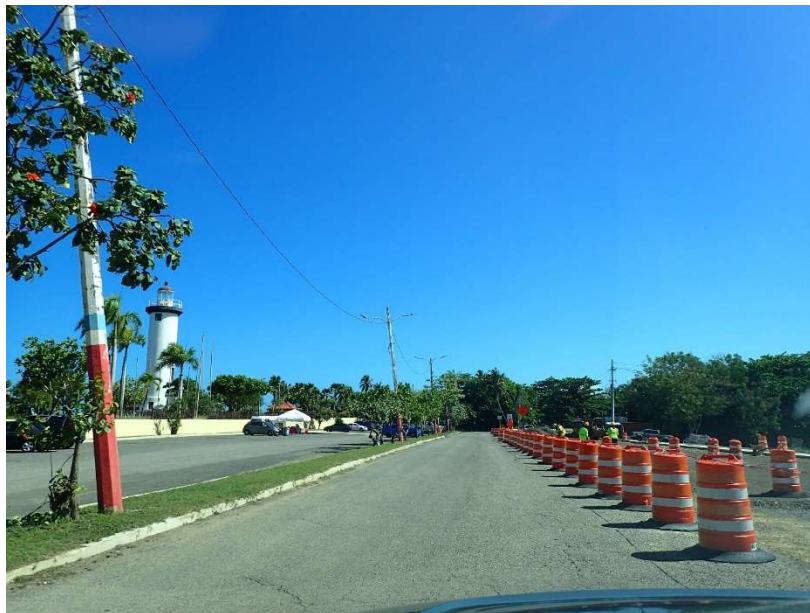
Storm drains leading from the site were found to be clear and free of debris. The beach west of the facility is readily utilized by the public. A construction project was underway to enlarge the parking area next to the lighthouse along the public road leading to the site entrance (PL-9). A demonstration camp was also established on the road leading to the site to protest the construction of a new bike path in the area (PL-10).

*PL-9. Construction in Front of Lighthouse*

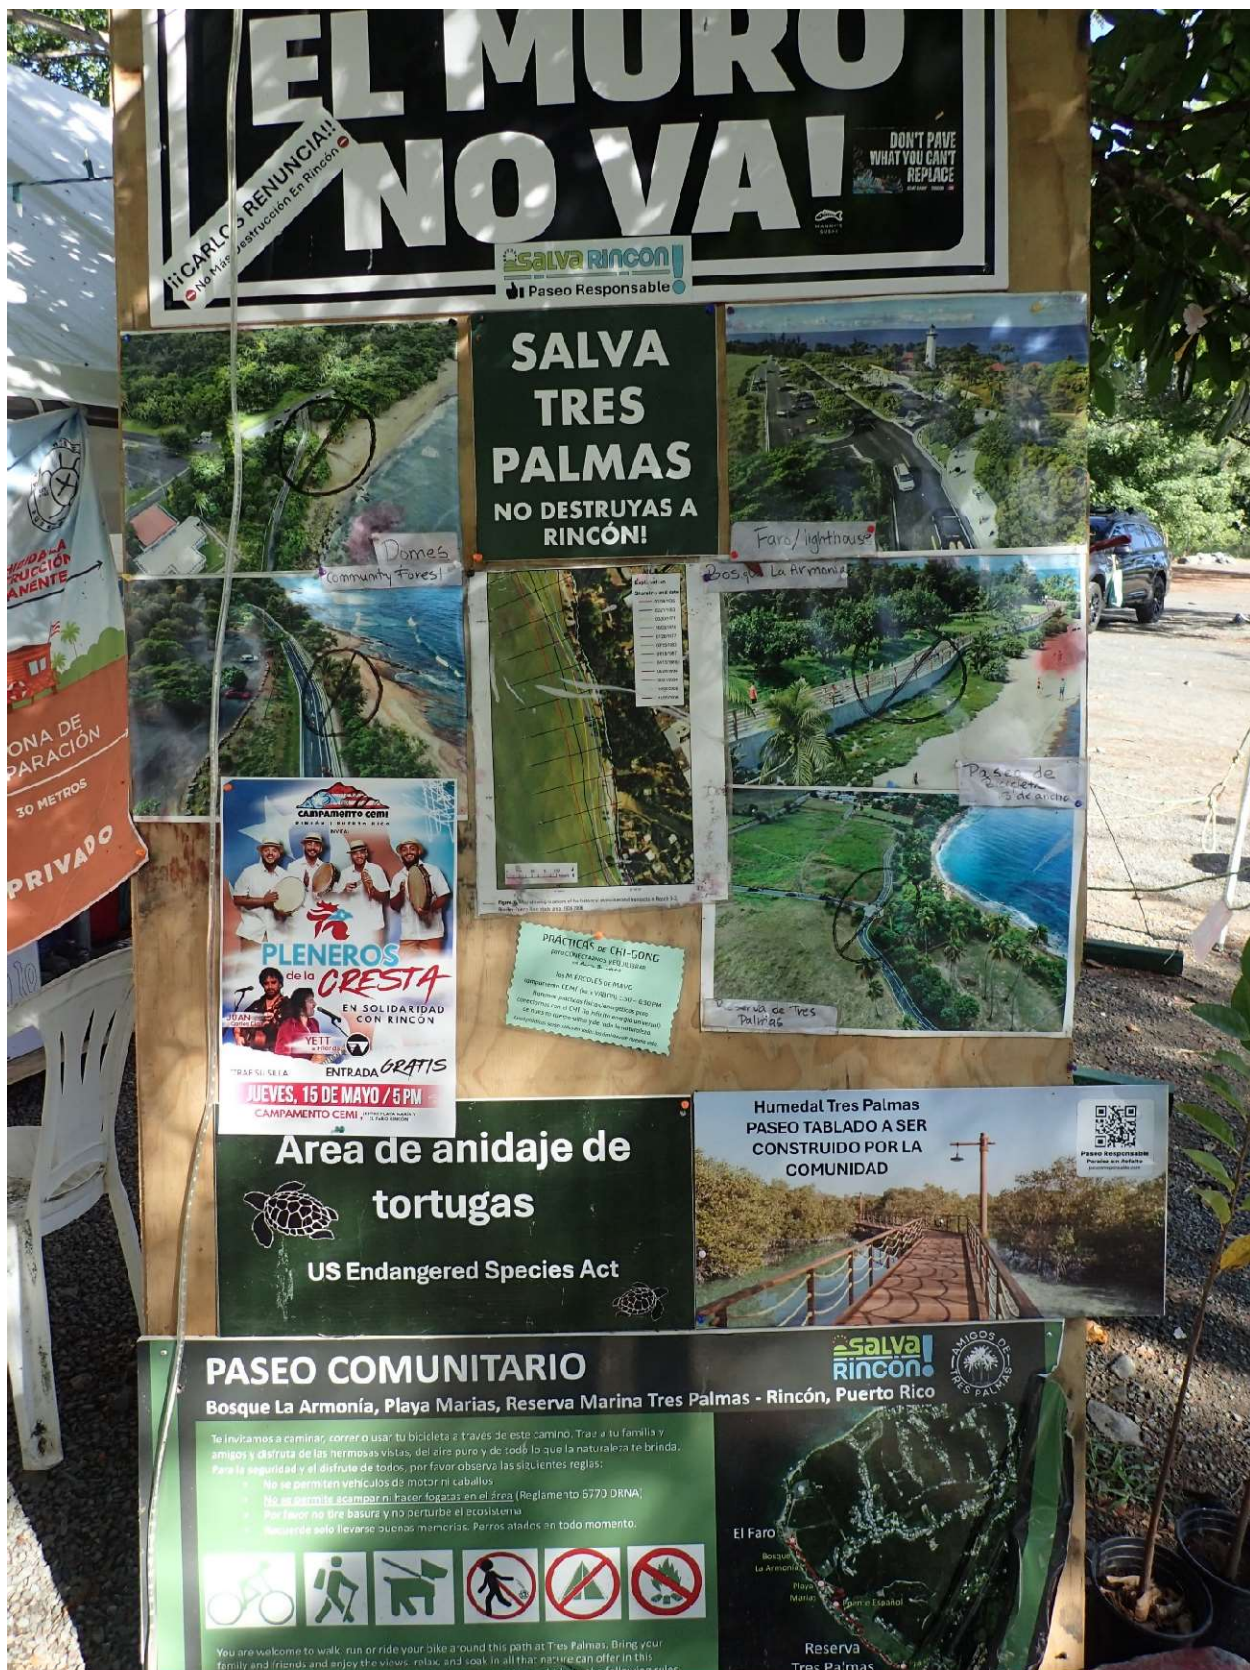
PL-10. Protest Signs
