Postclosure Inspection Report for the Tonopah Test Range and Nevada Test and Training Range, Nevada, Sites for Calendar Year 2025

March 2026

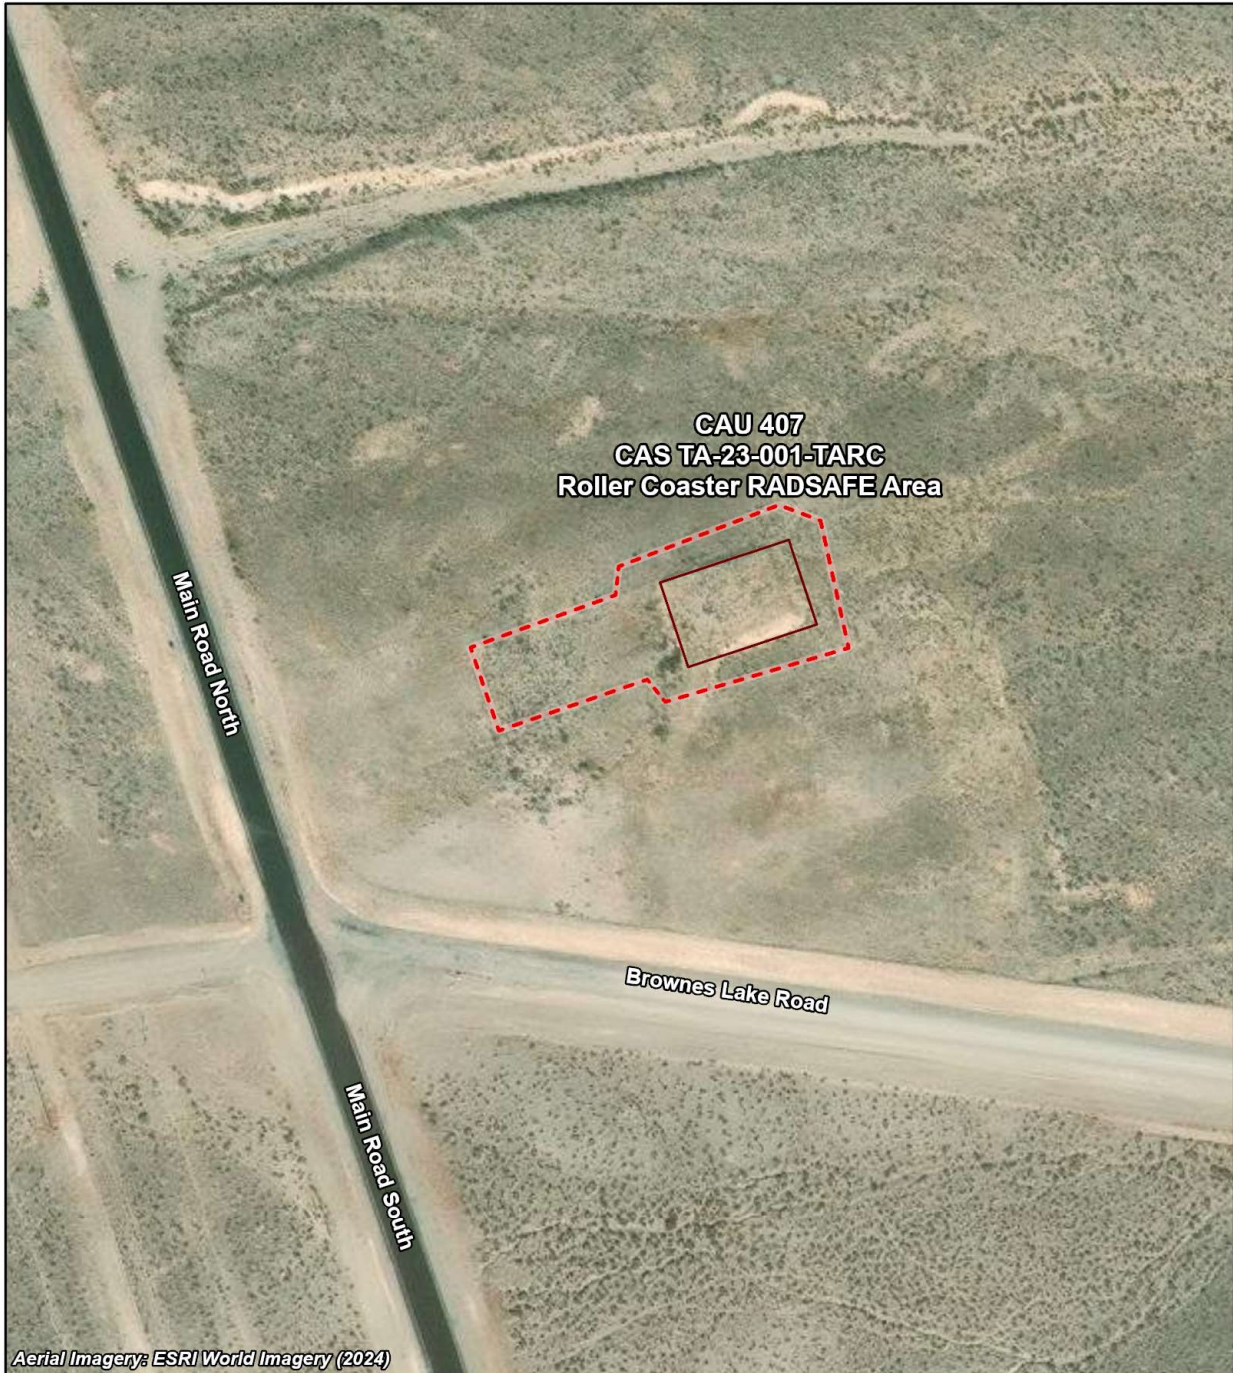
Figure 2. CAU 407, Roller Coaster RadSafe Area

Visual inspections were conducted according to the postclosure requirements for CAU 407, Roller Coaster RadSafe Area (TTR), CAS TA-23-001-TARC: Roller Coaster RadSafe Area, as described in the CAU 407 UR (DOE/EMNV 2019a). The site is shown in Figure 2 in Appendix A. Three sections of fence were broken and required repair. The sections of fence and the three associated signs were hanging down and had to be rehung. These sections were in the southwest, southeast, and east sides of the fence. Signs on the west end of the fence are faded and cracking and are starting to become difficult to read. Several small animal burrows were observed on the cell, but the burrows did not pose an imminent hazard to the integrity of the cell cover at the time of the inspection. No other repair or maintenance needs were observed.

The fence surrounding the CAU is starting to degrade. Numerous posts were loose, the fence strands are losing integrity, and the signs are becoming illegible. The fence and signs need to be replaced in the next few years.

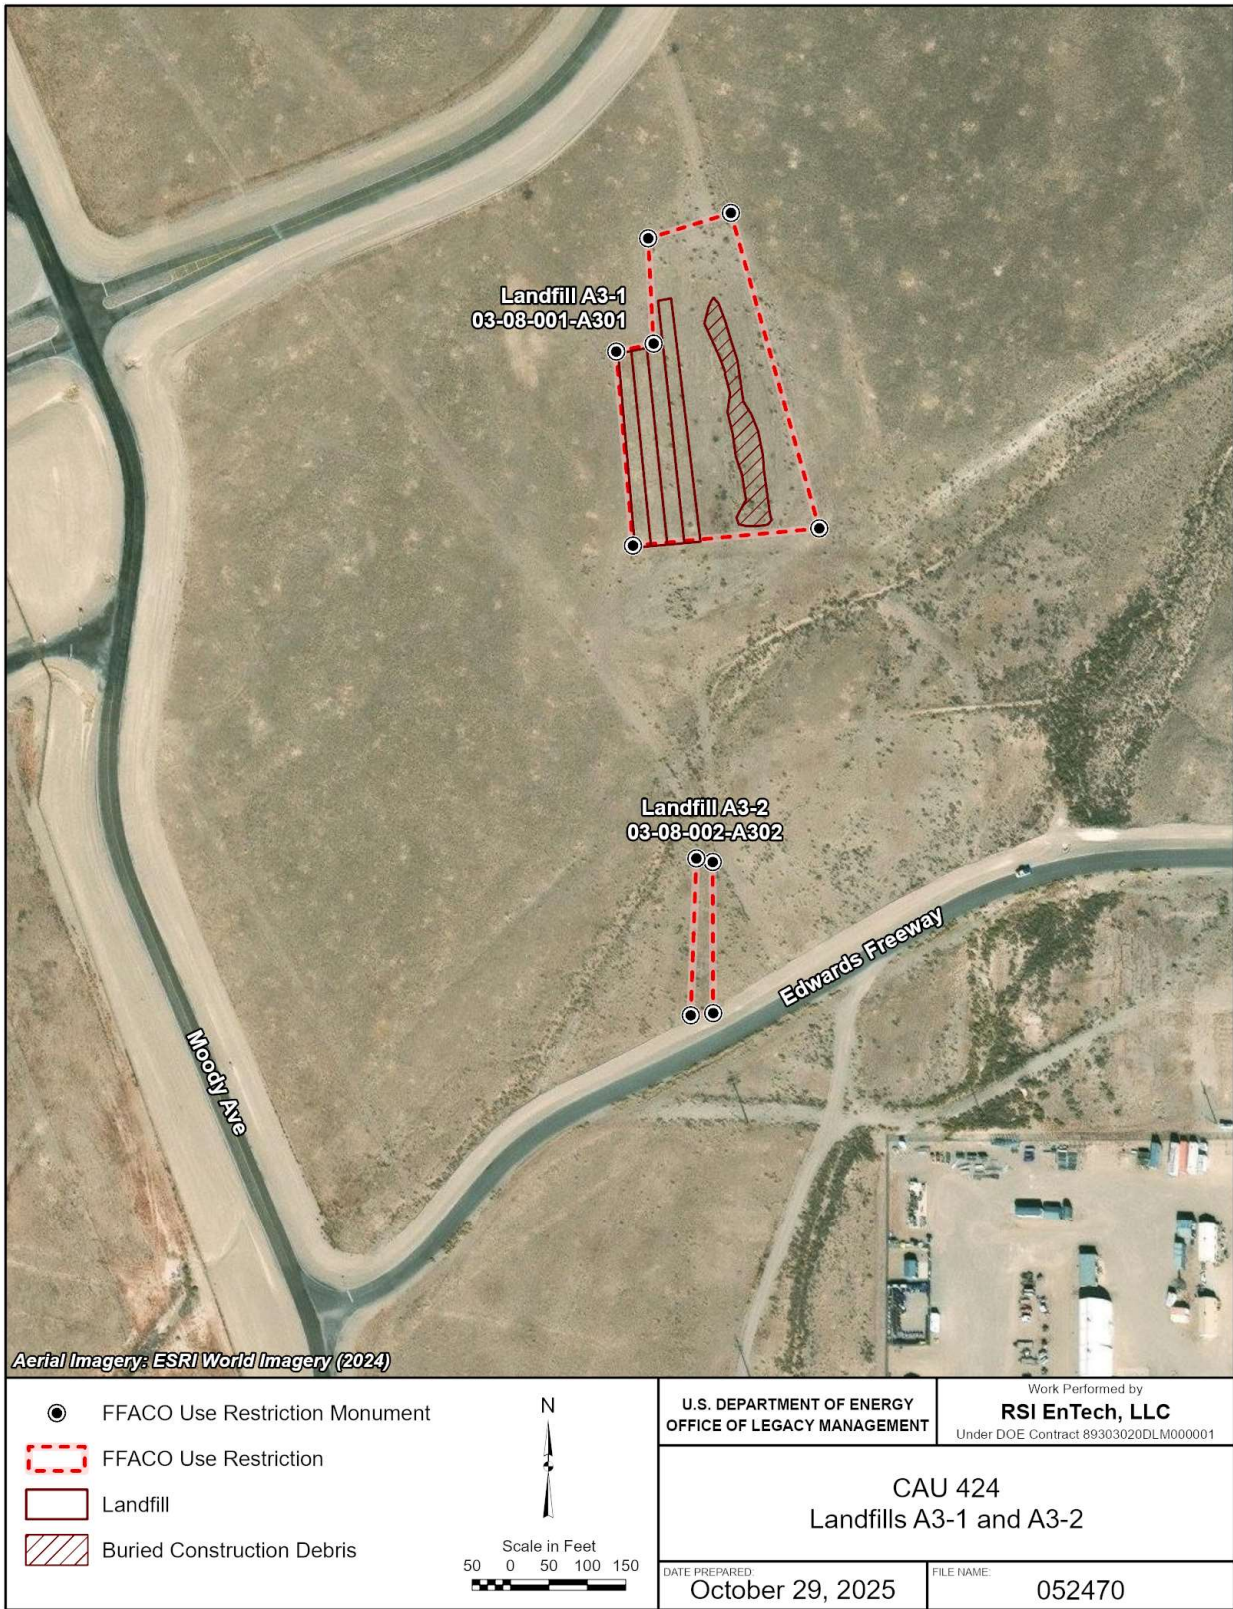
Figure 4. CAU 424, Landfills A3-1 and A3-2

Landfill Cell A3-1 (CAS 03-08-001-A301): All signs, monuments, and survey markers were in good condition. All corner monuments had warning signs. Several small animal burrows were observed on the cell, but the burrows did not pose an imminent hazard to the integrity of the cell cover at the time of the inspection. No repair or maintenance needs were observed. The site is shown in Figure 4 of Appendix A.

Landfill Cell A3-2 (CAS 03-08-002-A302): All signs, monuments, and survey markers were in good condition. All corner monuments had warning signs. Several small animal burrows were observed on the cell, but the burrows did not pose an imminent hazard to the integrity of the cell cover at the time of the inspection. No repair or maintenance needs were observed. The site is shown in Figure 4 of Appendix A.

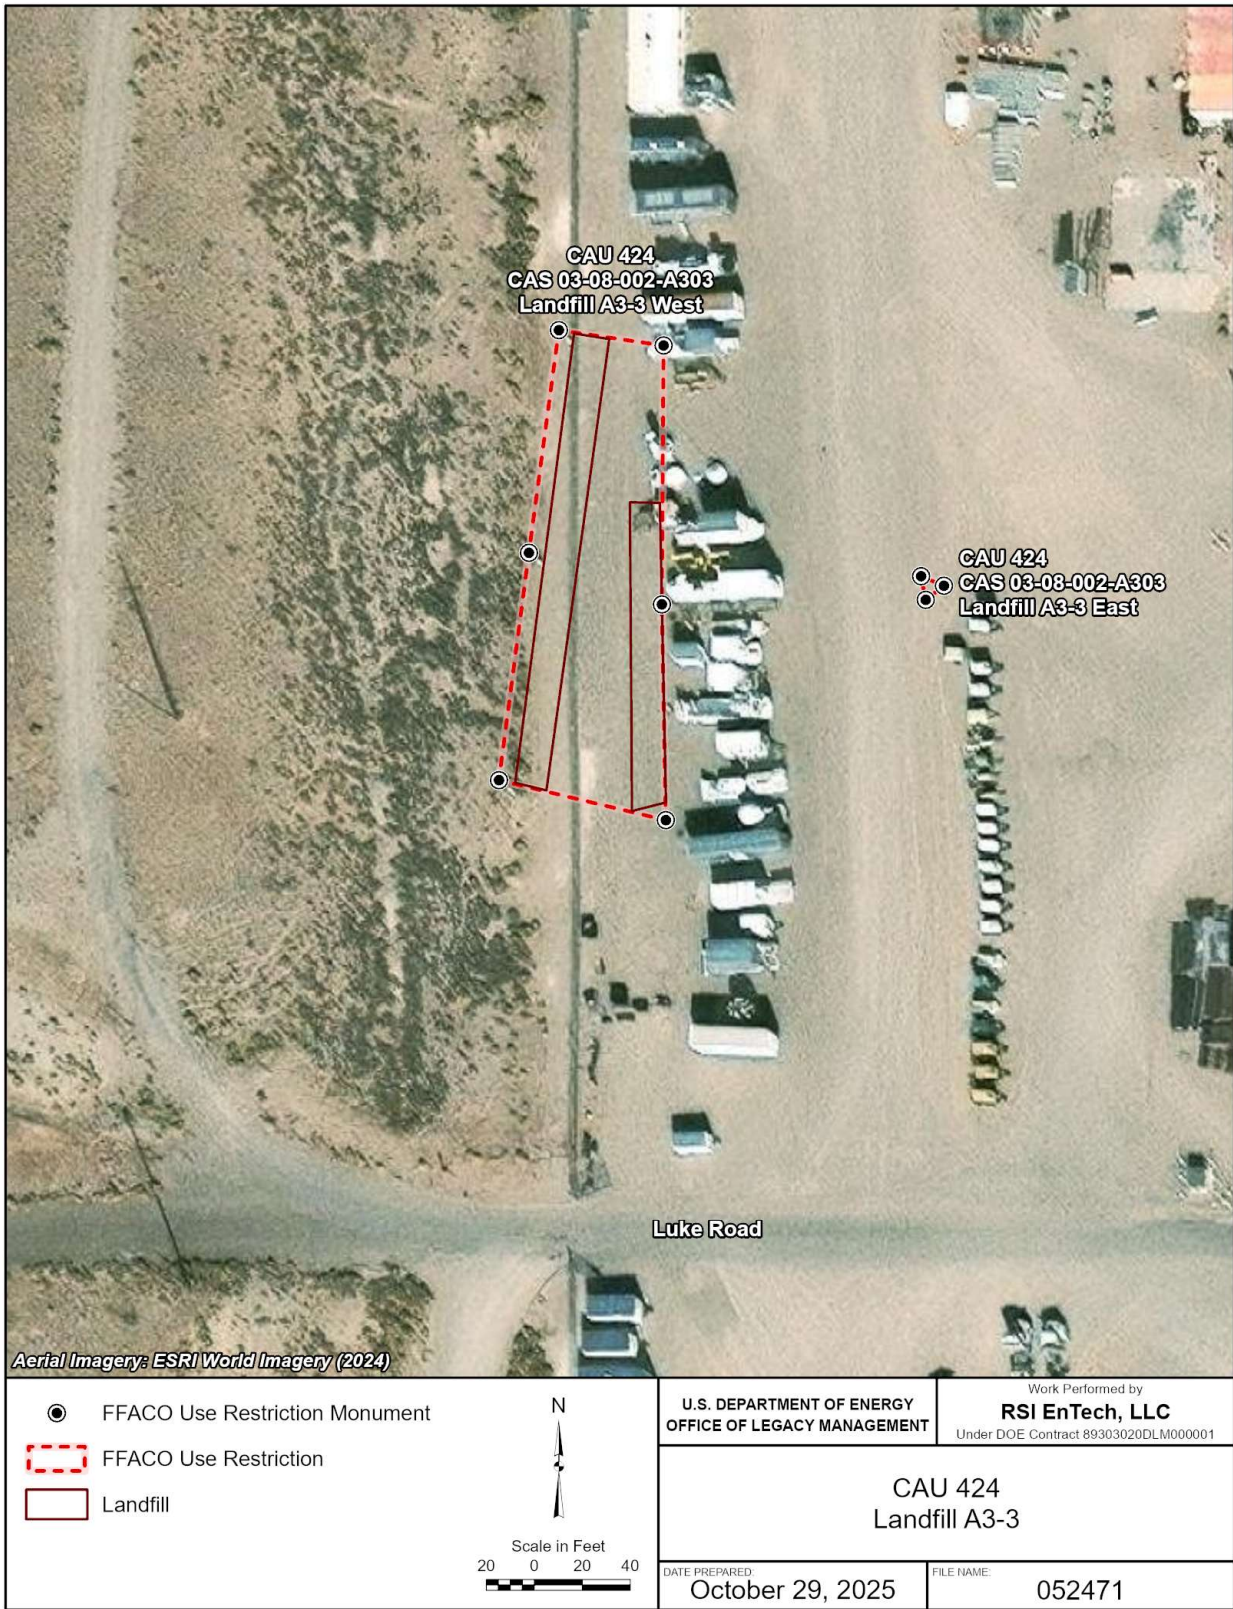
Figure 5. CAU 424, Landfill A3-3

Landfill Cell A3-3 (CAS 03-08-002-A303): All signs, monuments, survey markers (on the monuments), and ground survey markers were in good condition. All monuments had warning signs. The survey marker on the northeast corner of A303 (west) is obstructed by a vehicle tire. The vehicle is parked on top of the survey marker making identification difficult. Survey markers were difficult for the inspection team to find. Inspectors were only able to locate one of the three clustered ground-flush markers. The eastern and southern markers were not identified. Although the other two markers were unable to be found, it was obvious that the CAS had not been penetrated and was still functional and protective. The markers were buried under 6 inches of soil. No repair or maintenance needs were observed. The site is shown in Figure 5 of Appendix A.

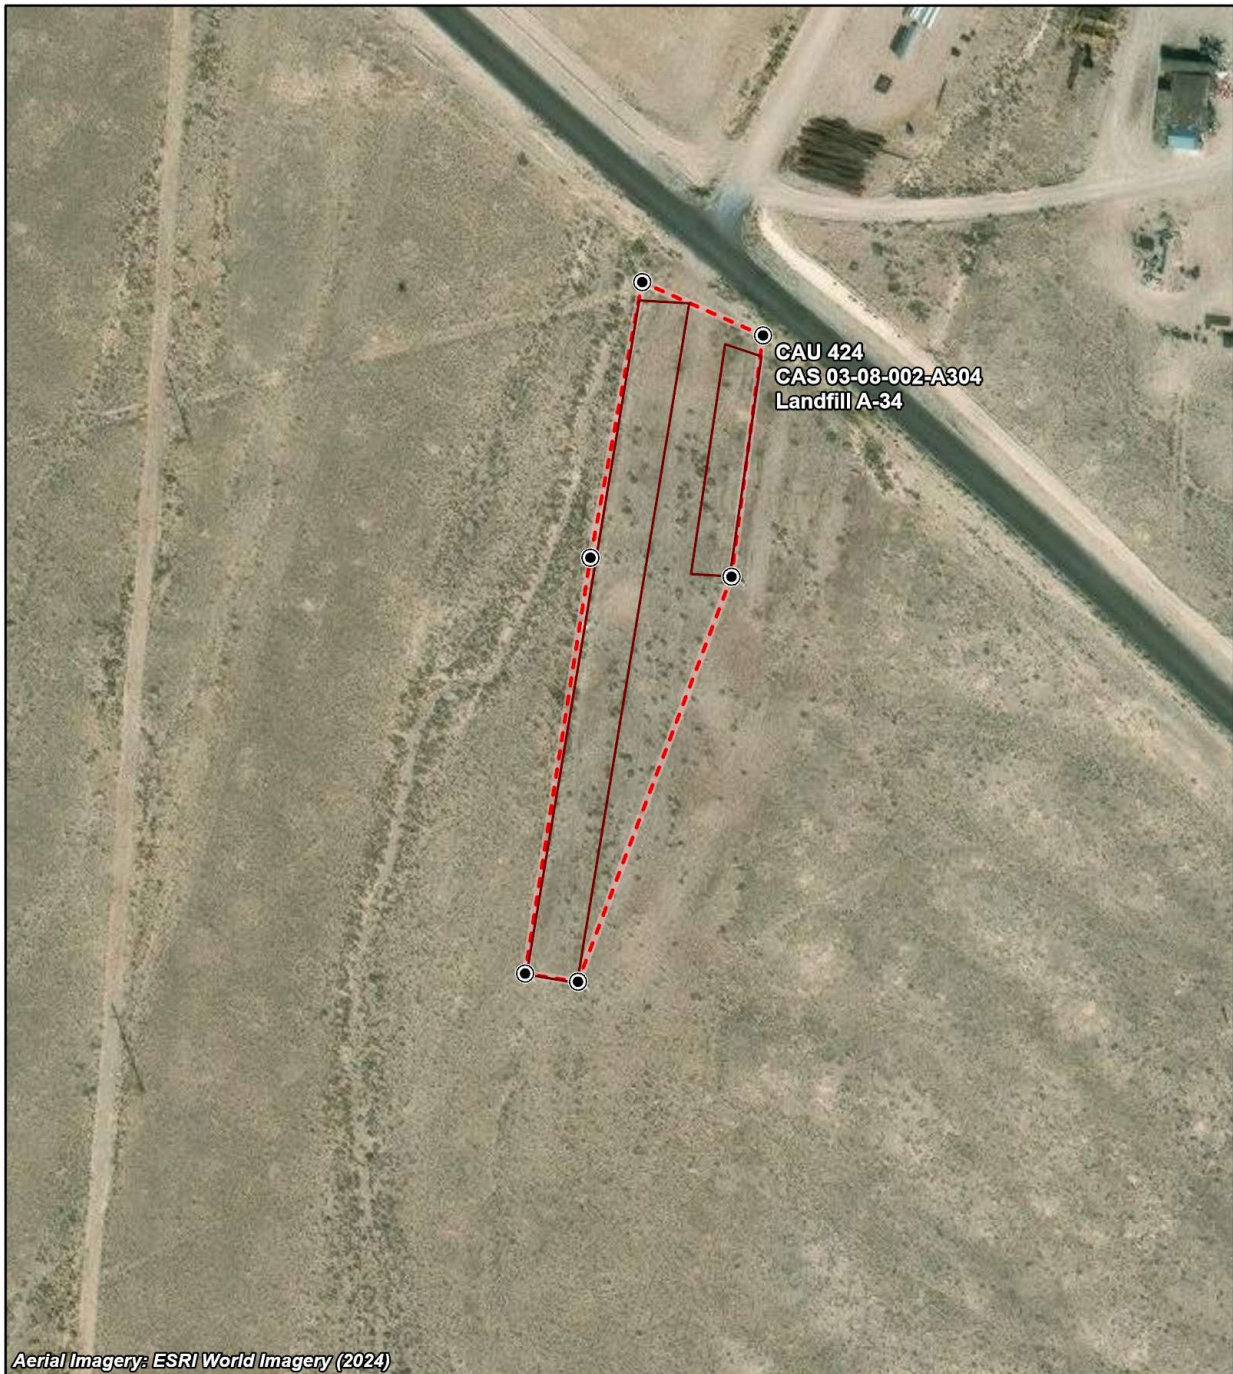
Figure 6. CAU 424, Landfill A3-4

Landfill Cell A3-4 (CAS 03-08-002-A304): All signs, monuments, and survey markers were in good condition. All monuments had warning signs. The large 7 × 7-foot area of densely packed animal burrows and additional 8-inch-diameter burrow, both identified in previous inspections, were monitored during the inspection, and no substantial changes were noted. The southwest monument has several animal burrows around the base. The burrows did not pose an imminent hazard to the integrity of the cell cover at the time of inspection. The western monument is deteriorating and has rebar exposed through the concrete. No repair or maintenance needs were observed. The site is shown in Figure 6 of Appendix A.

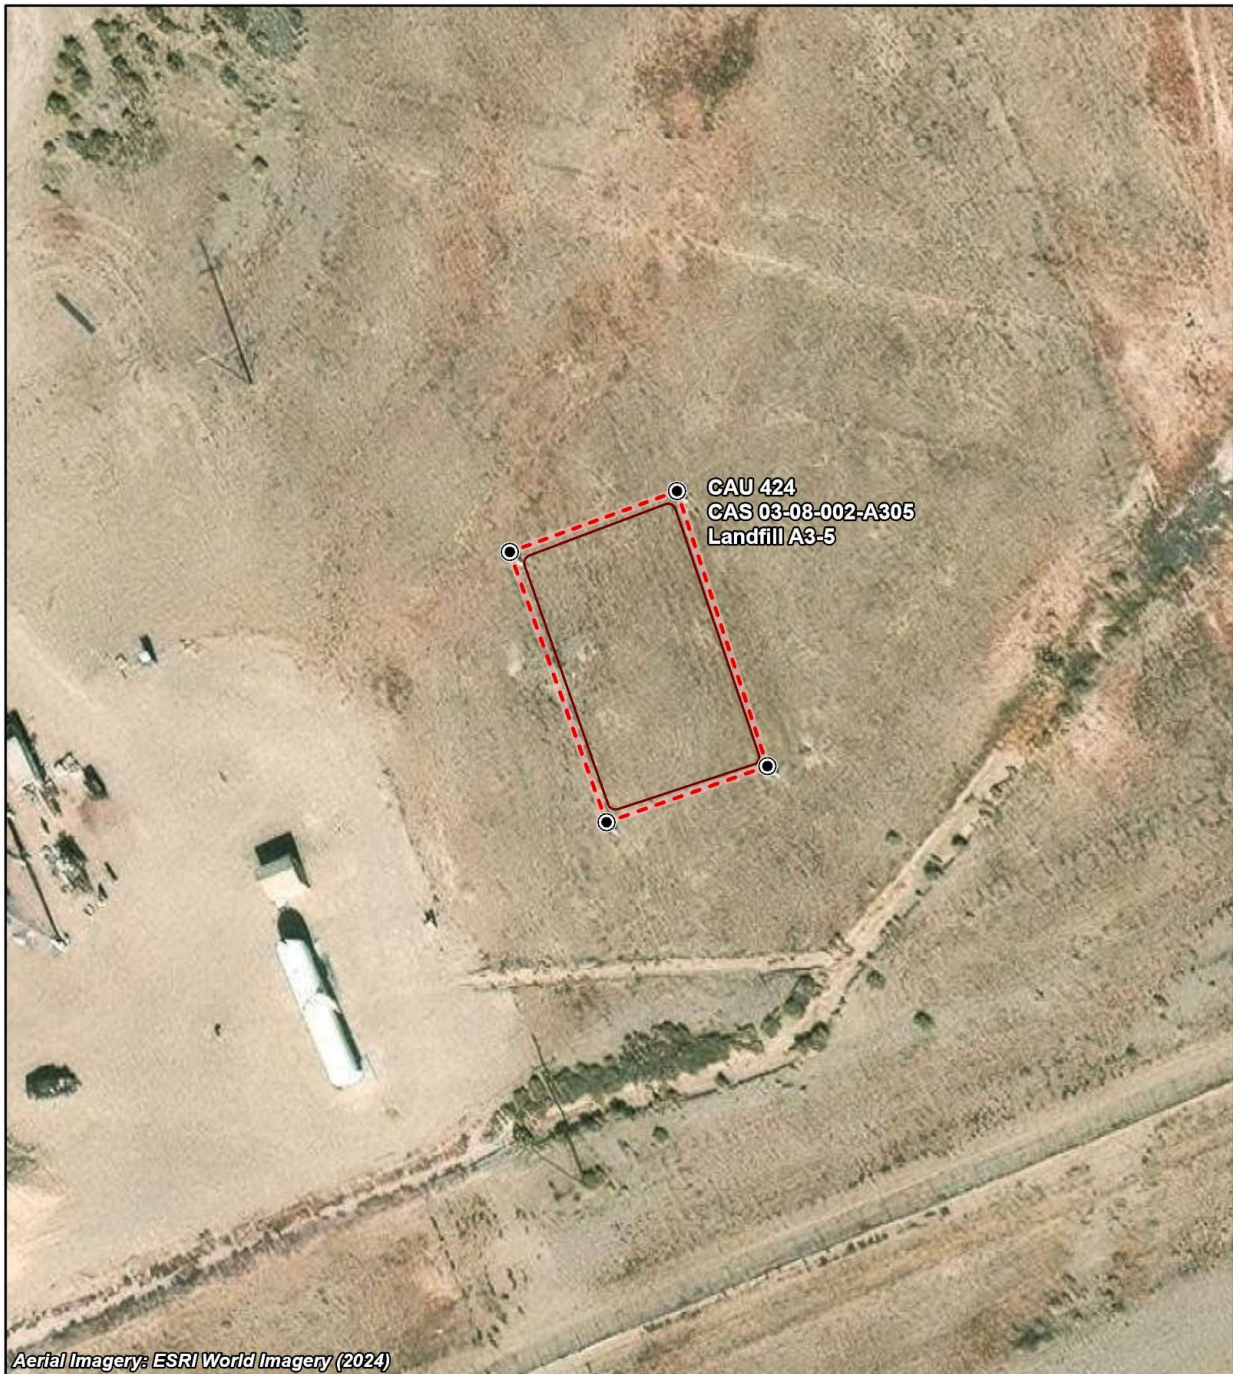
Figure 7. CAU 424, Landfill A3-5

Landfill Cell A3-5 (CAS 03-08-002-A305): All signs, monuments, and survey markers were in good condition. All monuments had warning signs. All four monuments have small animal burrows and minor erosion around the base. The northeast corner monument has signs of water erosion around the base. No repair or maintenance needs were observed. There was no evidence of unauthorized use like that discovered in the previous year's inspection. The site is shown in Figure 7 of Appendix A.

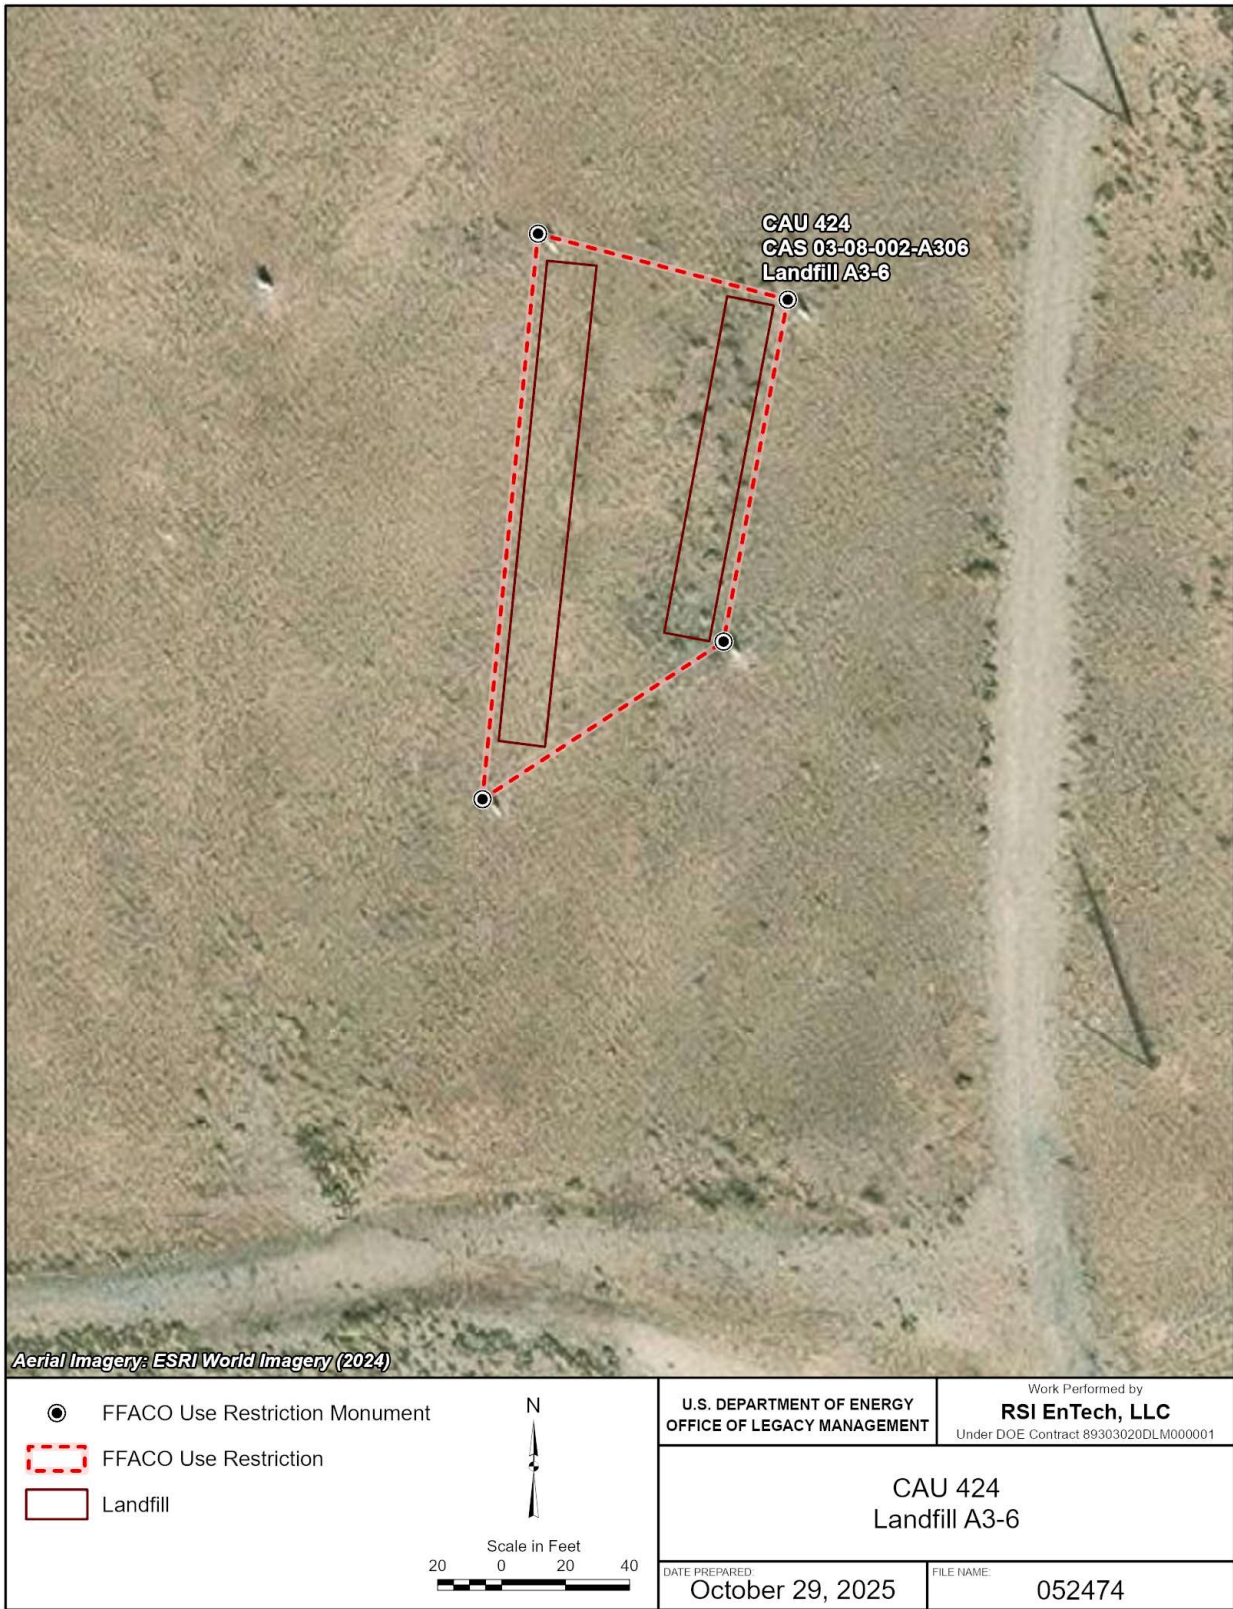
Figure 8. CAU 424, Landfill A3-6

Landfill Cell A3-6 (CAS 03-08-002-A306): All signs, monuments, and survey markers were in good condition. All monuments had warning signs. Several small animal burrows were observed on the cell. Metal debris was observed on the surface, along with a small sign denoting its presence on the cell. No repair or maintenance needs were observed. The site is shown in Figure 8 of Appendix A.

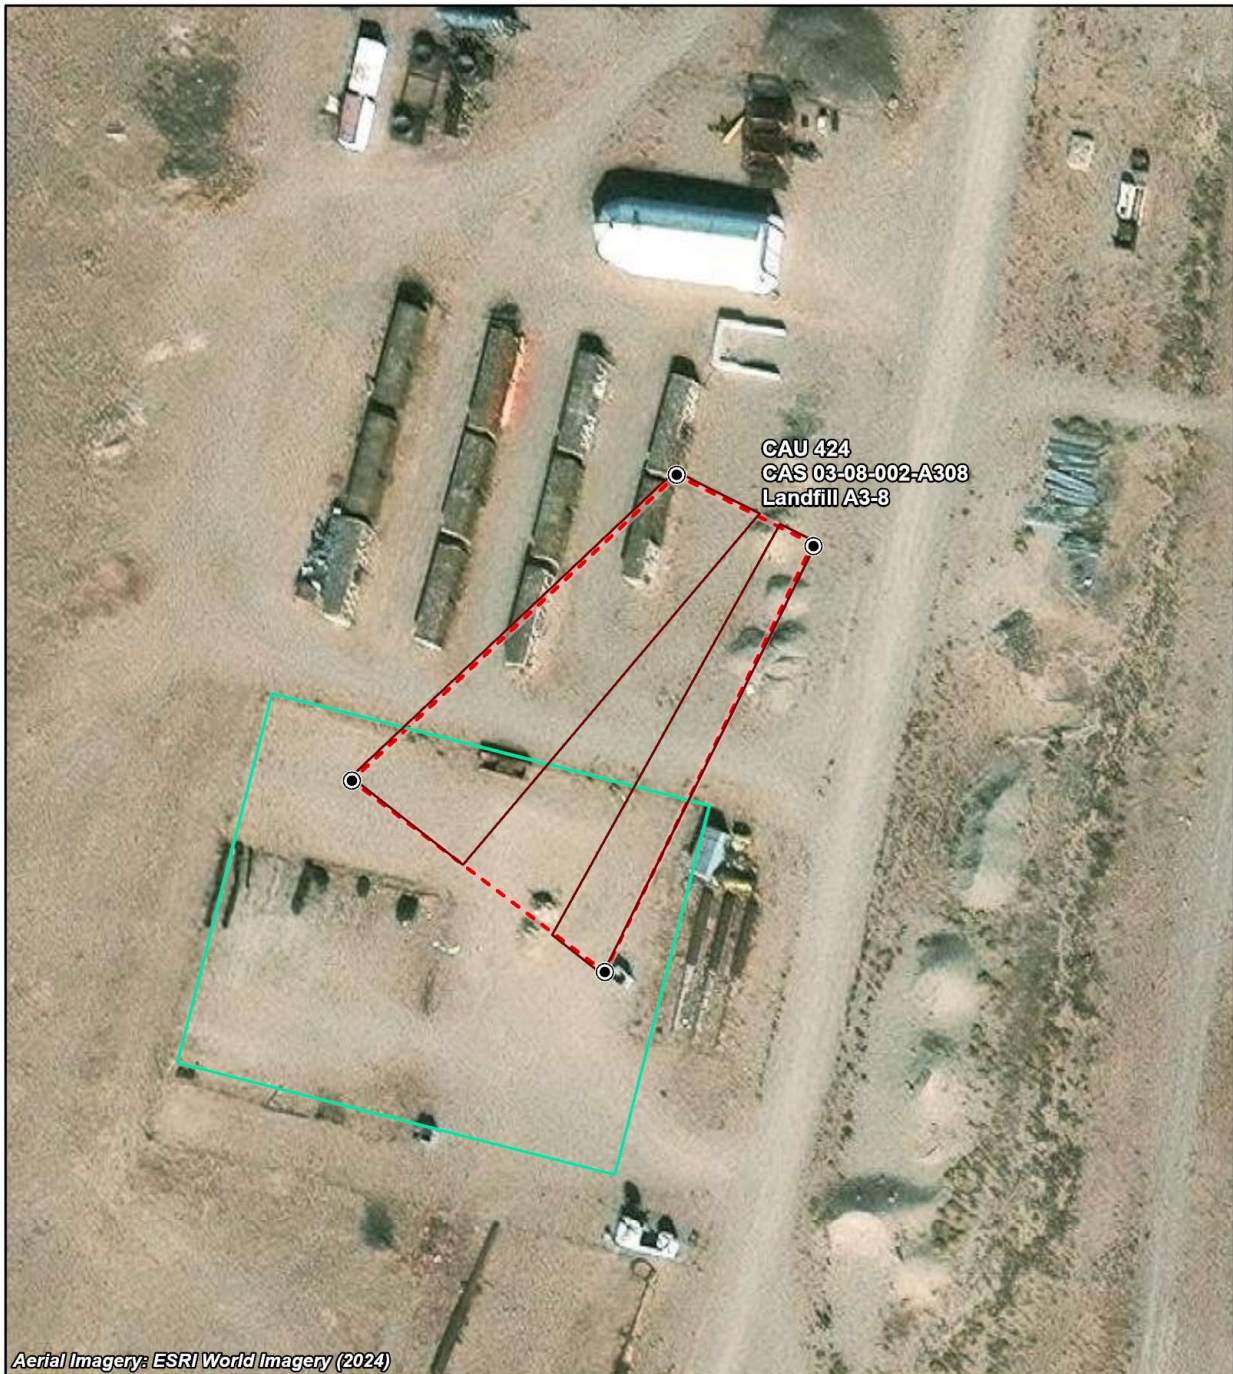
Figure 9. CAU 424, Landfill A3-8

Landfill Cell A3-8 (CAS 03-08-002-A308): All ground survey monuments and markers were in good condition. There is a dumpster directly adjacent to one of the ground-flush markers inside the fence. The marker is currently visible but has the potential to be covered in future inspections. No repair or maintenance needs were observed. The site is shown in Figure 9 of Appendix A.

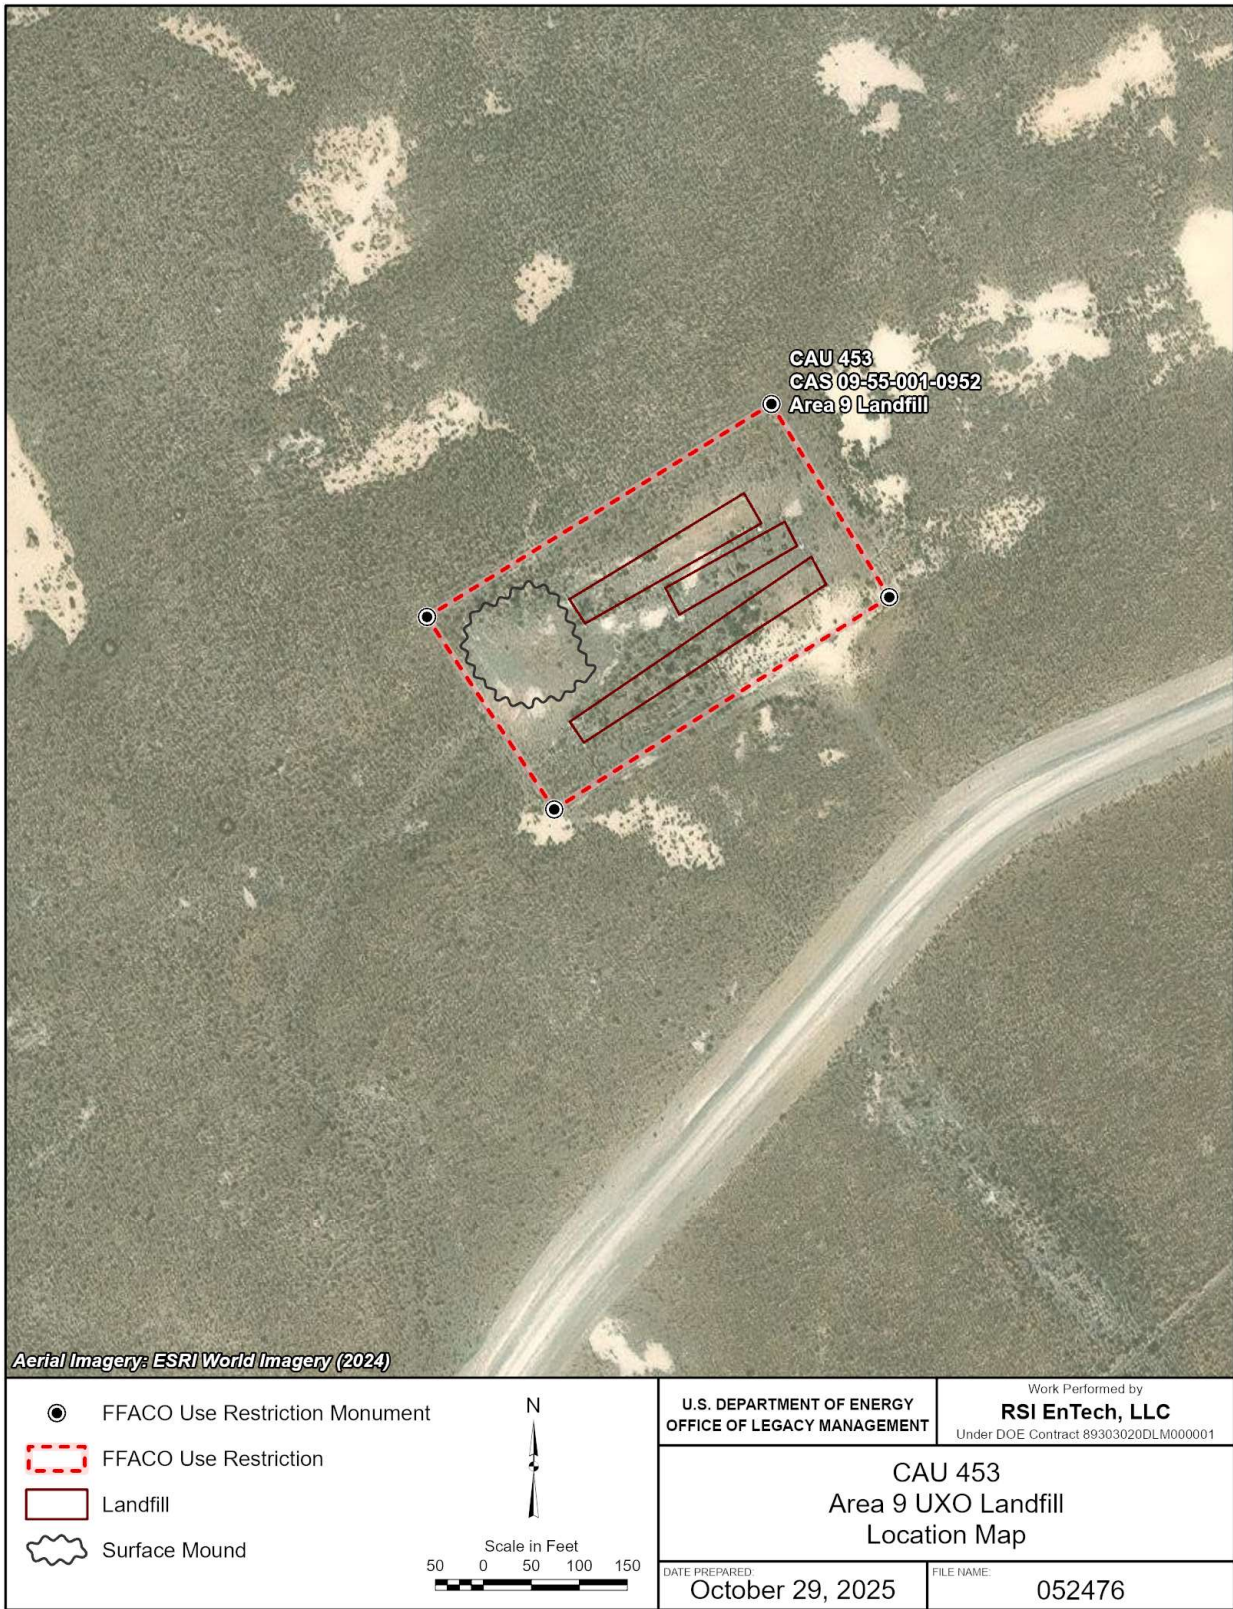
Figure 10. CAU 453, Area 9 UXO Landfill

Visual inspections were conducted according to the postclosure requirements for CAU 453, Area 9 UXO Landfill (TTR), CAS 09-55-001-0952: Area 9 Landfill, as described in the CAU 453 UR (DOE/EMNV 2019c). The site is shown in Figure 10 of Appendix A. The inspection was conducted on April 23, 2025. All signs and monuments were in good condition. The perimeter fence was in good condition. UR signs were attached to the fence and legible. Minor rills were observed by the western end of the cell. Rills were filled in with dirt. During the time of inspection, the erosion did not present an imminent hazard to the cell cover. No other repair or maintenance needs were observed.

During the inspection, the lock installed during the previous inspection event would not open. It is possible that dirt in the ingress or rust froze the lock. LM will work with Sandia National Laboratories to daisy chain the lock for future access. No other recommendations are proposed at CAS 09-55-001-0952: Area 9 Landfill.

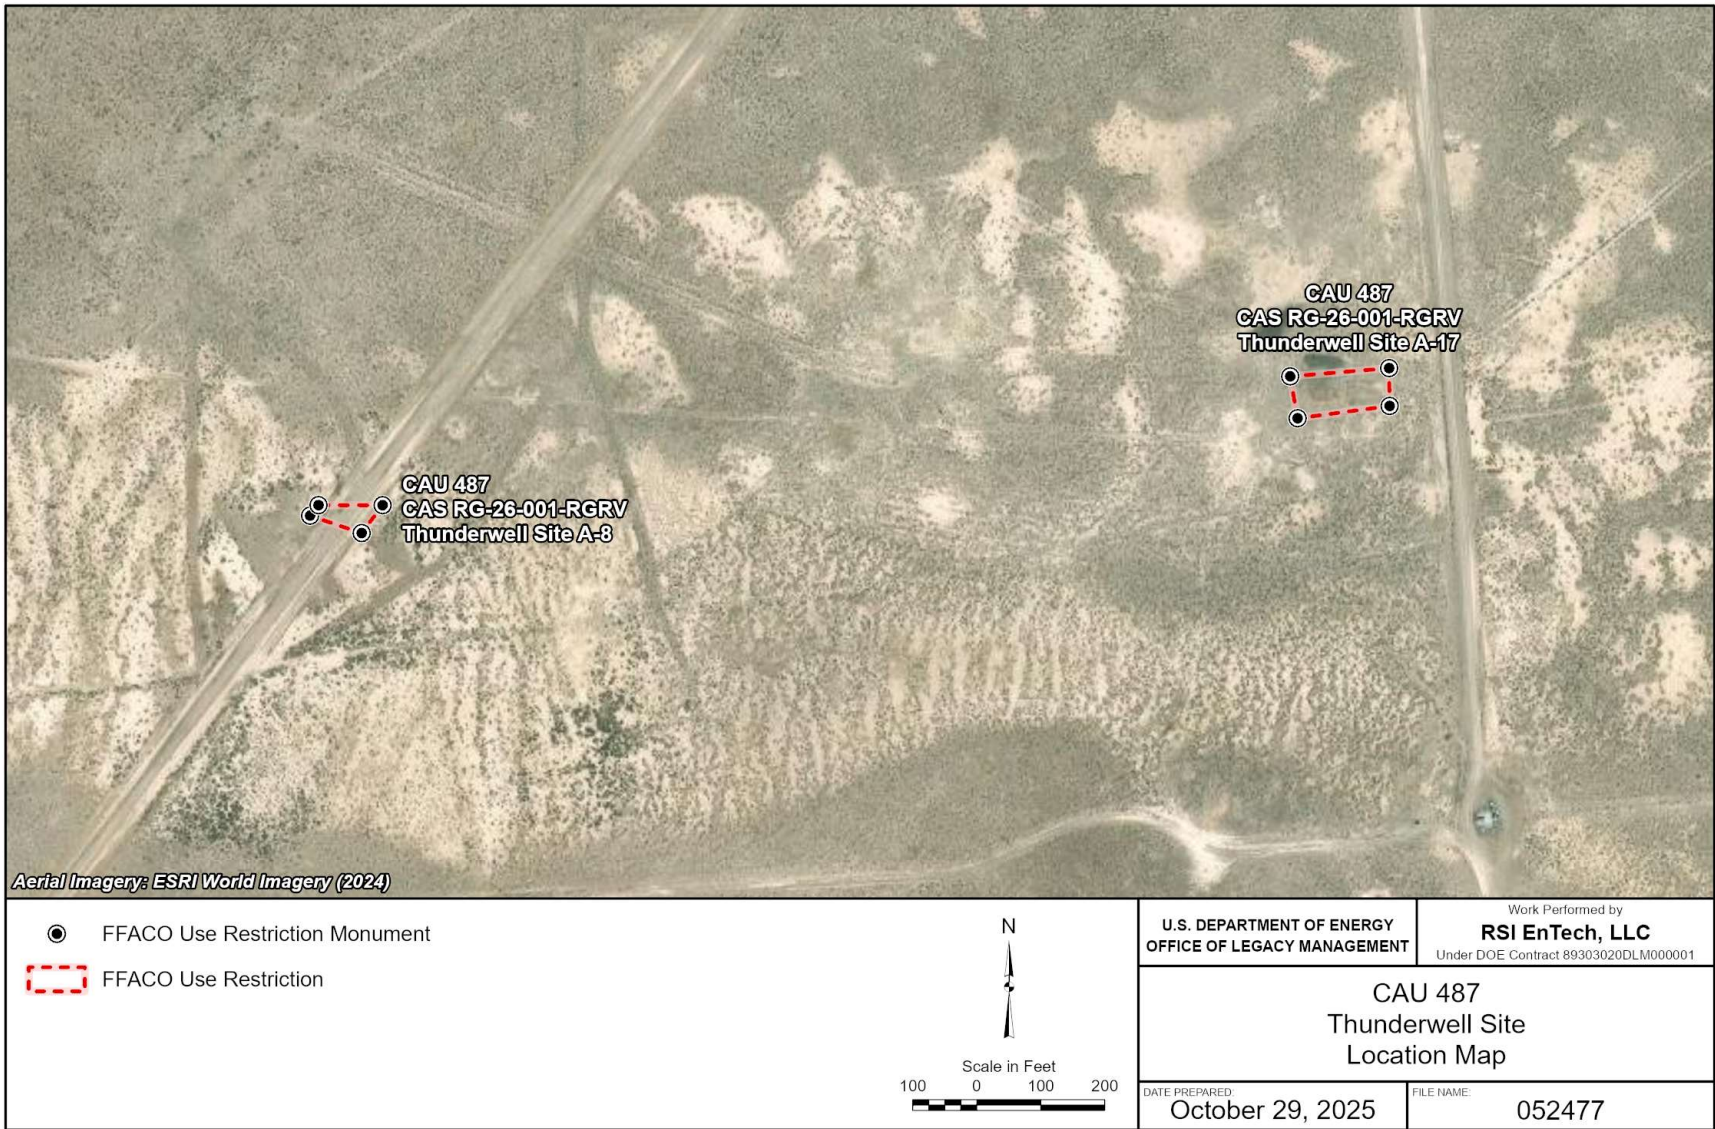
Figure 11. CAU 487, Thunderwell

Visual inspections were conducted according to the postclosure requirements for CAU 487, Thunderwell Site (TTR), CAS RG-26-001-RGRV: Thunderwell Site, as described in the CAU 487 UR (DOE/EMNV 2019d). The site is shown in Figure 11 of Appendix A. The annual inspection was conducted on April 23, 2025. The site is made up of two land parcels: the A-17 Anomaly and the A-8 Anomaly. All signs, monuments, and survey markers were in good condition. All monuments had warning signs. Two metal tubes are exposed to the surface. This has been observed in the past and does not present an imminent hazard to the integrity of the cell. Minor erosion was also observed on the cell cover. During the time of inspection, the erosion did not pose an imminent hazard to the cell cover. No repair or maintenance needs were observed.
