19.0 Tuba City, Arizona, Disposal Site

19.1 Compliance Summary

The site, located east of Tuba City, Arizona, was inspected on April 30, 2008. Results of the inspection are described below. Features and photograph locations (PLs) mentioned in this report are shown on Figure 19–1. Numbers in the left margin of this report refer to items summarized in the “Executive Summary” table.

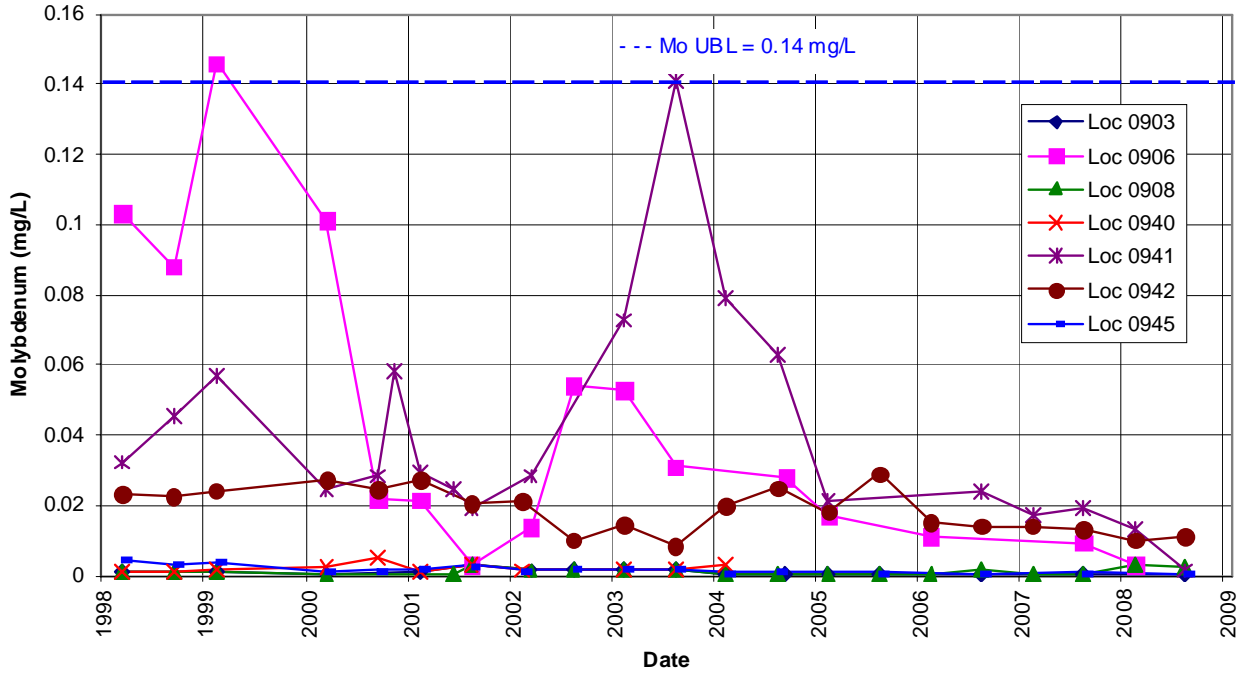
Figure 19-2. Time-Concentration Plots of Molybdenum in Groundwater at the Tuba City Disposal Site

In 2008, molybdenum concentrations in groundwater were below the 0.1 mg/L MCL and the 0.14 mg/L UBL in all wells (Figure 19–2). This has been the case since 2004, when concentrations began a downward trend in wells MW–0906 and MW–0941. Molybdenum concentrations in remaining wells have consistently been below 0.03 mg/L; results for MW–0908 and MW–0940 (last sampled in 2004) are comparable to background (MW–0945). Concentrations in both the off-site downgradient well MW–0903 and upgradient background well MW–0945 remain at or near the detection limit (0.0001 mg/L).

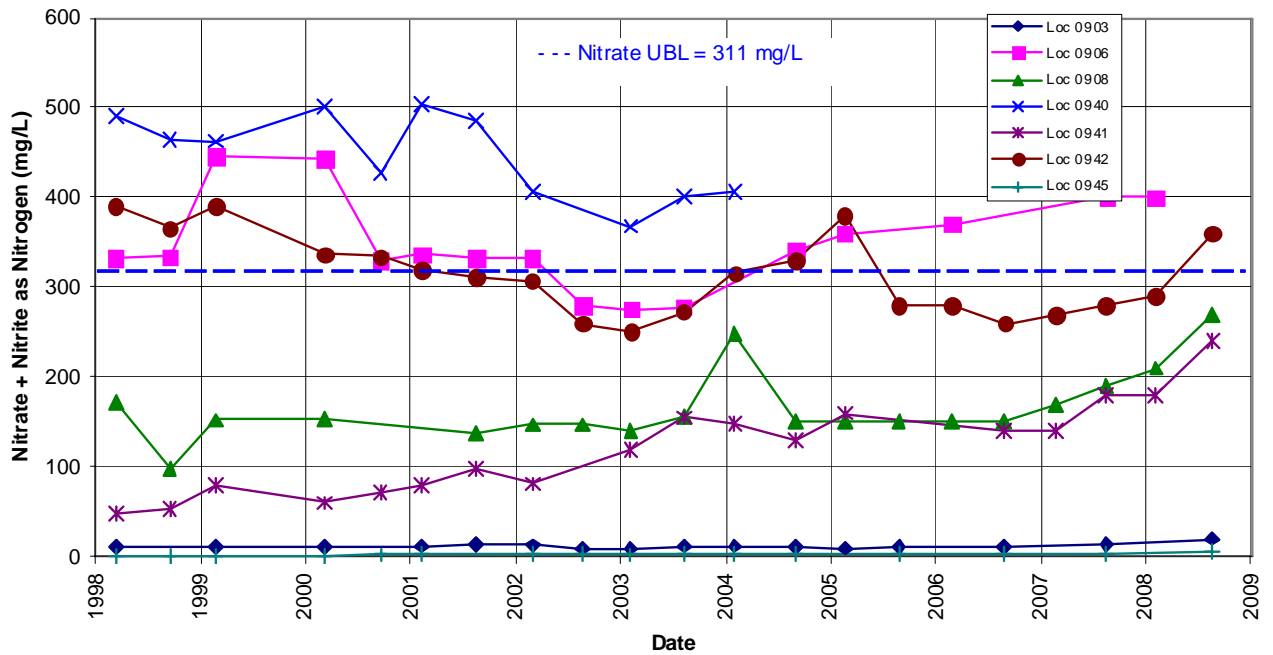
Figure 19-3. Time-Concentration Plots of Nitrate in Groundwater at the Tuba City Disposal Site

Since 1998, nitrate concentrations in all on-site downgradient wells—MW–0906, MW–0908, MW–0941, and MW–0942—have exceeded the 10 mg/L MCL by an order of magnitude or more. Nitrate concentrations in these wells have exhibited an upward trend since 2003 (Figure 19–3) and exceeded the 311 mg/L UBL in both MW–0906 (400 mg/L) and MW–0942 (360 mg/L) in 2008. Concentrations in off-site downgradient well MW–0903 remain well below the UBL, but the August 2008 measurement (20 mg/L) exceeded the MCL. Concentrations in the upgradient background well MW–0945 remain below the MCL.

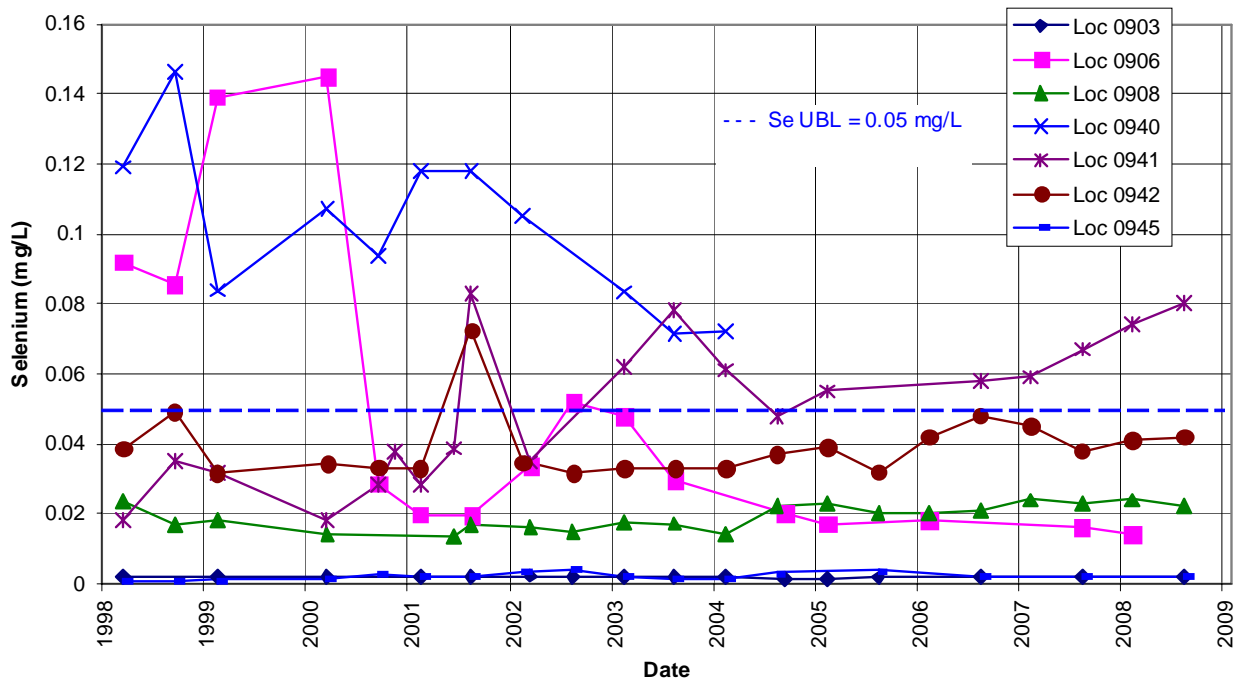
Figure 19–4. Time-Concentration Plots of Selenium in Groundwater at the Tuba City Disposal Site

Although selenium concentrations measured in groundwater in 2008 exceeded the 0.01 mg/L MCL in all wells except the upgradient background well MW–0945 and the off-site downgradient well MW–0903, concentrations were below the 0.05 mg/L UBL except for MW–0941 (0.08 mg/L, Figure 19–4). Concentrations in MW–0941 have displayed a recent upward trend since 2004 that fit into an overall upward trend since 1998.

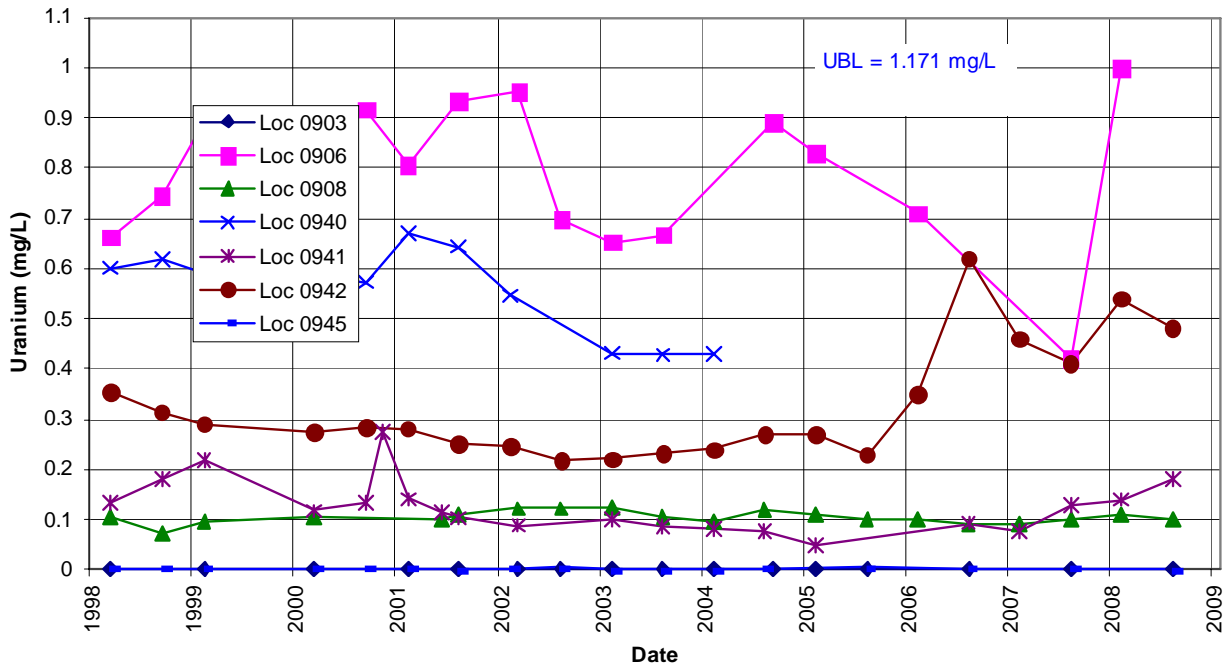
Figure 19–5. Time-Concentration Plots of Uranium in Groundwater at the Tuba City Disposal Site

In 2008, uranium concentrations in groundwater exceeded the 0.044 mg/L MCL but remained below the 1.171 mg/L UBL in all on-site downgradient wells (Figure 19–5). Concentrations in the upgradient well MW–0945 and the off-site downgradient well MW–0903 remain below 0.044 mg/L. No significant variations from recent trends occurred, with one exception: the uranium concentration in well MW–0906 essentially doubled since 2007—from 0.42 mg/L to 1.0 mg/L (the maximum concentration measured since LTSP monitoring began in 1998).

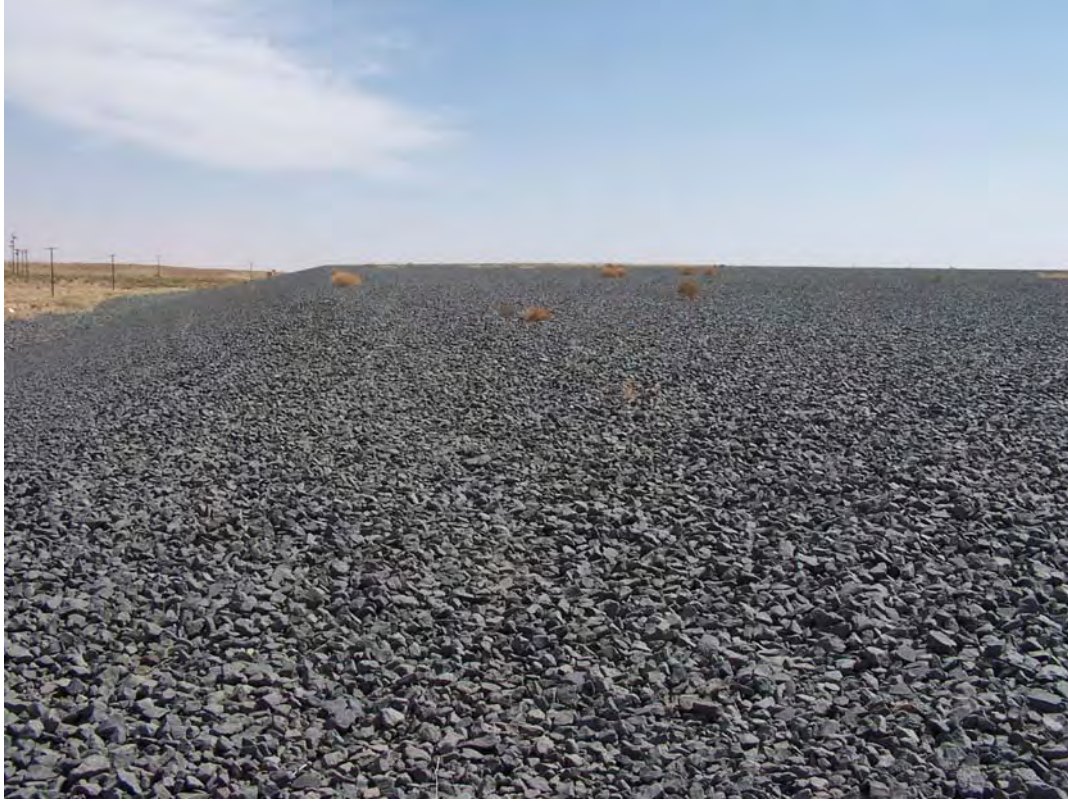
Disposal Cell—The disposal cell is covered with riprap to control erosion. At the time of the inspection, the rock cover material was in excellent condition and showed no signs of deterioration. No evidence of differential settlement or slumping was observed. All visible components of the disposal cell and cover were in excellent condition (PL-1).

TUB 4/2008. PL-1. The cell top and side slope along the northwest side of the disposal cell.

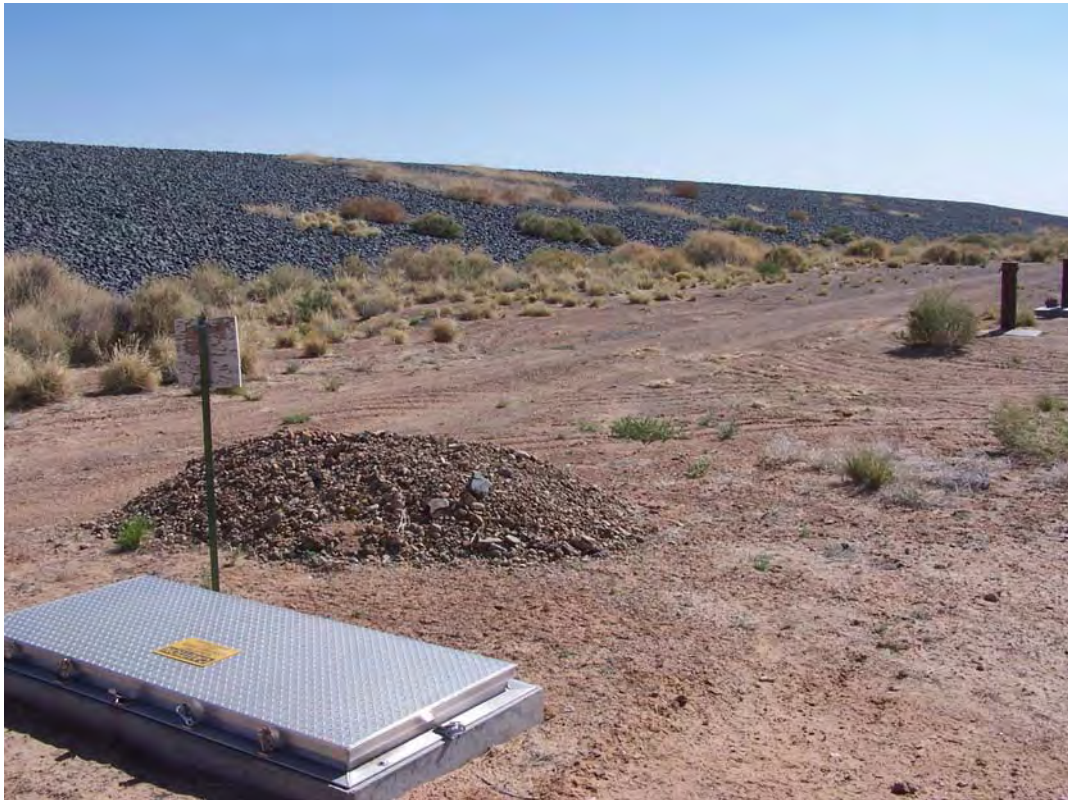
Photographs were taken of sand accretion and vegetation encroachment at specific locations on the south side slope (PL-2). Annual photographs are taken at these locations to document change in sand accretion and vegetation conditions at the site. Sand accretion appeared unchanged since 2007, and apart from several dead saltbush shrubs (resulting from the early-April herbicide application), vegetation also appeared unchanged.

TUB 4/2008. PL-2. Vegetation encroachment on the south side slope of the disposal cell (reference photograph taken from extraction well 1107).

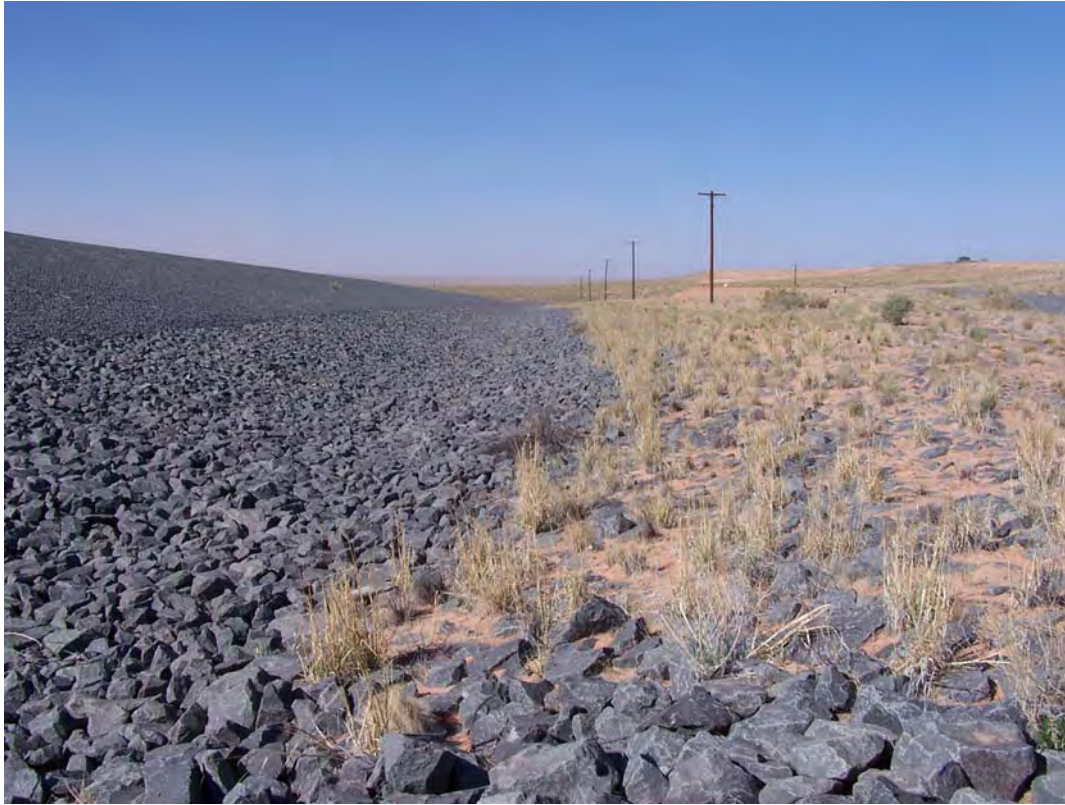
TUB 4/2008. PL-3. View of drainage ditch along the northwest side of the disposal cell.

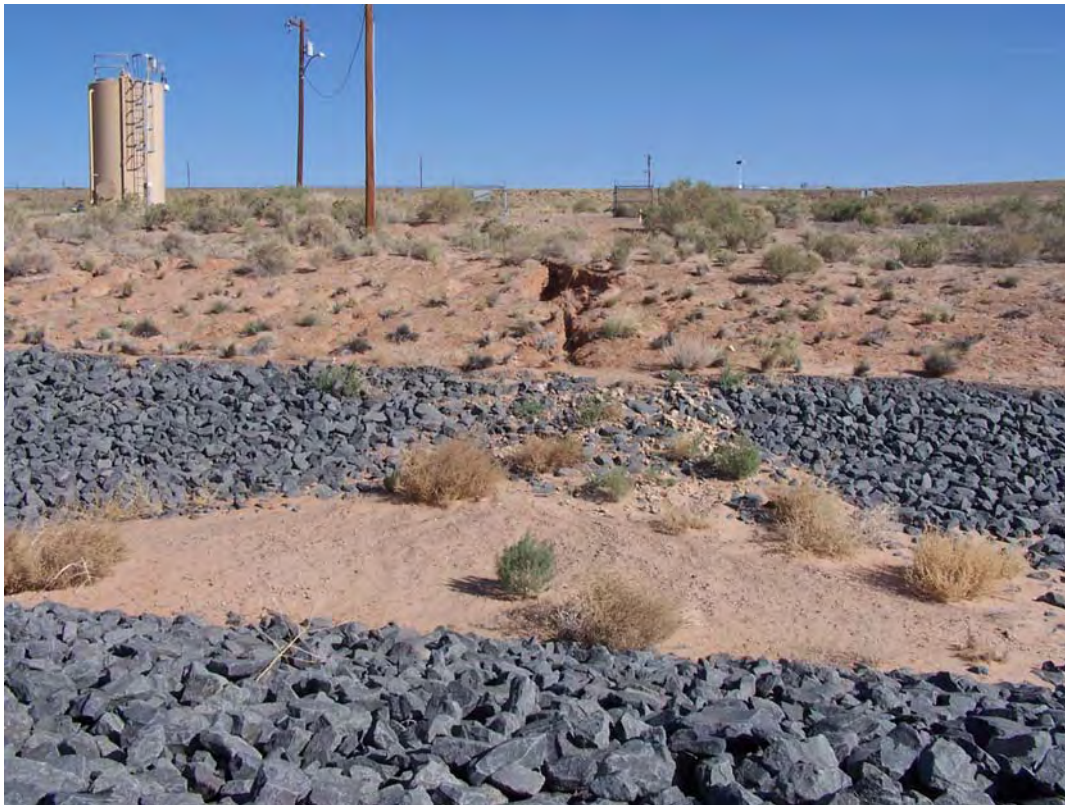
19D **Area Between the Disposal Cell and the Site Boundary**—The drainage ditch at the base of the disposal cell and the diversion channel, both located along the north and northwest sides of the cell, are in good condition (PL-3). As noted in the 2007 annual inspection, erosion along the north bank of the diversion channel near the distillate tank continues to result in sediment accumulation in the channel (PL-4). Although this erosion has had no apparent adverse impact on the performance of the channel (accumulated sediment would likely flush from the channel during a severe runoff event), the gully in this area was stabilized in November 2008.

TUB 4/2008. PL-4. Gully erosion and sediment deposition in the diversion channel near distillate tank.

In 2008, all 30 perimeter signs were replaced, deep-rooted vegetation on the disposal cell was treated with herbicide, the fence was repaired, and erosion on the bank of the diversion channel was repaired.

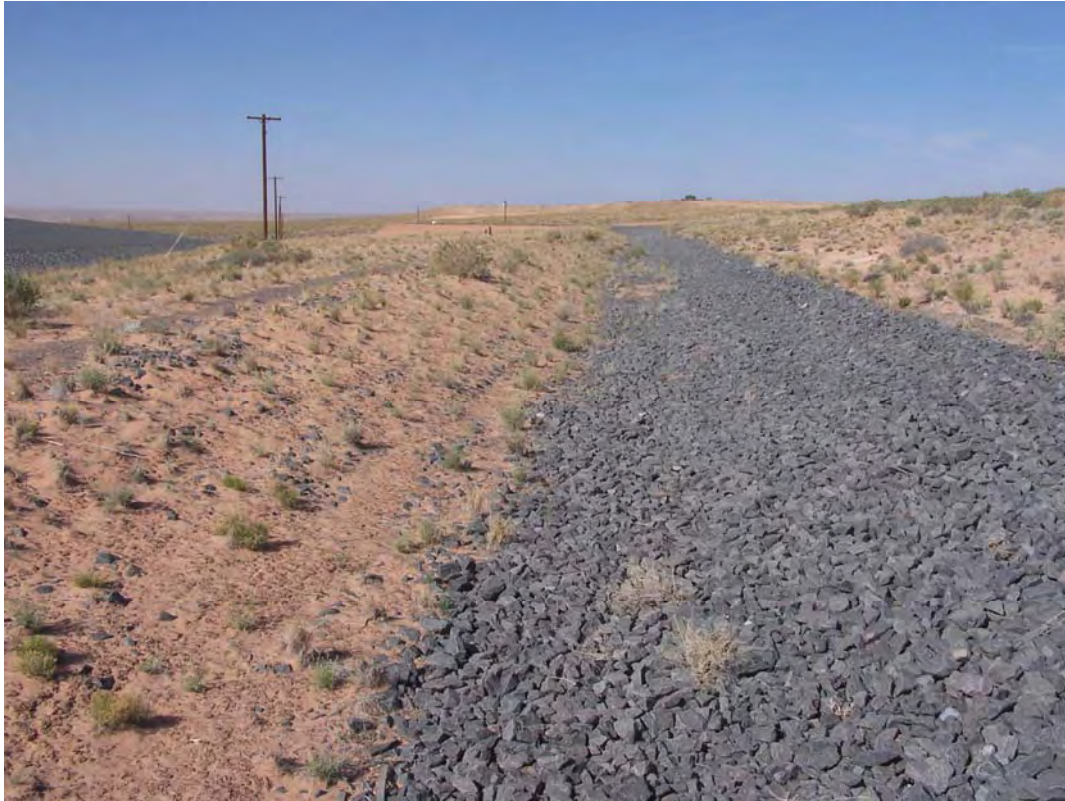
Since 2007, no significant increases in sand accretion and vegetation encroachment in the western and northwest segments of the diversion channel and drainage ditch were apparent (PL-5). In fact, there has been very little change at these locations since the monitoring of sand accretion began in 2001. Most important, the sand accumulations and vegetation along the channel and ditch are not adversely affecting the performance of these features.

TUB 4/2008. PL-5. Vegetation encroachment in windblown sand accumulating on the south bank of the diversion channel (repeat photograph taken from the footbridge).
