Independent Radiological
Verification Survey Results for
the Remedial Action Performed
at the Former
Bridgeport Brass Company
Facility, Adrian, Michigan
(AD001V)

Date Final issued — August 2002

OAK RIDGE NATIONAL LABORATORY

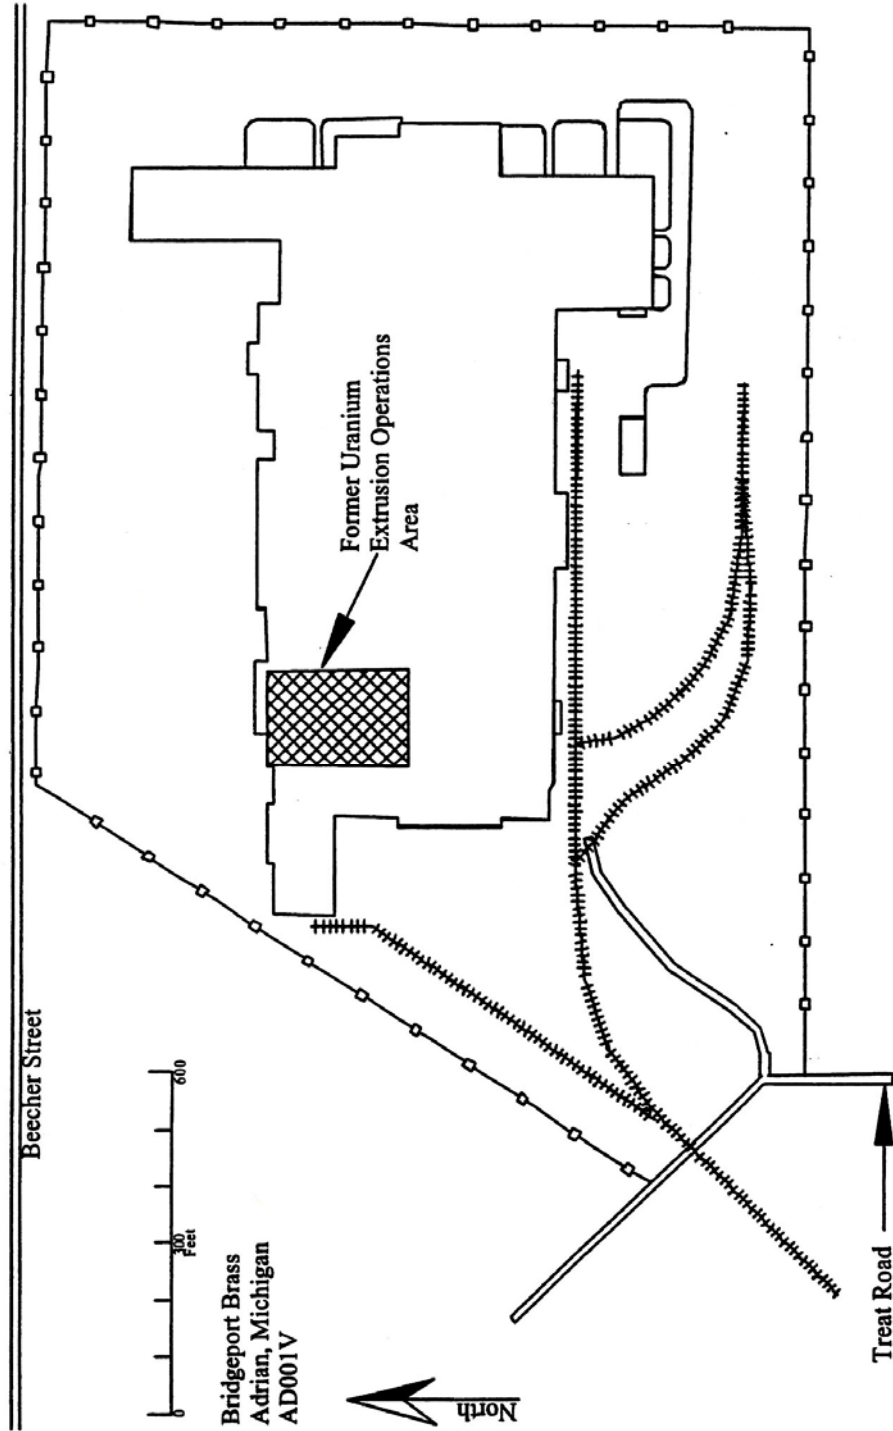
Fig. 2. Diagram showing the former uranium extrusion operations area within the former Bridgeport Brass Special Metals Extrusion Plant in Adrian, Michigan. (Scale is approximate)

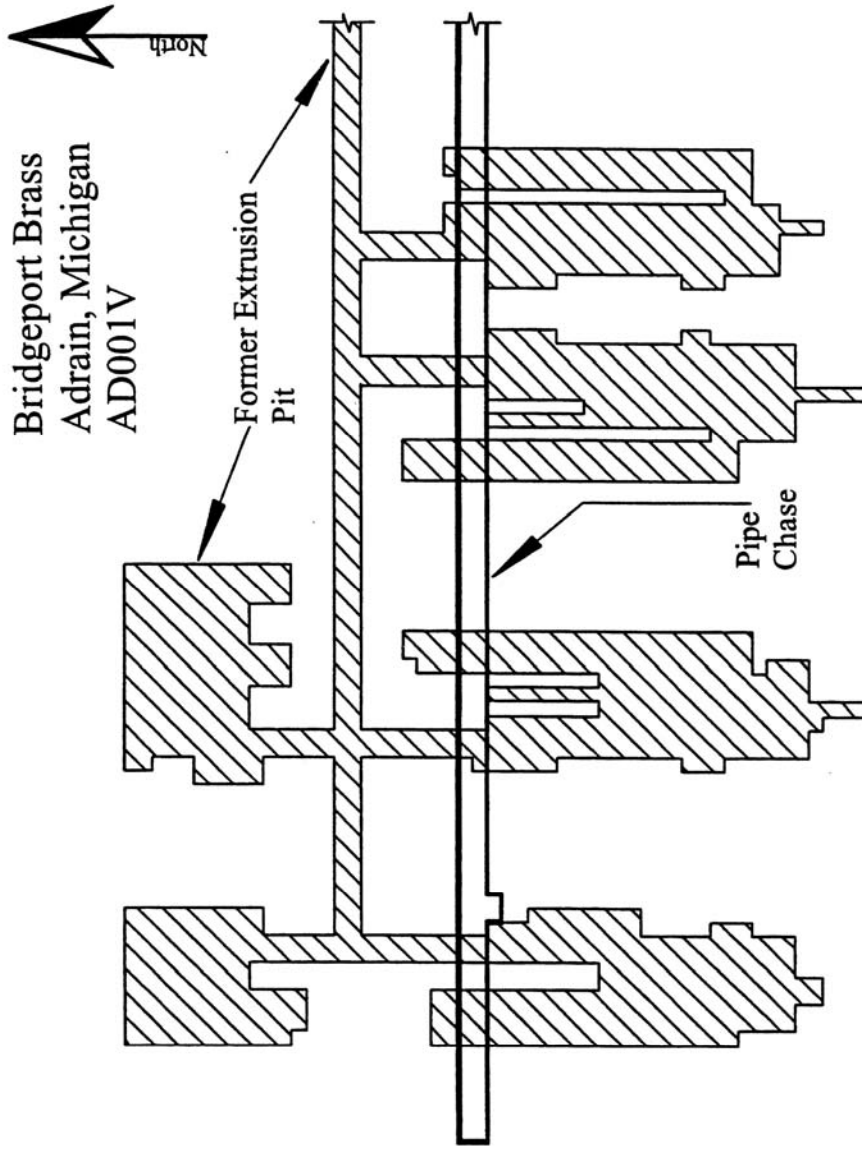
Following the remediation, all beta-gamma activity levels measured on surfaces within the pipe chase and the pipe chase lids were below the DOE guidelines for surface contamination (Table 1). Analytical results for the soil sample showed 1.8 ± 0.40 pCi/g of ^{238}U , a concentration slightly higher than background levels for the area (Table 2) but less than typical derived DOE guideline values for properties to be released for unrestricted use (Table 1). Concentrations of ^{226}Ra and ^{232}Th were 0.90 ± 0.18 and 0.50 ± 0.25 pCi/g, respectively, which are values within the range of background values found near Adrian.

Fig. 3. Diagram indicating the approximate location of the pipe chase in relation to the former extrusion pits and other areas in the building. (Not to scale)
