Post-Remedial Action Report for the Chapman Valve Site

Indian Orchard, Massachusetts

November 1996

Prepared for
United States Department of Energy
Oak Ridge Operations Office
Under Contract No. DE-AC05-91OR21949

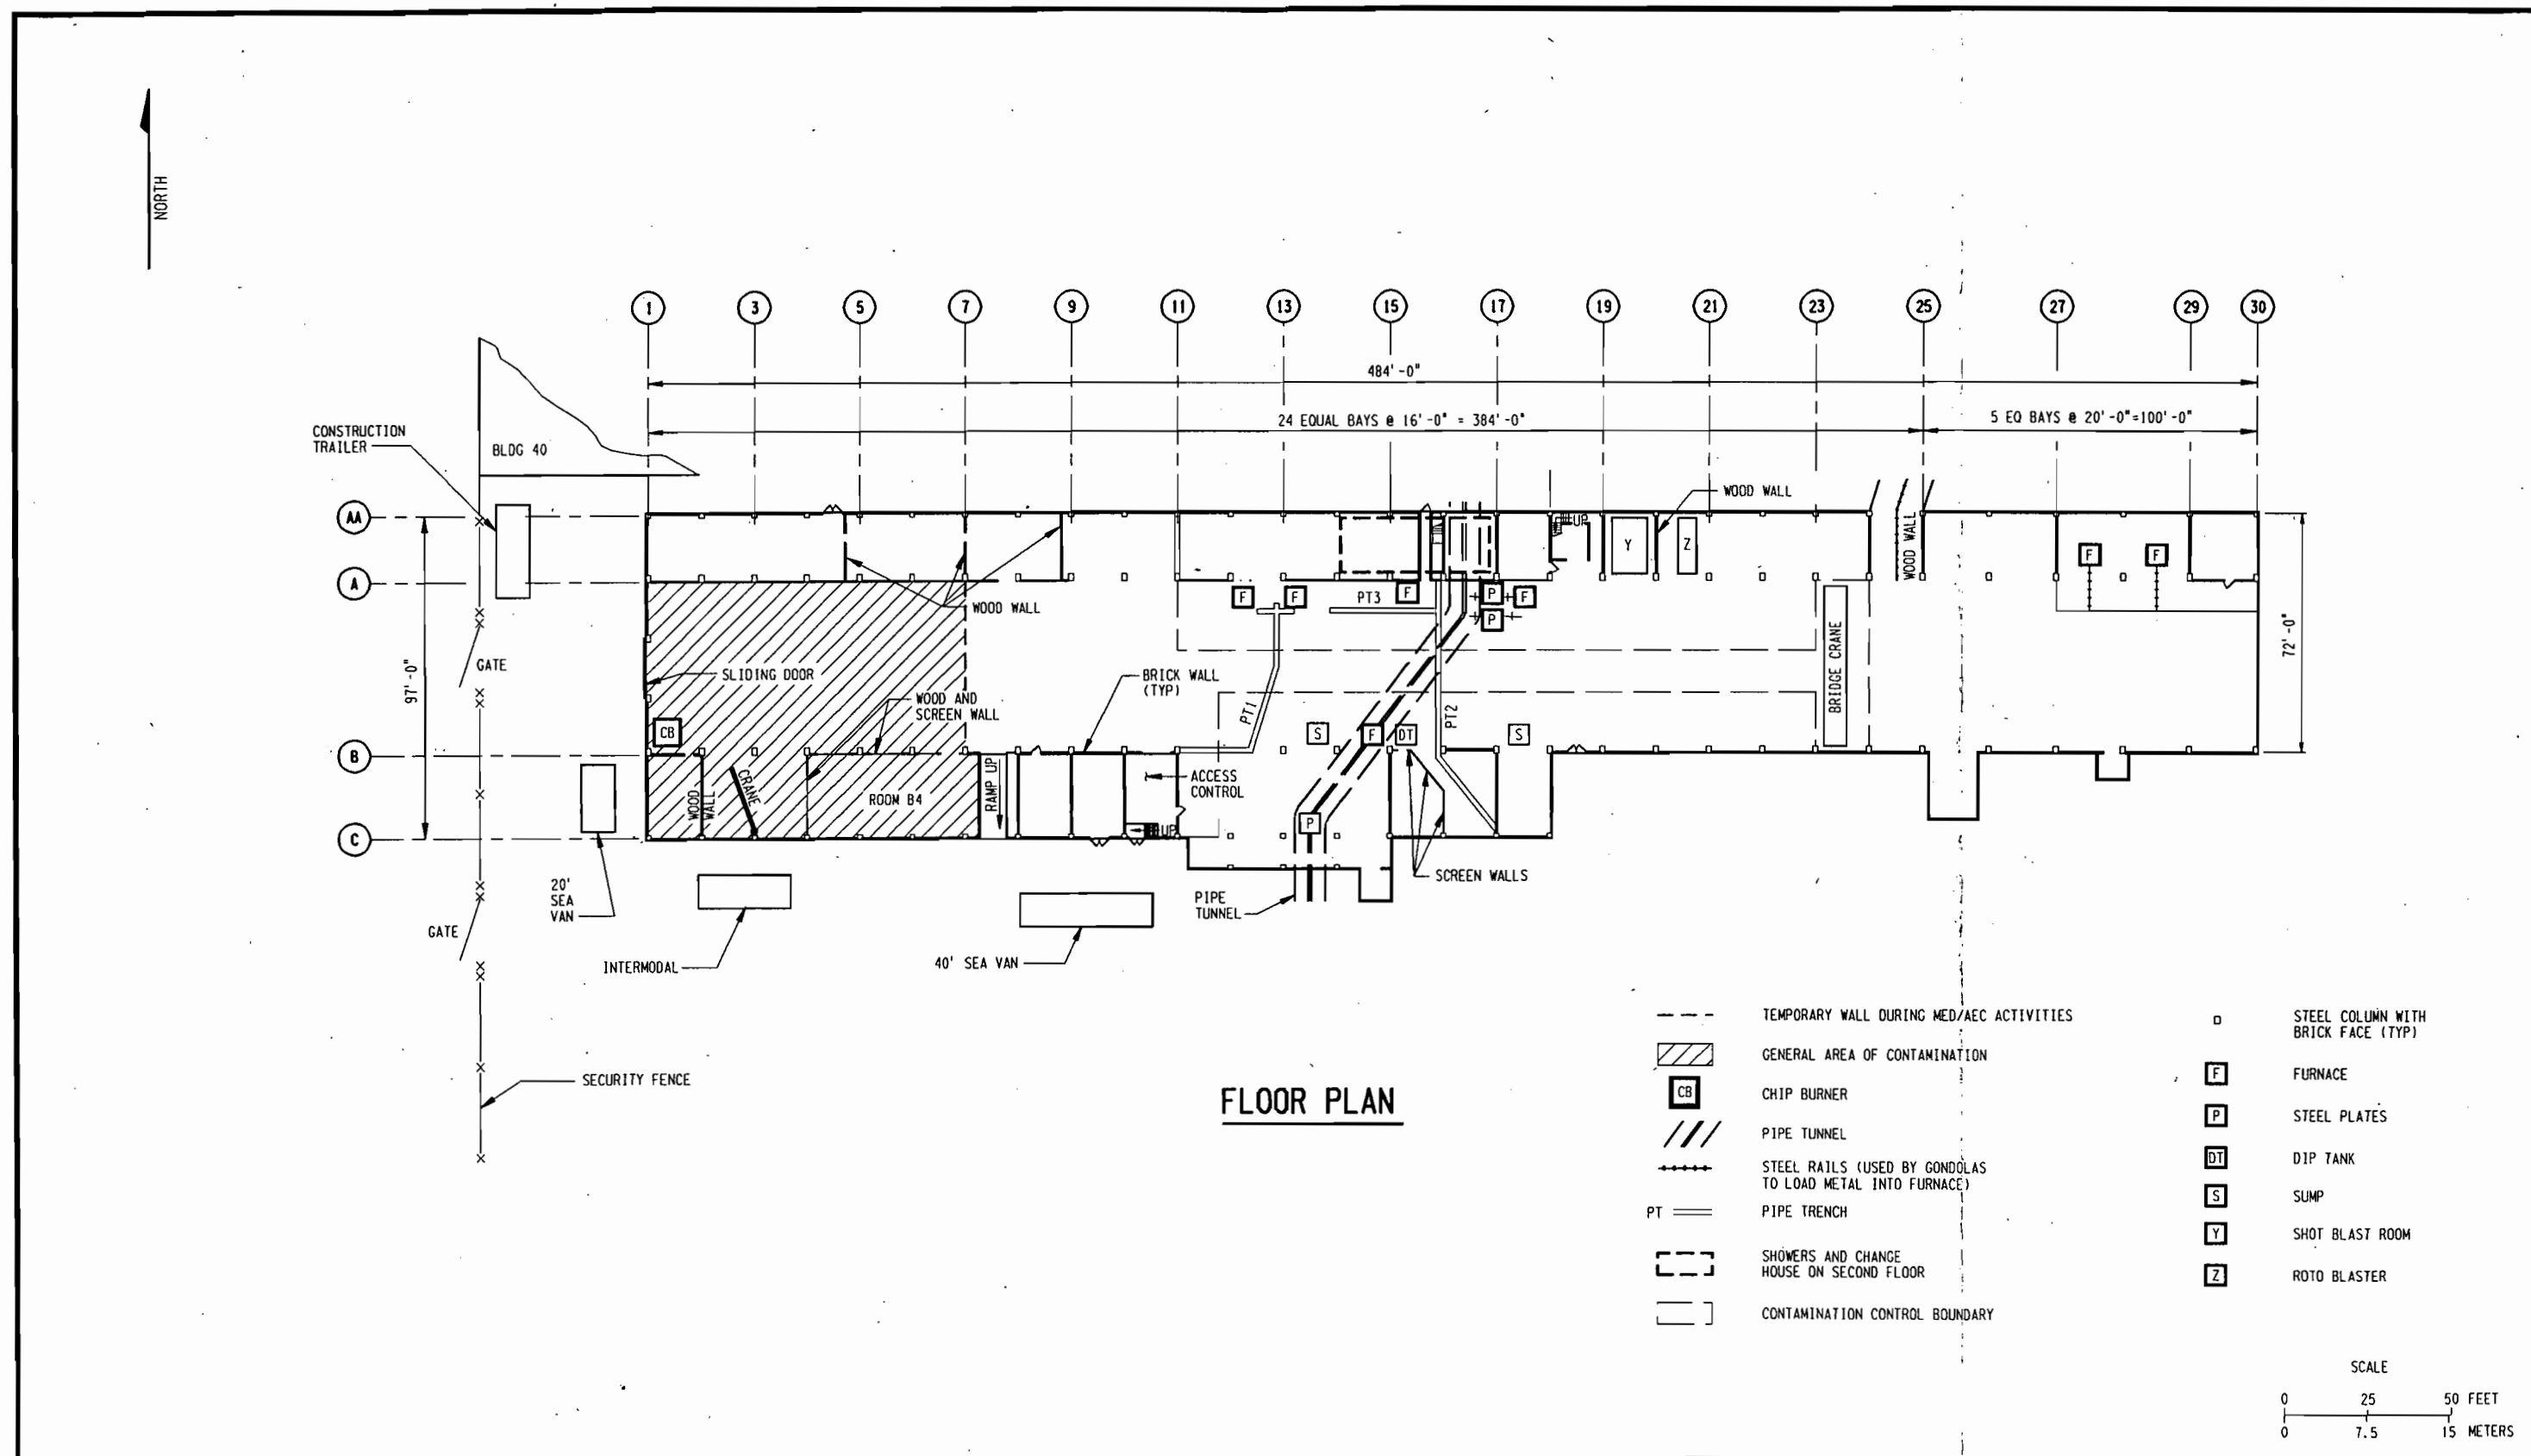
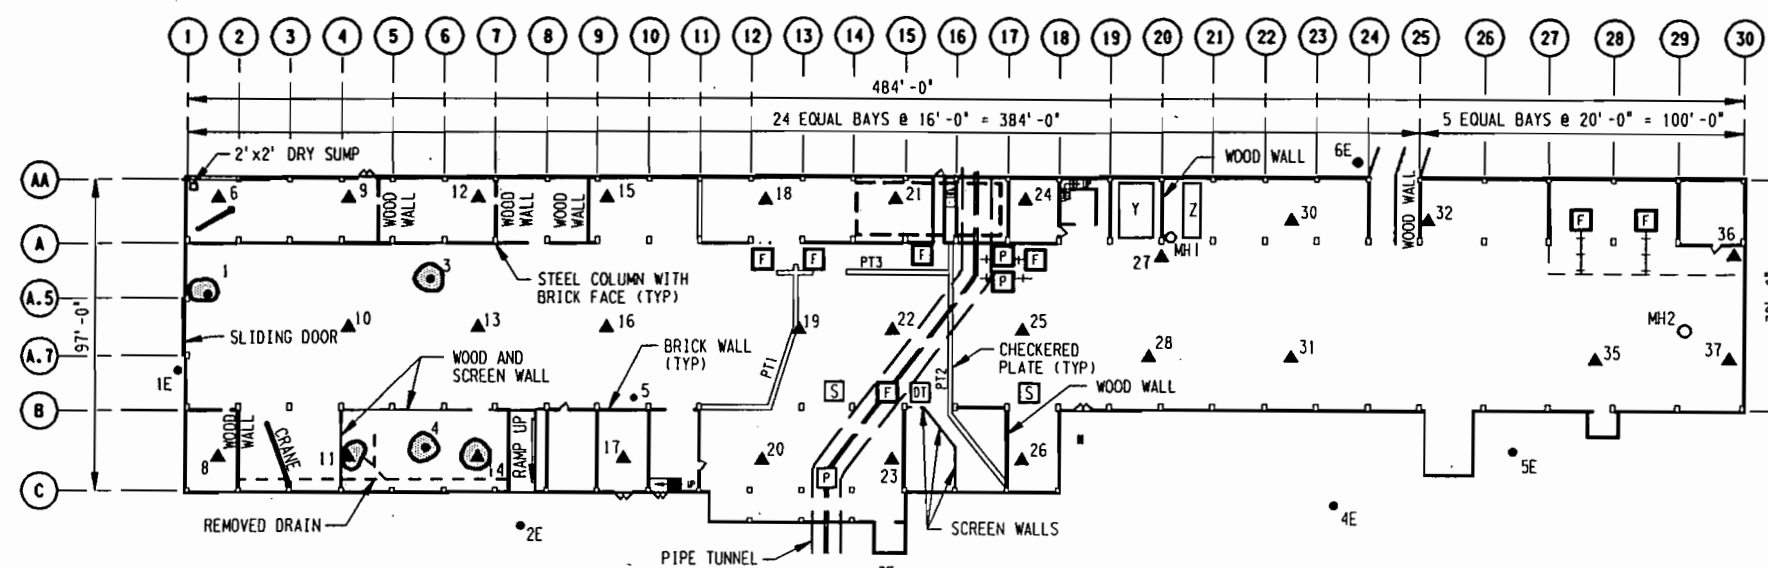
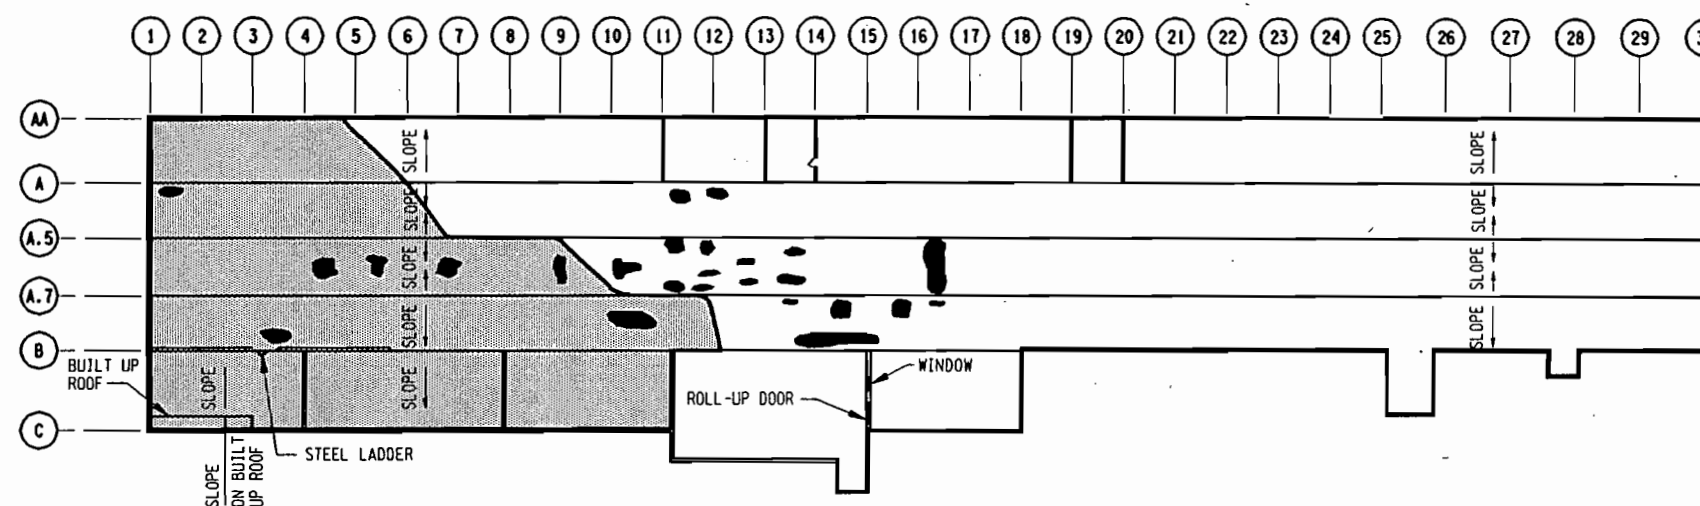
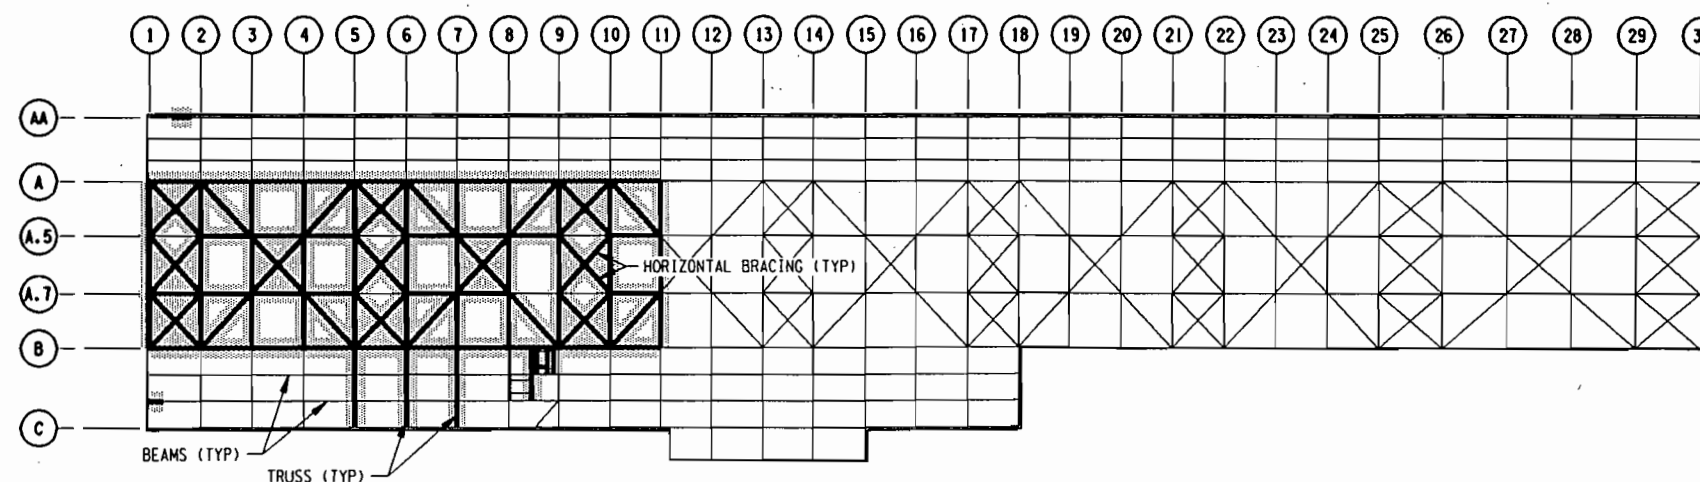
Figure 2
Chapman Valve
Building 23 - Plan View

In 1948, Chapman Valve set aside an area in the western end of building 23 (Figure 2) for the machining of uranium rods for the Atomic Energy Commission's (AEC's) Brookhaven National Laboratory. Uranium operations were terminated on November 8, 1948, at which time Chapman Valve had in its possession more than 27,000 pounds of metal scrap, oxides, and sweepings. This material was removed from the site several months after the contract was completed.

The PMC performed additional radiological surveys in November and December 1994 to supplement and refine existing survey information (BNL 1995). Characterization findings confirmed the presence of contamination in the western end of Building 23 (Figures 2, 3, 4, and 5). These findings are in agreement with historical process information obtained during interviews conducted with a former Chapman Valve supervisor. According to the supervisor, a temporary wall was constructed across the center portion of the building from floor to ceiling between columns A-7 and B-7 (Figure 2).

Additional contamination was identified in the southwest corner of grid A-1 at the former location of a chip burner that exhausted to the atmosphere through a nearby window. (Grid numbers are derived from the northwestern column number of the grid.) The exhaust location and the shape of the roof of the building caused more contamination to be deposited on the south roof than on the north roof, as indicated by characterization measurements. The uranium storage area was located in Room B-4 on the south side of the building between columns B-4 and B-7 (Figure 2). Characterization results showed no subsurface soil contamination below the floor slab.

Residual surface contamination was removed from the bridge crane located at grid A-23 (see Figure 2) by hand scraping with putty knives and vacuuming. The crane was decontaminated without disturbing painted surfaces except for several small areas where it was necessary to remove the paint along with the contamination. Before the paint was removed, the high-efficiency particulate air- (HEPA-) filtered vacuums were emptied to minimize the amount of material requiring treatment. Very-small-quantity-generator status permitted treatment and disposal of the lead-based paint onsite. The paint was dissolved in an acid solution and then mixed with concrete. The resulting concrete monoliths were surveyed and determined to be below the DOE residual surface contamination guidelines listed in Table 1. With the concurrence of the property owner and the State of Massachusetts, the concrete monoliths were left onsite. The wooden decking was removed from the crane and decontaminated using the same technique that was used on the crane. The decontaminated boards were also left onsite.

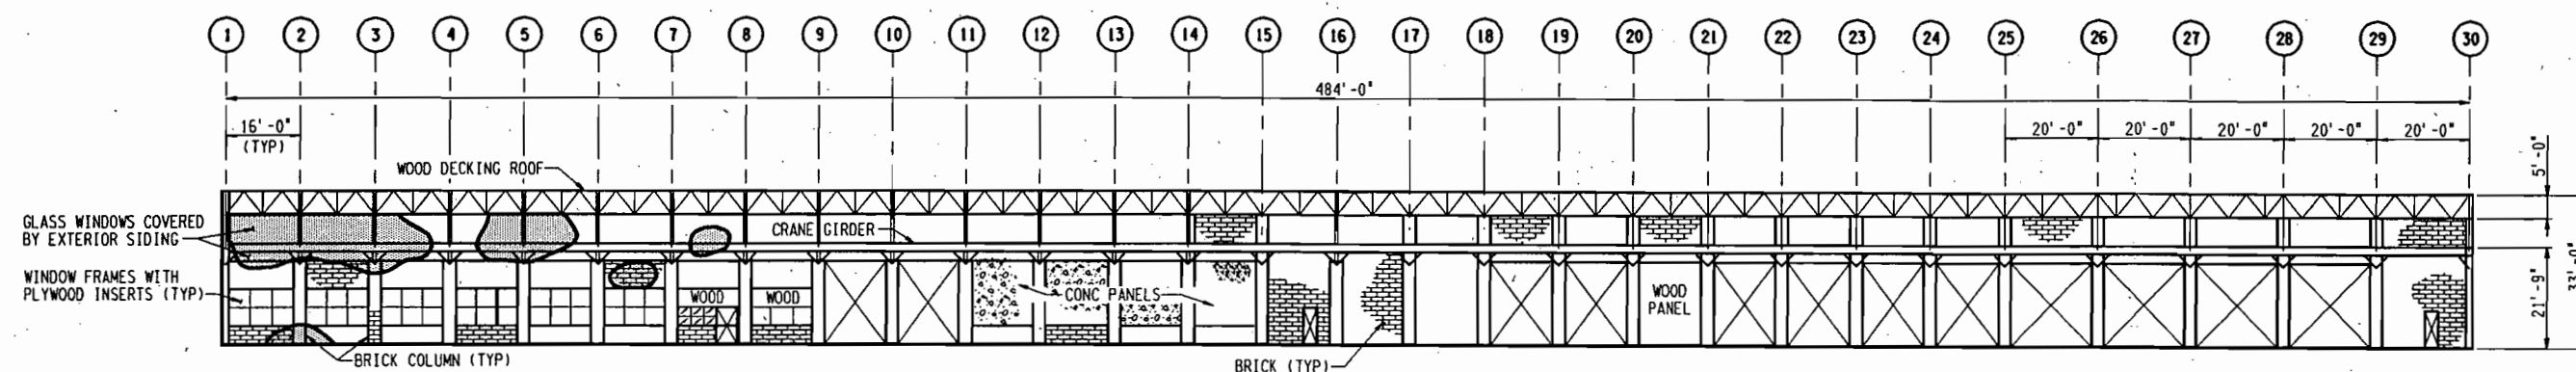
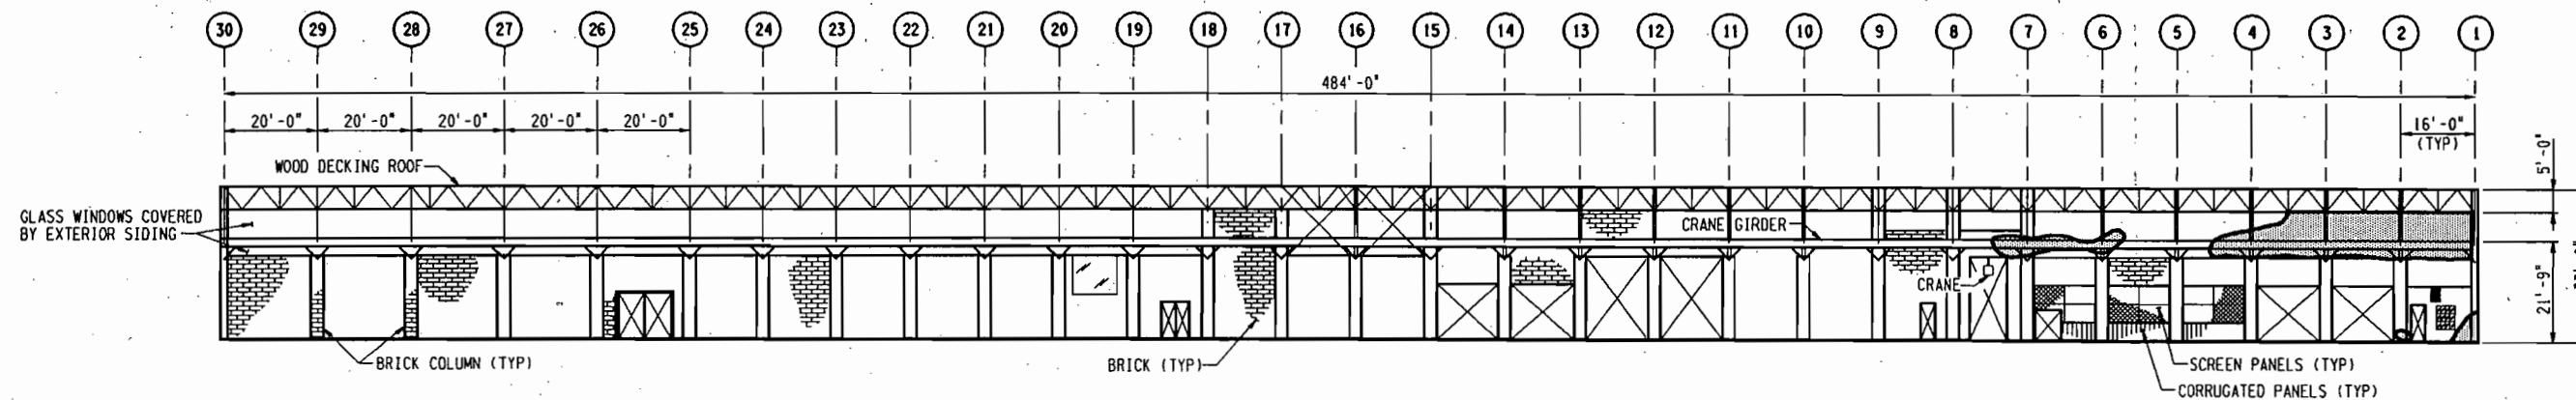
Figure 4
Chapman Valve - 1994 Characterization Results
Interior North and South Walls

Levels of contamination decreased from west to east in the building, and survey and sampling results from the east end indicated near-background radiological conditions. The exterior of the building, except for the roof and several locations on the west and south exterior walls, indicated near-background radioactivity.

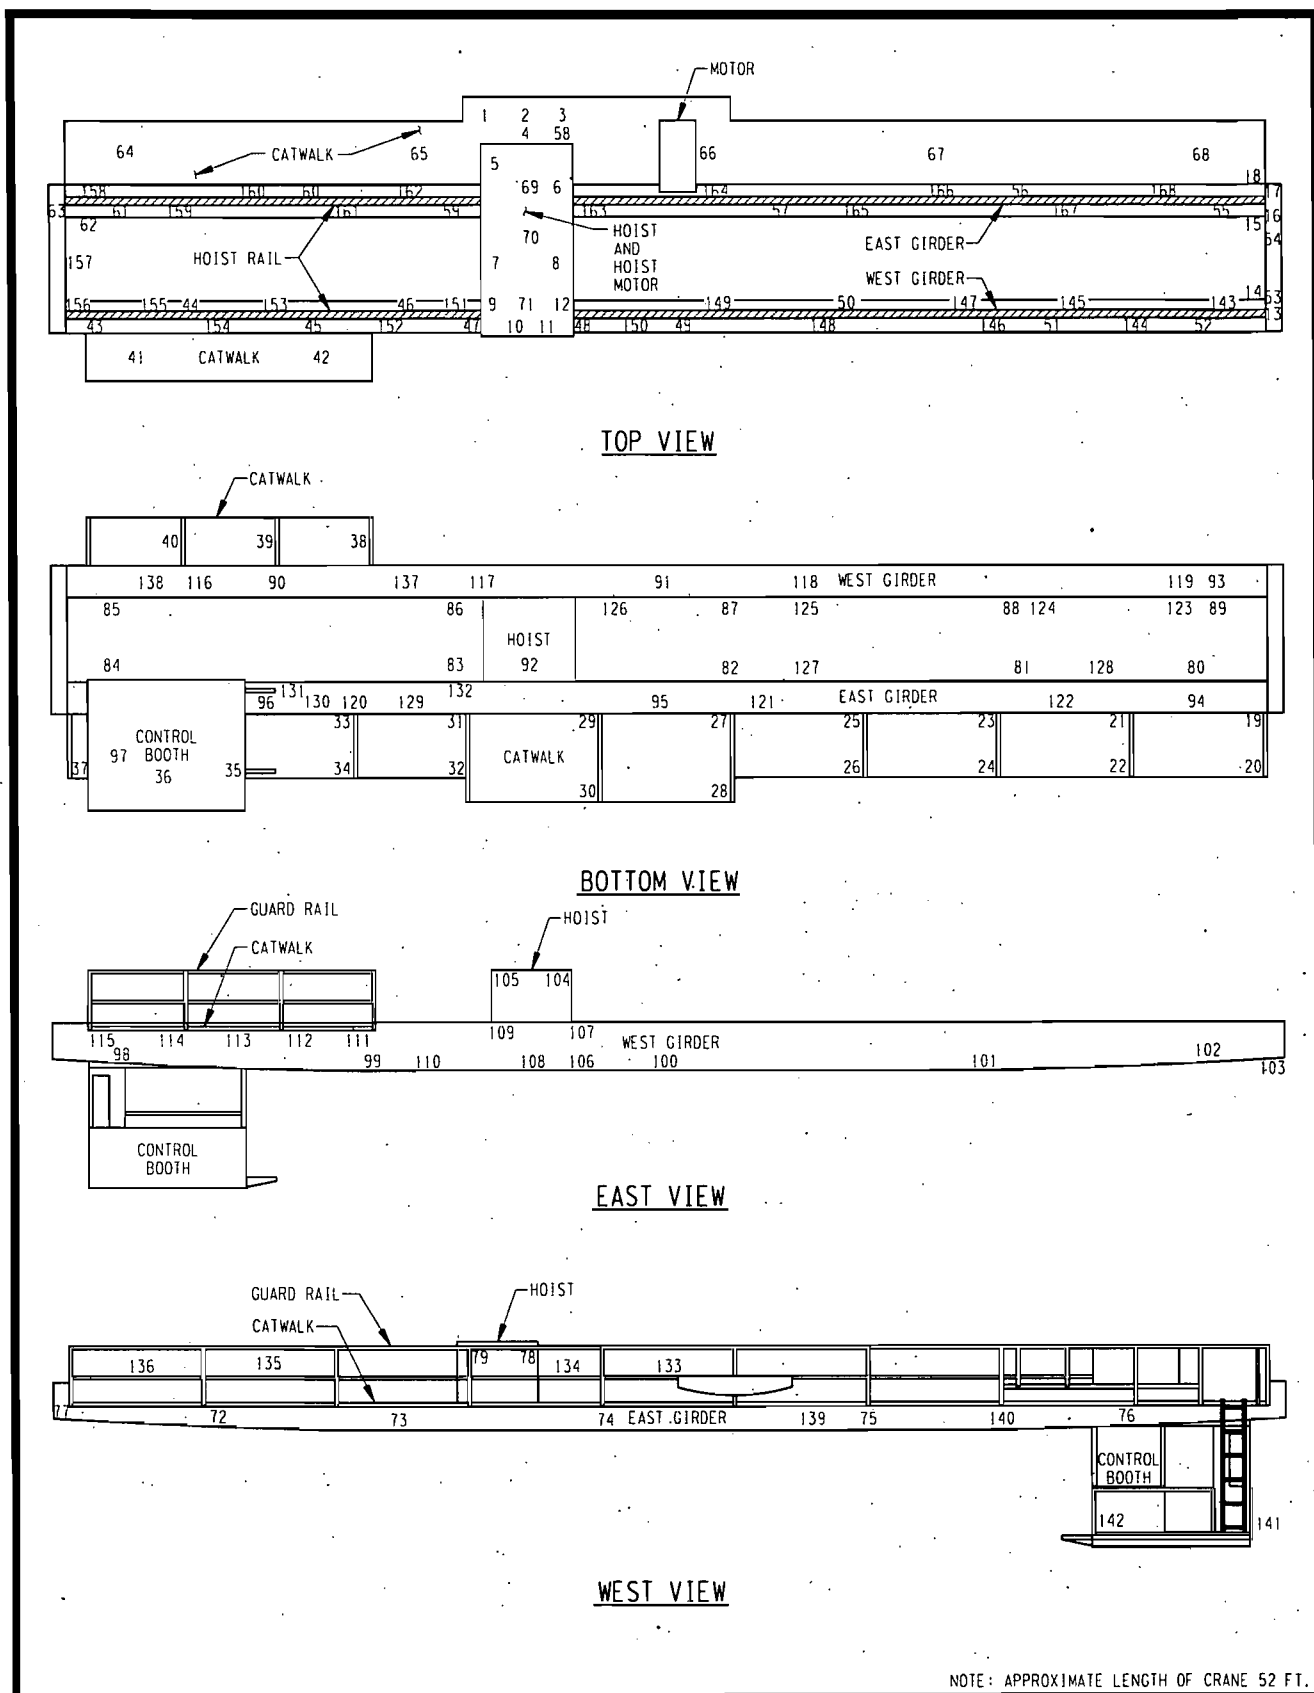
Figure 6
Post-Remedial Action Survey Locations
on Overhead Crane

Post-remedial action activities on the crane included surveys of direct and removable contamination and sampling of paint and dust residues to determine whether the waste should be classified as a RCRA mixed waste. Figure 6 shows the survey locations, and Table 4 presents the survey data. A total of 169 locations were surveyed. Direct alpha and beta-gamma average surface contamination readings were 44 and 520 dpm/100 cm², respectively. Average removable alpha and beta-gamma readings were 3 and 42 dpm/100 cm², respectively. The crane was decontaminated to comply with the DOE residual contamination guidelines listed in Table 1.

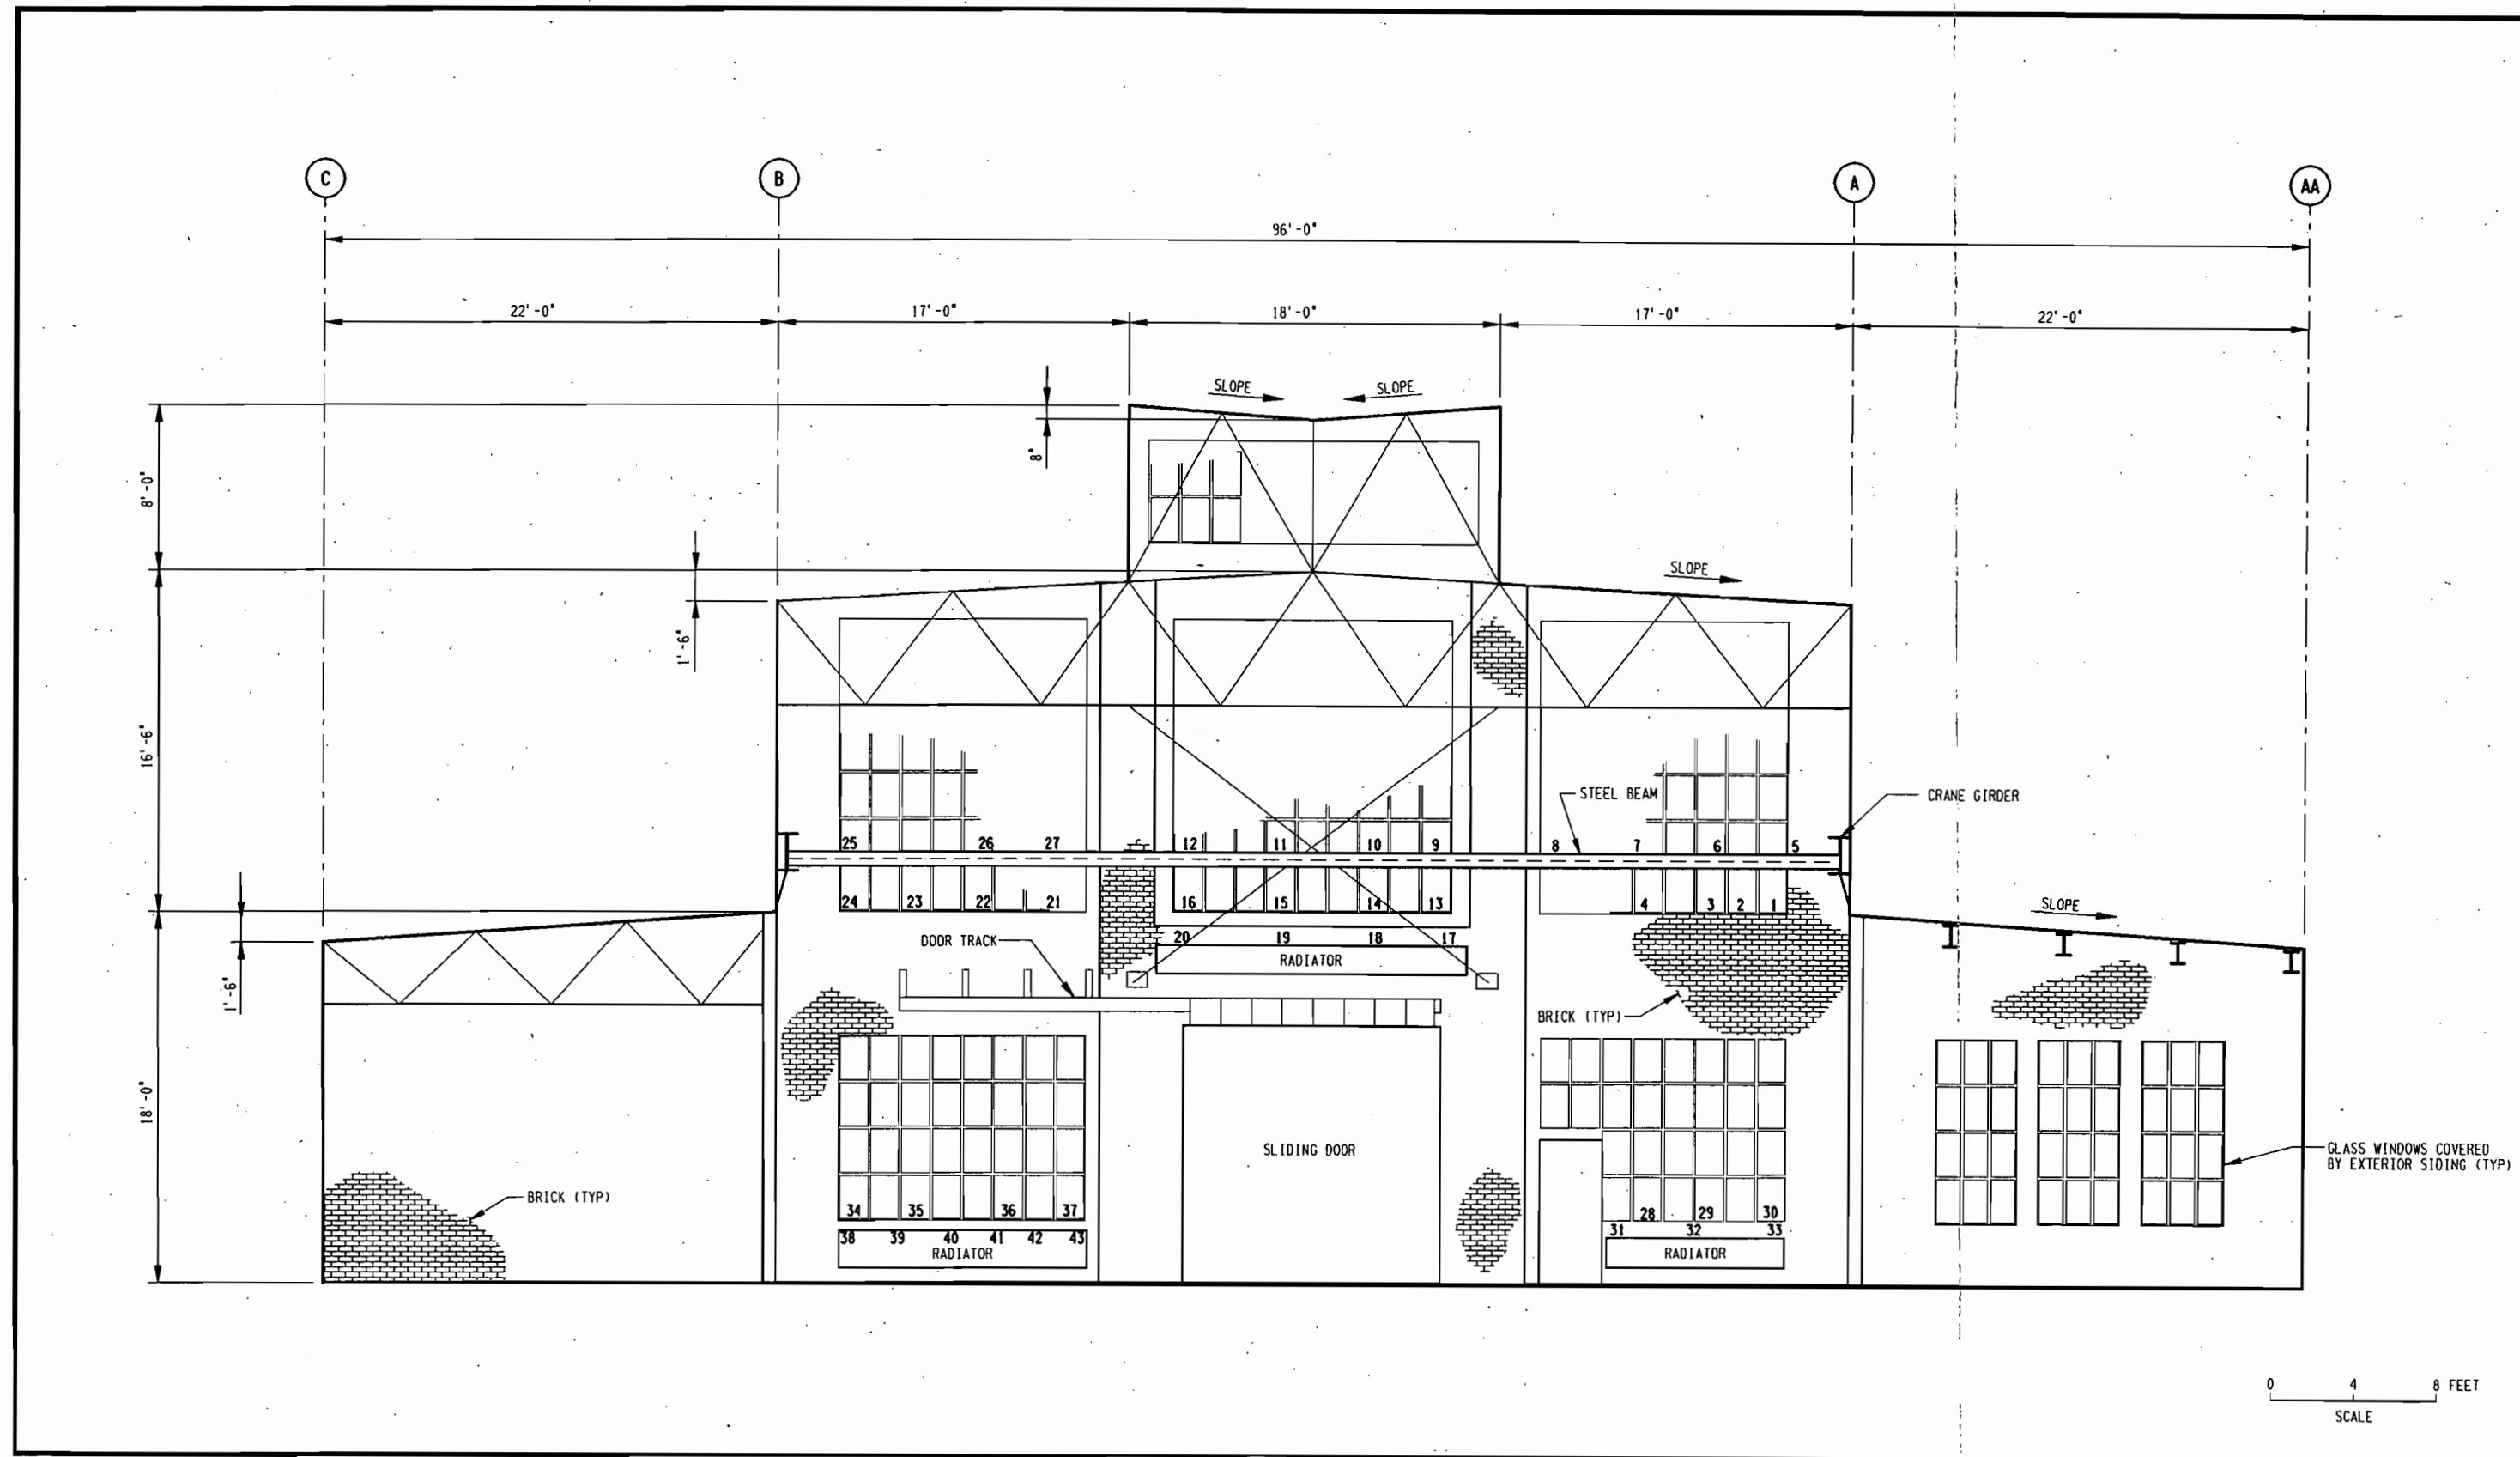
Figure 7
Post-Remedial Action Survey Locations
Interior West Wall

The ALARA approach to decontamination of the horizontal wall surfaces was to remove the contamination that exhibited a potential for resuspension or migration. Survey locations for the west, north, and south walls are shown in Figures 7, 8, and 9. Survey results for the west, north, and south walls are presented in Tables 6, 7, and 8. The maximum and average removable alpha measurements for the west wall were 164 and 17 dpm/100 cm²; for the north wall, the maximum and average measurements were 850 and 35 dpm/100 cm²; and measurements on the south wall were 111 and 17 dpm/100 cm², respectively. The maximum and average removable beta-gamma measurements for the west wall were

191 and 70 dpm/100 cm²; for the north wall, the measurements were 3,197 and 58 dpm/100 cm²; and measurements on the south wall were 319 and 45 dpm/100 cm², respectively. Except for a single reading on the north wall, all measurements were below the criterion of 1,000 dpm/100 cm² for removable contamination.

Horizontal surfaces on the walls of the main bay from column 1 to column 8 were decontaminated with a HEPA-filtered vacuum. Decontaminated surfaces included the crane rail, window sills, radiators, and a large pipe on the north wall. Preliminary hazard assessment calculations indicated that the wall contamination did not contribute significantly to the dose to a future demolition worker; however, because the dose to the demolition worker was primarily from removable contamination, the horizontal surfaces were vacuumed to remove the contamination, in accordance with DOE's ALARA policy. The radioactive dust generated from the operation was mixed with concrete to eliminate the potential for fugitive dust during transport and handling of the waste. The concrete/dust was placed in an intermodal container for disposal at a licensed disposal facility.

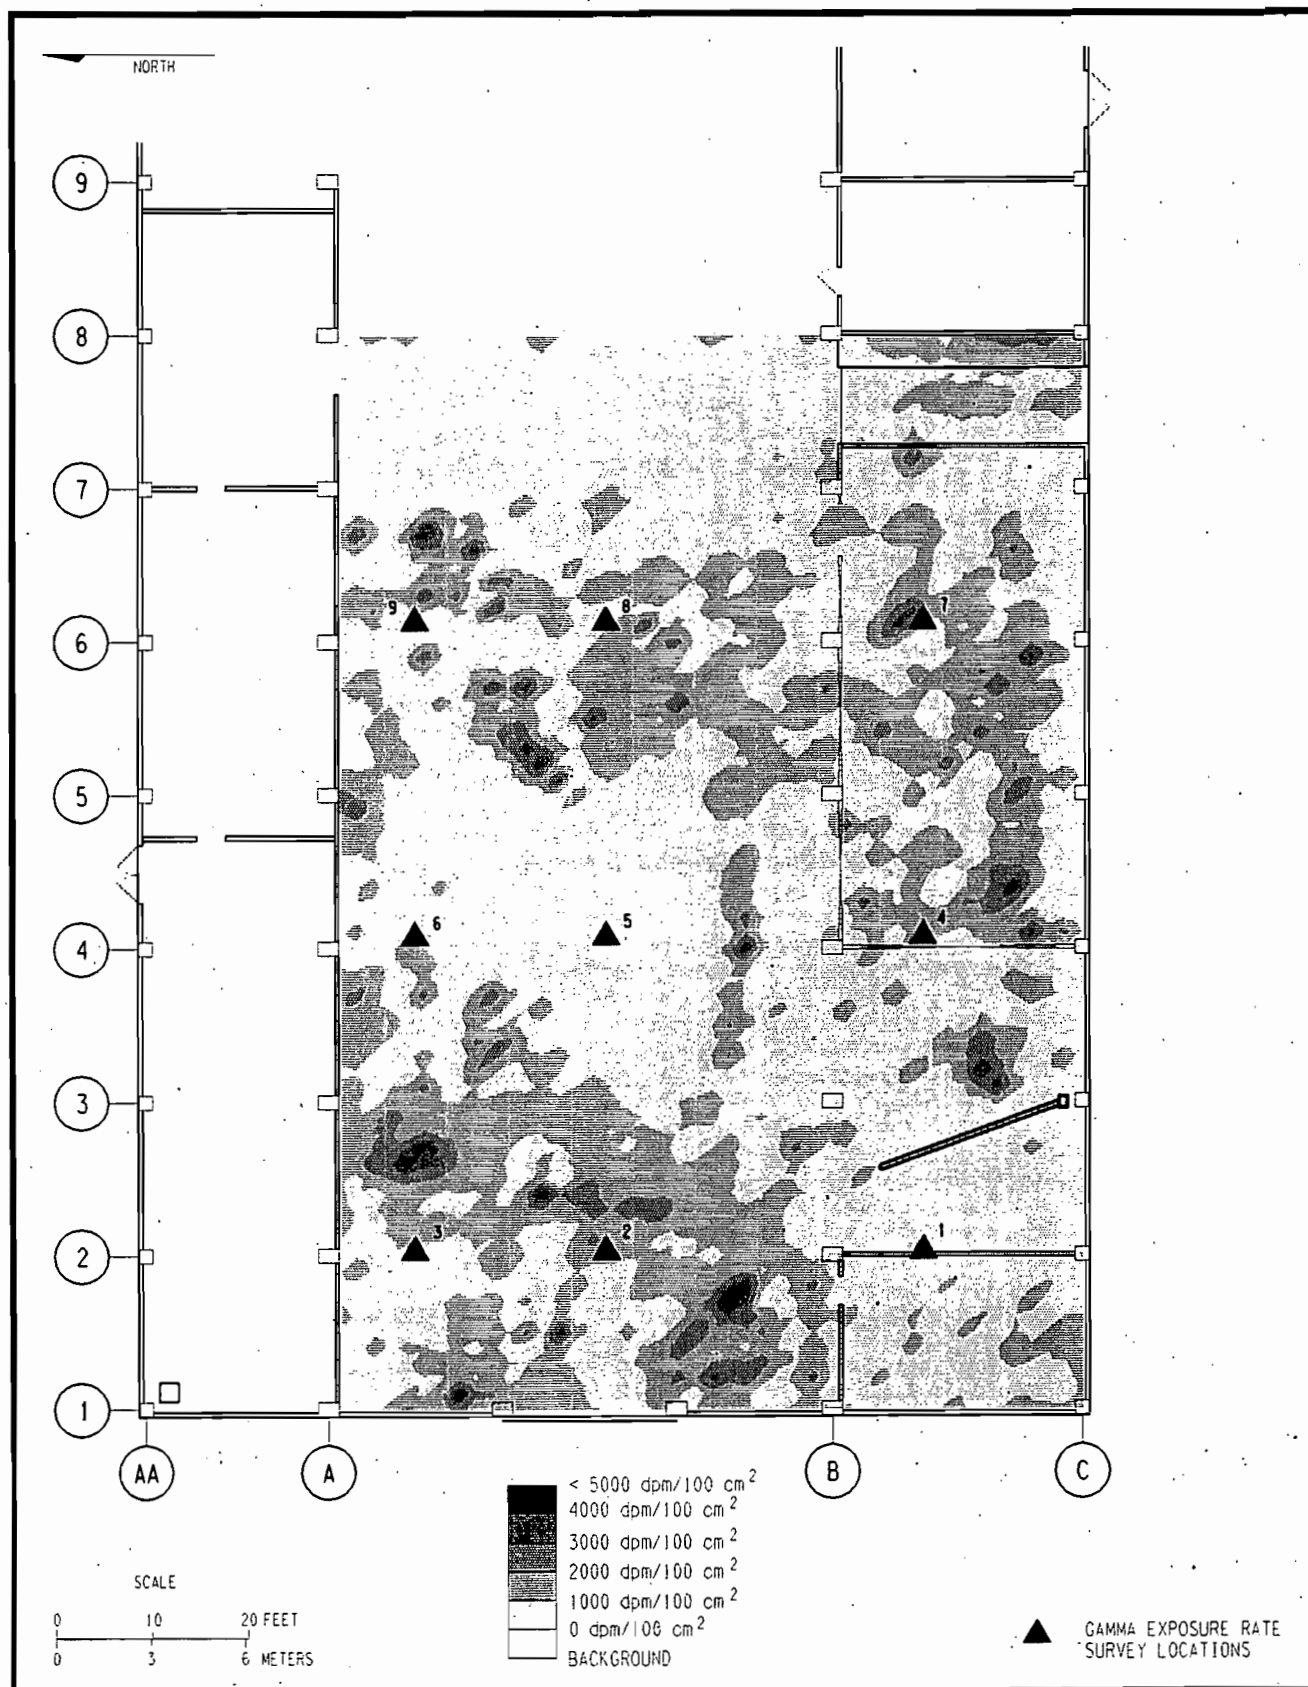
Figure 10
Chapman Valve Post-Remedial Action Floor Survey

Figure 10 shows survey results of 1,598 survey locations on the floor of Building 23; all results were below DOE Order 5400.5 criteria. Fixed beta-gamma contamination was the contaminant of concern on the floor; therefore, only fixed beta-gamma measurements are summarized in Figure 10. The average fixed beta-gamma measurement was 914 dpm/100 cm²; the minimum was -872 dpm/100 cm²; and the maximum was 4,934 dpm/100 cm². (Negative numbers indicate that the measurement was less than the minimum detectable activity and that after background was subtracted, the numerical value was negative.) A soil sample was also collected in the area where part of the west equipment door ramp was removed. Analytical results are presented in Table 9. The analytical result for uranium-238 was 2.0 pCi/g; for radium-226, the result was 0.47 pCi/g; and for thorium-232, the result was 0.41 pCi/g. A site-specific uranium guideline for CHV was not determined; however, these results were well below the typical uranium-238 guideline of 35 to 50 pCi/g for a FUSRAP site. The radium-226 and thorium-232 results are below the DOE Order 5400.5 criterion of 5 pCi/g for surface soils.

A backhoe and skid steer loader equipped with a hoe-ram attachment were used to remove the wooden block and concrete pads above the base slab in the main bay and the B-series rooms on the south side of Building 23 between columns 1 and 8. The wooden blocks and concrete pads were considered clean material based on volumetric sampling results (BNI 1995b) and were placed in a clean pile. This

material was left onsite, with the concurrence of the property owner. The floor was vacuumed with HEPA-filtered vacuums, and the dust was collected.

Self-tapping steel floor anchors were removed with a jackhammer and surveyed. Any floor anchors containing above-background contamination were placed in the intermodal container for disposal at the licensed disposal facility. Areas of the floor that required further decontamination were mechanically cleaned with side grinders equipped with vacuum shrouds connected to HEPA-filtered vacuums. During the survey of the floor, it was determined that part of the ramp at the west equipment door of Building 23 needed to be removed to provide access to contamination under the ramp. The portions of the ramp requiring removal were broken up with a jackhammer and a skid steer loader equipped with a hoe-ram attachment.
