## 7.0 Green River, Utah, Disposal Site

### 7.1 Compliance Summary

The Green River, Utah, Uranium Mill Tailings Radiation Control Act (UMTRCA) Title I Disposal Site was inspected on April 30, 2024. No changes were observed on the disposal cell or in the associated drainage features. Inspectors identified several minor maintenance issues at the site but did not identify concerns that required a follow-up or contingency inspection.

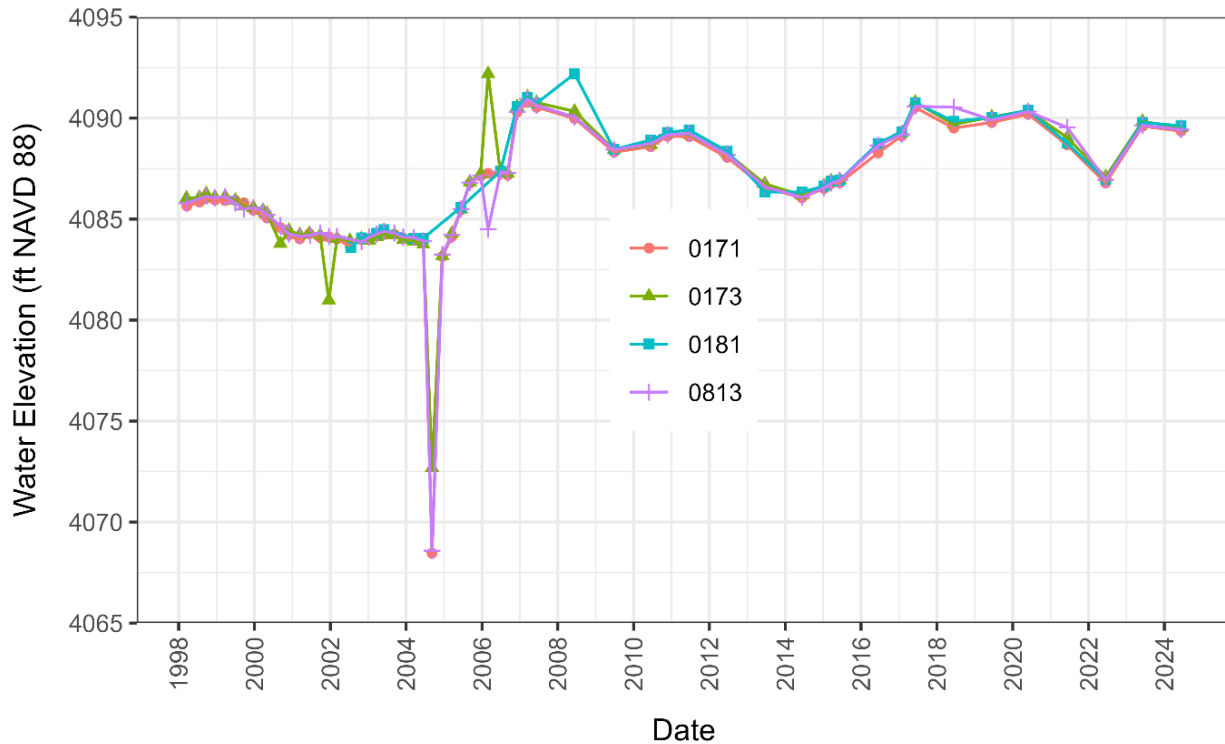
Figure 7-3. Groundwater Elevations at the Green River, Utah, Disposal Site, 1998–2024

In accordance with the LTSP, water levels in the POC wells are measured routinely. As shown in Figure 7-3, groundwater elevations measured from 1998 to 2024 typically have been consistent across the four POC wells, generally ranging from 4085 to 4090 ft. Water level data plotted in this figure are referenced to the North American Vertical Datum of 1988 (NAVD 88).

**Note:** The 11–15 ft drop in water levels in wells 0171, 0173, and 0813 recorded in September 2004 may have been due to instrument error or human error in recording the original field record. However, there is no conclusive evidence of error and the data as shown are consistent with available documentation.

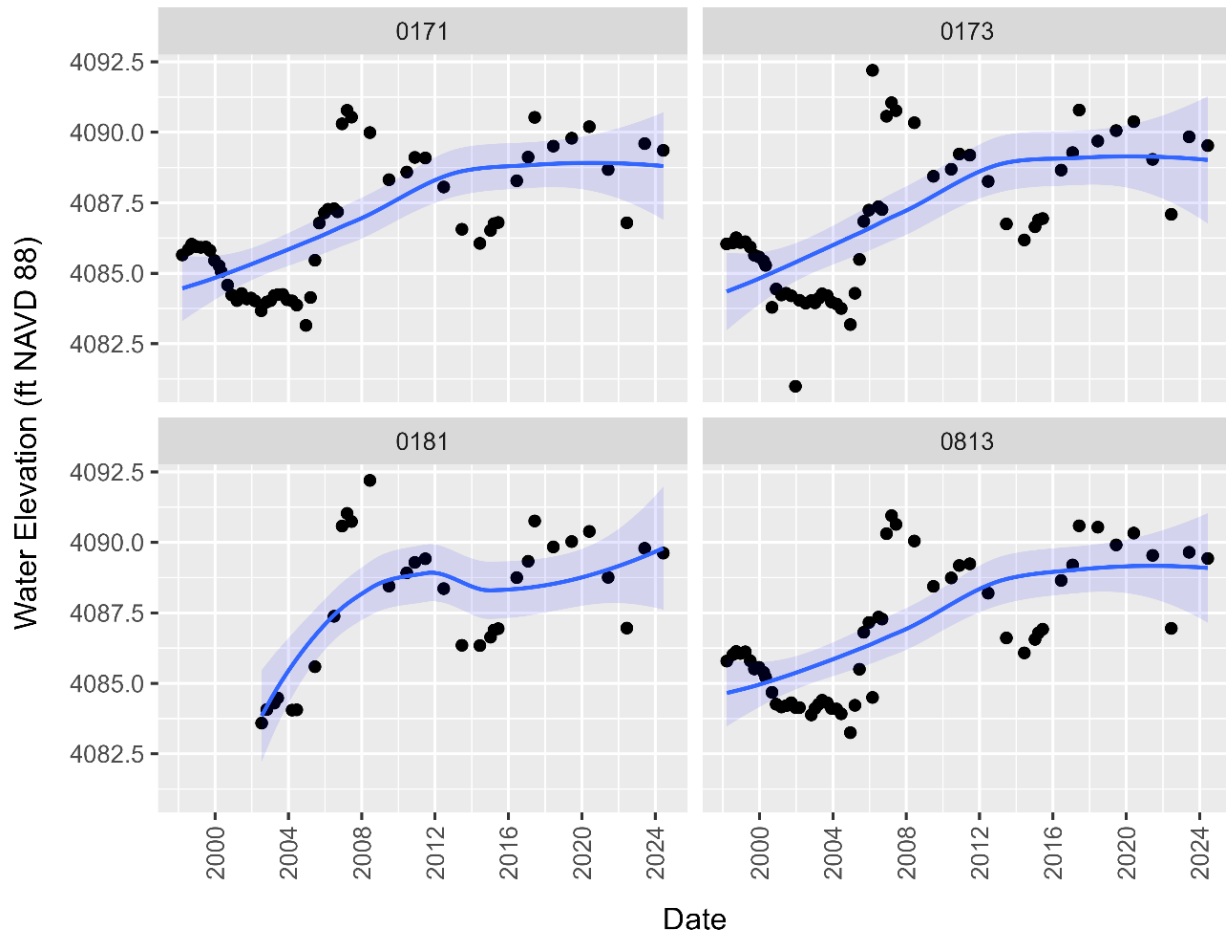
*Figure 7-4. 1998–2024 Groundwater Elevations at Green River, Utah, Disposal Site, POC Wells Excluding September 2004 Outlier Measurements*

Groundwater elevations in all four POC wells increased about 5 ft between 2004 and 2008 and have fluctuated since then (Figure 7-4). For the 1998–2024 time frame, Mann-Kendall trend analysis indicates statistically significant increasing trends in all four wells. Because of the periodic wide fluctuations in water levels since 2004, no significant trend is indicated if the dataset is limited to 2010–2024.

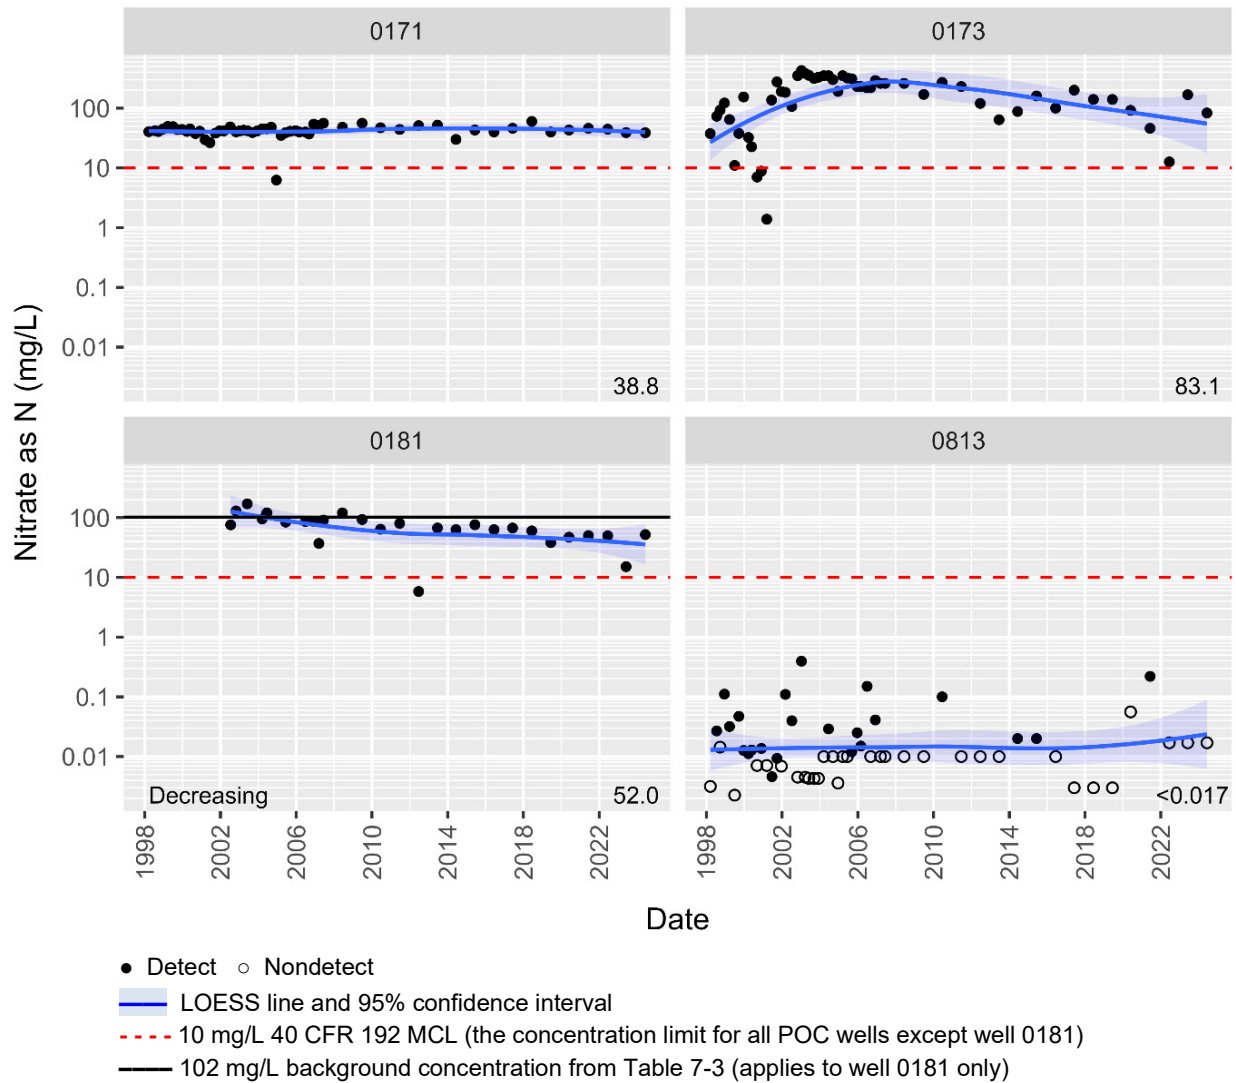
Figure 7-5. Nitrate Concentrations at POC Wells at the Green River, Utah, Disposal Site

Nitrate concentrations continue to exceed the 10 mg/L MCL in wells 0171, 0173, and 0181 (Figure 7-5). Nitrate concentrations have been stable in well 0171, averaging about 43 mg/L, but highly variable in well 0173 (with a mean and standard deviation of  $181 \pm 118$  mg/L). Nitrate concentrations in well 0181 (52.0 mg/L in 2024) have been below the concentration limit (background value of 102 mg/L) since 2009 but typically above the 10 mg/L MCL. Nitrate concentrations in well 0813 have been well below the 10 mg/L MCL; most results have been below detection limits.

For the 1998–2024 time frame, a significant decreasing trend in nitrate concentrations was found for well 0181 (no significant trend in the remaining wells). For the 2008–2024 dataset (after 2008, wells were consistently sampled annually), significant decreasing trends were found for all wells except well 0813 (Table 7-5).

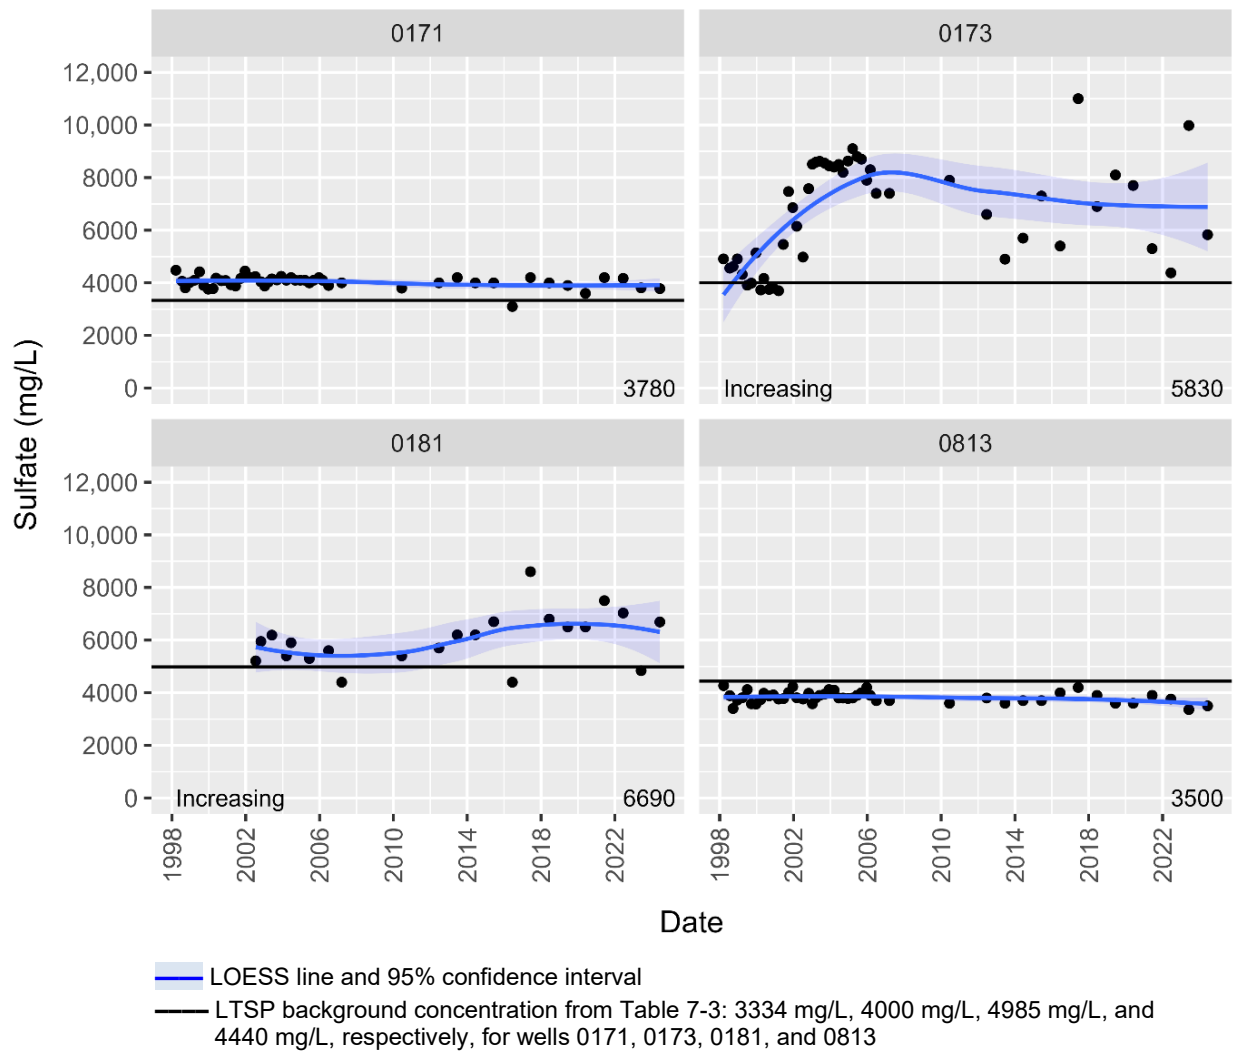
Figure 7-6. Sulfate Concentrations at POC Wells at the Green River, Utah, Disposal Site

Figure 7-6 shows the time-concentration plots for sulfate in POC wells relative to the corresponding well-specific background concentration limits listed in Table 7-3. Sulfate concentrations typically exceed the LTSP background concentrations in all wells except 0813 (Figure 7-6). Sulfate concentrations in well 0171 have been stable (averaging about 4000 mg/L), while those in well 0173 have been the highest and most variable, particularly since 2010. Consistent with most historical measurements, sulfate concentrations in well 0181 exceeded the corresponding concentration limit (4985 mg/L). Sulfate concentrations in well 0813 remain below the corresponding concentration limit of 4440 mg/L (Figure 7-6).

Using the full (1998–2024) dataset, significant increasing trends in sulfate concentrations were found for wells 0173 and 0181 (Table 7-5). For well 0173, this finding stems largely from the approximate doubling of sulfate concentrations between 1998 and 2006. Using the 2008–2024 time frame, no significant trend in sulfate concentrations were found for any POC well.

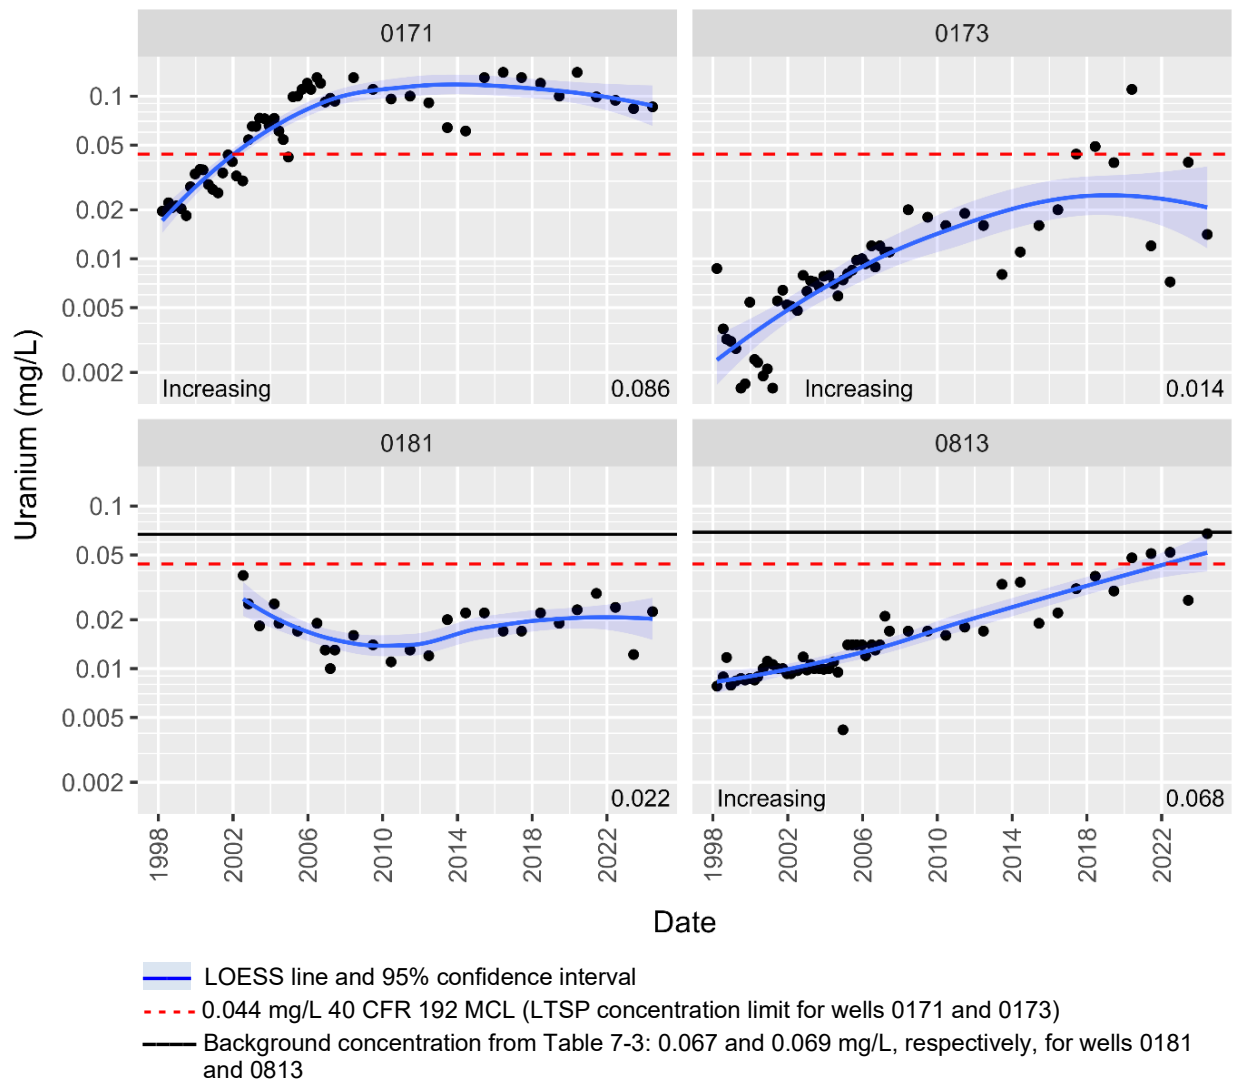
Figure 7-7. Uranium Concentrations at POC Wells at the Green River, Utah, Disposal Site

Figure 7-7 shows the time-concentration plots for uranium in POC wells relative to the LTSP concentration limits listed in Table 7-3. In 2024, uranium concentrations exceeded the corresponding LTSP concentration limit only in well 0171 (Table 7-4), where results have exceeded the 0.044 mg/L MCL since late 2002 (with one exception). As observed for nitrate and sulfate, uranium concentrations in well 0173 have been highly variable since 2010 and appear to be somewhat correlated with fluctuating water levels in this well (Figure 7-4).

Based on the full (1998–2024) dataset, a significant increasing trend in uranium concentrations was found for all but one well (0181). For the 2008–2024 time frame, the trend is still increasing for wells 0173 and 0813 (Table 7-5). This increasing trend is particularly apparent in well 0813, where the most recent result (0.068 mg/L)—the highest on record for this well since the LTSP was issued—is nearly equal to the corresponding 0.069 mg/L concentration limit.

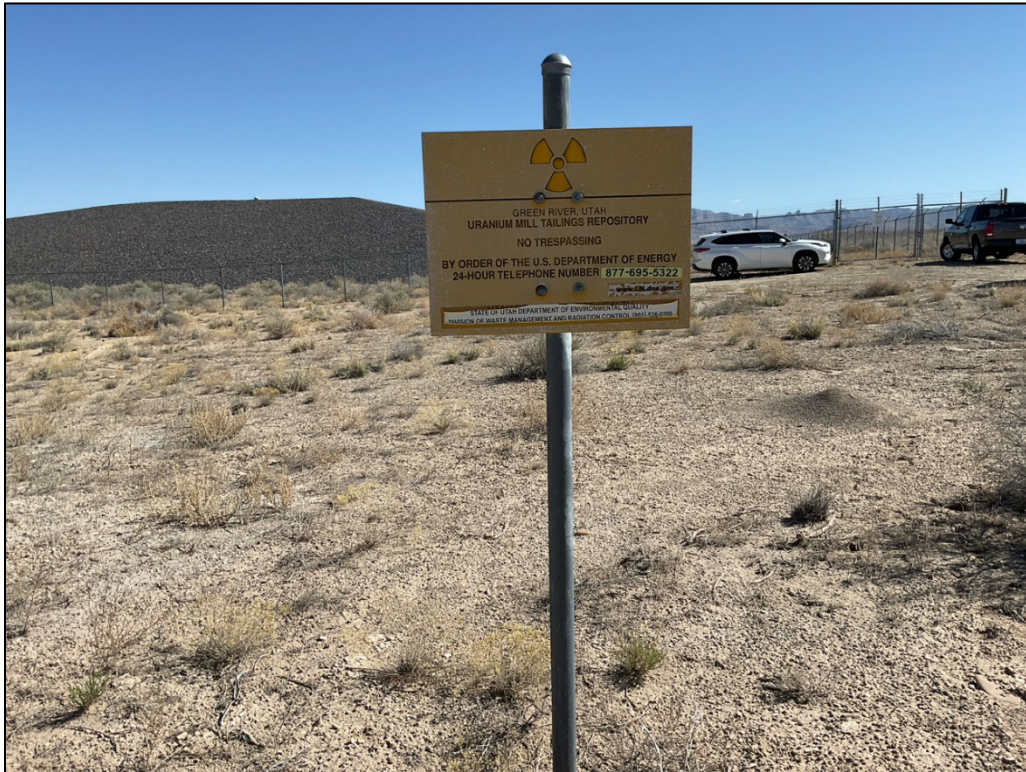
*PL-1. Entrance Sign*

Access to the site is either from U.S. Highway 6 and 50 heading east from the Town of Green River or from U.S. Interstate 70 via S 1600 E Street. The paved access road crosses property owned by the state and the U.S. Army. Access was granted to LM through right-of-way agreements with both entities. Entrance to the site is through an open gate in the paved road right-of-way fence; LM does not own the gate or the right-of-way fence and access via the gate is not controlled. Past this gate, a dirt road leads across state land to the site. The access road divides near the entrance to the disposal cell, with one branch leading to a locked gate in the security fence that encloses the disposal cell and the other providing access around the outside of the security fence. The entrance sign is next to the access road where it enters the site. The sign is heavily faded and will be replaced before the next annual inspection (PL-1). The lock on the steel site access gate in the right-of-way was in place and working as intended. No other maintenance needs were identified.

- Replacement of the entrance sign
- Replacement of perimeter signs P1, P2, P5, P6, P8, P11, and P12
- Installation of a T-post as a marker near boundary monument BM-7
- Treatment of vegetation and debris along the security fence

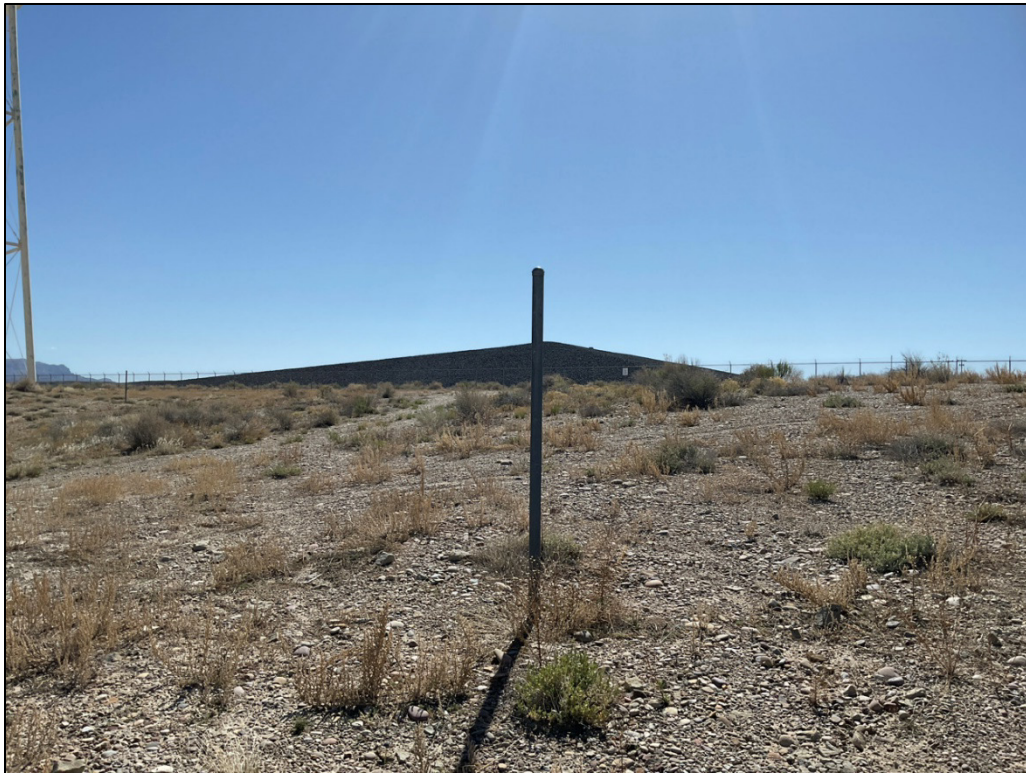
*PL-2. Perimeter Sign P2*

Seventeen perimeter signs, attached to steel posts set in concrete, are positioned along the unfenced property boundary. Perimeter signs P1, P2 (PL-2), P5, and P6 were missing and will be replaced before the next annual inspection. Perimeter signs P8 and P11 were faded and will be replaced before the next annual inspection. Perimeter sign P12 was dented and will be replaced before the next annual inspection. All other perimeter signs were present with several that were dented, had bullet holes, or sun damage (faded or illegible). Perimeter signs P1, P2, P5, P6, P8, P11, and P12 will be replaced before the next annual inspection along with any other perimeter signs exhibiting damage. Two new signs for prohibited activities and emergency instructions were installed along the security fence at the entrance gate during the 2024 inspection. No other maintenance needs were identified.

The area between the security fence and the site boundary is primarily open space but includes access roads, a stormwater diversion channel, and monitoring wells. The site property boundary is not fenced, and trespassing occurs on the site from several access points through state- and privately owned land. Unauthorized access to the site is primarily from the west through a former mill access gate that has been broken off its hinges; LM is not responsible for the gate or associated fence. The site is also accessible through remote, unfenced, open-access points to the north and east. The site will continue to be monitored for adverse public use typically indicated by trash, tire ruts, fire rings, and vandalism. Inspectors did not find new trash dumps or indications of vandalism (except for missing perimeter sign P2) during the inspection.

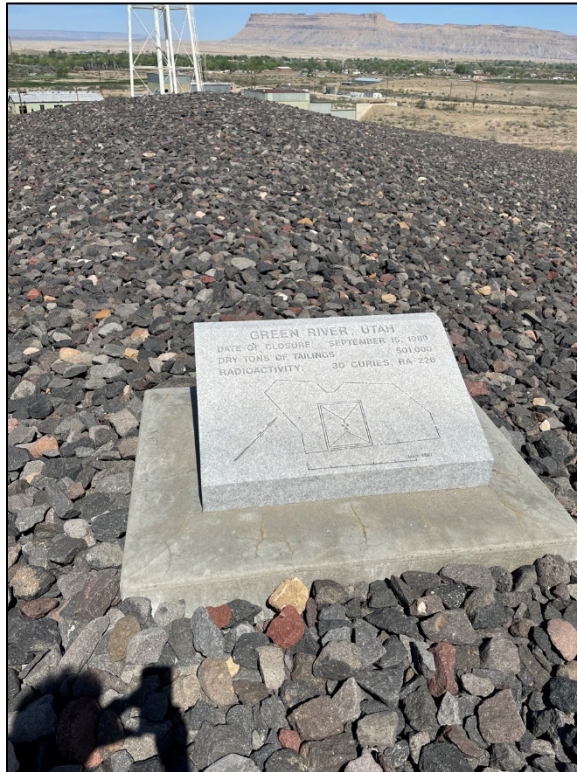
*PL-3. Site Marker SMK-2*

The site has two granite markers. Site marker SMK-1 is inside the security fence near the southwest corner of the site, and site marker SMK-2 (PL-3) is on the top of the disposal cell. The concrete base of site marker SMK-1 has several minor cracks, but they do not compromise the integrity of the base, and repairs are not necessary at this time. No maintenance needs were identified.

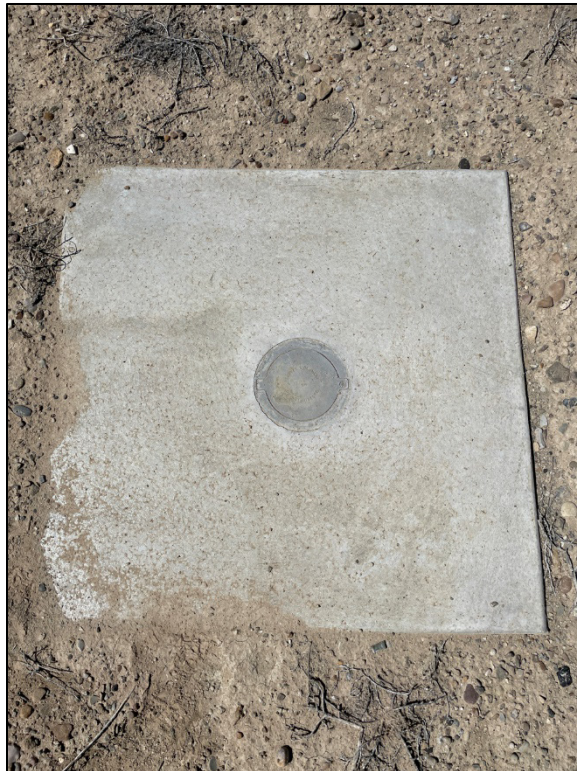
*PL-4. Quality Control Monument QC-3*

Four aerial survey quality control monuments (PL-4) were inspected. No maintenance needs were identified.

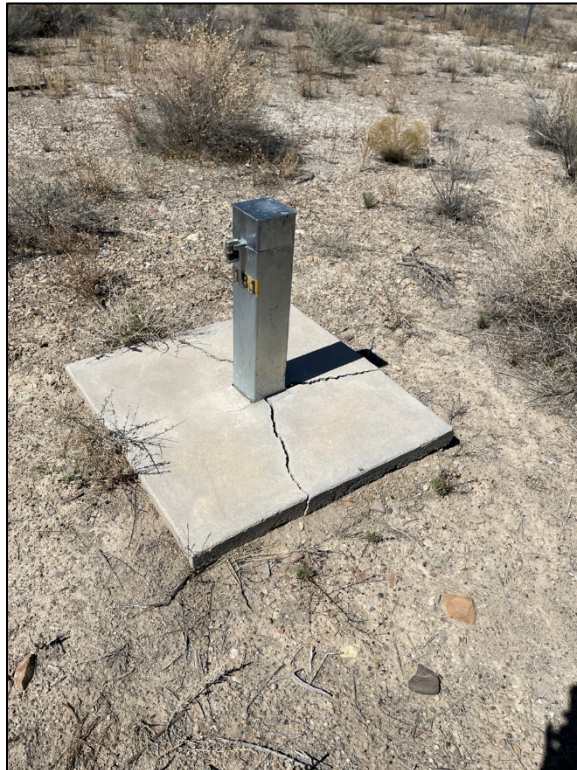
*PL-5. Monitoring Well 0181*

Twenty-two monitoring wells are on or near the site. The LTSP establishes four POC wells at the site for postclosure groundwater monitoring. All wellhead protectors observed during the inspection were undamaged. Monitoring well 0181 has a cracked concrete pad (PL-5). Some of the concrete monitoring well pads were cracked, but the wellhead protectors at those wells are stable, and repairs are not necessary at this time. No other maintenance needs were identified.

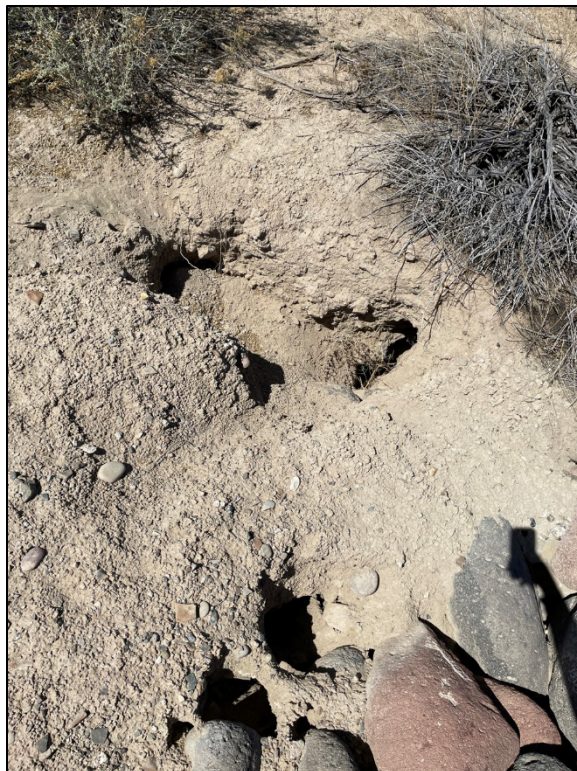
*PL-6. Erosion at South Corner of Disposal Cell*

A boulder-filled trench, known as an apron, surrounds the disposal cell. The apron was intact and stable. Inspectors noted small (less than 8 square feet) instances of erosion and possible soil piping features along the base of the side slopes that have been observed during previous inspections. The rills and piping features are formed from stormwater runoff along the perimeter road draining into the disposal cell apron. This occurrence is not a concern because the erosion is minor and the sediment has not filled the apron or become visible in the apron, indicating that the apron's performance is not adversely affected. Inspectors will continue to monitor these features. Possible erosion or an animal burrow was found on the south corner of the drainage channel (PL-6). Inspectors will continue to monitor the area in the future. No additional maintenance is needed.

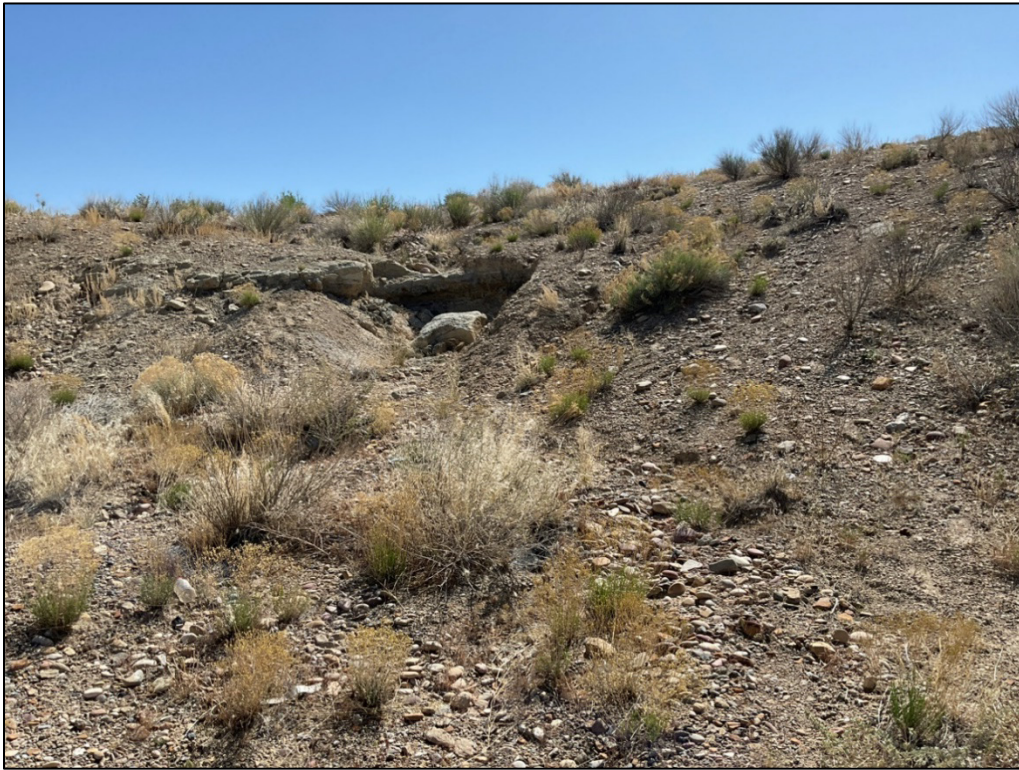
*PL-7. Erosion near Perimeter Sign P7 and the Water Tower*

Signs of erosion noted during previous inspections appear in multiple areas in the site perimeter. Erosional rills are present on the west side of the site near perimeter sign P7 and the water tower (PL-7) but are currently not affecting site surveillance features. Rills and gullies are also present along the escarpment northeast of the disposal cell between boundary monument BM-7 and survey monument SM-3 (approximately 400 feet [ft] from the base of the disposal cell). The maximum gully depth in this area is approximately 3 ft, but the erosion appears to be stabilizing as larger rocks drop to the bottom of the gullies and provide armoring. A portion of the

stormwater diversion channel along the southeast side of the site continues to erode slowly. These erosional features could eventually damage site surveillance features (i.e., perimeter signs, boundary monuments, and the security fence). The closest erosional features are approximately 300 ft from the disposal cell and do not pose a risk to its integrity at this time. Inspectors will continue to monitor these features. No immediate maintenance needs were identified.
