ORNL/TM-11119

**PRELIMINARY SITE
SURVEY REPORT FOR THE
UNIROYAL CHEMICAL COMPANY,
FORMERLY THE
DIAMOND MAGNESIUM COMPANY,
720 FAIRPORT-NURSERY ROAD,
PAINESVILLE, OHIO
(DMP001)**

Date Published - March 1990

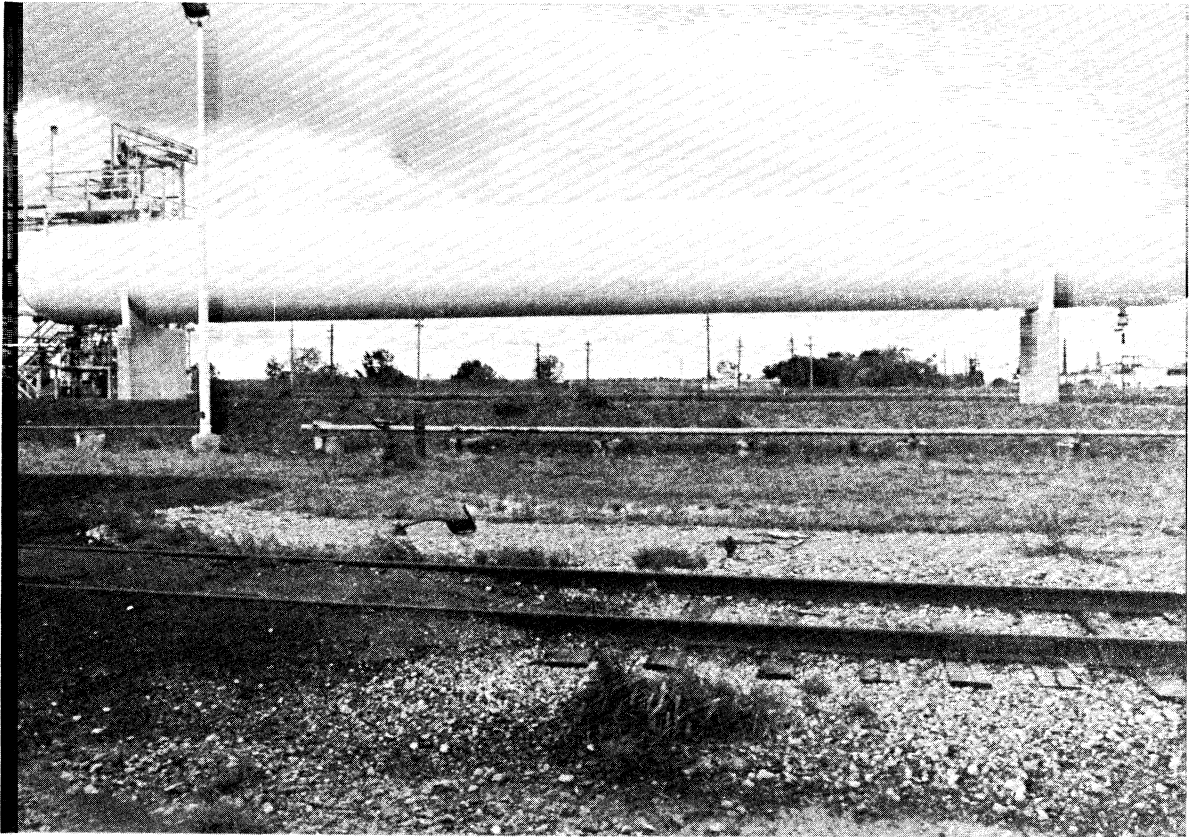
ORNL-PHOTO 3208-89

Fig. 3. View of the butadiene storage tank west of the buildings at Uniroyal Chemical Company, 720 Fairport-Nursery Road, Painesville, Ohio (DMP001).

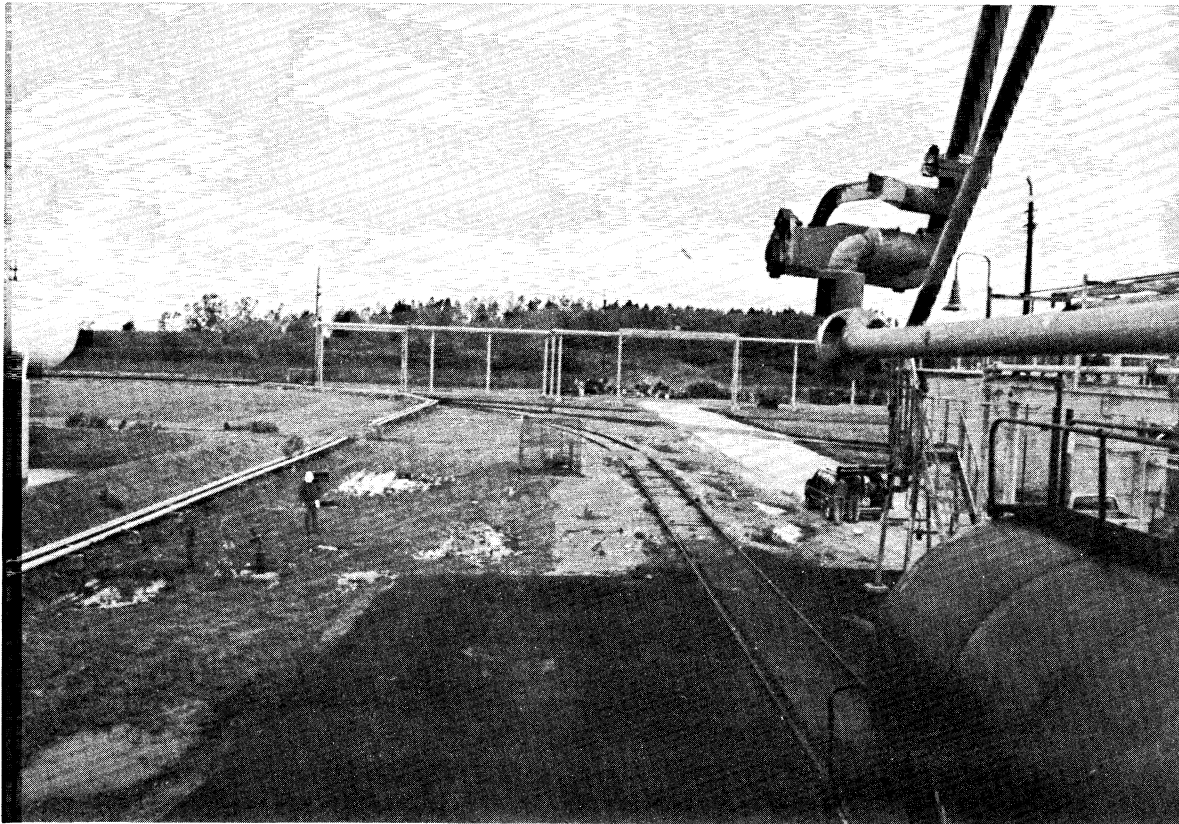
ORNL-PHOTO 3209-89

Fig. 4. Northwestern view of the butadiene storage tank and earthen dike at Uniroyal Chemical Company, 720 Fairport-Nursery Road, Painesville, Ohio (DMP001).

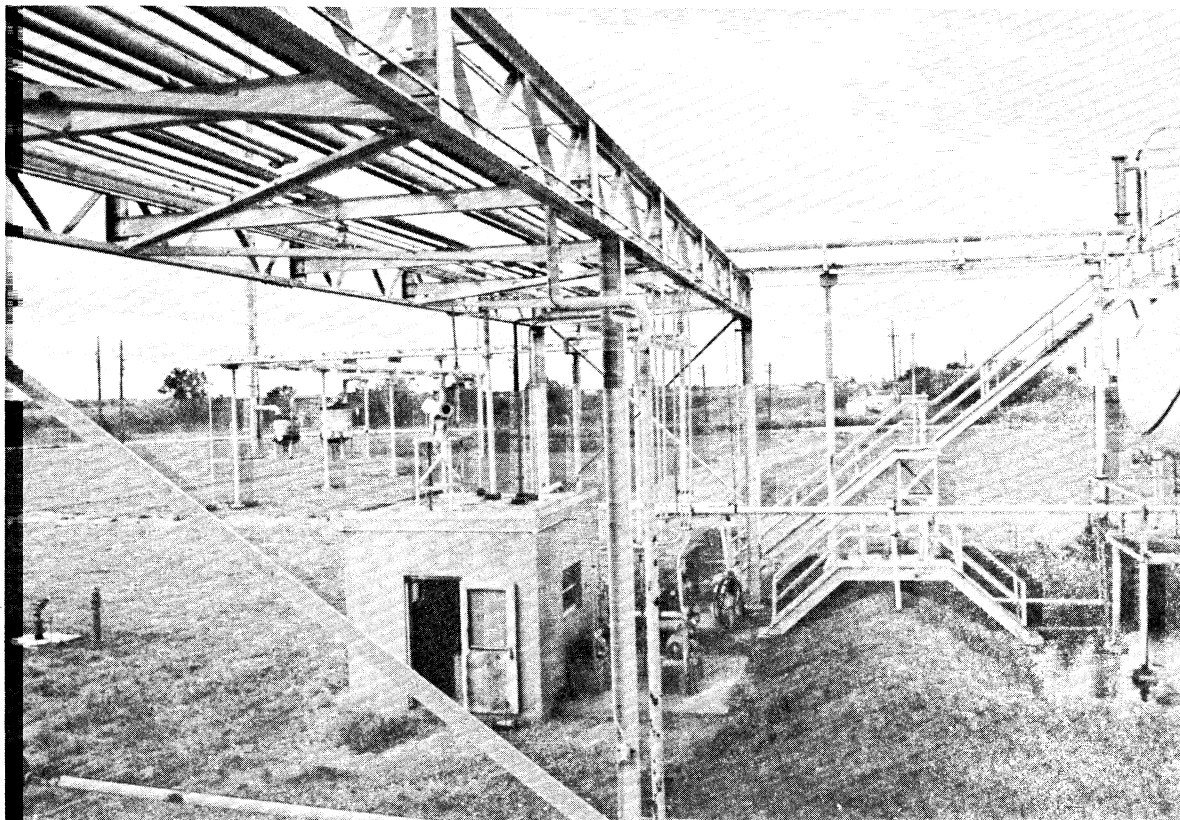
ORNL-PHOTO 3210-89

Fig. 5. Western view of the property, showing the overhead pipe rack system from the southern end of the butadiene storage tank at Uniroyal Chemical Company, 720 Fairport-Nursery Road, Painesville, Ohio (DMP001).

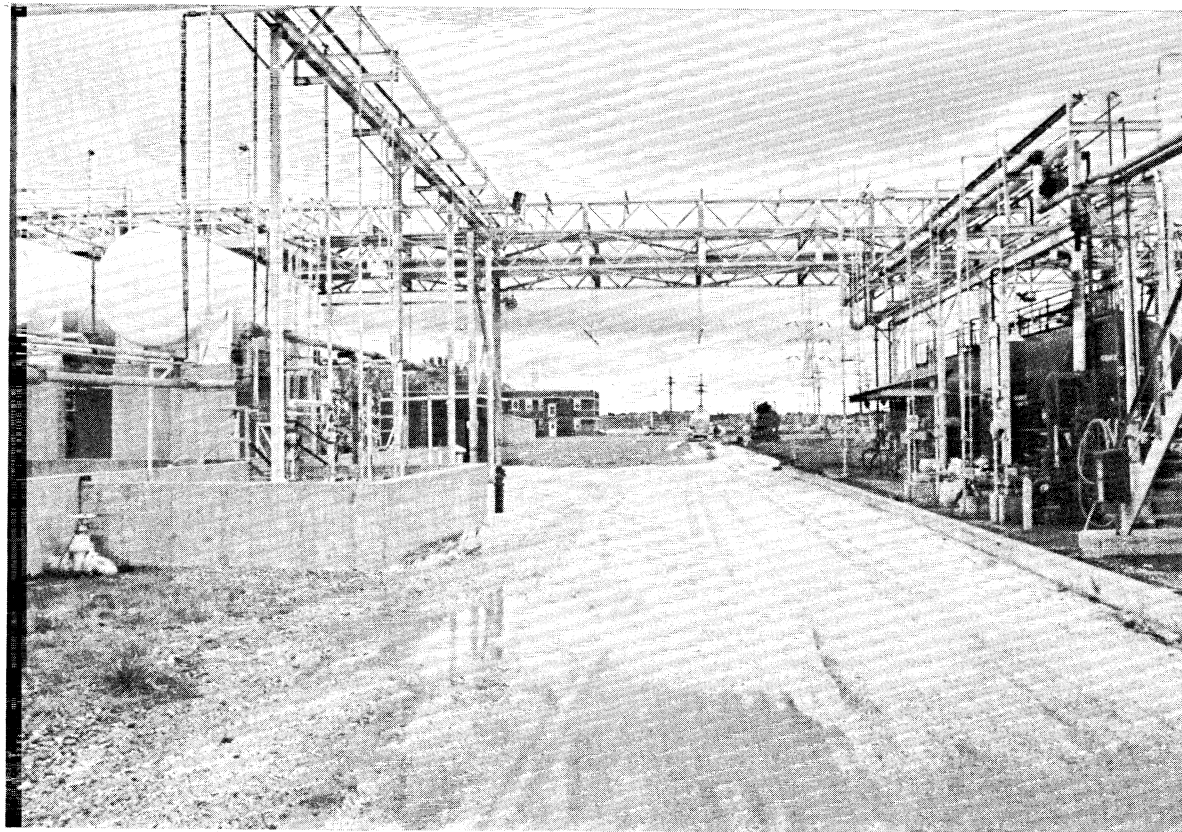
ORNL-PHOTO 3211-89

Fig. 6. Southern view of the overhead pipe rack system between the buildings on the left and the spill containment area on the right at Uniroyal Chemical Company, 720 Fairport-Nursery Road, Painesville, Ohio (DMP001).

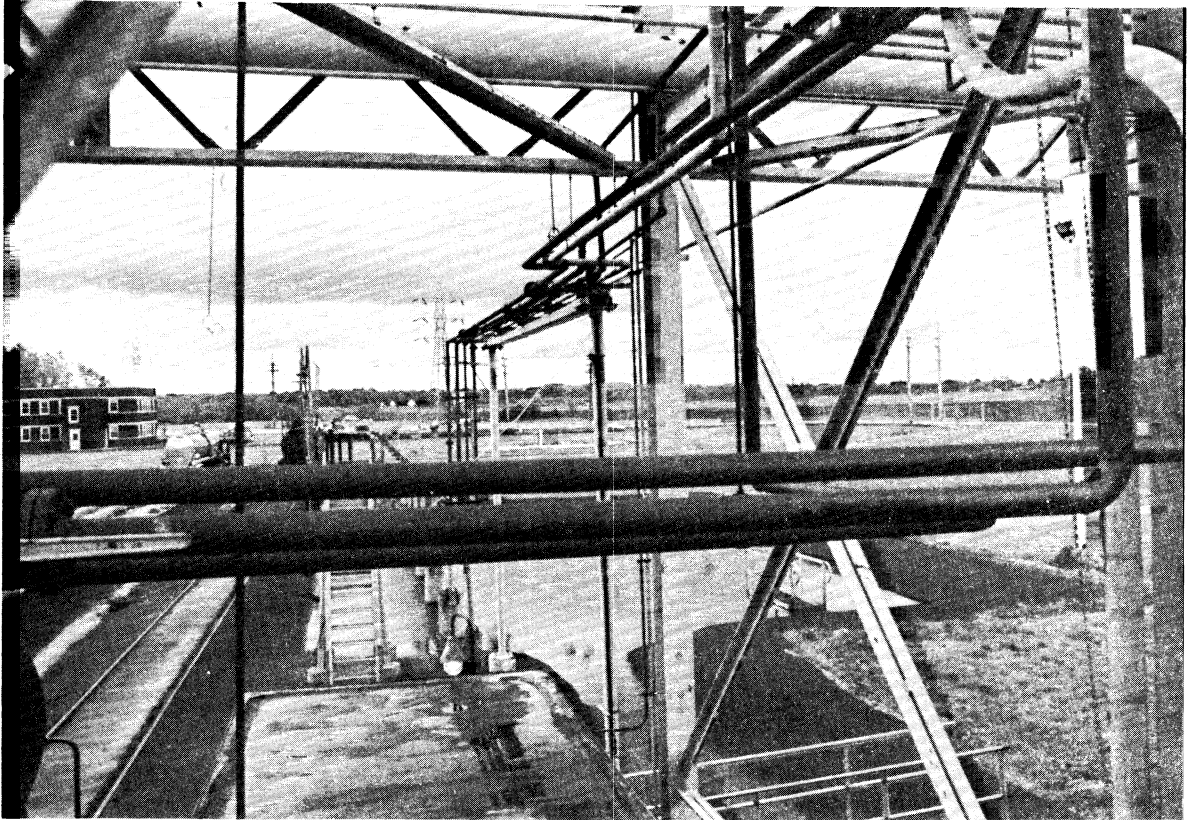
ORNL-PHOTO 3212-89

Fig. 7. Southern view of the spill containment area for railroad tank cars, showing the spill retention basin west of the buildings at Uniroyal Chemical Company, 720 Fairport-Nursery Road, Painesville, Ohio (DMP001).

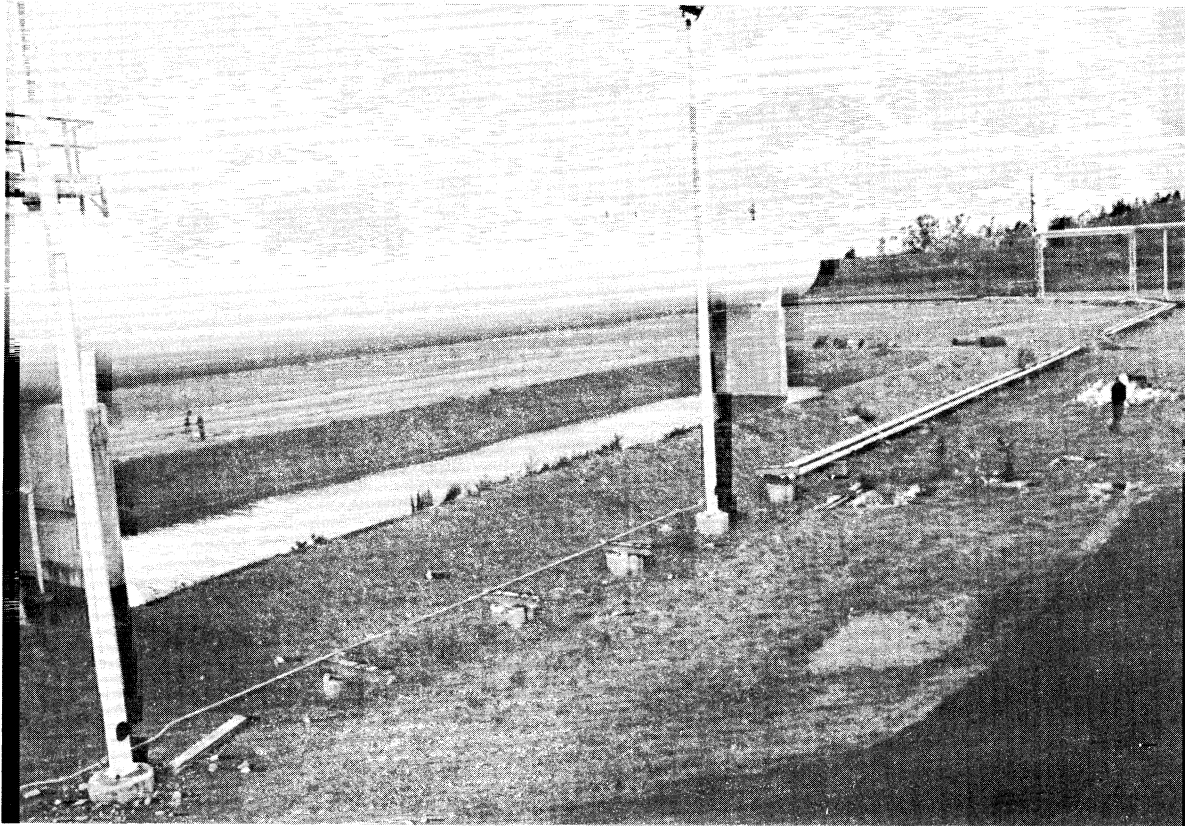
ORNL-PHOTO 3213-89

Fig. 8. Northern view of the property from the spill containment area west of the buildings at Uniroyal Chemical Company, 720 Fairport-Nursery Road, Painesville, Ohio (DMP001).

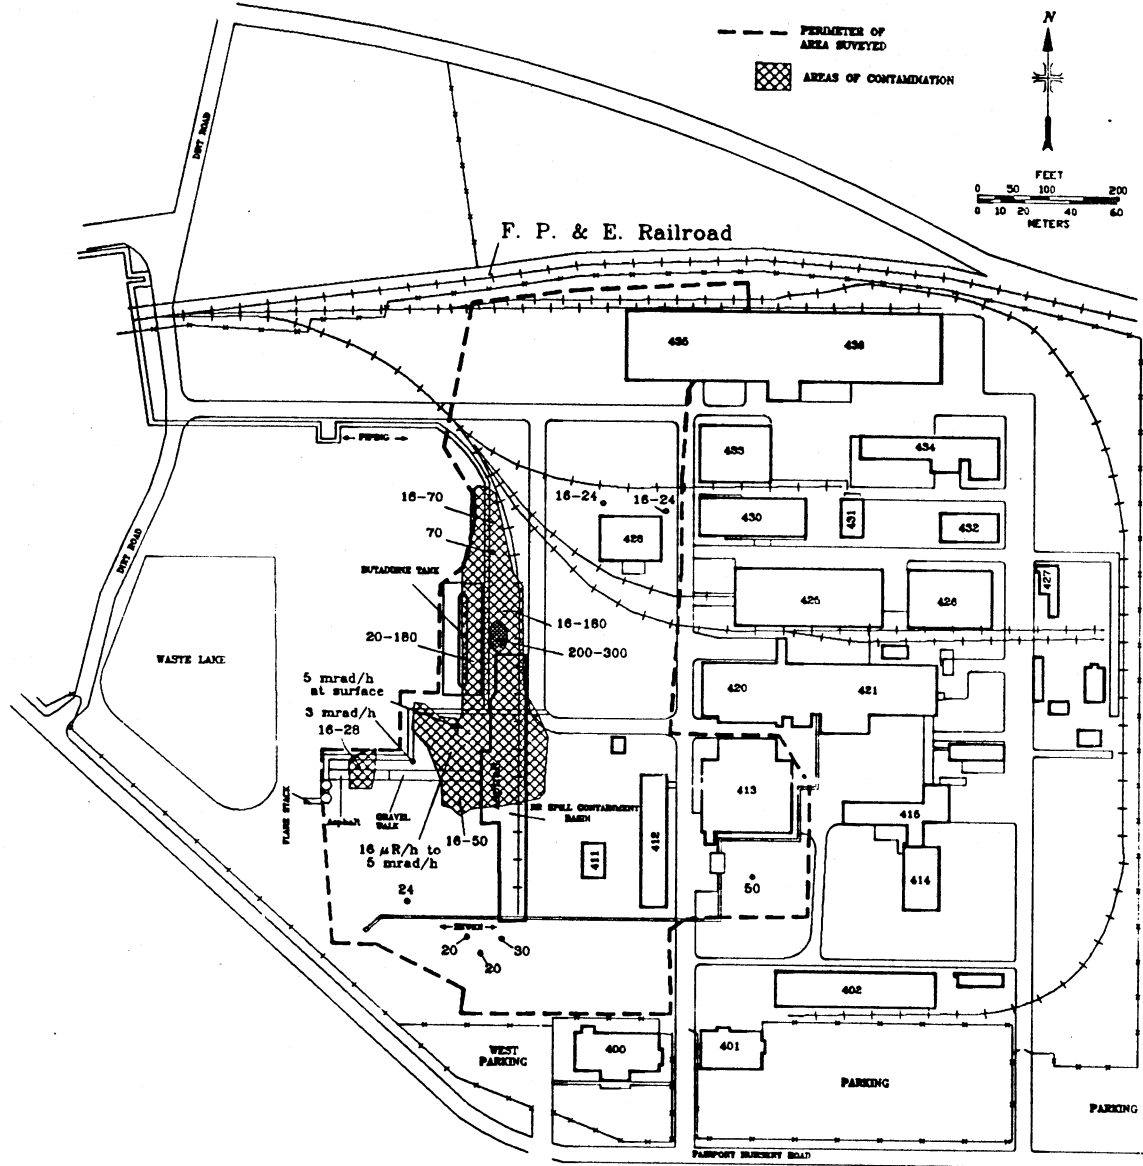
ORNL-DWG 89-13119

Gamma radiation levels measured during a gamma scan of selected portions of the property surface west of the buildings are given in Fig. 9. Gamma exposure rates over the major portion of the property ranged from 4 to 8 $\mu\text{R/h}$. However, the section involving the spill containment area and a number of smaller spots had elevated gamma levels, ranging up to 5 mrad/h at the ground surface. The larger areas of elevated measurements are shaded in Fig. 9. The two highest levels were within this shaded area. One spot, measuring 5 mrad/h on the surface, was found south of the pipe rack and yielded a "stone" with an exposure rate of 50 mrad/h at 1 cm. Soil sample B1 was taken from this location. The other spot, east of the flare stack, had gamma levels of 3 mrad/h on the surface and yielded a "stone", measuring 20 mrad/h at 1 cm. Soil sample B4 was taken from this area. Although the "stones" appeared to contain a majority of the activity, additional contamination was associated with each area. Elevated gamma levels were evident apparently under the asphalt in several places in the spill containment area; however, no samples were taken from beneath the asphalt. The fire water lines had been installed through the most heavily contaminated regions which ranged from 8 to 150 $\mu\text{R/h}$. Soil samples B3, B6, B7, and B8 were taken in this grassy area. The soil making up part of the dike was elevated, and high spots were found both inside and outside the dike wall and at the level of the surrounding soil. Soil sample B5 was taken near the flare stack in an area with exposure rates ranging from 16 to 28 $\mu\text{R/h}$. Other scattered spots ranged from 16 to 24 $\mu\text{R/h}$. A cluster of spots were found around the sanitation filter, south of the sewer ditch, measuring between 10 and 30 $\mu\text{R/h}$.

Fig. 9. Gamma radiation levels ($\mu\text{R}/\text{h}$) measured on selected portions of the property surface at Uniroyal Chemical Company, 720 Fairport-Nursery Road, Painesville, Ohio (DMP001).

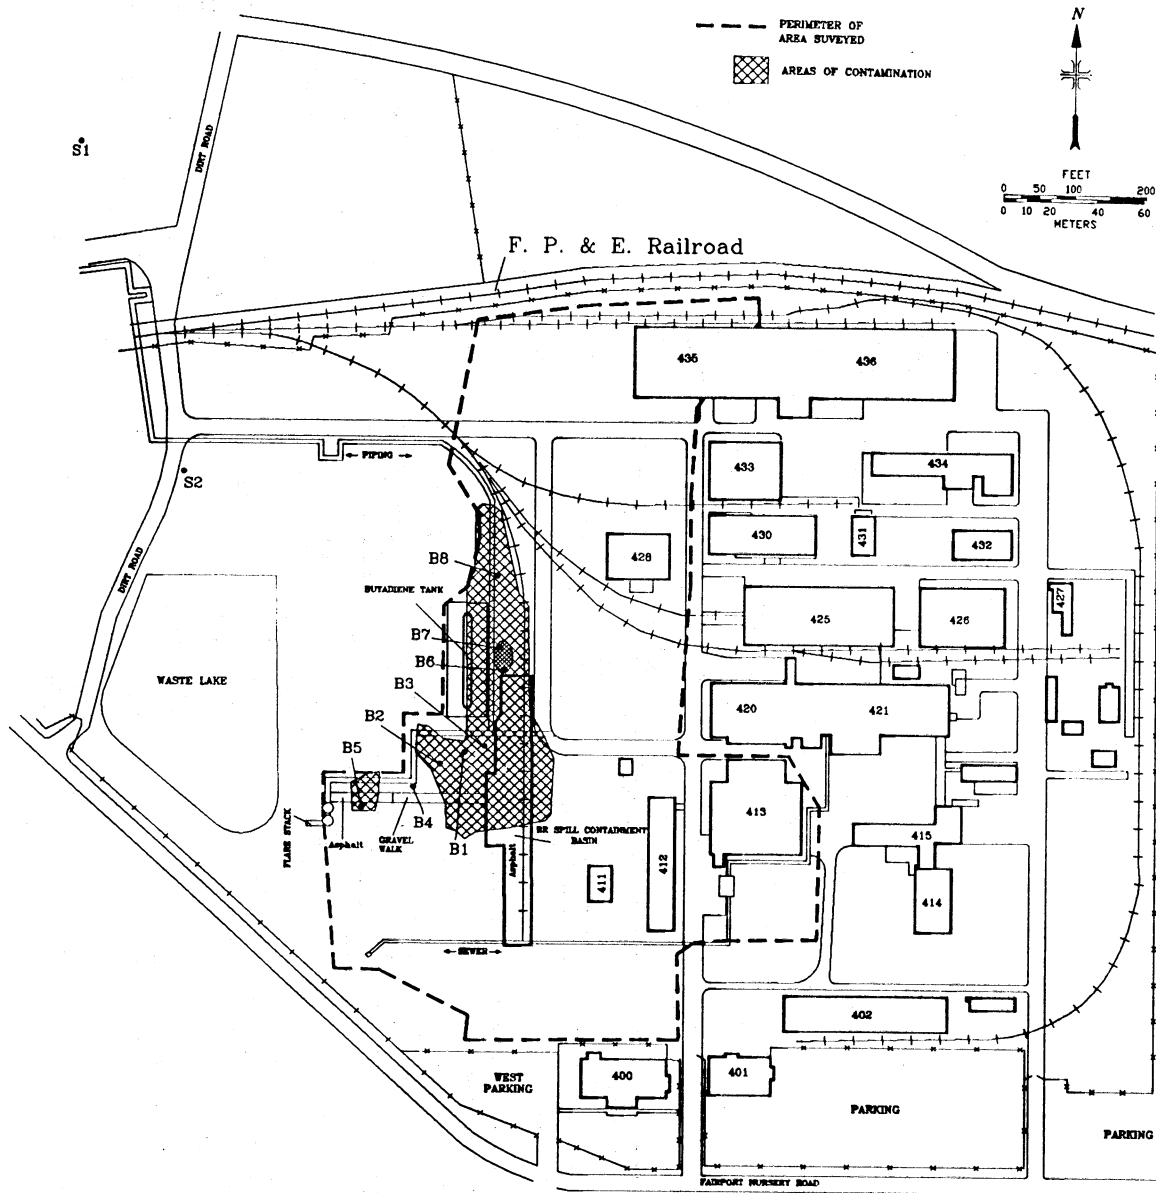
ORNL-DWG 89-13181

Systematic and biased soil samples were taken from various locations on the property for radionuclide analyses. Locations of the systematic (S) and biased (B) samples are shown in Fig. 10, with results of laboratory analyses provided in Table 3. Concentrations of radium, thorium, and uranium in the systematic samples were all near background levels for the Ohio area (Table 2), ranging from 1.30 to 1.39 pCi/g, 1.14 to 1.33 pCi/g, and <1.51 to 1.91 pCi/g, respectively. Concentrations of radium, thorium, and uranium in the biased samples ranged from 1.92 to 1200 pCi/g, 0.54 to <2.81 pCi/g, and 2.04 to 130 pCi/g, respectively. DOE guidelines for uranium are derived on a site-specific basis. While none have been derived for this site, guidelines for ²³⁸U typically range between 35 and 150 pCi/g.

Many of the biased soil samples were above DOE guideline values for radium and uranium (Table 1). Biased sample B6B contained the highest concentrations of these two radionuclides, with values of 1200 pCi/g for ^{226}Ra and 130 pCi/g for ^{238}U .

Fig. 10. Diagram showing locations of soil samples taken at Uniroyal Chemical Company, 720 Fairport-Nursery Road, Painesville, Ohio (DMP001).

Measurements and results of soil sample analyses taken at 720 Fairport-Nursery Road indicate that the property contained radioactive contamination, from both ^{238}U and ^{226}Ra . The concentration and extent of uranium and radium in several soil samples taken on this property were in excess of applicable DOE criteria (Table 1). These materials were found at all biased sample locations shown in Fig. 10. Based on the results of this radiological assessment, it is recommended that a follow-up, detailed radiological survey of both surface and subsurface environs be performed to more precisely define the extent of the contamination.
