Fernald Preserve Aquifer Restoration Extraction Well and Pump Maintenance Improvements – 9427

This paper presents the results of 2008 maintenance improvements on the extraction well field at the Fernald Preserve. The maintenance of the extraction well pumps and screens was improved by changing both the chemical mixture used to clean the wells and pumps, and the cleaning technique. Initial results are very favorable. Pump life and well yield appear to be significantly improved. The improvements have also mitigated hazards that workers face and substantially decreased spending.

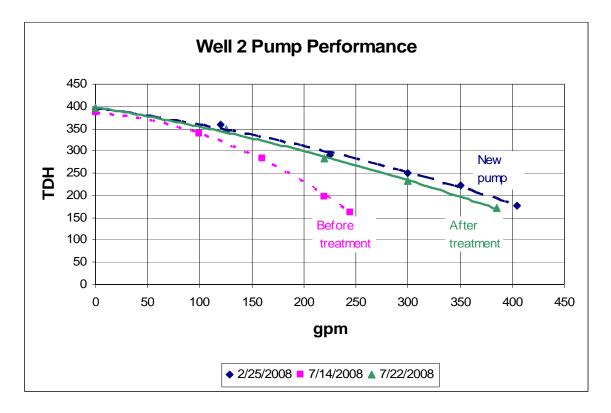
Fig. 3. Performance of Well 2 Pump Before and After Treatment

After surging for several hours manually or overnight using the control system, the pH of the solution in the discharge pipe was checked. If the pH was less than 4, pump surging was continued. When the pH reached or surpassed 4, the solution was pumped to a portable tank, using the well pump. The color of the solution being pumped was observed, and the pH was tested after about 200 gallons had been pumped. Pumping was continued in approximately 200-gallon increments until the pH of the solution was between 6 and 7 and the discharge water was clear. The pump was restarted, with its variable frequency drive or flow control valve set to allow the maximum possible flow rate. The pump was allowed to run at maximum capacity for at least 2 hours, and then the controller was reset to the desired set point. After a day or 2 of routine operation, another performance test was conducted. The results of the before-and-after performance tests were compared to the performance test conducted when the pump was new. Figure 3 below shows the results of cleaning Well 2 with the hydrochloric/glycolic mixture. Treating the well restored its performance almost completely.

After three wells were treated with each chemical combination, it was determined that the mixture of hydrochloric and glycolic acids was much better at improving pump performance than the mixture of sulfamic and glycolic acids was. As of the writing of this paper, 14 of 23 wells have been treated with the hydrochloric/glycolic mixture.

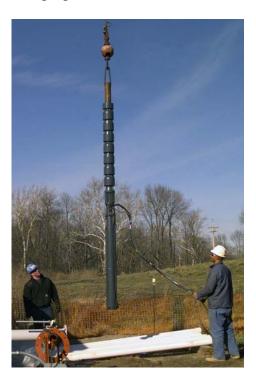
Fig. 4. Installing Pump & Motor in Well

Three main safety improvements have been realized by using the new treatment chemicals. The first is that the pump is treated while still in the well. This eliminated all hazards associated with the use of a crane to pull the discharge pipe, pump, and motor from the well and then reinstall the new pump with the old motor and discharge pipe. Figure 4 below shows workers installing a new pump and motor in a well. The discharge pipe, pump, and motor assemblies typically weigh over 2,000 pounds. The types of hazards eliminated are falling objects from a failed crane or an improper lifting, back injuries from disconnecting discharge pipes, crushed hands from handling discharge pipes, and electrical injuries from improper disconnection or reconnection of the motor.
