Quarterly Site Inspection Report for the Fernald Preserve, Ohio, Site, September 2020

September 2020

U.S. DEPARTMENT OF
ENERGY

Legacy
Management

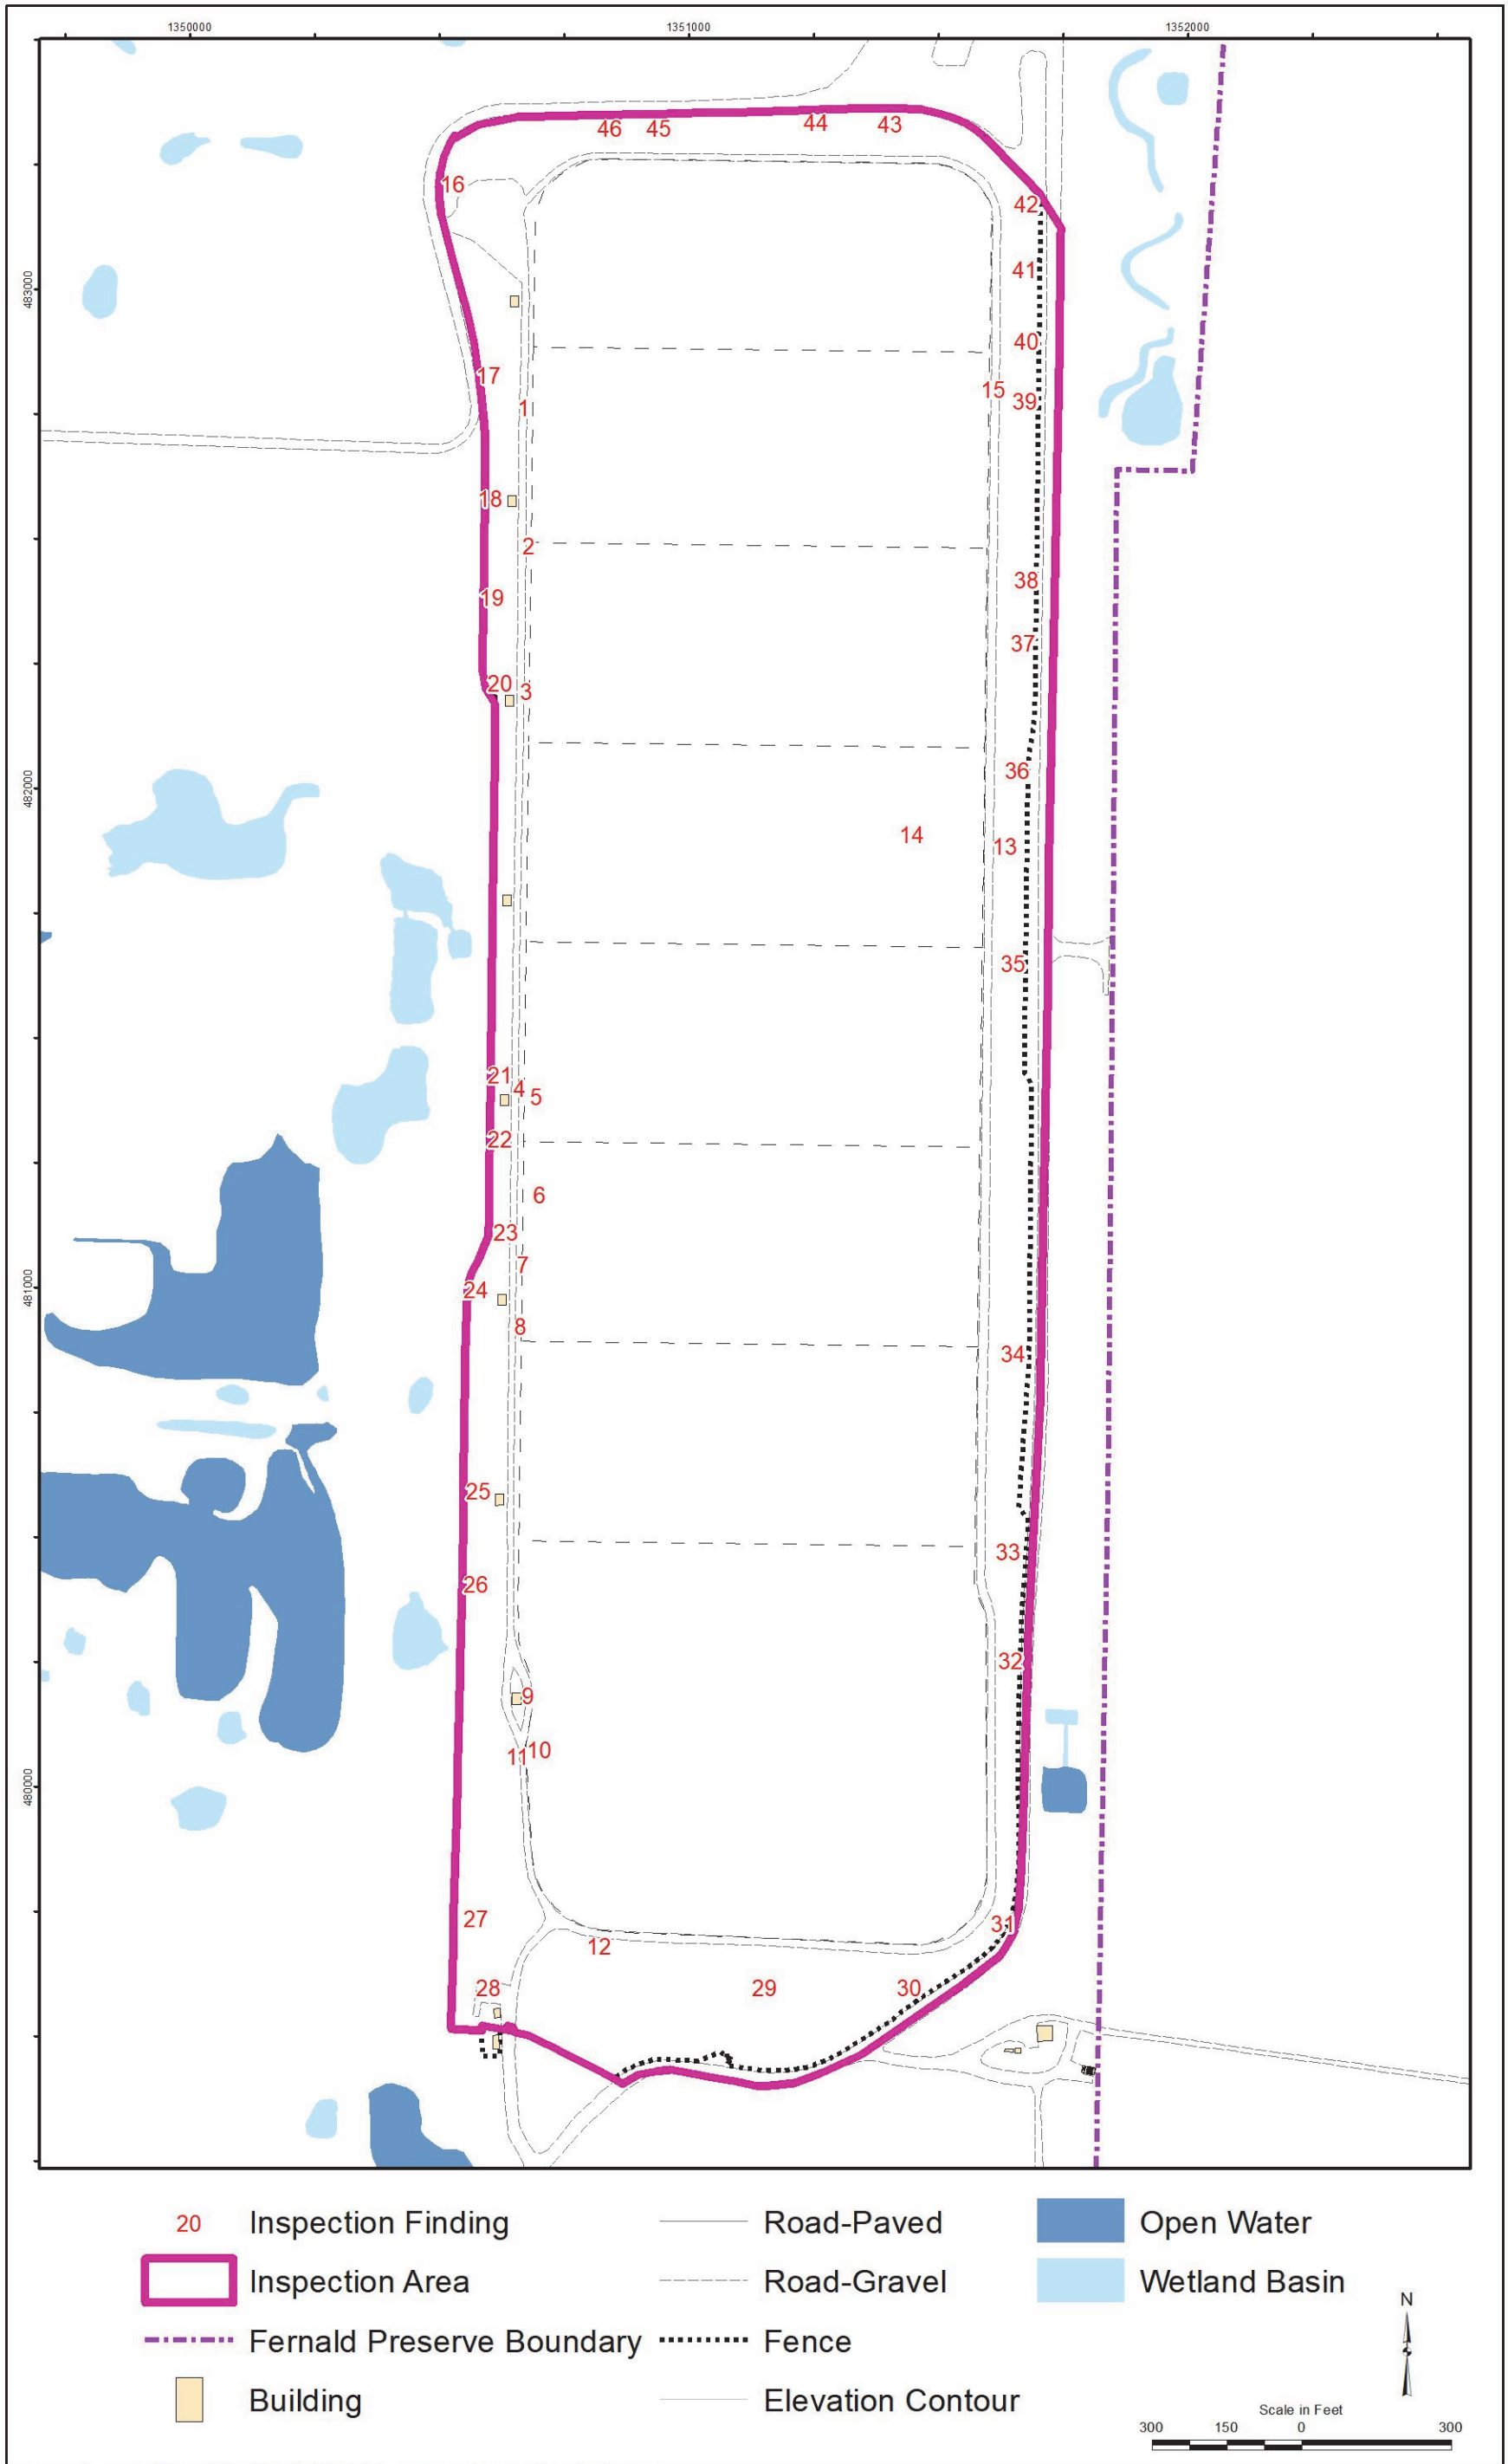
OSDF Inspection Findings, September 2020

Map No.	Location	GPS?	Type of Finding	Description	Photo
1	Cell 2, inner west drainage	Yes	Vegetation	Honeysuckle	09012020_41_02
2	Cell 3, inner west drainage	Yes	Vegetation	Box elder	09012020_41_03
3	Cell 3, inner west drainage	Yes	Vegetation	Honeysuckle	09012020_41_04
4	Cell 5, inner west drainage	No	Vegetation	Pear tree	
5	Cell 5, west toe	No	Vegetation	Giant ragweed	
6	Cell 6, inner west drainage	Yes	Vegetation	Honeysuckle	09012020_41_05
7	Cell 6, inner west drainage	Yes	Vegetation	Box elder	09012020_41_06
8	Cell 6, inner west drainage	Yes	Vegetation	Honeysuckle	09012020_41_07
9	Cell 8, inner west drainage, across from VH	Yes	Vegetation	Honeysuckle	09012020_41_08
10	Cell 8, inner west drainage	Yes	Vegetation	Honeysuckle	09012020_41_09
11	Cell 8, west toe, along road	Yes	Biointrusion	Animal burrow	09012020_41_10
12	Cell 8, south drainage	Yes	Vegetation	Honeysuckle (2)	09012020_41_11
13	Cell 4, east drainage	Yes	Vegetation	Cottonwood	09012020_41_12

14	Cell 4, east face and into Cell 3	Yes	Vegetation	Pear trees scattered across slope	09012020_41_13

Map No.	Location	GPS?	Type of Finding	Description	Photo
15	Cell 2, east toe	No	Vegetation	Pear tree	
16	Cell 1, west perimeter fence	Yes	Vegetation	Mulberry and thistle	09012020_43_01
17	Cell 2, west perimeter fence	No	Vegetation	Cedar and cottonwood trees	
18	Cell 2, west outer drainage and perimeter fence	No	Vegetation	Honeysuckle	
19	Cell 3, west outer drainage and perimeter fence	No	Vegetation	Willow trees	
20	Cell 3, behind VH 3	No	Vegetation	Honeysuckle and elm trees	
21	Cell 5, west perimeter fence	No	Vegetation	Mulberry	
22	Cell5/6 boundary, west perimeter fence	No	Vegetation	Thistle and dogwood	
23	Cell 6, west perimeter fence, near raptor perch	No	Vegetation	Mulberry	
24	Cell 6, west perimeter fence behind VH 6	No	Vegetation	Dogwood, multiflora rose, cedar, mulberry, honeysuckle and ash	
25	Cell 7, west perimeter fence behind VH 7	No	Vegetation	Cedar and pear trees	
26	Cell 8, west perimeter fence	No	Vegetation	Cedar tree

27	Cell 8, southwest corner drainage	No	Vegetation	Thistle	
28	Cell 8, southwest corner drainage	No	Vegetation	Willow tree	
29	Cell 8, south drainage	No	Vegetation	Hackberry	
30	Cell 8, southeast corner drainage	No	Vegetation	Hackberry

Map No.	Location	GPS?	Type of Finding	Description	Photo
31	Cell 8, southeast corner drainage	No	Vegetation	Honeysuckle and hackberry	
32	Cell 8, east perimeter fence	No	Vegetation	Honeysuckle	
33	Cell 8, east perimeter fence and drainage	No	Vegetation	Thistle	
34	Cell 6, east perimeter fence	No	Vegetation	Ash tree	
35	Cell 5, east perimeter fence	No	Vegetation	Mulberry	
36	Cell 4, east perimeter fence	No	Vegetation	Honeysuckle and pear trees	
37	Cell 3, east perimeter fence	No	Vegetation	Dogwood	
38	Cell 3, east perimeter fence	No	Vegetation	Honeysuckle	
39	Cell 2, east perimeter fence	No	Vegetation	Woody vegetation	
40	Cell 1, east perimeter fence	No	Vegetation	Honeysuckle and dogwood	
41	Cell 1, east perimeter fence	No	Vegetation	Mulberry, thistle and pear tree	
42	Cell 1, northeast corner drainage	No	Vegetation	Ash, cedar, dogwood, and pear trees	
43	Cell 1, north perimeter fence	No	Vegetation	Cedar trees

44	Cell 1, north drainage	No	Vegetation	Sycamore and cottonwood trees	
45	Cell 1, north drainage	No	Vegetation	Ash, cottonwood and dogwood trees	
46	Cell 1, north perimeter fence	No	Vegetation	Pear and elm trees
