SUBJECT: Transmittal of the December 2016 Fernald Quarterly Inspection Report

Fernald Preserve Field Walkdown Inspection Summary

Fernald Preserve OSDF Walkdown Inspection Summary

FERNALD PRESERVE

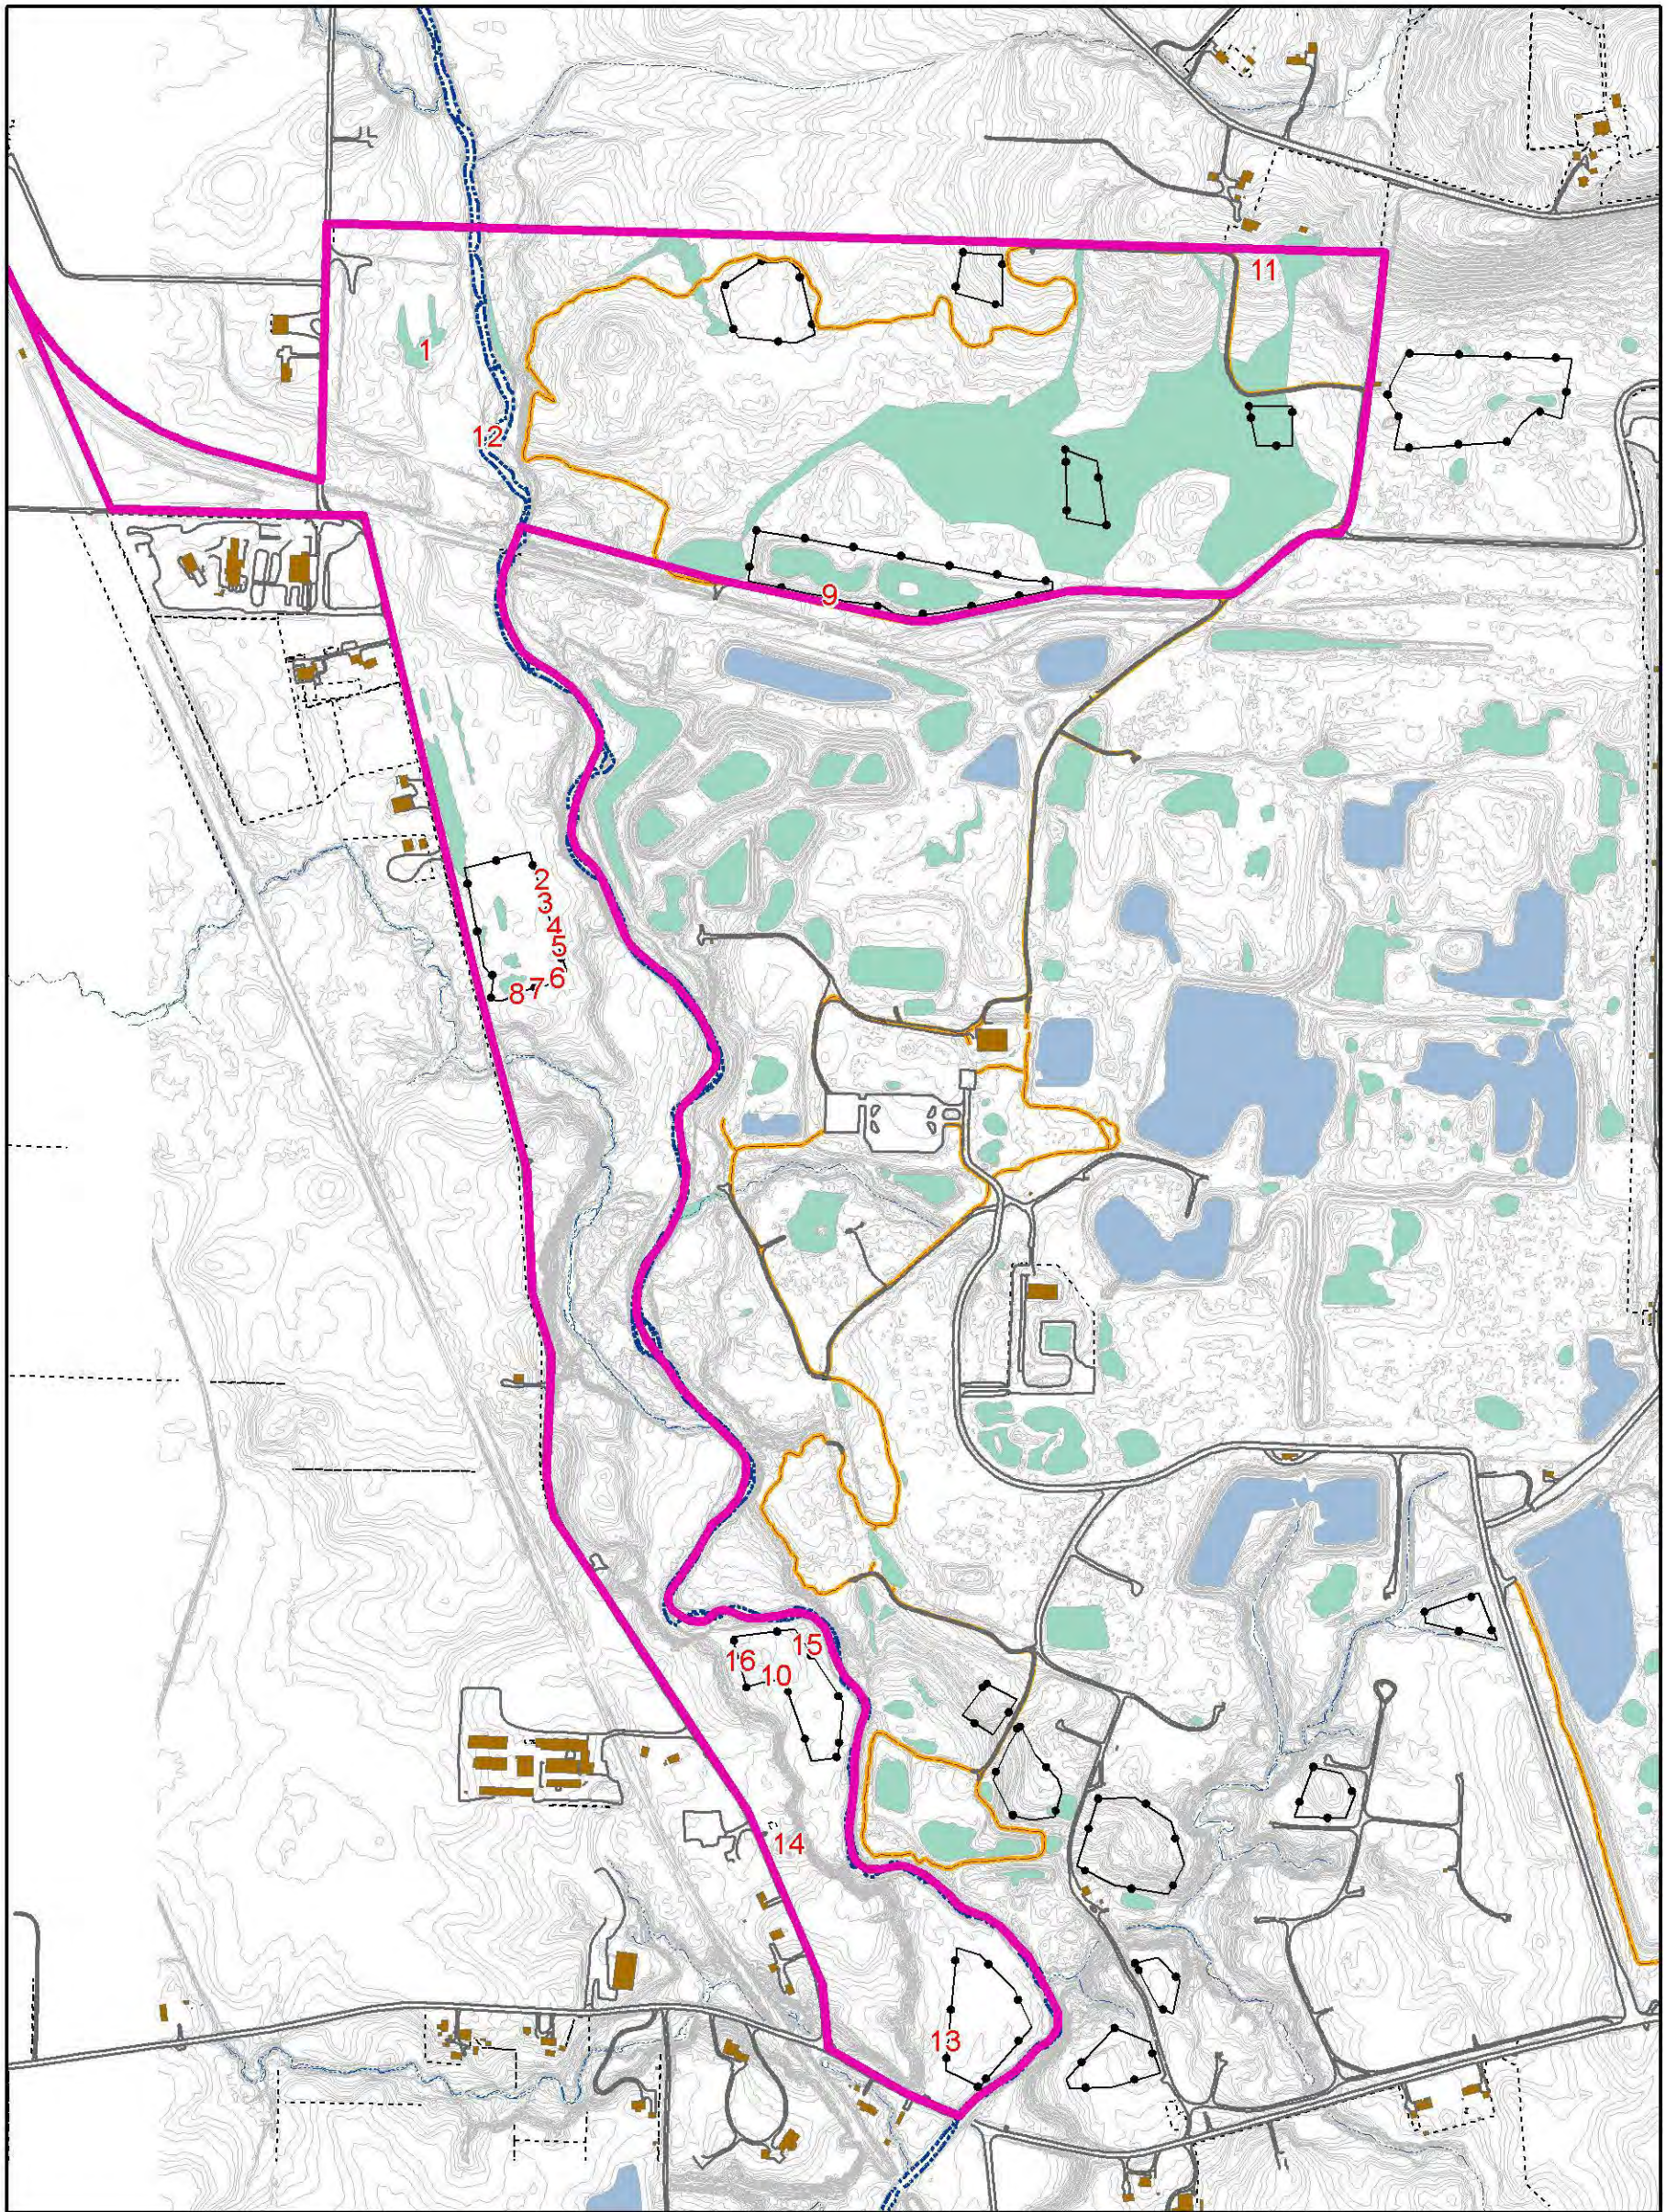
Figure 1
West Quadrant Inspection Findings, December 2016

Map No.	Location	GPS?	Type of Finding	Description	Photo? (File No.)
1	By Pond	Yes	Other	Old coverboards around pond need to be removed	12072016_43_01
2	East side of deer fence	Yes	Fencing	Hole in deer fence	12072016_43_02
3	East side of deer fence	Yes	Fencing	Hole in deer fence	12072016_43_03
4	East side of deer fence	Yes	Fencing	Deer fence gate is down	12072016_43_04
5	East side of deer fence	Yes	Fencing	Hole in deer fence	12072016_43_05
6	South side of deer fence	Yes	Fencing	Hole in deer fence	12072016_43_06
7	South side of deer fence	Yes	Fencing	Hole in deer fence	12072016_43_07
8	South side of deer fence	Yes	Fencing	Hole in deer fence	12072016_43_08
9	South side of deer fence, along Hickory Trail	Yes	Fencing	Hole in deer fence	12072016_41_01
10	West side of deer fence	Yes	Fencing	Hole in deer fence	12072016_41_03
11	In ditch south of trail	No	Other	Top of car battery and trash	
12	Adjacent to Paddys Run	No	Other	Remains of a buck; the hide of which appears to have been removed in one piece.

13	West side of fence	No	Fencing	Hole in deer fence

Map No.	Location	GPS?	Type of Finding	Description	Photo? (File No.)
14	Drainage south of Duke Energy station	Yes	Debris	Concrete	12072016_41_02
15	East side of deer fence	No	Fencing	Hole in deer fence	
16	West side of deer fence	No	Fencing	Hole in deer fence

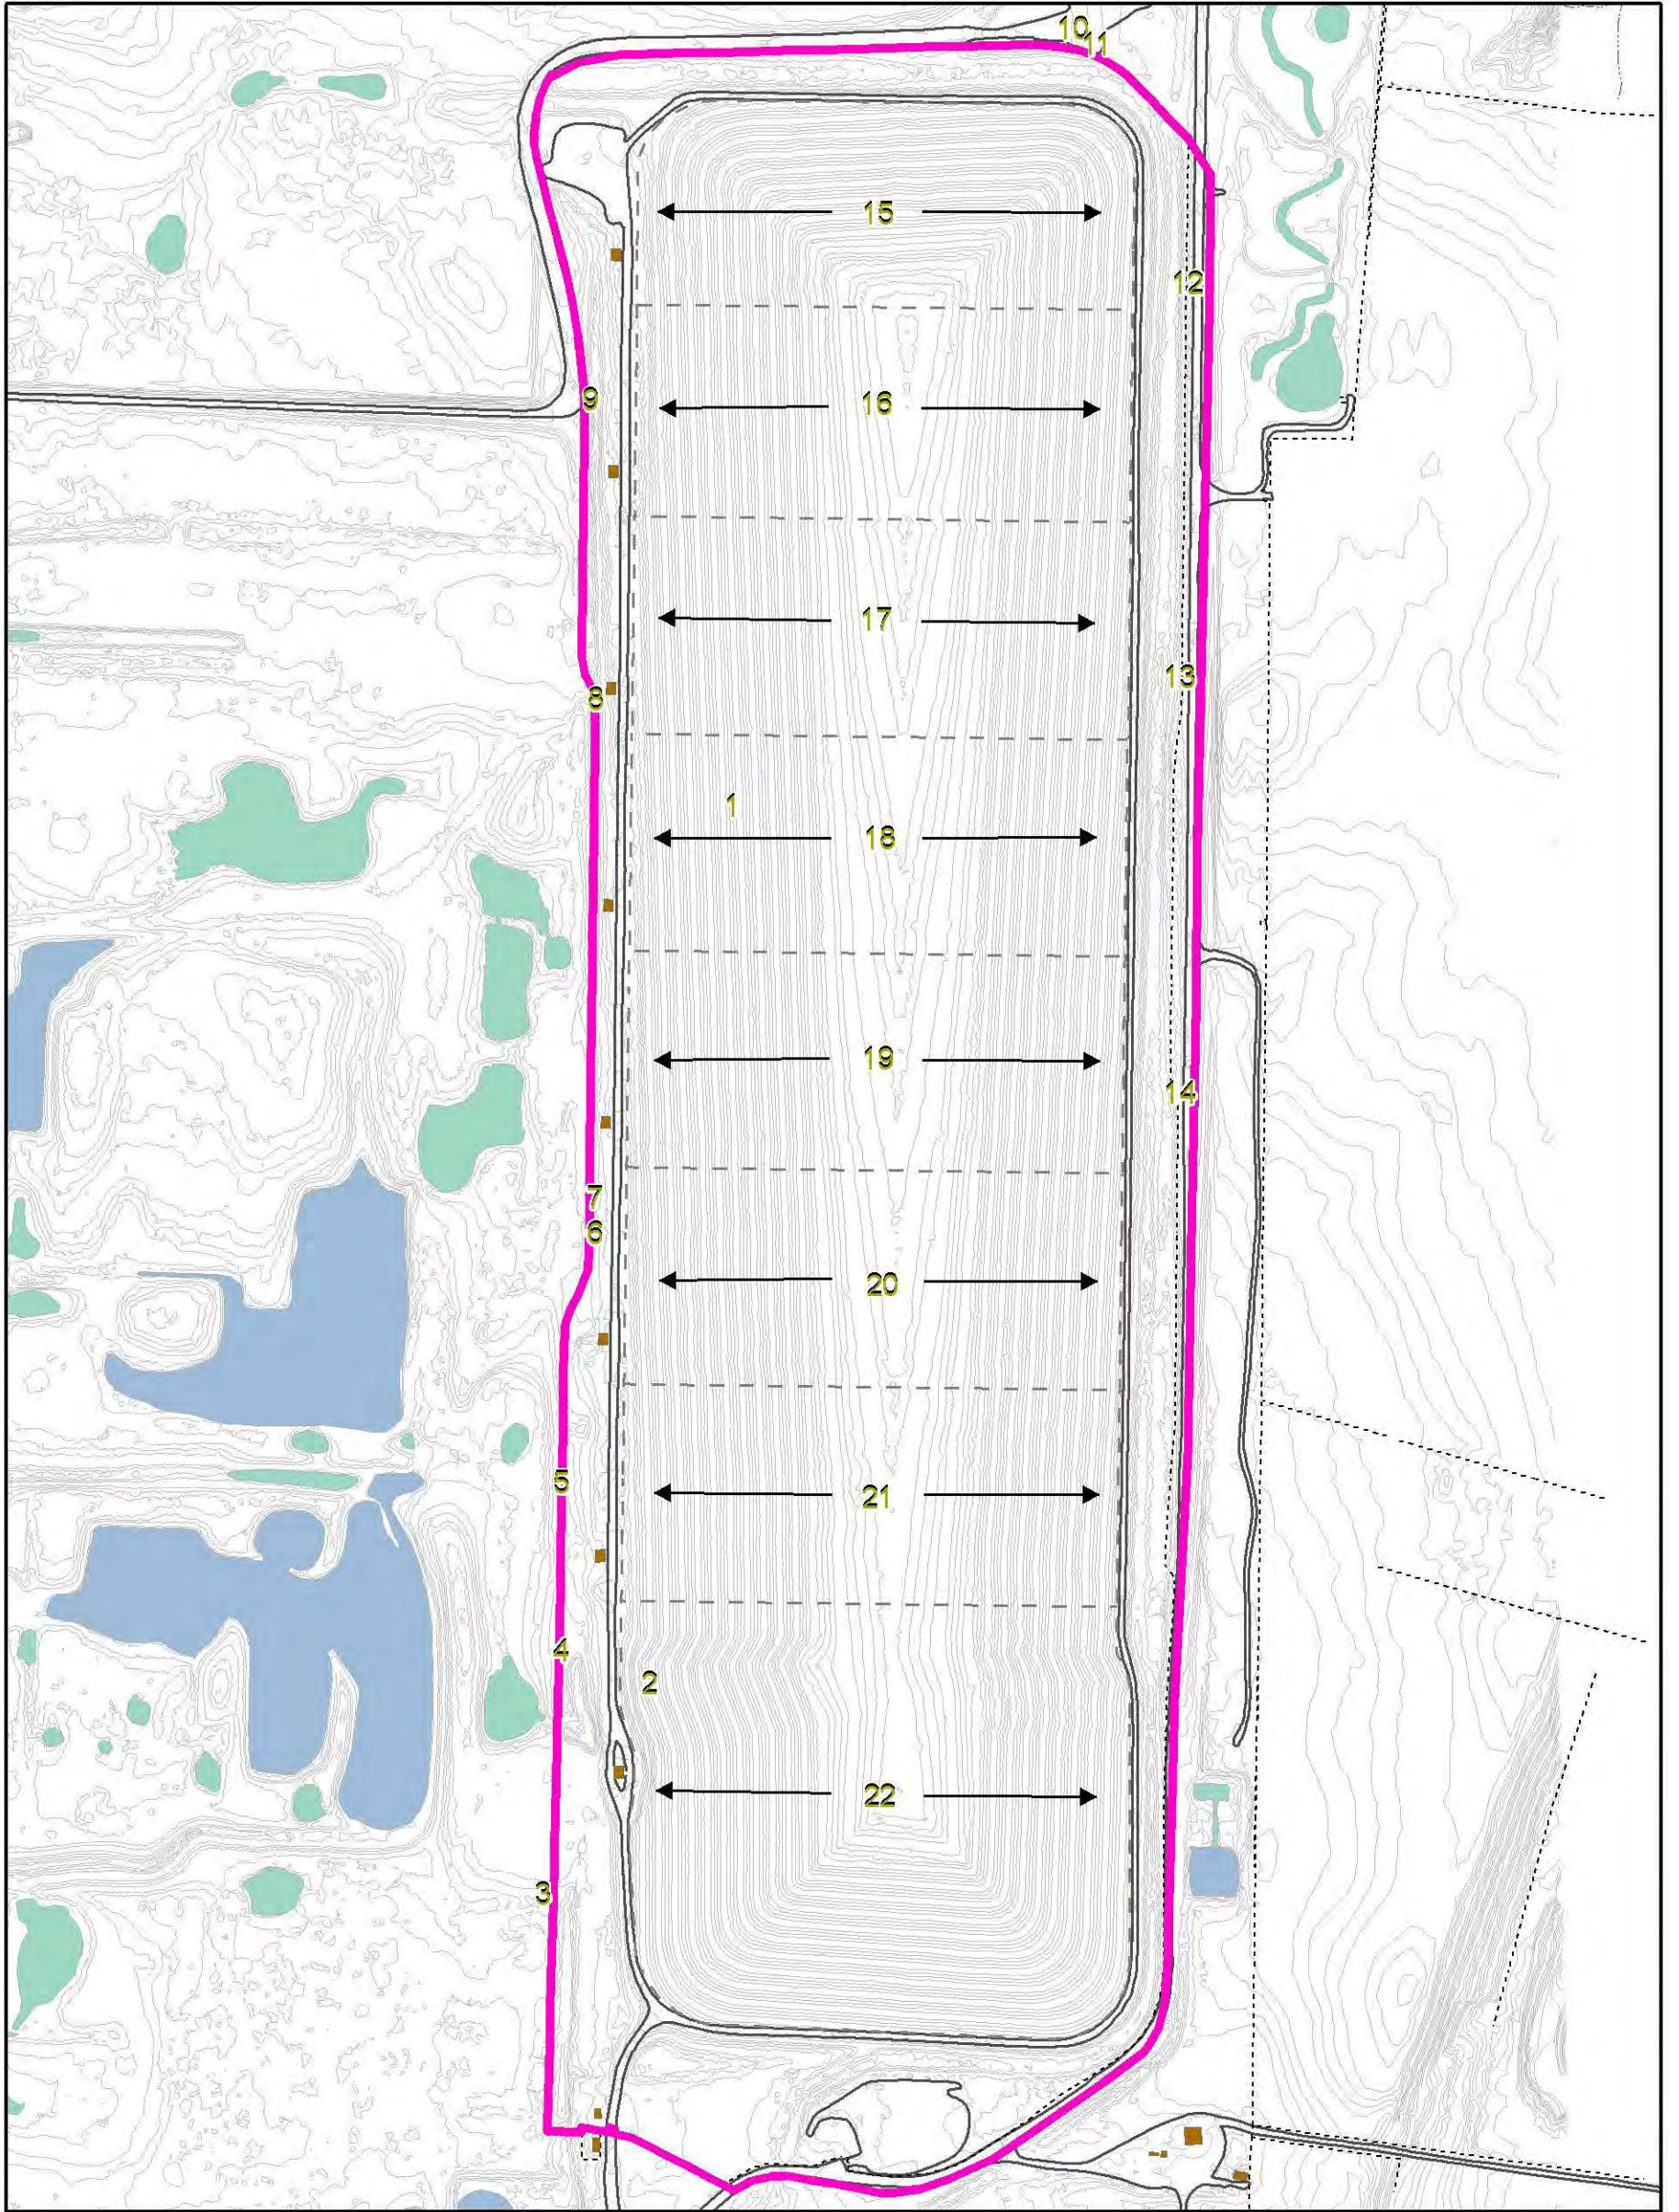
Figure 2
OSDF Inspection Findings, December 2016

Map No.	Location	GPS?	Type of Finding	Description	Photo? (File No.)
1	Cell 4, west face	Yes	Rock	Rock	12012016_41_03
2	Cell 8, west toe	Yes	Biointrusion	Groundhog burrow	12012016_44_03
3	West perimeter fence at Cell 8	Yes	Biointrusion	Animal burrow under fence	12012016_43_03
4	West perimeter fence at north end of Cell 8	Yes	Biointrusion	Animal burrow under fence	12012016_43_04
5	West perimeter fence at Cell 7	Yes	Biointrusion	Burrow under fence	12012016_43_05
6	West perimeter fence at Cell 6	Yes	Fencing	Tree in fence	12012016_43_06
7	West perimeter at north end of Cell 6	Yes	Fencing	Damaged fence post	12012016_43_07
8	West perimeter fence behind VH 3	Yes	Biointrusion	Animal burrow	12012016_43_08
9	West outer drainage at Cell 2	Yes	Other	Standing water in drainage	12012016_43_09
10	North perimeter fence	Yes	Biointrusion	Animal burrow under fence	12012016_43_10
11	North perimeter fence	Yes	Biointrusion	Animal burrow under fence	12012016_43_11

12	East perimeter fence at Cell 1	Yes	Biointrusion	Animal burrow under fence	12012016_43_12
13	East perimeter fence at Cell 3	Yes	Biointrusion	Animal burrow under fence	12012016_43_13
14	East perimeter fence at Cell 5	Yes	Biointrusion	Animal burrow under fence	12012016_43_14

Map No.	Location	GPS?	Type of Finding	Description	Photo? (File No.)
15	Across Cell 1 cap	No	Vegetation	Scattered invasive woody and herbaceous vegetation	
16	Across Cell 2 cap	No	Vegetation	Scattered invasive woody and herbaceous vegetation	
17	Across Cell 3 cap	No	Vegetation	Scattered invasive woody and herbaceous vegetation	
18	Across Cell 4 cap	No	Vegetation	A few invasive woody and herbaceous vegetation	
19	Across Cell 5 cap	No	Vegetation	Scattered invasive woody and herbaceous vegetation	
20	Across Cell 6 cap	No	Vegetation	Scattered invasive woody and herbaceous vegetation	
21	Across Cell 7 cap	No	Vegetation	Scattered invasive woody and herbaceous vegetation	
22	Across Cell 8 cap	No	Vegetation	Scattered invasive woody and herbaceous vegetation
