Subject: Transmittal of the June 2018 Fernald Quarterly Inspection Report

This letter is the June 2018 quarterly inspection report for the Fernald Preserve at the Fernald, Ohio, Site. Inspections are conducted as directed by the *Comprehensive Legacy Management and Institutional Controls Plan* (LMICP) (LMS/FER/S03496). This letter also fulfills the reporting requirements specified in the Environmental Covenant, which is Appendix D of the *Consent Decree Resolving Ohio's Natural Resource Damage Claim Against DOE* (State of Ohio 2008). The inspections confirm that the activity and use limitations for the Fernald Preserve remain in place and are being complied with.

Fernald Preserve OSDF Walkdown Inspection Summary

On-Site Disposal Facility Inspection Photographs

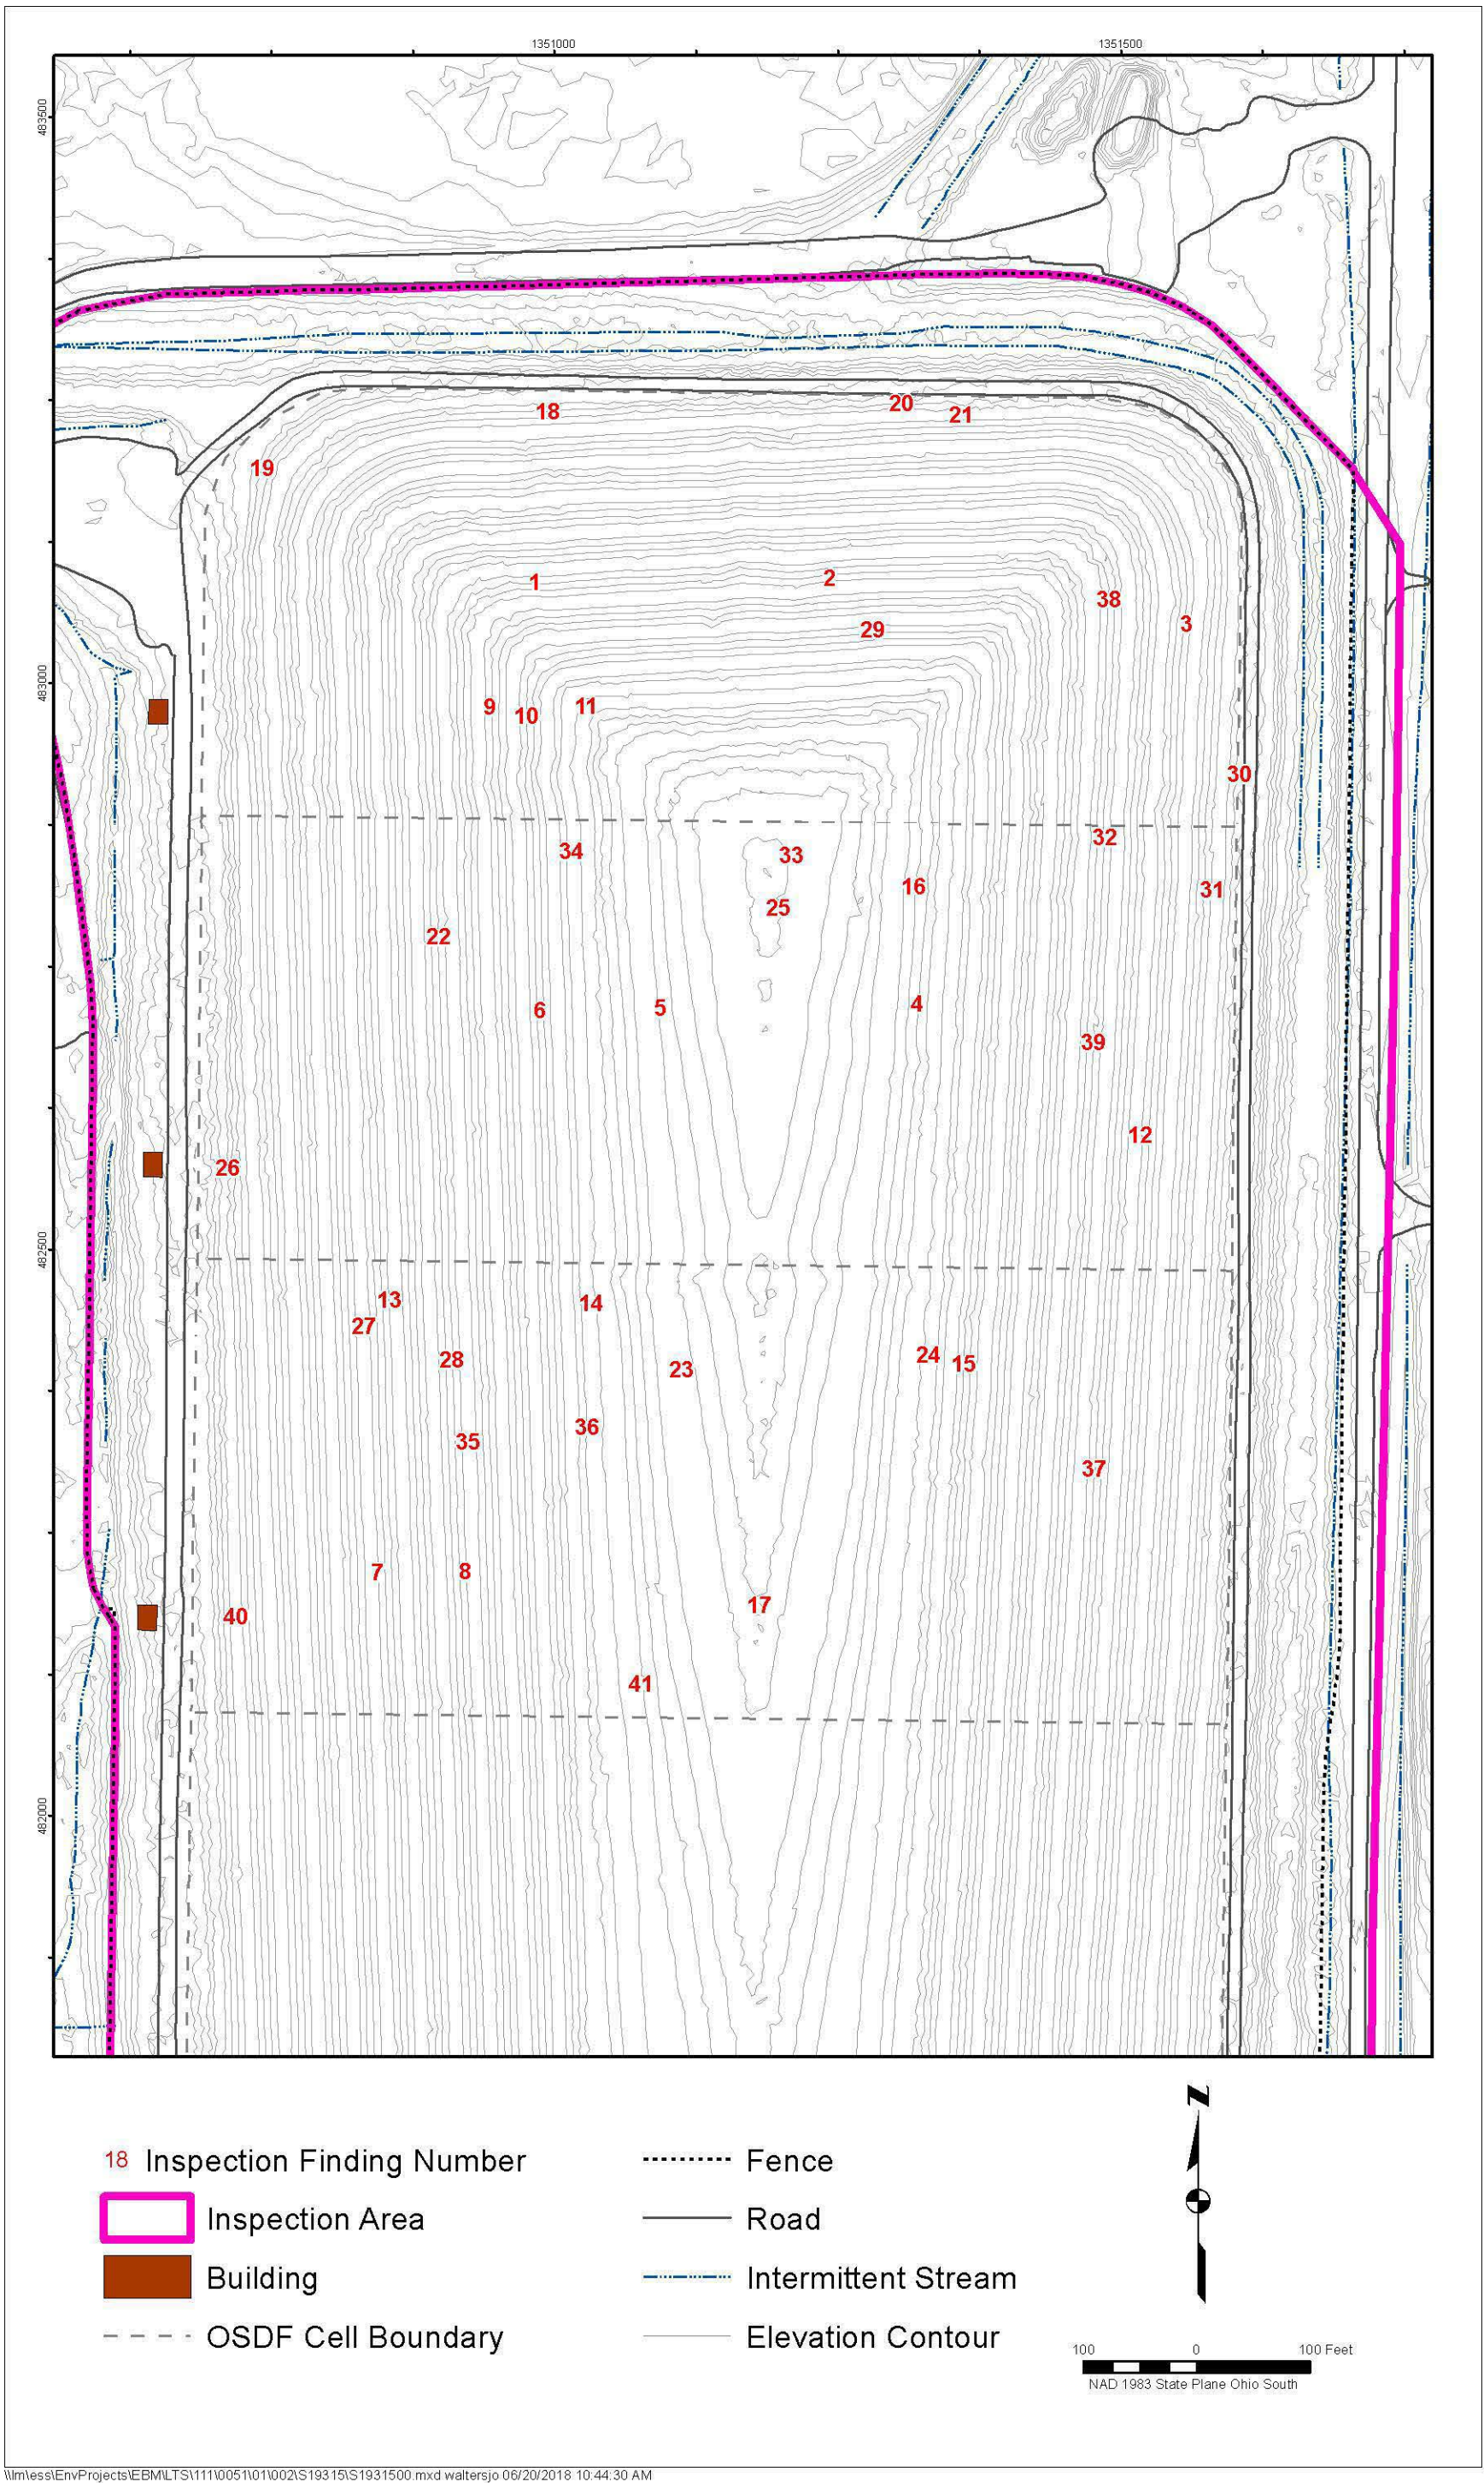
Figure 1. April 10, 2018 OSDF Cells 1, 2, and 3, Post Burn Inspection

The OSDF prescribed burn follow-up inspection of cell caps 1, 2 and 3 took place on April 10 (Figure 1). The inspection included a walk-over of all three cell caps with participation by Ohio EPA and Navarro. Findings primarily included numerous rocks exceeding the 4-inch diameter size limit, noxious weeds and several debris findings. Inspecting the caps following a burn allows for a more thorough inspection of the cap, as all vegetation and thatch have been removed. Findings such as debris, animal burrows, erosion, and rocks, are more visible and easier to identify. Under normal circumstances, the vegetation on the cap obstructs the view of the cap surface.

Map No.	Location	GPS?	Type of Finding	Description	Photo
1	Cell 1, west 6:1	Yes	Rock	Rock	04102018_42_01
2	Cell 1, top	Yes	Rock	Several rocks	04102018_42_02
3	Cell 1, east 6:1	Yes	Rock	Rock	04102018_42_03
4	Cell 2, east 6:1	Yes	Rock	Rock	04102018_42_04
5	Cell 2	Yes	Debris	Brick	04102018_42_05
6	Cell 2, west 6:1	No	Debris	Concrete	
7	Cell 3, west 6:1	Yes	Debris	Metal	04102018_42_06
8	Cell 3, west 6:1	Yes	Rock	Rock	04102018_42_07
9	Cell 1, west 6:1	Yes	Debris	Tile	04102018_44_01
10	Cell 1, west 6:1	Yes	Biointrusion	Animal burrow	04102018_44_02
11	Cell 1, top northwest 6:1	Yes	Other	Damage to abandoned monitoring infrastructure	04102018_44_03
12	Cell 2, east 6:1	Yes	Rock	Rock	04102018_44_04
13	Cell 3, west 6:1	Yes	Rock	Rock	04102018_44_05
14	Cell 3, top west 6:1	Yes	Rock	Rock	04102018_44_06

Map No.	Location	GPS?	Type of Finding	Description	Photo
15	Cell 3, east 6:1	Yes	Debris	Tile	04102018_44_07
16	Cell 2, east 6:1 near top	No	Vegetation	Canada thistle	
17	Cell 3, top south	No	Vegetation	Canada thistle	
18	Cell 1, north toe	No	Vegetation	Pear tree	
19	Cell 1, northwest corner	No	Structure	Corner survey marker is damaged	
20	Cell 1, north toe	Yes	Vegetation	Cedar trees (2)	04102018_41_01
21	Cell 1, north toe	Yes	Rock	Rock	04102018_41_02
22	Cell 2, west 6:1	Yes	Vegetation	Tree	04102018_41_04
23	Cell 3, top west 6:1	Yes	Vegetation	Grapevine	04102018_41_07
24	Cell 3, east top	Yes	Rock	Rock	04102018_41_08
25	Cell 2, top	Yes	Vegetation	Mulberry	04102018_41_03
26	Cell 2, west toe	Yes	Vegetation	Pear tree	04102018_41_05
27	Cell 3, west 6:1	Yes	Erosion	Erosion	04102018_41_06
28	Cell 3, west 6:1	No	Vegetation	Pear tree	
29	Cell 1, north 6:1	Yes	Rock	Rock	04102018_40_01
30	Cell 1, east toe	Yes	Debris	Wire	04102018_40_03

31	Cell 2, east toe	Yes	Settlement	Holes, possible soil settling	04102018_40_05
32	Cell 2, east 6:1	Yes	Biointrusion	Animal burrow	04102018_40_06
33	Cell 2, top	Yes	Vegetation	Shrub	04102018_40_07

Map No.	Location	GPS?	Type of Finding	Description	Photo
34	Cell 2, west 6:1 top	Yes	Debris	Asphalt	04102018_40_08
35	Cell 3, west 6:1	Yes	Rock	Rock (2)	04102018_40_09
36	Cell 3, west 6:1 top	Yes	Rock	Rock	04102018_40_10
37	Cell 3, east 6:1	Yes	Biointrusion	Animal burrow and tile	04102018_40_11
38	Cell 1, east 6:1	No	Debris	Concrete	
39	Cell 2, east 6:1	No	Debris	Glazed tile	
40	Cell 3, west toe across from valve house	No	Erosion	Erosion in several places at an along rip rap, 6" deep	
41	Cell 3, west 6:1, near top	No	Rock	Rocks

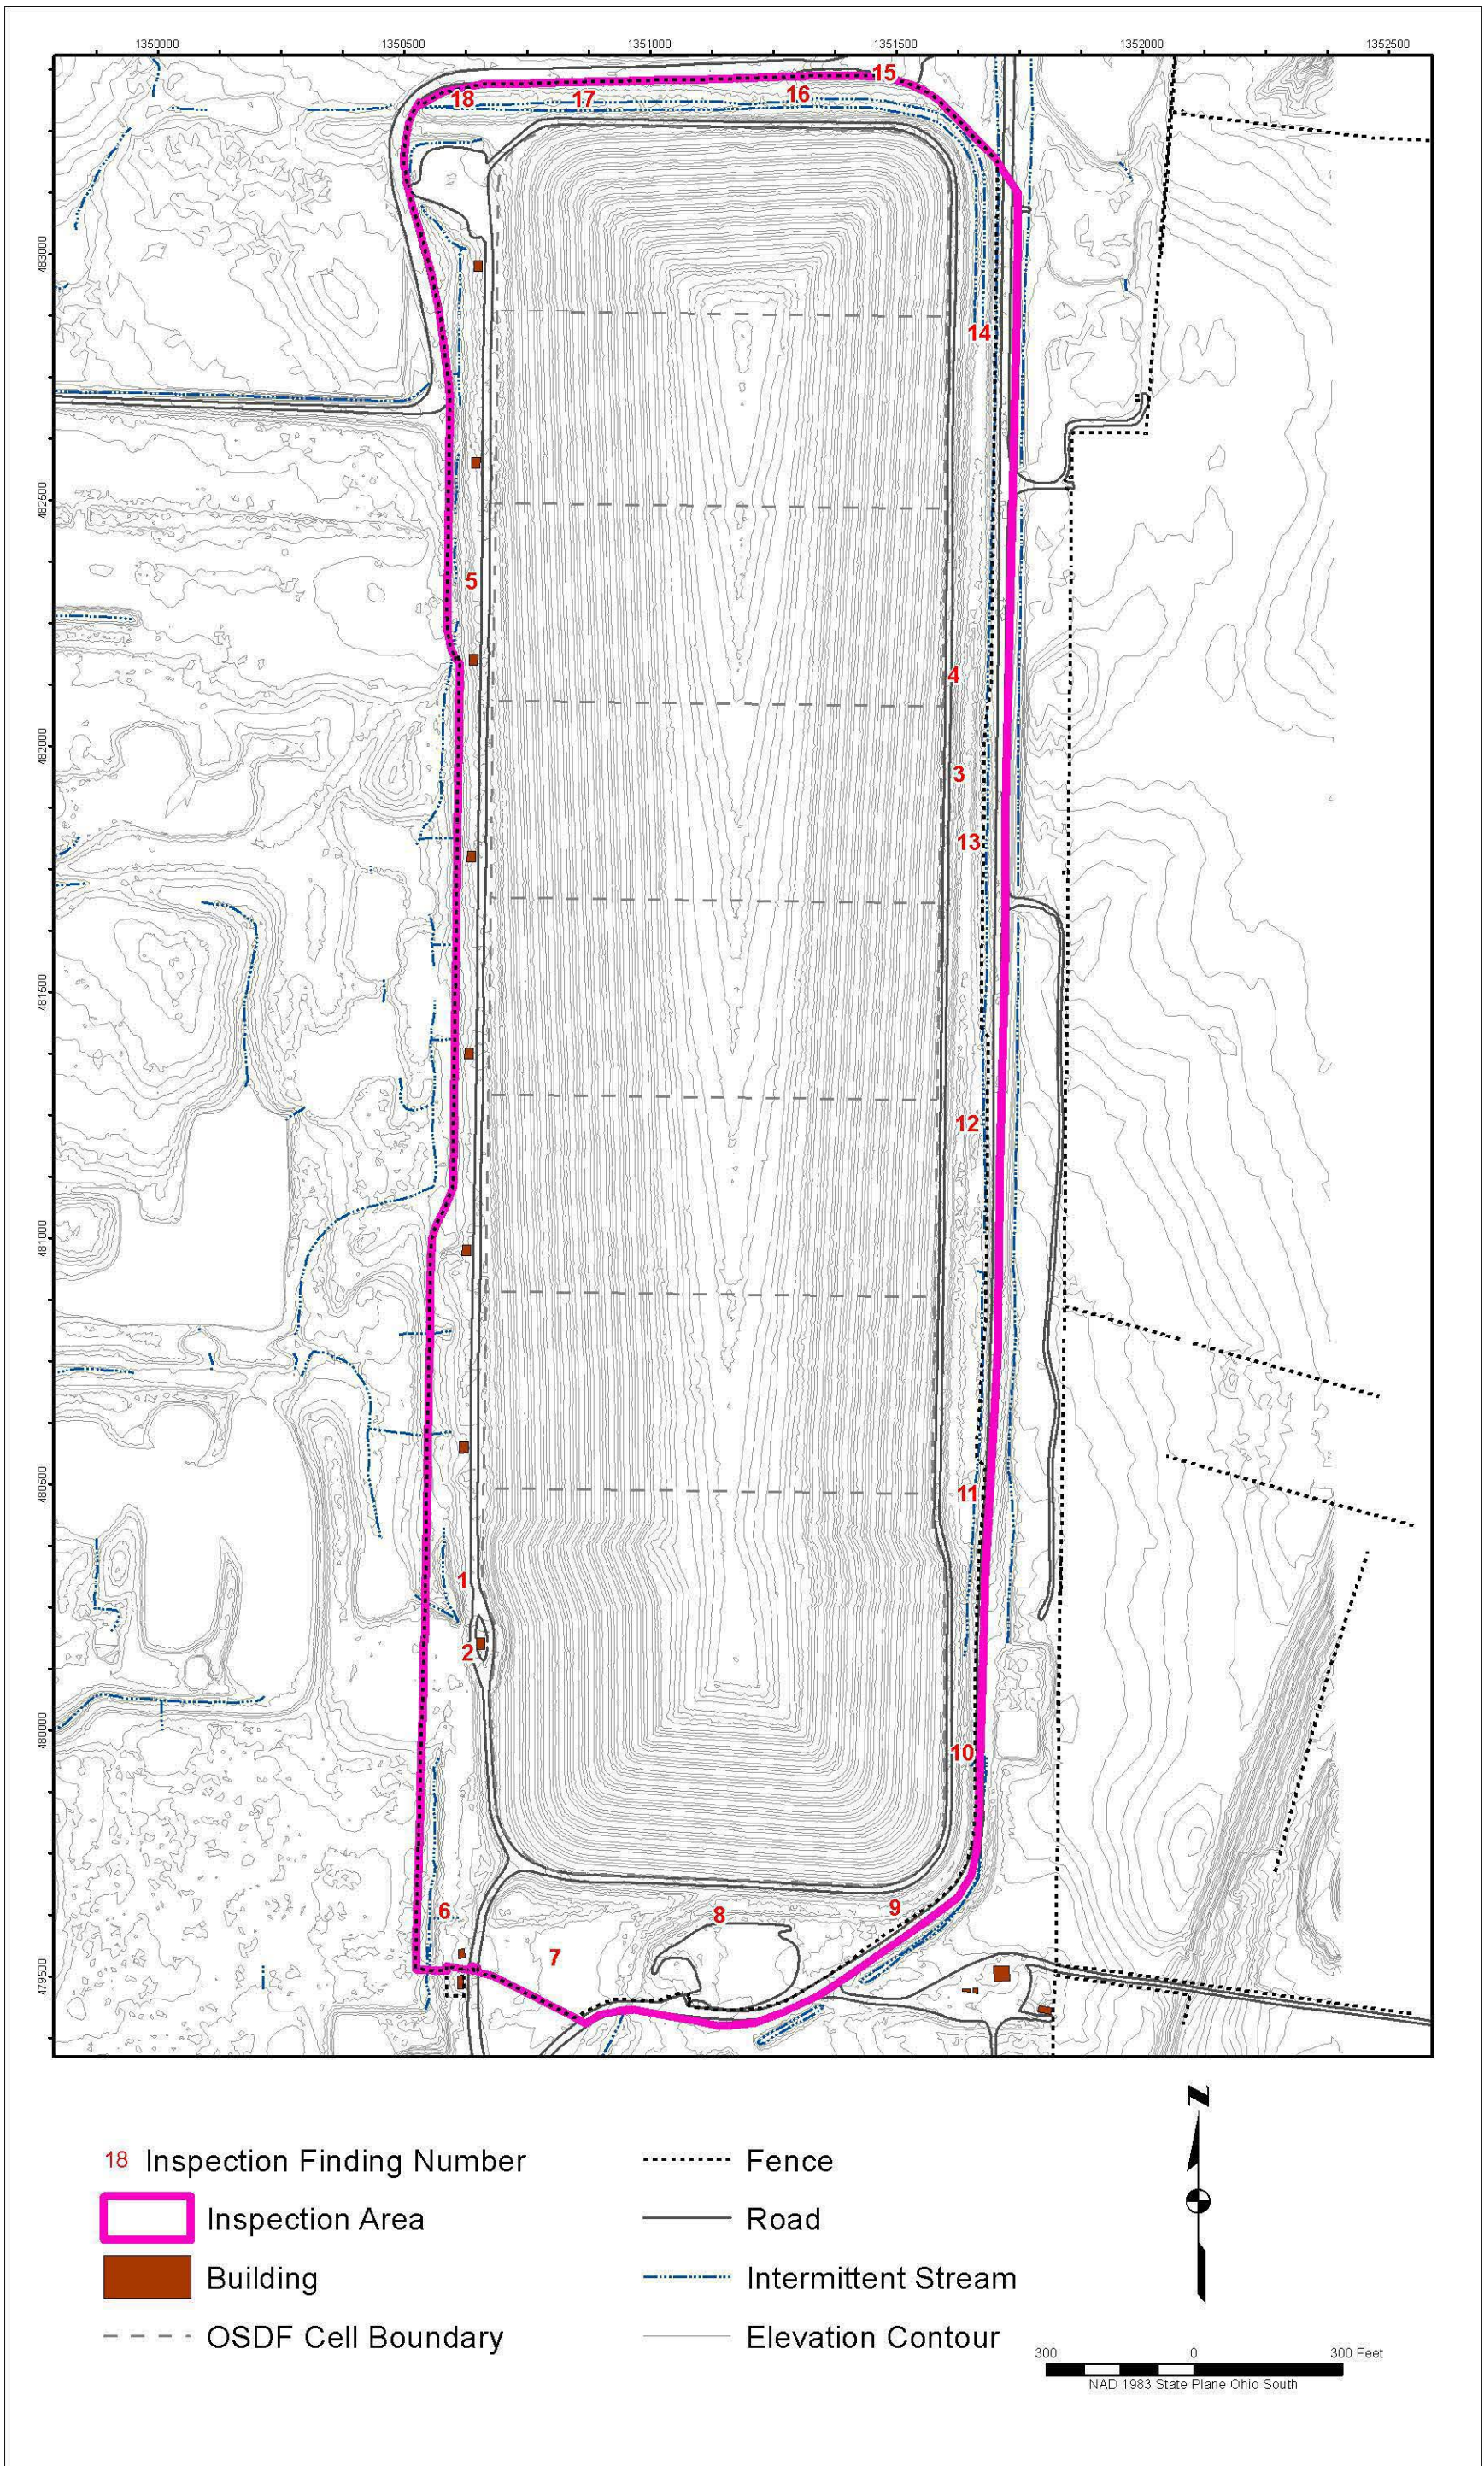
Figure 2. OSDF June 2018 Inspection

The June 2018 quarterly OSDF inspection took place on June 6, with participation by the Department of Energy, Navarro, and the Ohio EPA. The inspection included a walk-down of the OSDF toe, drainages, and fence line. Findings primarily included woody and invasive herbaceous vegetation, both on the toe and in the drainages. Herbicide and/or physical removal will be used to clear the unwanted vegetation. Broken couplers were identified at one location on the perimeter chain link fence. The integrity of the fence is not compromised, but the couplers will be repaired or replaced.

Map No.	Location	GPS?	Type of Finding	Description	Photo
1	Cell 8, outer west drainage	Yes	Vegetation	Several trees need removed	06062018_41_01
2	Cell 8, outer west drainage, behind VH 8	Yes	Vegetation	Cedar trees	06062018_41_02
3	Cell 4, east drainage	Yes	Vegetation	Willow	06062018_40_01
4	Cell 3/4 boundary, east drainage	Yes	Vegetation	Ash tree	06062018_40_02
5	Cell 3, outer west drainage, between VH 2 and VH 3	No	Vegetation	Teasel and musk thistle	
6	Cell 8, outer west drainage, southwest corner	No	Vegetation	Trees in drainage, thistle on banks	
7	Cell 8, south prairie field east of gate and along fence	No	Vegetation	Woody vegetation and teasel	
8	Cell 8, south drainage, south side	No	Vegetation	Thistle and woody vegetation	
9	Cell 8, south drain, southeast corner	No	Vegetation	Teasel	
10	Cell 8, east drainage	No	Vegetation	Woody vegetation	
11	Cell 7/8 boundary, east drainage along fence	No	Vegetation	Woody vegetation and teasel

12	Cell 6, east drainage, along fence	No	Vegetation	Woody vegetation and teasel

Map No.	Location	GPS?	Type of Finding	Description	Photo
13	Cell 4, east drainage, along fence	No	Vegetation	Musk thistle	
14	Cell 2, east drainage, in cattails	No	Vegetation	Willow	
15	North fence line	Yes	Fencing	Couplers broken from fence	06062018_43_01; 06062018_43_02
16	Cell 1, north drain, along fence	No	Vegetation	Teasel and thistle	
17	Cell 1, north drainage	No	Vegetation	Woody vegetation	
18	Cell 1, north drainage, northwest corner	No	Vegetation	Teasel

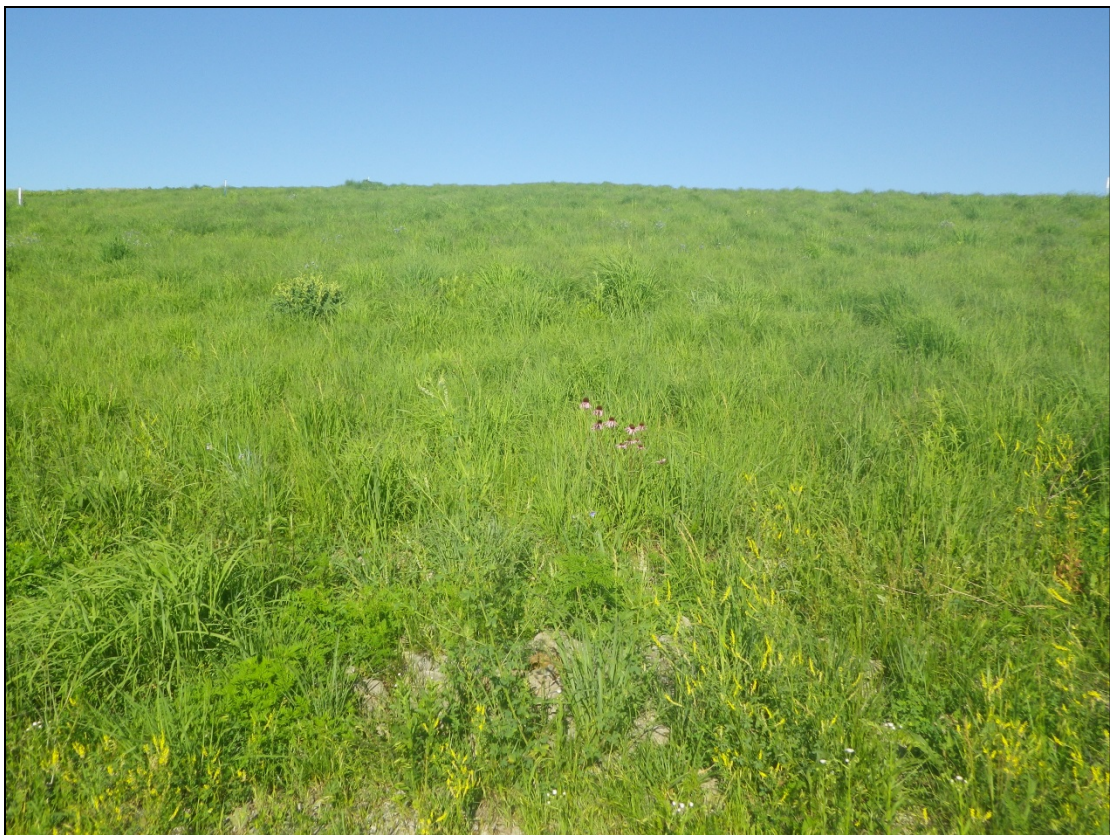
IMGP6786

East Face Cell 1

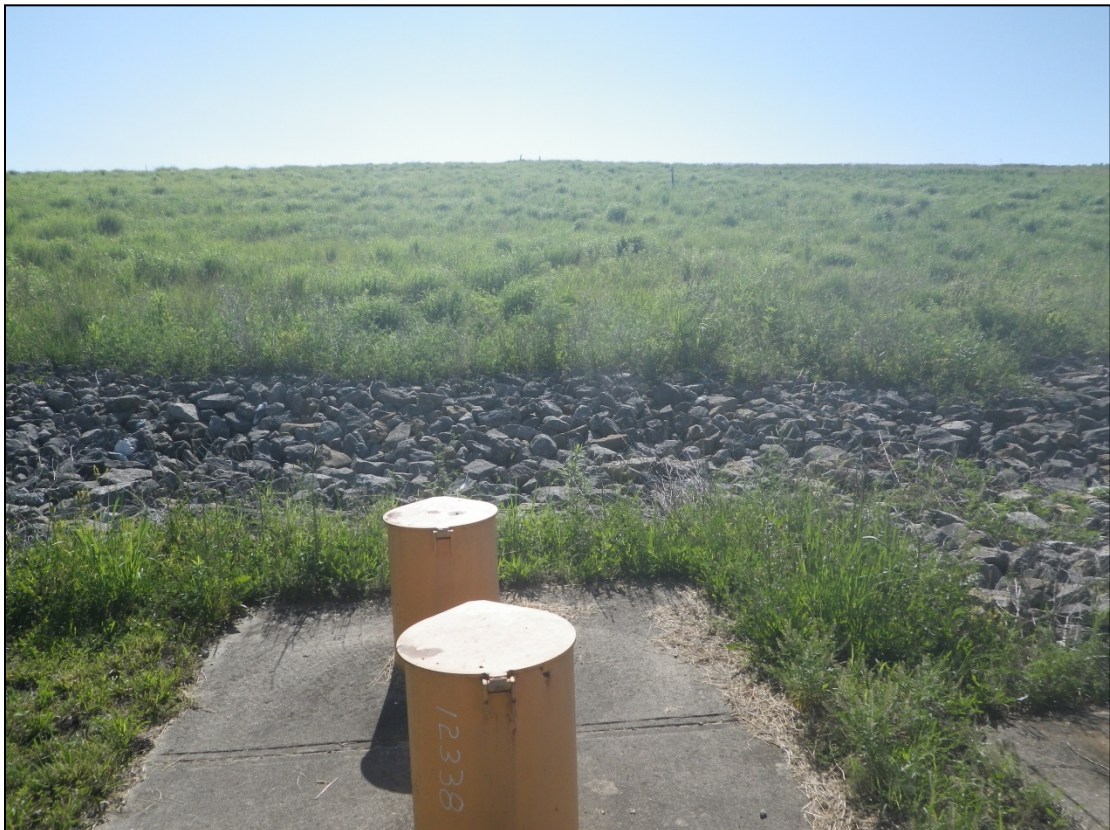
IMGP6790

West Face Cell 1

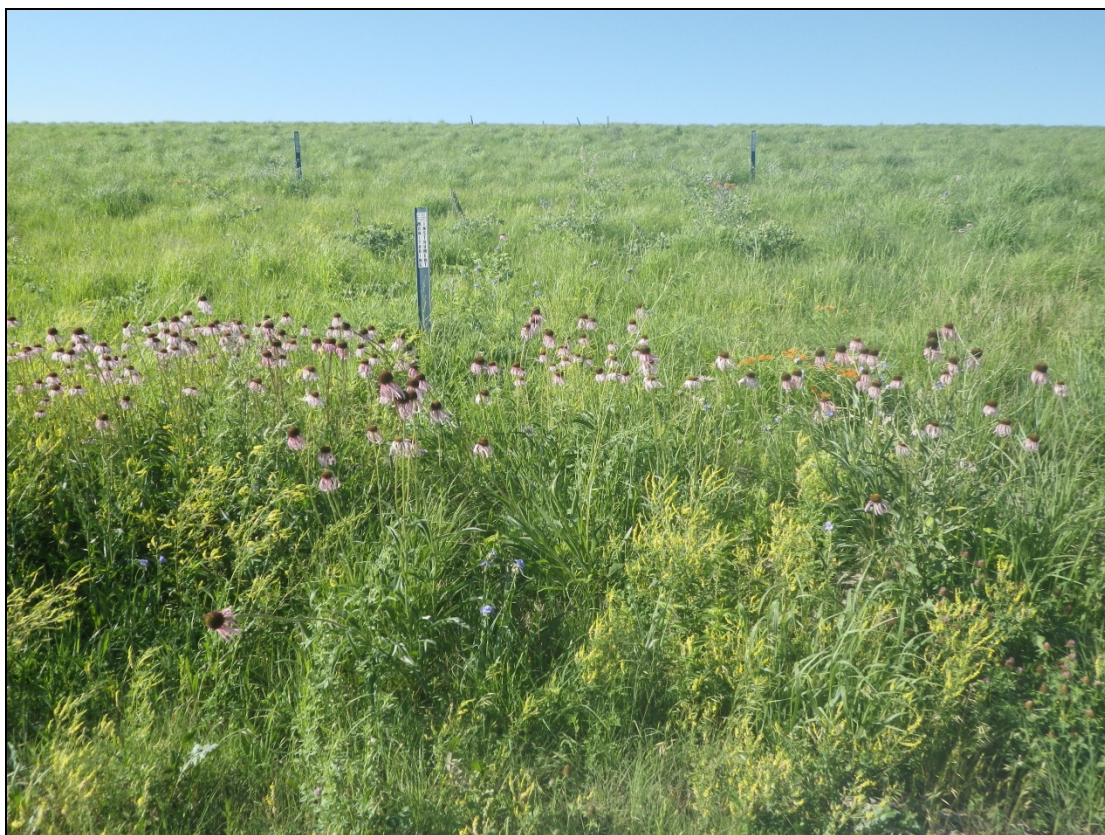
IMGP6788

North Face Cell 1

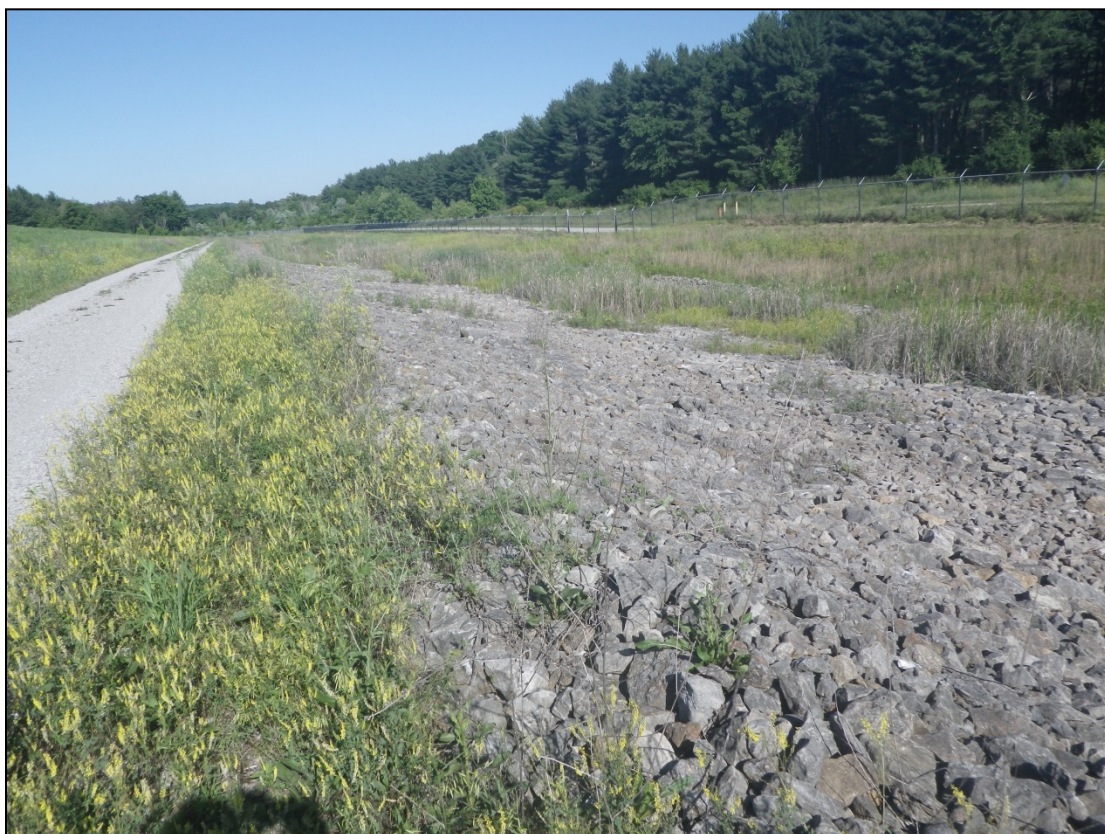
IMGP6787

North Drainage (looking west)

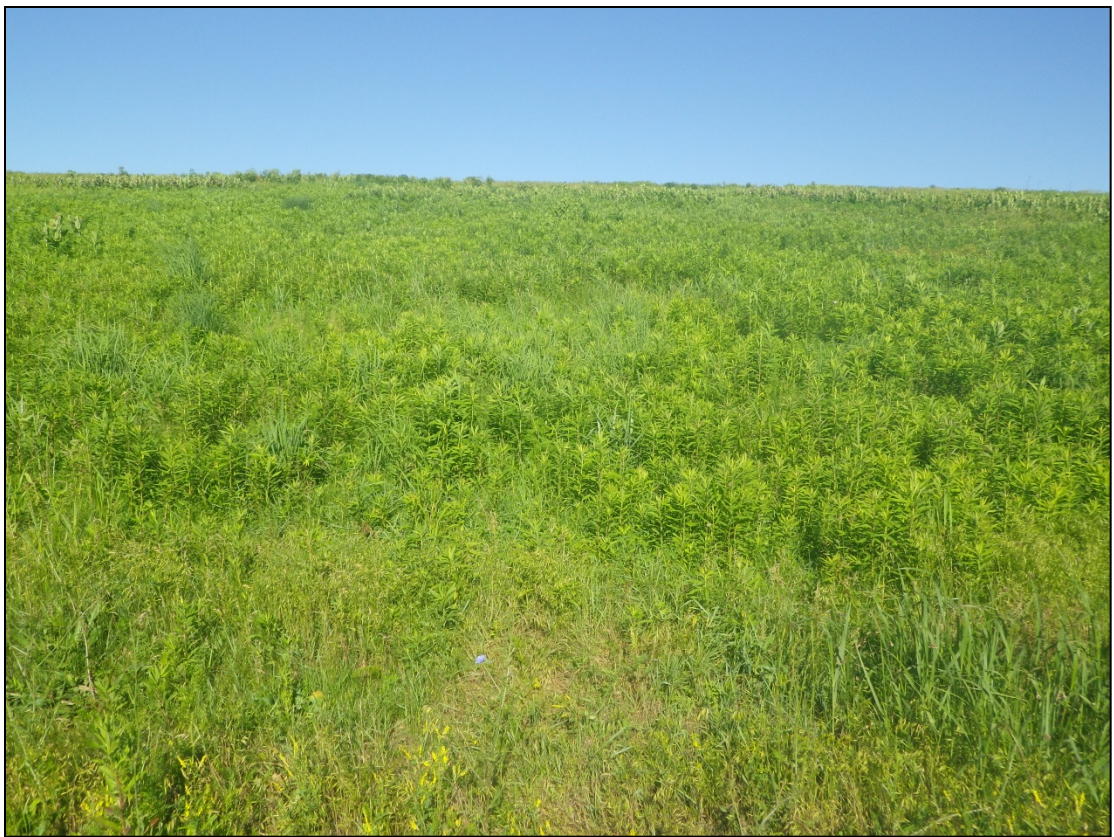
IMGP6784

East Face Cell 2

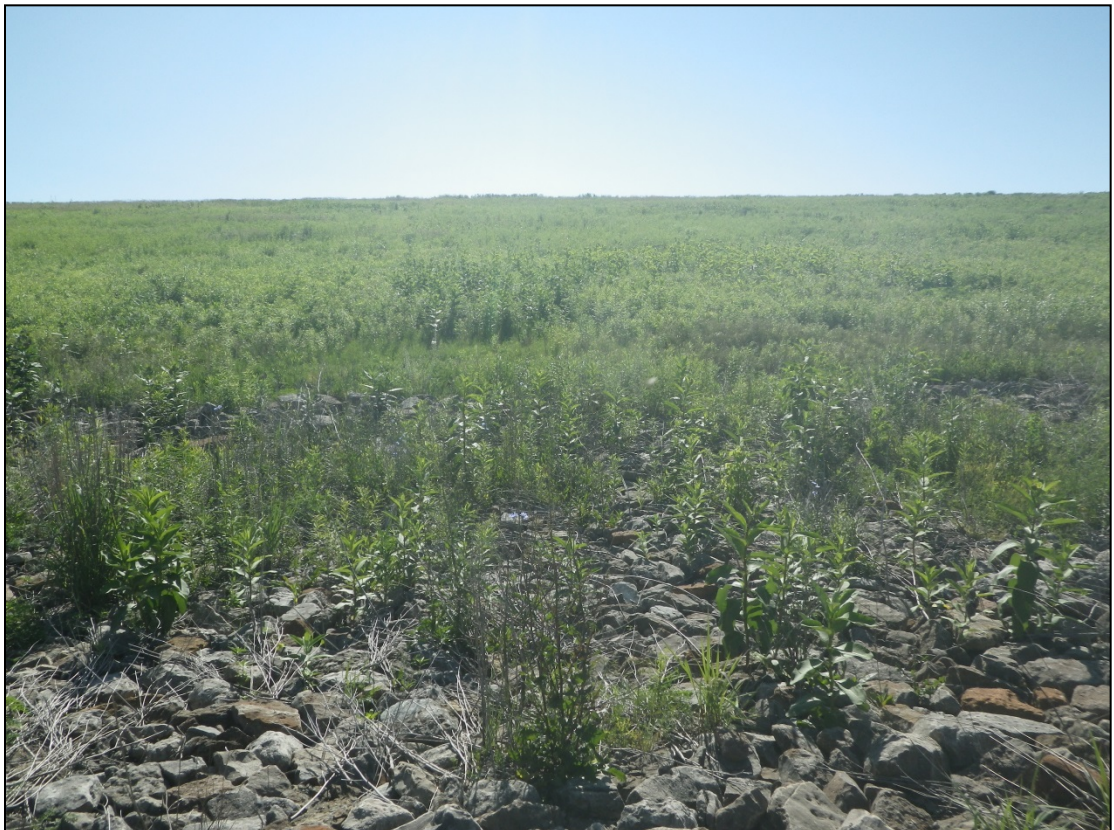
IMGP6791

West Face Cell 2

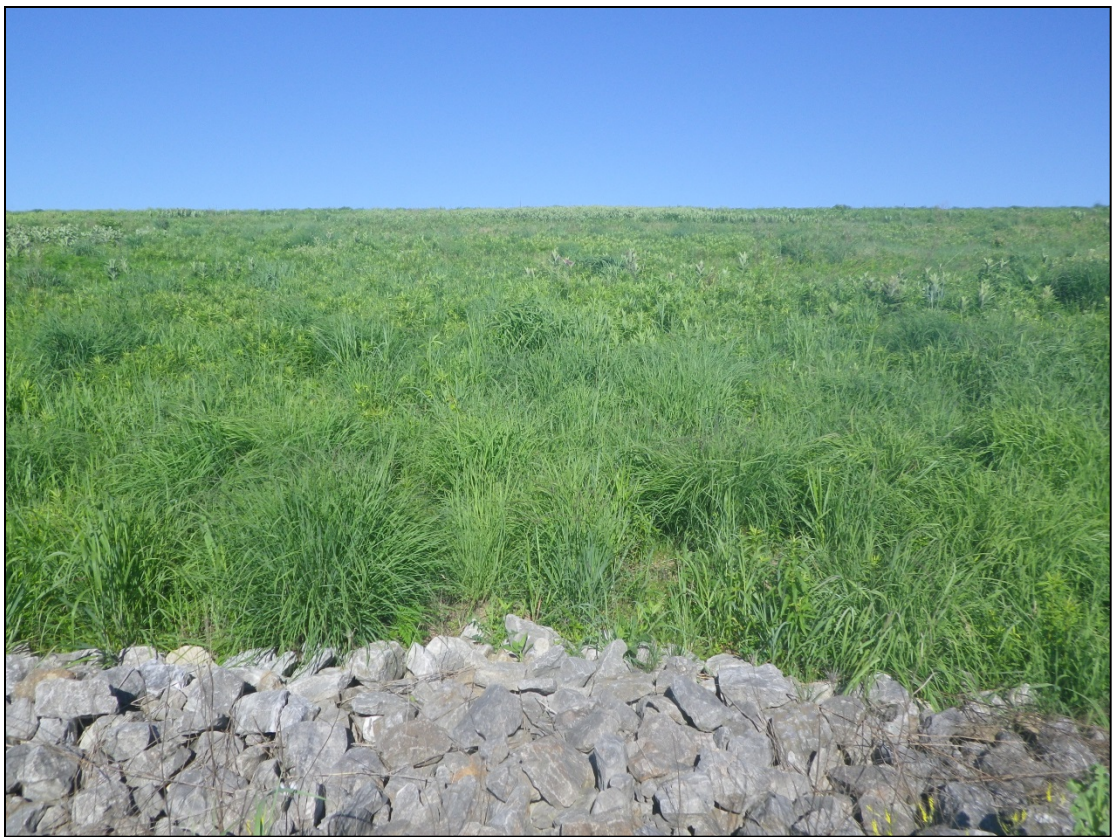
IMGP6783

East Face Cell 3

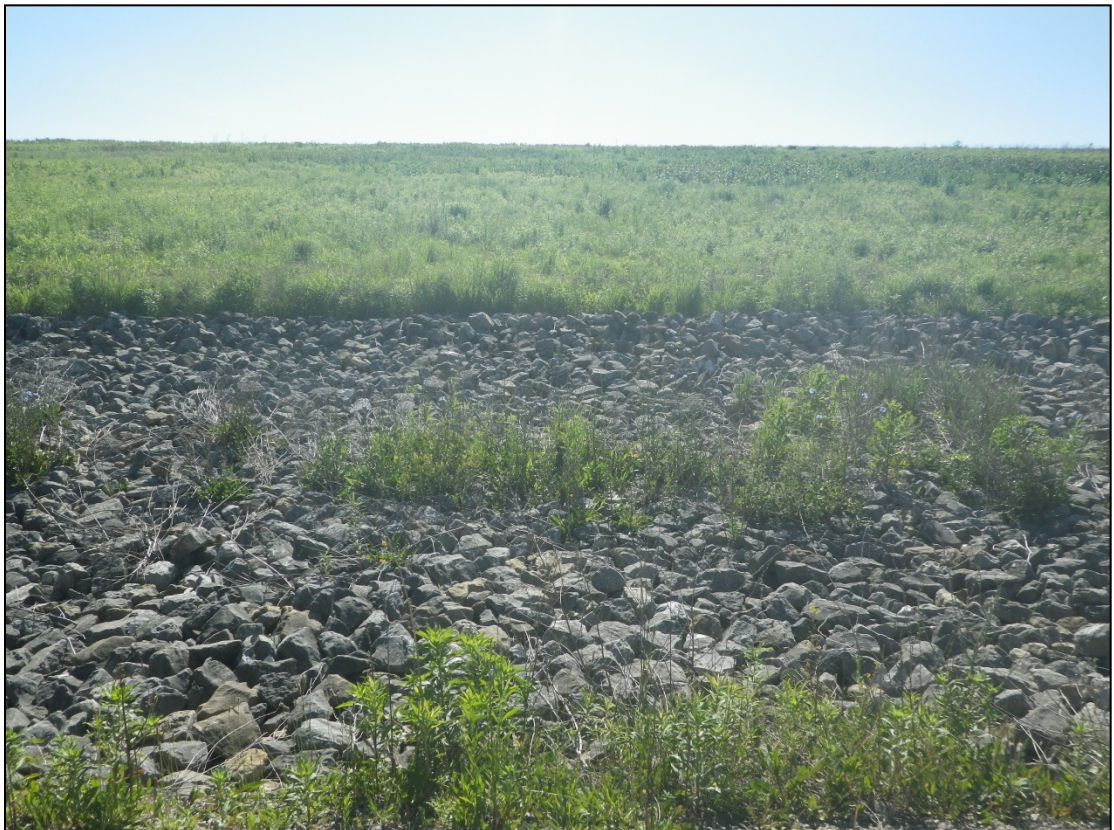
IMGP6792

West Face Cell 3

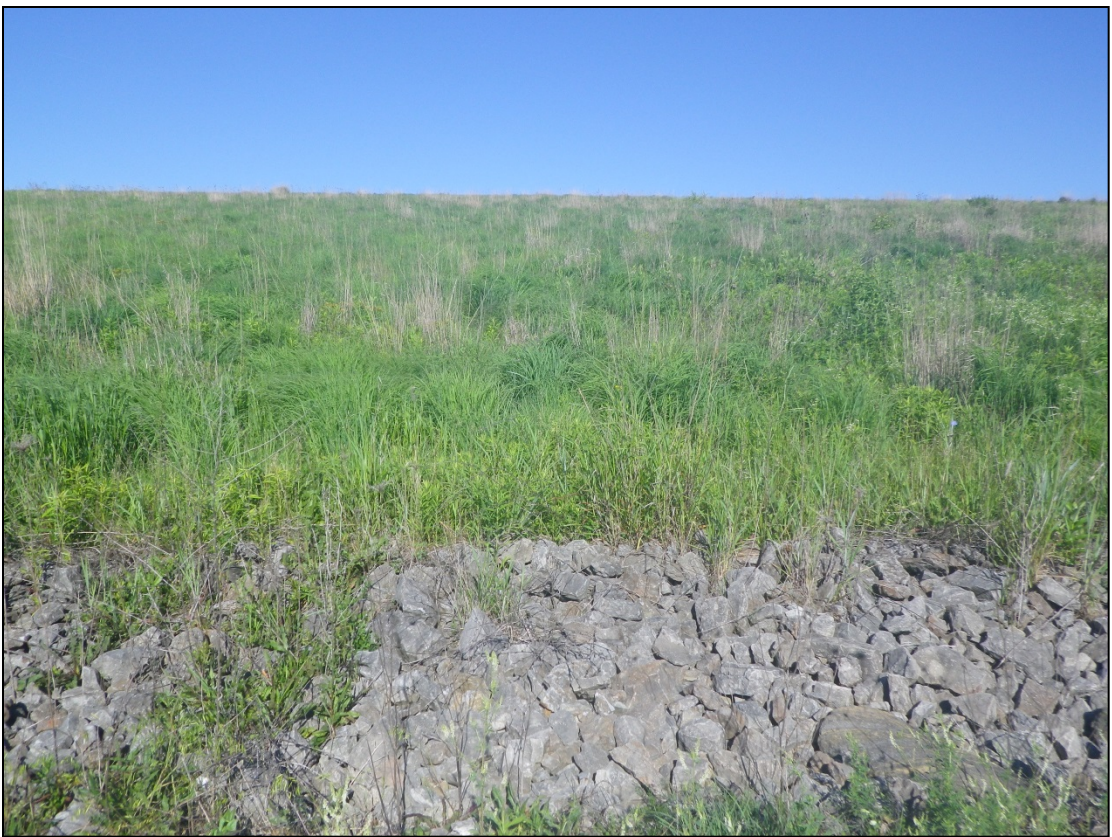
IMGP6781

East Face Cell 4

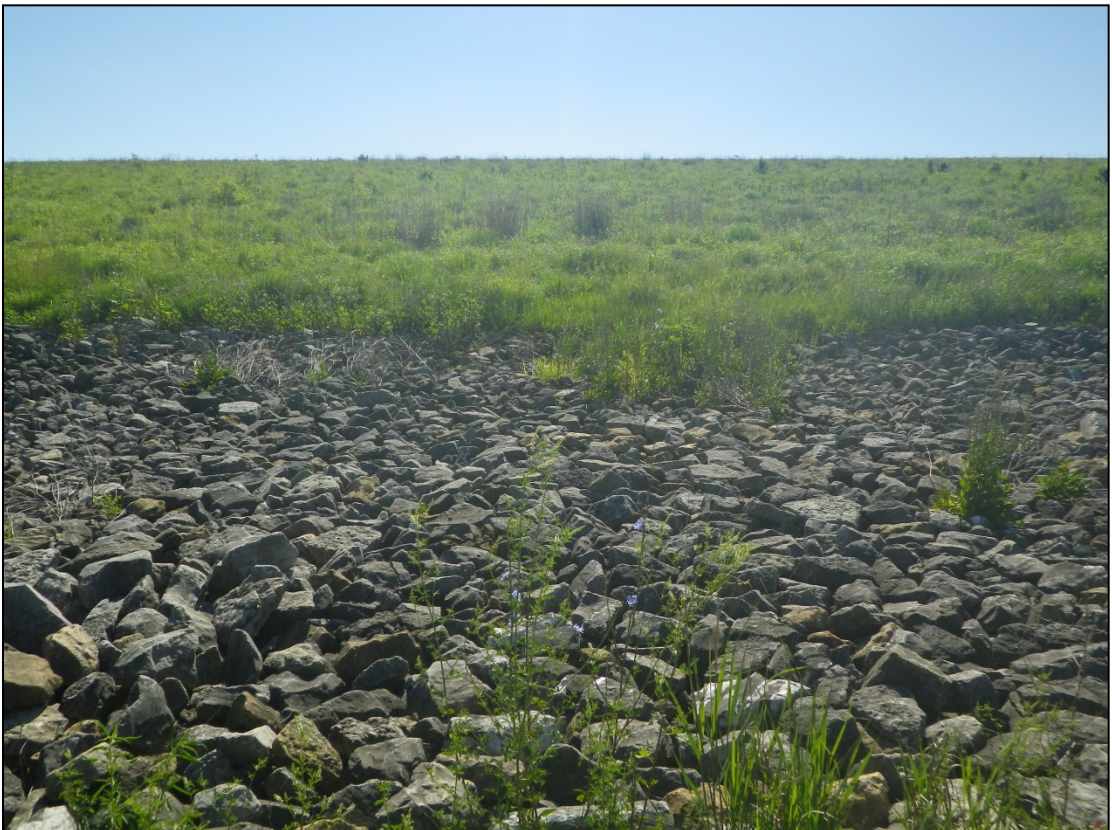
IMGP6793

West Face Cell 4

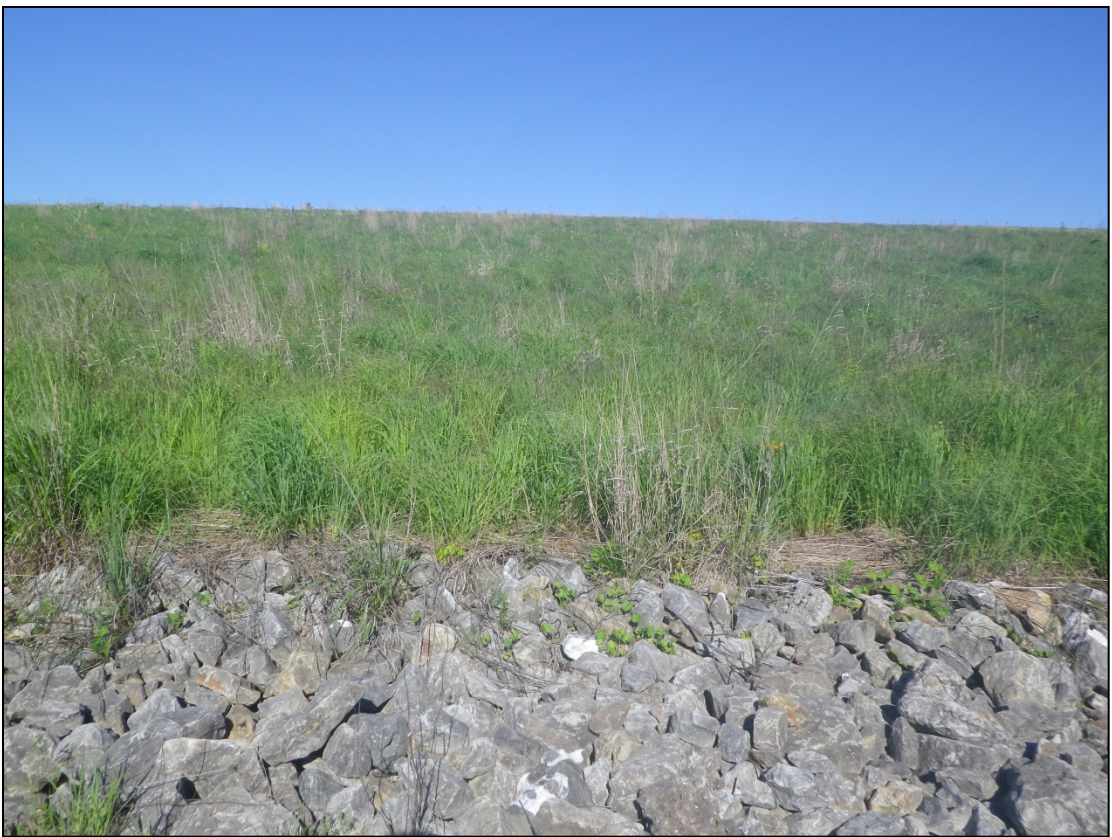
IMGP6780

East Face Cell 5

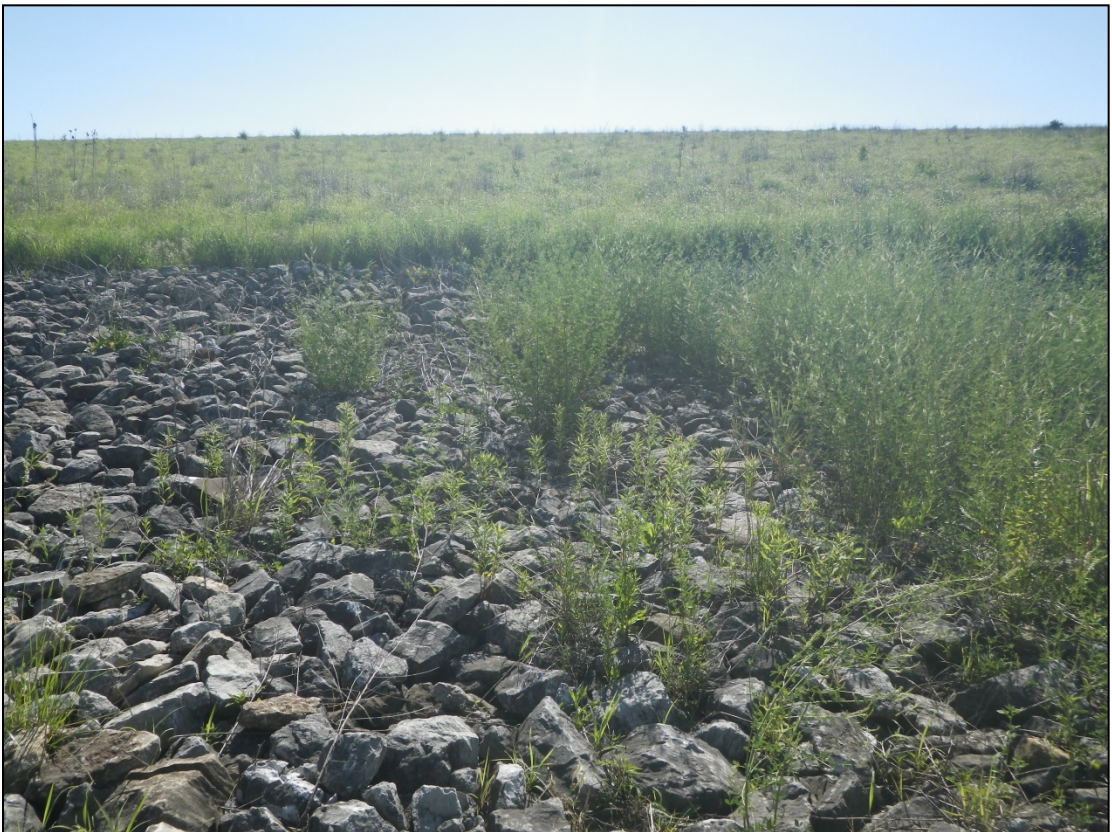
IMGP6794

West Face Cell 5

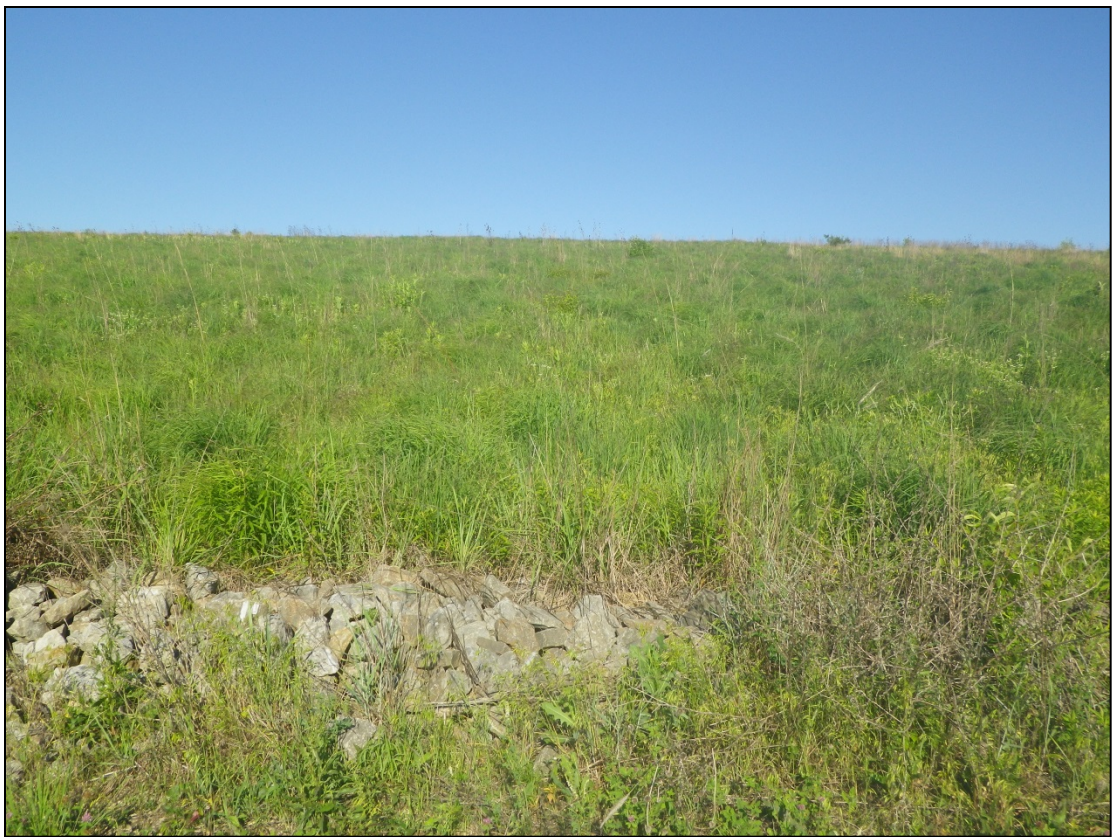
IMGP6779

East Face Cell 6

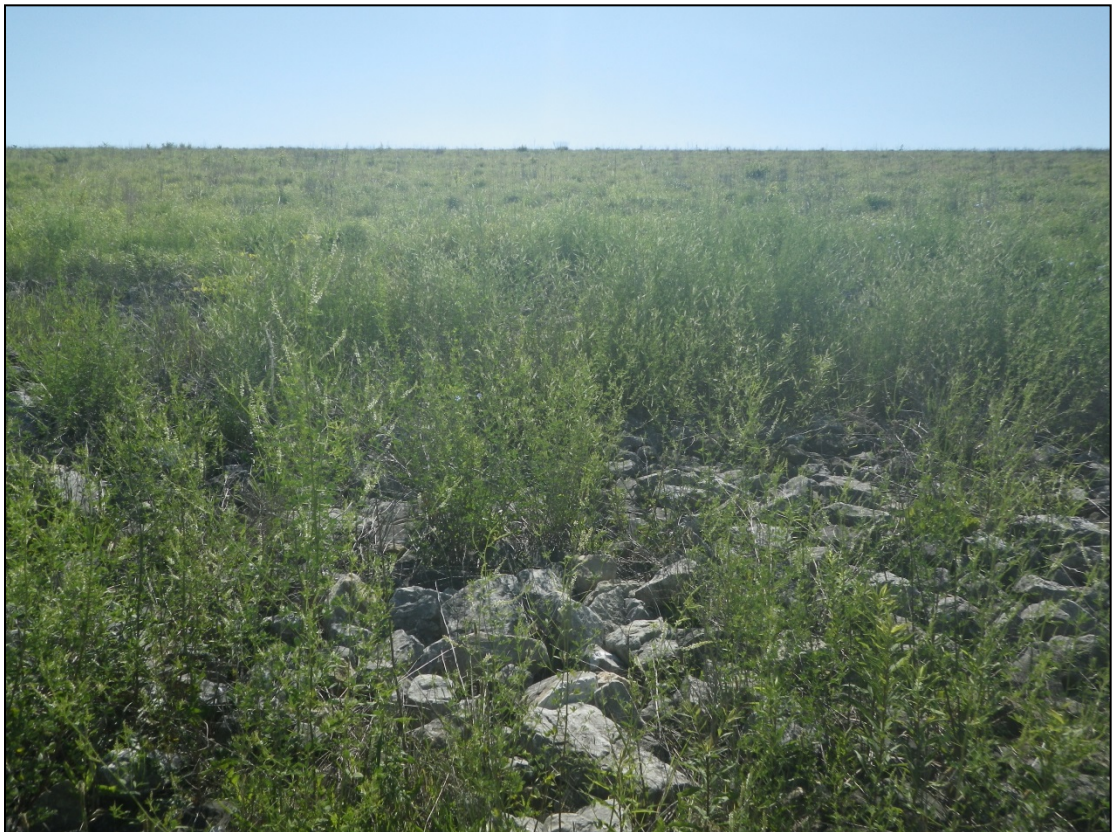
IMGP6795

West Face Cell 6

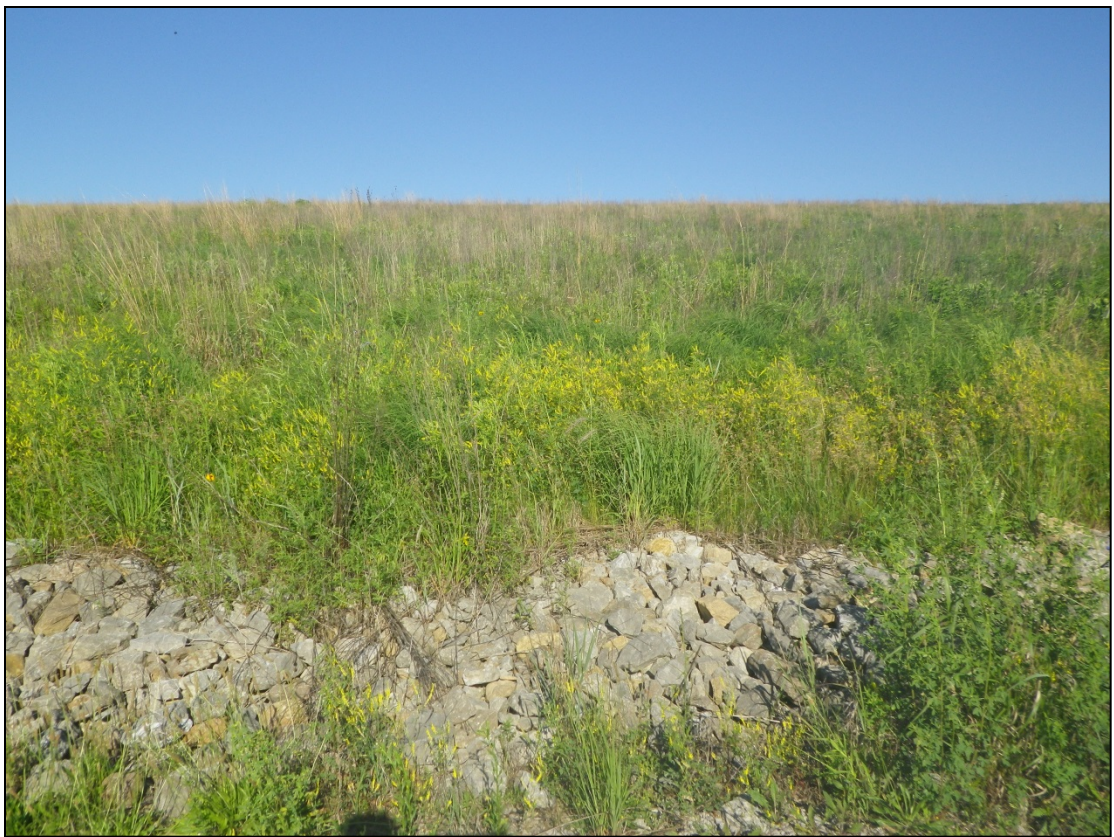
IMGP6777

East Face Cell 7
