Subject: Transmittal of the June 2018 Fernald Quarterly Inspection Report

This letter is the June 2018 quarterly inspection report for the Fernald Preserve at the Fernald, Ohio, Site. Inspections are conducted as directed by the *Comprehensive Legacy Management and Institutional Controls Plan* (LMICP) (LMS/FER/S03496). This letter also fulfills the reporting requirements specified in the Environmental Covenant, which is Appendix D of the *Consent Decree Resolving Ohio's Natural Resource Damage Claim Against DOE* (State of Ohio 2008). The inspections confirm that the activity and use limitations for the Fernald Preserve remain in place and are being complied with.

Fernald Preserve OSDF Walkdown Inspection Summary

On-Site Disposal Facility Inspection Photographs

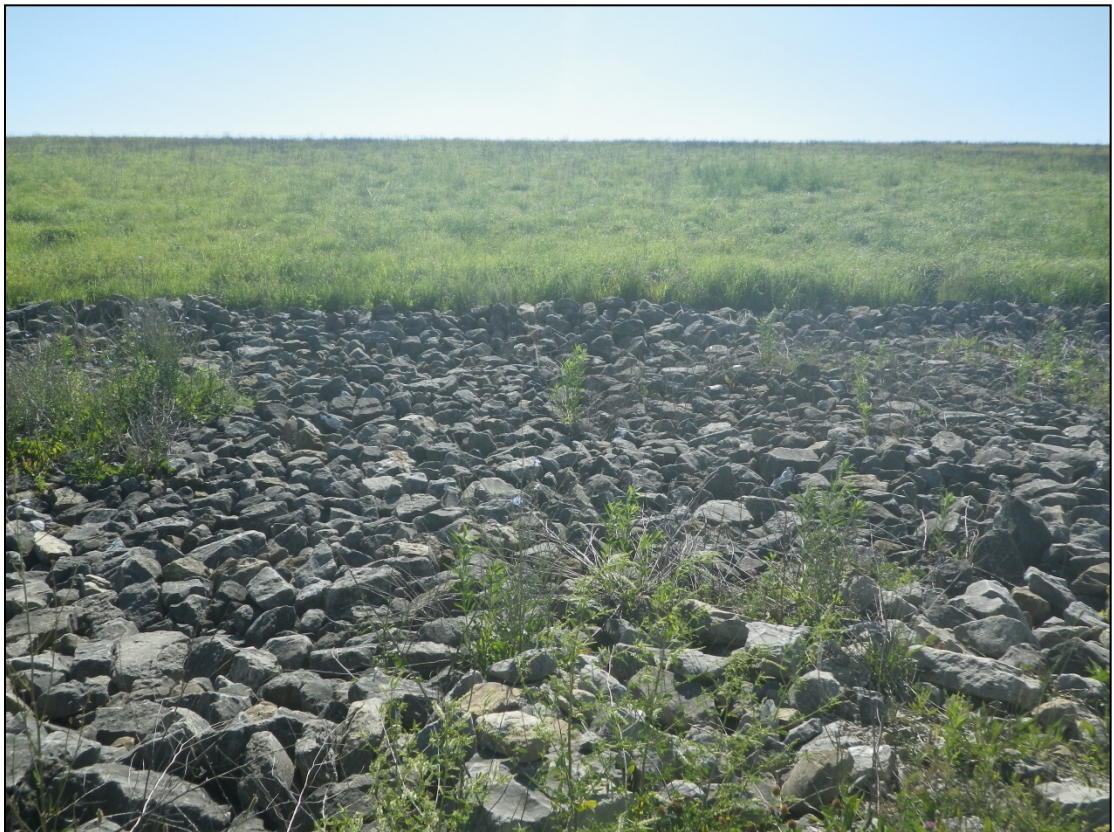
IMGP6796

West Face Cell 7

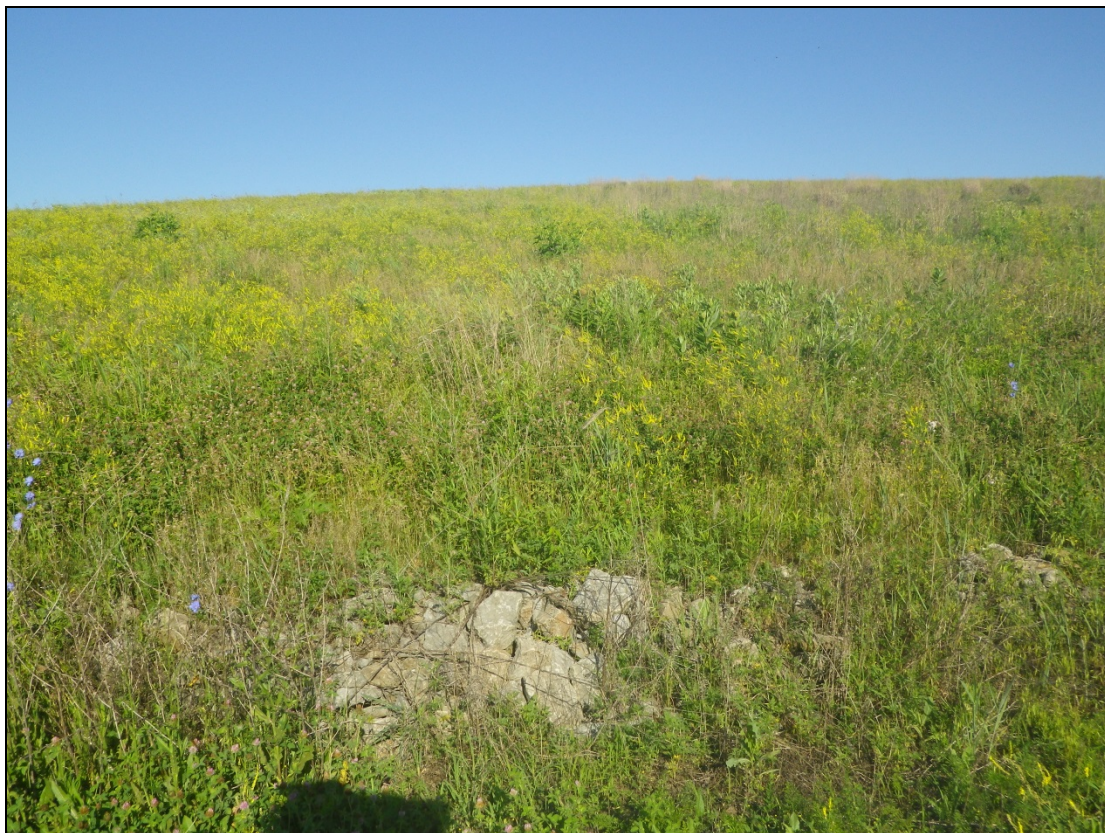
IMGP6776

East Face Cell 8

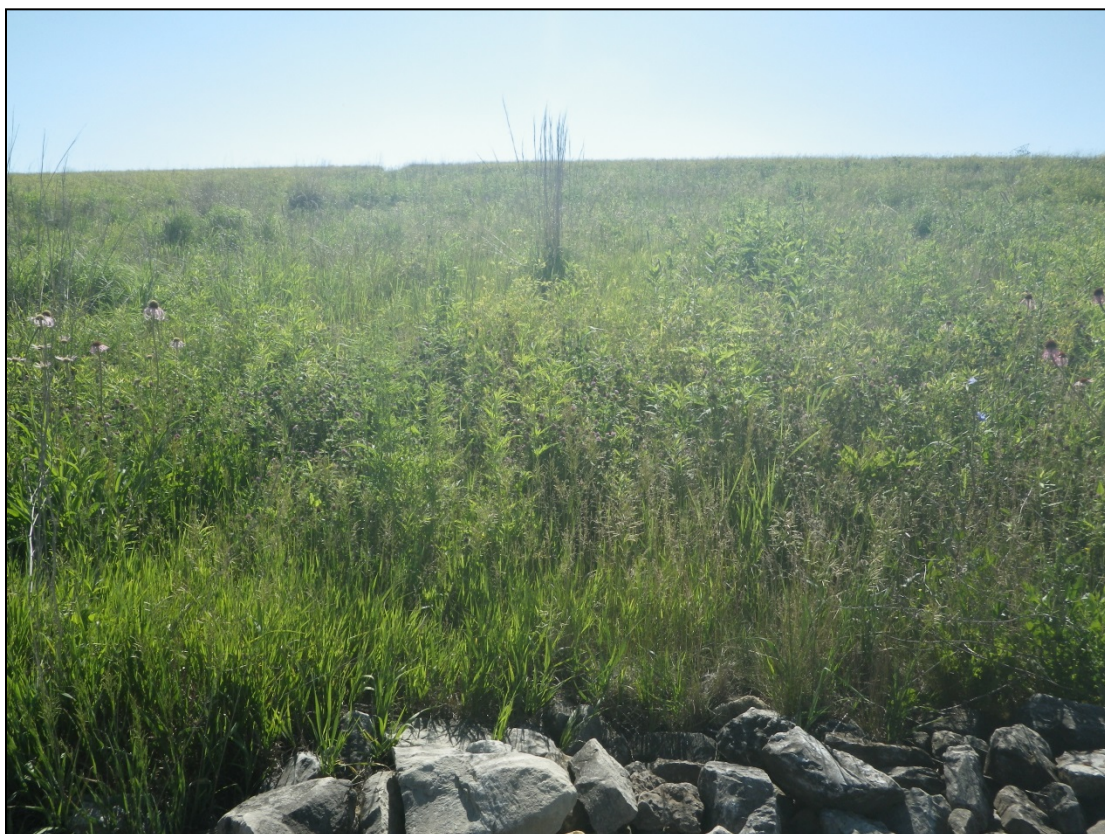
IMGP6797

West Face Cell 8

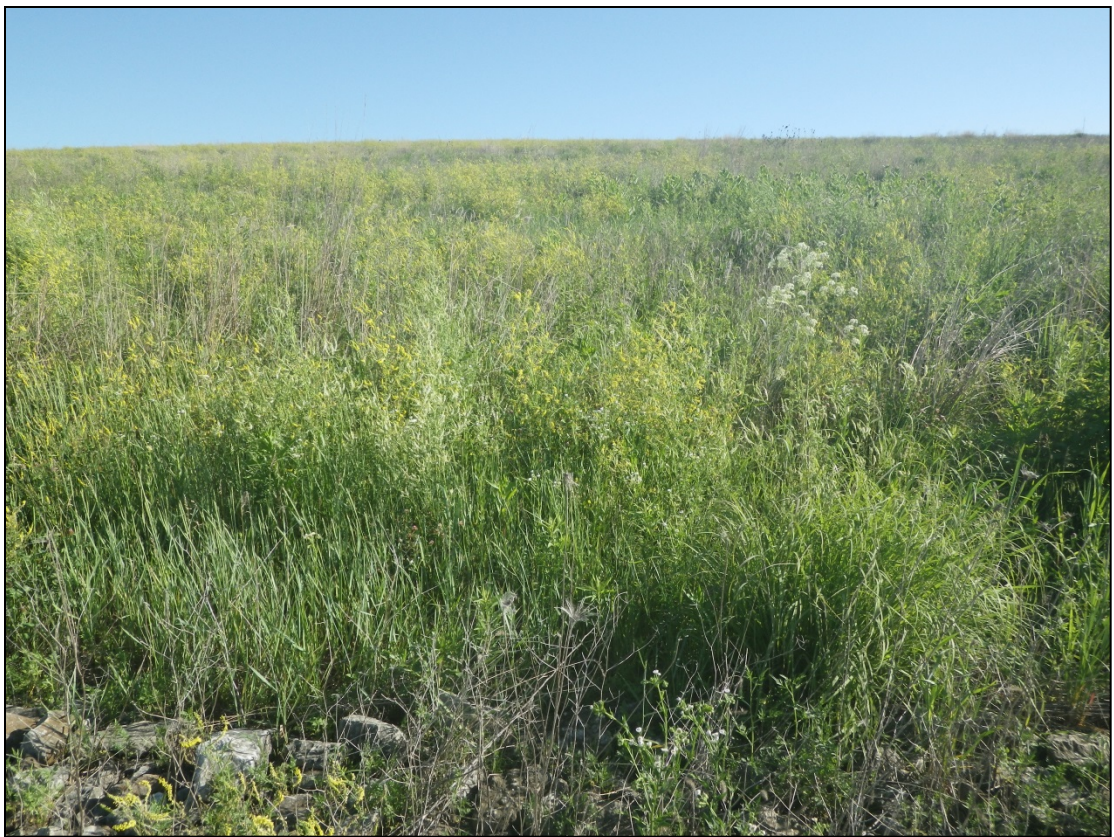
IMGP6774

South Face Cell 8

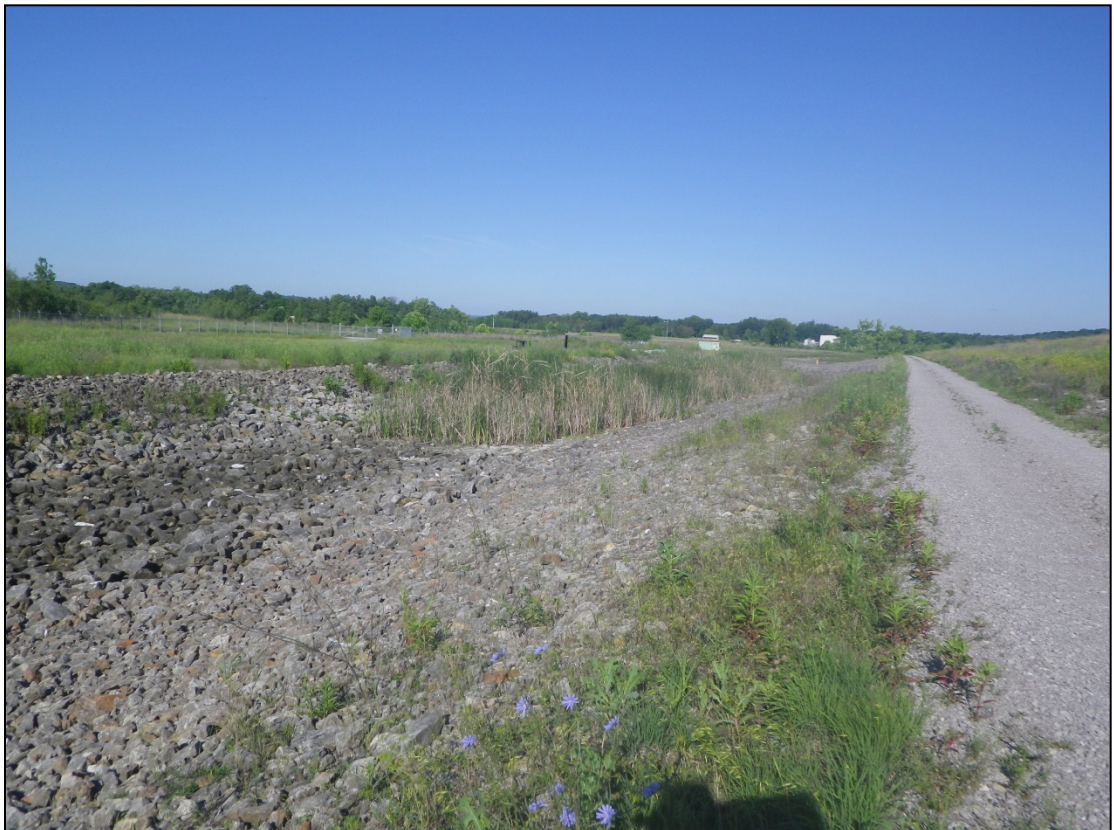
IMGP6775

South Drainage (looking west)

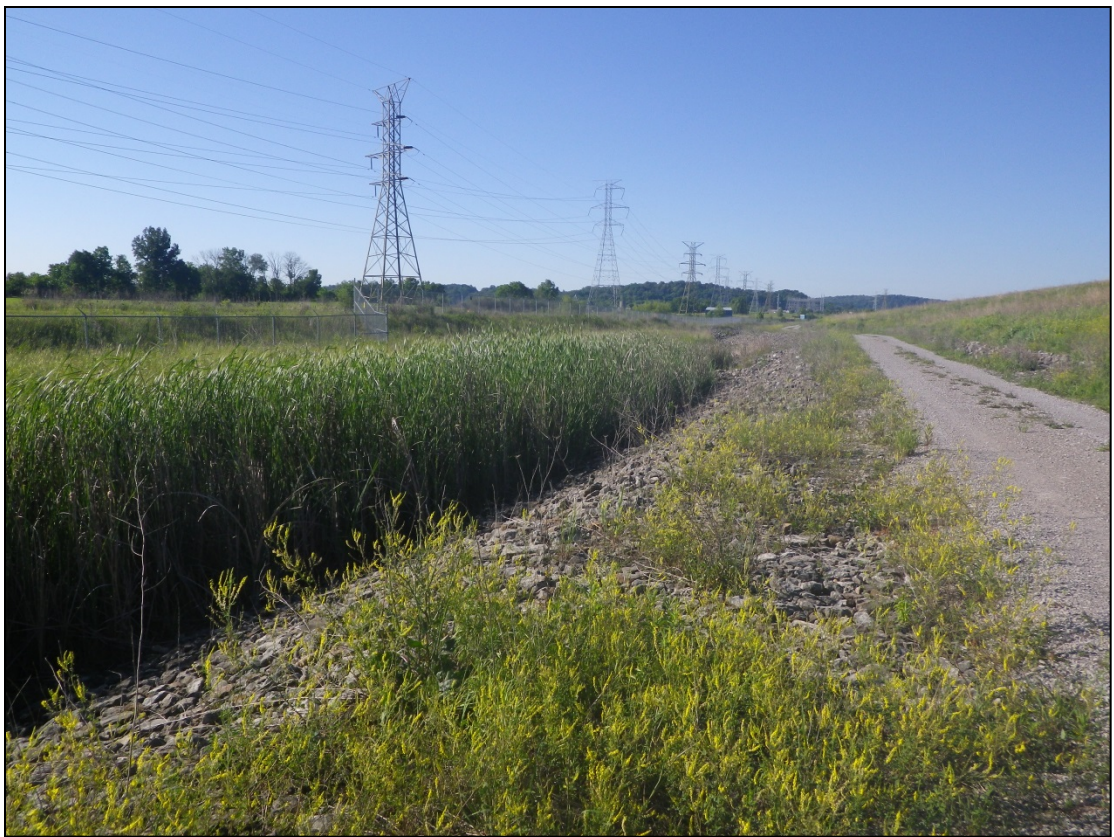
IMGP6778

East Drainage Cell 7 (looking south)

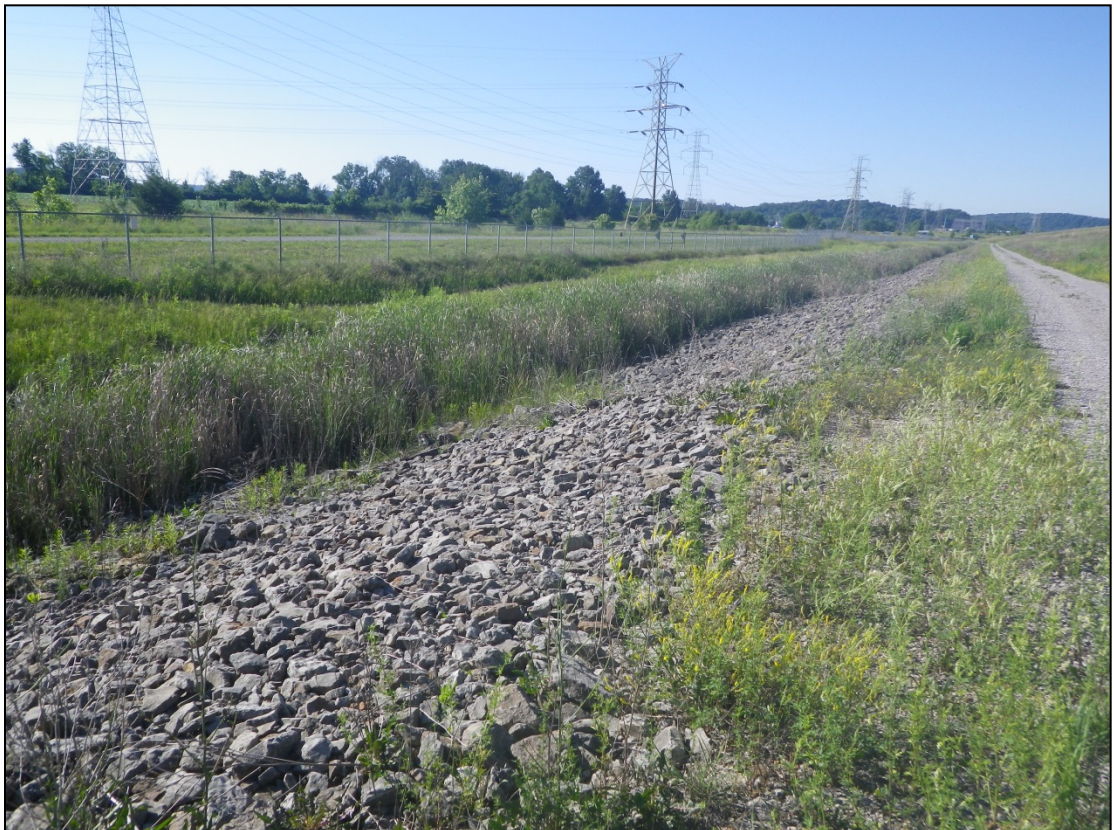
IMGP6782

East Drainage Cell 4 (looking south)

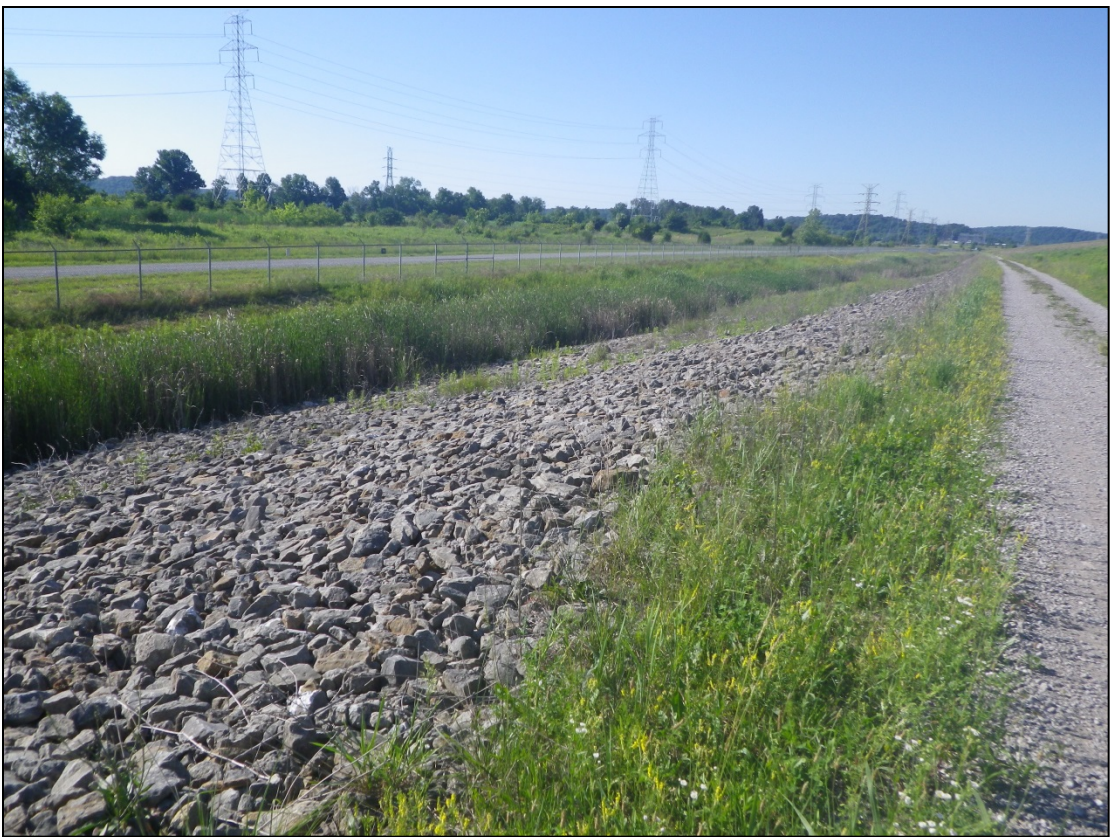
IMGP6785

East Drainage Cell 1 (looking south)

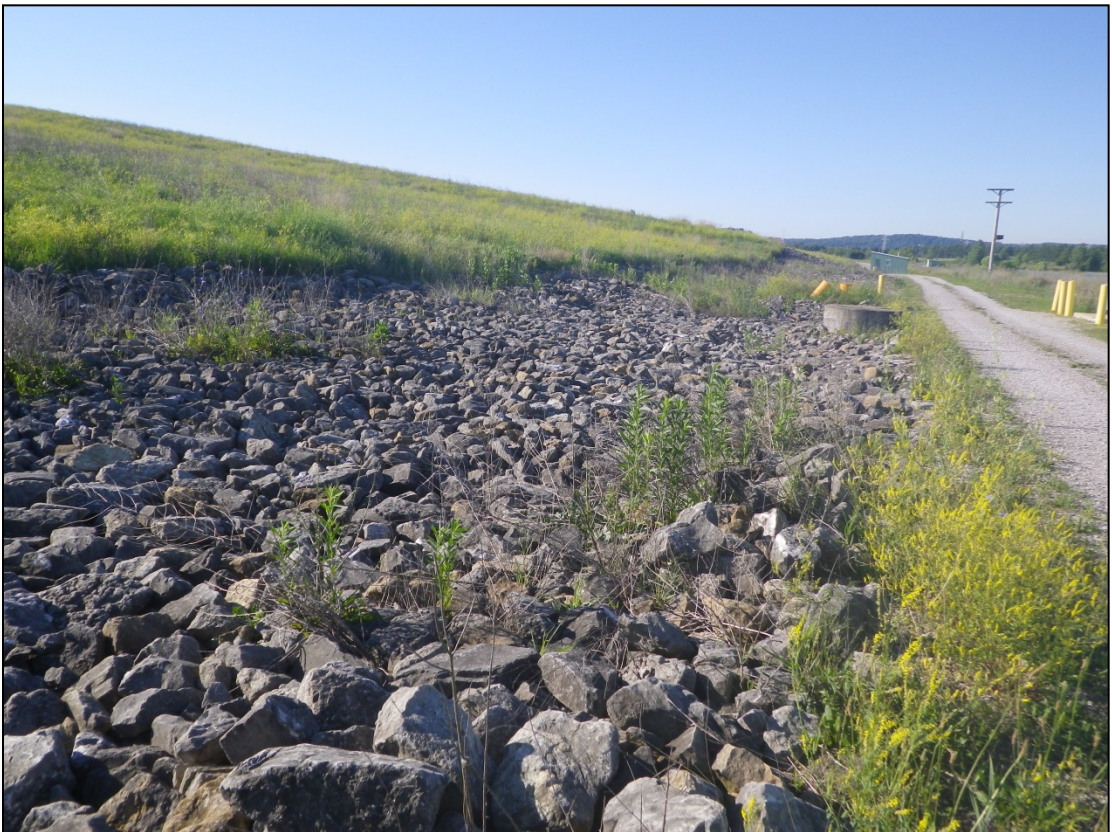
IMGP6771

West Inner Drainage Cell 7 (looking south)

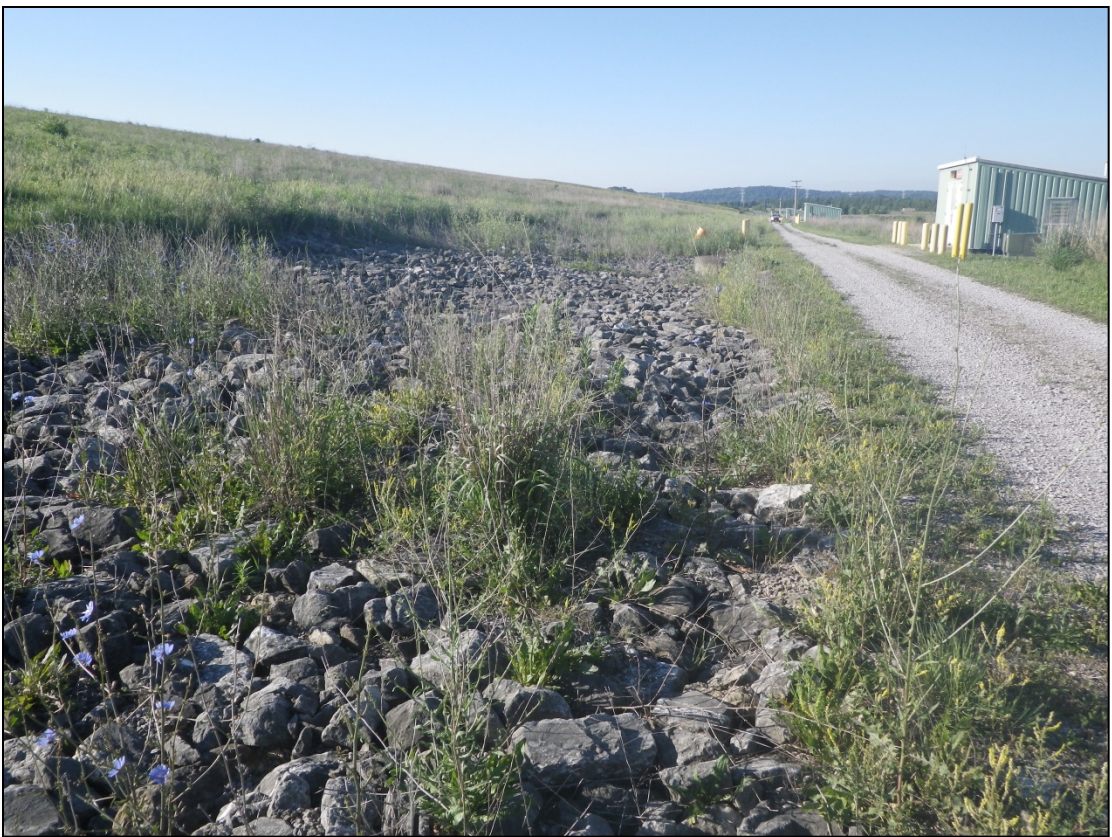
IMGP6770

West Inner Drainage Cell 4 (looking south)

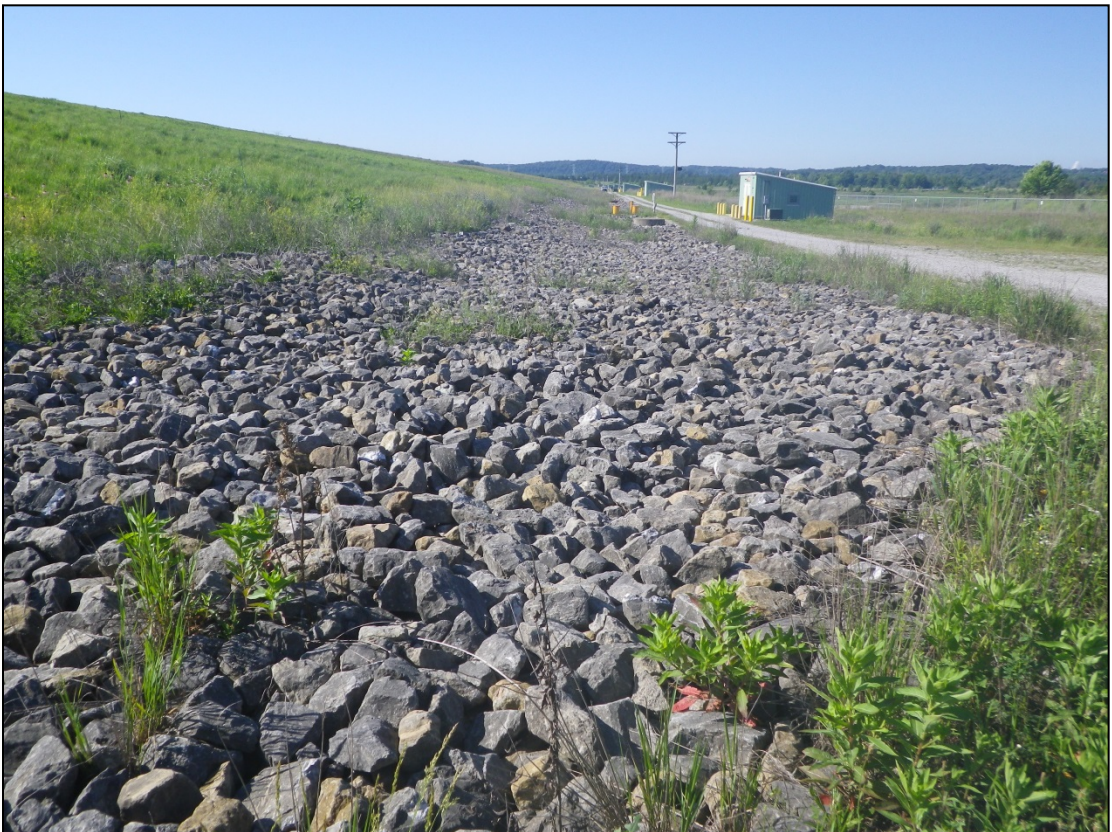
IMGP6789

West Inner Drainage Cell 1 (looking south)

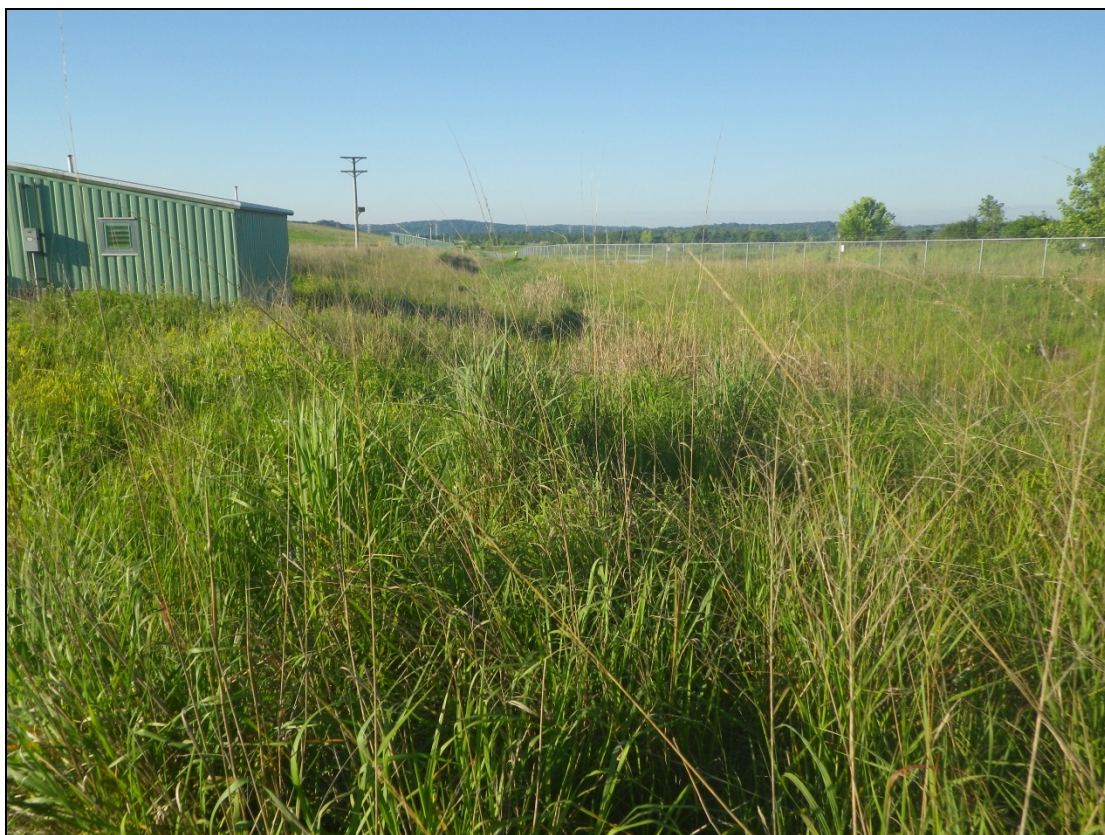
IMGP6769

West Outer Drainage Cell 1 (looking south)

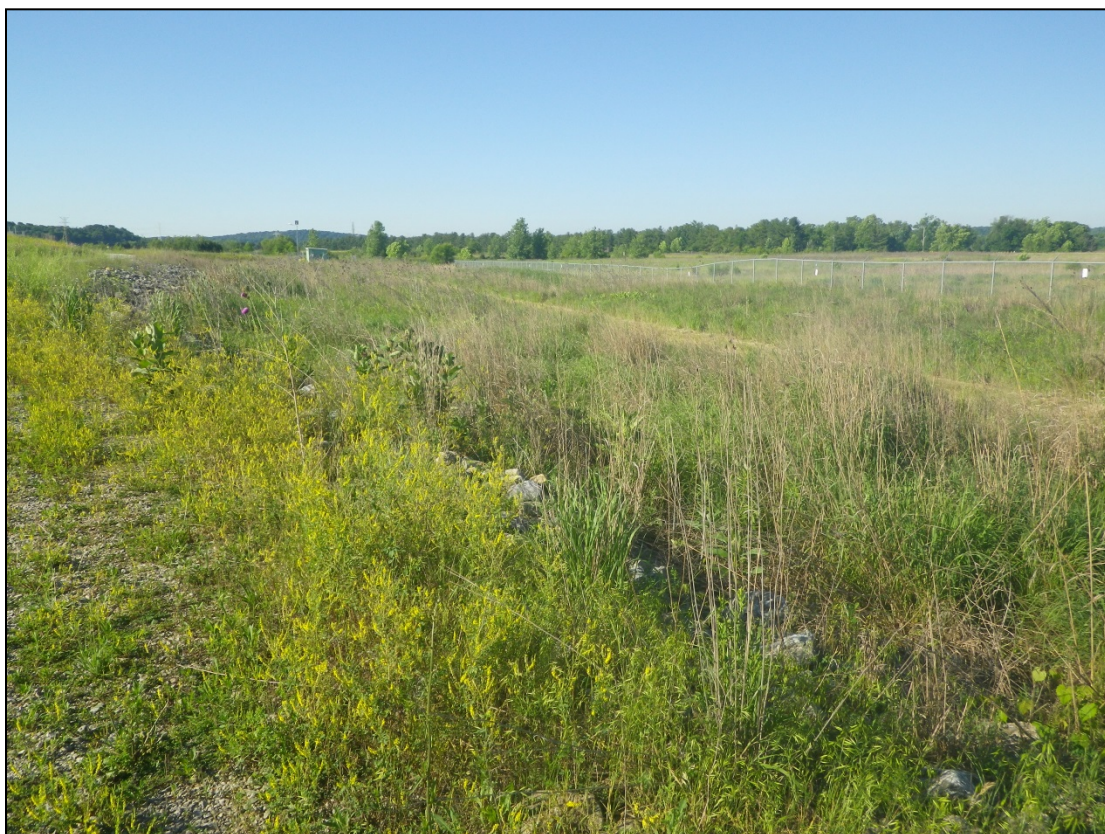
IMGP6773

West Outer Drainage Cell 8 (looking south)

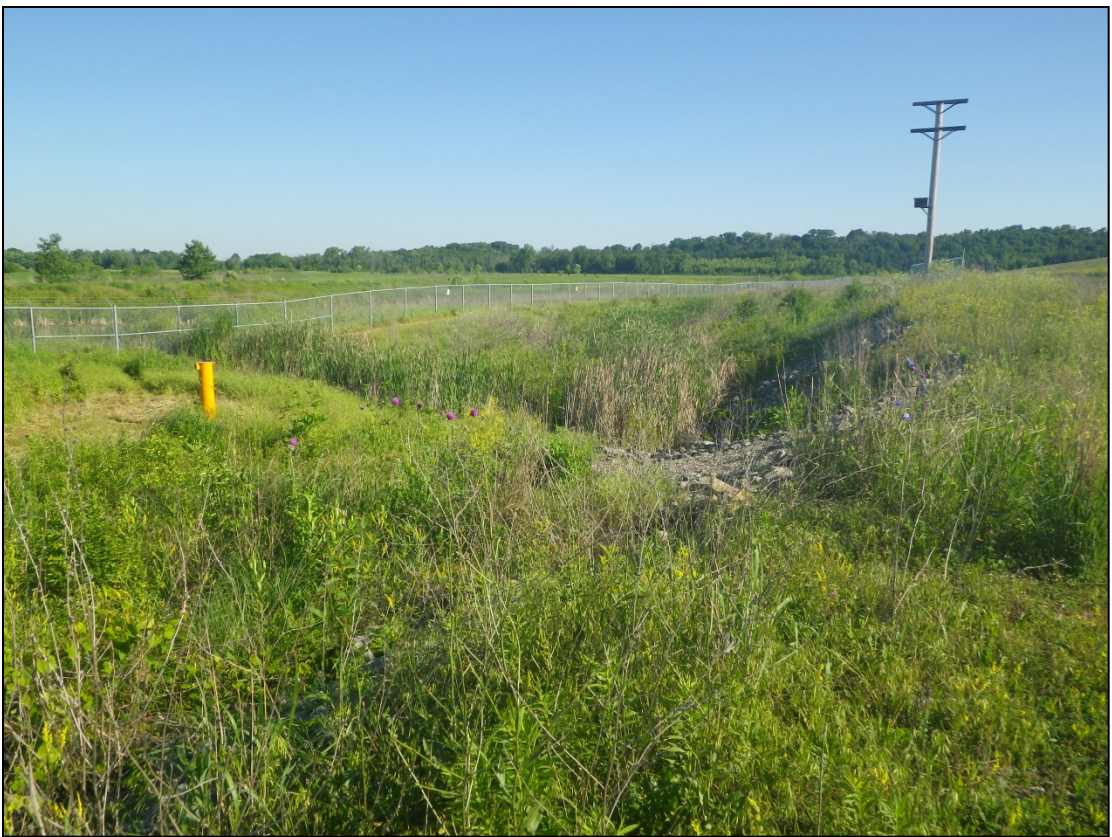
IMGP6772

West Outer Drainage Cell 8 (looking north)
