8.0 Gunnison, Colorado, Disposal Site

8.1 Compliance Summary

The U.S. Department of Energy (DOE) Office of Legacy Management (LM) conducted the Gunnison, Colorado, Uranium Mill Tailings Radiation Control Act (UMTRCA) Title I Disposal Site inspection on September 7, 2021. No cause for a follow-up inspection was identified.

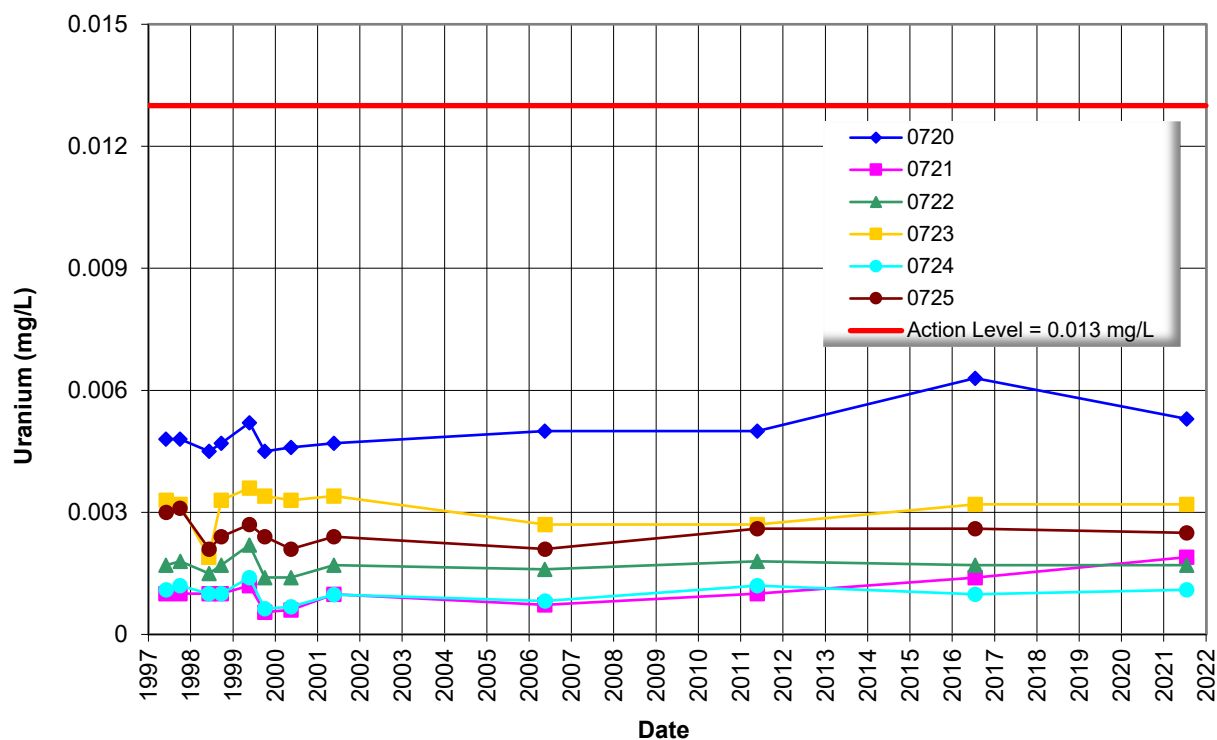
Figure 8-3. Uranium in Groundwater at POC Wells at the Gunnison, Colorado, Disposal Site

The concentrations of uranium in samples collected from POC wells ranged from 0.001 mg/L to 0.005 mg/L as shown in Table 8-3 and in a time-versus-concentration graph (Figure 8-3). Uranium concentrations were consistent with historical results in wells 0720, 0722, 0723, 0724, and 0725; however, they slightly exceeded the historical maximum in well 0721. Uranium results from the POC wells were below the action level of 0.013 mg/L.

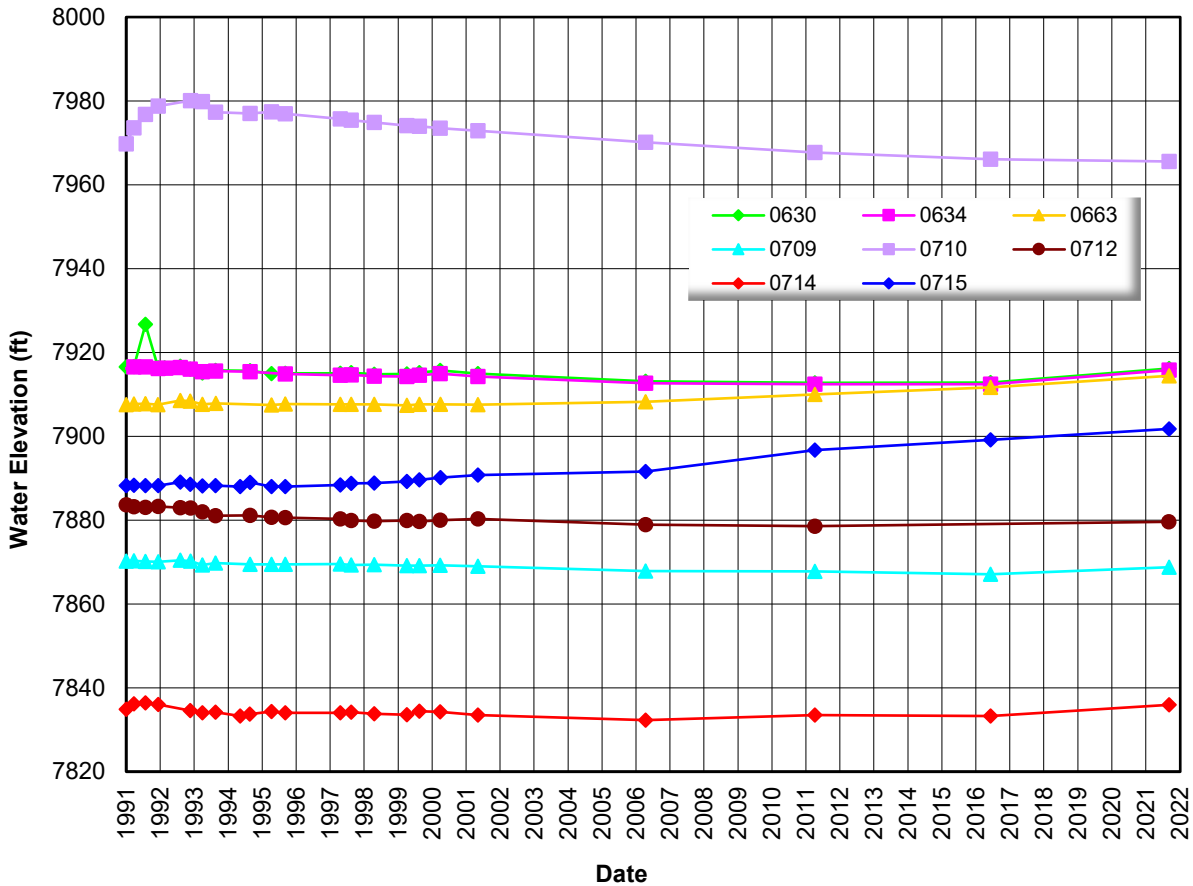
Figure 8-4. Groundwater Elevations at Selected Monitoring Wells at the Gunnison Disposal Site

Groundwater elevations from the entire monitoring network were measured in July 2021. In general, the measurements for groundwater elevations in groundwater level monitoring wells (Figure 8-4) show a gradual groundwater elevation decrease before and after completion of the disposal cell in 1995. Wells 0663 and 0715 are the exception, with groundwater elevations having increased approximately 6.7 and 14 feet, respectively, since 1995. In addition, with the exception of well 0710, the groundwater elevation in each well increased from 2016 to 2021 (Figure 8-4 and Figure 8-5).

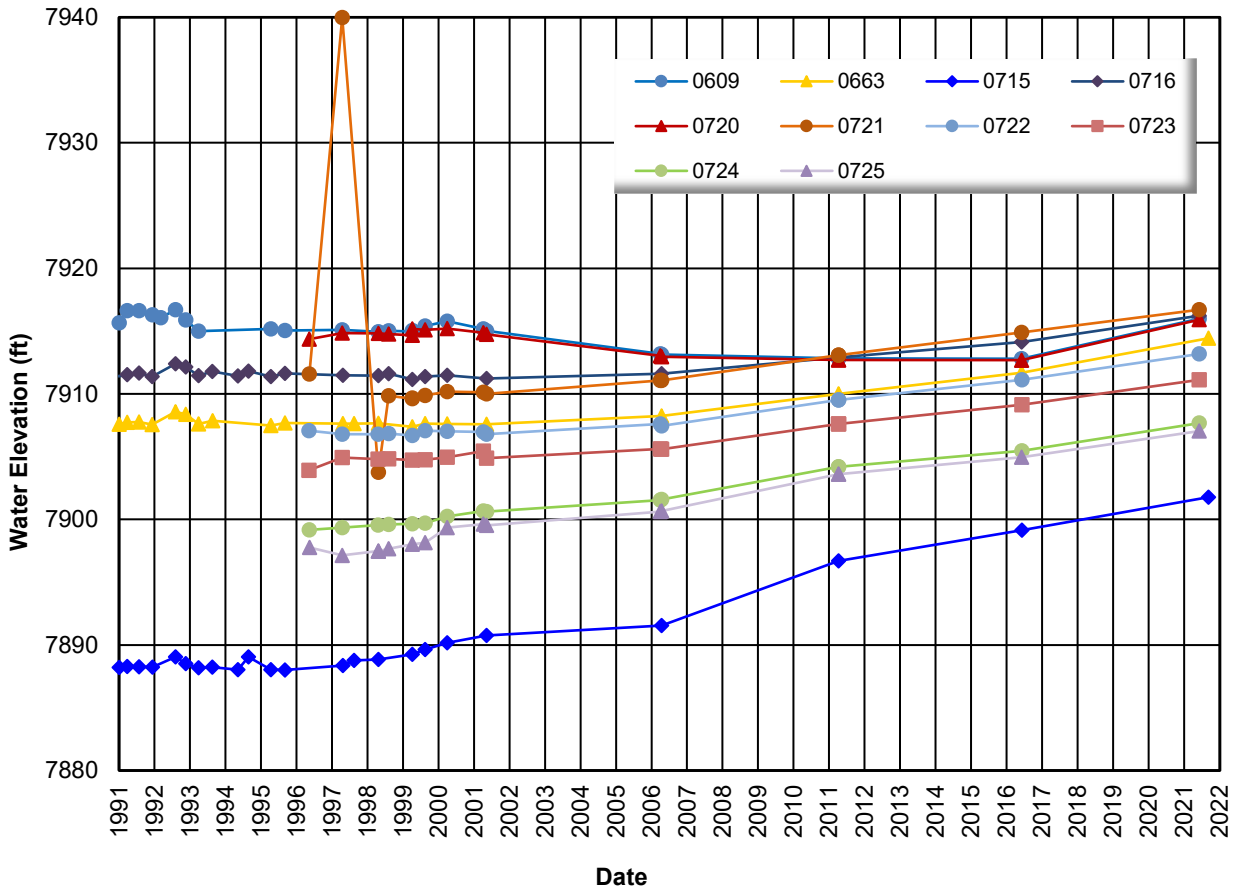
Figure 8-5. Groundwater Elevations at POC Wells, Background Monitoring Wells, and Wells 0715 and 0663 at the Gunnison Disposal Site

Groundwater elevations from wells 0663 and 0715 are plotted along with the POC wells (0720 through 0725) and the background wells (0609 and 0716) for comparison (Figure 8-5). Similar increases in groundwater elevations are seen for these other wells, except for wells 0609 and 0720, located just beyond the southwestern corner of the cell (Figure 8-2). A cause for the increasing groundwater elevations at wells 0663, 0715, 0716, and 0721 through 0725 has not been determined, but further evaluation is planned in 2022. Water level trends in these wells will continue to be monitored to determine if observed trends become a basis of concern.

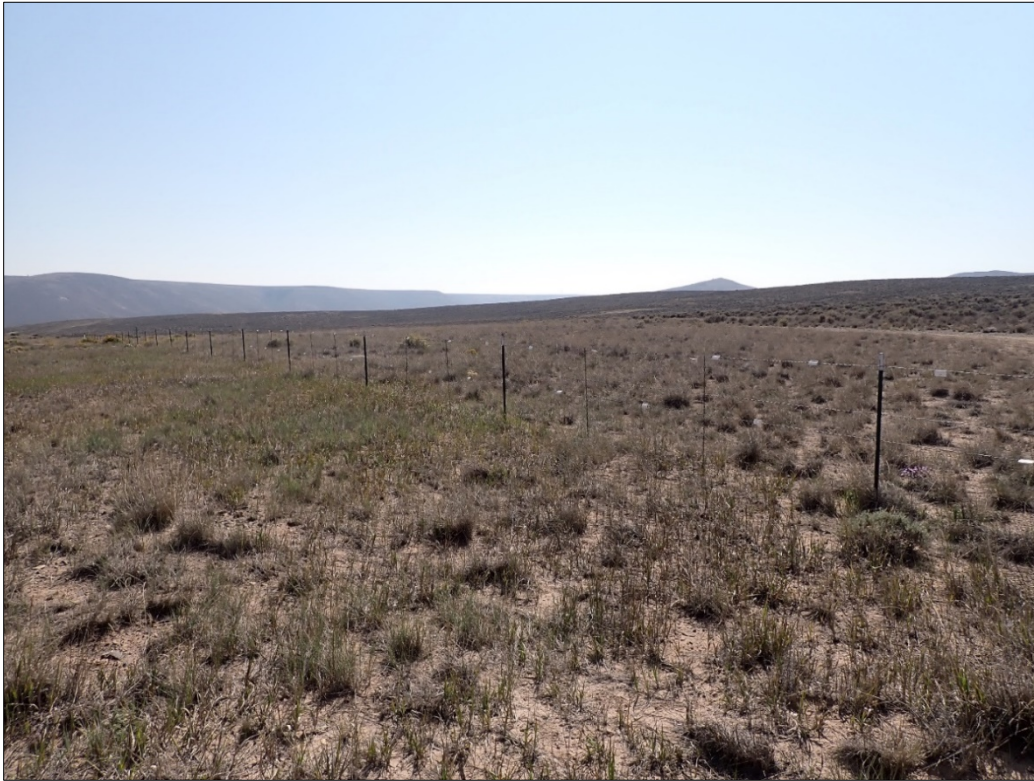
A three-strand barbed-wire perimeter fence encloses the site; most of it is set along the property boundary. In 2019, fence flagging (PL-1) was added to protect sage-grouse and antelope that occupy the area. The perimeter fence was intact.

PL-1. Southeast Perimeter Fence with Flagging

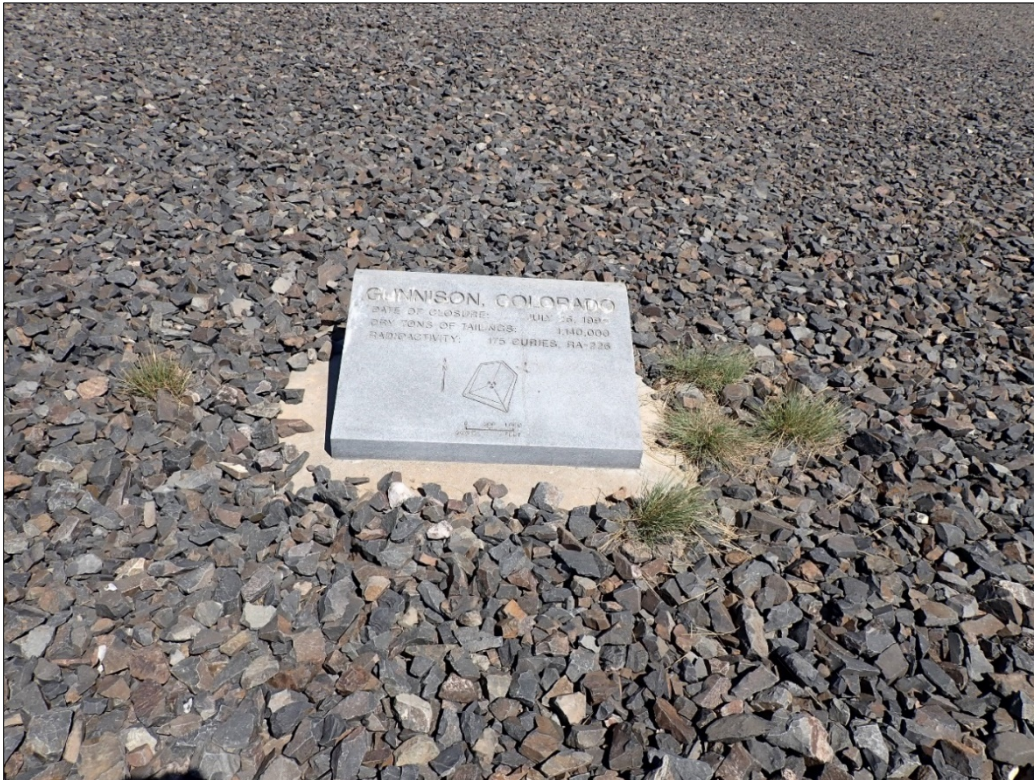
The site has two granite site markers. Site marker SMK-1 is just inside the entrance gate, and site marker SMK-2 (PL-2) is on the top slope of the disposal cell. The base of site marker SMK-2 has a small, insignificant crack and remains stable. No maintenance needs were identified.

PL-2. Site Marker SMK-2

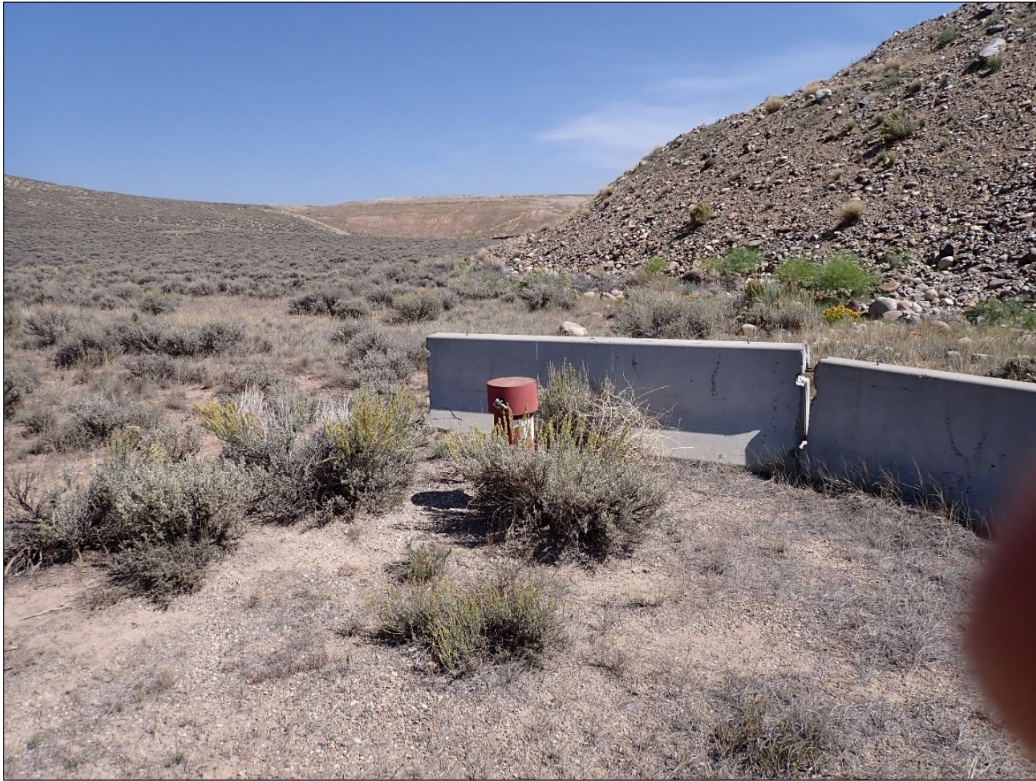
Gunnison County landfill operators have placed concrete barriers to protect monitoring well 0716, which is on landfill property, from landfill activities. Vegetation near well 0716 was beginning to overgrow the well (PL-3) and was treated following the inspection. The cracked base of monitoring well 0709 (PL-4) was repaired. No other maintenance needs were identified.

Gunnison County owns the land that adjoins the site boundary to the north and east and uses the land for a municipal landfill. The nearest landfill operations continue to be approximately 400 feet north of the site. Although landfill activities do not affect the site, inspectors will continue to monitor the level of activity occurring near the site boundary and surveillance features (e.g., fences and monitoring wells). With regard to groundwater flow, the landfill operations are cross gradient from the disposal cell. The only current concern for activities that could affect a site asset is a spoil pile near monitoring well 0716 (Figure 8-1 and PL-3). Inspectors will continue to monitor this area. No other maintenance needs were identified.

PL-3. Well 0716 Overgrown with Vegetation and Nearby Spoil Pile

- Treated vegetation on top slope and side slope of disposal cell
- Replaced remaining plastic perimeter signs
- Replaced entrance sign and perimeter signs P1 and P3
- Treated vegetation around monitoring well 0716
- Repaired concrete base around monitoring well 0709
- Plugged prairie dog colony holes

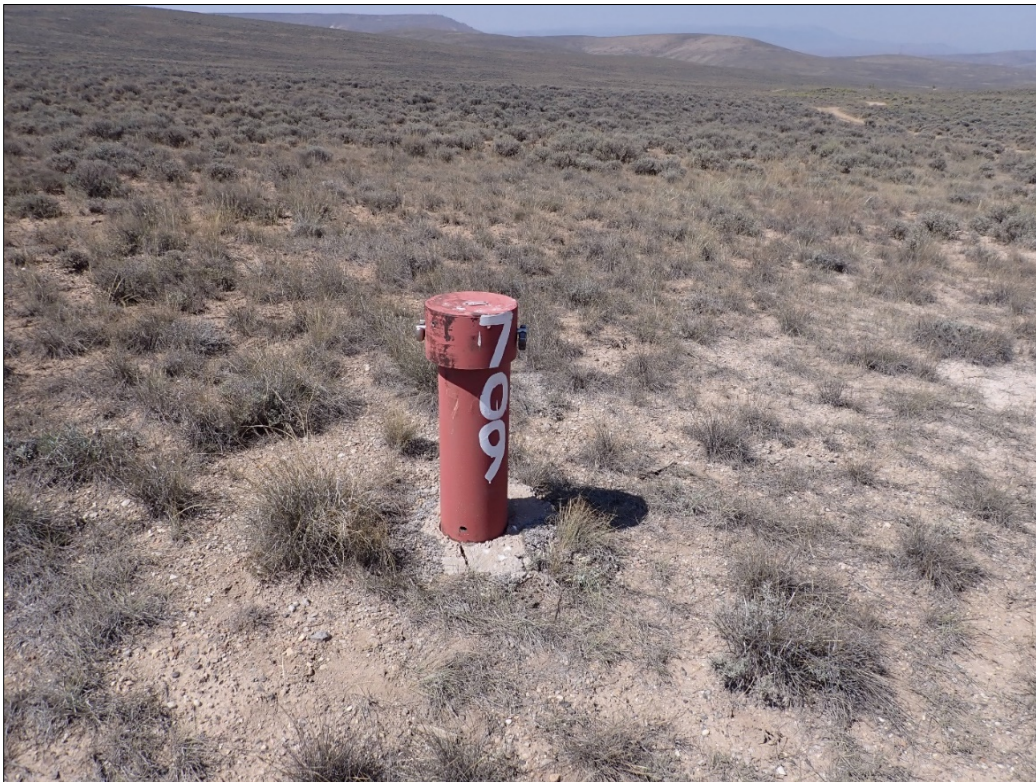
The site has 16 groundwater monitoring wells. The wellhead protectors were locked and properly labeled. Bullet damage is present on the wellhead protector of monitoring wells 0634 and 0712, but the well casings are not impacted and remain functional. The bullet-damaged locks reported in the 2020 inspection report (wells 0630 and 0712) will be replaced before the next inspection. The well casing at well 0709 had a cracked base and was repaired following the 2021 inspection.

PL-4. Cracked Base of Well 0709

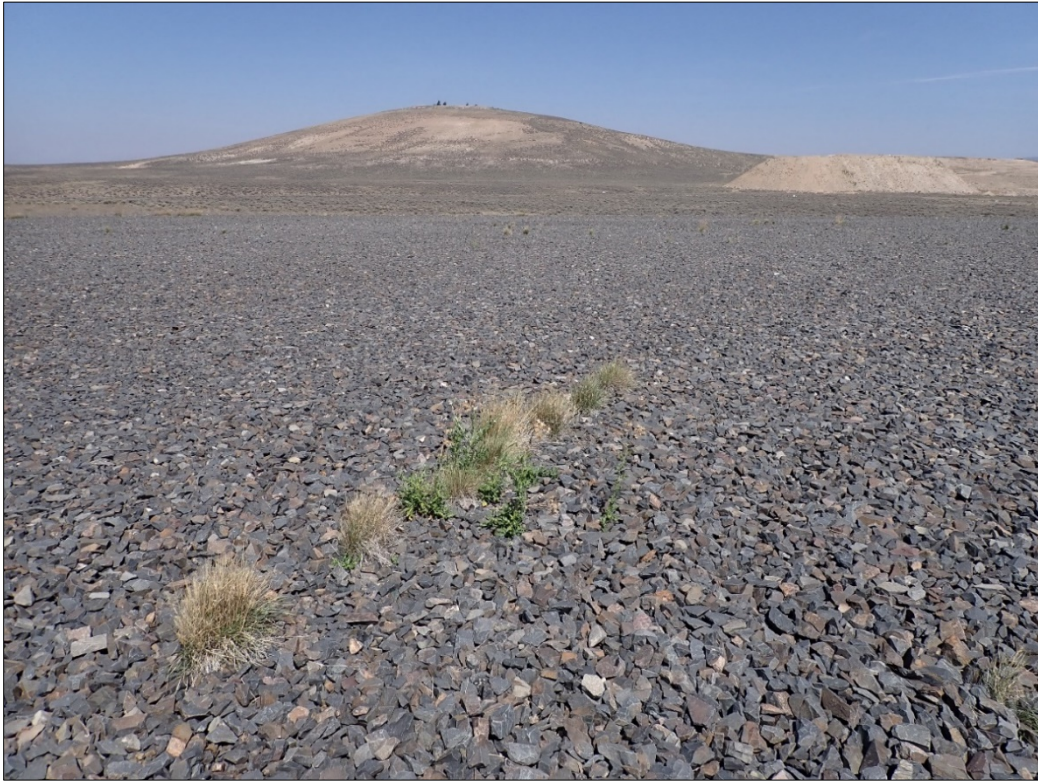
There was no evidence of settling, slumping, erosion, or any other modifying process that might affect the integrity of the top slope of the disposal cell. Several isolated patches of grass have established on the top slope; however, these shallow-rooted plants do not degrade the performance of the radon barrier component of the disposal cell's engineered cover. Several small grasses were discovered on the cell top slope (PL-5). This vegetation was treated as necessary following the inspection. No other maintenance needs were identified.

PL-5. Vegetation on Disposal Cell Top Slope
