8.0 Gunnison, Colorado, Disposal Site

The U.S. Department of Energy (DOE) Office of Legacy Management (LM) conducted the Gunnison, Colorado, Uranium Mill Tailings Radiation Control Act (UMTRCA) Title I Disposal Site inspection on September 7, 2022. No cause for a follow-up inspection was identified.

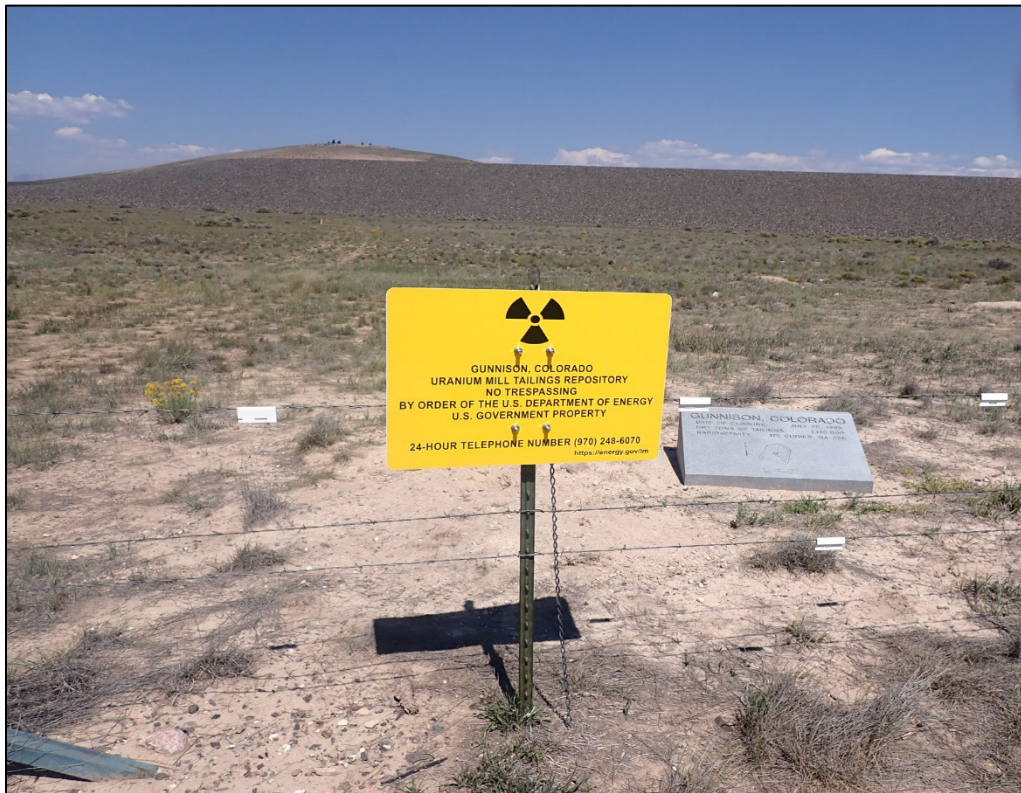
PL-1. Entrance Sign

Access to the site is from Gunnison County Road 42 onto U.S. Bureau of Land Management (BLM) Route 3068, a gravel road maintained by BLM. Entrance to the site is through a locked gate that is part of the perimeter fence. The entrance gate was locked and functional, and the entrance sign was intact and legible (PL-1). Locks were replaced at the access gates during the inspection. No other maintenance needs were identified.

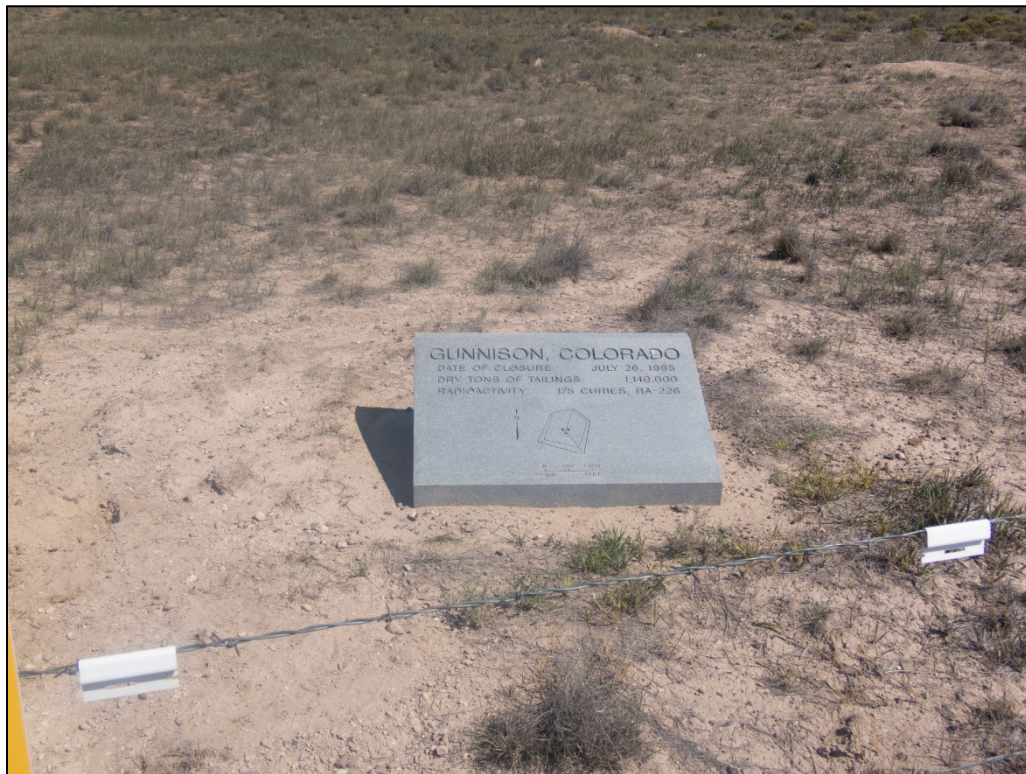
PL-2. Site Marker SMK-1

The site has two granite site markers. Site marker SMK-1 (PL-2) is just inside the entrance gate, and site marker SMK-2 is on the top slope of the disposal cell. The concrete base of site marker SMK-2 has cracks lining up with each of the four monument corners but remains stable. No maintenance needs were identified.

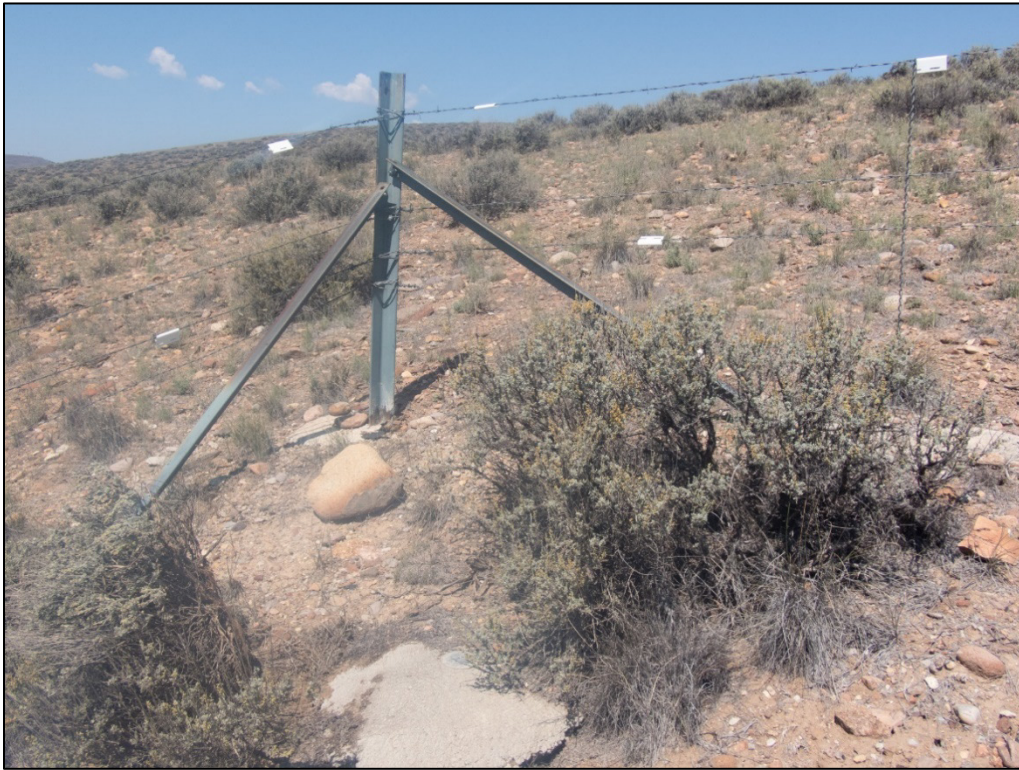
PL-3. Boundary Monument BM-4 with Corner Posts in Background

Three combined survey and boundary monuments and eight additional boundary monuments delineate the property boundary (PL-3). Inspectors noted that boundary monument BM-4 is slightly undercut but remains stable. No maintenance needs were identified.

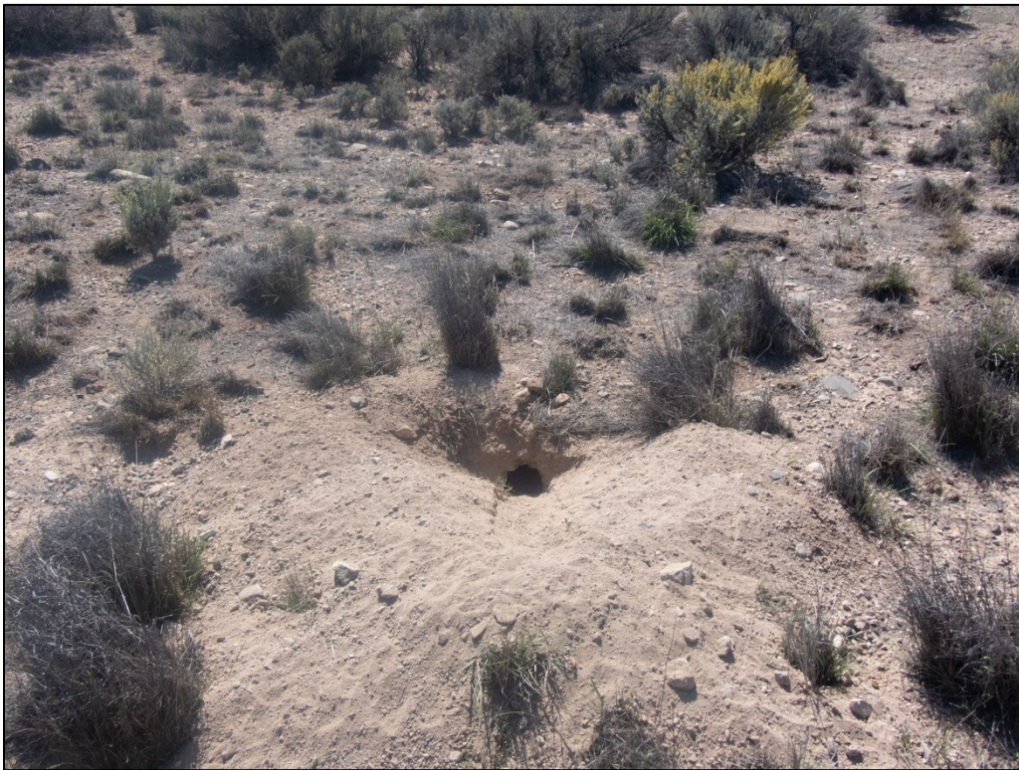
PL-4. Prairie Dog Hole near Perimeter Sign P2

Reclaimed and undisturbed areas comprise the area between the disposal cell and the site boundary. In general, the vegetation in the reseeded, reclaimed areas consists of well-established grass; native plants are much less abundant and less diverse in reclaimed areas than they are in undisturbed areas. Former erosion areas are stable and naturally revegetating with native plant species. Several new prairie dog burrows were observed by inspectors inside the perimeter fence near perimeter signs P1, P2, and P3 (PL-4). Inspectors noted that the prairie dog colony appears to be expanding and will be monitored to ensure that the holes do not damage any DOE assets or become a nuisance. No maintenance needs were identified.

The area beyond the site boundary for a distance of 0.25 mile was visually observed for erosion, changes in land use, or other phenomena that might affect the long-term integrity of the site. A prairie dog colony that has been observed along the southwestern boundary of the site appears to be moving inside the perimeter fence as noted in Section 8.4.2.3. Inspectors will continue to monitor this area.
