## 8.0 Gunnison, Colorado, Disposal Site

The U.S. Department of Energy (DOE) Office of Legacy Management (LM) conducted the Gunnison, Colorado, Uranium Mill Tailings Radiation Control Act (UMTRCA) Title I Disposal Site inspection on August 31, 2023. No cause for a follow-up inspection was identified.

The site, 6 miles southeast of Gunnison, Colorado, was inspected on August 31, 2023. The inspection was conducted by J. Lobato and M. Guziak of the Legacy Management Support contractor. M. Hurt (LM site manager), M. Cosby (Colorado Department of Public Health and Environment), and M. Schmidt and S. Casebolt (Gunnison County Public Works) also attended the inspection. The purposes of the inspection were to confirm the integrity of visible features at the site, identify changes in conditions that might affect conformance with the LTSP, and evaluate whether maintenance or follow-up inspection and monitoring are needed.

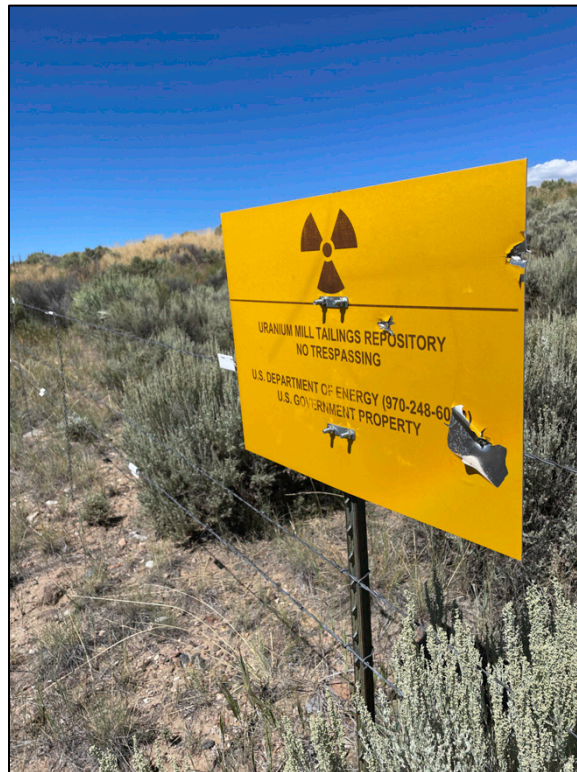
There are 45 perimeter signs bolted to the perimeter fence posts. Perimeter signs P2, P3, P35, P40, P44, and P45 (PL-1) have bullet damage but remain legible. No other maintenance needs were identified.

*PL-1. Perimeter Sign P40 with Bullet Holes*

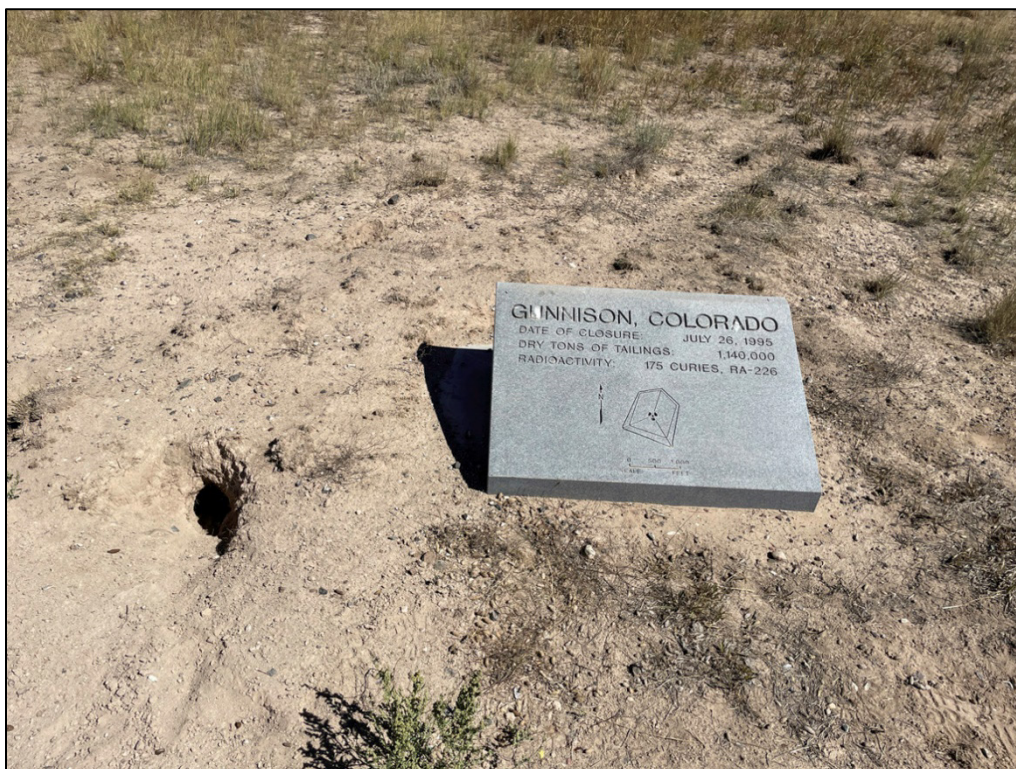
The site has two granite site markers. Site marker SMK-1 (PL-2) is just inside the entrance gate, and site marker SMK-2 is on the top slope of the disposal cell. The concrete base of site marker SMK-2 has cracks lining up with each of the four monument corners but remains stable. No maintenance needs were identified.

*PL-2. Site Marker SMK-1*

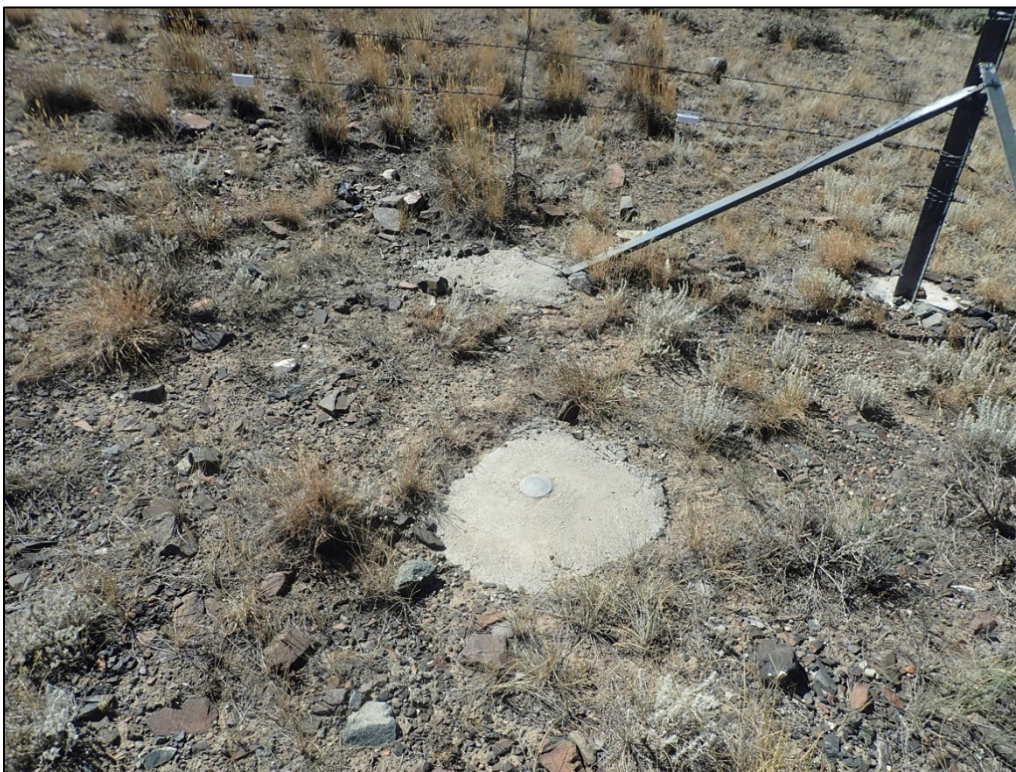
Three combined survey and boundary monuments and eight additional boundary monuments delineate the property boundary (PL-3). Inspectors noted that boundary monument BM-4 is slightly undercut but remains stable. No maintenance needs were identified.

*PL-3. Boundary Monument BM-8*

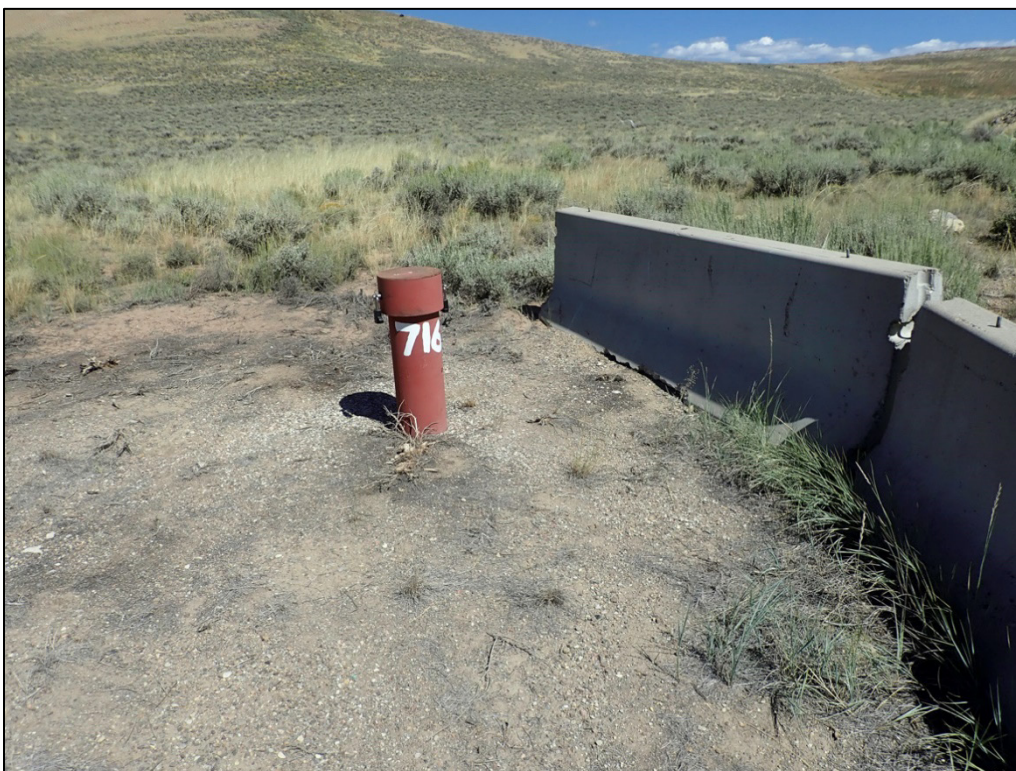
The site has 16 groundwater monitoring wells. The wellhead protectors were locked and properly labeled. Bullet damage is on the wellhead protector of monitoring wells 0634 and 0712, but the well casings are not impacted and remain functional. Monitoring well 0716 is on landfill property. Gunnison County landfill operators have placed concrete barriers to protect monitoring well 0716 (PL-4) from landfill activities. The concrete around monitoring well 0715 is beginning to spall (PL-5). Four monitoring well locks (monitoring wells 0634, 0710, 0714, and 0715) were replaced before the inspection as part of a programmatic effort. No maintenance needs were identified.

Gunnison County owns the land adjacent to the site boundary to the north and east and uses the land for a municipal landfill. The nearest landfill operations continue to be approximately 400 feet north of the property boundary. Although landfill activities do not affect the site, inspectors will continue to monitor the level of activity occurring near the site boundary and surveillance features (e.g., fences and monitoring wells). There is a spoil pile near monitoring well 0716 (Figure 8-1) that inspectors will continue to monitor. No maintenance needs were identified.

*PL-4. Monitoring Well 0716 with Concrete Barriers*

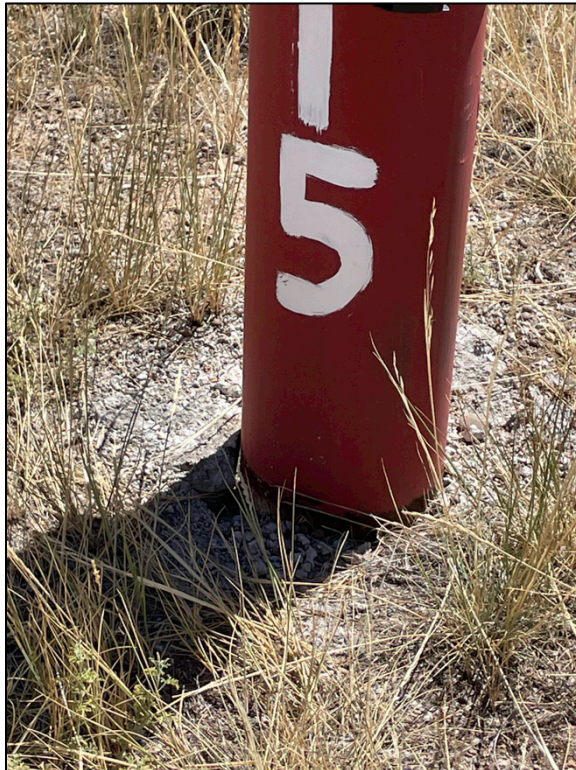
*PL-5. Monitoring Well 0715 with Concrete Spalling at Base*

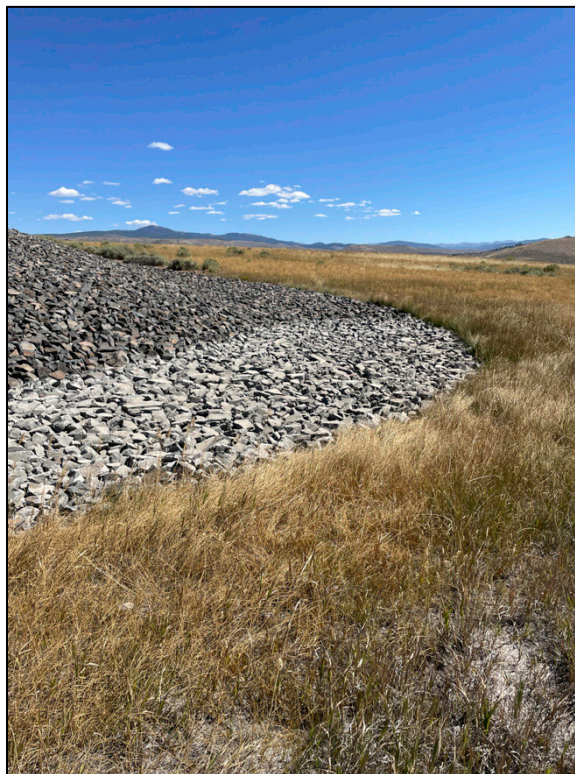
Stormwater runoff from the disposal cell occasionally accumulates in a low-lying area at the southeast corner of the disposal cell apron (PL-6). The riparian-type vegetation that has become established there indicates that the area retains moisture. Water collection in this area does not pose a problem because the disposal cell surfaces are designed to drain to the southeast, and any water that ponds there is below the elevation of tailings placed under the engineered cover. No maintenance needs were identified.

*PL-6. Evidence of Water Accumulation on Southeast Toe of Disposal Cell*

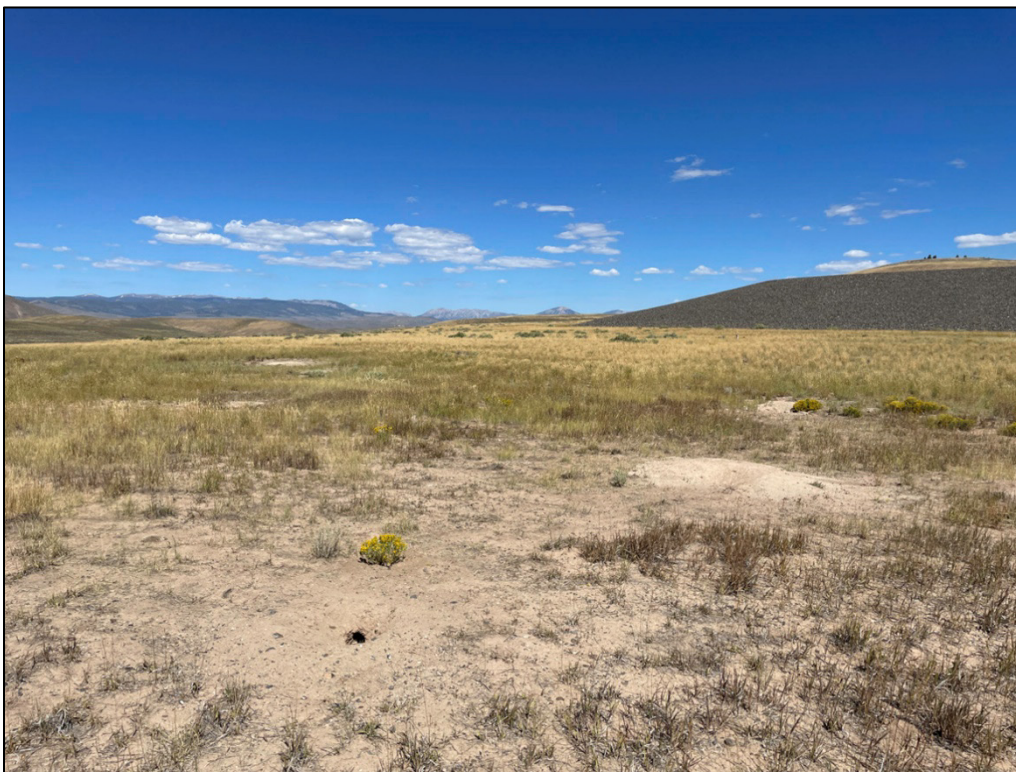
Reclaimed and undisturbed areas comprise the area between the disposal cell and the site boundary. In general, the vegetation in the reseeded, reclaimed areas consists of well-established grass; native plants are much less abundant and less diverse in reclaimed areas than they are in undisturbed areas. Former erosion areas are stable and naturally revegetating with native plant species. Inspectors observed several new prairie dog burrows inside the perimeter fence near perimeter signs P1, P2, and P3 (PL-7). Inspectors noted that the prairie dog colony appears to be expanding and will be monitored to ensure that the holes do not damage any DOE assets or become a nuisance. The closest burrow to the southern riprap apron is approximately 280 feet away. No maintenance needs were identified.

The 0.25-mile area beyond the site boundary was visually observed for erosion, changes in land use, or other phenomena that might affect the long-term integrity of the site. A prairie dog colony that has been observed along the southwestern boundary of the site has moved inside the perimeter fence, as noted in Section 8.4.2.3. Inspectors will continue to monitor and track the extent of the prairie dog colony in this area.

*PL-7. Prairie Dog Colony Area*
