## 8.0 Gunnison, Colorado, Disposal Site

The U.S. Department of Energy (DOE) Office of Legacy Management (LM) conducted the Gunnison, Colorado, Uranium Mill Tailings Radiation Control Act (UMTRCA) Title I Disposal Site inspection on September 10, 2024. No cause for a follow-up inspection was identified.

The site, 6 miles southeast of Gunnison, Colorado, was inspected on September 10, 2024. The inspection was conducted by J. Lobato and D. Atkinson of the Legacy Management Support contractor. A. Farinacci (LM site manager) and M. Cosby and A. Lawrence (Colorado Department of Public Health and Environment) also attended the inspection. The purposes of the inspection were to confirm the integrity of visible features at the site, identify changes in conditions that might affect conformance with the LTSP, and evaluate whether maintenance or follow-up inspection and monitoring are needed.

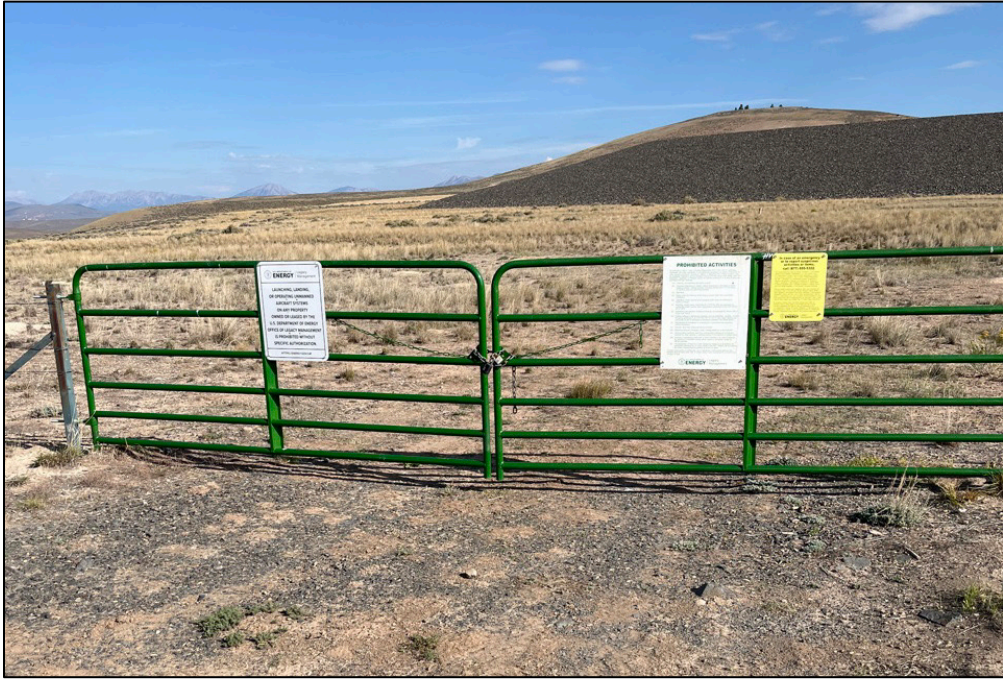
Access to the site is from Gunnison County Road 42 onto U.S. Bureau of Land Management (BLM) Route 3068, a gravel road maintained by BLM. Entrance to the site is through a locked gate that is part of the perimeter fence (PL-1). The entrance gate was locked and functional, and the entrance sign was intact and legible. The site has two additional access gates, one on the east fence line and the other on the north fence line, that provide access to several offsite monitoring wells. Although not part of the inspection results, all three barbed-wire gates were replaced with metal gates following the inspection. Gates were locked at the time of the inspection. No maintenance needs were identified.

*PL-1. Entrance Gate*

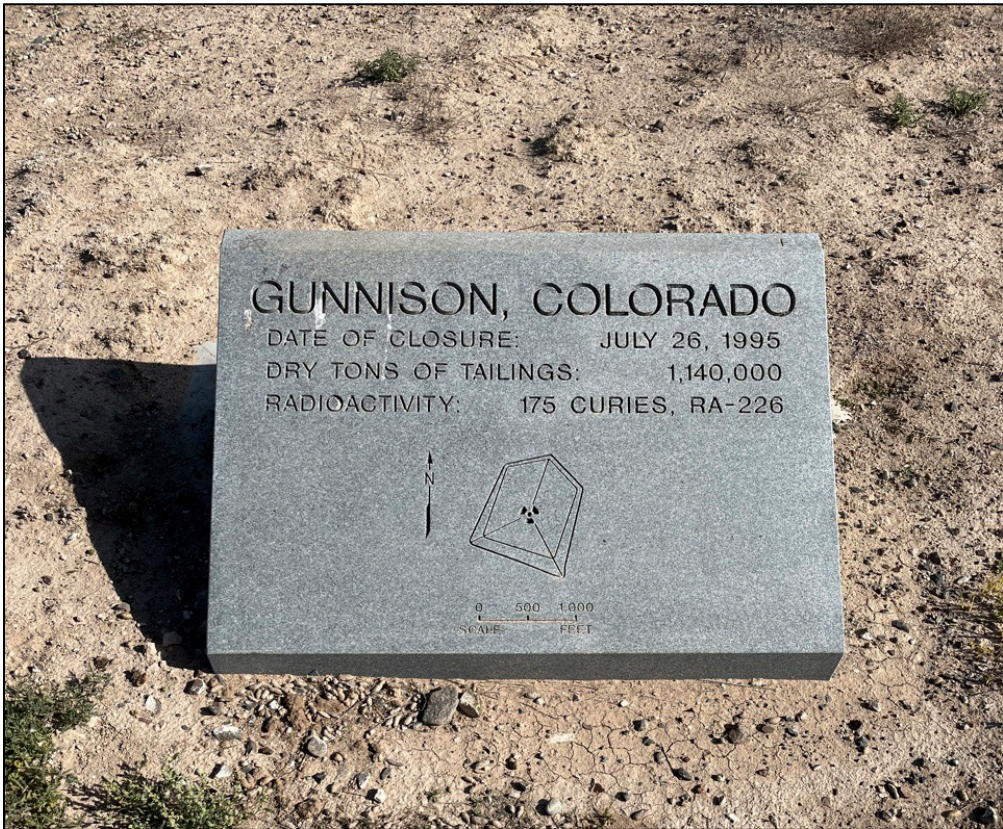
The site has two granite site markers. Site marker SMK-1 (PL-2) is just inside the entrance gate, and site marker SMK-2 is on the top slope of the disposal cell. The concrete base of site marker SMK-2 has cracks lining up with each of the four monument corners but remains stable. No maintenance needs were identified.

*PL-2. Site Marker SMK-1*

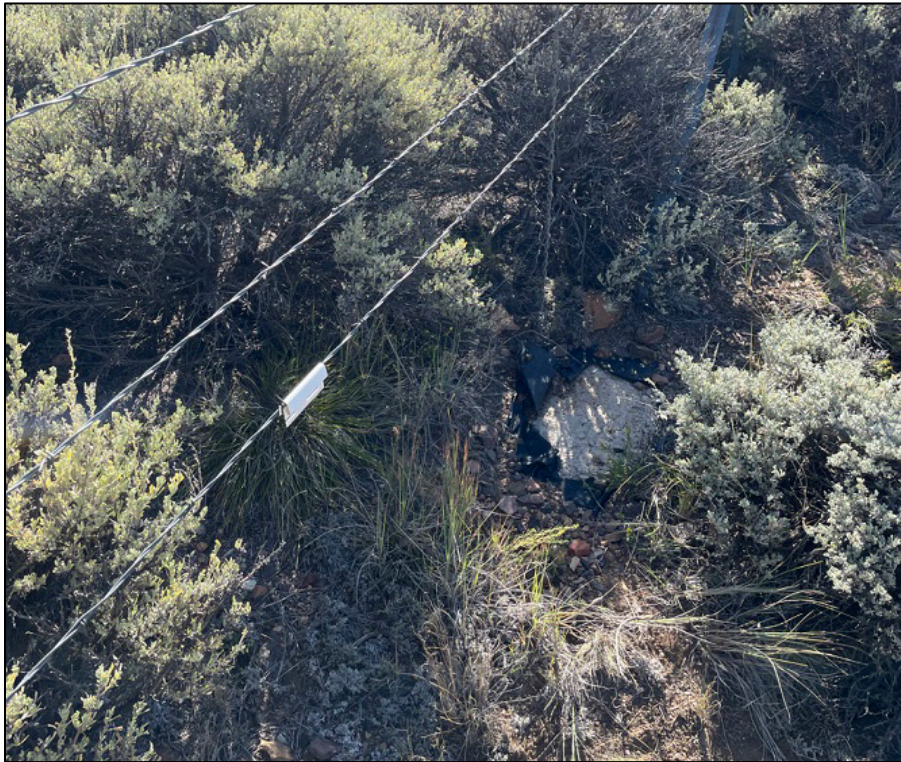
Three combined survey and boundary monuments and eight additional boundary monuments delineate the property boundary. Inspectors noted that boundary monument BM-6 is obscured by vegetation (PL-3), which will be treated. During the 2023 inspection, inspectors noted that boundary monument BM-4 was slightly undercut but remains stable. No other maintenance needs were identified.

*PL-3. Boundary Monument BM-6*

- Perimeter signs P38 and P40 will be replaced
- Vegetation obscuring boundary monument BM-6 will be treated
- The woody plant growing on the north side of the top of the disposal cell will be treated
- Dense thistle growth along the west side of the disposal cell will be treated

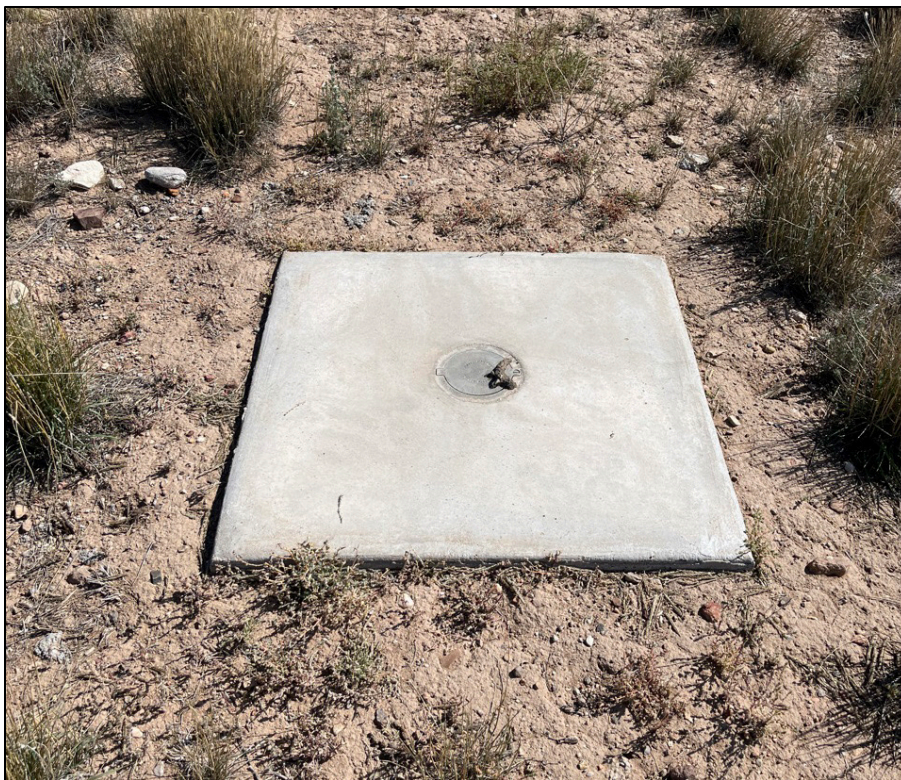
In October 2022, four permanent aerial survey quality control monuments were installed at the site for an aerial survey of the disposal cell (PL-4). No maintenance needs were identified.

*PL-4. Quality Control Monument QC-1*

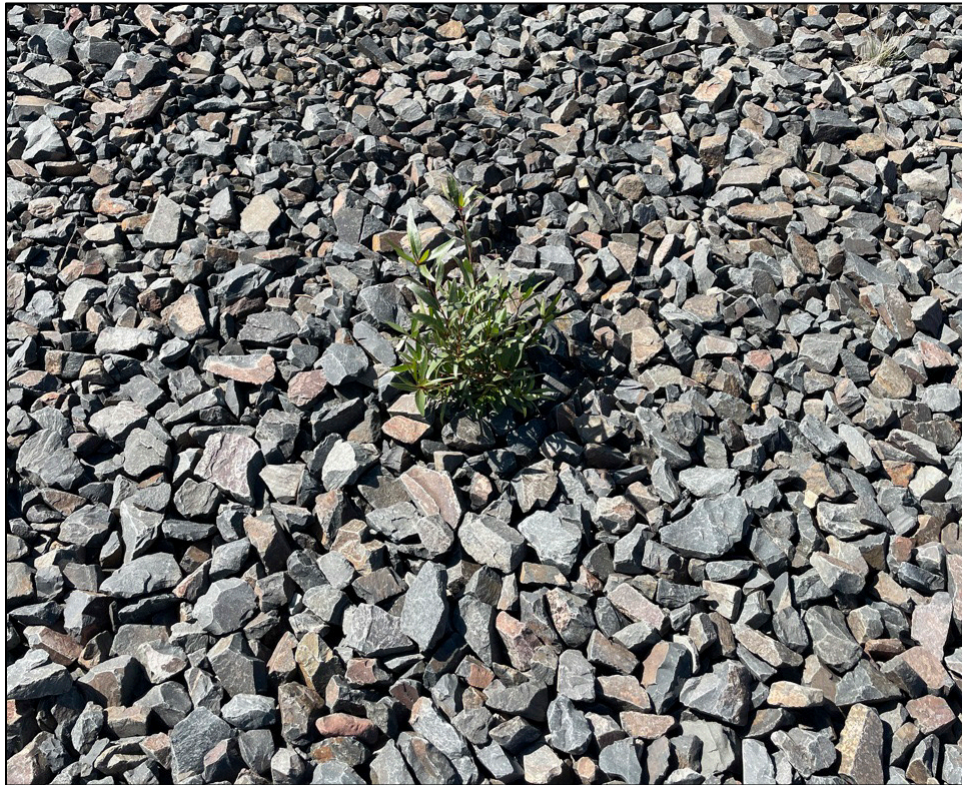
There was no evidence of settling, slumping, erosion, or any other modifying process that might affect the integrity of the top slope of the disposal cell. Inspectors noted a woody plant growing on the north side of the top of the disposal cell (PL-5), which will be treated. Several isolated patches of grass have established on the top slope; however, these shallow-rooted plants do not degrade the performance of the radon barrier component of the disposal cell's engineered cover. No other maintenance needs were identified.

*PL-5. Woody Vegetation on Disposal Cell*

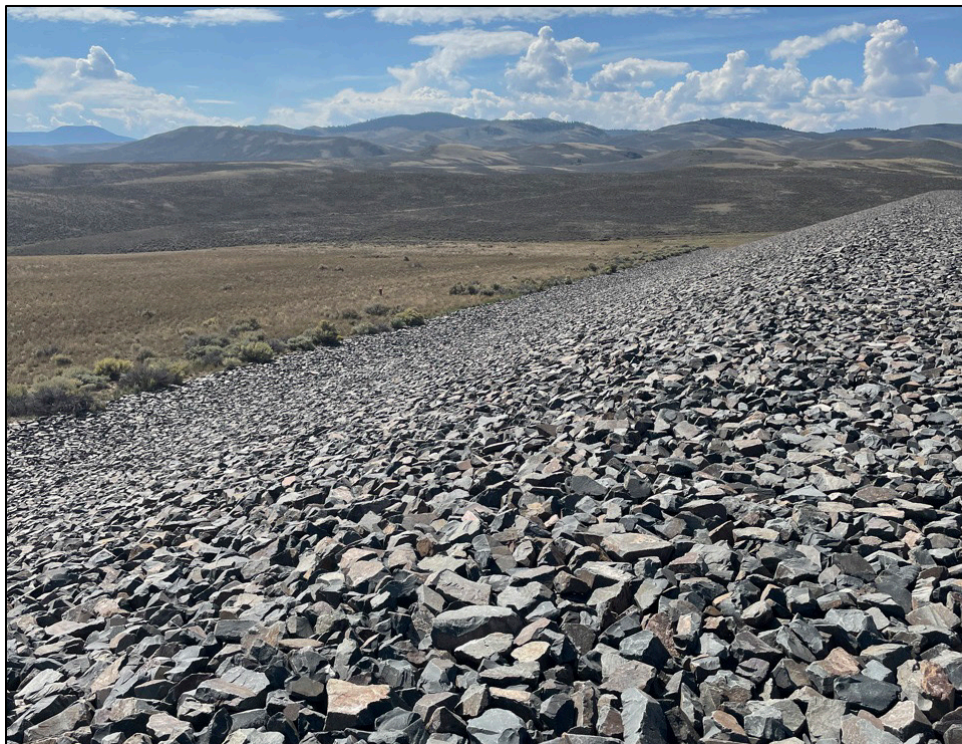
The disposal cell, completed in 1995, occupies 29 acres and is armored with basalt riprap to control erosion. Basalt riprap armors the disposal cell side slopes (PL-6), the apron that collects and diverts stormwater runoff from the disposal cell, and the two diversion channels that protect the disposal cell from precipitation run-on. There was no evidence of settling, slumping, erosion, or any other modifying process that might affect the integrity of the disposal cell side slopes, apron, or diversion channels. Six historical test areas that were armored with riprap were last

*PL-6. East Side Slope*

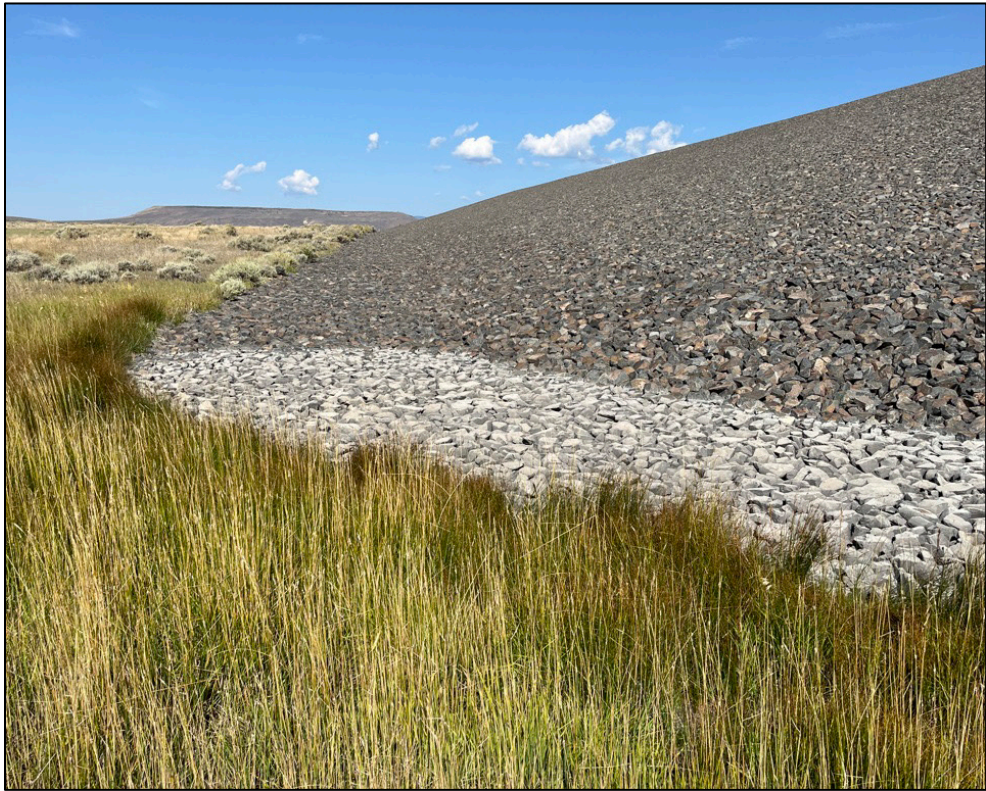
inspected during the 2017 annual inspection; in accordance with the LTSP (DOE 1997), monitoring is no longer required because no rock degradation has been observed. Stormwater runoff from the disposal cell occasionally accumulates in a low-lying area at the southeast corner of the disposal cell apron (PL-7). The riparian-type vegetation that has become established there indicates that the area retains moisture. Water collection in this area does not pose a problem because the disposal cell surfaces are designed to drain to the southeast, and any water that ponds there is below the elevation of tailings placed under the engineered cover. No maintenance needs were identified.

*PL-7. Ponding from Stormwater Runoff*

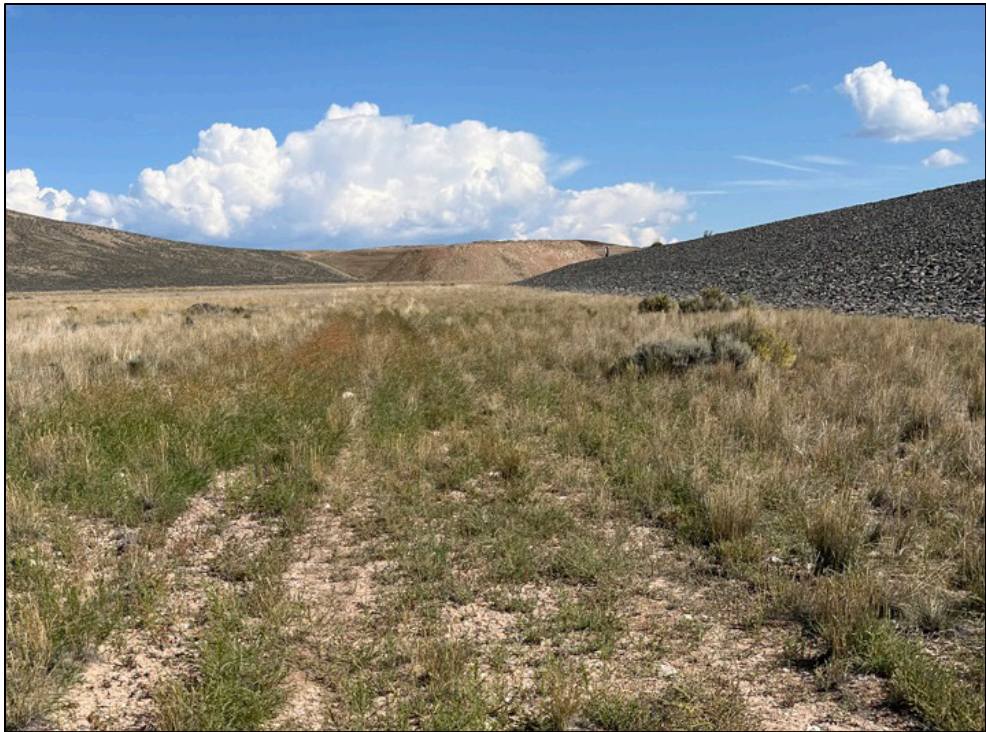
Reclaimed and undisturbed areas comprise the area between the disposal cell and the site boundary. In general, the vegetation in the reseeded, reclaimed areas consists of well-established grass; native plants are much less abundant and less diverse in reclaimed areas than they are in undisturbed areas. Former erosion areas are stable and naturally revegetating with native plant species. Inspectors noted dense thistle growth along the west side of the disposal cell (PL-8), which will be treated. Inspectors have been monitoring several prairie dog burrows inside the perimeter fence near perimeter signs P1, P2, and P3. Inspectors noted that the prairie dog colony appears to be expanding and will be monitored to ensure that the holes do not damage any DOE assets or become a nuisance. The closest burrow to the southern riprap apron is approximately 280 feet away. No other maintenance needs were identified.

*PL-8. Dense Thistle Growth*
