ORNL/RASA-94/1

**RESULTS OF THE RADIOLOGICAL
SURVEY
at the former
HERRING-HALL-MARVIN SAFE
COMPANY (3rd Floor)
1550 Grand Boulevard, Hamilton, Ohio
(HO001)**

Date issued —March 1994

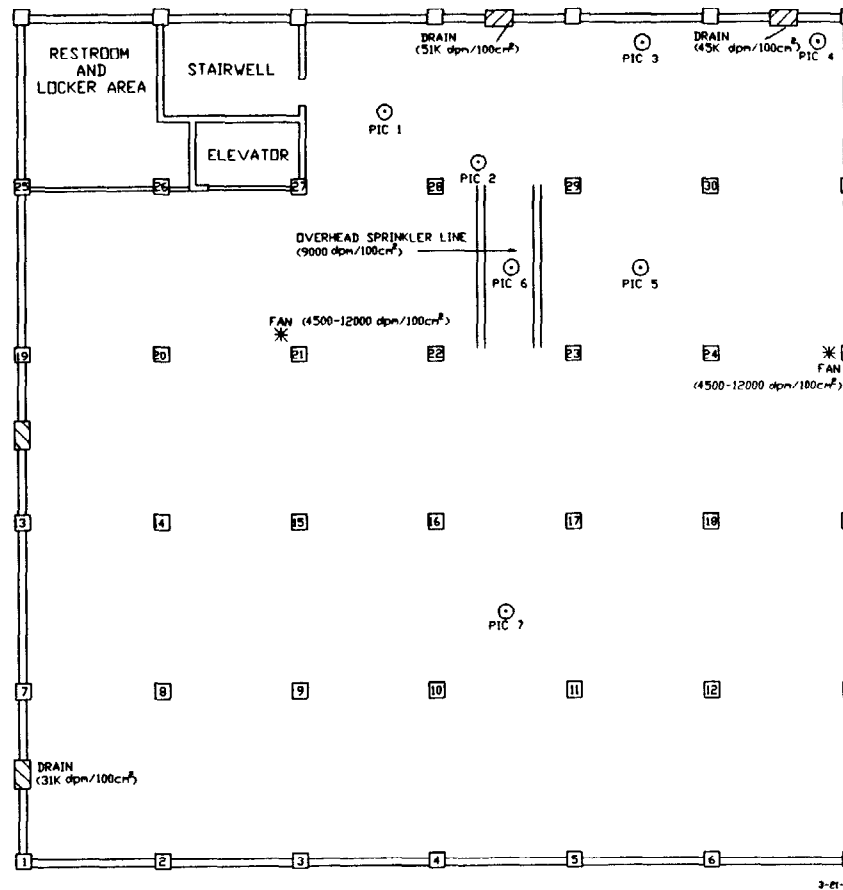
Fig. 2. Diagram of the third floor of the former Herring-Hall-Marvin Safe Company facility showing the numbered columns and grid blocks in the area surveyed. Locations of the PIC and overhead data are shown.

Very little contamination was found on the overhead structures on the third floor (see Figure 2). Two fans were contaminated above guidelines, with maximum beta-gamma values of 12000 dpm/100 cm^2 measured. Two fire protection sprinkler pipes in block 22 were beta-gamma contaminated at maximum values of 9000 dpm/100 cm^2 .

Along the bottom of each wall were floor drains (there were eight), which lead directly to the outside (see Fig. 2). All of the drains were plugged with debris and "paint sealed" from the outside. The drains in blocks 1, 28, and 30 were contaminated with beta-gamma levels of 31,000, 51,000, and 45,000 dpm/100 cm², respectively. The outside walls and structures below the drains were surveyed and no contamination was found.

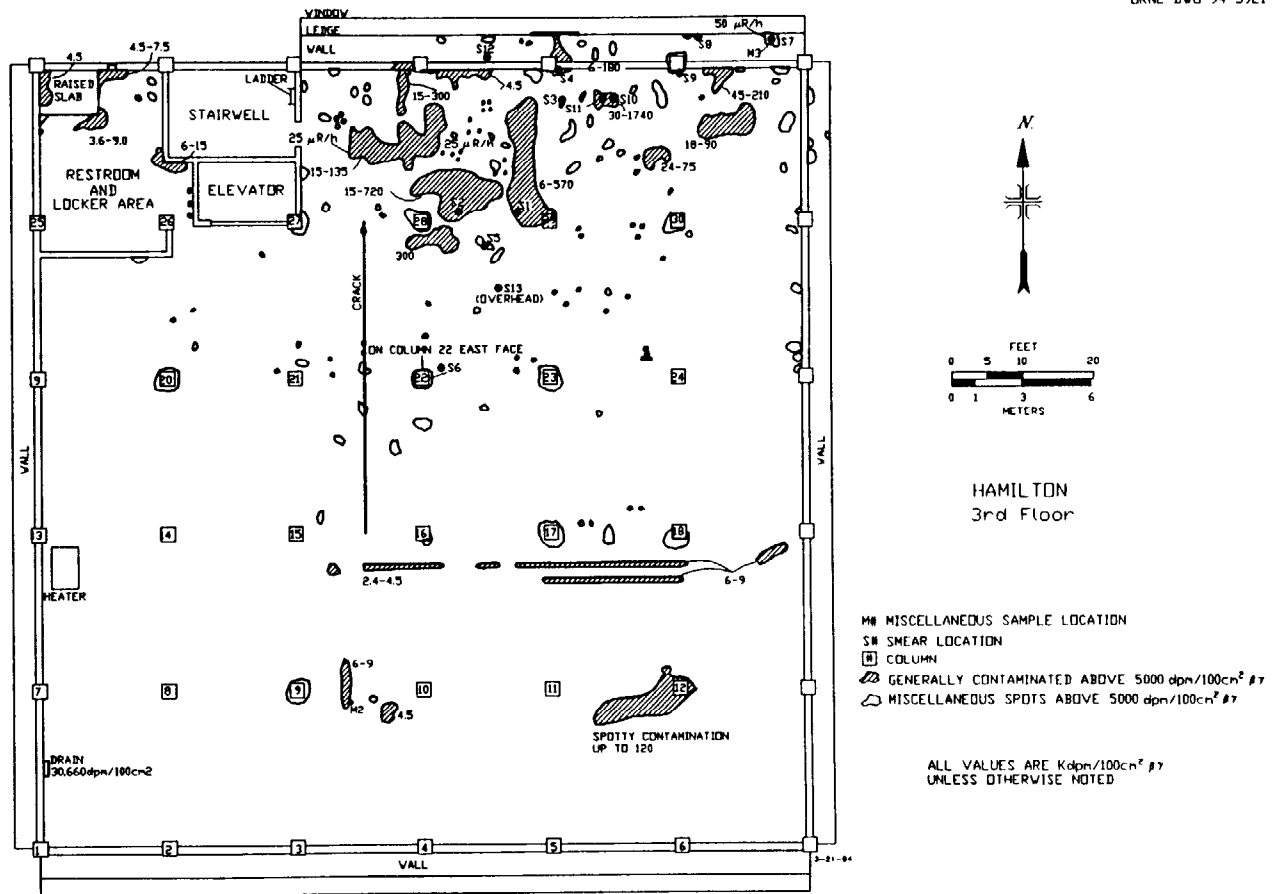
Fig. 3. Diagram of the third floor of the former Herring-Hall-Marvin Safe Company facility showing the smear locations and the areas of contamination relative to the grid blocks.

The third floor contained many areas of contamination as shown on Figure 3. Because of the amount of contamination, not all spots were marked in blocks 20 and above. Thirteen spots were characterized in detail (see Table 2) and are located on Figure 3 by smear number (S#). The maximum direct measurement for gamma was 81 $\mu\text{R}/\text{h}$, for beta/gamma was 1,500,000 dpm/100 cm^2 and for alpha was 1750 dpm/100 cm^2 . Seven PIC measurements ranging from 7 to 9 $\mu\text{R}/\text{h}$ were taken.

The north wall was generally contaminated above guidelines and the east wall was spottily contaminated. Most of the contamination was covered with paint, and therefore many of the values on Figure 3 may be low.

Location & Smear number	Gamma ^a exp rate 1 m (μR/h)	Gamma ^a exp rate surface (μR/h)	Direct activity levels ^b (dpm/100cm ²)		Removable activity levels ^c (dpm/100cm ²)		Location ^d
			Beta/gamma	Alpha	Beta/gamma	Alpha	
1	7	39	639000	630	120	61	Floor, 10 ft E of column #28
2	7	18	645000	70	94	16	Floor, 5 ft E, 1 ft N of column #28
3	7	8	18000	0	94	3	Floor, 14 ft N, 1 ft E of column #29
4	7.5	11	156000	140	94	19	Floor, NW corner of block 29
5	8	21	891000	1750	1010	748	Floor, 14 ft N, 10 ft E of column 22
6		15	279000	280	94	45	E side of column #22, 1.5 ft above floor
7	9	52	1494000	350	94	13	Wall, 1 ft below ledge, 4 ft W of NE corner block 30
8	7	11	138000	70	94	3	Wall, 2 in below ledge 6 ft E of NW corner of block 30
9	8	18	246000	280	94	10	Floor, NW corner of block 29
10	8	81	306000	70	160	142	Floor, 13 ft N, 10 ft E of column #29
11	8	61	1551000	350	150	161	Floor, 13 ft N, 8 ft E of column #29
12		7	42000	0	110	6	Drain at base of N wall, block 28

13			12000	0	94	3	Overhead, fire sprinkler pipe, center of block 22

Radiological assessments in this survey demonstrated that radioactive residuals were in excess of DOE guidelines for surface contamination on over 25% of the third floor. Spotty contamination was also present on the remaining area of that floor. The contaminant was definitely identified by gamma spectroscopy as normal uranium, which was the material handled by the Herring-Hall-Marvin Safe Company. The current owner, Diebold, was advised of the survey results, and because of the contamination, restricted access to the third floor was recommended.

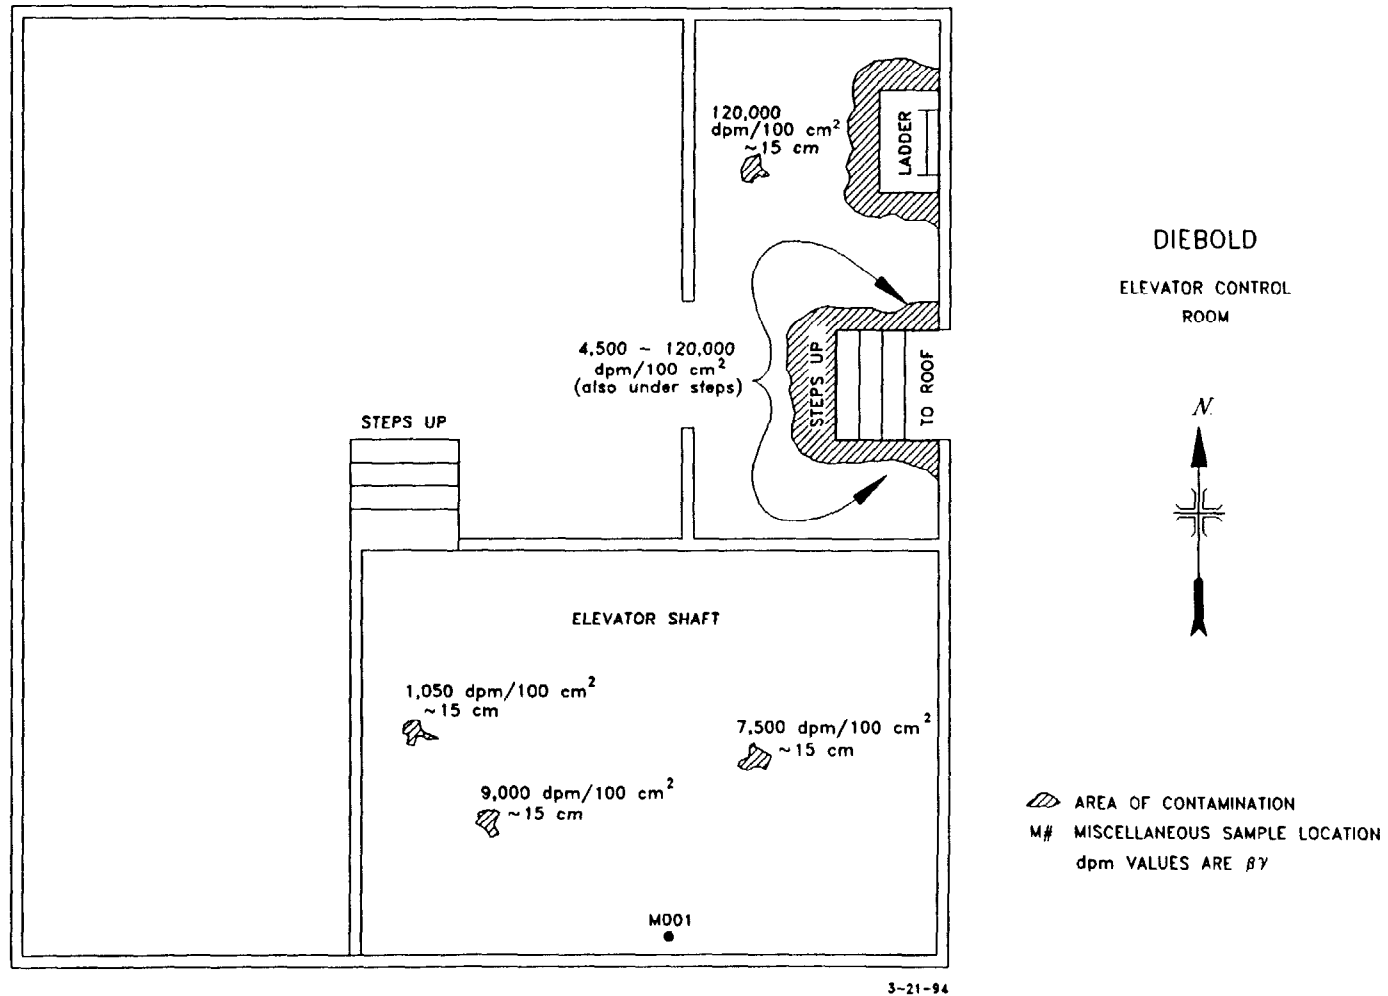
Fig. 4. Diagram of the third floor area above the elevator shaft in the former Herring-Hall-Marvin Safe Company facility, showing the locations of the areas of contamination.

No radiation measurements were distinguishable from background levels in the elevator and elevator shaft (Fig. 4). One spot (<100 cm^2) was found in the stairwell and was removed by sampling. Another spot ($\approx 300 \text{ cm}^2$) was found in the second floor restroom and was likewise removed. The only other spot found apart from the third floor was on the first floor in a floor crack about 15 feet from the stairwell. This spot was also removed (these spots are not shown).

An area above the elevator and stairwell, accessible only by ladder, had several spots and small areas which were above the surface contamination guidelines. See Figure 4 for radiation measurements and locations.
