ORNL/RASA-95/14

**Results of the Radiological  
Verification Survey at the Former  
Herring-Hall-Marvin Safe Company,  
1550 Grand Boulevard, Hamilton Ohio  
(HO001V)**

Date issued —November 1995

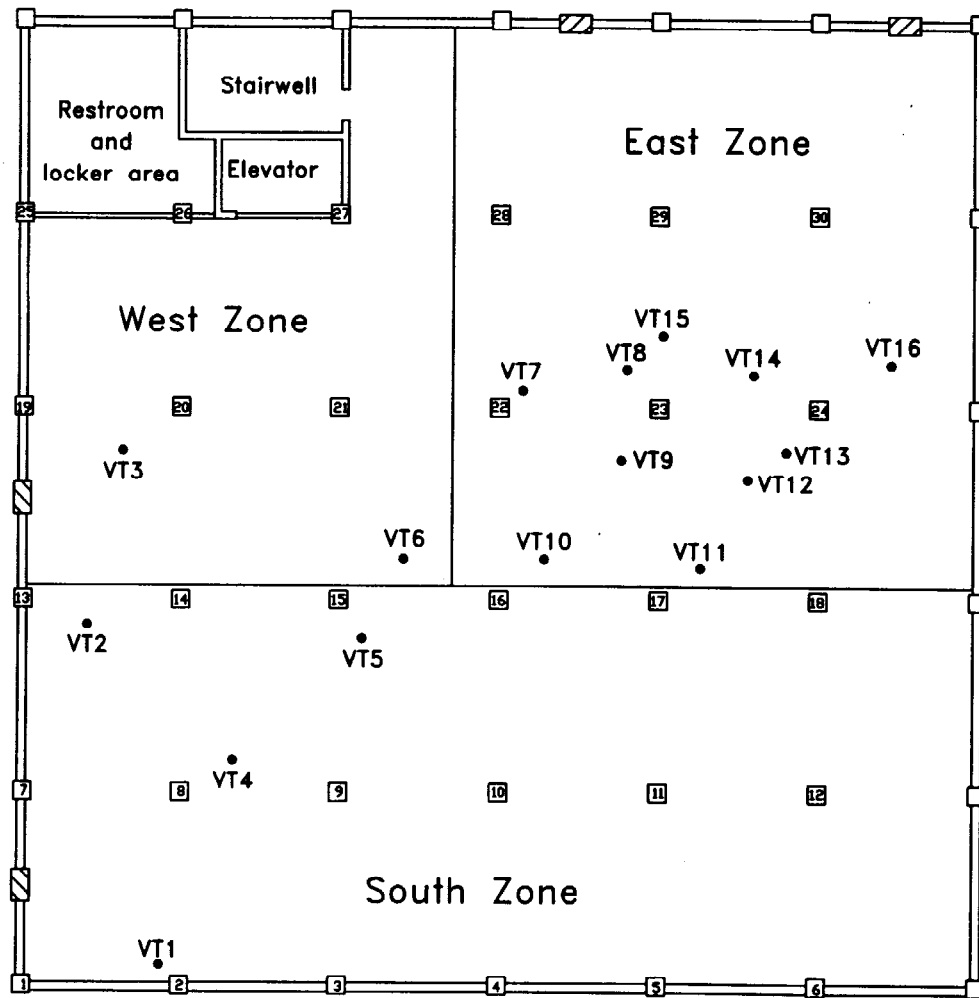
The radiological verification survey began by collecting and analyzing smears from 3-inch core holes across the entire third floor. Cores were cut from the floor by the remediating subcontractor to remove lead floor anchors. No discernible radioactivity above naturally occurring background was detected in scans or on smears collected from the core holes in any of the three established zones. Locations of transferable smear samples are shown on Fig. 2 and analytical results are presented in Table 2.

Fig. 2. Diagram of the third floor of the former Herring-Hall-Marvin Safe Company facility, showing locations of smears (relative to the numbered columns) taken from 3-in core holes in the floor throughout this area. The 3rd floor was divided into three zones for the remedial action and verification survey.

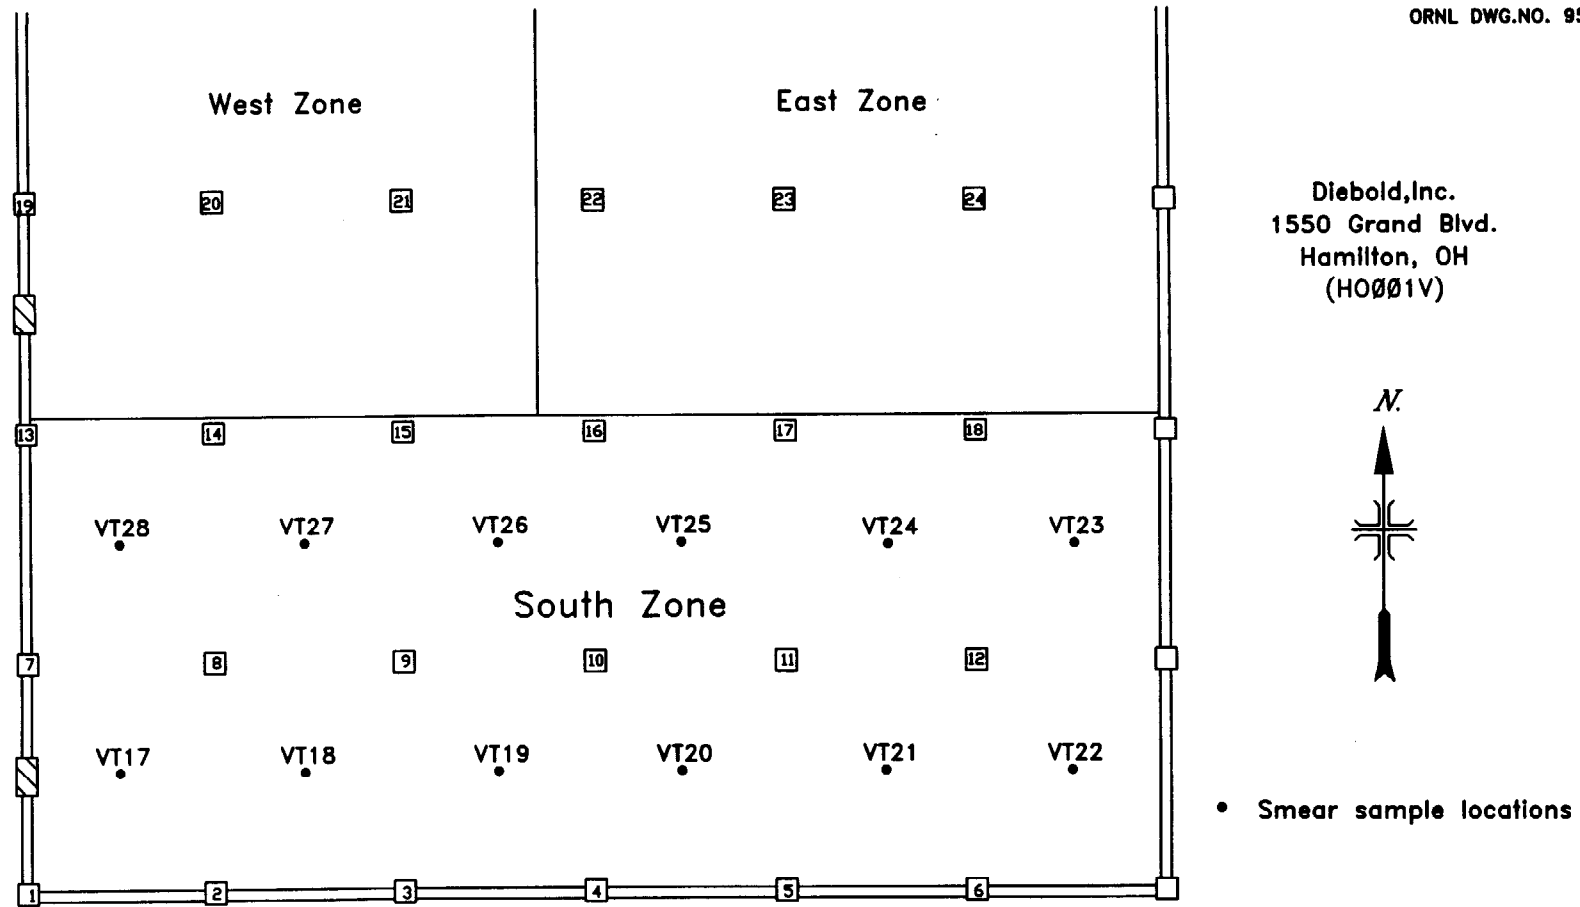
Fixed beta-gamma activity on floors, walls, columns and wall drains ranged up to 1300 dpm/100 cm<sup>2</sup>. Fixed beta-gamma activity on ceilings ranged up to 700 dpm/100 cm<sup>2</sup>. Alpha activity on the floors and walls was below guidelines. Gamma exposure rates at one meter above floor level ranged from 3 to 5 μR/h. Results of the smear analysis showed that all smears were below guidelines for transferable alpha and beta-gamma activity. Locations of the smears are shown in Fig. 3, and analytical results are presented in Table 2.

The south zone was verified by the ORNL survey team as having no fixed or transferable contamination in excess of established guidelines, and the zone remained isolated by the plastic curtain until the entire third floor was verified below guidelines.

Fig. 3. Diagram indicating smear locations in the South Zone on the 3rd floor of the former Herring-Hall-Marvin Safe Company facility.

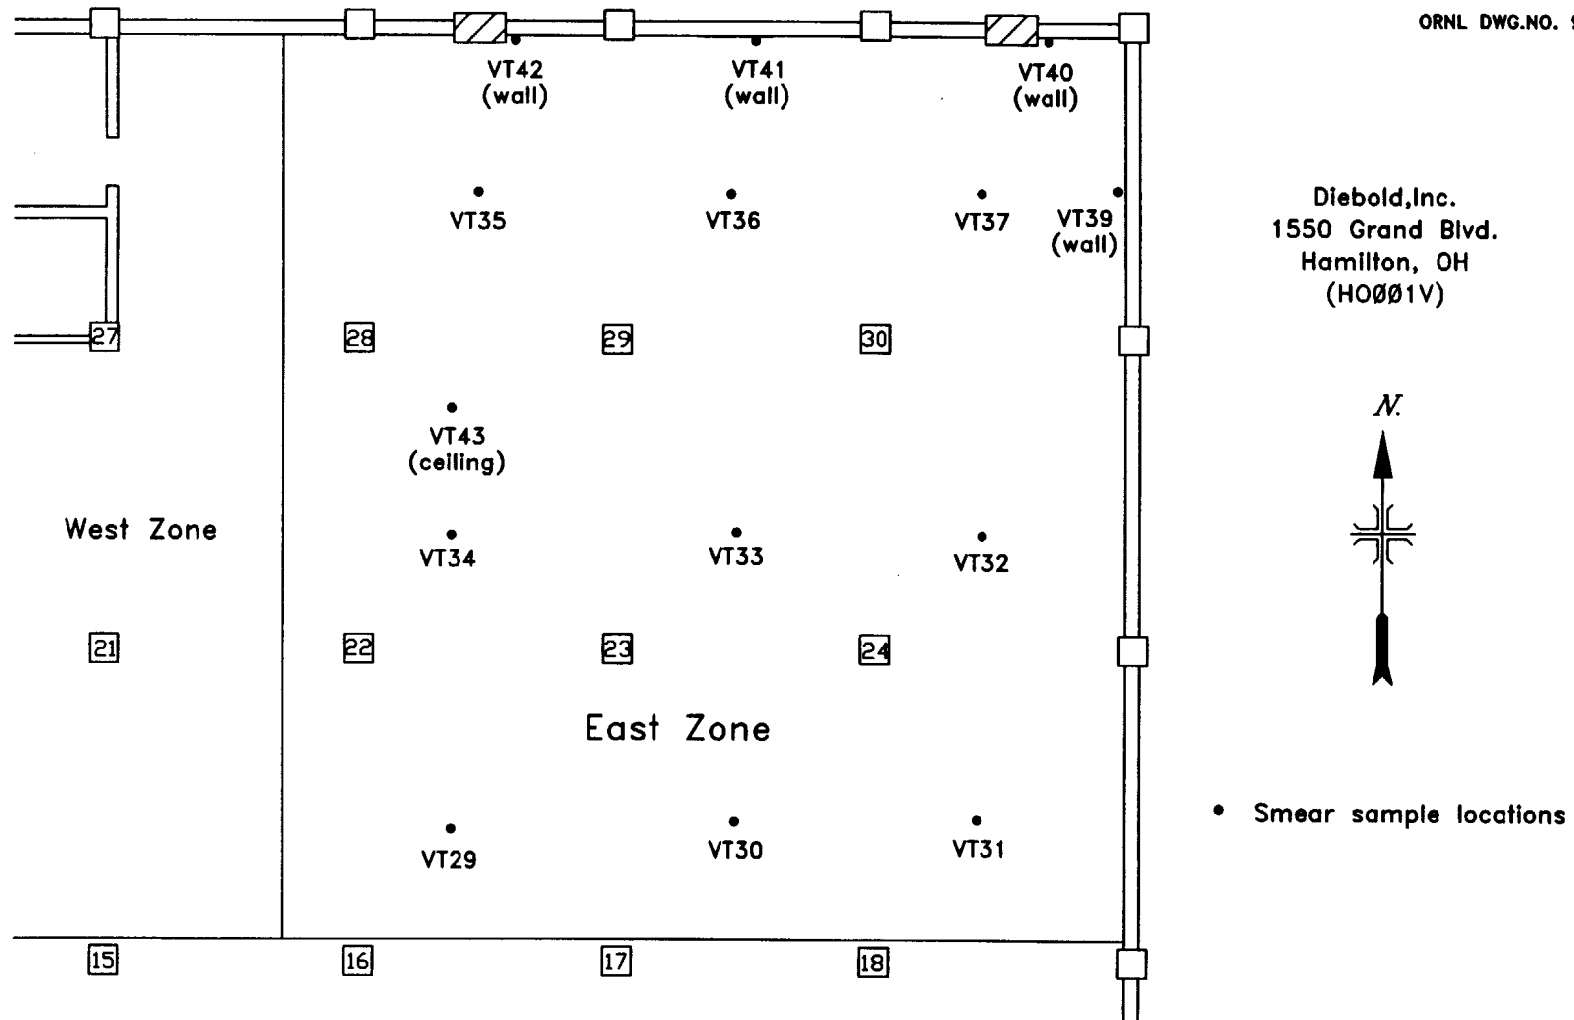
Initially, the investigation of the east zone revealed numerous areas in which established guidelines were still exceeded, requiring additional remediation (e.g., beta-gamma residuals measured up to 120,000 dpm/100 cm<sup>2</sup> around the column located in the southwest corner of block 22. Other areas within the east zone ranged from just slightly above guideline levels up to 21,000 dpm/100 cm<sup>2</sup>). These areas were identified with paint to expedite remedial efforts within the zone. Remediation continued in the evenings, and areas not meeting guidelines were rechecked for residuals the next morning.

Final fixed alpha contamination of the floor and walls ranged from none detectable up to 140 dpm/100 cm<sup>2</sup>. Maximum fixed beta-gamma activity on floors was 1100 dpm/100 cm<sup>2</sup>, and maximum fixed beta-gamma on walls, including columns and wall drains measured 4500 dpm/100 cm<sup>2</sup>. Fixed beta-gamma on ceilings ranged from none detectable up to 4100 dpm/100cm<sup>2</sup>. Gamma exposure rates at one meter above floor level ranged from 3 to 5 μR/h. Analysis of the smears taken from the east zone indicated that all transferable radioactivity levels were below guidelines. Locations of the smears are shown in Fig. 4, and analytical results are presented in Table 2.

Fig. 4. Diagram indicating smear locations in the East Zone on the 3rd floor of the former Herring-Hall-Marvin Safe Company facility.

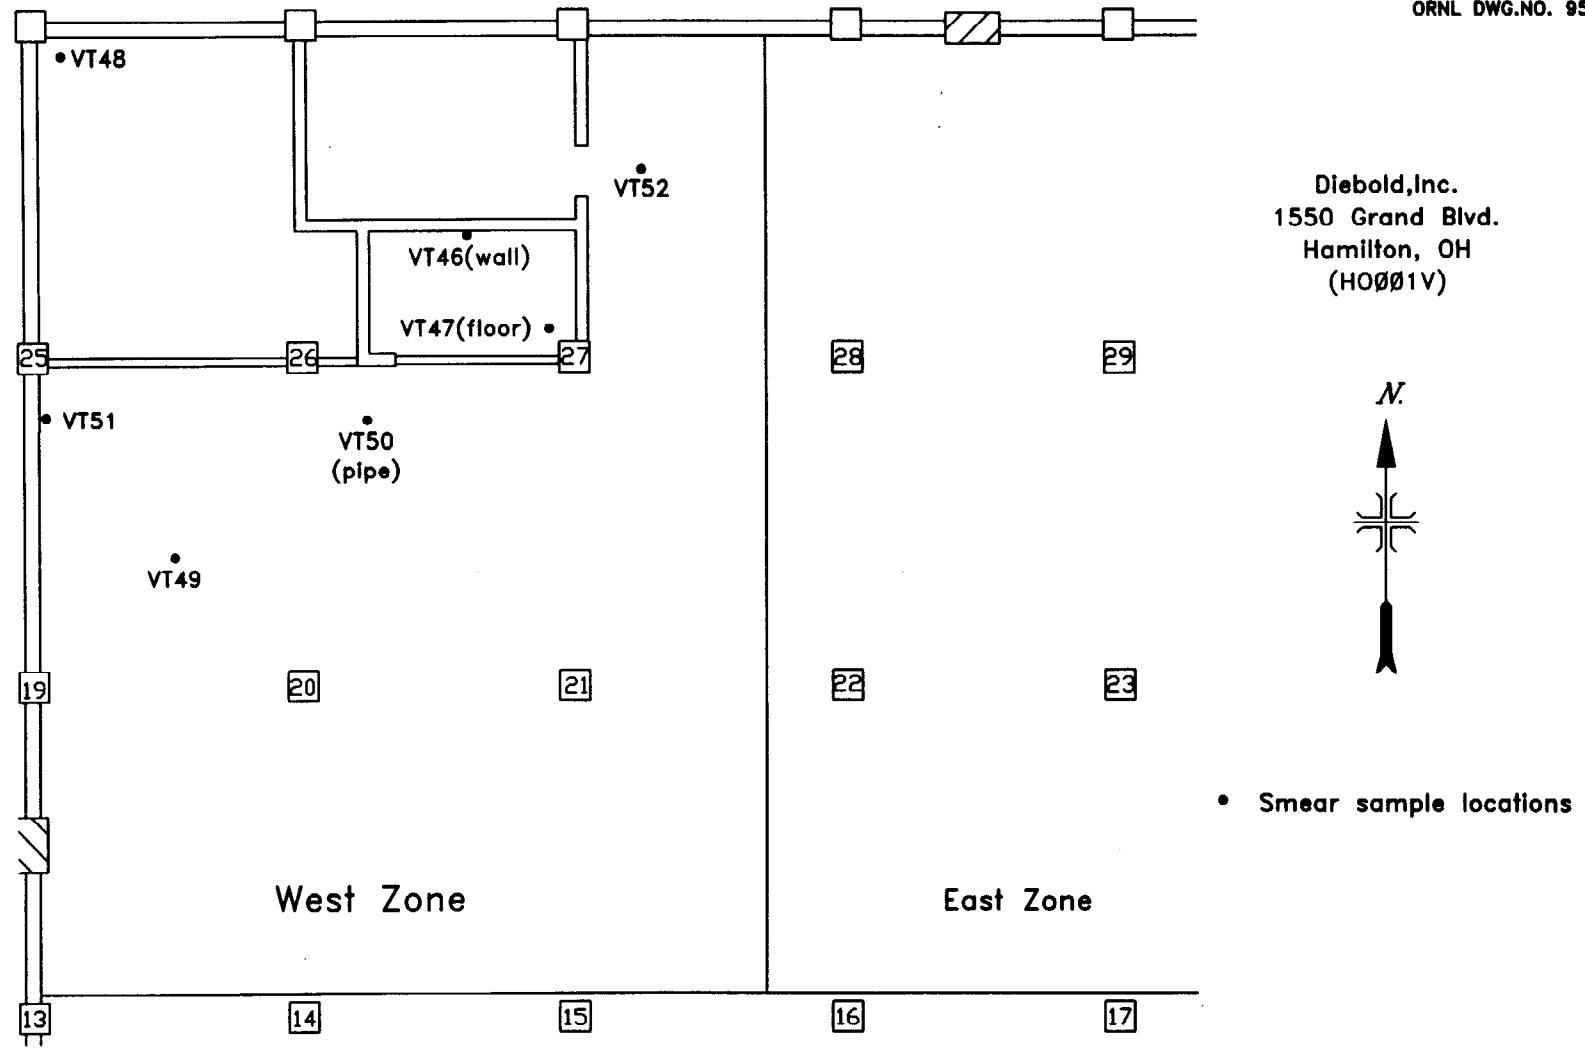
The west zone included the elevator penthouse and elevator shaft. The initial survey located limited contamination in excess of established guidelines on the third floor and elevator penthouse (e.g., one small floor area on the third floor just south of the elevator doorway measured 31,000 dpm/100 cm<sup>2</sup> of fixed beta-gamma activity. Several deposits of beta-gamma contamination were located on the floor of the elevator shaft where a maximum of 128,000 dpm was measured. Most of these deposits were around the interface between the elevator shaft walls and elevator shaft floor). One small deposit of

5,000 dpm/100 cm<sup>2</sup> beta-gamma was also located in dust on a board attached to the north elevator shaft wall; however, it was immediately remediated to background levels by the ORNL survey team. The contractor continued remediation in the west zone until no other uranium residuals in excess of guidelines could be located.

When final measurements for fixed contamination in this zone were made, maximum alpha contamination of the floor and walls was 280 dpm/100 cm<sup>2</sup>; maximum beta-gamma activity on floors and floor drains was 1900 dpm/100 cm<sup>2</sup>; maximum beta-gamma on walls including columns and wall drains was 3300 dpm/100 cm<sup>2</sup>; and maximum beta-gamma on ceilings was 3500 dpm/100 cm<sup>2</sup>. Gamma exposure rates at one meter above floor level ranged from 10 to 13  $\mu$ R/h. In the restroom where red brick was present, gamma measurements ranged from 10 to 18  $\mu$ R/h. All of these measurements are well below DOE guidelines.

Fig. 5. Diagram indicating smear locations in the West Zone on the 3rd floor of the former Herring-Hall-Marvin Safe Company facility.

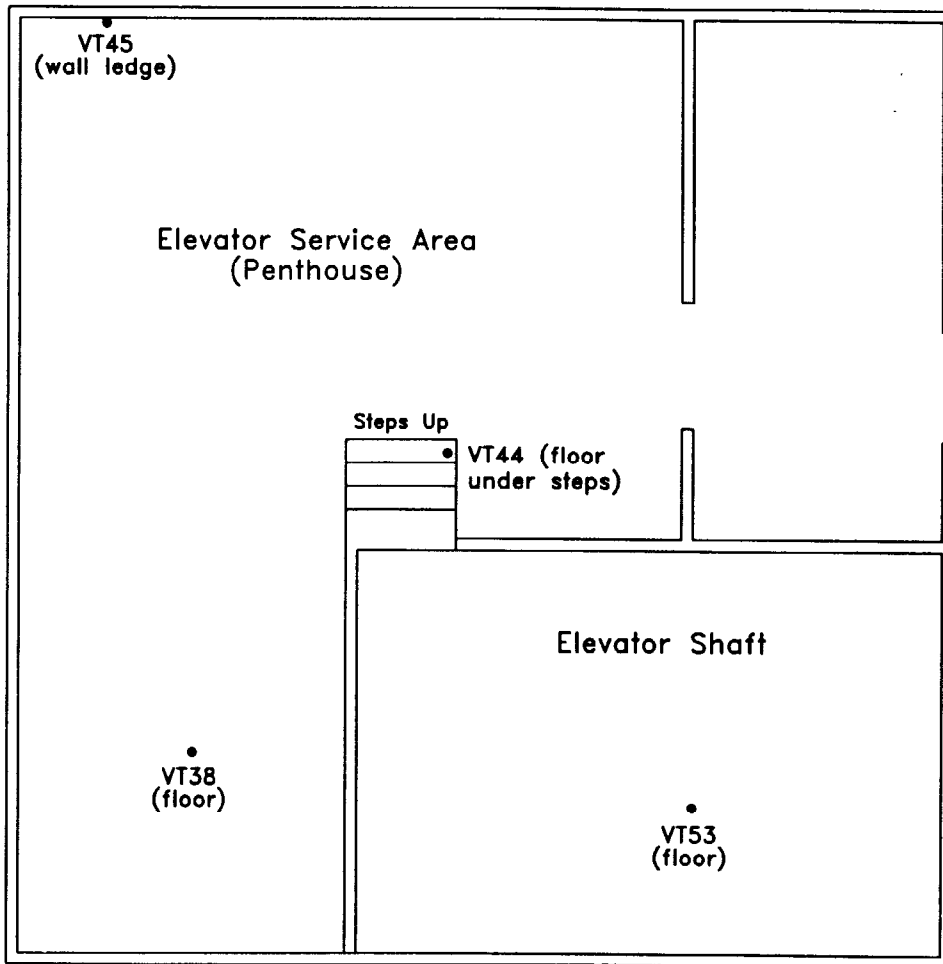
Following these further remedial efforts in the west zone, beta-gamma scans were again conducted by the ORNL team over all overhead pipes and conduits, floor surfaces, and accessible surfaces of all drain openings. Also, ~30% of all walls and exposed ceilings and ~75% of all support columns were re-scanned for beta-gamma activity. Alpha measurements were collected over ~1% of these same surfaces. Smear samples were systematically collected in the west zone, including the elevator, elevator shaft and penthouse, and analyzed for transferable radioactivity. Locations of the smears are shown in Figs. 5 and 6, and analytical results are presented in Table 2.

Fig. 6. Diagram indicating smear locations in the elevator shaft and service area above the shaft (penthouse) in the former Herring-Hall-Marvin Safe Company facility.

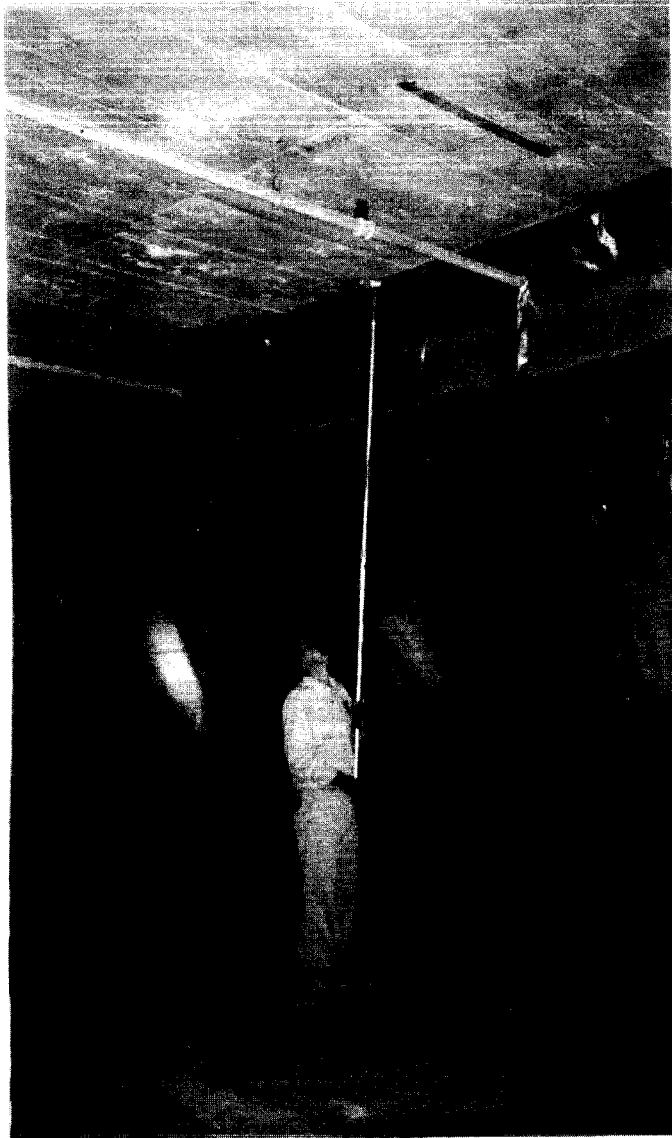
**Fig. 7. Photographs of the verification work in progress on the 3rd floor of the Herring-Hall-Marvin Safe Co. facility. In the background are the plastic curtains used to separate the clean areas from the rest of the facility.**
