# **2008 Annual Inspection and Radiological Survey Results for the Piqua, Ohio, Decommissioned Reactor Site**

The former Piqua Nuclear Power Facility (PNPF), a decommissioned nuclear power demonstration facility, was inspected on April 24, 2008. The site, located on the east bank of the Great Miami River in Piqua, Ohio, is in good physical condition. There is no requirement for a follow-up inspection.

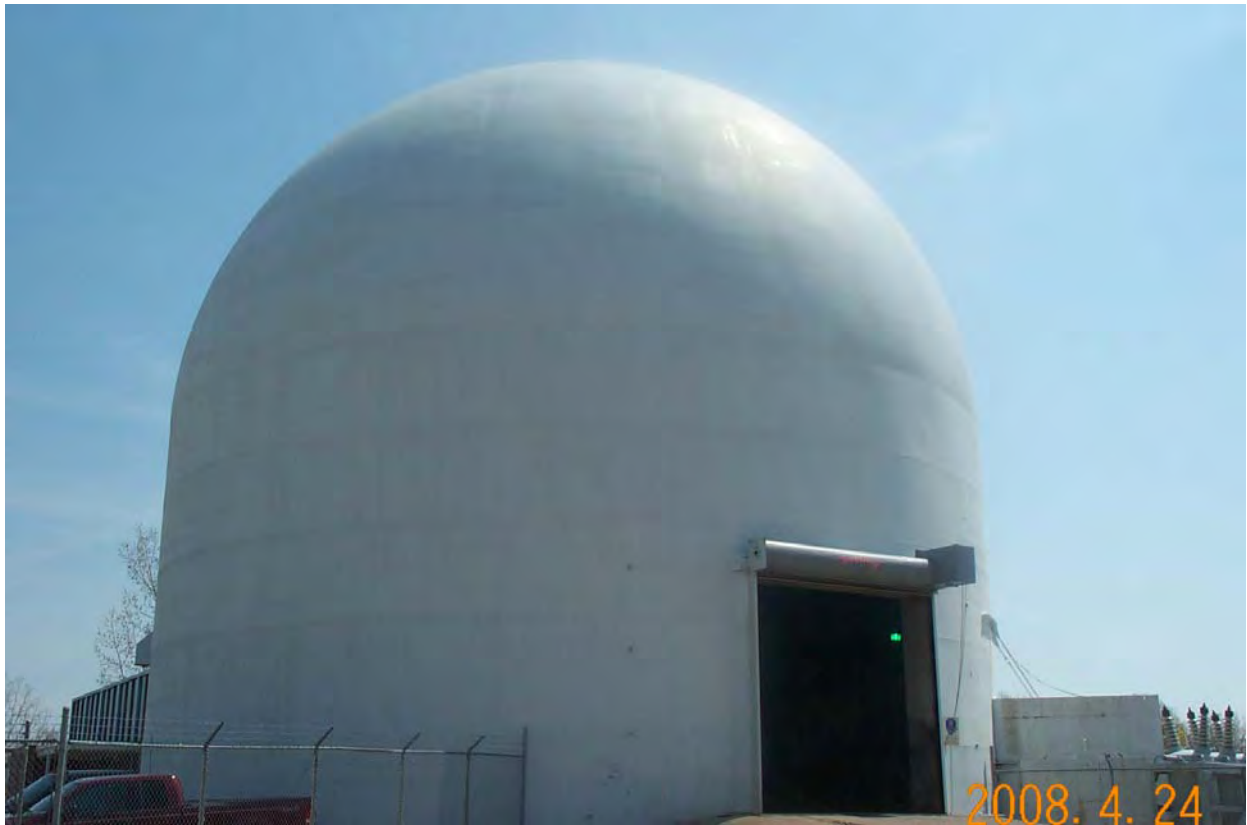
The Containment Building exterior was refurbished around 1995. The exterior of the reactor containment building is in good shape (PL-1). Rust stains are present on the northeast side of the containment building (PL-2). This area will be checked again next year to determine if the rust staining is increasing.

PIQ 4/2008. PL-1. Containment Dome.

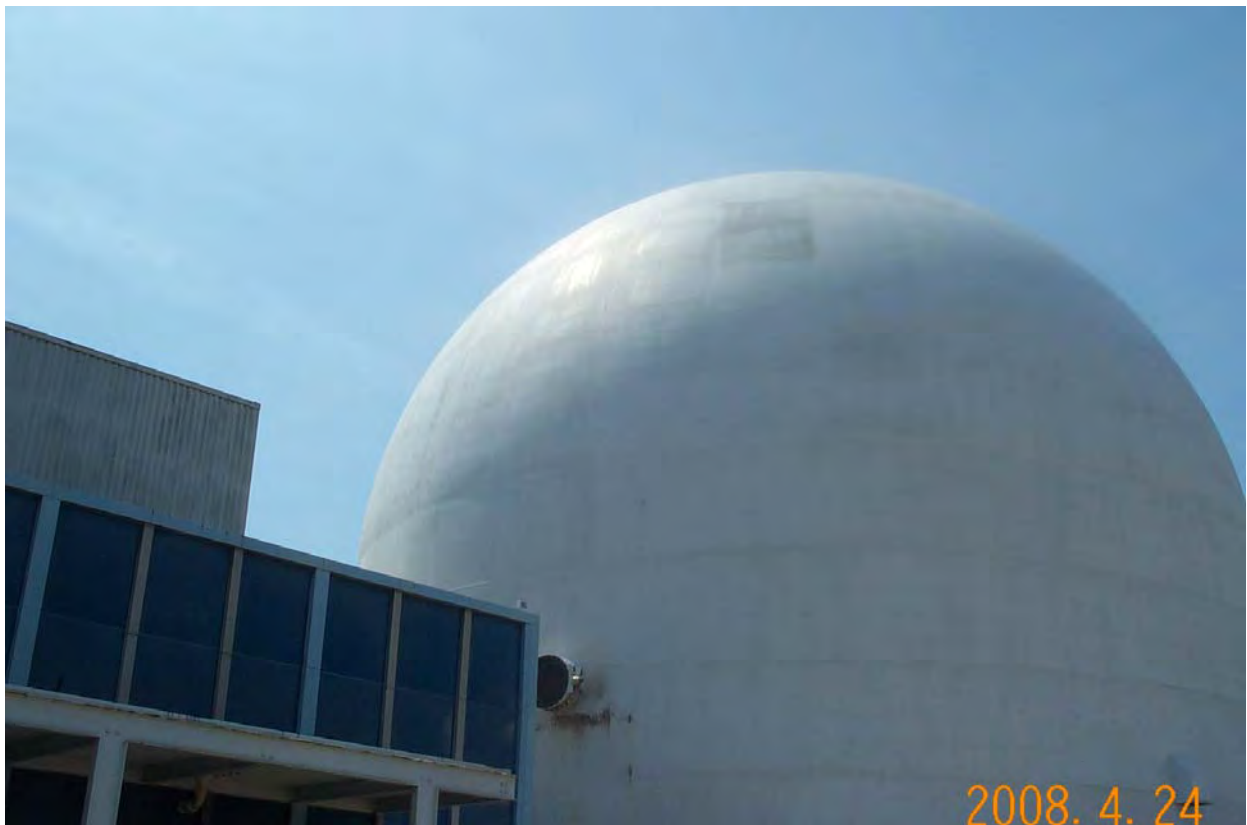
2. Rust staining is present on the exterior surface of the containment dome, next to the flat roof separating the containment dome from the office building (page 2).

PIQ 4/2008. PL-2. Containment Dome.

**Recommendation:** Check area again next year to determine if the rust stains are increasing.

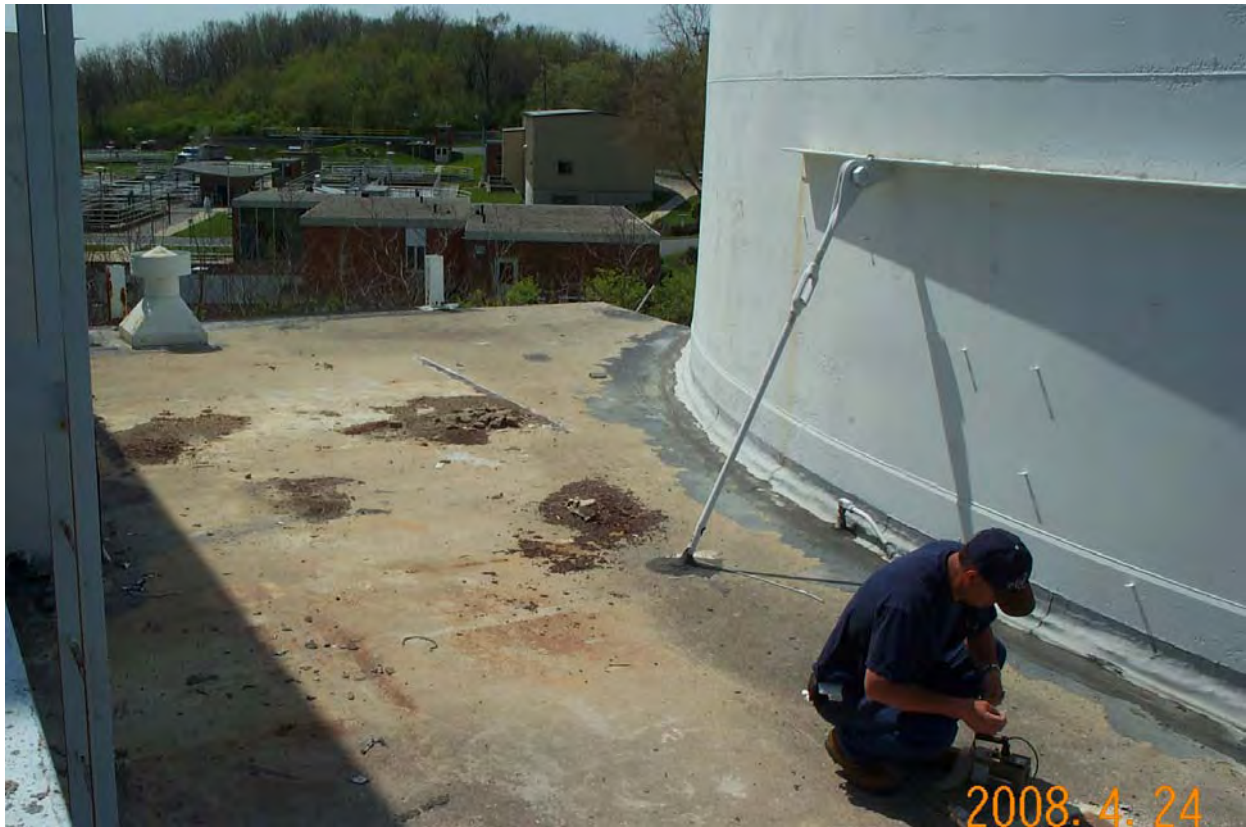
During 2007 PPS removed HVAC equipment from the flat roof between the containment dome and office building (PL-3). The scrap metal was sent to Franklin Iron and Metal in Dayton, Ohio. The HVAC features have been removed from the 111-foot level inspection drawings.

PIQ 4/2008. PL-3. Flat Roof, 111-foot level, HVAC Equipment Removed.

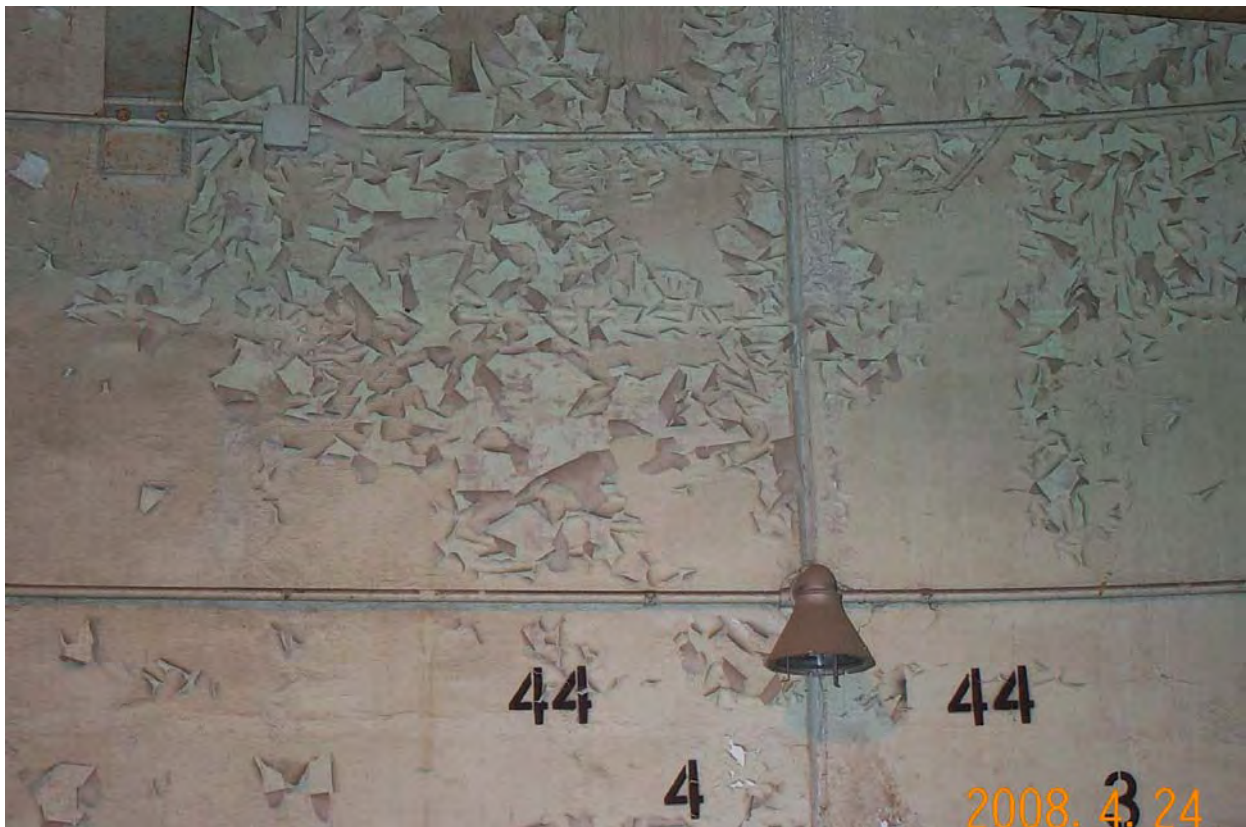
Paint peeling off the interior facility walls and falling to the floor is a concern, especially at the 56-foot level (PL-4). Peeling paint that is falling onto the floors was analyzed in 2006 and found to contain 0.35 percent lead. The paint will probably continue to peel and fall to the floor. Inspectors are not exposed to unacceptable risk when performing routine inspection activities. PPS is aware of the presence of lead-based paint.

3. Peeling paint was observed on most areas of the interior dome walls, as noted on prior inspections, and is starting to fall onto the floors. This paint has been previously tested and found to contain approximately 0.35 percent lead (page 2).

PIQ 4/2008. PL-4. Peeling Pain, 56-foot level.

**Recommendation:** The facility manager is aware that the peeling paint contains approximately 0.35 percent lead. DOE and contractor staff will follow health and safety recommendations when entering the property.

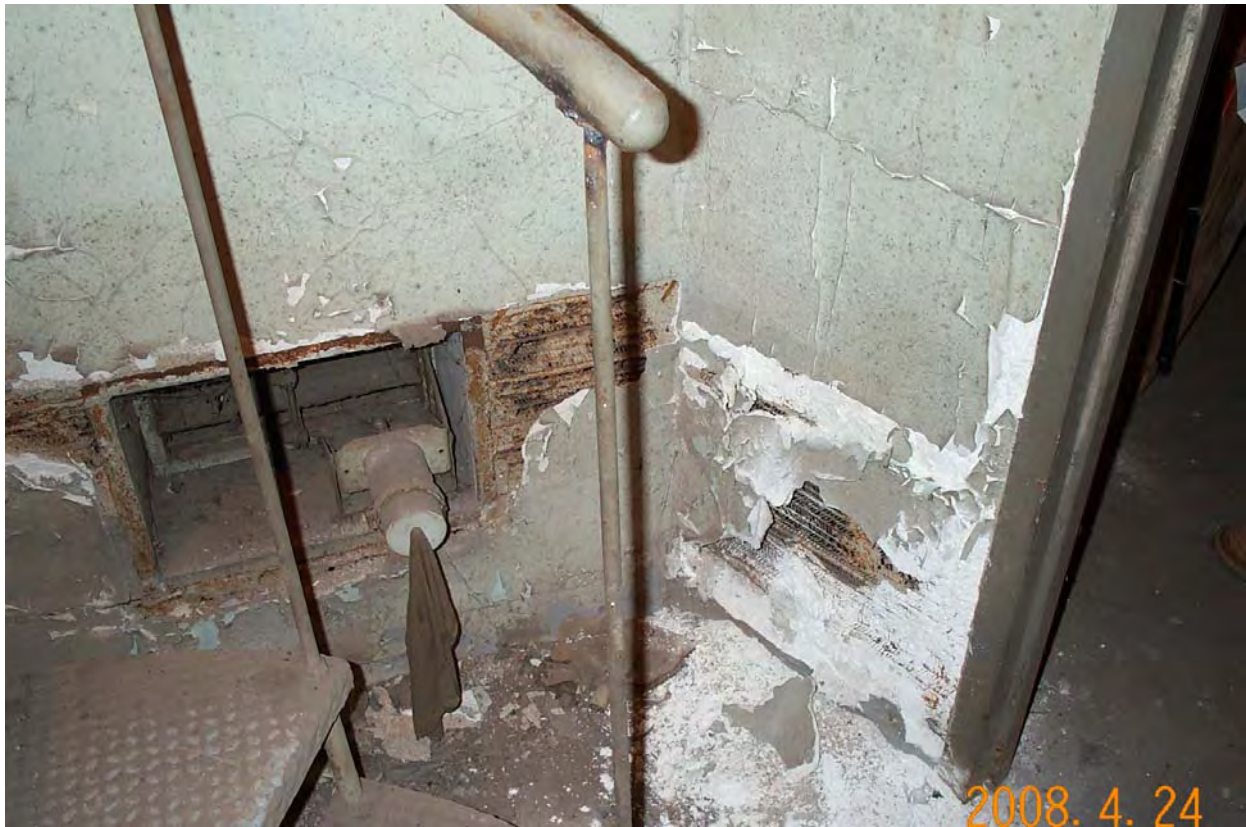
Plaster is falling off the walls at the base of the spiral staircase at the 56-foot level (PL-5) and on the 79-foot level wall of the auxiliary building. This damage has been noted on prior inspections and the condition remains unchanged. Plaster is also damaged just outside the entrance to the spiral staircase at the 56-foot level (PL-6). PPS stores spools of cable on the 56-foot level. It appears that some of these spools have rolled into the walls, damaging the plaster, as shown in PL-6.

PIQ 4/2008. PL-5. Water Damage, Base of Spiral Stairs, 56-foot level.

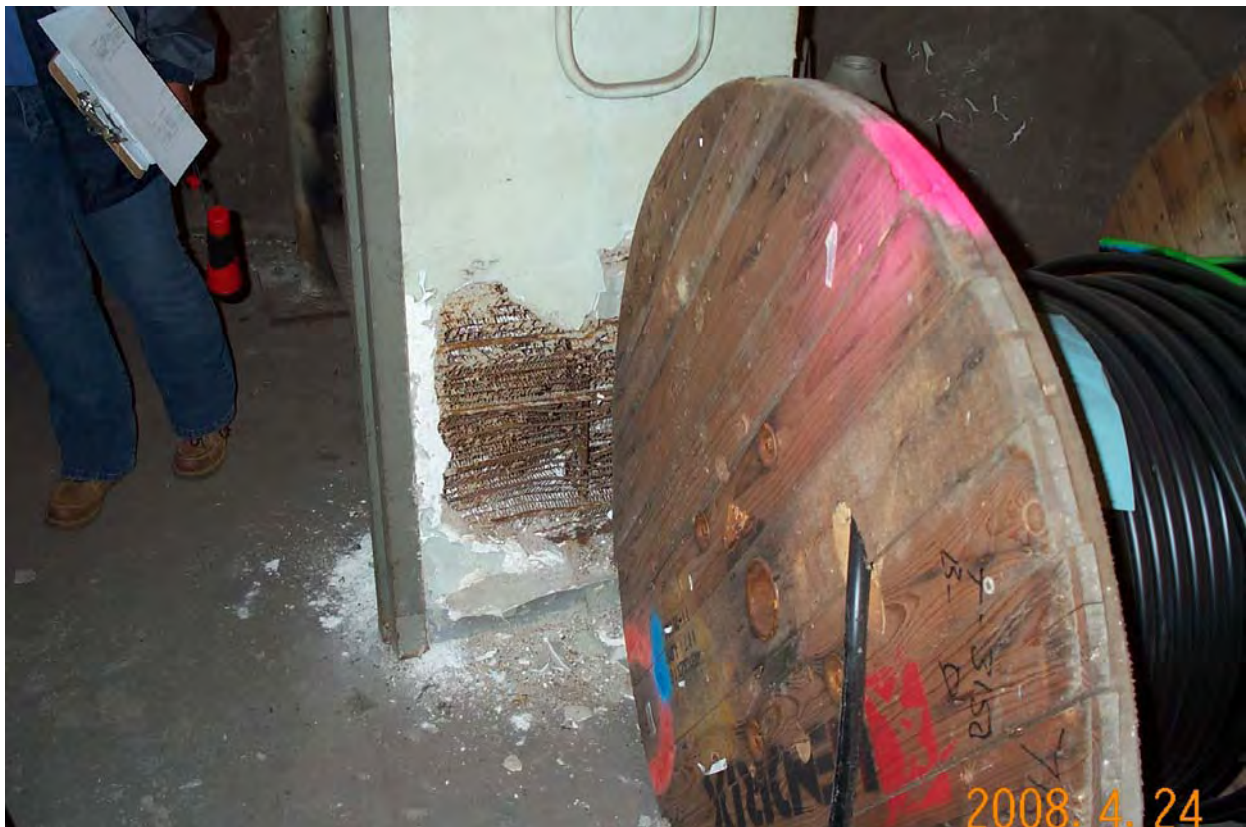
PIQ 4/2008. PL-6. Damage to Walls by Cable Spools, 56-foot level.

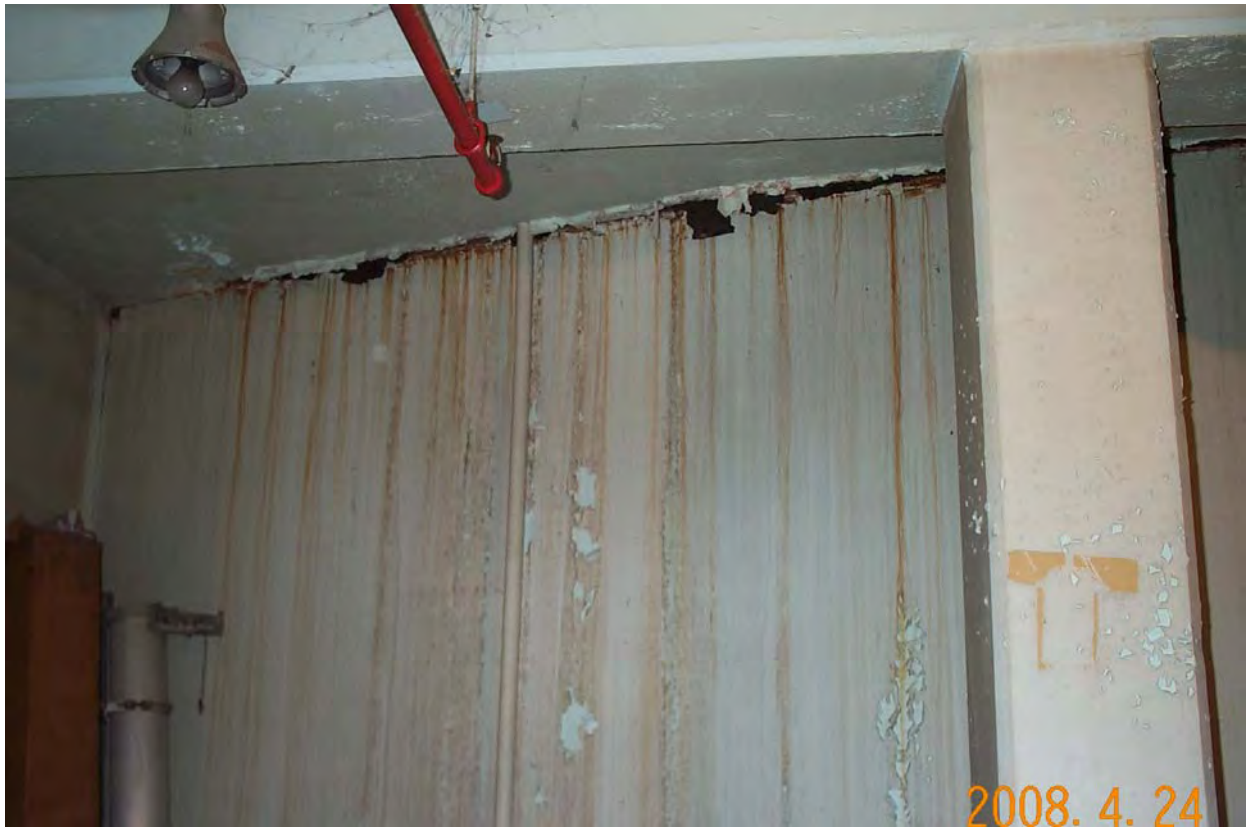
Possible water damage is present on the 79-foot level in room B-1. The southwest side of this room is the curved wall of the containment structure. Rust is present along the upper seam of this wall, where the wall meets the ceiling, and rust staining is present on the wall (PL-7). Paint is

PIQ 4/2008. PL-7. Water corrosion along seam of wall in Room B-1, 79-foot level.

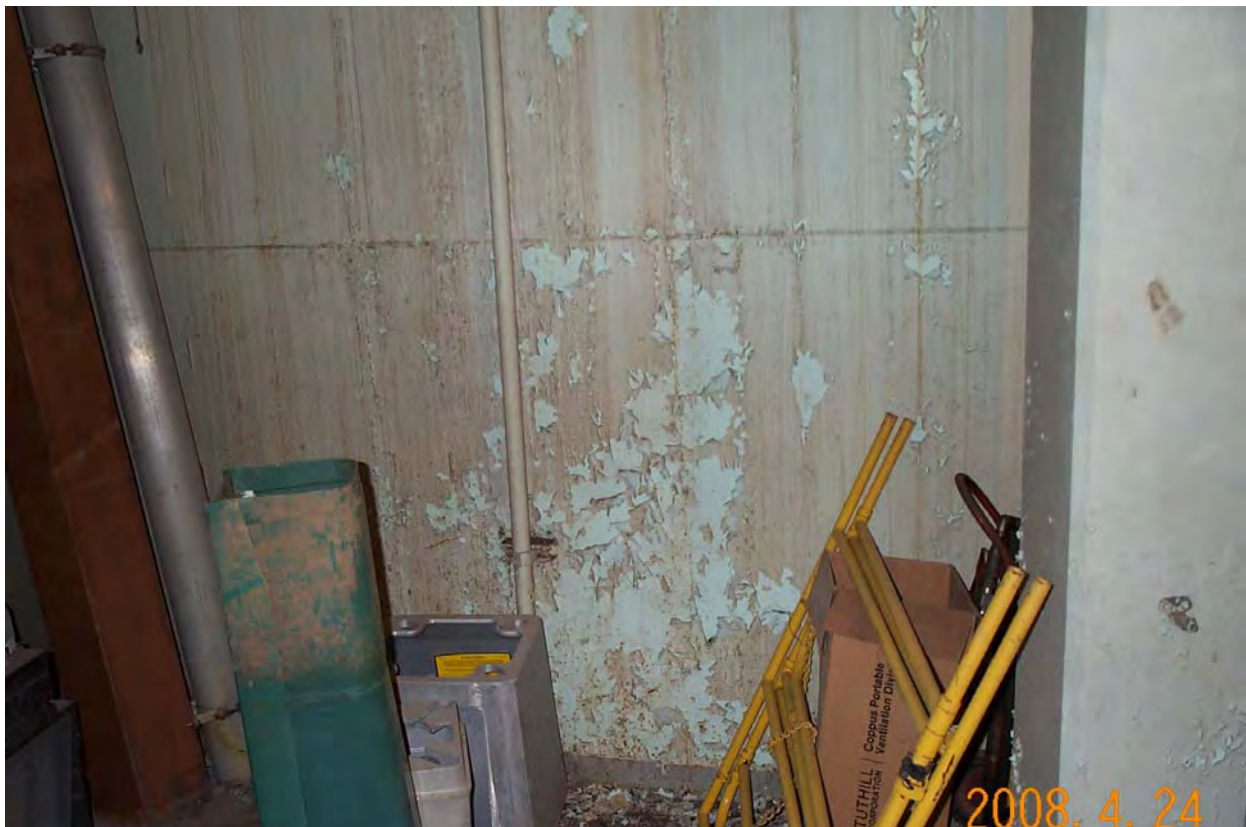
also peeling off the wall (PL-8). Pipe insulation on the 79-foot level exhibits some damage, but appears intact; friable asbestos is not evident (PL-9).

PIQ 4/2008. PL-8. Peeling paint, Room B-1, 79-foot level.

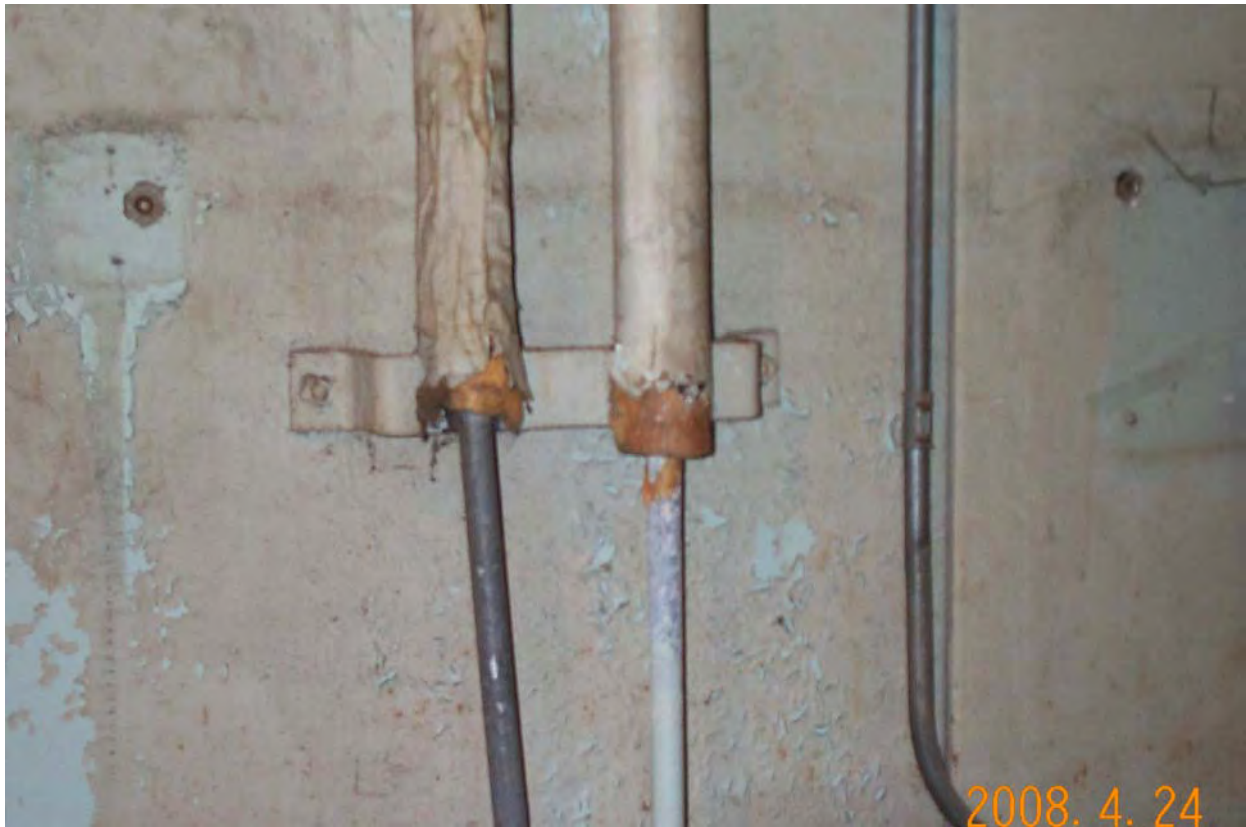
PIQ 4/2008. PL-9. Worn insulation, 79-foot level.

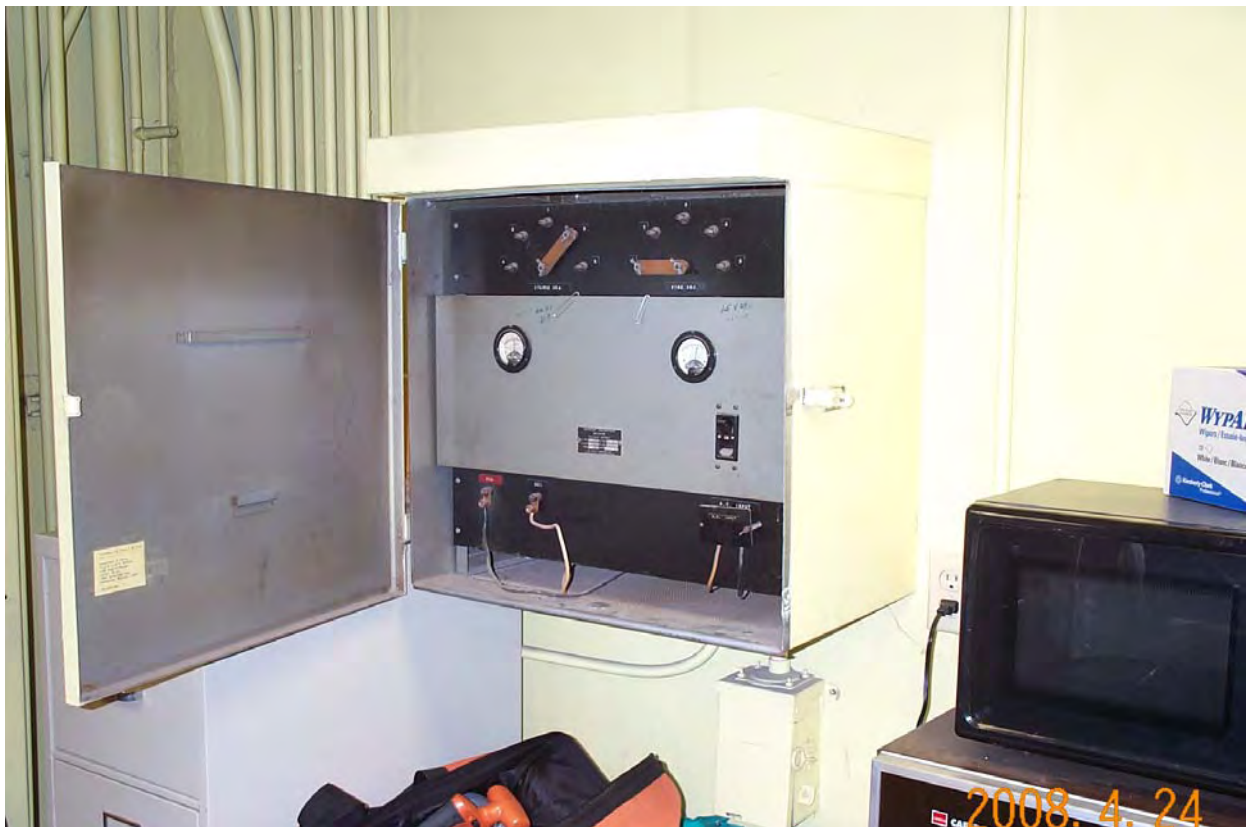
The system consists of 10 carbon (graphite) electrodes, buried radially approximately 10 to 20 feet from the building foundation, and a rectifier unit that provides DC current. The rectifier unit is mounted in the break room south of and outside the airlock on the 100-foot level (PL-10). Each carbon electrode is 3 inches in diameter and 60 inches long. The electrodes are connected to the rectifier unit by a header cable; splices are protected in flush-mounted boxes. A structure contact point for monitoring potential can be found on the shell associated with each electrode; some of the contact points also have cables remaining from an abandoned zinc anode protection system. The system also includes reference electrodes and test holes.

PIQ 4/2008. PL-10. Rectifier control panel, 100-foot level.

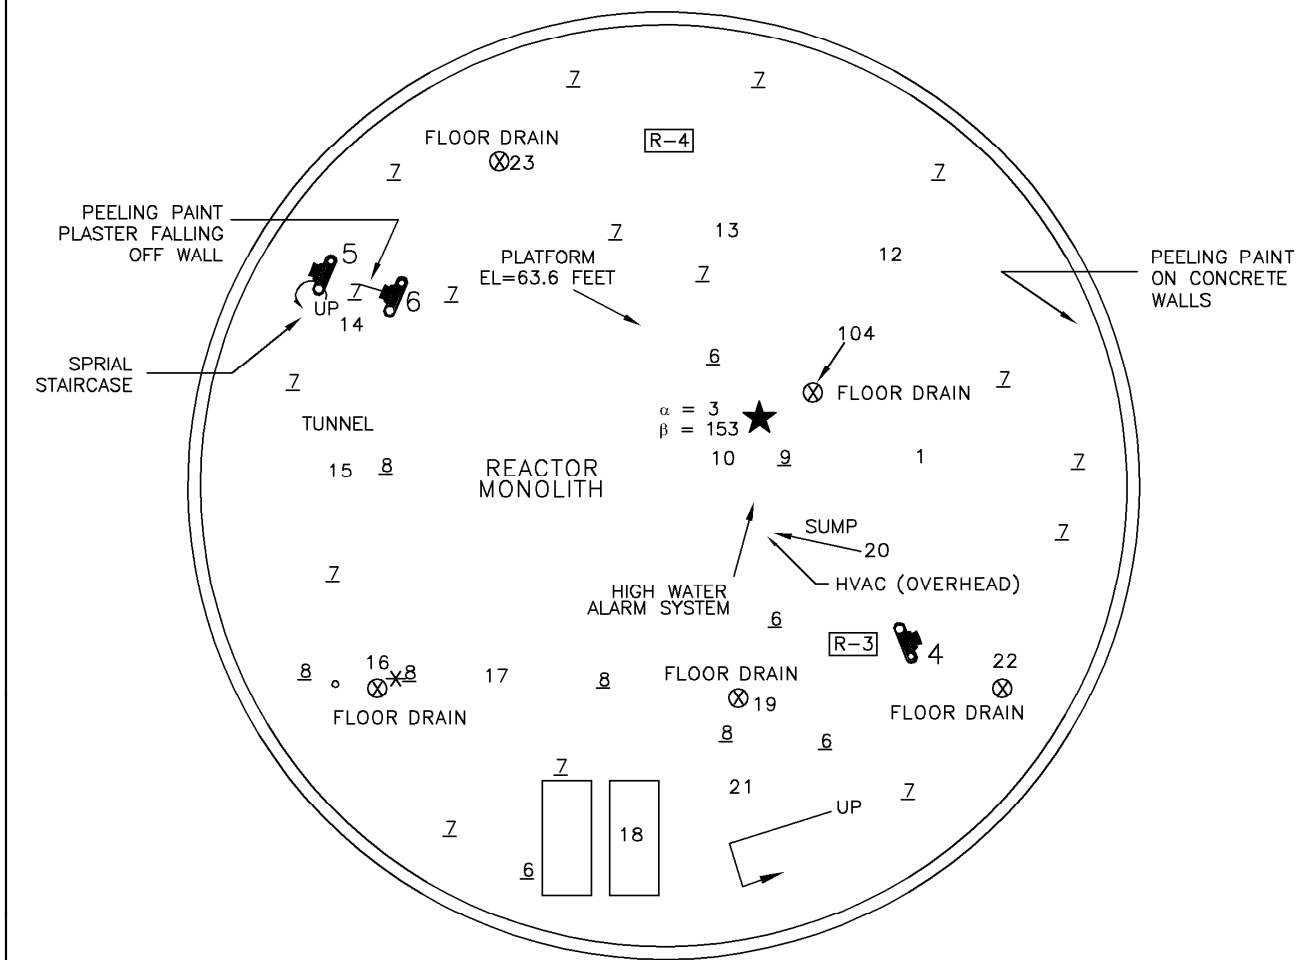
PLAN - 56 FOOT LEVEL

Table 2 presents direct surface and removable activity results. Direct surface measurement results indicate the floor drain at the lowest level of the containment building exhibited a direct beta activity of 3,825 disintegrations per minute per 100 square centimeters (dpm/100 cm<sup>2</sup>). The smear from this location indicated that no removable activity is present. This result is consistent with previous surveys. All other direct measurements were below the MDA.

NOTE: ALL 2008 GAMMA CONTACT AND GENERAL AREA READINGS WERE  $\leq$  BKGD ON THE 56-FOOT LEVEL.

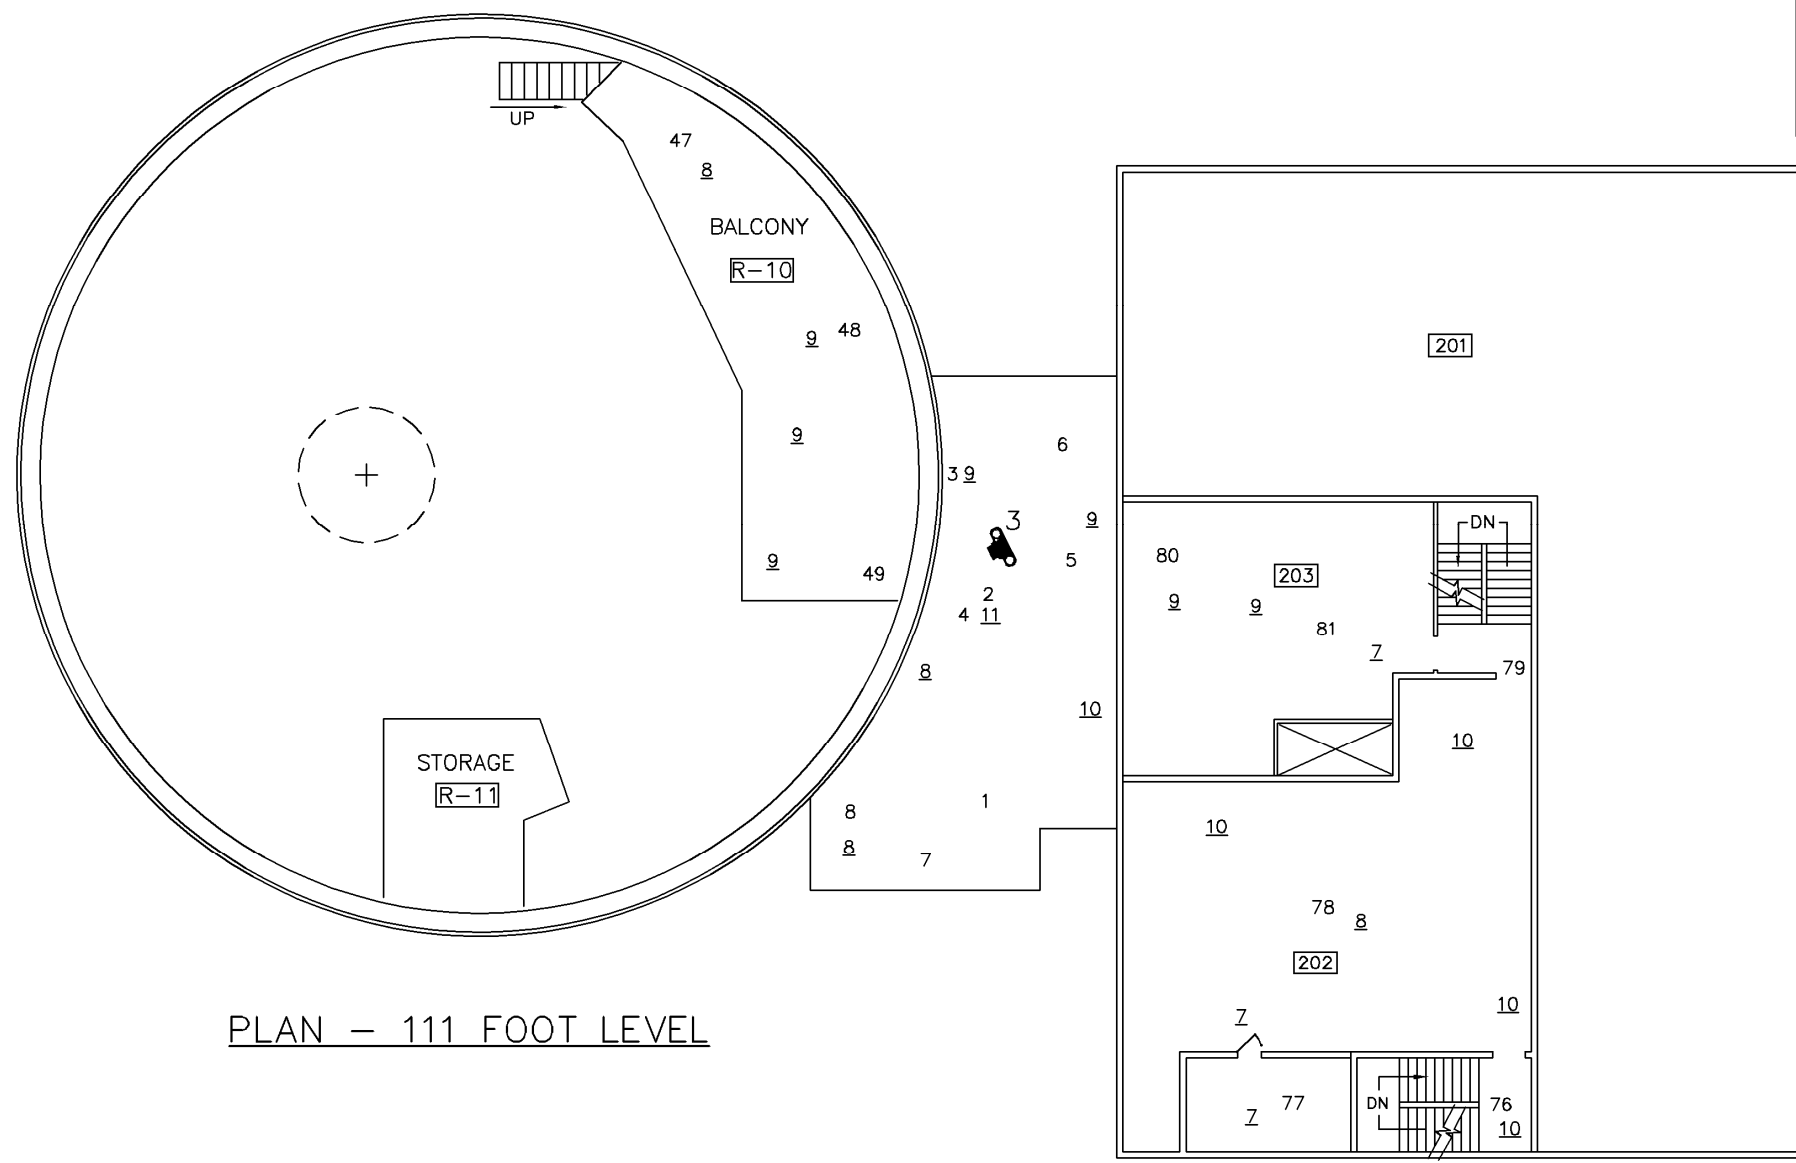
PLAN - 111 FOOT LEVEL

NOTE: SAMPLES 1-5 WERE DELETED BECAUSE HVAC EQUIPMENT HAS BEEN REMOVED FROM THE ROOF.

NOTE: ALL 2008 GAMMA CONTACT AND GENERAL AREA READINGS WERE  $\leq$  BKGD ON THE 111-FOOT LEVEL.
