2009 Annual Inspection and Radiological Survey Results for the Piqua, Ohio, Decommissioned Reactor Site

The former Piqua Nuclear Power Facility (PNPF), a decommissioned nuclear power demonstration facility, was inspected on April 9, 2009. The site, located on the east bank of the Great Miami River in Piqua, Ohio, is in good physical condition. There is no requirement for a follow-up inspection.

This report presents the findings of the annual U.S. Department of Energy (DOE) inspection of the Piqua Nuclear Power Facility (PNPF) in Piqua, Ohio. This facility is assigned to the DOE Office of Legacy Management (LM) for long-term custody and care.

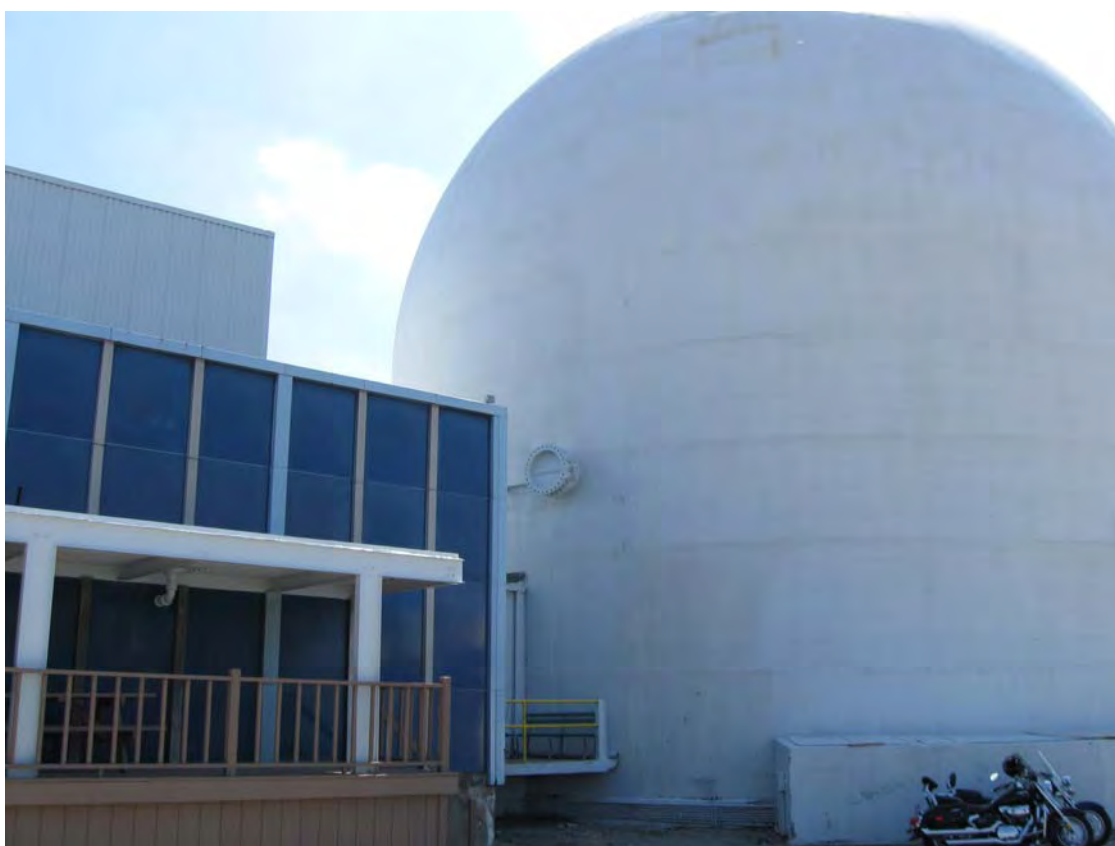
The Containment Building exterior was refurbished around 1995. The exterior of the reactor containment building is in good shape (PL-1). Rust stains that were present on the northeast side of the containment building during the 2008 inspection are no longer present (PL-2).

PIQ 4/2009. PL-1. Containment Dome.

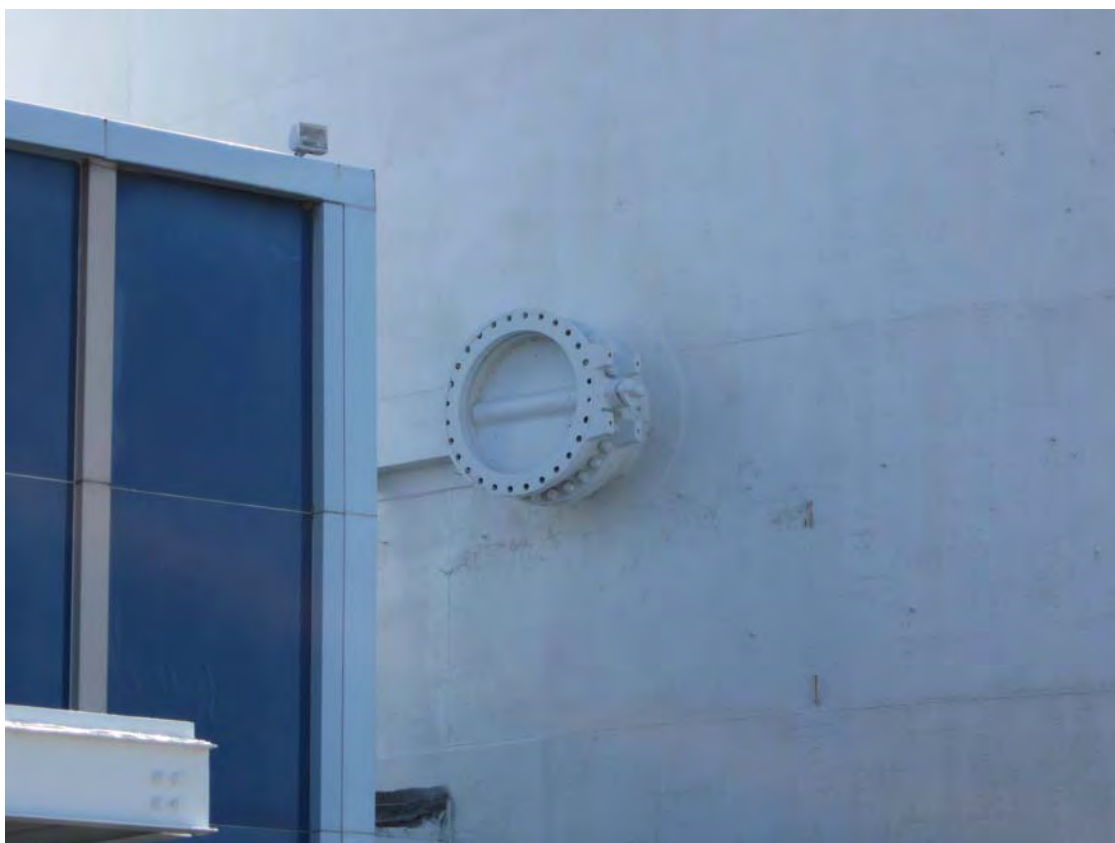
PIQ 4/2009. PL-2. Containment Dome.

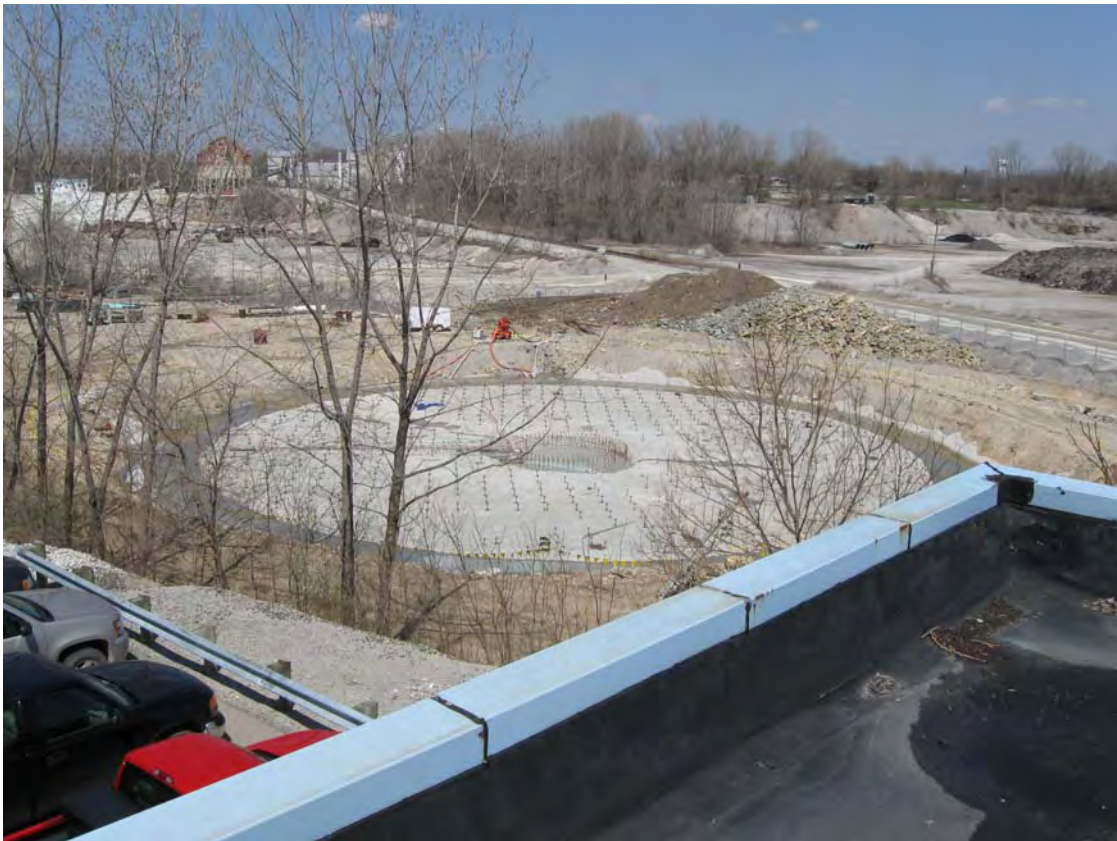
The city water department began construction of a large water retention tank immediately east of the facility since the 2008 inspection. The foundation for the tank was installed at the time of the inspection this year (PL-3). Construction of the water retention tank should not affect the integrity of the PNPf entombment. No other changes in the area immediately surrounding the Piqua facility were observed.

PIQ 4/2009. PL-3. New construction east of the facility.

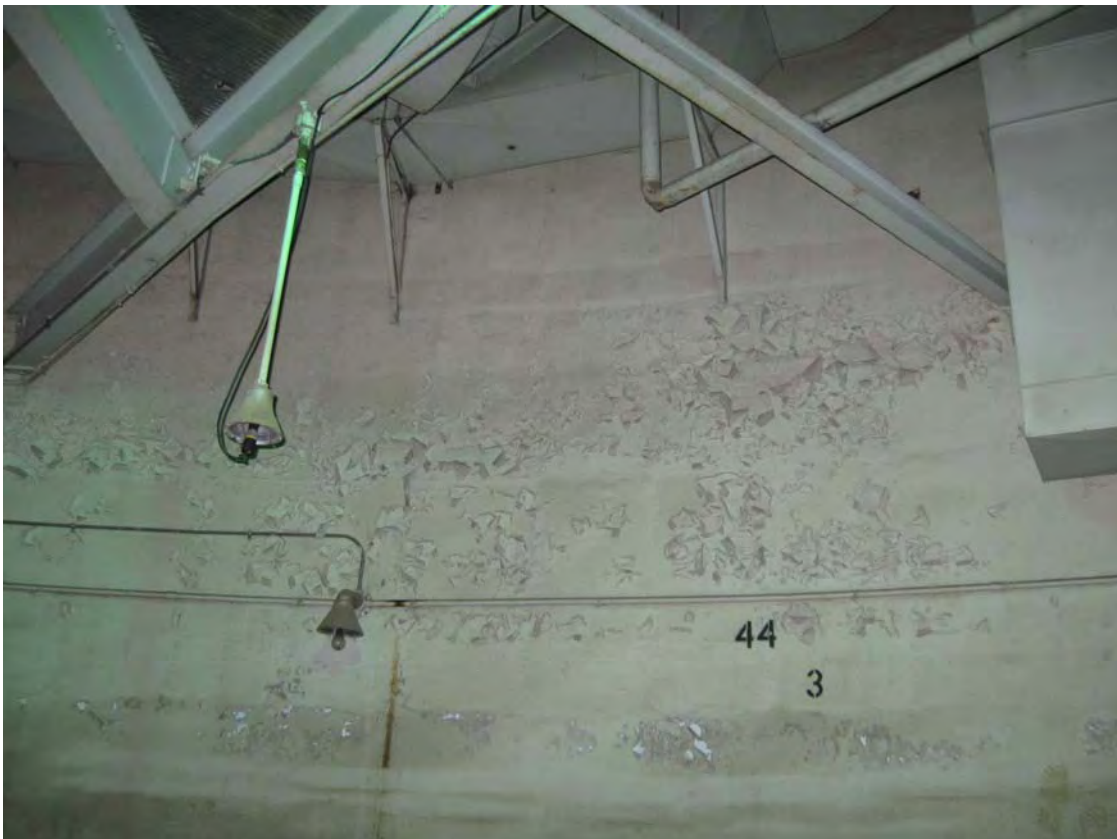
56 foot level: The 56-foot level is the lowest level of the facility. PPS uses this level to store cable spools. The amount of peeling paint on the interior walls appears to be unchanged from the 2008 inspection (PL-4). Peeling paint that is falling onto the floors was analyzed in 2006 and found to contain 0.35 percent lead. The paint will probably continue to peel and fall to the floor. Inspectors are not exposed to unacceptable risk when performing routine inspection activities. PPS is aware of the presence of lead-based paint.

1. As noted at last year's inspection and on prior inspections, peeling paint was observed on areas of the interior dome walls and was falling onto the floors. The deeper levels of the facility are the ones most impacted by the peeling paint. This paint has been previously tested and found to contain approximately 0.35 percent lead (page 2).

PIQ 4/2009. PL-4. Peeling Paint on interior wall: 56 foot level.

Recommendation: The facility manager is aware that the peeling paint contains approximately 0.35 percent lead. DOE and contractor staff will follow health and safety recommendations when entering the property.

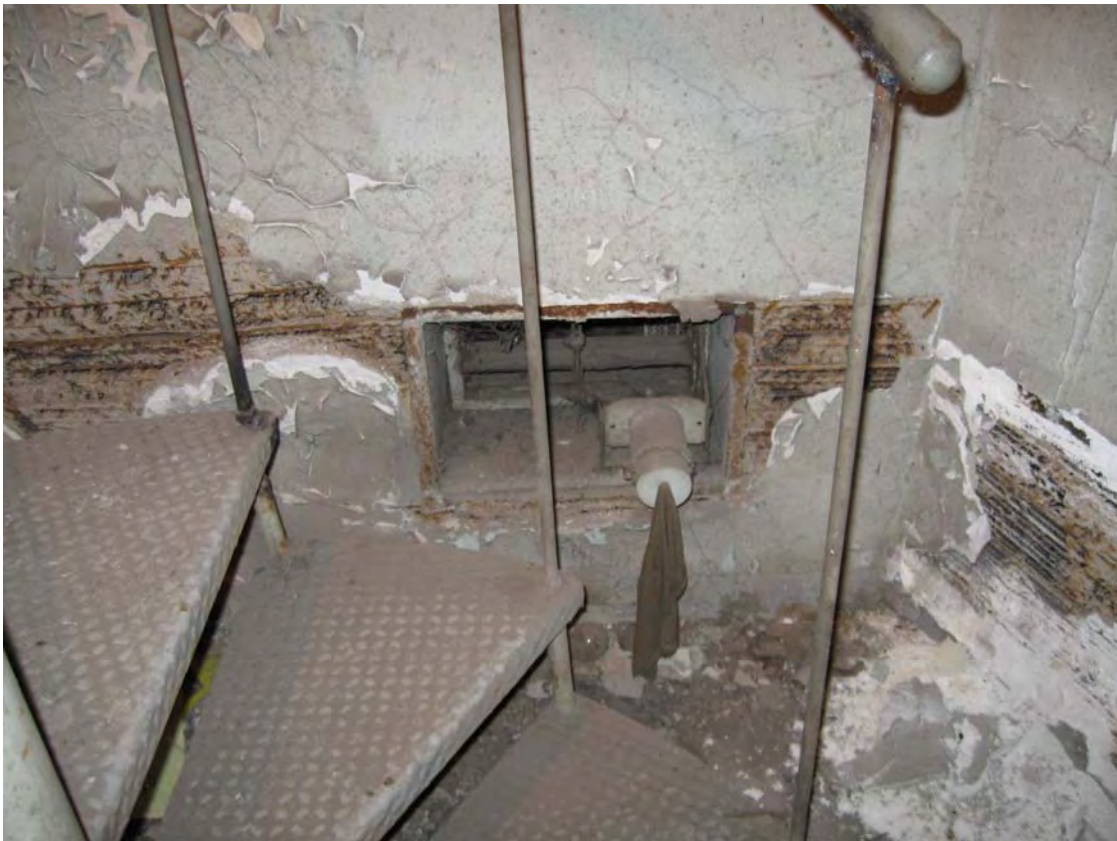
A spiral staircase is present in the west corner of the facility. Plaster is falling off the walls at the base of the spiral staircase at the 56-foot level (PL-5). This damage was noted in the 2008 inspection report. Plaster is also damaged just outside the entrance to the spiral staircase at the 56-foot level. It appears that some of the cable spools have rolled into the walls, damaging the plaster, as shown in PL-6.

PIQ 4/2009. PL-5. Base of Spiral Staircase: 56 foot level

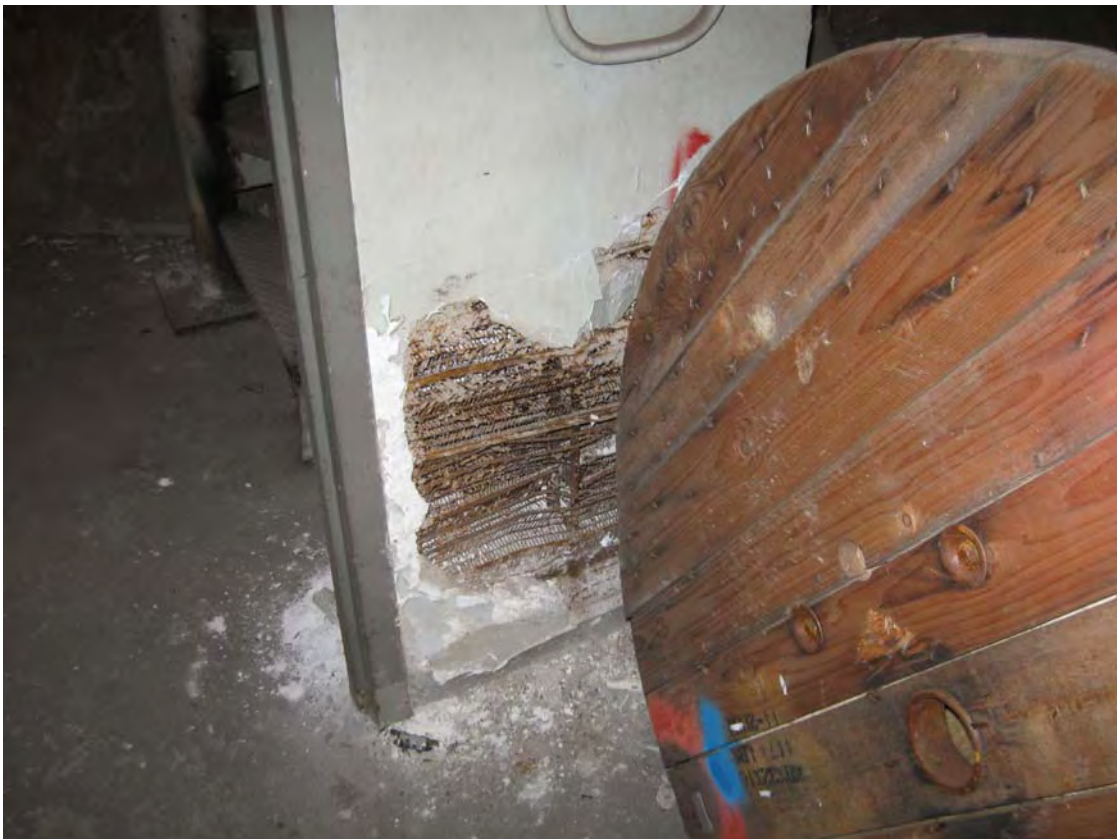
PIQ 4/2009. PL-6. Damage to Walls by Cable Spools: 56 foot level.

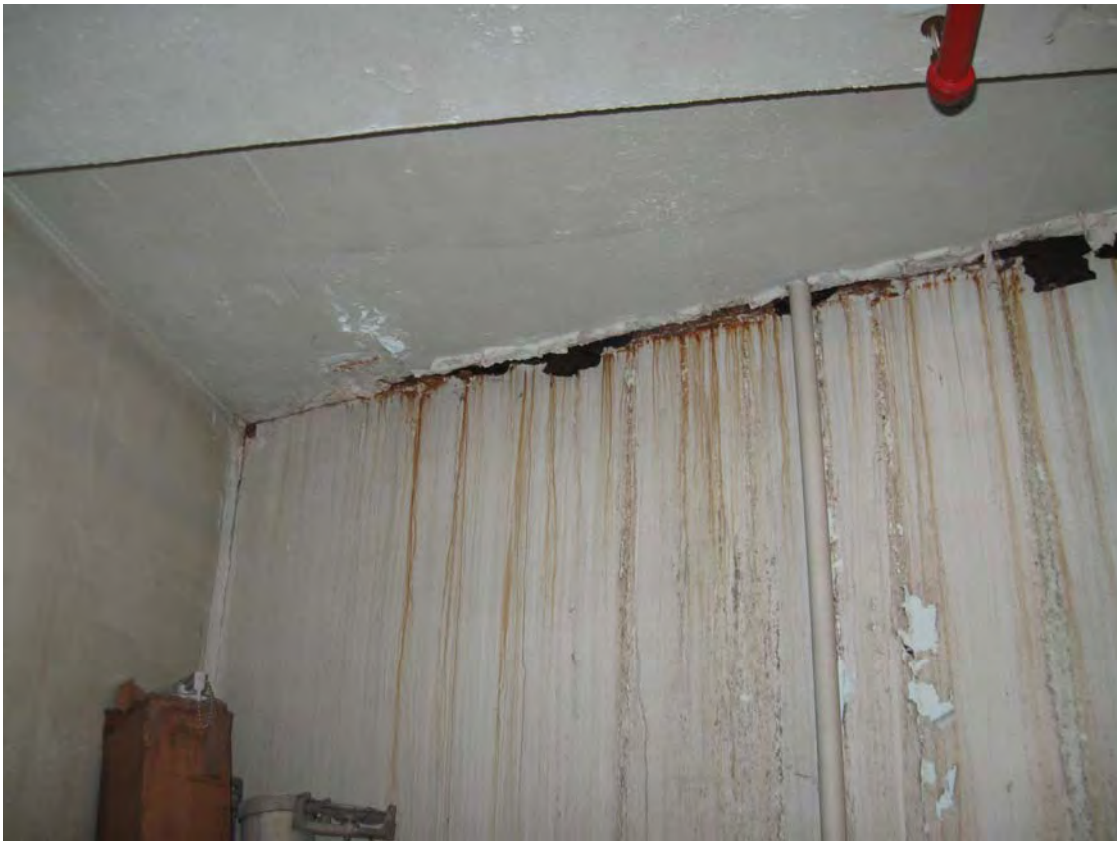
79 foot level: Conditions concerning broken plaster, peeling paint and possible water damage noted in the 2008 inspection appeared to be about the same. Possible water damage is present on the 79 foot level in room B-1. The southwest side of this room is the curved wall of the containment structure. Rust is present along the upper seam of this wall, where the wall meets the ceiling, and rust staining is present on the wall (PL-7). Paint is also peeling off the wall of Room B-3 (PL-8).

PIQ 4/2009. PL-7. Water corrosion along seam of wall in Room B-1: 79-foot level.

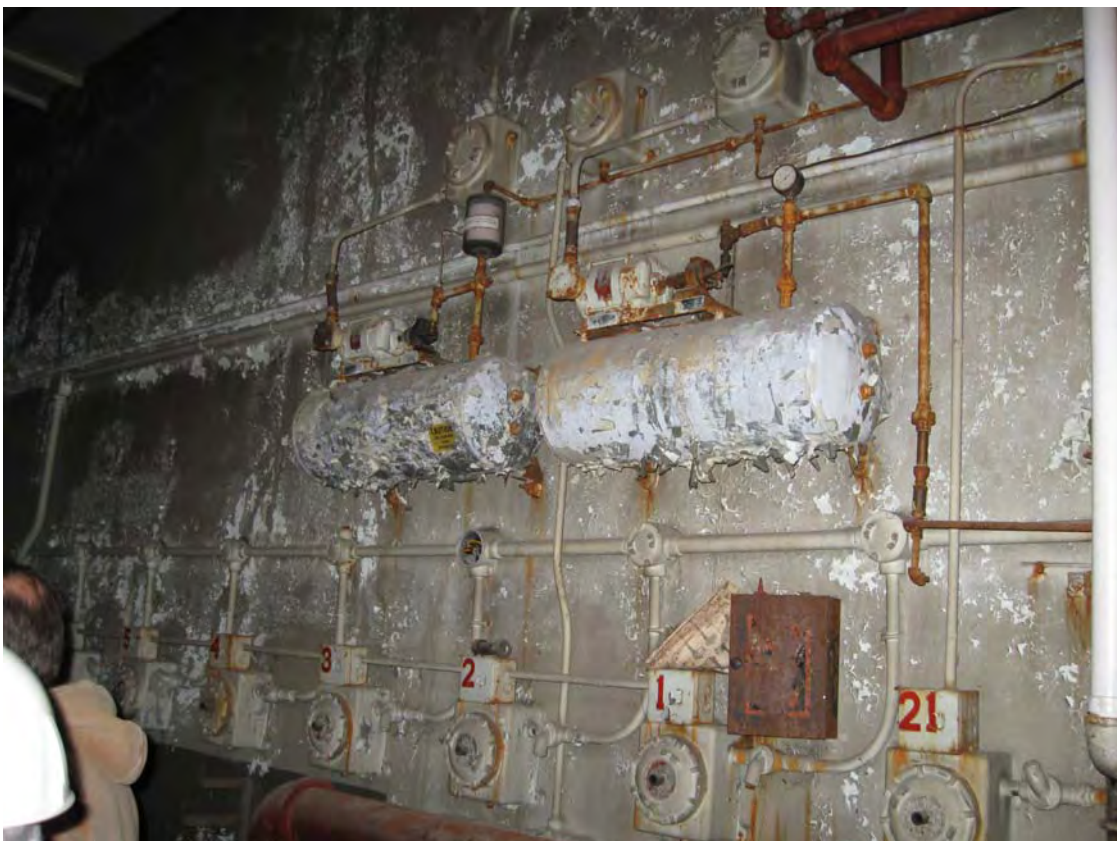
PIQ 4/2009. PL-8. Peeling paint, Room B-3: 79-foot level.

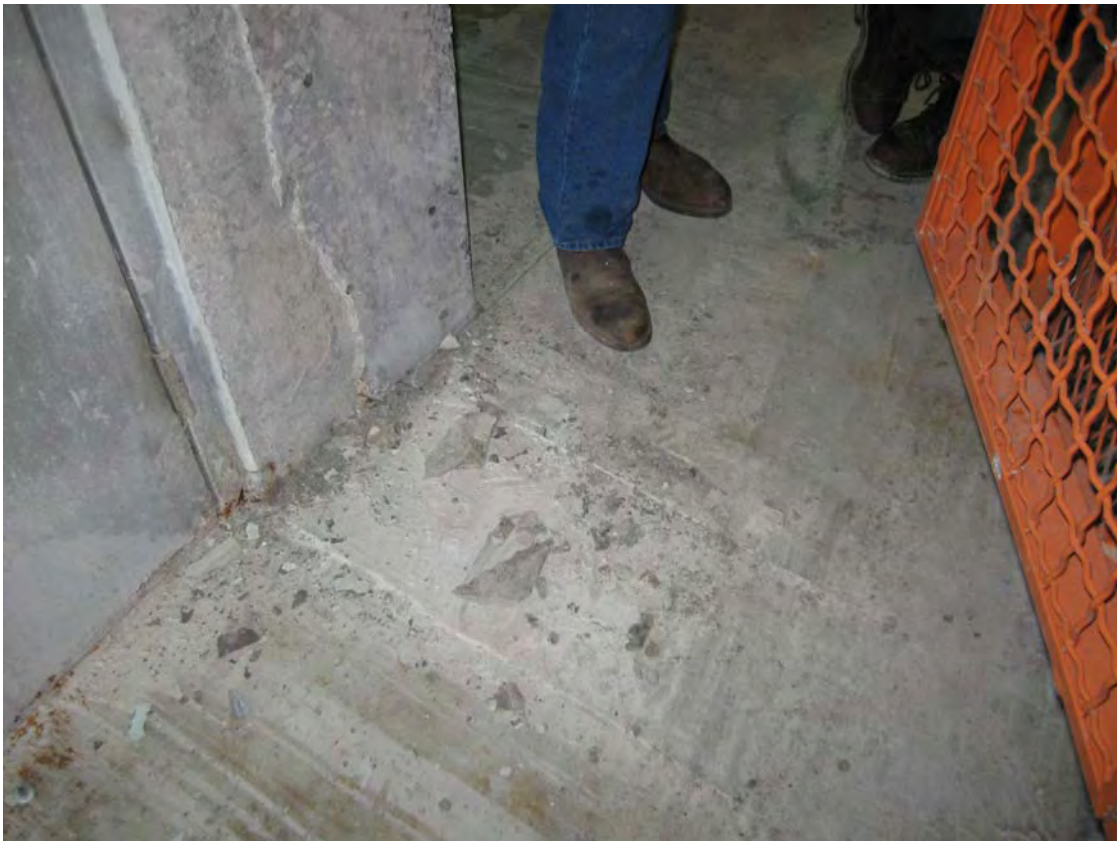
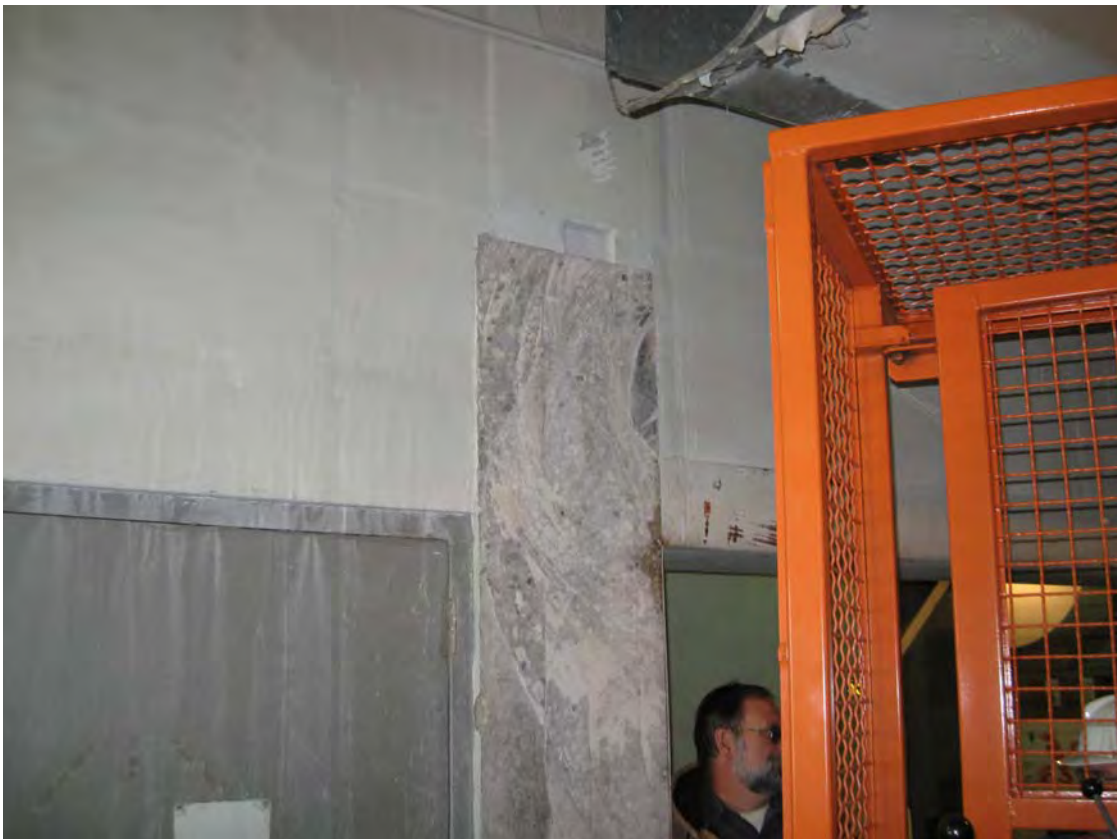
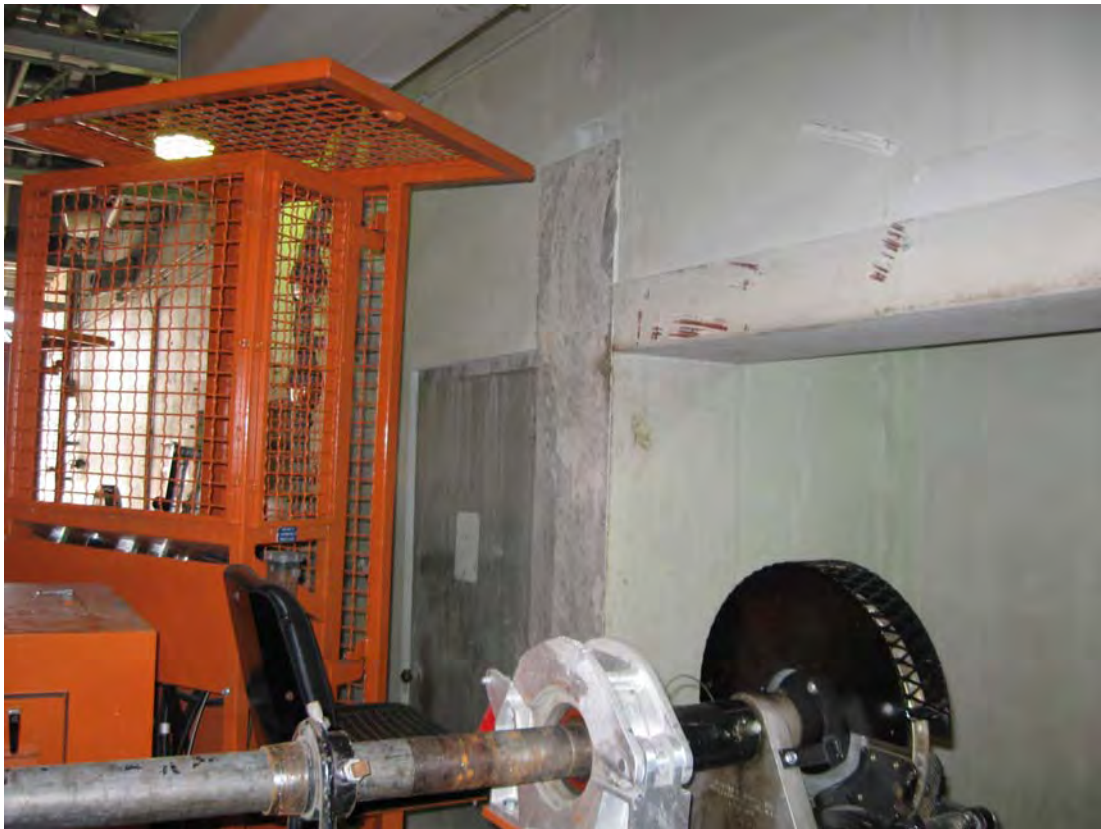
PPS modified Room B-4. The room is used to store large equipment and trailers. A small section of wall in the back of the room was removed in order to utilize more of the room for storage (PL-9, PL-10, and PL-11). The inspection map has been updated accordingly.

PIQ 4/2009. PL-9. Removed wall: 79-foot level.

PIQ 4/2009. PL-10. Removed wall: 79-foot level.

PIQ 4/2009. PL-11. Removed wall: 79-foot level.

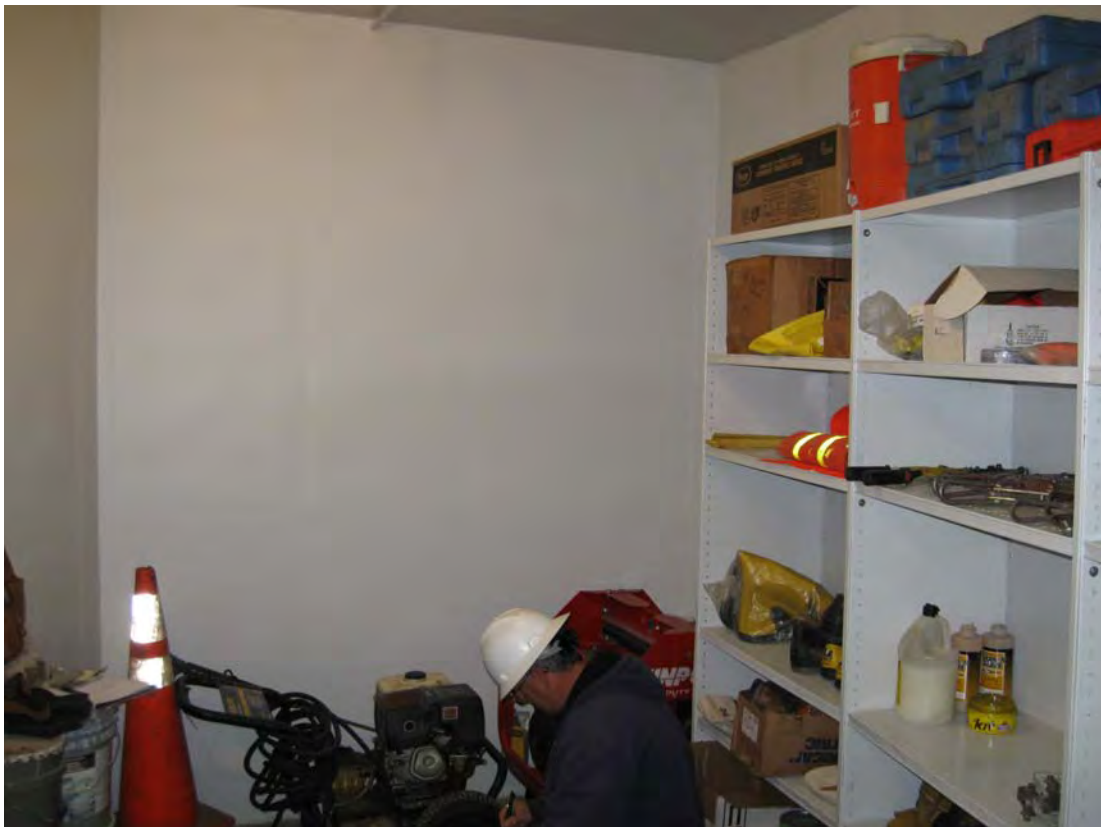
100 foot level: PPS completed some minor remodeling in Rooms R-6 and R-7. The rooms were cleaned out, walls freshly painted, and shelves installed. An air duct opening that once connected the two rooms was filled in and painted over (PL-12 and PL-13). New epoxy flooring was installed in Rooms 115 and 121-A. A new air conditioner unit was installed in Room 121-A. The room containing the rectifier unit control panel was freshly painted. The 100-foot level inspection drawing has been updated accordingly to reflect these changes.

PIQ 4/2009. PL-12. Renovations in Room R-7. Painting, shelving, removal of air duct connecting to Room R-6: 100 foot level

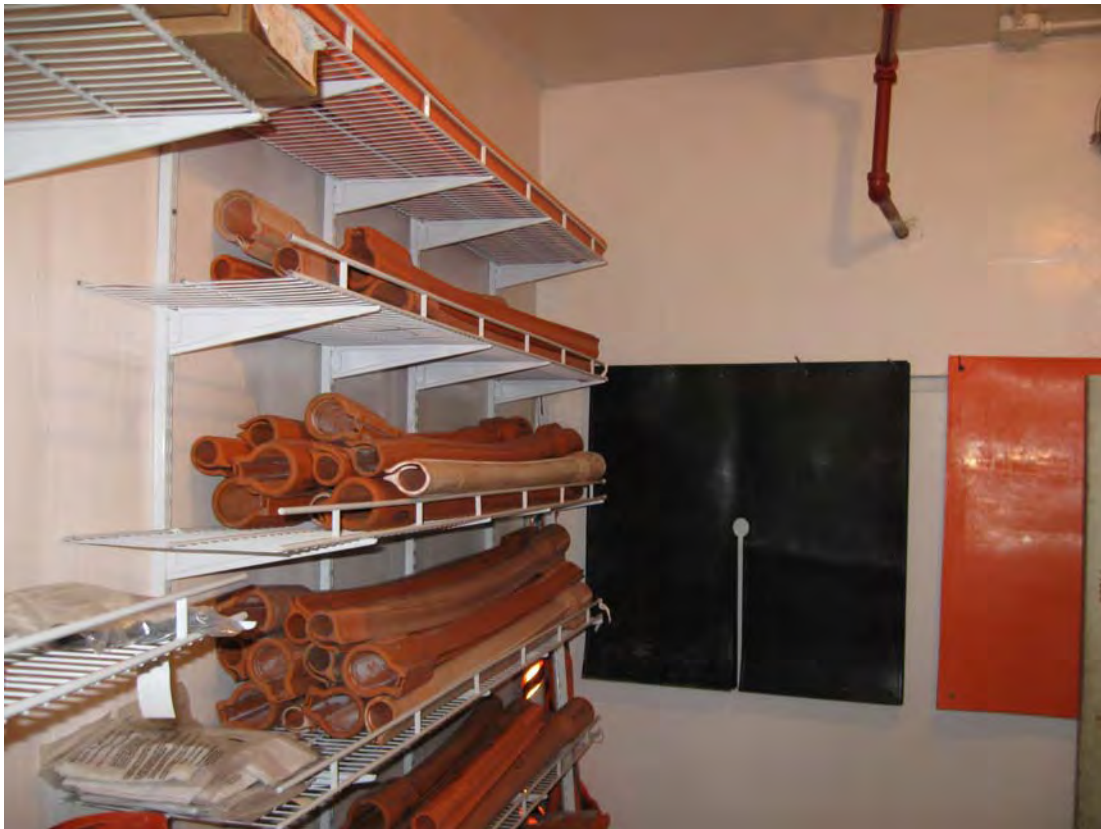
PIQ 4/2009. PL-13. Renovations in Room R-6, Painting, shelving, removal of air duct connecting to Room R-7: 100 foot level

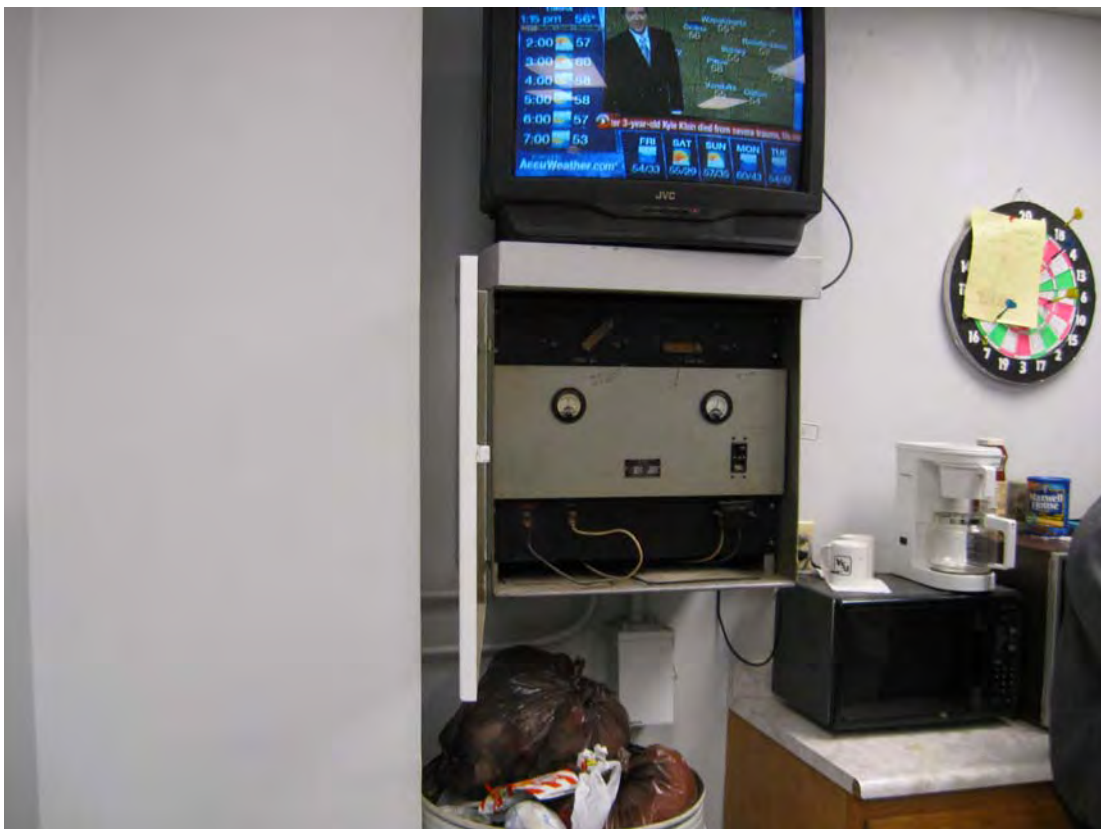
The system consists of 10 carbon (graphite) electrodes, buried radially approximately 10 feet to 20 feet from the building foundation, and a rectifier unit that provides DC current. The rectifier unit is mounted in the break room south of and outside the airlock on the 100-foot level (PL-14). Each carbon electrode is 3 inches in diameter and 60 inches long. The electrodes are connected to the rectifier unit by a header cable; splices are protected in flush-mounted boxes. A structure contact point for monitoring potential can be found on the shell associated with each electrode; some of the contact points also have cables remaining from an abandoned zinc anode protection system. The system also includes reference electrodes and test holes.

PIQ 4/2009. PL-14. Rectifier control unit

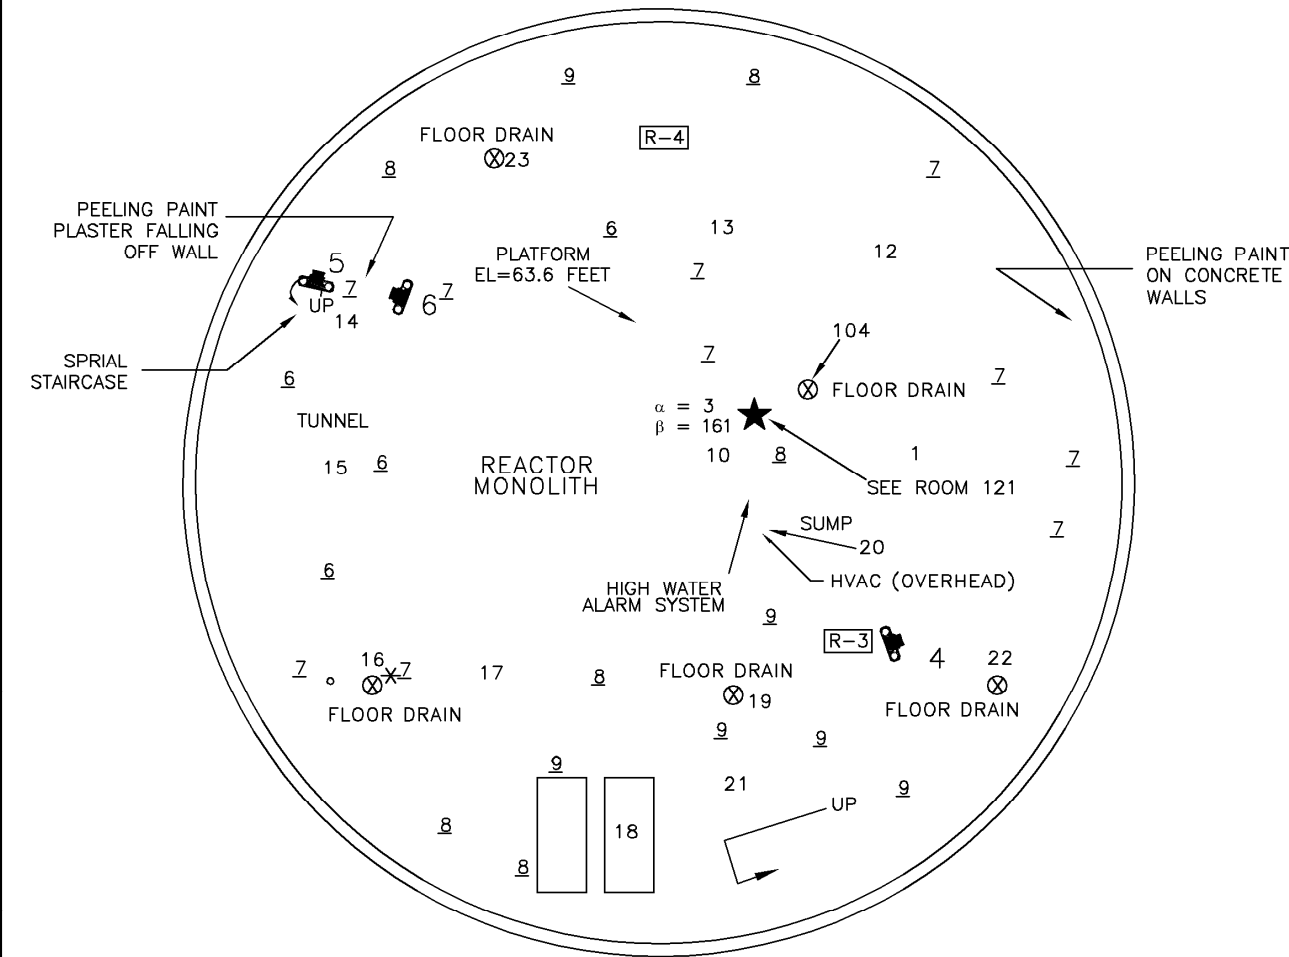
PLAN - 56 FOOT LEVEL

Table 2 presents direct surface and removable activity results. Direct surface measurement results indicate the floor drain at the lowest level of the containment building exhibited a direct beta activity of 2,240 disintegrations per minute per 100 square centimeters (dpm/100 cm²). The smear from this location indicated that no removable activity is present. This result is consistent with previous surveys. Also, one location on the 83 foot level (Location #28) located on the HVAC duct had a reading of 812 disintegrations per minute per 100 square centimeters (dpm/100 cm²) direct beta source (smear < MDA). All other direct measurements were below the MDA.

NOTE: ALL 2009 GAMMA CONTACT AND
GENERAL AREA READINGS
WERE \leq BKGD ON THE 56-FOOT LEVEL.
