2010 Annual Inspection and Radiological Survey Results for the Piqua, Ohio, Decommissioned Reactor Site

Summary

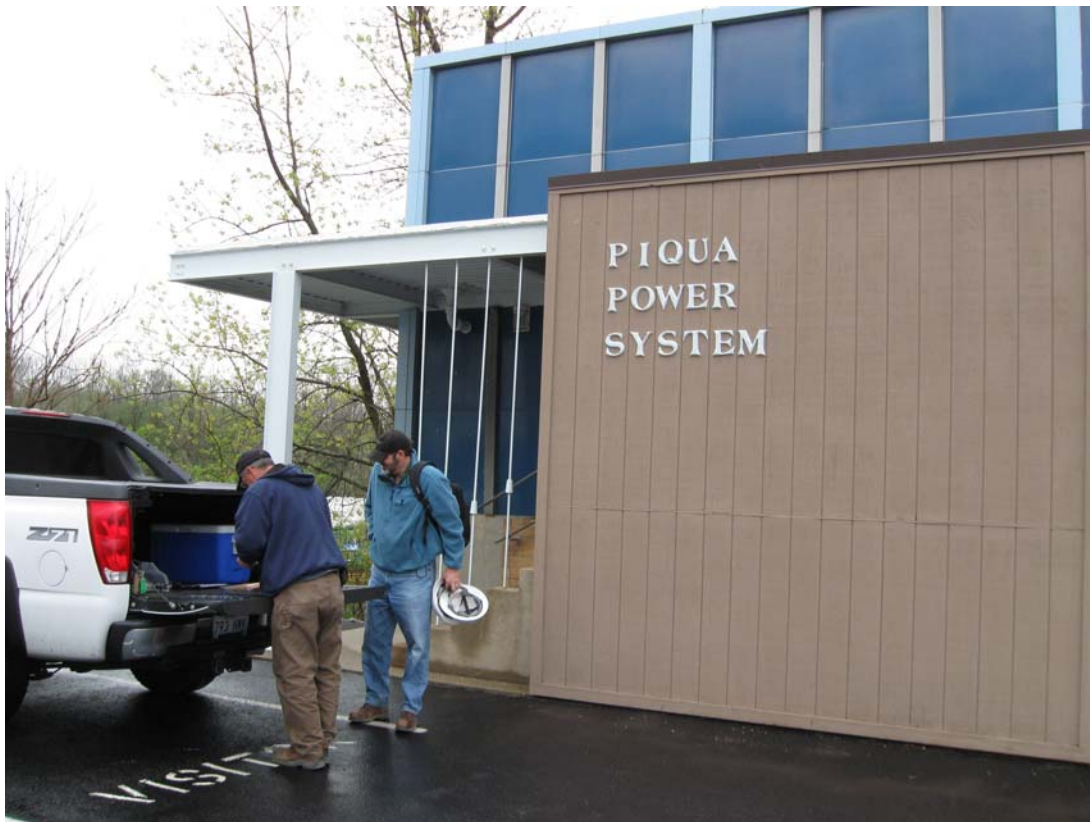
PIQ 4/2010. PL-1. Entrance to the Piqua auxiliary building.

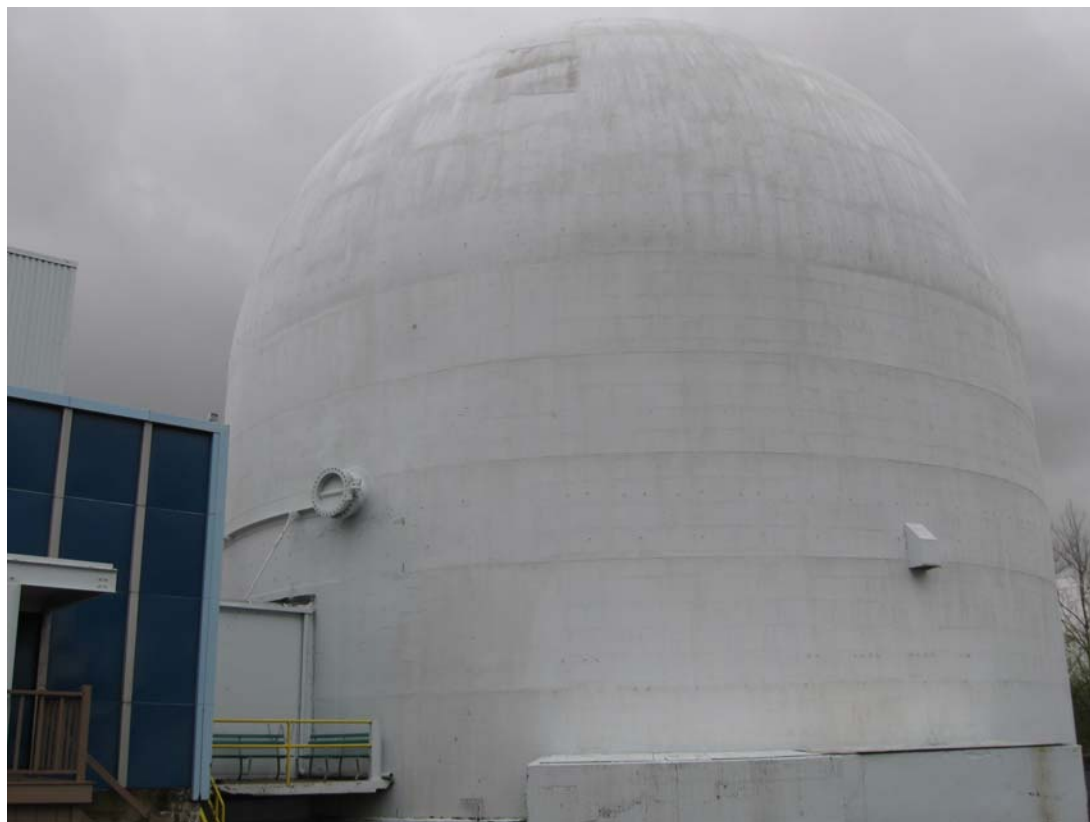
The Containment Building exterior was refurbished around 1995. The exterior of the reactor containment building was in good shape (PL-2 and PL-3).

PIQ 4/2010. PL-2. Exterior of the Piqua containment building.

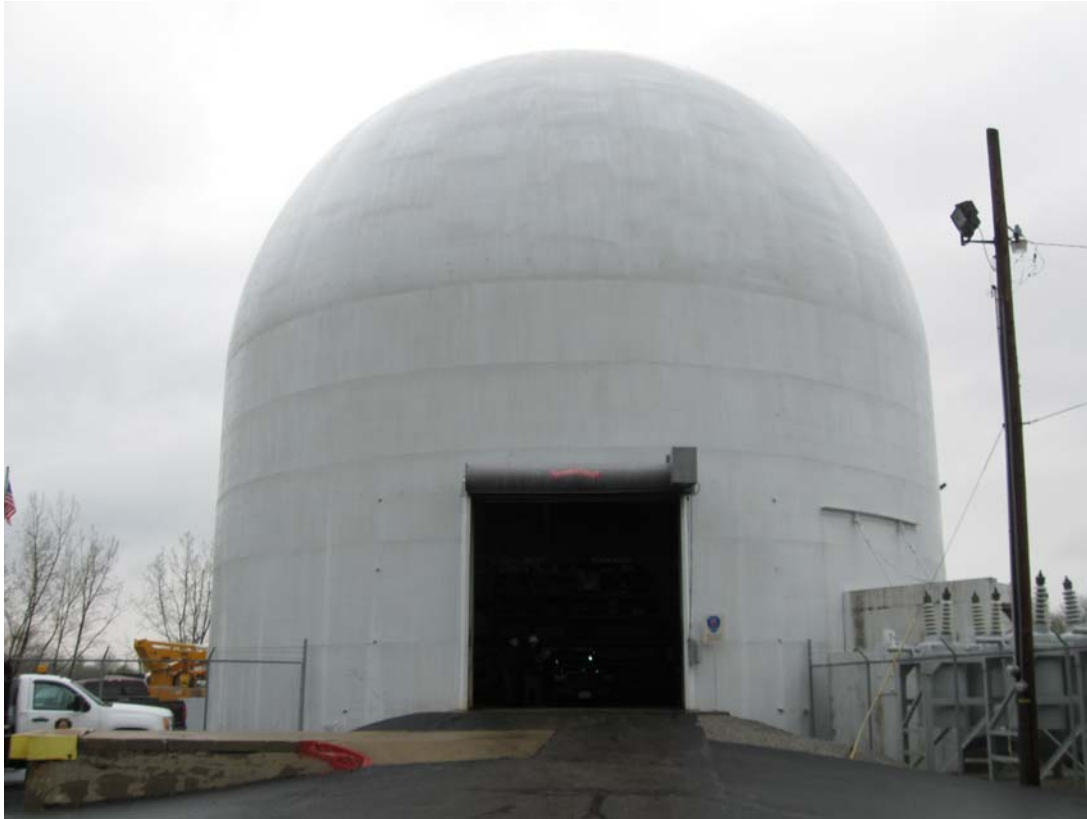
PIQ 4/2010. PL-3. Exterior of the Piqua containment building.

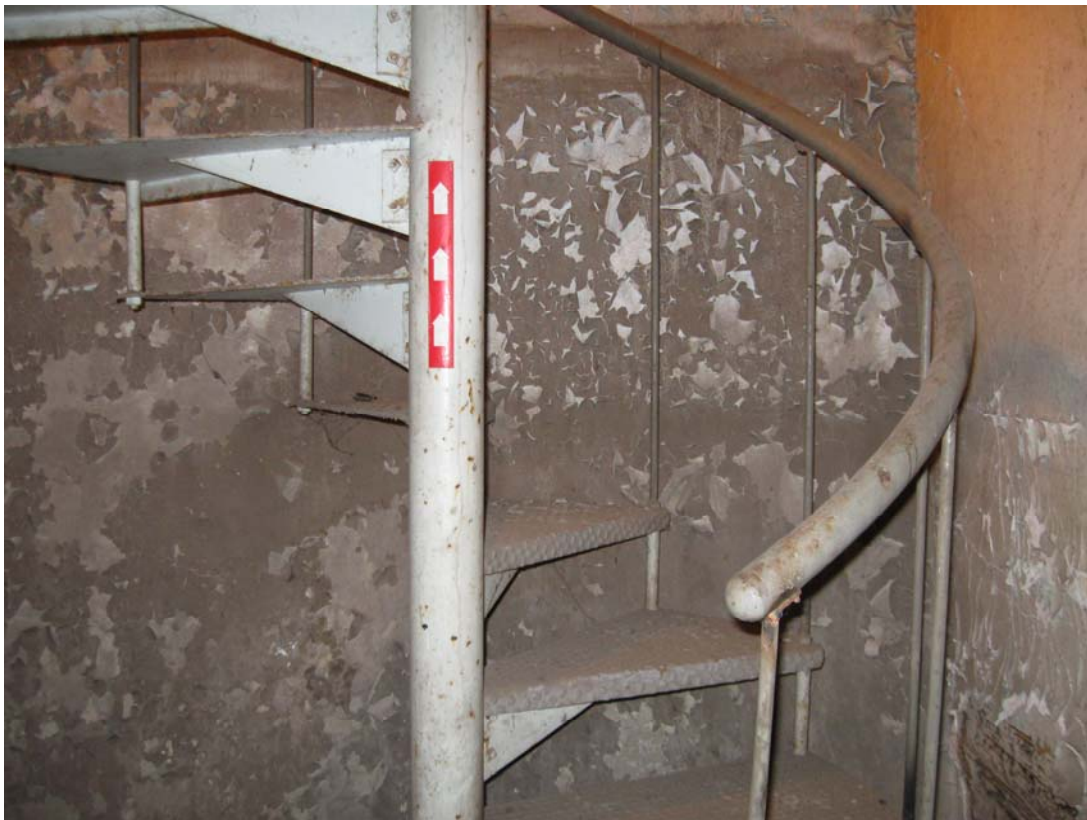
A spiral staircase is present in the containment structure. Plaster is falling off the walls at the base of the spiral staircase at the 56-foot level. Plaster is damaged just outside the entrance to the spiral staircase at the 56-foot level (PL-4). Cable spools have rolled into the walls, damaging the plaster. This damage has been noted in previous inspection reports.

PIQ 4/2010. PL-4. Base of spiral staircase: 56-foot level.

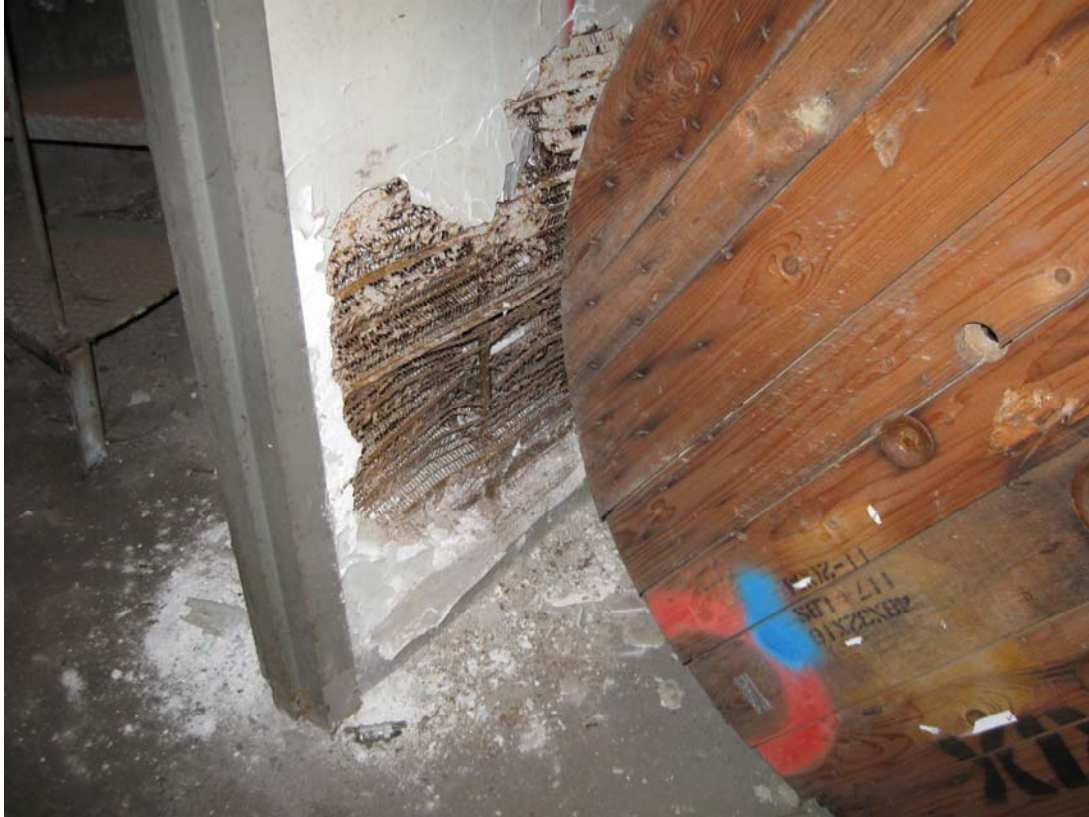
PIQ 4/2010. PL-5. Damage to walls by cable spools: 56-foot level.

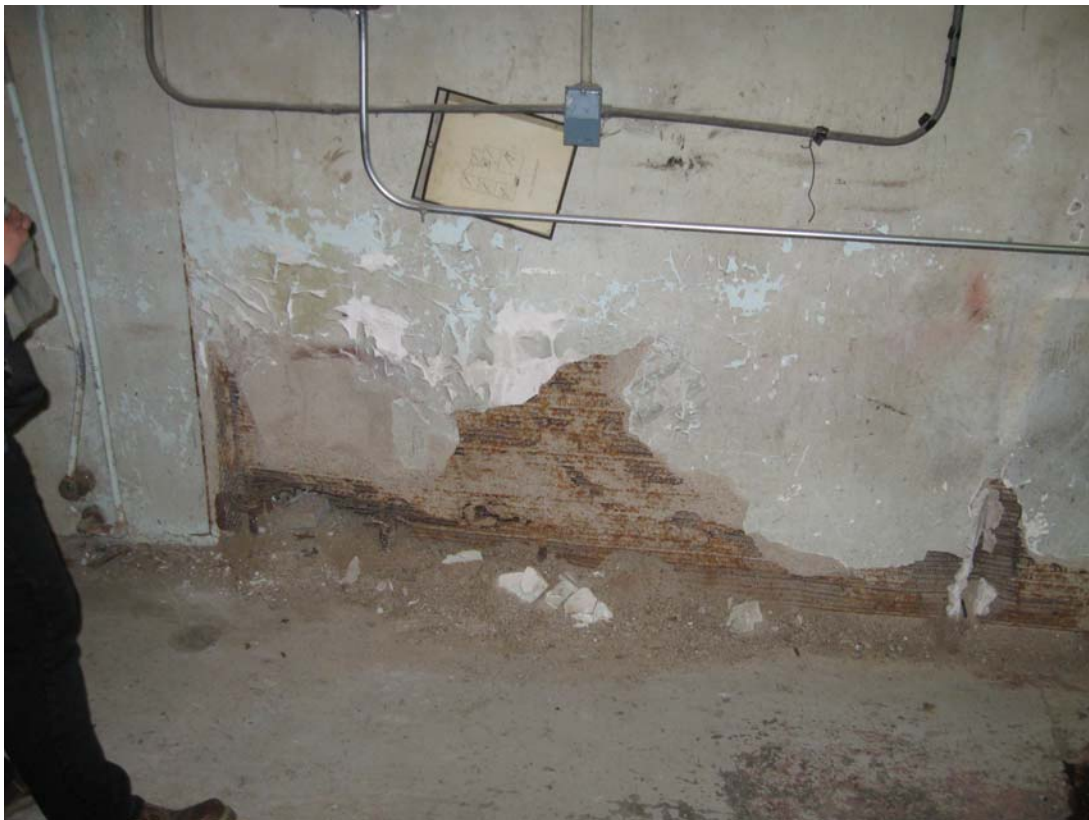
79-foot level: Conditions concerning broken plaster, peeling paint, and water damage noted in previous inspections appeared to be about the same. The area of broken wall plaster in Room B-4 remained unchanged from last year (PL-6).

PIQ 4/2010. PL-6. Damage to base of interior wall in Room B-4 of auxiliary building: 79-foot level.

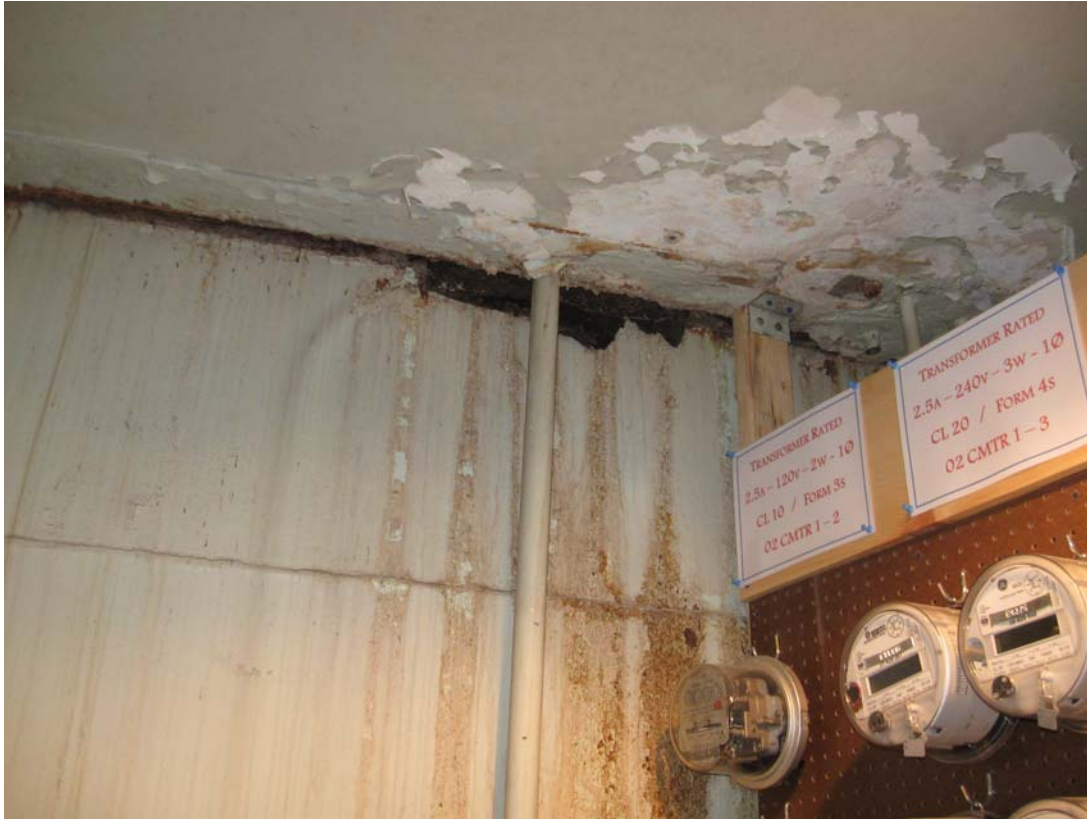
Evidence for water seeping along the ceiling seam of the Operating Air Pressure (OAP) room was observed (peeling paint and rust stains) (PL-7). This room is located directly above Room B1. Evidence for water seeping from the ceiling seam of Room B-1 was noted during the 2009 inspection. The southwest wall of both rooms is the curved wall of the containment structure. Both rooms show evidence for water seeping along the same wall of the containment building. The condition was noted on the 79-foot level site inspection map. PPS personnel were informed of the condition following the inspection.

2. Evidence for water seeping along the ceiling seam of the OAP room and underlying Room B-1 on the 79-foot level was noted during the inspection (page 2).

PIQ 4/2010. PL-7. Water and rust stains on seam of ceiling in OAP room of auxiliary building: 79-foot level.

Recommendation: The condition was noted on the 79-foot level site inspection map and will be checked during future inspections. PPS personnel were informed of the condition following the inspection.

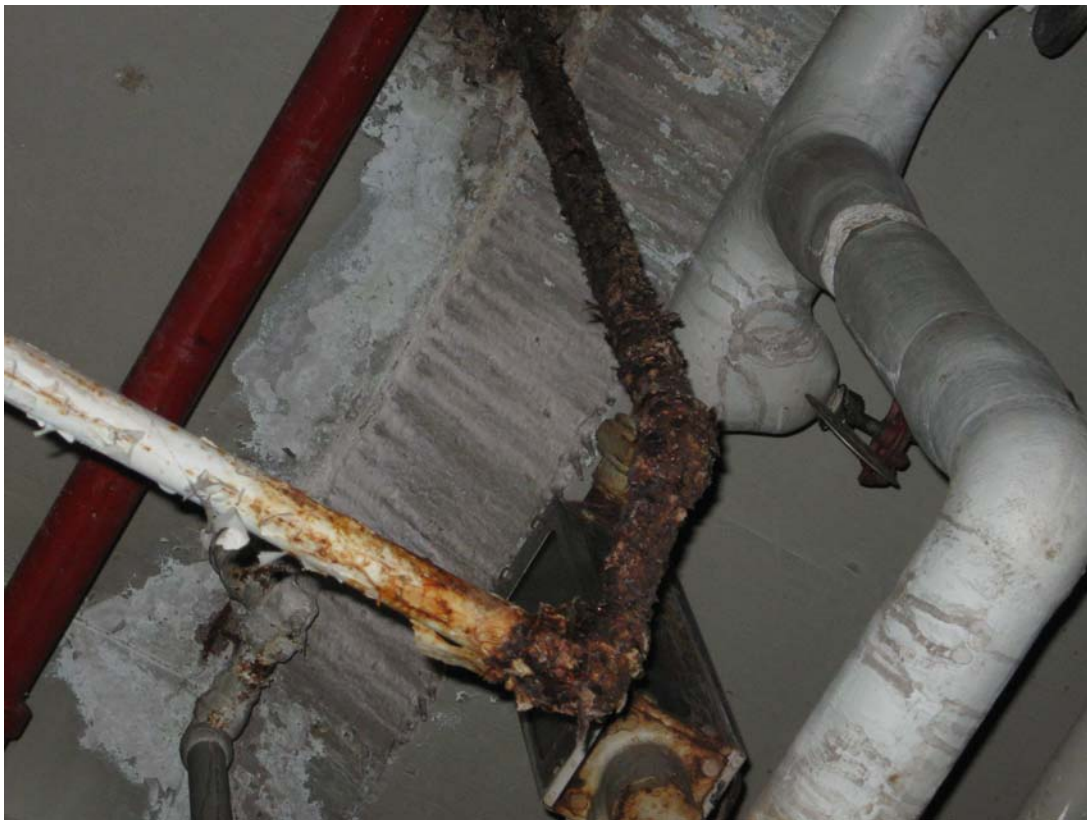
Water was observed to be slowly dripping down the outside surface of a pipe that extends out of the ceiling of Room B-5 (PL-8). Water stains on the floor of Room B-5 and along the sides of boxes stored in Room B-5 were also observed (PL-9). PPS personnel were informed of the condition following the inspection.

3. Water was observed to be slowly dripping down the outside surface of a pipe that extends out of the ceiling of Room B-5 (PL-8). Water stains on the floor of Room B-5 and along the sides of boxes stored in Room B-5 were also observed (PL-9) (page 2).

PIQ 4/2010. PL-8. Pipe in ceiling of Room B-5 of auxiliary building. Water was slowly dripping down the outside surface of the pipe during the inspection.

Recommendation: The condition was noted on the 79-foot level site inspection map and will be checked during future inspections. PPS personnel were informed of the condition following the inspection.

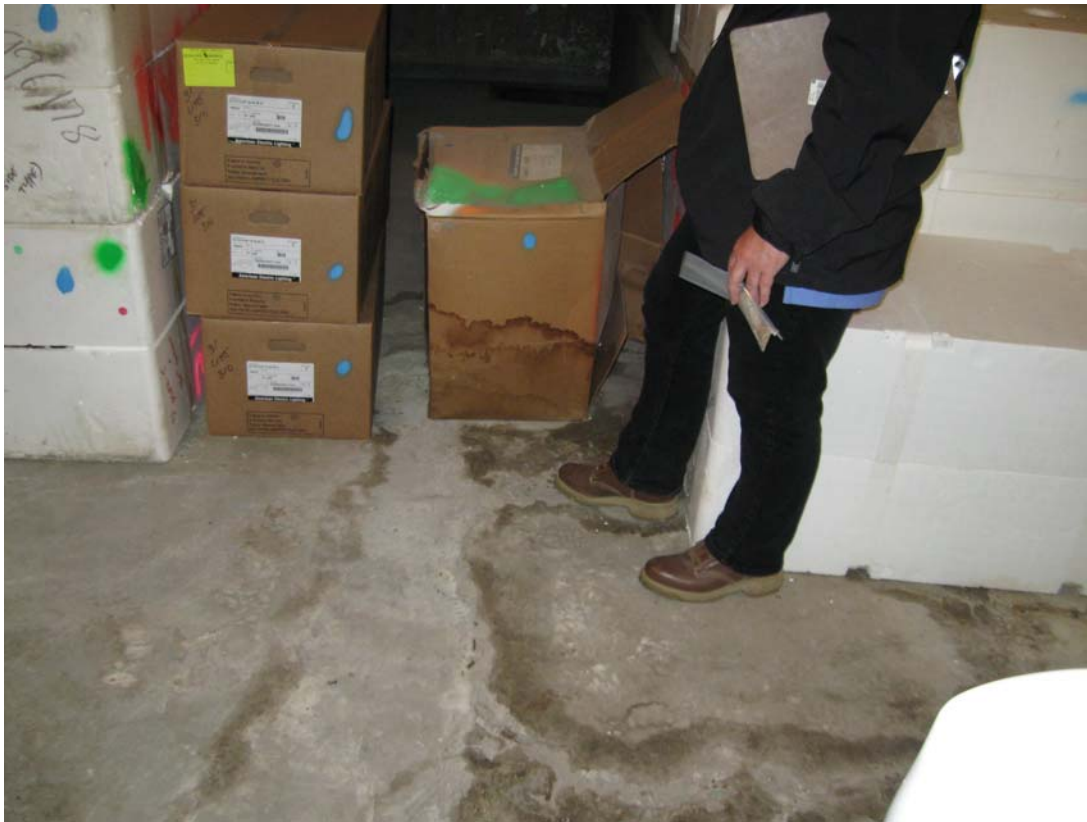
PIQ 4/2010. PL-9. Water stains on the floor of Room B-5 of auxiliary building: 79-foot level.
Water staining on boxes in background.

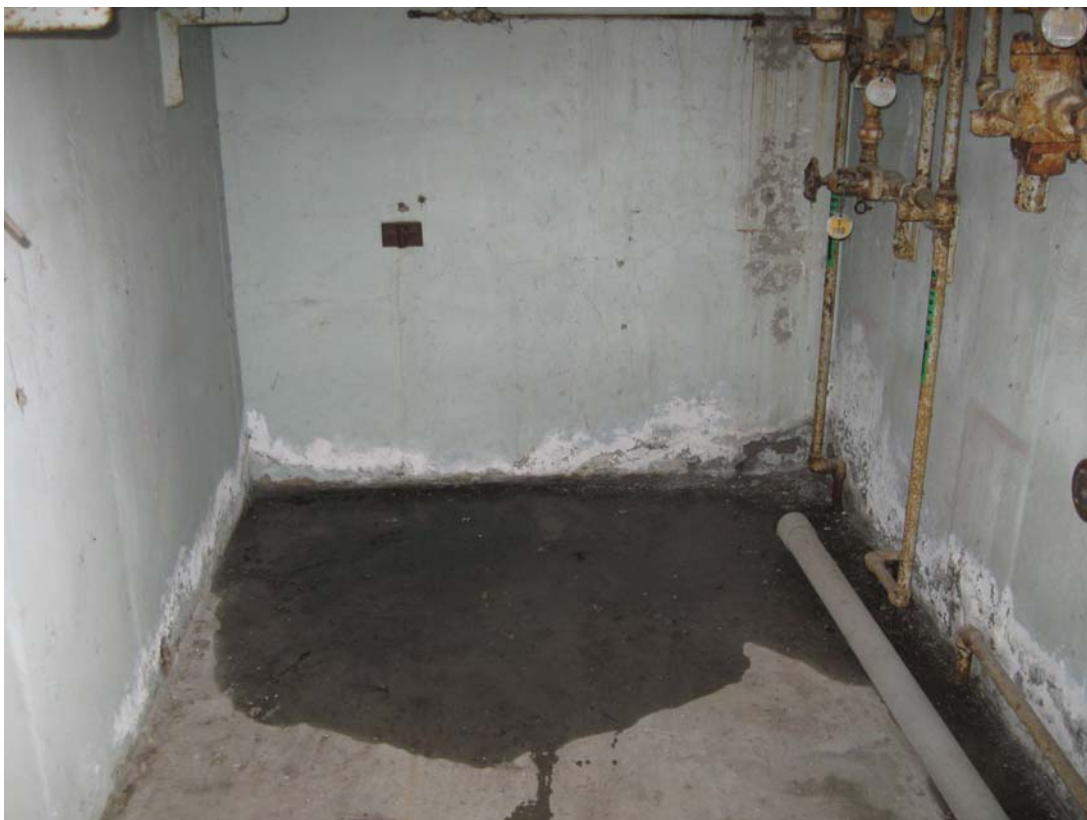
100-foot level: Water was observed on the floor of Room 125 (PL-10). This room is an outside room off the loading dock. It is no longer used by PPS and is kept locked. Water staining is present along the wall in the back corner of the room (PL-11) as well as around a vent in the ceiling of the room (PL-12). Water was ponded on the corner of the roof above this room; all around the ceiling vent (PL-13). Damage to the outside corner of the room was also observed (PL-14). This damage may be contributing to the water seen inside the room. It is recommended that the outside corner of the room be repaired to minimize further deterioration that might be caused by water/ice interactions. It is further recommended that the reason why water is ponding and not properly draining from the corner of the roof above Room 125 be determined and corrected.

4. Water was observed on the floor of Room-125 (PL-10). This room is an outside room off the loading dock. It is no longer used by PPS and is kept locked. Water was ponded on the corner of the roof above this room, all around the ceiling vent (PL-13). Damage to the outside corner of the room was also observed (PL-14) (page 3).

PIQ 4/2010. PL-10. Water present on floor of Room 125, off the outside loading dock: 100-foot level.

Recommendation: It is recommended that the outside corner of the room be repaired to minimize further deterioration that might be caused by water/ice interactions. It is further

recommended that the reason why water is ponding and not properly draining from the corner of the roof above Room-125 be determined and corrected. PPS personnel were informed of the condition following the inspection.

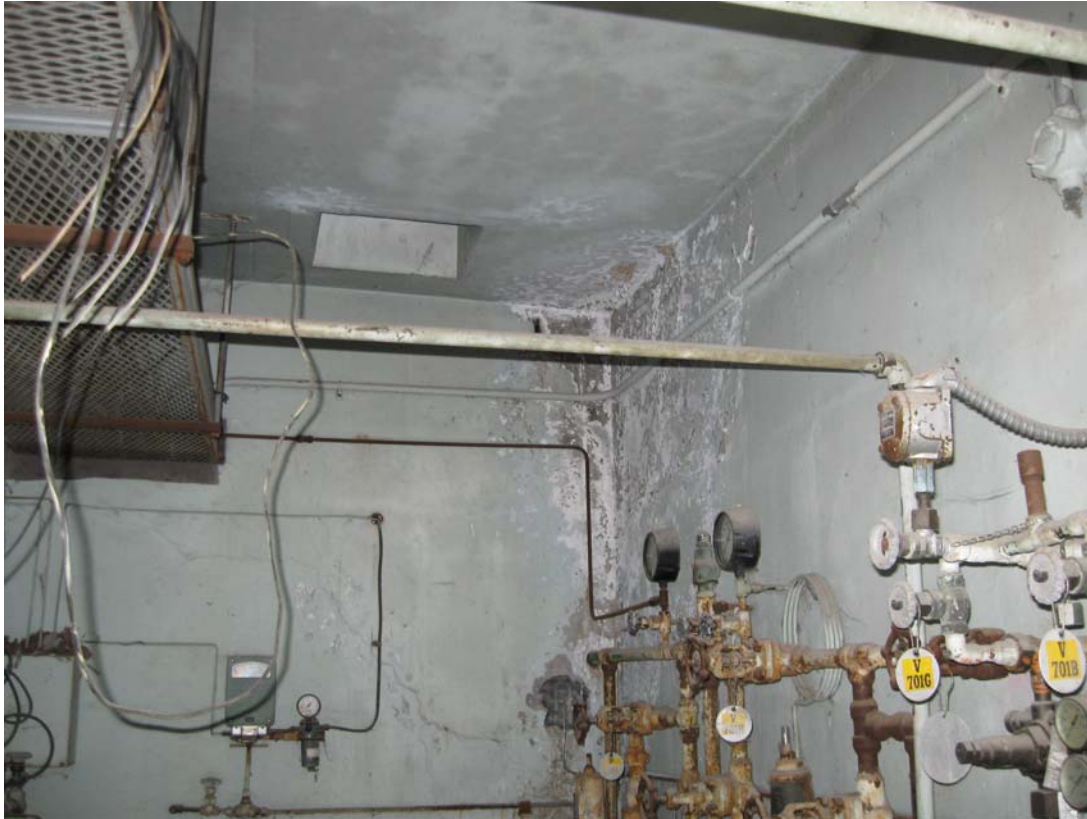
PIQ 4/2010. PL-11. Water appears to be leaking down the back corner of Room 125.

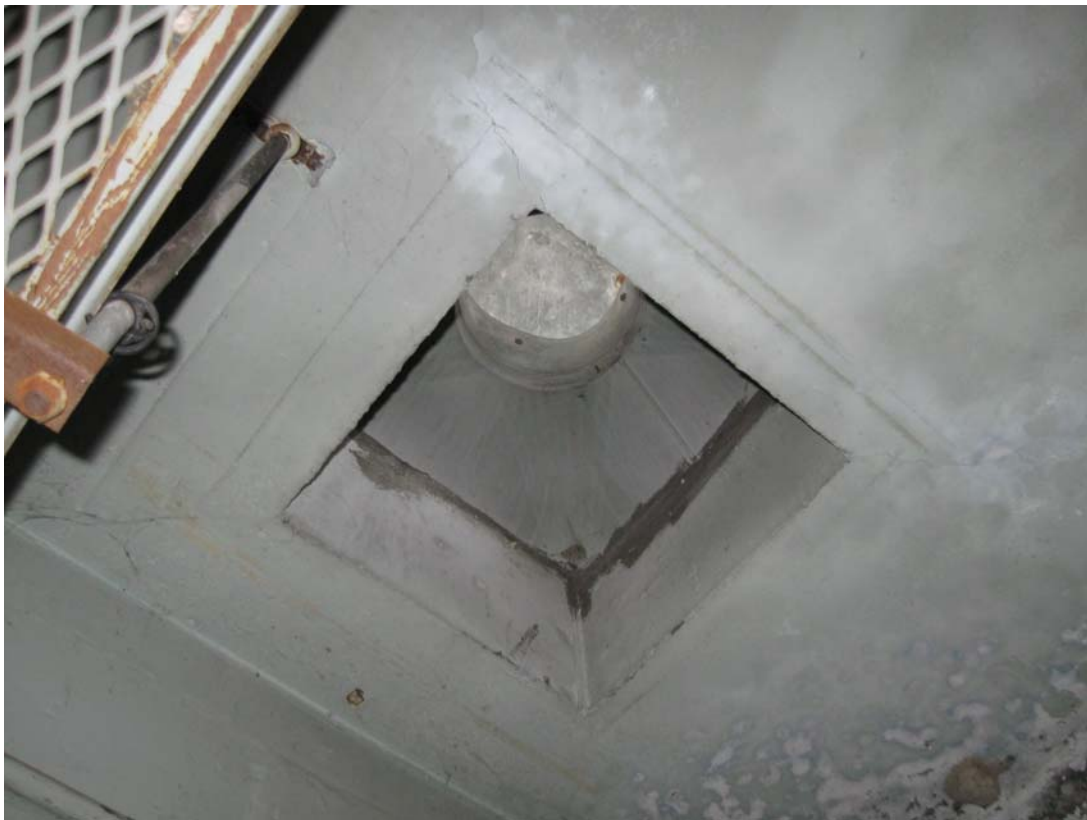
PIQ 4/2010. PL-12. Water noticeable around air vent in ceiling of Room 125: 100-foot level.

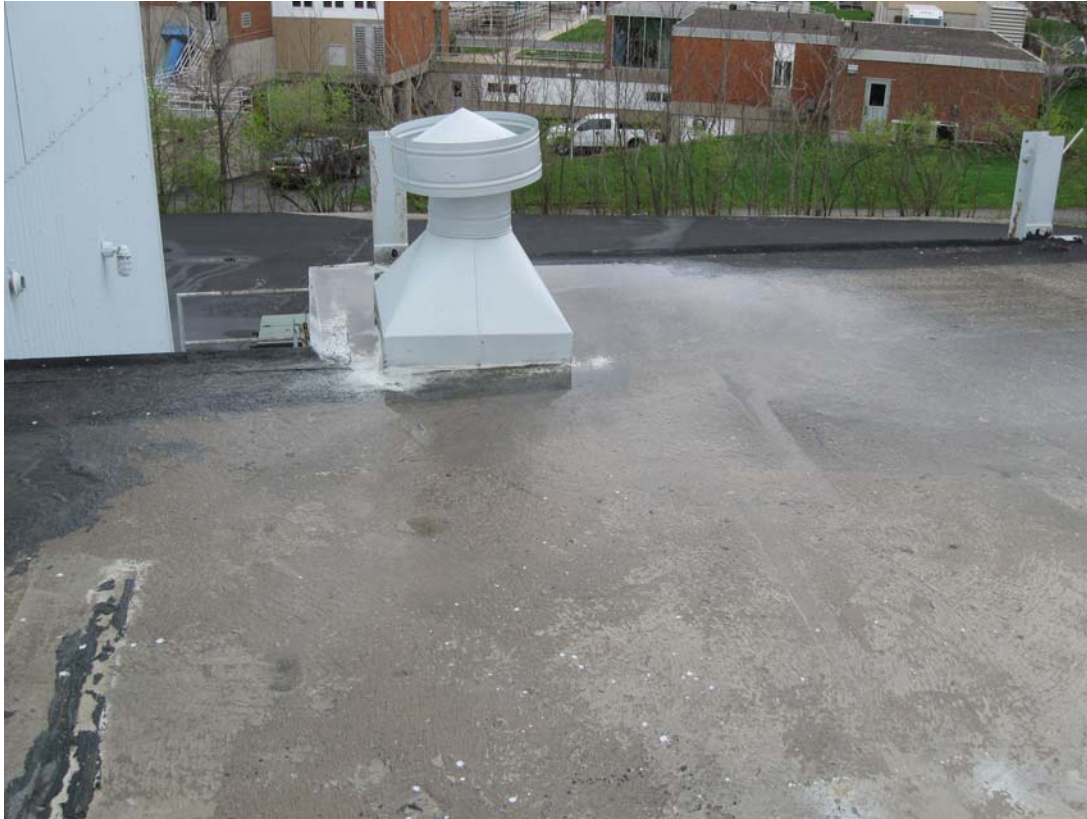
PIQ 4/2010. PL-13. Roof above Room 125. Water collected in corner. Corner of roof not draining properly.

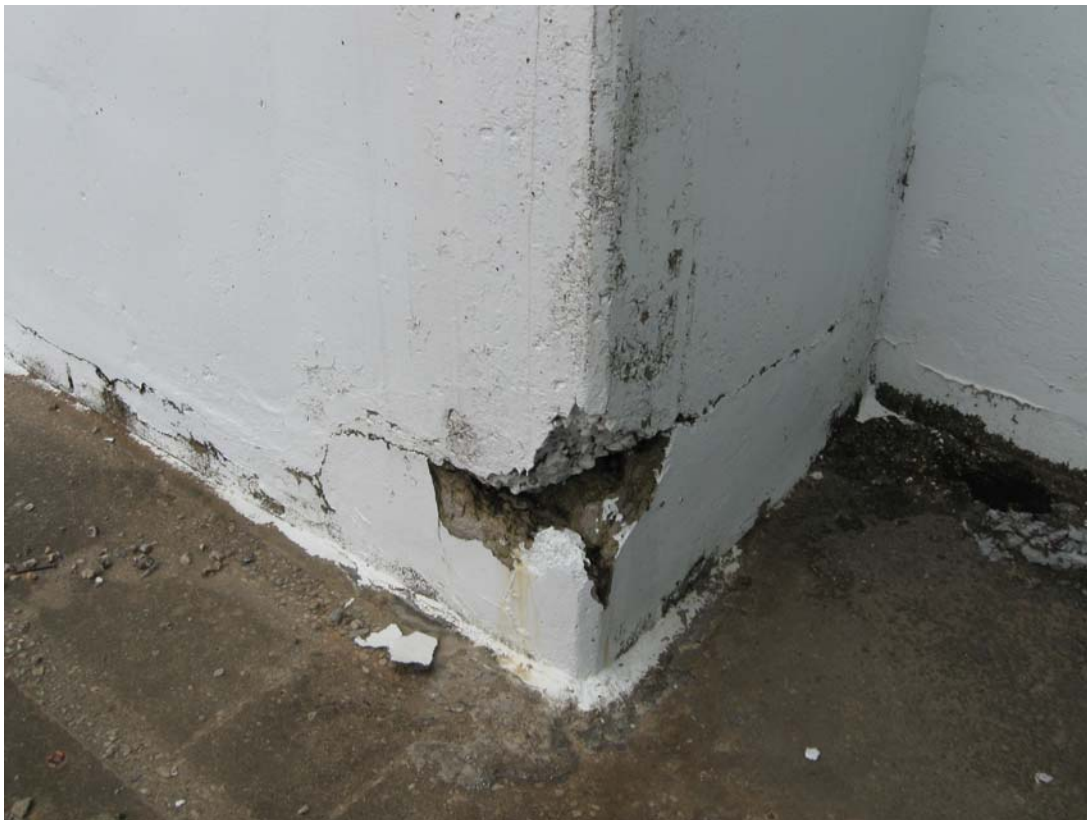
PIQ 4/2010. PL-14. Concrete damage on outside corner of Room 125: 100-foot level.

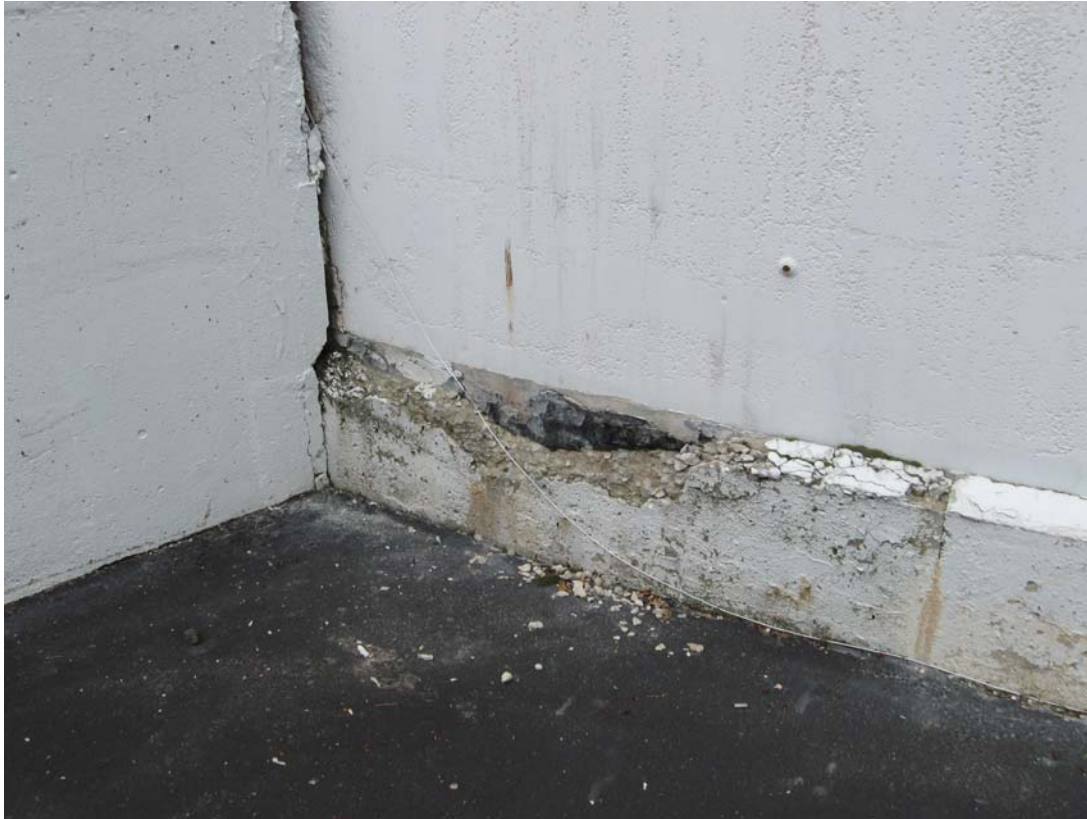
The concrete around the base of the outside wall of the containment structure is cracking in several places (PL-15, PL-16, and PL-17). The cracks are allowing water to enter, freeze and expand, and further damage the concrete. It is recommended that the cracks be repaired and any damaged concrete areas be patched while the damage is still minor to avoid larger problems and repair costs in the future. PPS personnel were informed of the finding following the inspection.

5. The concrete around the base of the outside wall of the containment structure is cracking in several places (PL-15, PL-16, and PL-17). The cracks are allowing water to enter, freeze and expand, and further damage the concrete (page 3).

PIQ 4/2010. PL-15. Concrete damage around base of containment building. Water is seeping into small crack at base of building and impacting concrete.

Recommendation: It is recommended that the cracks be repaired and any damaged concrete areas be patched while the damage is still minor to avoid larger problems and repair costs in the future. PPS personnel were informed of the condition following the inspection.

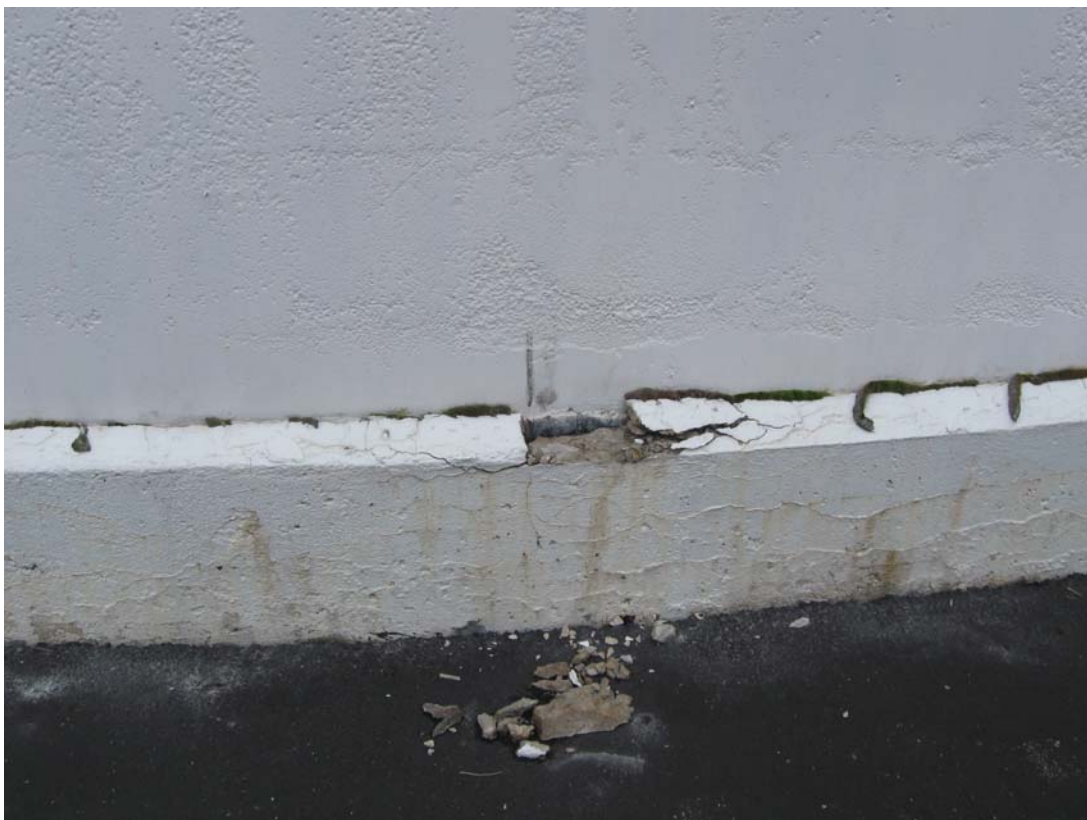
PIQ 4/2010. PL-16. Concrete damage around the base of containment building. Water is seeping into small crack at base of building and impacting concrete.

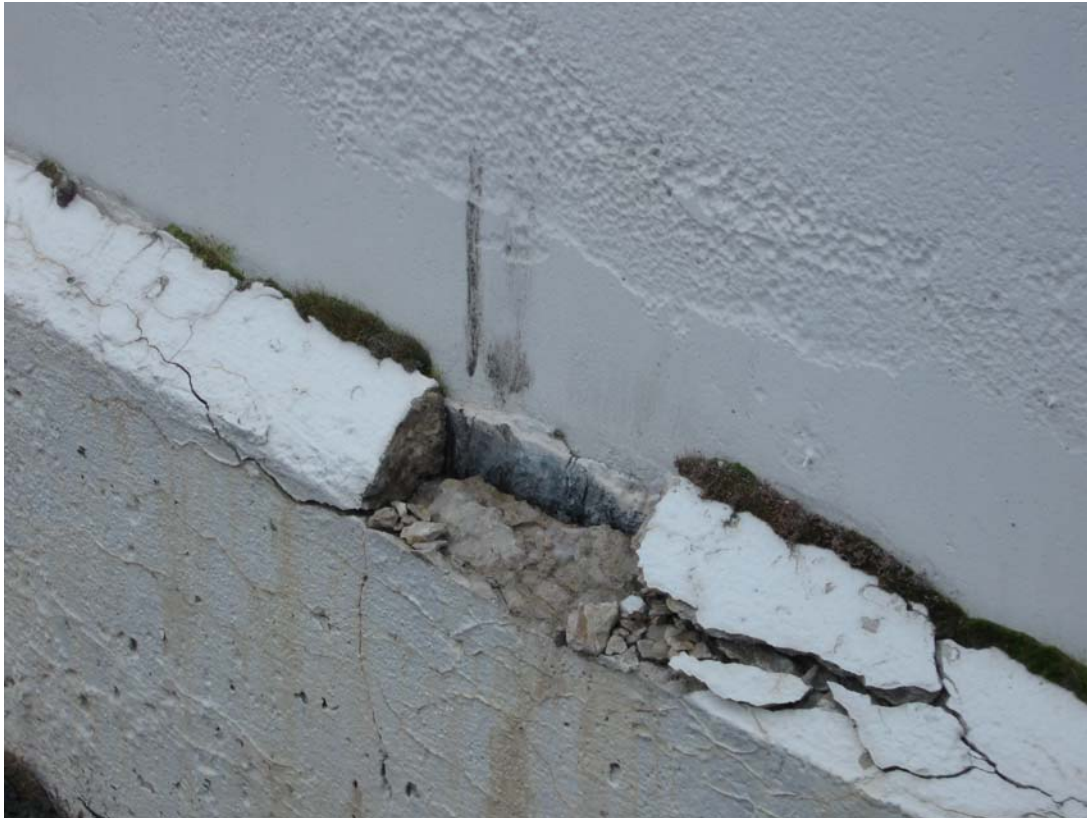
PIQ 4/2010. PL-17. Damaged concrete around base of containment dome. Top seam needs to be cleaned out and weatherproofed to keep water from causing further damage.
