# **2011 Annual Inspection and Radiological Survey Results for the Piqua, Ohio, Decommissioned Reactor Site**

The former Piqua Nuclear Power Facility (PNPF), a decommissioned nuclear power demonstration facility, was inspected on April 6, 2011. The site, located on the east bank of the Great Miami River in Piqua, Ohio, was in good physical condition. There is no requirement for a follow-up inspection.

ANNUAL INSPECTION CONDUCTED  
APRIL 6, 2011

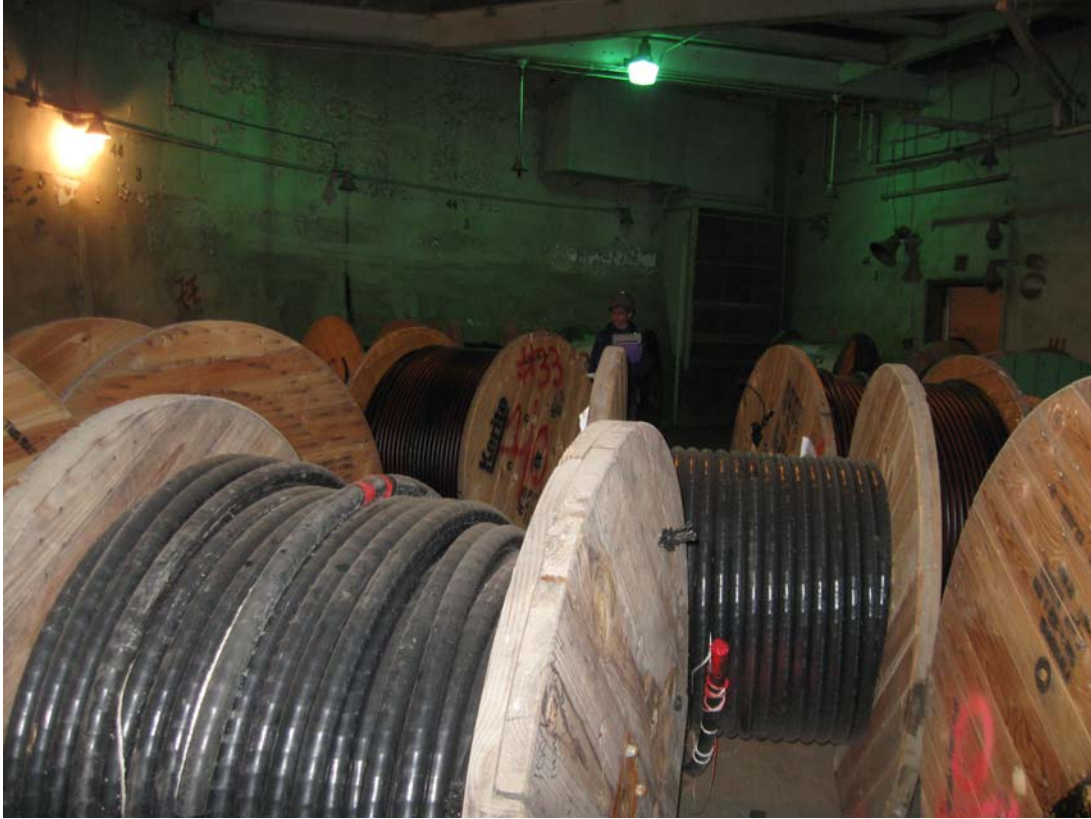
56 foot level: The 56-foot level is the lowest level of the facility. It is used to store cable spools (PL-1). The condition of peeling paint on the interior walls of the containment building remains unchanged from the 2010 inspection. Peeling paint (that is falling onto the floors) was analyzed in 2006 and found to contain 0.35 percent lead. The paint will probably continue to peel and fall to the floor. Inspectors are not exposed to unacceptable risk when performing routine inspection activities. Piqua personnel are aware of the presence of the lead-based paint.

PIQ 4/2011. PL-1. Cable spools stored on 56-foot level of containment structure.

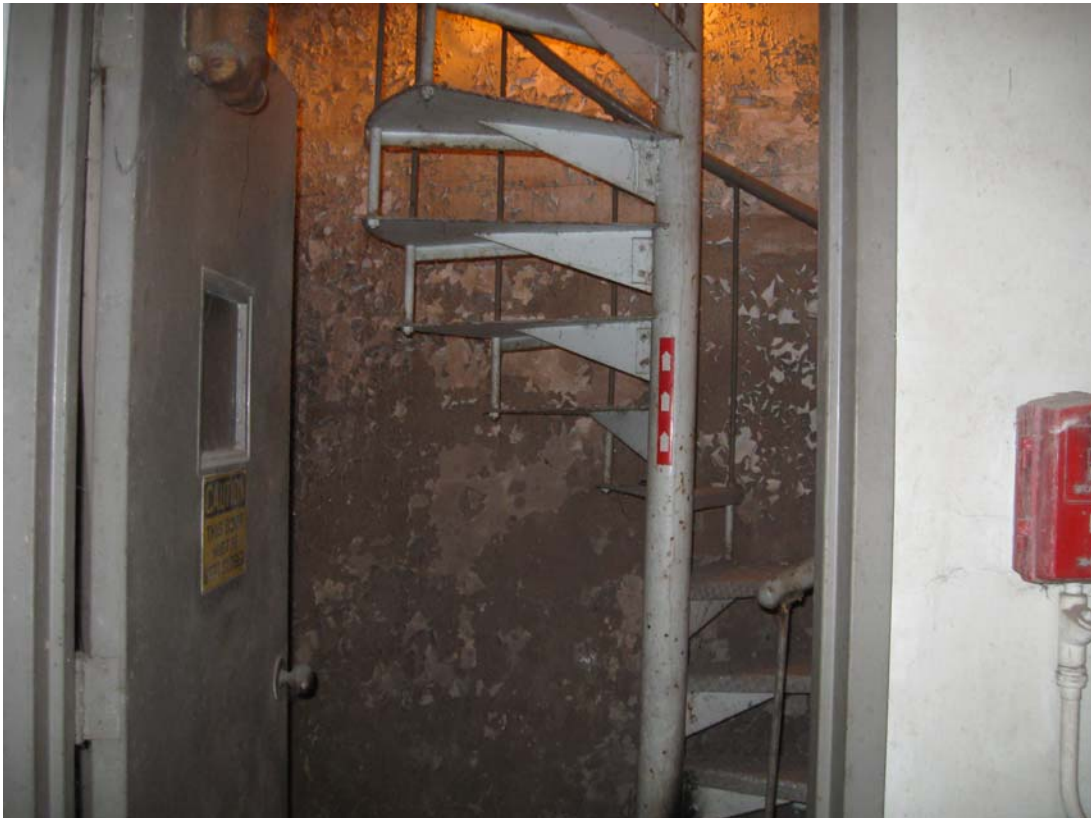
A spiral staircase is present in the containment structure (PL-2). Plaster is falling off the walls of the staircase enclosure and cable spools have rolled into the wall damaging the plaster at the entrance to the spiral staircase on the 56-foot level. This damage has been noted in previous inspection reports.

PIQ 4/2011. PL-2. Base of spiral staircase.

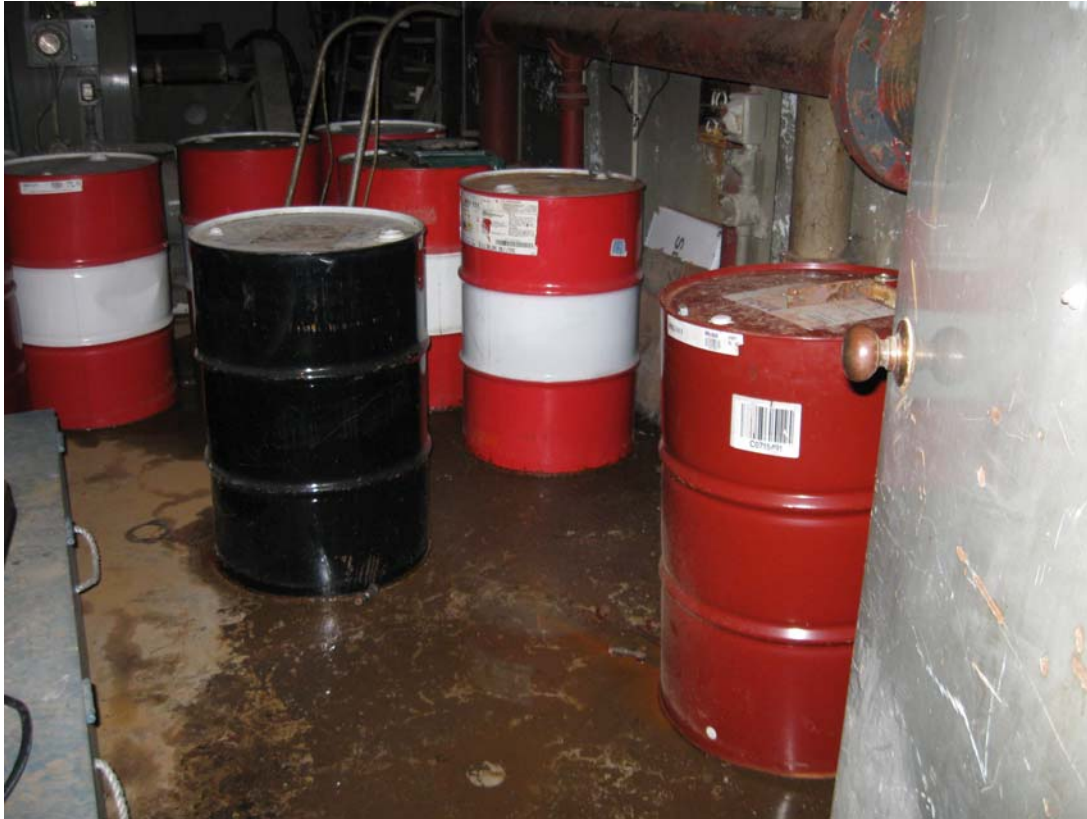
Room B-3 was not accessible due to the presence of approximately ½ inch of water on the floor (PL-3). Heavy rains occurred just prior to the inspection. It appears that ponded water next to the outside wall of the building managed to seep into the building. PPS personnel were unaware of the water and stated that they would determine the cause and correct the situation. A follow-up inspection is not required. Gamma readings could not be obtained in Room B-3 during this year's inspection due to the water. Previous year's results from this room have been below the minimum detectable level (MDA).

PIQ 4/2011. PL-3. Water on floor of Room B-3.

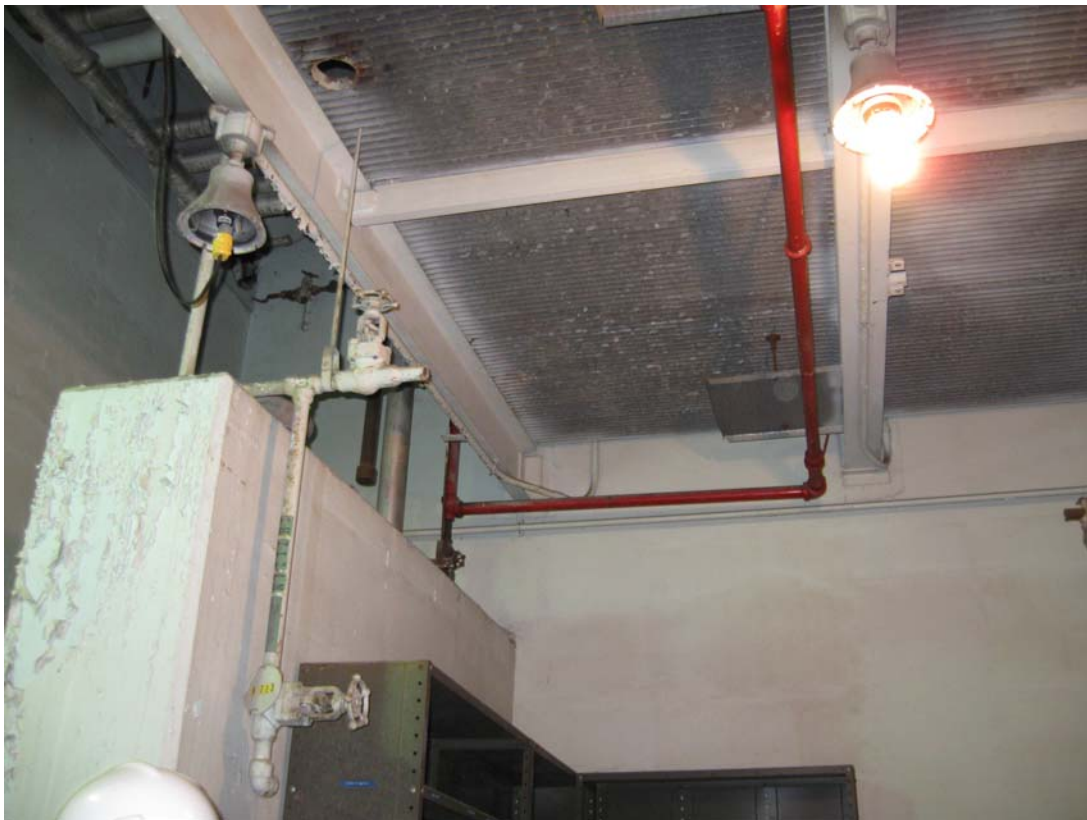
During the 2010 inspection water was observed to be slowly dripping down the outside surface of an aged sprinkler system pipe on the ceiling of Room B-5. The sprinkler system was no longer in use, so Piqua personnel removed it from the roof (PL-4).

PIQ 4/2011. PL-4. Old pipes from sprinkler system removed.

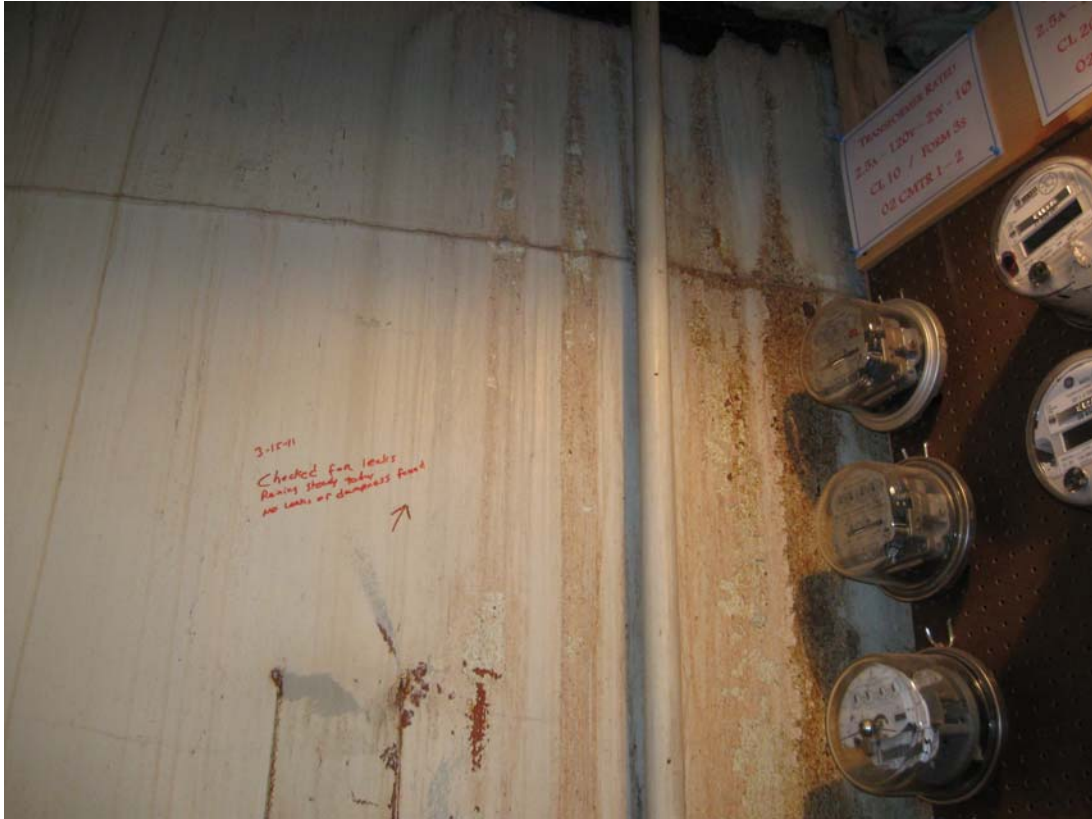
Fresh water stains were noted on the wall of Room B-5 by Piqua personnel since the last inspection (PL-5). Piqua personnel reported that repairs were made to the outside seam of the roof just above the water stains (PL-6). Despite the heavy rain just prior to the inspection, inspection personnel did not notice any water dripping down the wall in the area of the stains, but water was observed on the floor of Room B-5 near the stained walls (PL-7). The areas with water on the floor are identified on the inspection maps and will be checked again next year.

PIQ 4/2011. PL-5. Fresh water stains on wall of Room B-5.

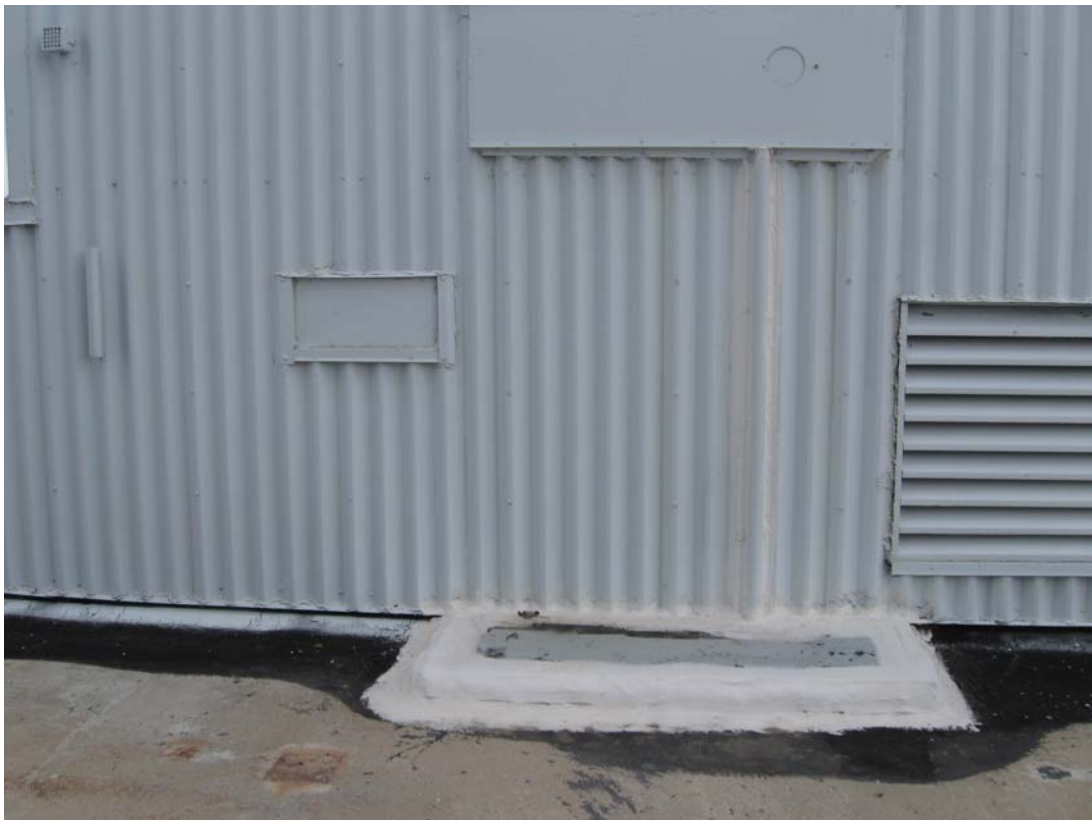
PIQ 4/2011. PL-6. Repair to roof. Above fresh water stains on wall of Room B-5.

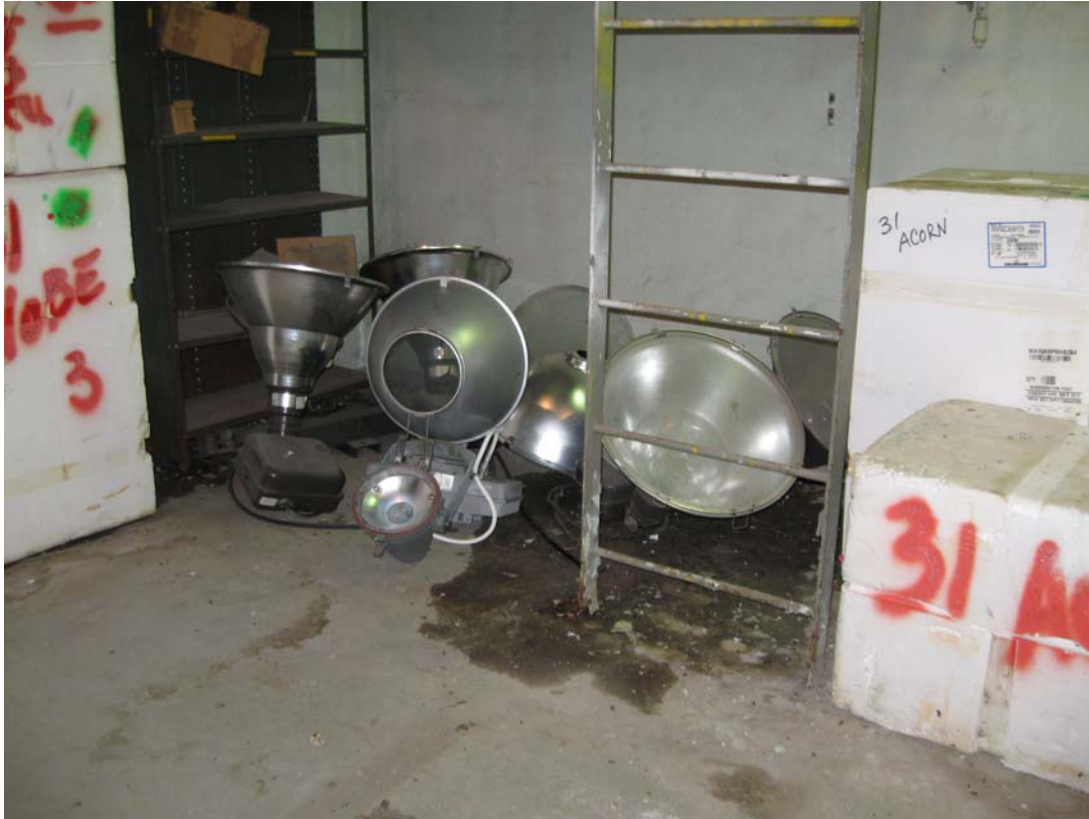
PIQ 4/2011. PL-7. Water of floor of Room B-5.

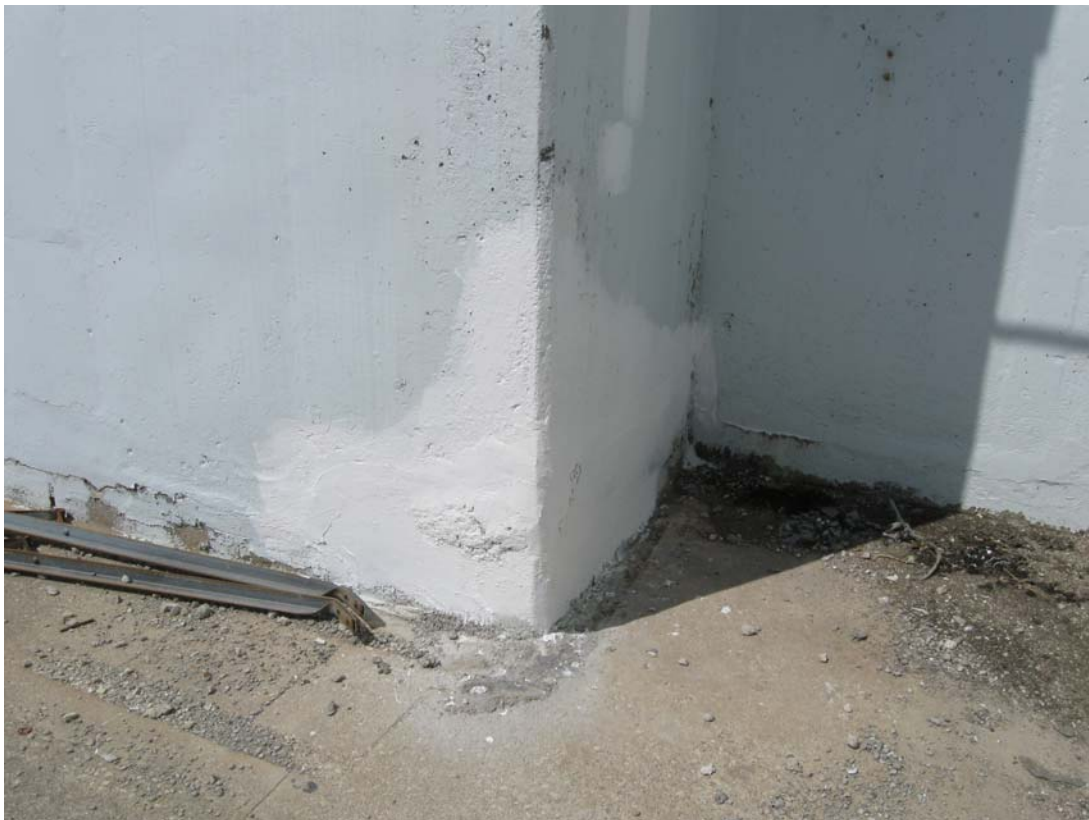
100 foot level: During the 2010 inspection, the roof above Room 125 had ponded water and was not properly draining, water was observed on the floor of Room 125, and the outside corner of the room was damaged. Room 125 is accessed from the loading dock. It is no longer used by Piqua personnel and is kept locked. Piqua personnel repaired the outside corner of the room (PL-8) and corrected the roof drainage problem above the room (PL-9). A small amount of water was present on the floor of Room 125 during this year's inspection. The area with the water on the floor has been noted on the inspection maps and will be checked again next year.

PIQ 4/2011. PL-8. Repairs made to corner of Room 125.

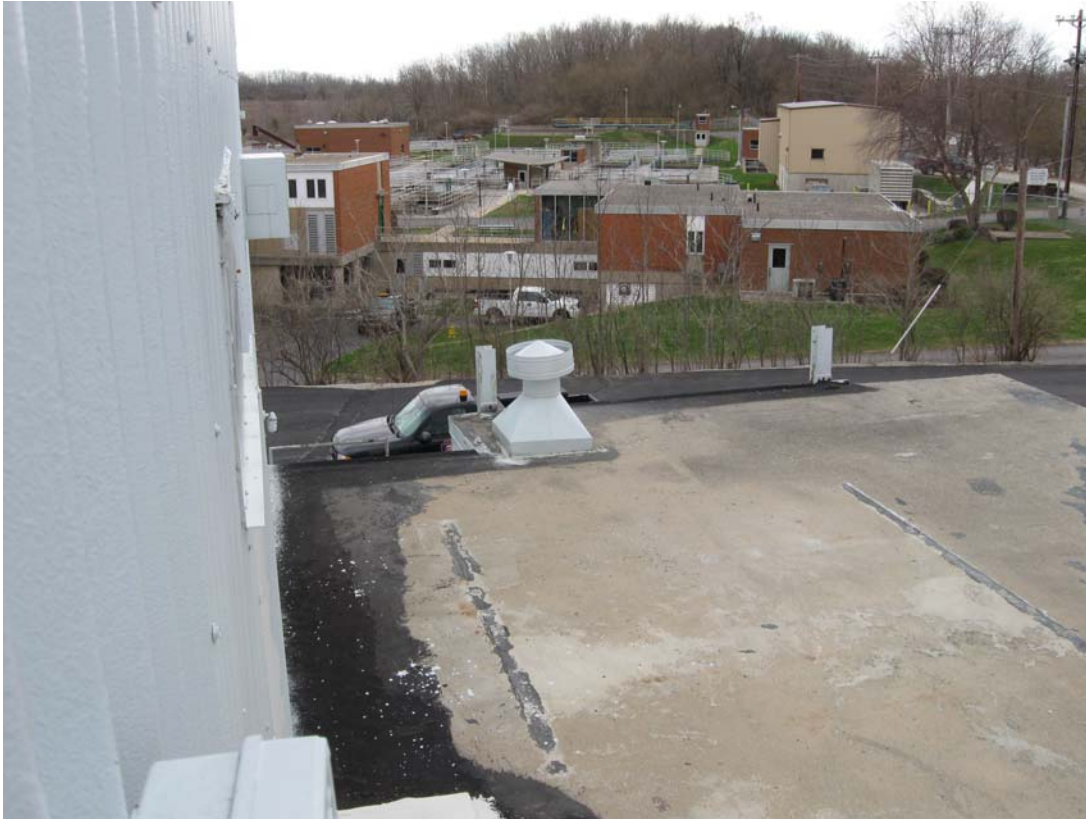
PIQ 4/2011. PL-9. Repair made to corner of roof above Room 125. Water no longer ponding on area of roof.

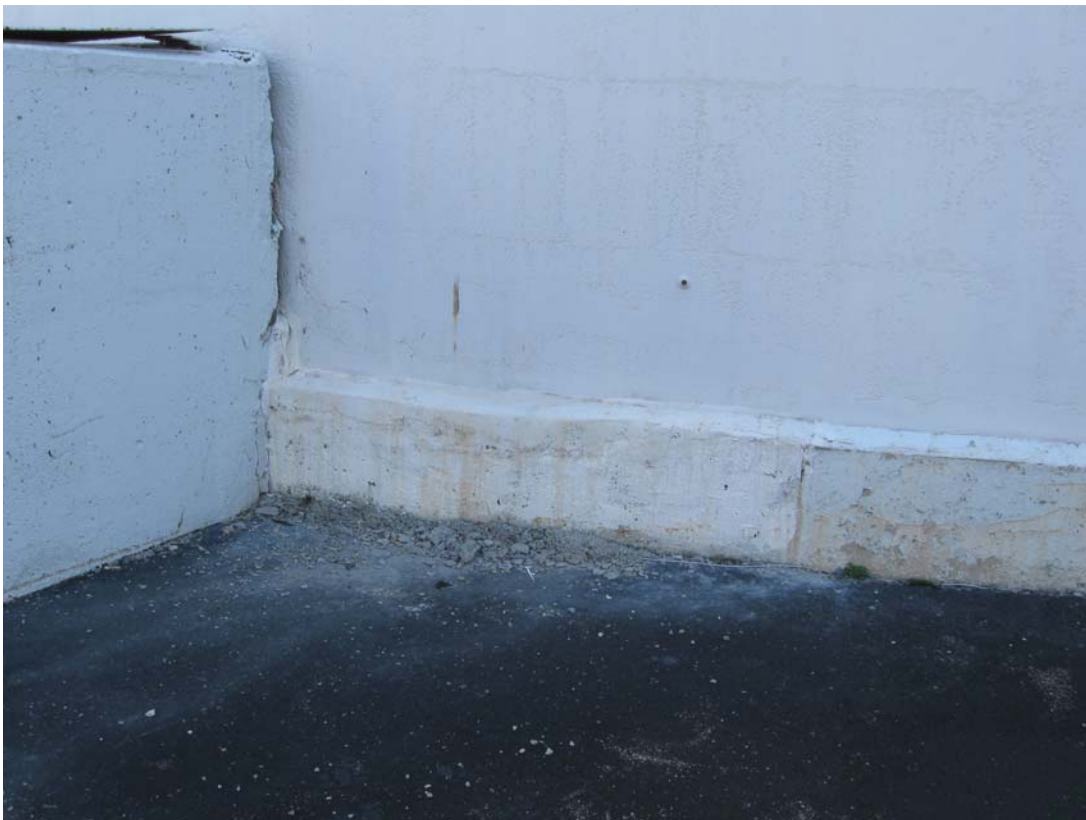
During the 2010 inspection, the concrete around the base of the outside wall of the containment structure was cracking in several places. The cracks appeared to be allowing water to enter, freeze and expand, and further damage the concrete. Piqua personnel sealed the cracks and repaired the damaged concrete (PL-10). Also during the 2010 inspection, a marked emergency exit was found to be blocked by some boxes. PPS personnel moved the boxes that were blocking the exit. No further action is required.

PIQ 4/2011. PL-10. Repair made to concrete at base of containment dome.

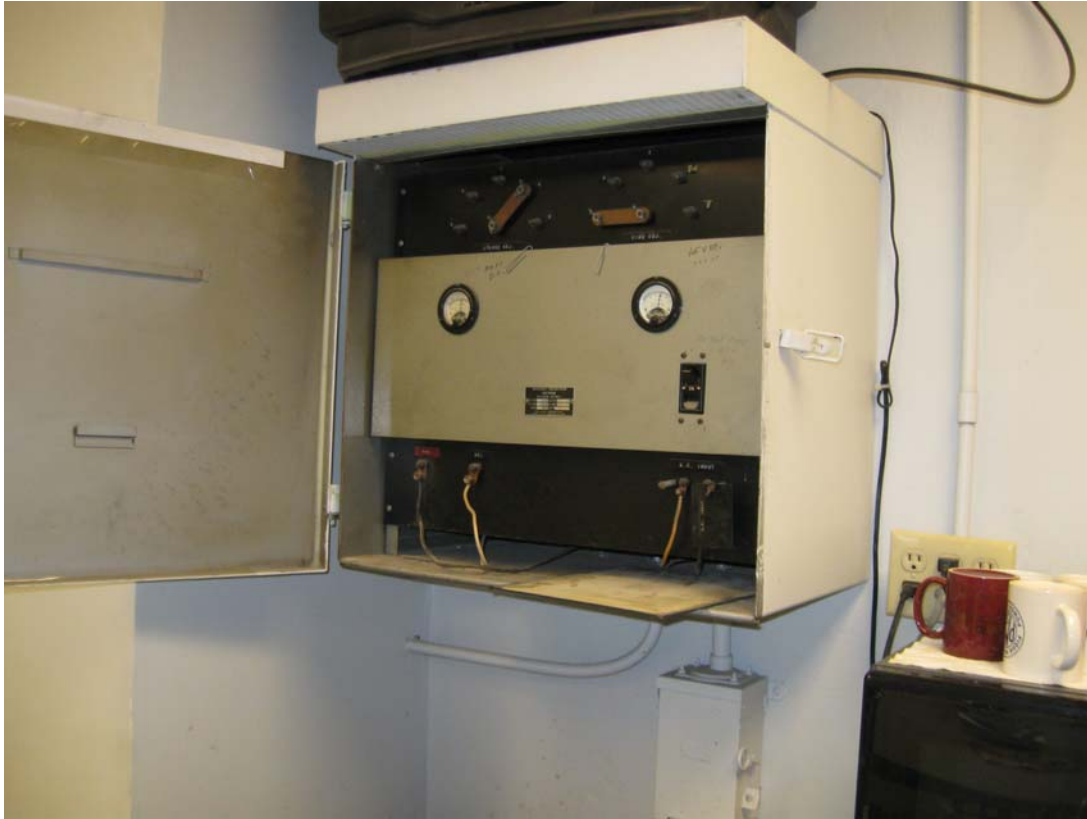
The entire system was checked by a qualified service provider in April 2010, resulting in the replacement of one of the header cables. According to the maintenance log kept with the unit, the system is being checked by plant personnel, but 4 of the last 12 monthly log entries were missing. Piqua plant personnel were notified of the missing log entries.

PIQ 4/2011. PL-11. Rectifier Unit Control Box.

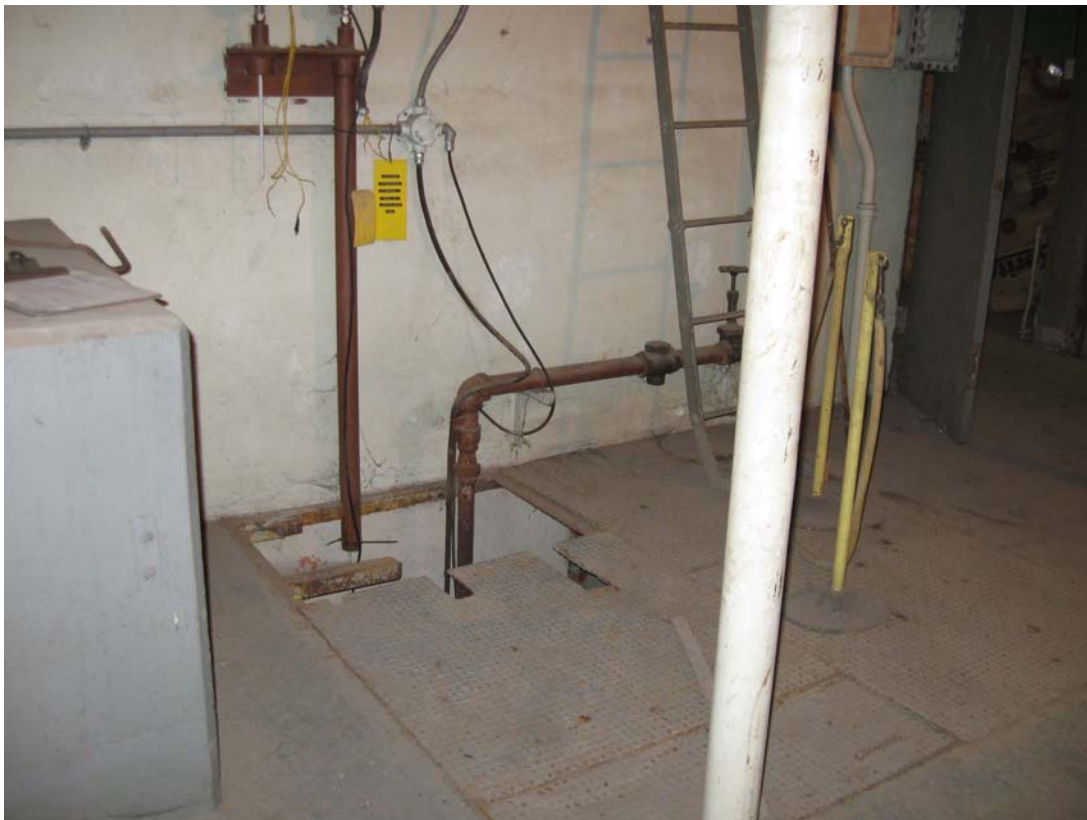
An alarm system is installed in the sump on the 56-foot level to detect high water levels before they rise to the bottom of the pressure vessel (PL-12). This system is designed to prevent immersion and accelerated corrosion of the pressure vessel. The alarm triggers when the sump fills to near overflow, alerting personnel to both high water and possible sump pump failure. The alarm registers in the auxiliary building on the Supervisory Control and Data Acquisition system, which is monitored 24 hours a day by an operator. The alarm system is included in the monthly building inspection. The reactor sump alarm test log indicates that the alarm is being tested monthly, but the entry for the February 2011 check was missing from the log. Piqua plant personnel were notified of the missing log entry. Very little water was present in the base of the sump during the inspection.

PIQ 4/2011. PL-12. Sump in basement of containment structure.

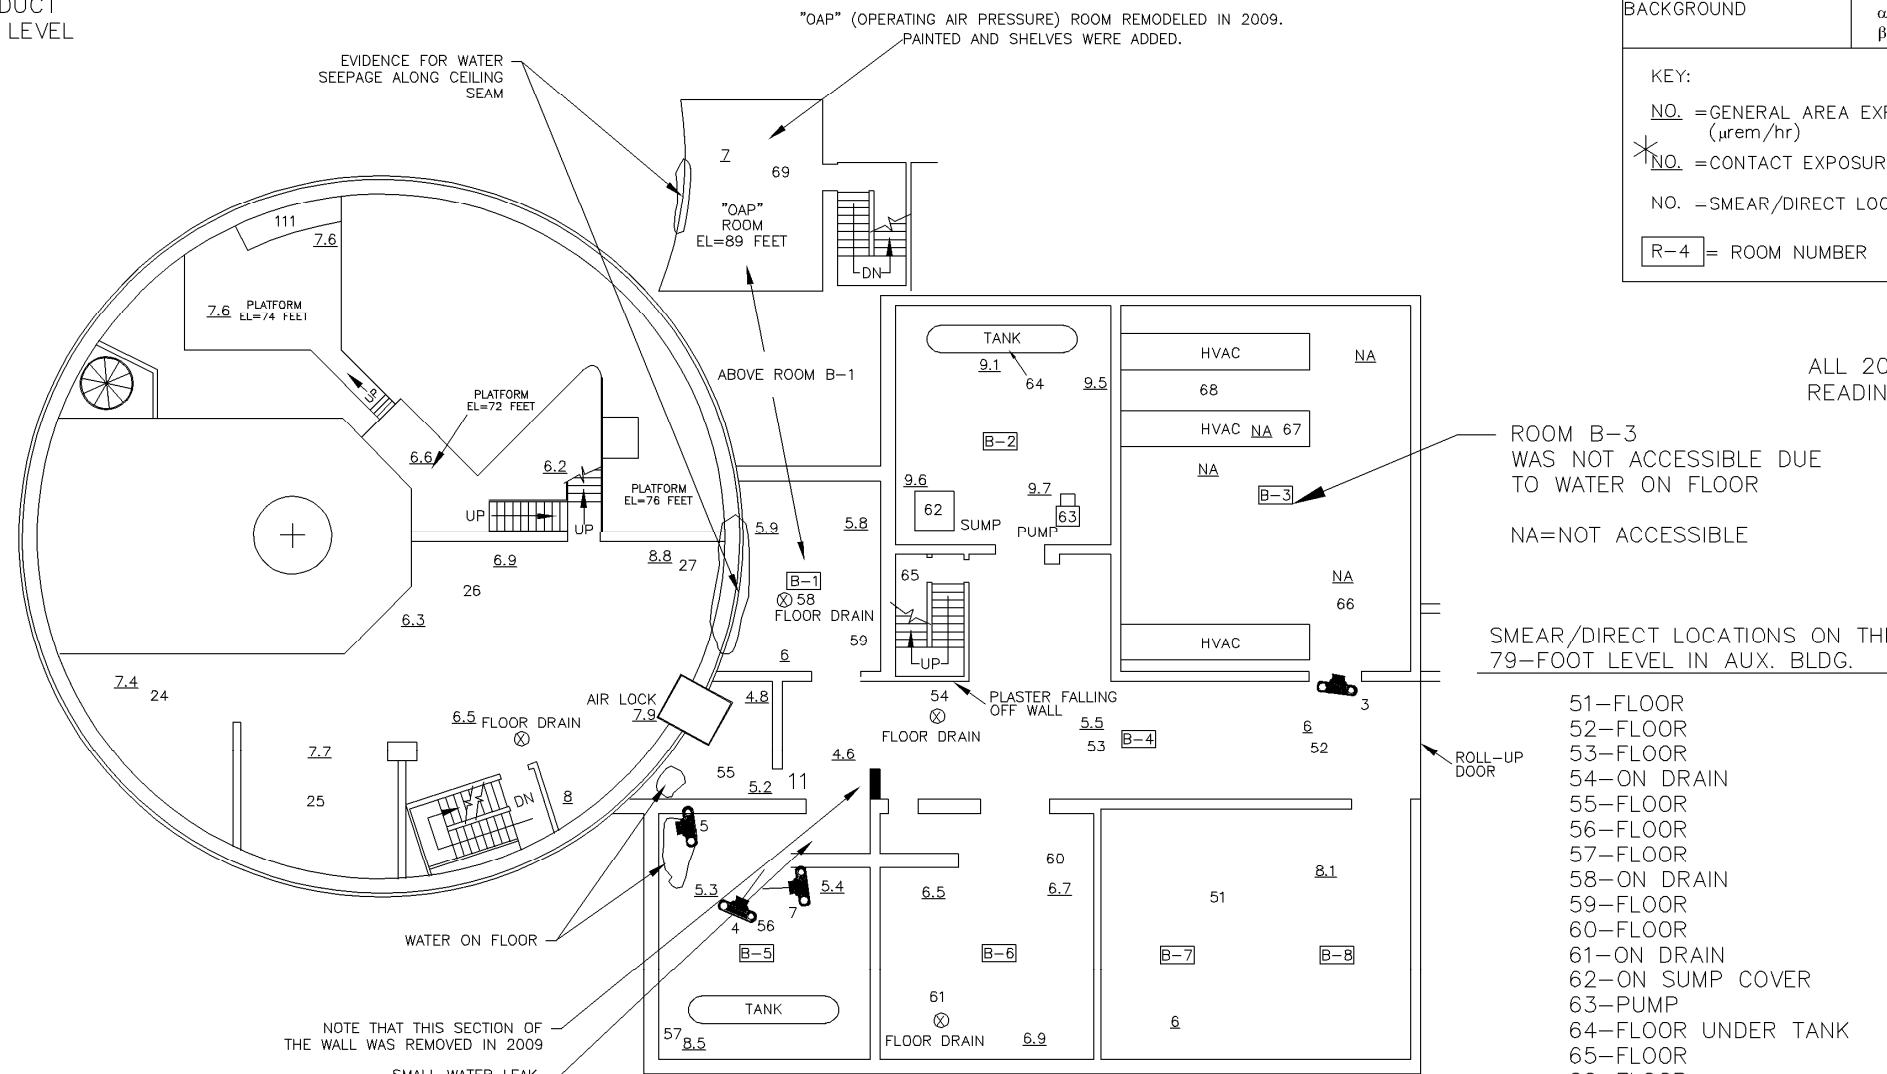
PLAN - 79 FOOT LEVEL

ROOM B-3 WAS NOT ACCESSIBLE DUE TO WATER ON FLOOR  
NA=NOT ACCESSIBLE
