# **2013 Annual Inspection and Radiological Survey Results for the Piqua, Ohio, Decommissioned Reactor Site**

The former Piqua Nuclear Power Facility (PNPF), a decommissioned nuclear power demonstration facility, was inspected on April 18, 2013. The site, located on the east bank of the Great Miami River in Piqua, Ohio, is in good physical condition. There is no requirement for a follow-up inspection.

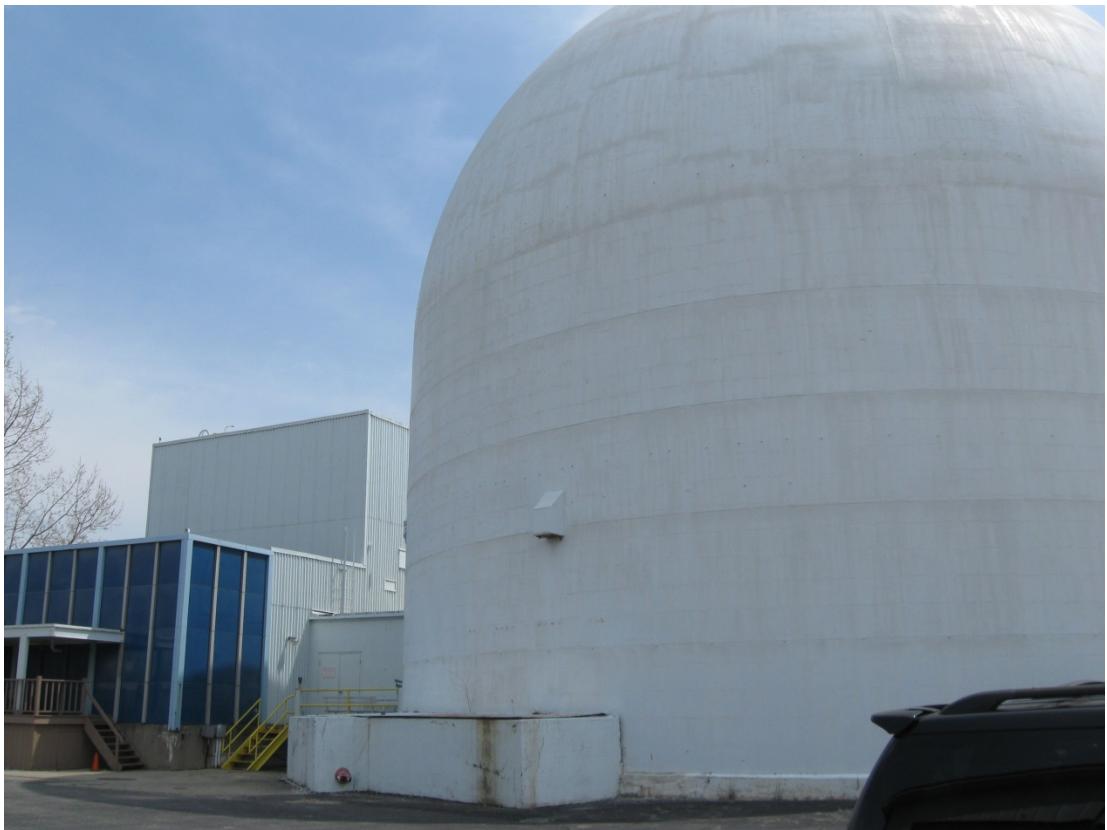
The Containment Building exterior was refurbished around 1995. The exterior of the reactor containment building was in good condition (PL-1).

PIQ 4/2013. PL-1. Exterior of the Piqua containment building.

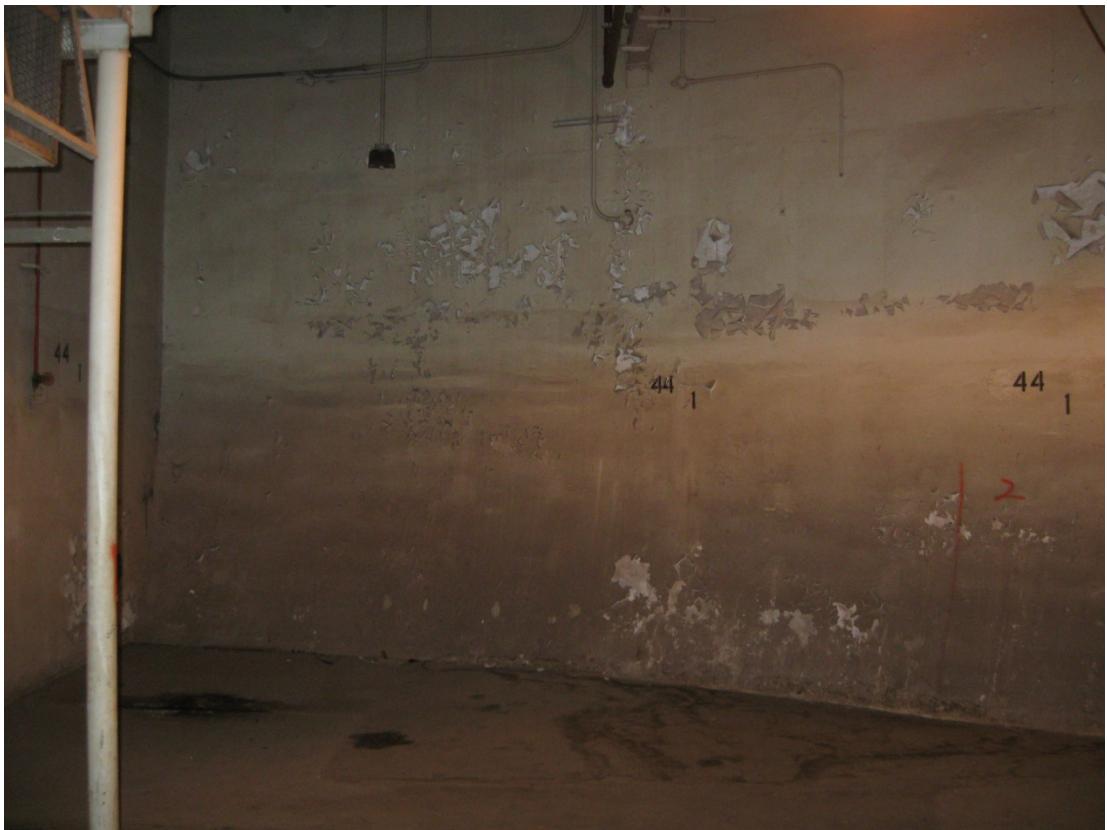
56 foot level: The 56-foot level is the lowest level of the facility. It was previously used to store cable spools. With departure of the Piqua PPS group, the level was empty. The condition of peeling paint on the interior walls of the containment building remains unchanged from the 2012 inspection (PL-2). Peeling paint (that is falling onto the floors) was analyzed in 2006 and found to contain 0.35 percent lead. The paint will probably continue to peel and fall to the floor. Inspectors are not exposed to unacceptable risk when performing routine inspection activities. Piqua personnel are aware of the presence of the lead-based paint.

PIQ 4/2013. PL-2. Peeling paint on wall of 56 foot level.

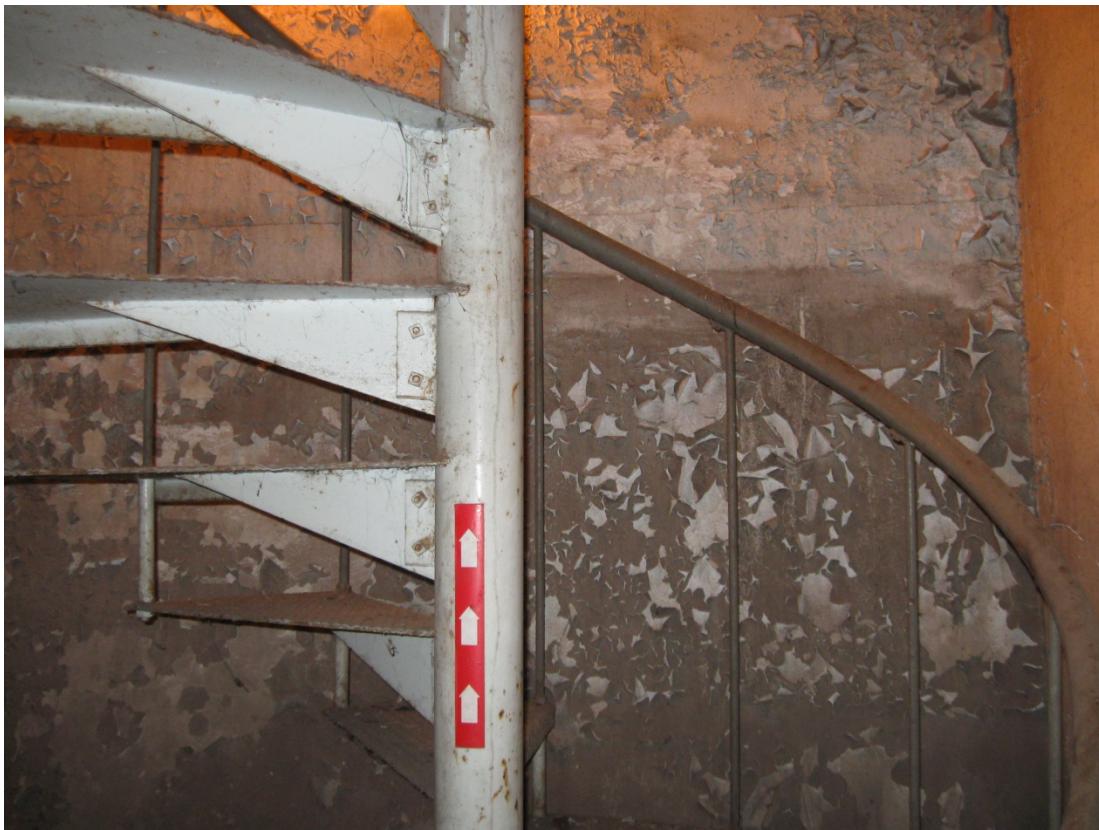
A spiral staircase is present in the containment structure (PL-3). Plaster is falling off the walls of the staircase enclosure and cable spools have rolled into the wall damaging the plaster at the entrance to the spiral staircase on the 56-foot level. This damage has been noted in previous inspection reports (PL-4).

PIQ 4/2013. PL-3. Base of spiral staircase.

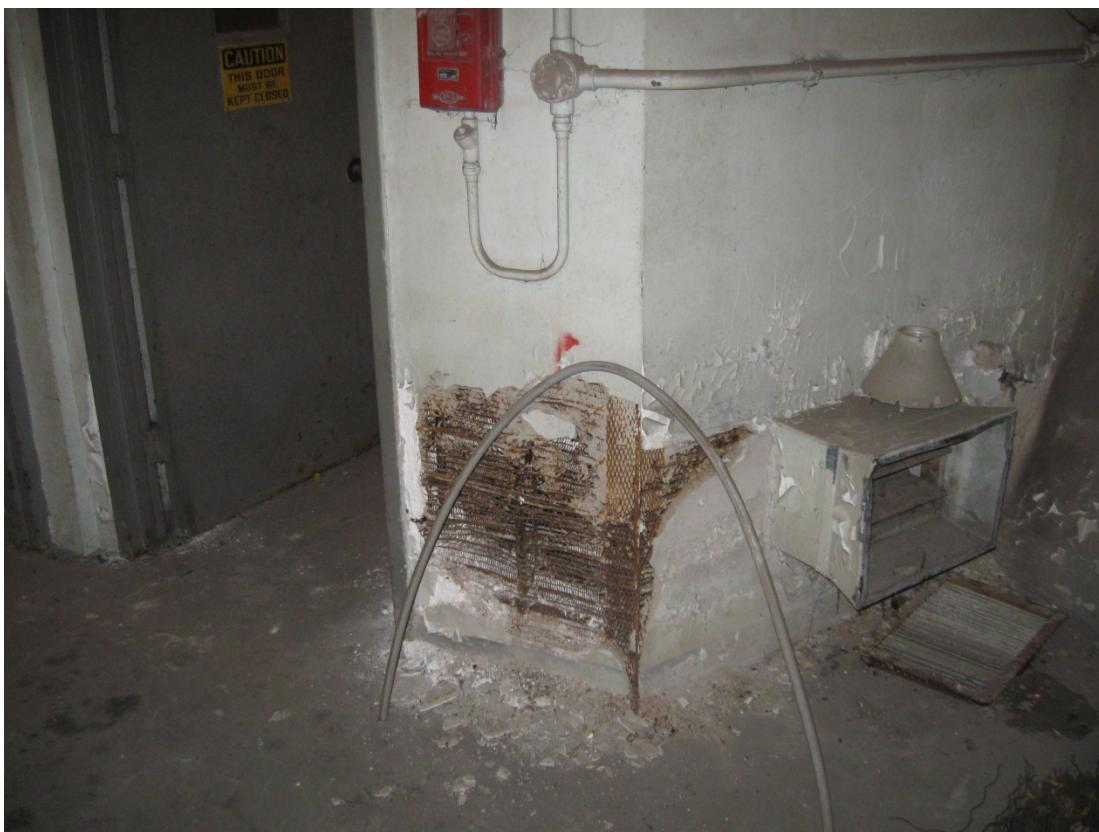
PIQ 4/2013. PL-4. Damaged wall near entrance to spiral staircase.

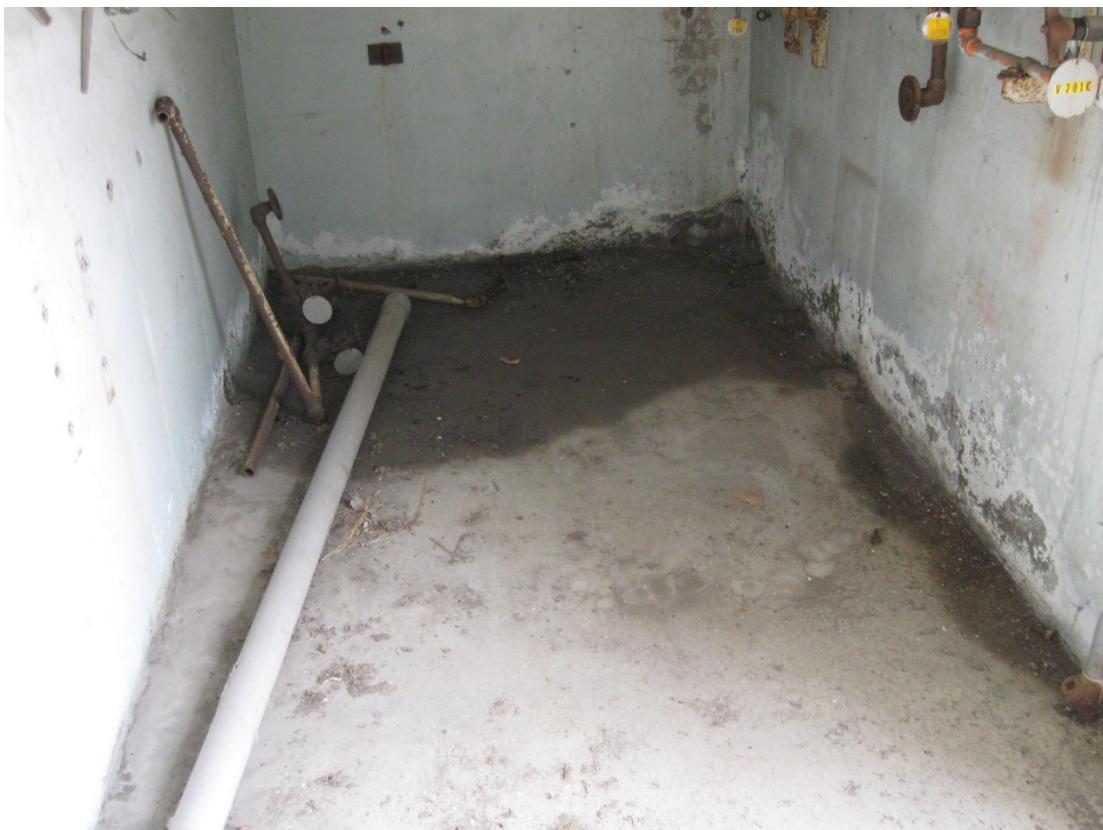
100 foot level: During the 2010 inspection, the roof above Room 125 had ponded water and was not properly draining, water was observed on the floor of Room 125, and the outside corner of the room was damaged. Room 125 is accessed off of the loading dock. It is no longer used by Piqua personnel and is kept locked. Piqua personnel repaired the outside corner of the room and

corrected the roof drainage problem above the room in 2011. The roof appears to be draining properly and no water was observed on the floor of Room 125 during this year's inspection, but the floor was damp (PL-5).

PIQ 4/2013. PL-5. Damp floor of Room 125.

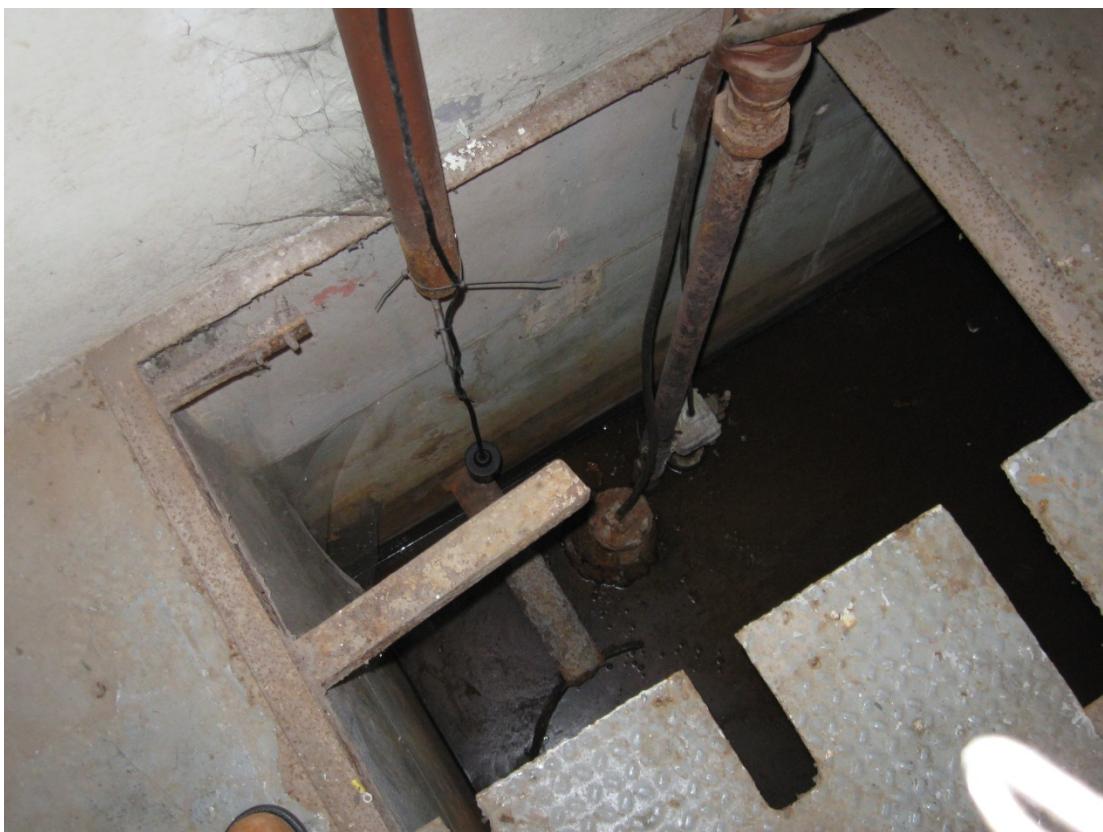
An alarm system is installed in the sump on the 56-foot level to detect high water levels before they rise to the bottom of the pressure vessel (PL-6). This system is designed to prevent immersion and accelerated corrosion of the pressure vessel. The alarm triggers when the sump fills to near overflow, alerting personnel to both high water and possible sump pump failure. The alarm registers in the auxiliary building on the Supervisory Control and Data Acquisition system, which is monitored 24 hours a day by an operator. The alarm system is included in the monthly building inspection. The reactor sump alarm test log indicates that the alarm is being tested monthly, but some monthly entries were missing from the log. Piqua plant personnel were notified of the missing log entries. Subsequent information provided by Piqua personnel indicates that the sump is being properly maintained. Very little water was present in the base of the sump during the inspection.

PIQ 4/2013. PL-6. Sump.

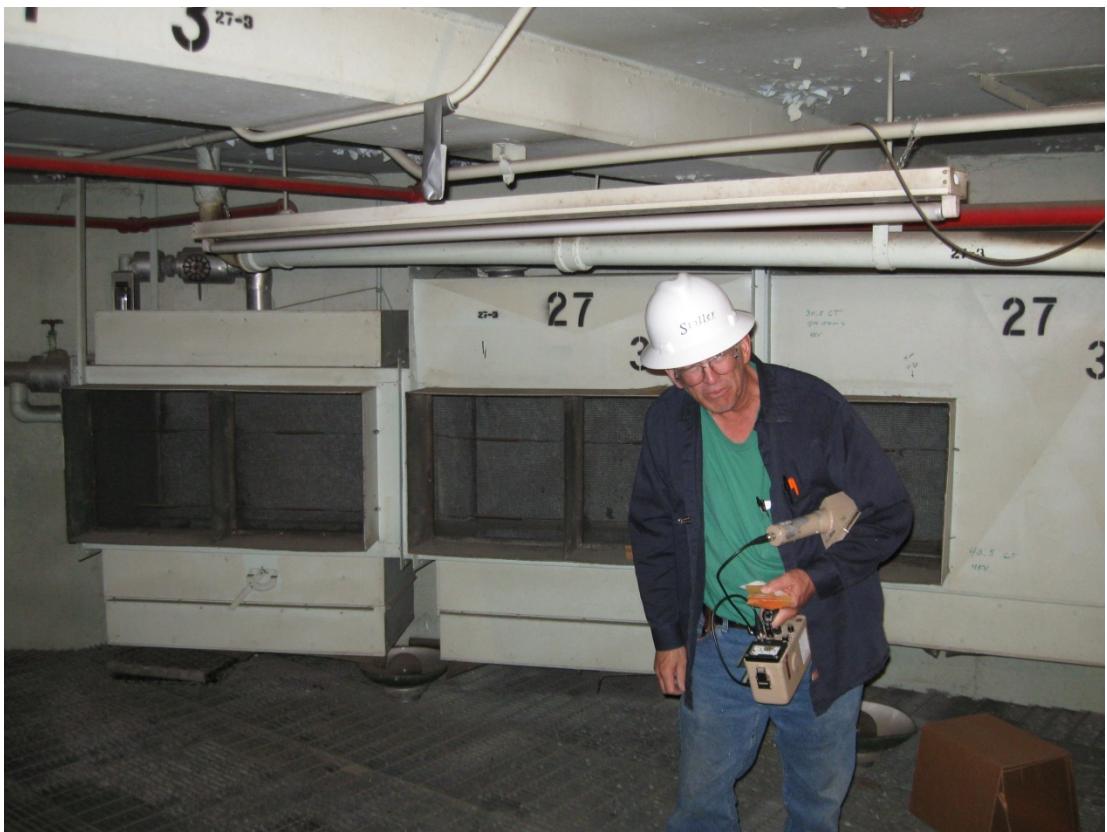
S.M. Stoller staff performed the annual radiological survey on the interior of the reactor containment building, auxiliary building, and exterior areas (PL-7). A total of 106 sample locations were checked for both removable and surface contamination using direct measurements and smears for the detection of alpha and beta-gamma activity. Gamma exposure rates also were measured. Prior to 2008, 111 sample locations were surveyed. Locations 1-5 were removed from the survey in 2008 because the HVAC equipment being sampled was removed.

PIQ 4/2013. PL-7. Rad tech conducting radiation survey.
