2014 Annual Inspection and Radiological Survey Results for the Piqua, Ohio, Decommissioned Reactor Site

Summary

The former Piqua Nuclear Power Facility (PNPF), a decommissioned nuclear power demonstration facility, was inspected on April 16, 2014. The site, located on the east bank of the Great Miami River in Piqua, Ohio, is in good physical condition. There is no requirement for a follow-up inspection.

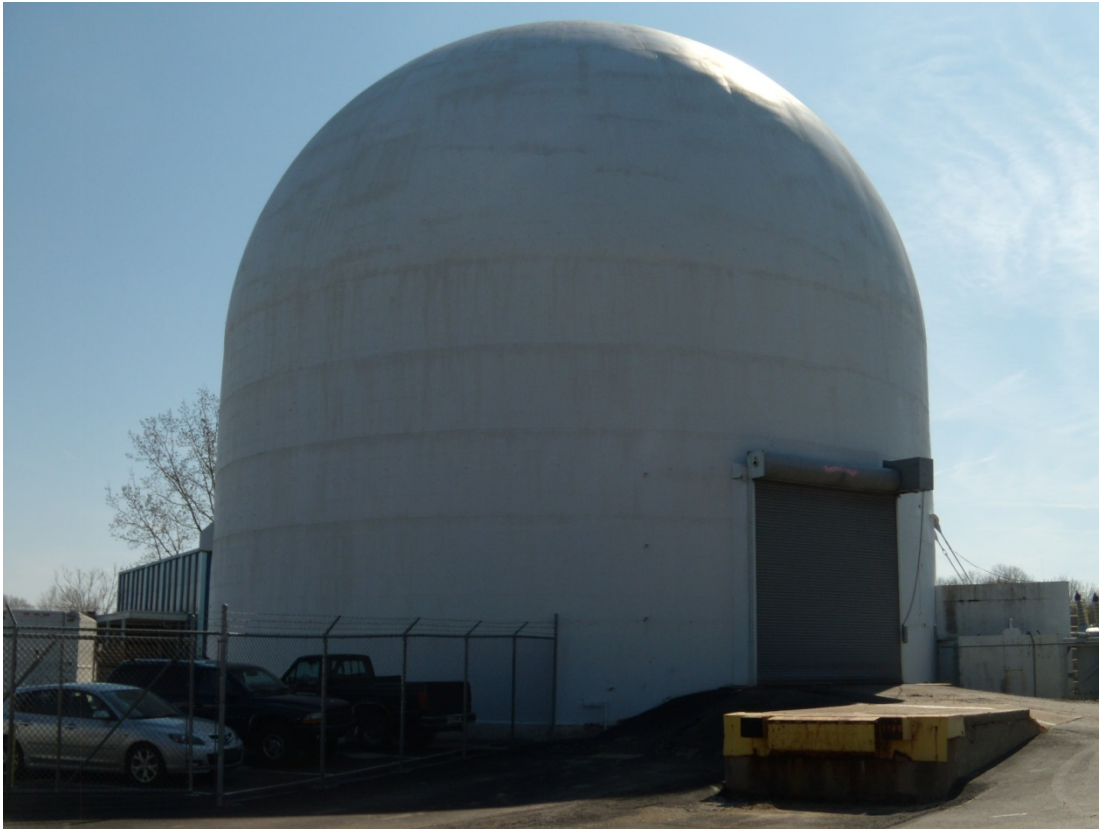
The Containment Building exterior was refurbished around 1995. The exterior of the reactor containment building was in good shape (PL-1).

PIQ 4/2014. PL- 1. Outside view of containment dome.

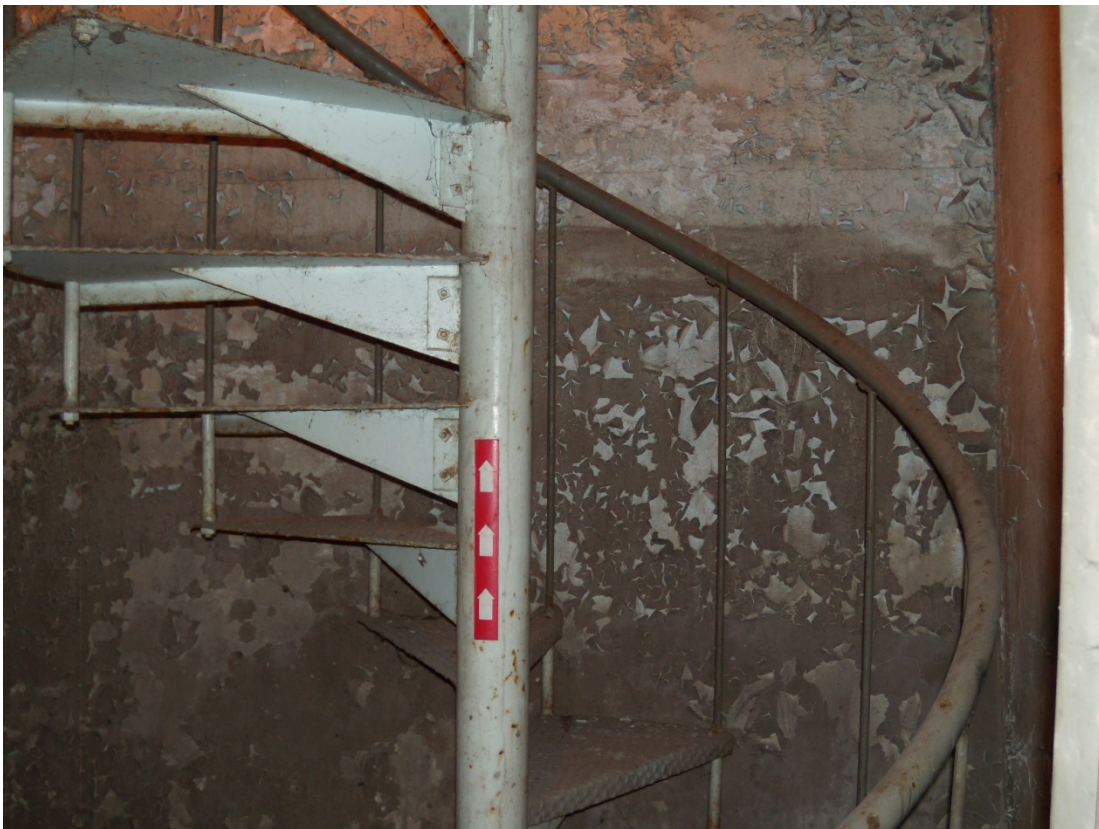
A spiral staircase is present in the containment structure (PL-2). Plaster is falling off the walls of the staircase enclosure. This damage has been noted in previous inspection reports (PL-3).

PIQ 4/2014. PL- 2. Spiral staircase.

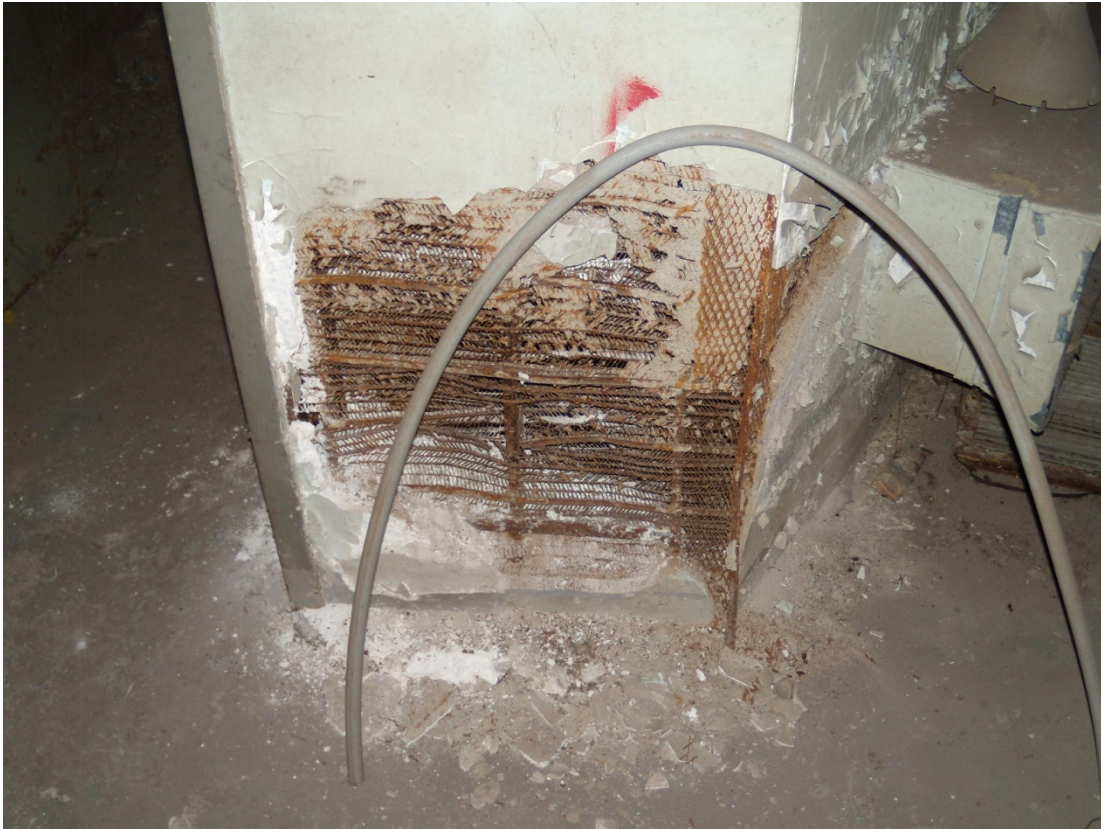
PIQ 4/2014. PL- 3. Wall damage.

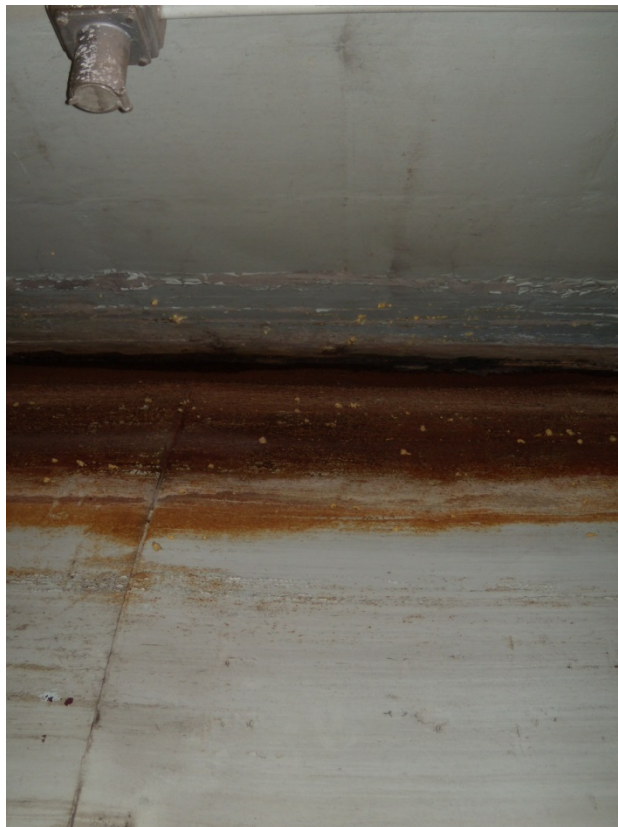
Fresh moisture was present in the room next to B-1. The fresh moisture was noted on the site inspection map (PL-4). The cause for this moisture is believed to be a crack along the outer wall of the containment structure (PL-5). It is recommended that this crack be filled in to prevent further moisture from seeping into the structure.

- 1) Fresh moisture was noted on the wall, outside of Room B-1 on the 79 foot level. The cause for this moisture is believed to be a crack along the outer wall of the containment structure.

PIQ 4/2014. PL- 4. Active water stain.

Recommendation: It is recommended that this crack be filled in to prevent further moisture from seeping into the structure.

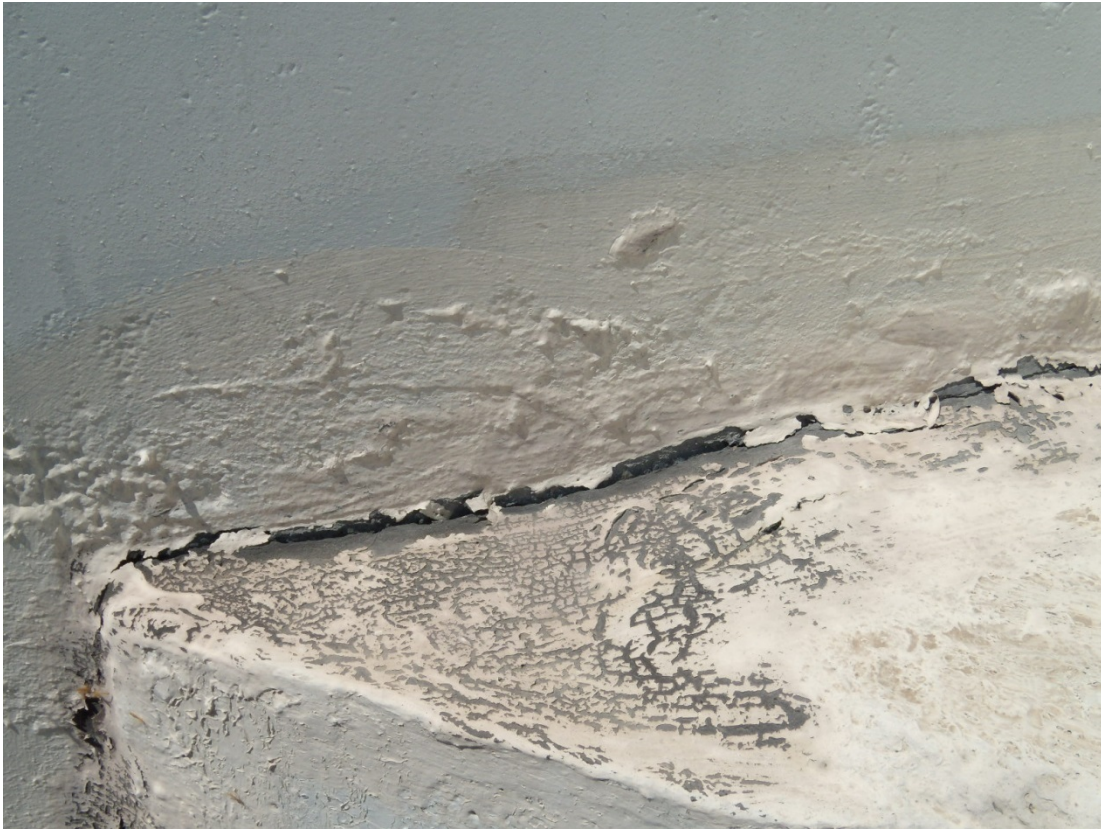
PIQ 4/2014. PL- 5. Crack around base of containment dome.

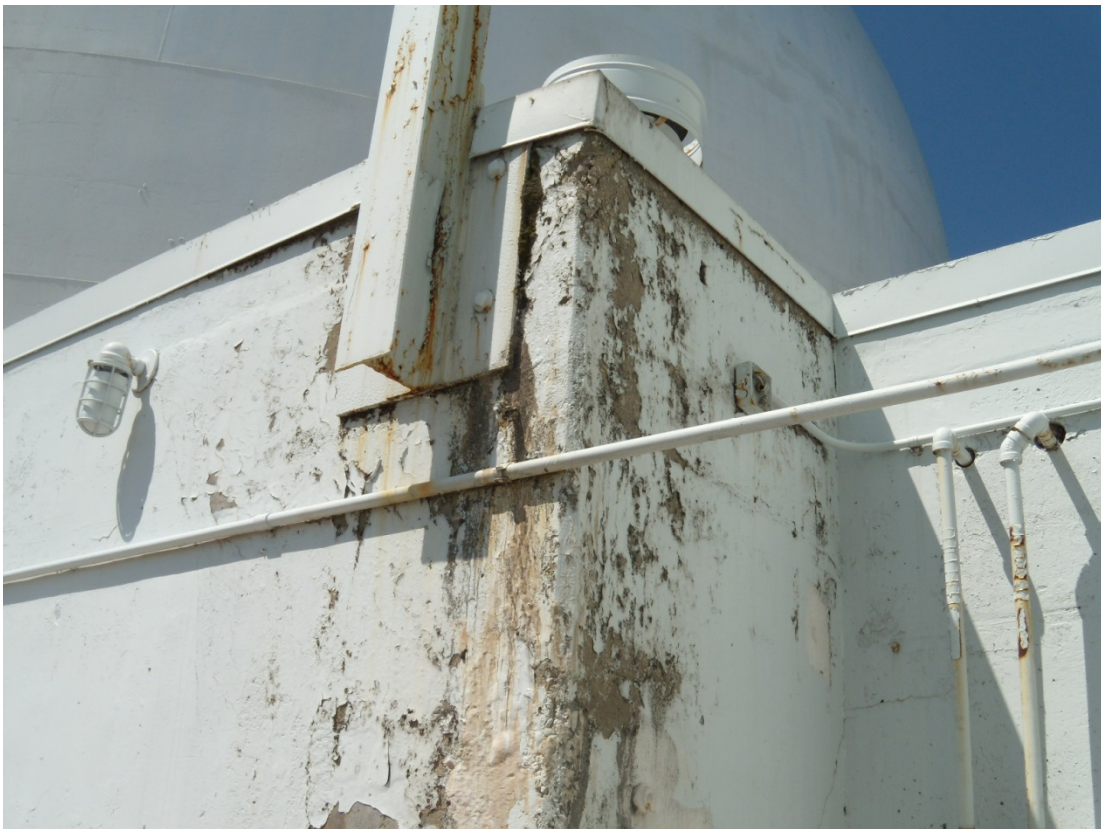
100 foot level: During the 2010 inspection, the roof above Room-125 had ponded water and was not properly draining, water was observed on the floor of Room-125, and the outside corner of the room was damaged. Room-125 is accessed off of the loading dock. It is no longer used by Piqua personnel. Piqua personnel repaired the outside corner of the room and corrected the roof drainage problem above the room in 2011. The roof appears to be draining properly and no water was observed on the floor of Room-125 during this year's inspection. The outer corner of the roof appears to be getting worse though (PL-6). Inspectors will continue to watch the outer corner to determine if the deterioration is progressing.

PIQ 4/2014. PL- 6. Outside corner of room 125.

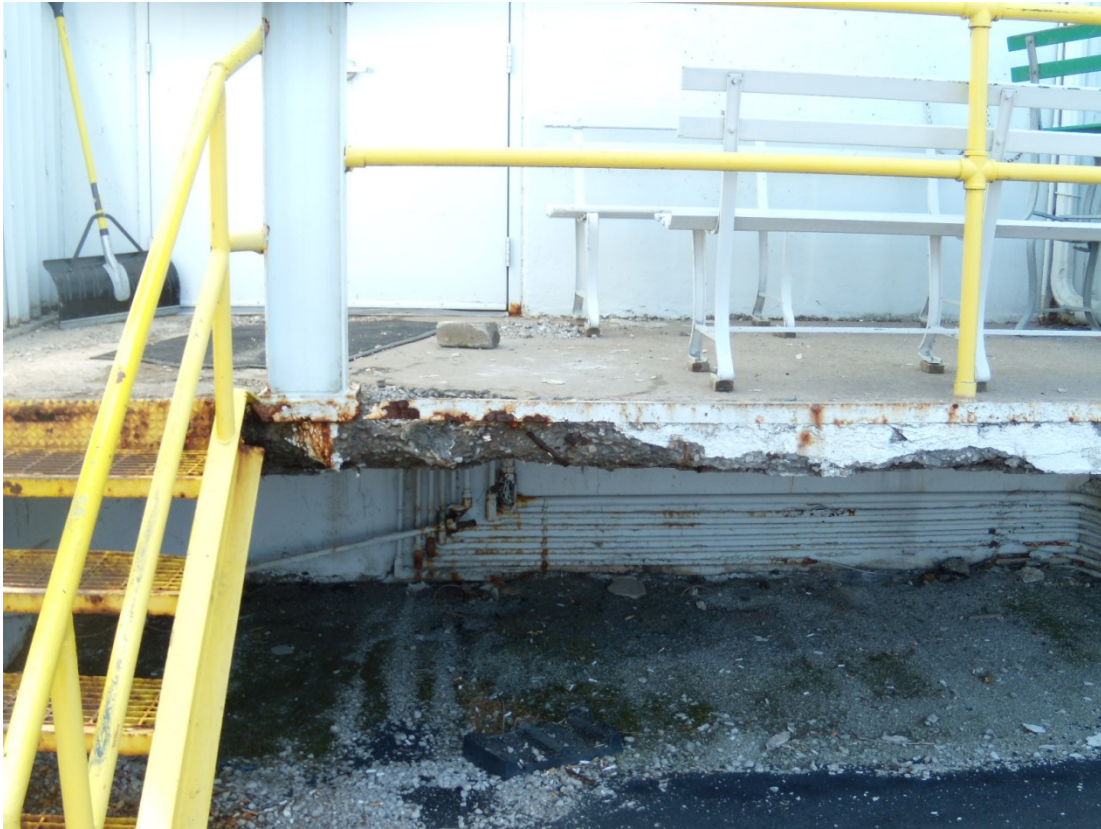
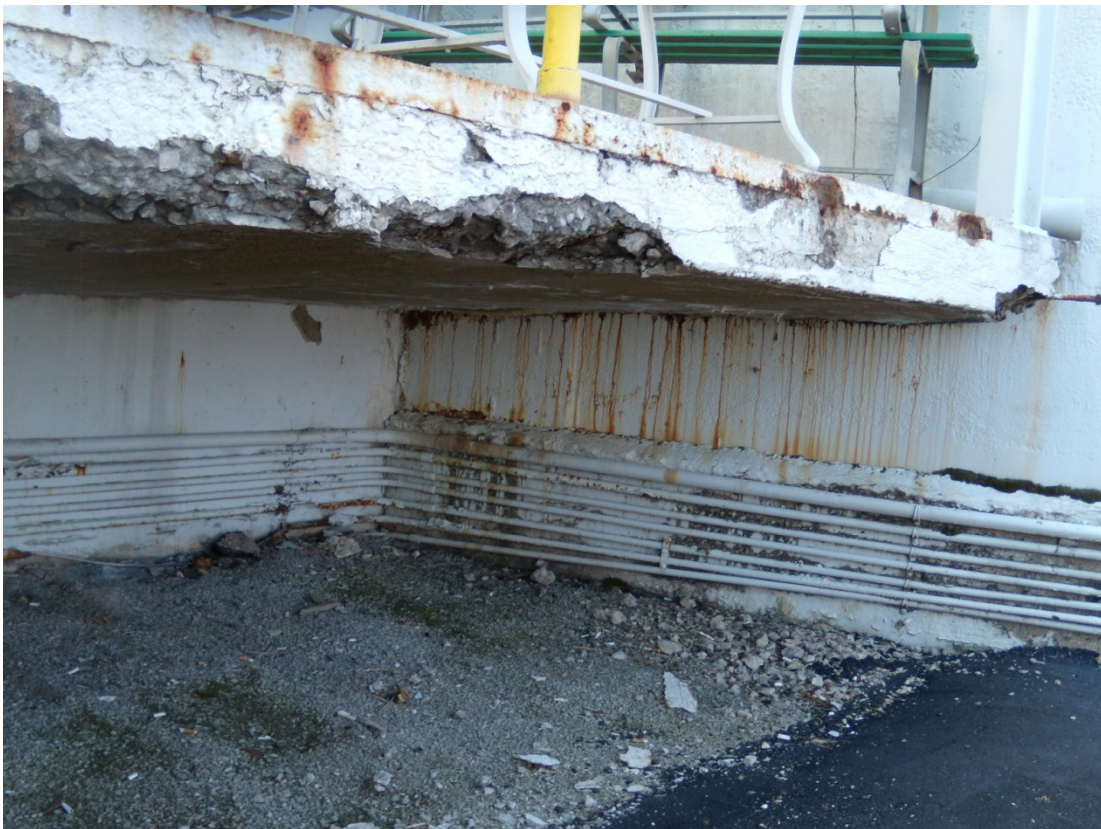
Inspectors noted that the extreme cold of the past winter appears to have had an impact on a platform that is located between the Auxiliary building and the containment structure (PL-7 and PL-8). It is recommended that the platform be examined, and a determination made as to how it is attached to the containment dome structure. If collapse of the platform could damage the wall of the containment dome, it is recommended that the platform be reinforced so that is not allowed to fall down.

- 2) Inspectors noted that the extreme cold of the past winter appears to have had an impact on a platform that is located between the Auxiliary building and the containment structure.

PIQ 4/2014. PL- 7. Break platform on northwest side of Auxiliary Building.

PIQ 4/2014. PL- 8. Break platform on northwest side of Auxiliary Building.

Recommendation: It is recommended that the platform be examined, and a determination made as to how it is attached to the containment dome structure. If collapse of the platform could damage the wall of the containment dome, it is recommended that the platform be reinforced so that it is not allowed to fall down.

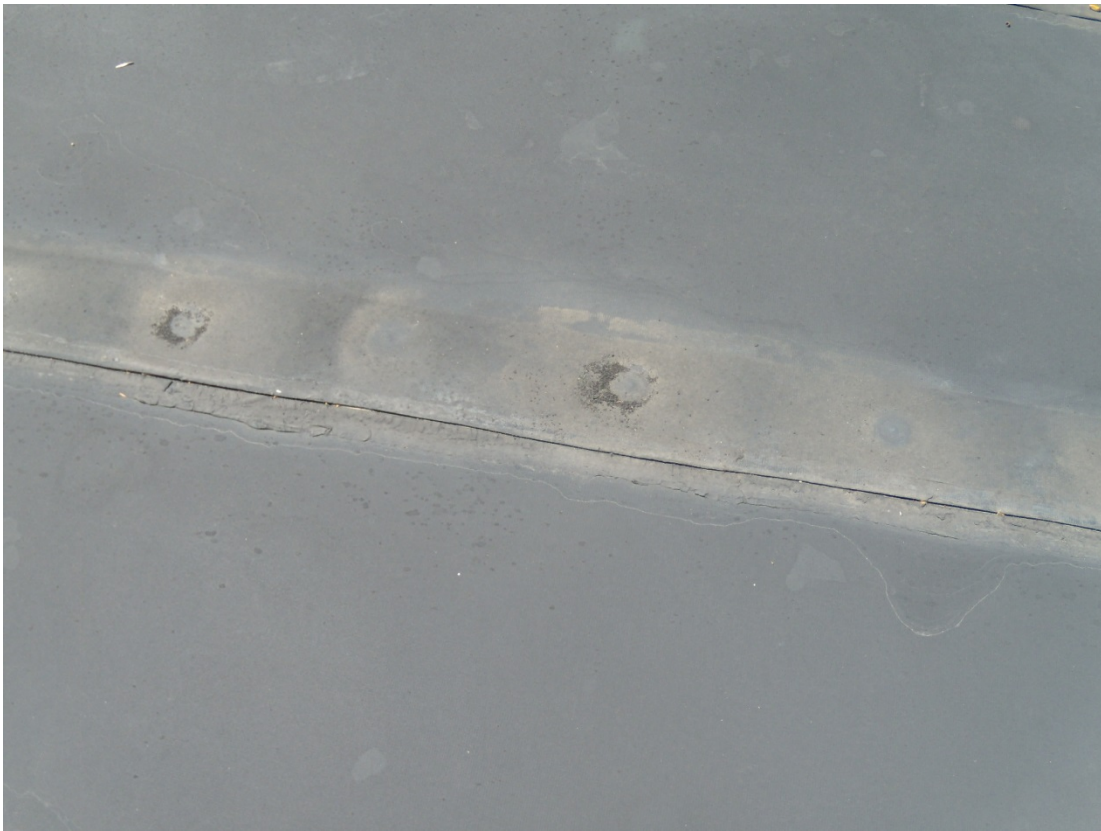
Inspectors noted several of the roofing fabric seems are beginning to separate (PL-9). Inspectors also noted that several of the roof drains were partially plugged with material and plant growth (PL-10 and PL-11). Post inspection discussions with Piqua personnel revealed that Piqua is aware of the roof items and will be taking action shortly to address them.

PIQ 4/2014. PL- 9. Seams in roof material separating.

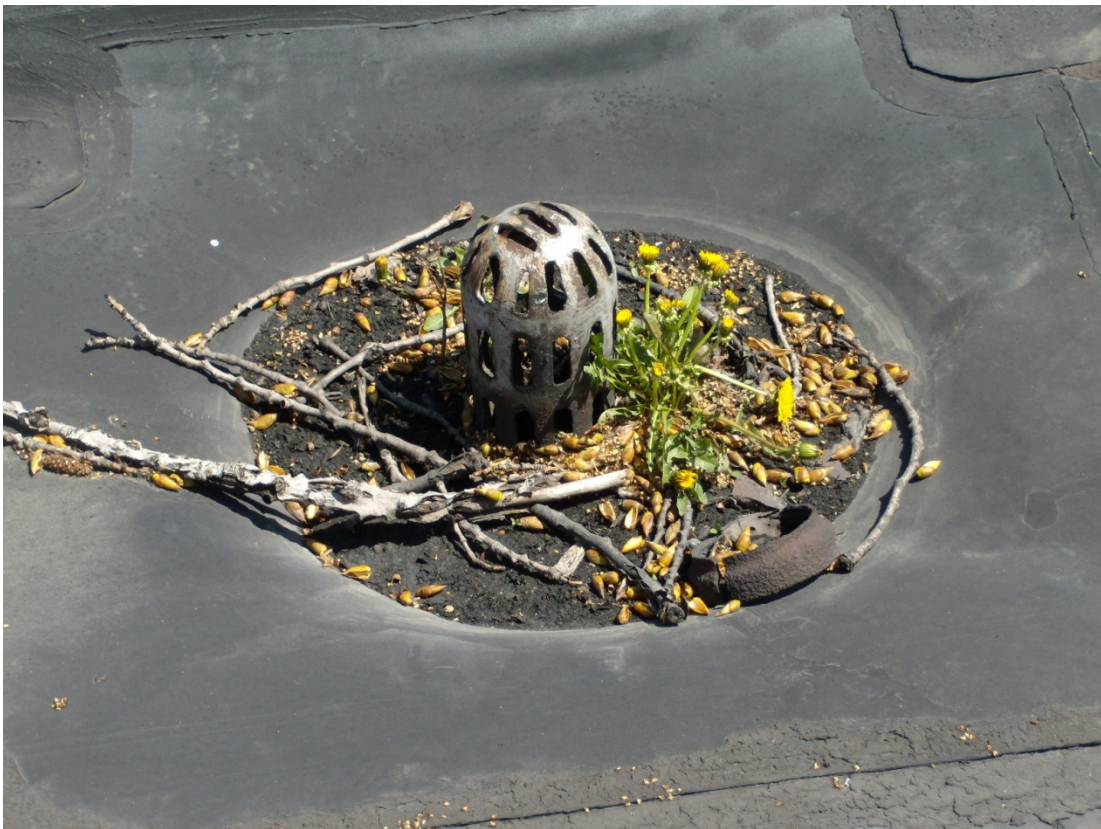
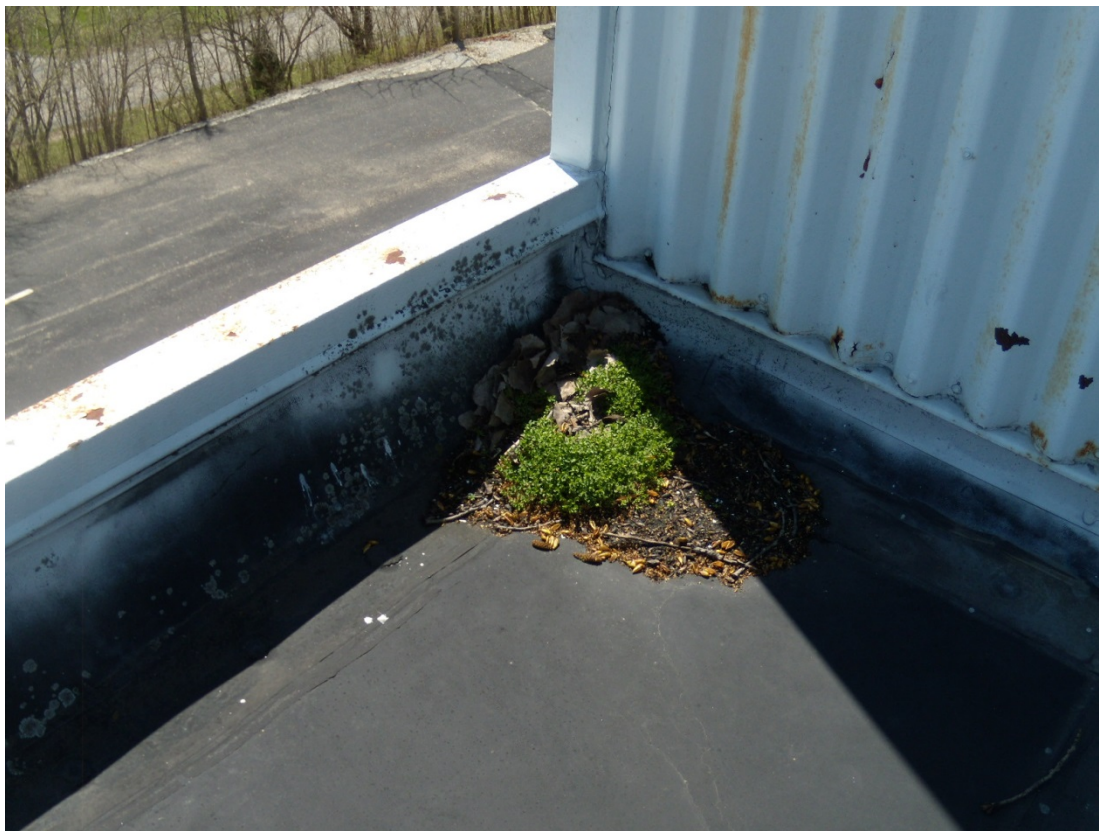
PIQ 4/2014. PL- 10. Weeds growing around roof drains.

PIQ 4/2014. PL- 11. Weeds growing around roof drains.

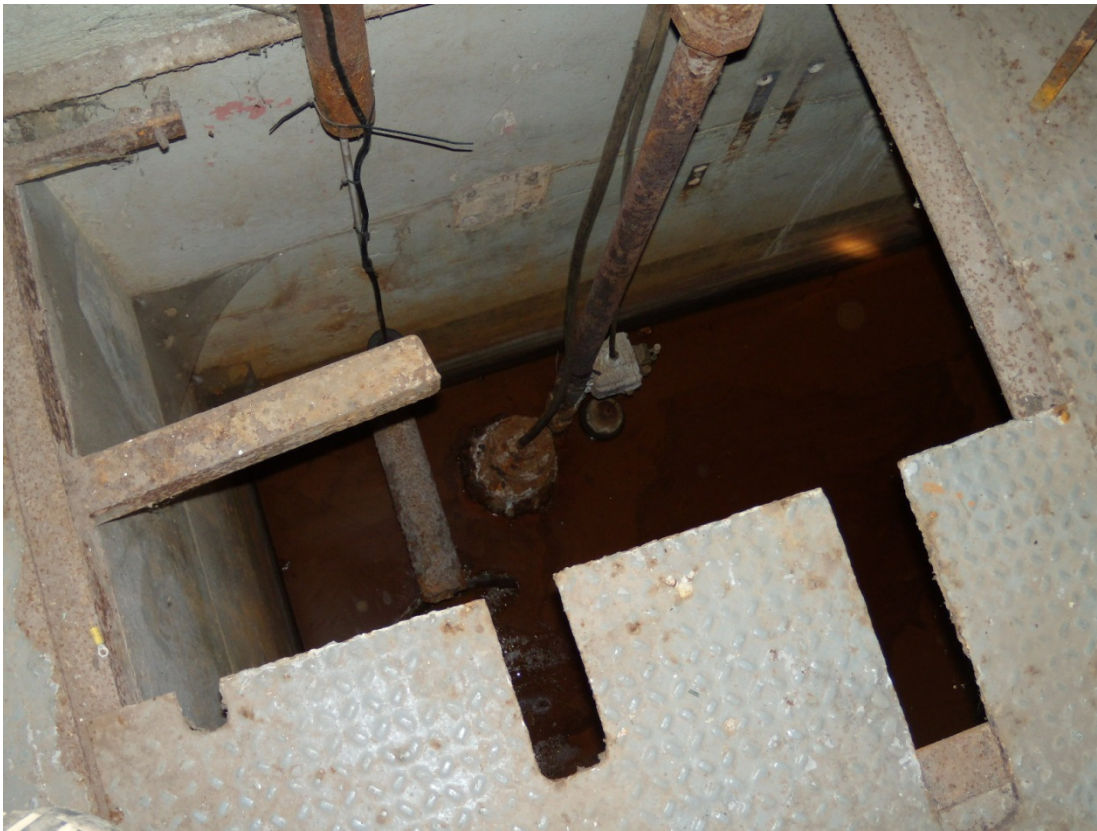
An alarm system is installed in the sump on the 56-foot level to detect high water levels before they rise to the bottom of the pressure vessel (PL-13). This system is designed to prevent immersion and accelerated corrosion of the pressure vessel. The alarm triggers when the sump fills to near overflow, alerting personnel to both high water and possible sump pump failure. The alarm registers in the auxiliary building on the Supervisory Control and Data Acquisition system, which is monitored 24 hours a day by an operator. The alarm system is included in the monthly building inspection. The reactor sump alarm test log indicates that the alarm is being tested monthly. The log indicated that the February entry was missing (PL-14). Water was present in the base of the sump during the inspection.

PIQ 4/2014. PL- 13. Water in base of sump.

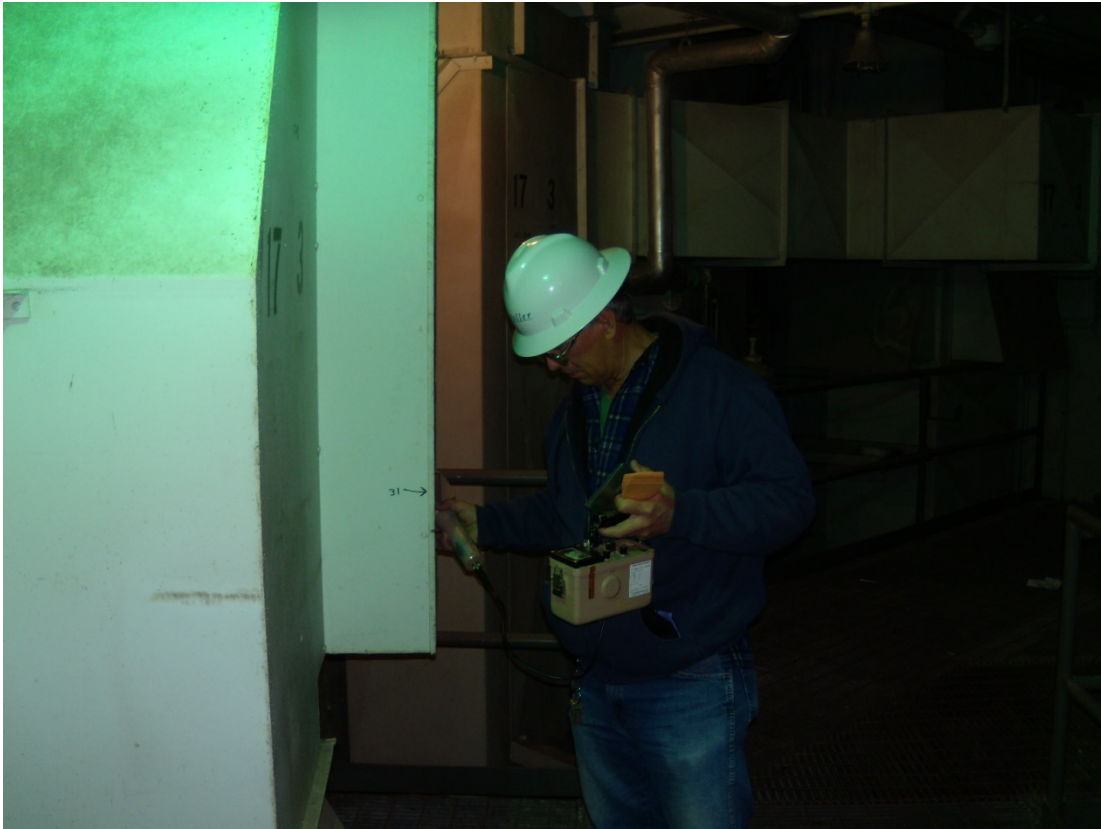
S.M. Stoller staff performed the annual radiological survey on the interior of the reactor containment building, auxiliary building, and exterior areas (PL-15). A total of 106 sample locations were checked for both removable and surface contamination using direct measurements and smears for the detection of alpha and beta-gamma activity. Gamma exposure rates also were measured. Prior to 2008, 111 sample locations were surveyed. Locations 1-5 were removed from the survey in 2008 because the HVAC equipment being sampled was removed.

PIQ 4/2014. PL-15. Radiation tech taking a reading.

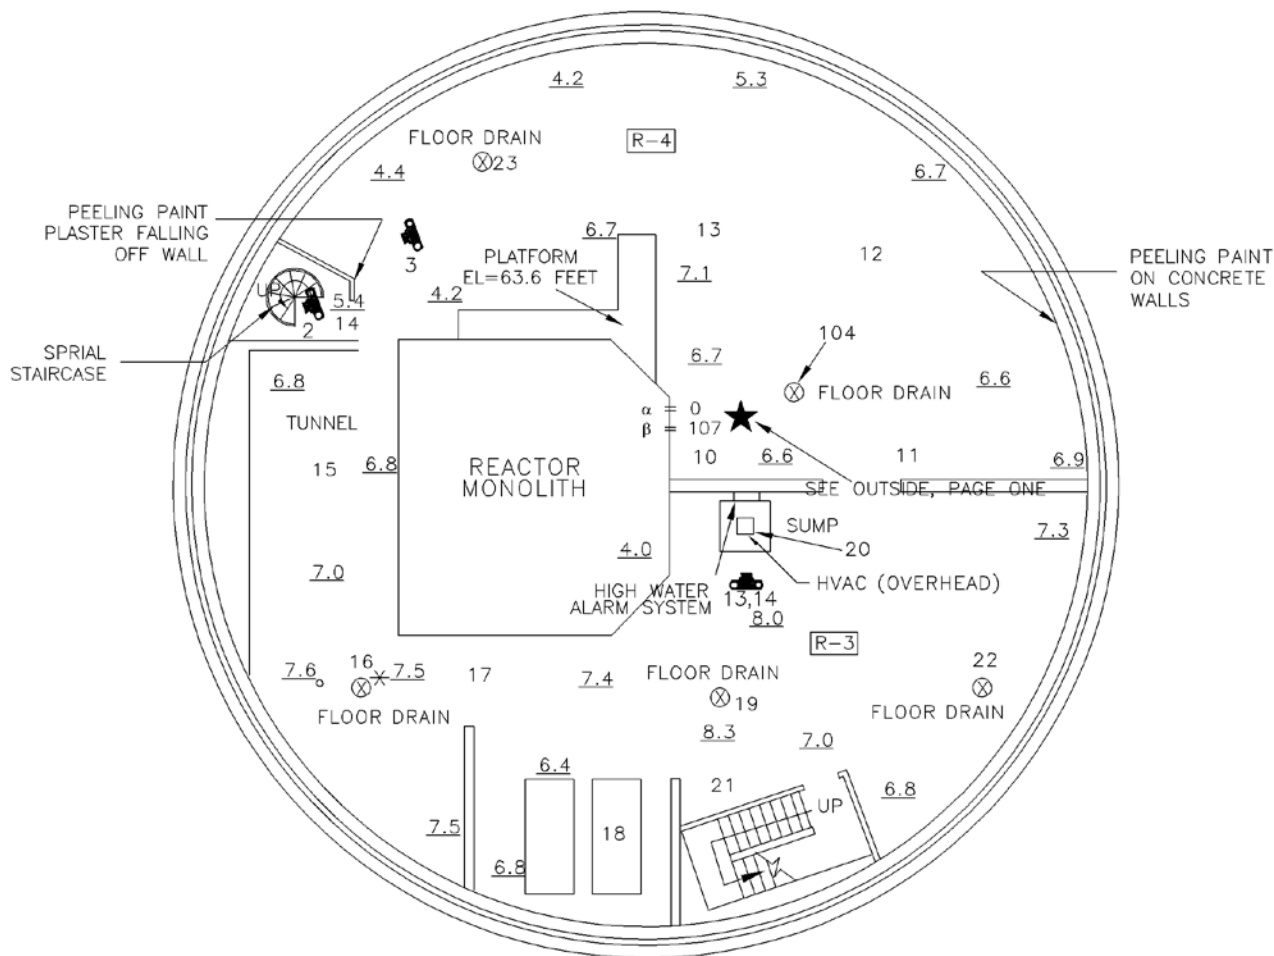
PLAN - 56 FOOT LEVEL

NOTE: ALL 2014 GAMMA READINGS WERE < BKGD ON THIS LEVEL.
