2015 Annual Inspection and Radiological Survey Results for the Piqua, Ohio, Decommissioned Reactor Site

Summary

The former Piqua Nuclear Power Facility (PNPF), a decommissioned nuclear power demonstration facility, was inspected on April 22, 2015. The site, located on the east bank of the Great Miami River in Piqua, Ohio, was in good physical condition. There is no requirement for a follow-up inspection.

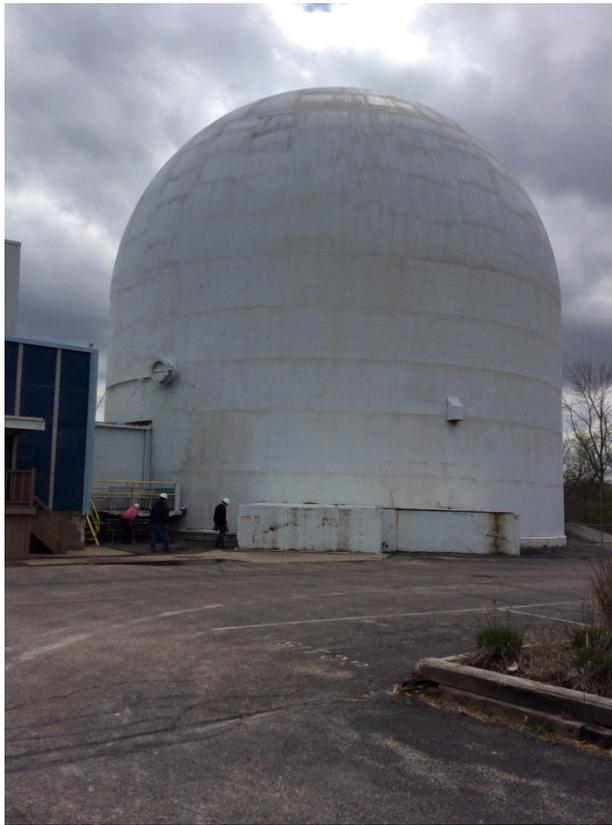
The Containment Building exterior was refurbished around 1995. The exterior surface of the reactor containment building was in good condition (PL-1).

PIQ 4/2015. PL-1. Containment dome.

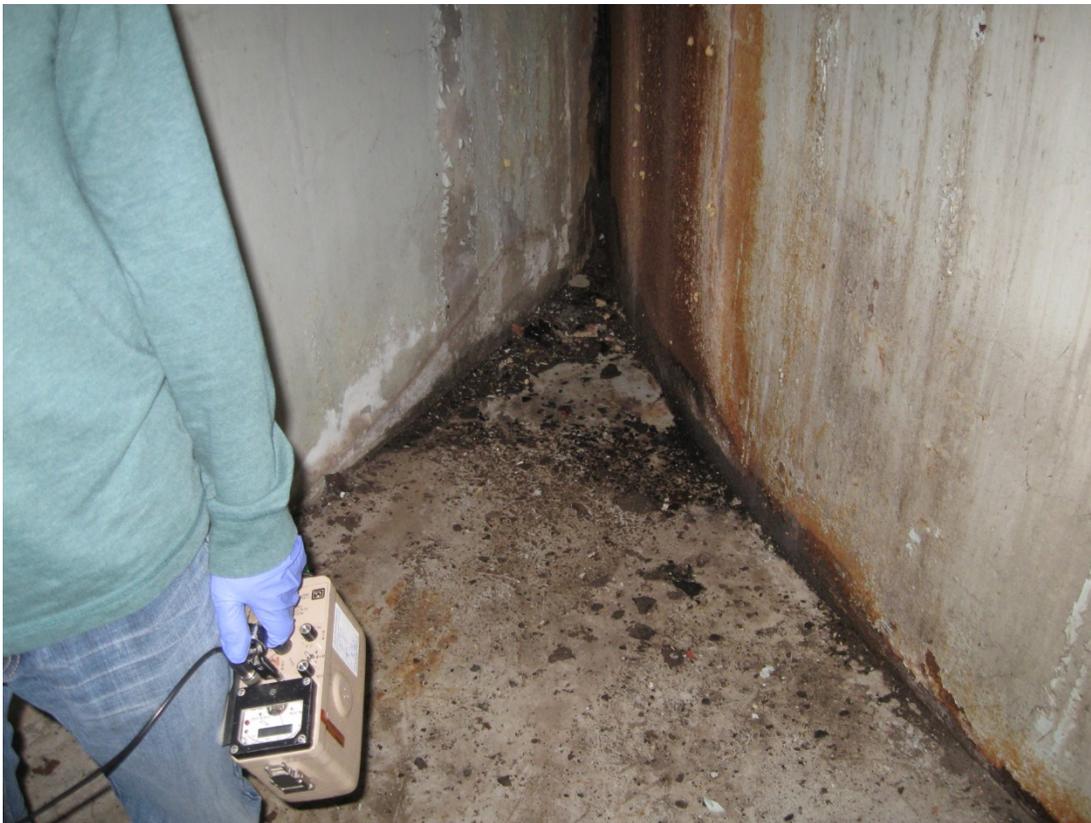
Fresh moisture was present in the room next to B-1. The fresh moisture was noted on the site inspection map last year (PL-2). The cause for this moisture is believed to be a crack along the outer wall of the containment structure. It is recommended that this crack be filled in to prevent further moisture from seeping into the structure.

- 1) Fresh moisture was noted on the wall, outside of Room B-1 on the 79-foot level. The cause for this moisture is believed to be a crack along the outer wall of the containment structure.

PIQ 4/2015. PL-2. Fresh active staining in corner.

Recommendation: It is recommended that the crack on the outer wall be sealed to prevent further moisture from seeping into the structure.

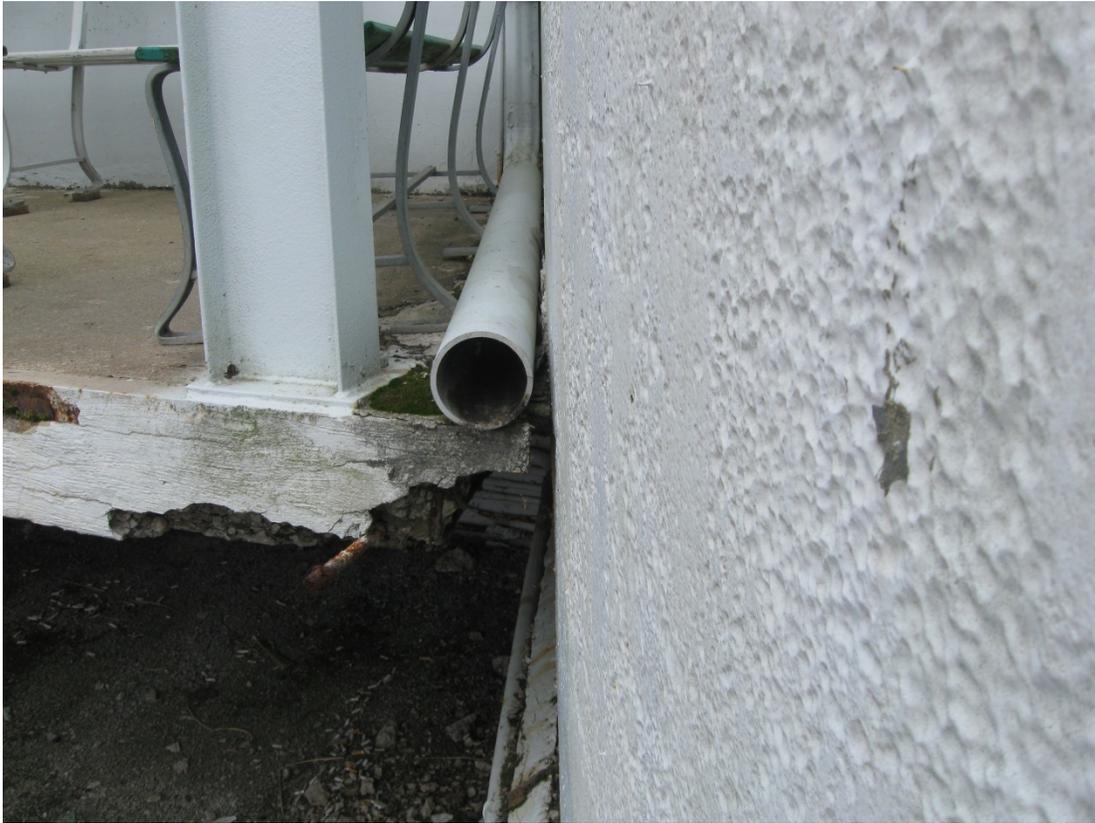
Inspectors noted in 2014 that the extreme cold of the winter appeared to have an impact on the platform that is located between the Auxiliary building and the containment structure (PL-3). It is recommended that the platform be examined, and a determination made as to how it is attached to the containment dome structure. If collapse of the platform could damage the wall of the containment dome, it is recommended that the platform be reinforced so that it does not collapse.

- 2) Inspectors noted that the extreme cold of the past winter appears to have had an impact on a platform that is located between the Auxiliary building and the containment structure.

PIQ 4/2015. PL-3. Separation between deck and containment dome.

Recommendation: It is recommended that the platform be examined, and a determination made as to how it is attached to the containment dome structure. If collapse of the platform could damage the wall of the containment dome, it is recommended that the platform be reinforced so that it does not collapse.

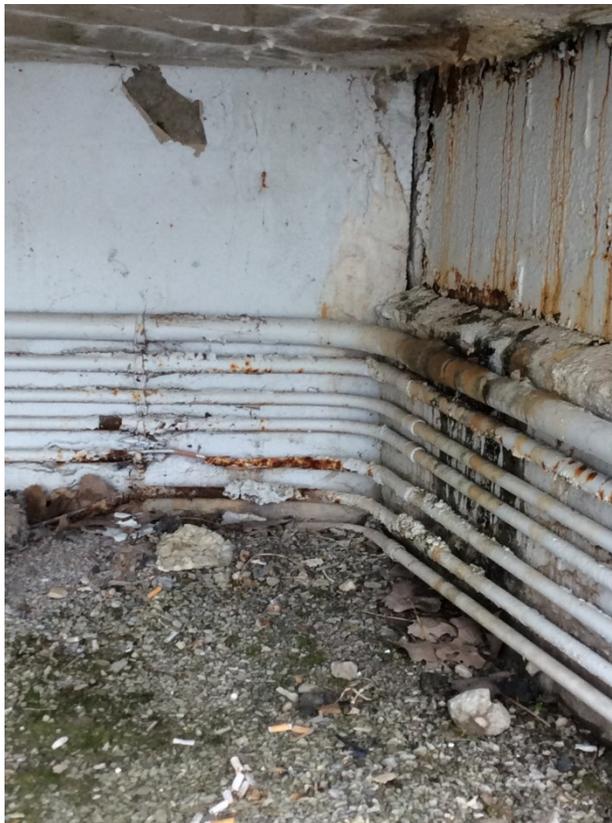
It was noted during this year's inspection that there were several areas with exposed electric wires on the outside of the facility (PL-4 through PL-10). It is recommended that Piqua personnel properly secure these exposed wires. If the wires have been properly isolated from energy sources, and are no longer energized, they need to be labeled as such.

- 3) It was noted during this year's inspection that there were several areas with exposed electric wires on the outside of the facility. If the wires have been properly isolated from energy sources, and are no longer energized, they need to be labeled as such.

PIQ 4/2015. PL-4. Broken conduit below deck.

Recommendation: It is recommended that Piqua personnel properly address these exposed wires.

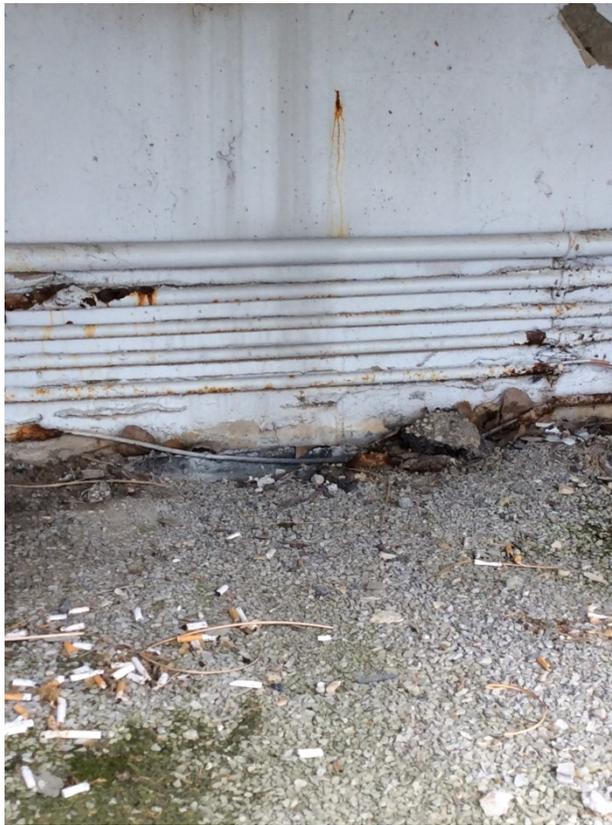
PIQ 4/2015. PL-5. Broken conduit below deck.

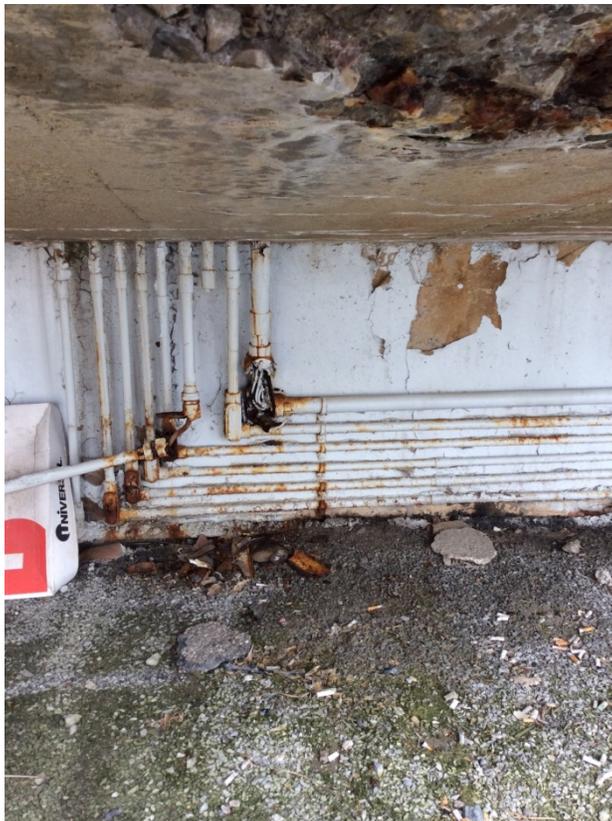
PIQ 4/2015. PL-6. Broken conduit below deck.

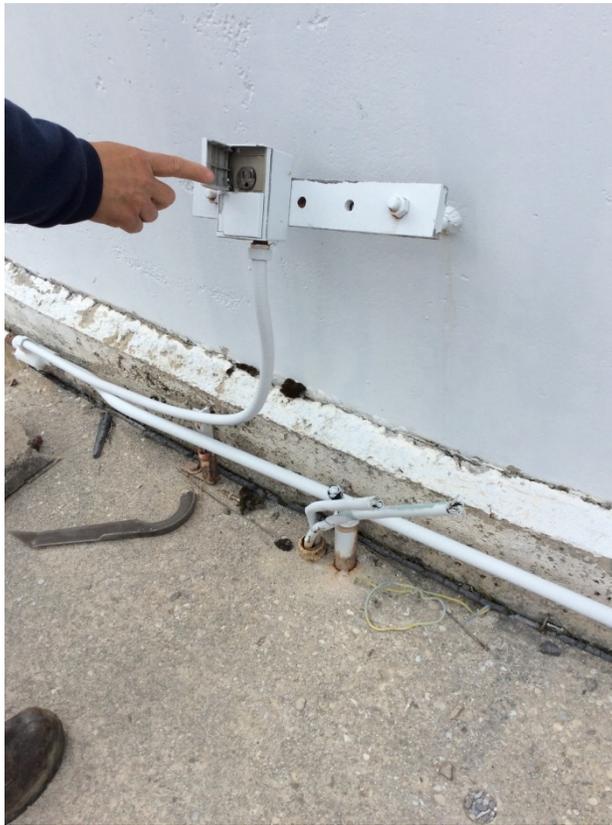
PIQ 4/2015. PL-7. Broken electrical conduit leading to outlet.

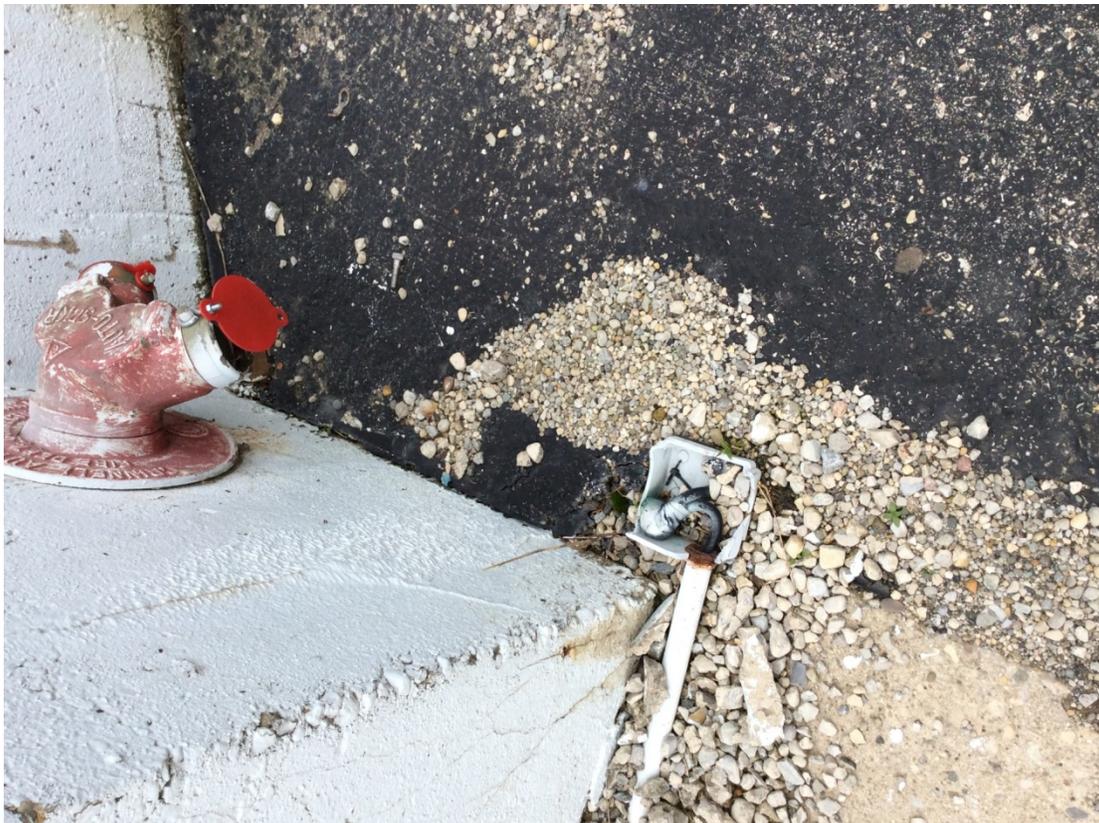
PIQ 4/2015. PL-8. Broken electric box.

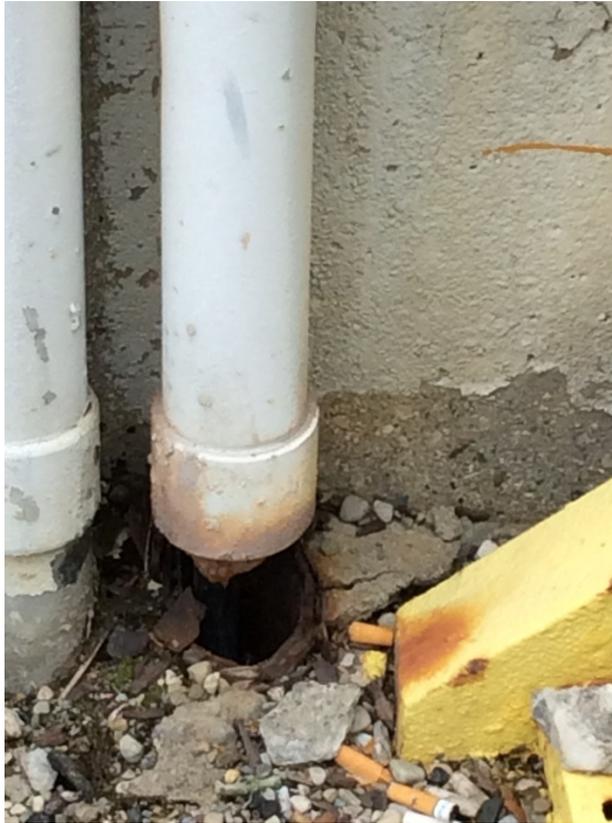
PIQ 4/2015. PL-9. Broken electric conduit.

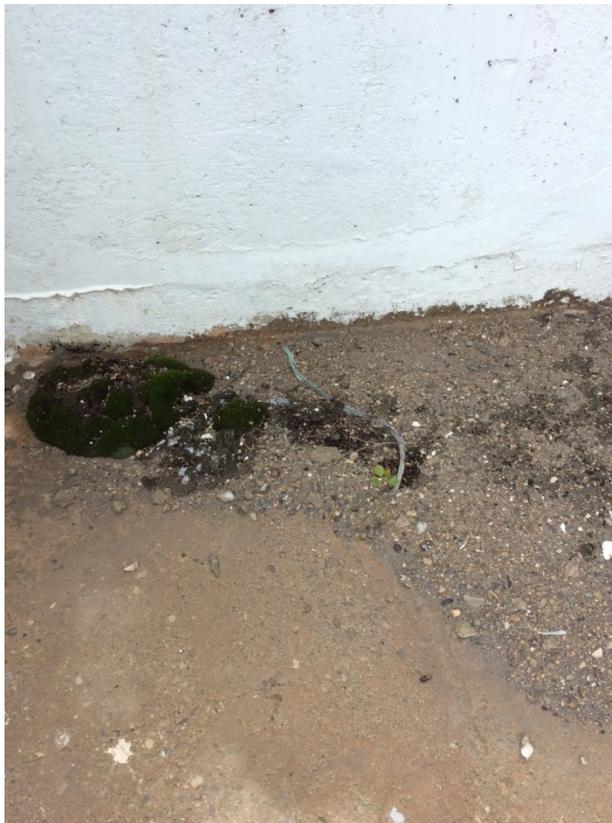
PIQ 4/2015. PL-10. Exposed cable in ground.

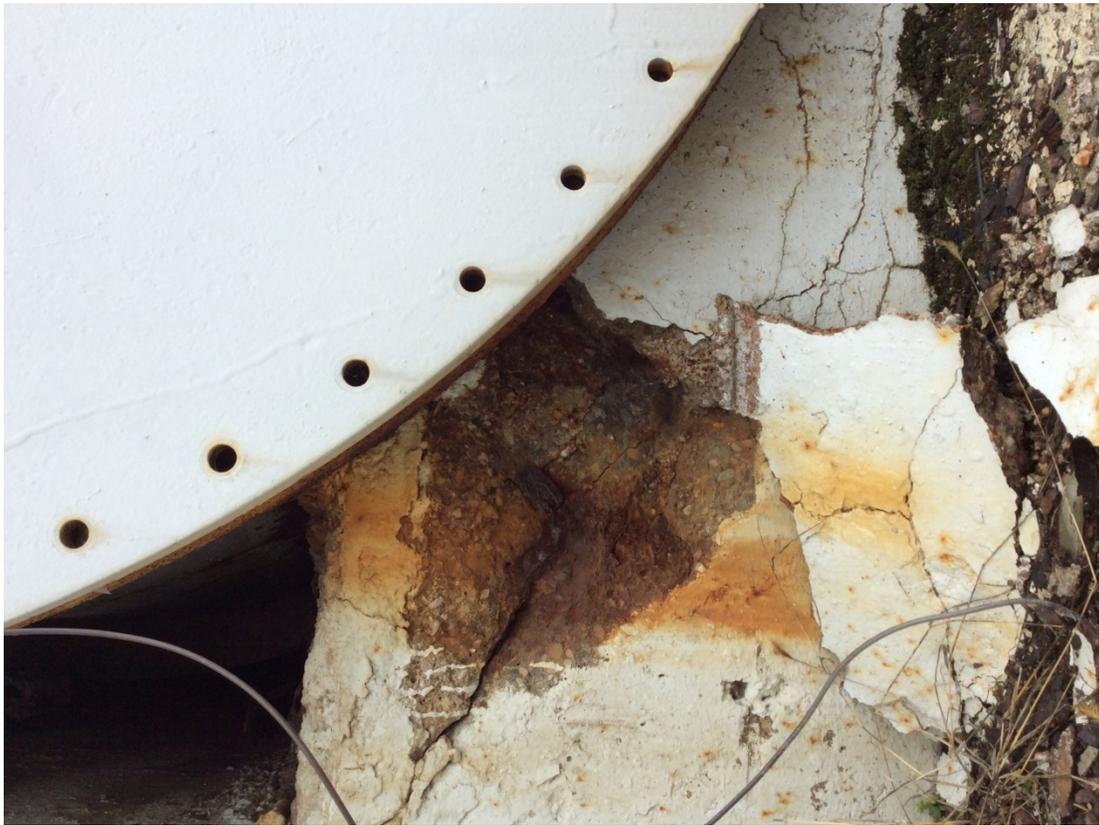
It was noted in this year's inspection that the concrete around the south west air lock is in poor condition. Numerous cracks were present and some small pieces of concrete are falling off (PL-11 and PL-12). It is recommended that Piqua personnel make concrete repairs to this airlock.

- 4) It was noted in this year's inspection that the concrete around the south west air lock is in bad condition. Numerous cracks were present and some small pieces of concrete are falling off.

PIQ 4/2015. PL-11. Concrete around southwest airlock.

- 5) Recommendation: It is recommended that Piqua personnel make concrete repairs to this airlock.

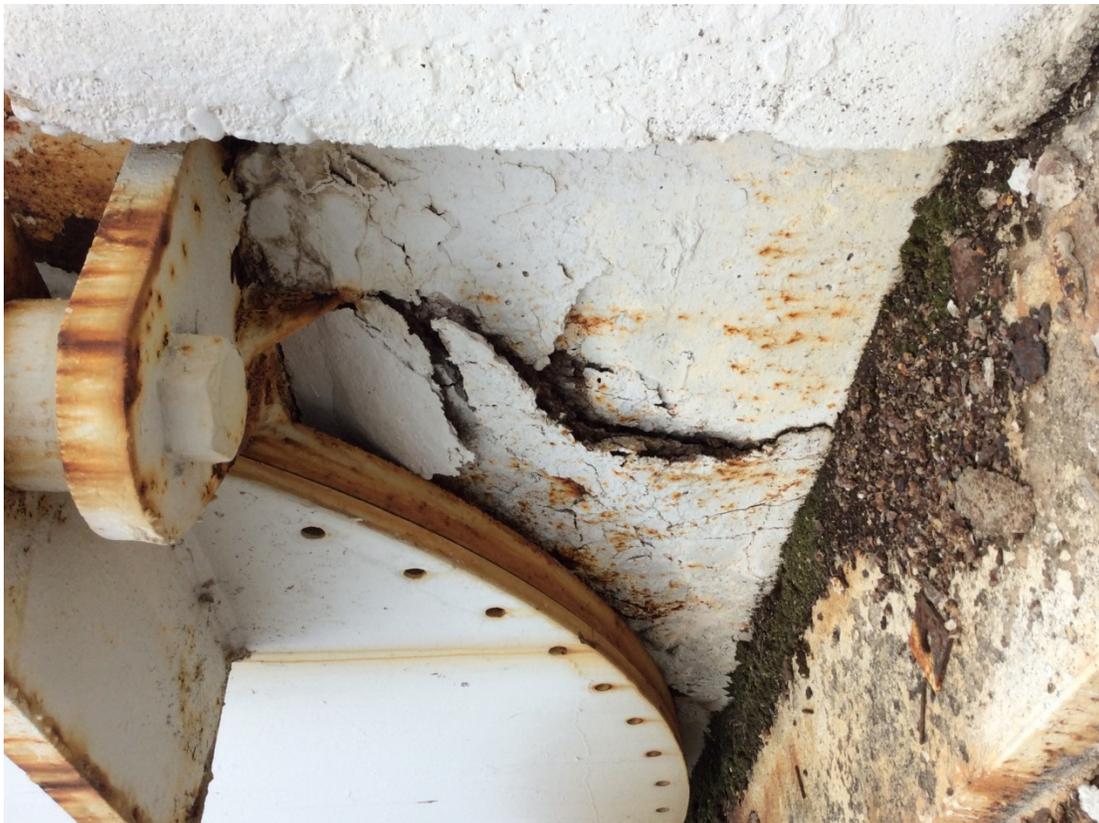
PIQ 4/2015. PL-12. Concrete around southwest airlock.

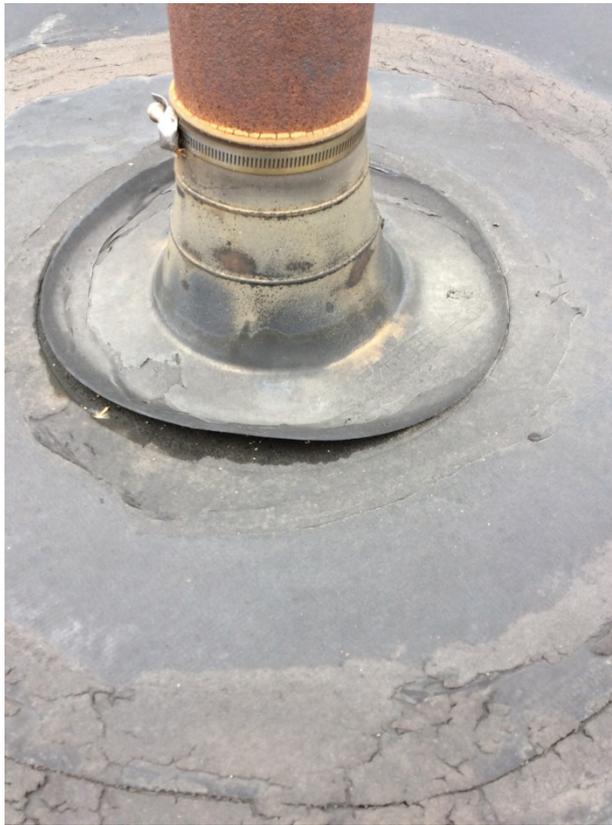
Roof Top: Inspectors this year found that several roof issues from the previous year have not been addressed. Specifically, several of the roofing fabric seams are beginning to separate (PL-13). Inspectors also noted that several of the roof drains continue to be partially plugged with material and plant growth causing water to pond on the roof fabric and not properly drain (PL-14, PL-15, and PL-16). Inspectors this year also found one small hole in the roofing fabric (PL-17). It is recommended that the City of Piqua address these roof concerns before they develop into larger issues.

- 6) Inspectors this year found that several roof issues from the previous year had not been addressed. Specifically, several of the roofing fabric seams are beginning to separate, roof drains continue to be partially plugged with material and plant growth causing water to pond on the roof fabric and not properly drain, and one small hole was observed in the roof fabric.

PIQ 4/2015. PL-13. Roof fabric separating around vent.

Recommendation: It is recommended that the City of Piqua address these roof issues.

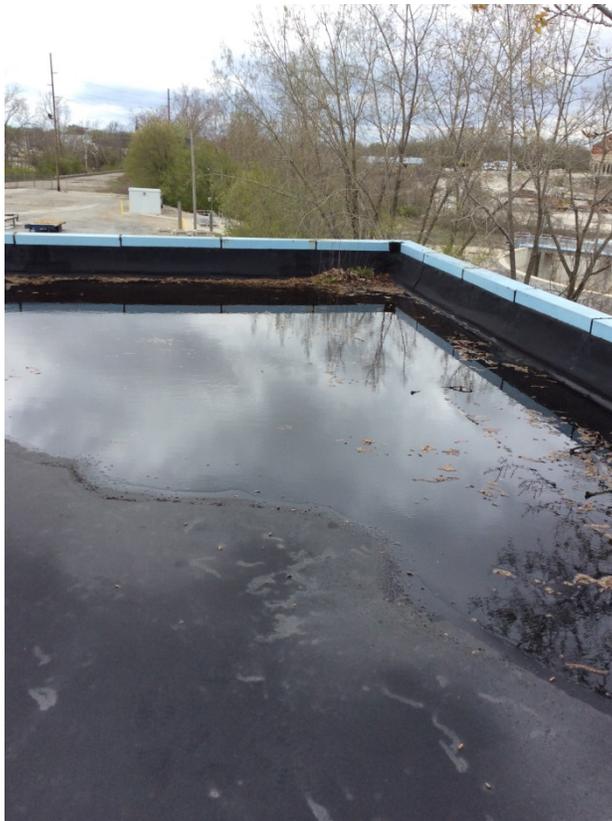
PIQ 4/2015. PL-14. Water ponded on northeast corner of roof.

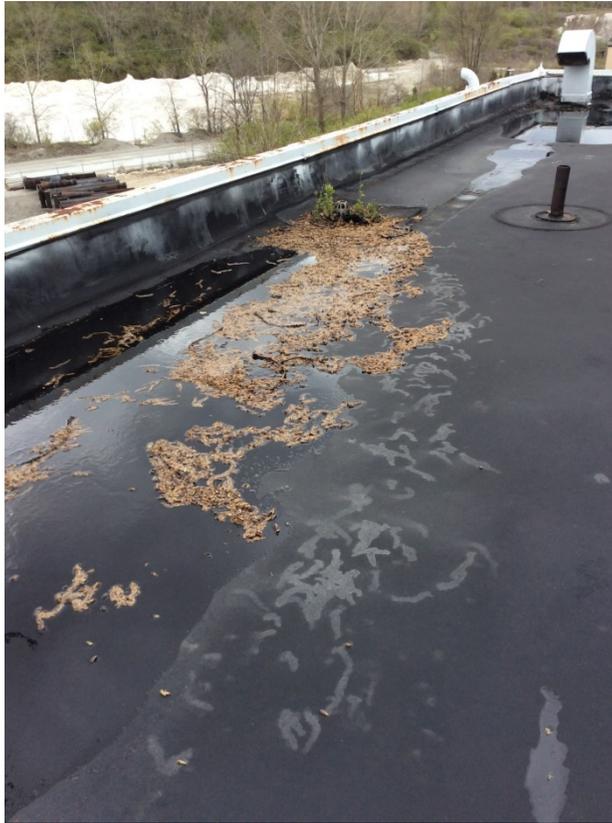
PIQ 4/2015. PL-15. Drain clogged with vegetation on roof.

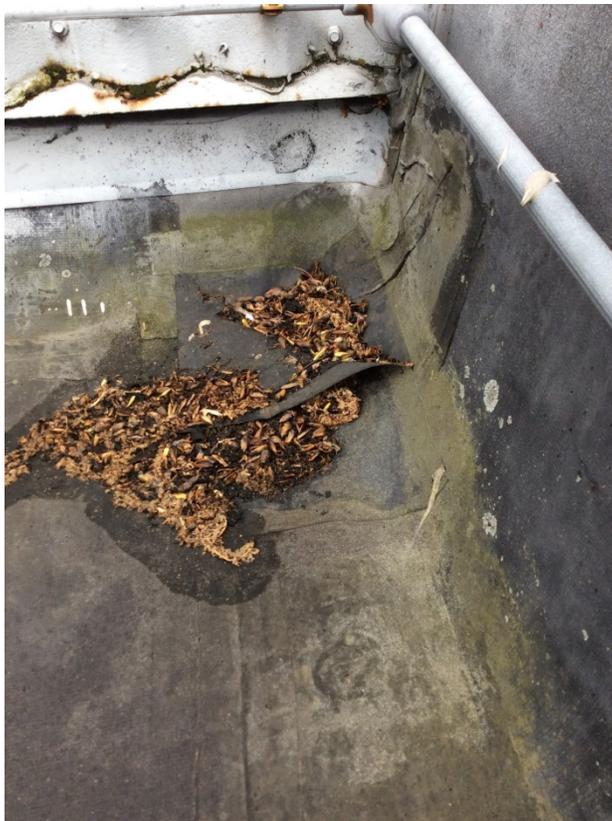
PIQ 4/2015. PL-16. Roof fabric separating.

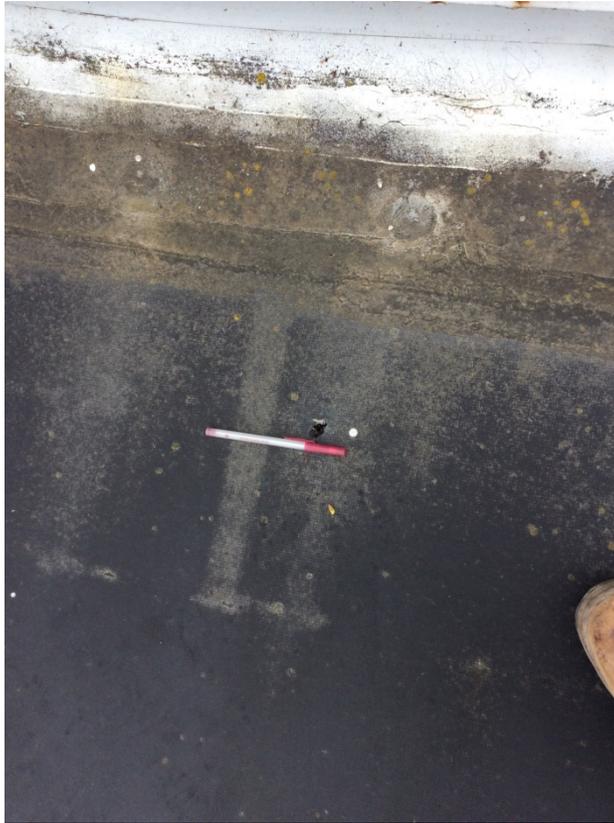
PIQ 4/2015. PL-17. Small hole in roof fabric.

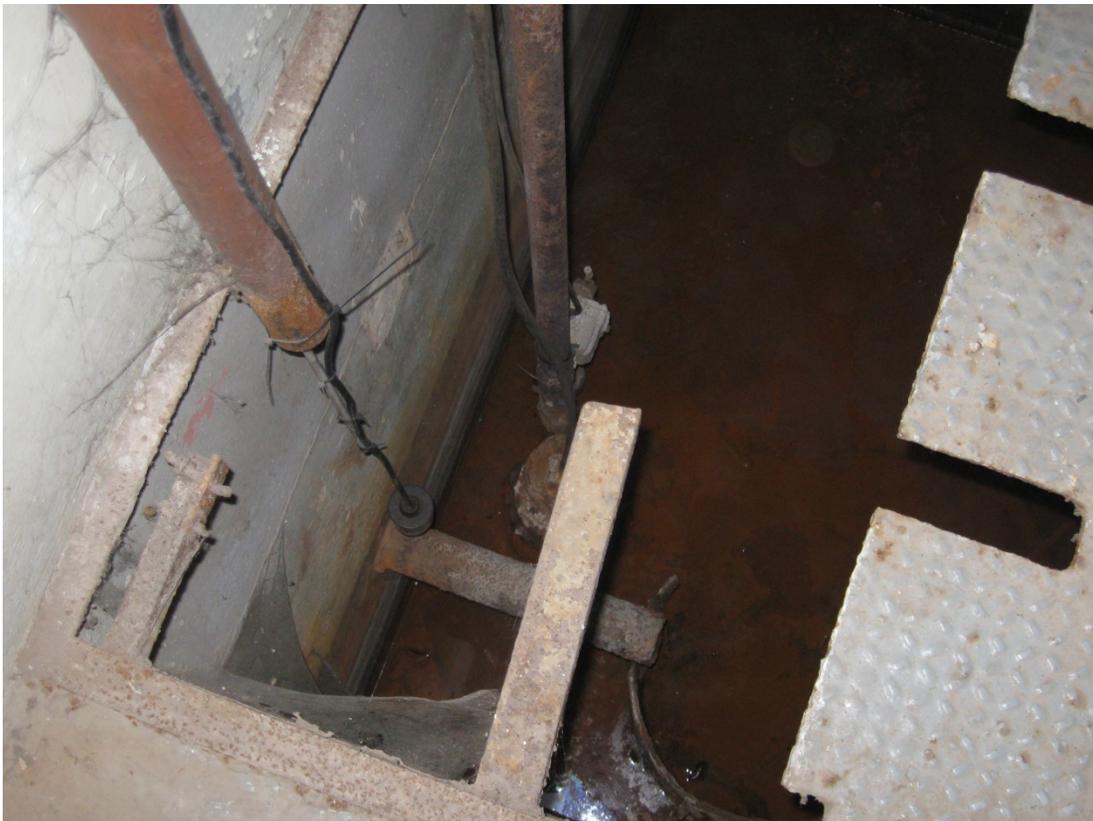
An alarm system is installed in the sump on the 56-foot level to detect high water levels before they rise to the bottom of the pressure vessel (PL-18). This system is designed to prevent immersion and accelerated corrosion of the pressure vessel. The alarm triggers when the sump fills to near overflow, alerting personnel to both high water and possible sump pump failure. The alarm registers in the auxiliary building on the Supervisory Control and Data Acquisition system, which is monitored 24 hours a day by an operator. The alarm system is included in the monthly building inspection. The reactor sump alarm test log indicates that the alarm is being tested monthly.

PIQ 4/2015. PL-18. Floor sump.
