ORNL/RASA-96/8

**Results of the Independent  
Radiological Verification  
Survey at B&T Metals,  
425 West Town Street,  
Columbus, Ohio  
(CO001V)****M. E. Murray  
V. P. Patania  
C. A. Johnson****MANAGED AND OPERATED BY  
LOCKHEED MARTIN ENERGY RESEARCH CORPORATION  
FOR THE UNITED STATES  
DEPARTMENT OF ENERGY**

Date Issued - June 1997

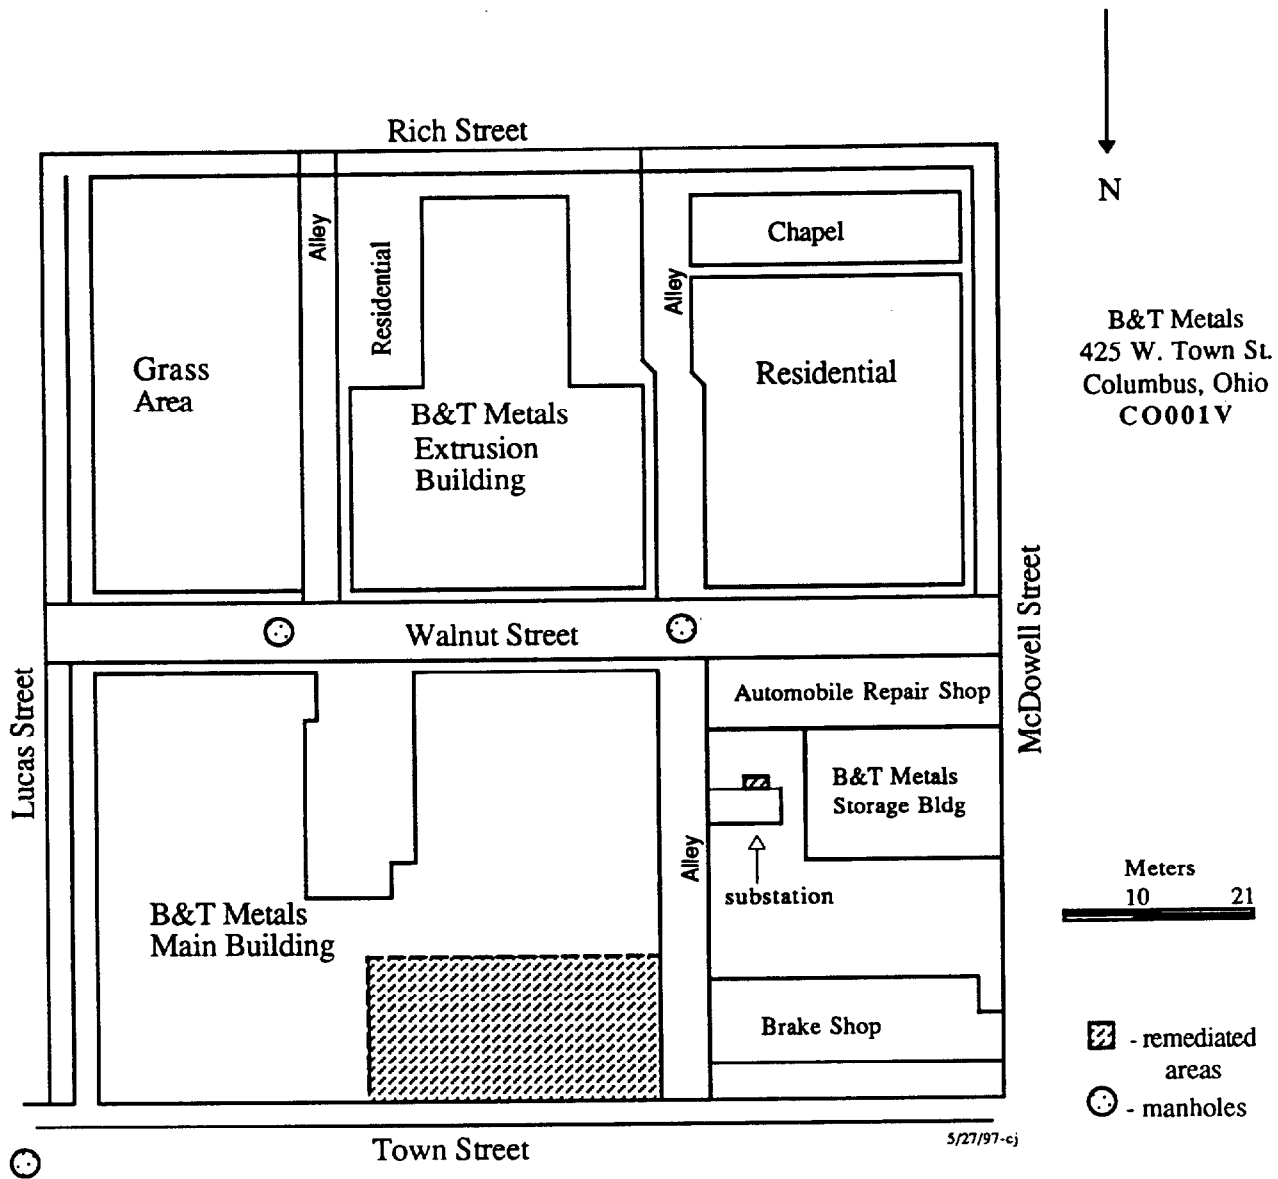
The areas remediated involved (1) a soil area west of the main building and south of the substation, (2) the northwest corner of the main building and the rain gutters above this area, and (3) three outside man-holes near the building (see Fig. 1).

Two manholes outside the south side of the main building (Fig. 1) were surveyed for beta-gamma activity. Several spots along the southern sides of the manholes were found that ranged from 1250 to 1500 dpm/100 cm<sup>2</sup> above background. The third manhole, located on Town Street, was not surveyed by ORNL; however, ORNL staff reviewed the BNI survey data and found it to reasonably demonstrate compliance.

Fig. 1. Drawing of the buildings on the B&T Metals property, Columbus, Ohio. The two manholes on the south side of the main building were also surveyed.

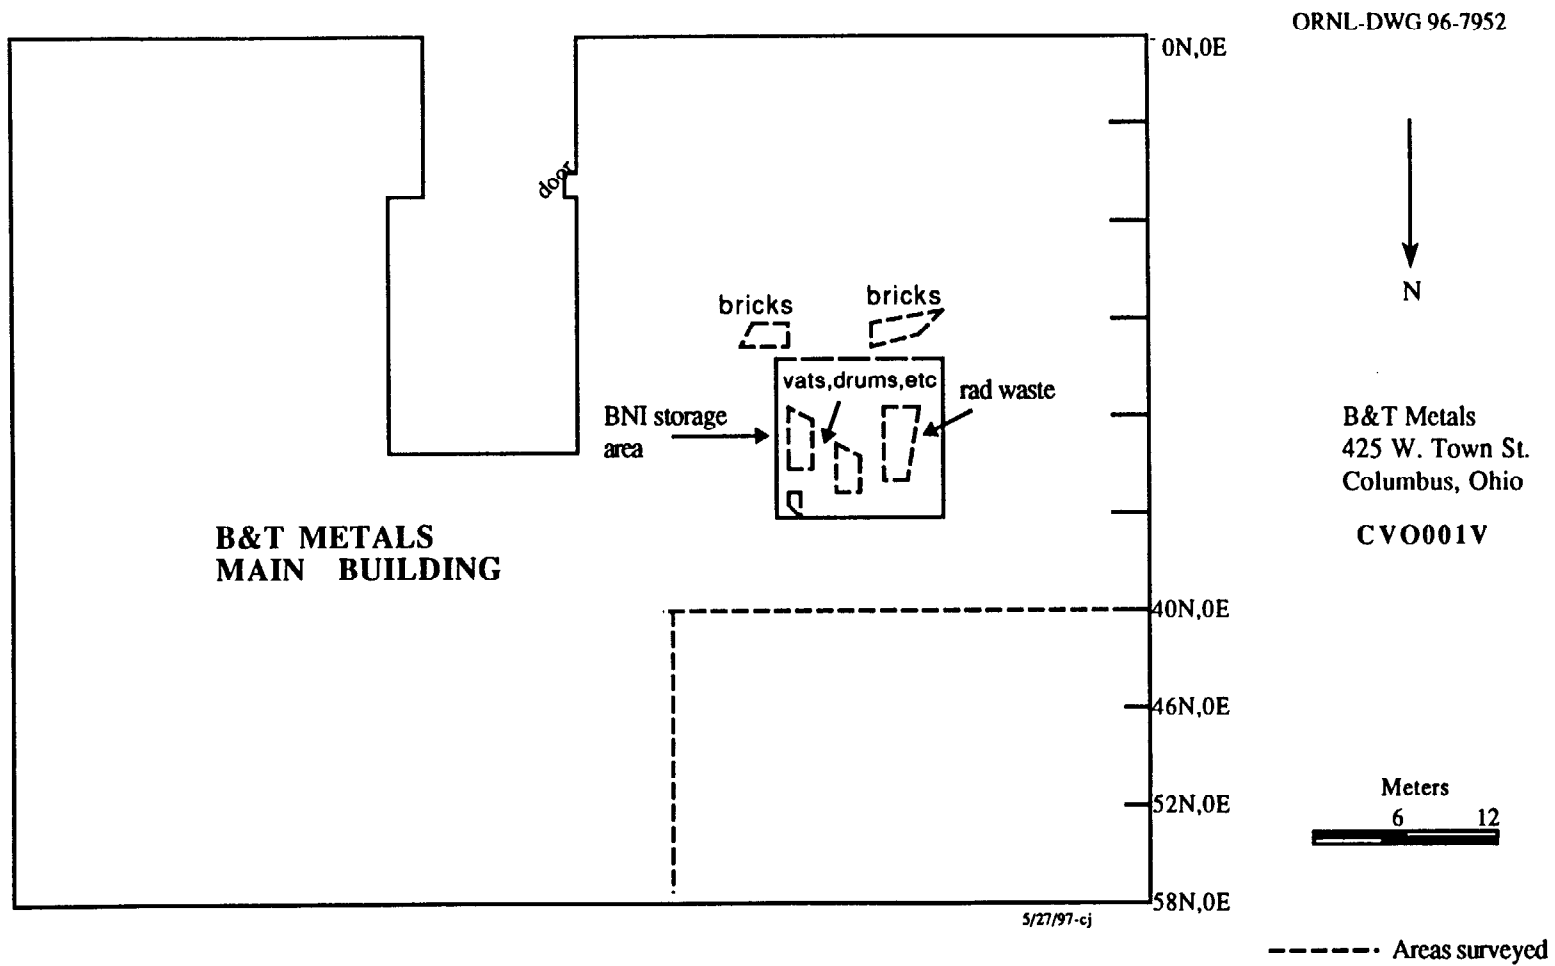
Fig. 2. Drawing showing the general location of materials surveyed and left in the BNI storage area in the main building of the B&T Metals Company.

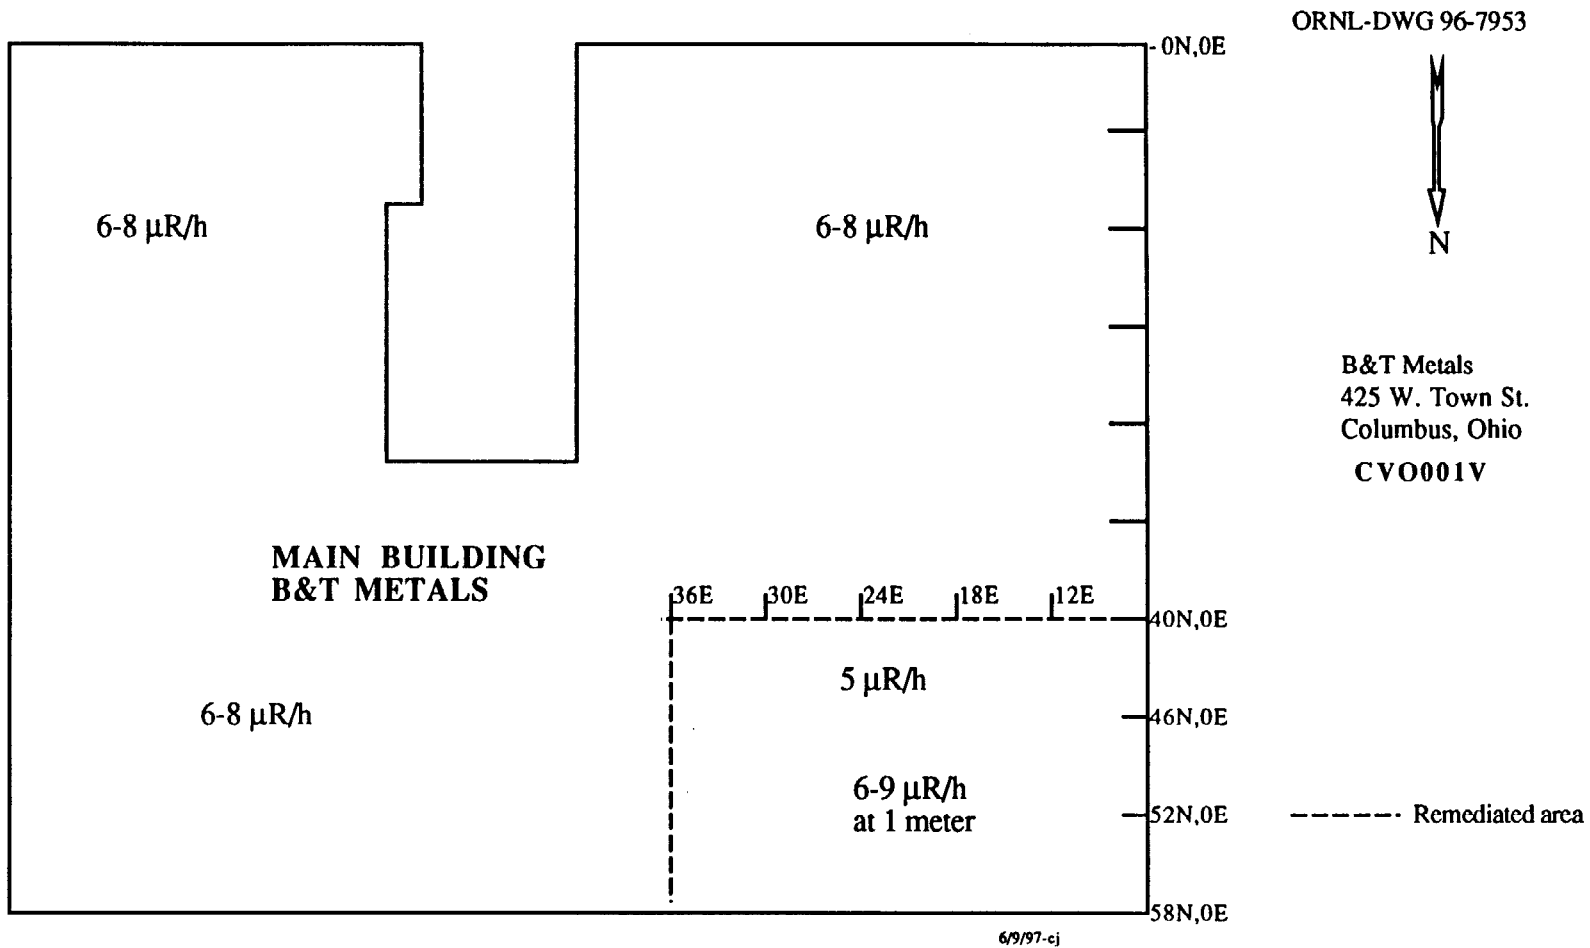
Gamma exposure rates ranged from 6 to 9  $\mu\text{R/h}$  at 1 m above the floor while surface exposure rates ranged from 6 to 8  $\mu\text{R/h}$  on the first and second floors of the main building (Fig. 3). These values are comparable to the typical range of background levels for the area of 7 to 9  $\mu\text{R/h}$  (Table 2). Gamma levels at accessible floor and wall surfaces were slightly higher on contact with bricks, concrete, and other materials that contain naturally occurring radioactivity.

Fig. 3. Drawing showing gamma measurements taken throughout the main building on the property of the B&T Metals Company. The northwest corner of the building (remediated area) is marked off in 6-m grids.

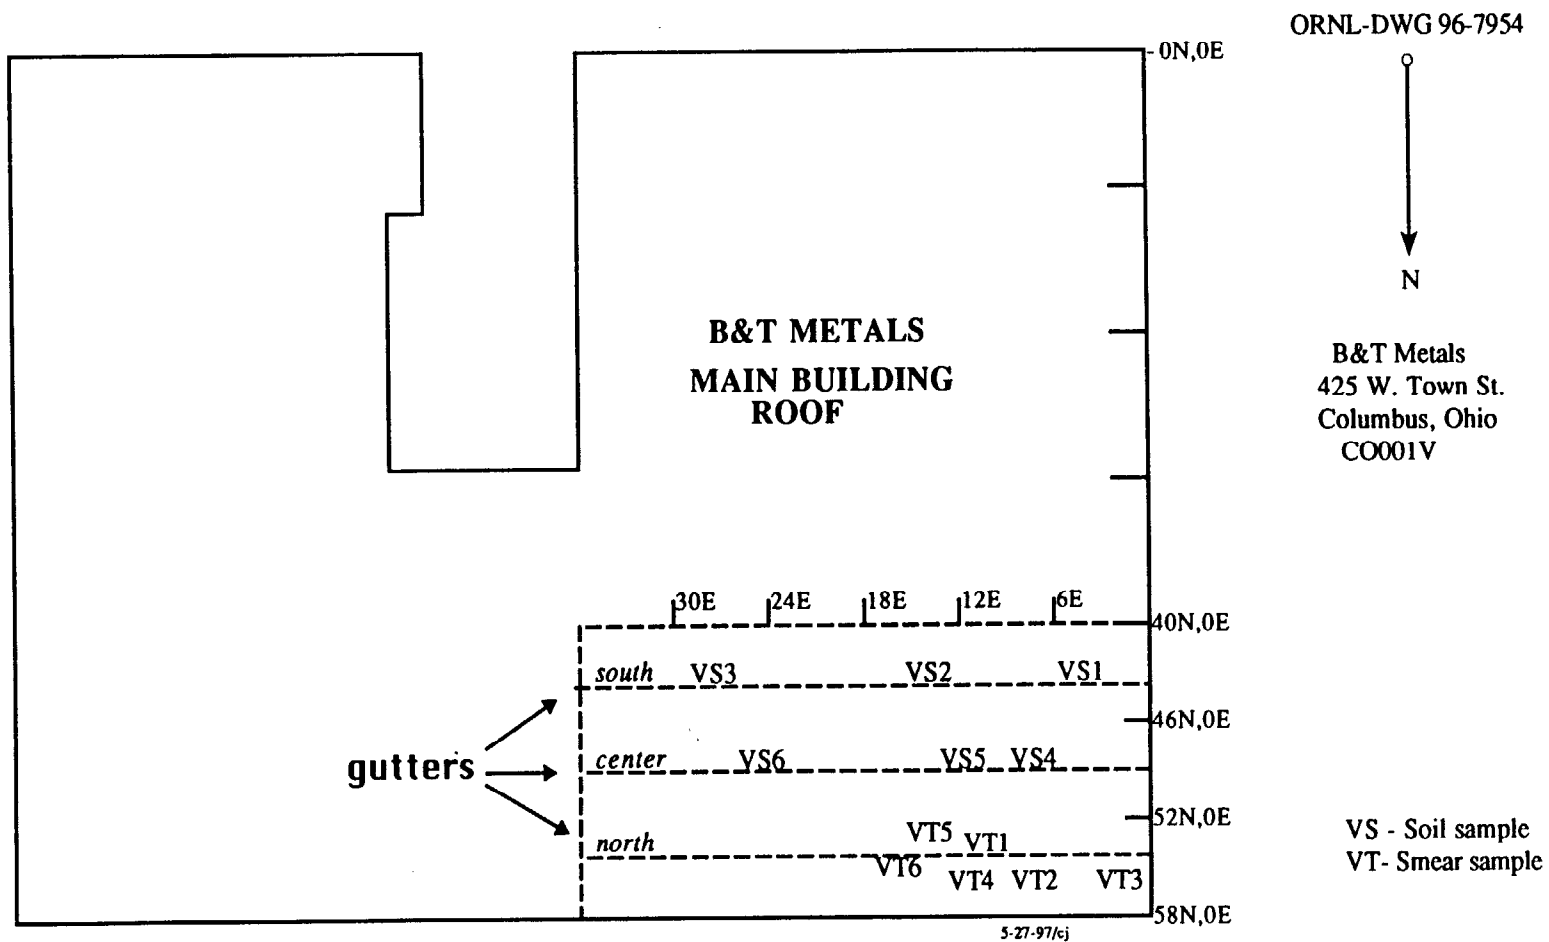
The gutters running east to west on the roof (Fig. 4) were surveyed for residual activity. Spots ranging from 240 to 320 dpm/100 cm<sup>2</sup> were measured on the center and south gutters. Samples were taken of the tar-like material in the gutters and analyzed for radionuclide concentrations. Results of the analysis are shown on Table 3.

The general scan range of the north gutter was 1500 to 4500 dpm/100 cm<sup>2</sup> beta-gamma, with spots ranging from 1500 to 2750 dpm/100 cm<sup>2</sup>. The north gutters did not have the tar base, therefore no samples could be taken at the elevated spots. Even though the direct measurements were less than the guidelines for fixed contamination, smears were taken from the north gutter at these spots to ensure the guidelines for transferrable contamination were satisfied.

The locations of the smears are shown on Figs. 4 and 5. Results from the smear analyses indicate no removable beta-gamma or alpha activity above guidelines. Results of the smear analyses are presented on Table 4. With the exception of one smear sample taken from an overhead truss which measured 42 dpm/100 cm<sup>2</sup> alpha activity (sample VT7), all other measurements were less than the instrument-specific critical detection level ( $L_c$ )\*.

Fig. 4. Drawing showing the northwest corner of the roof of the main building where the north, south, and center gutters lie east to west. Approximate locations of the soil and smear samples taken from the gutters are indicated. The results of the analyses are shown in Tables 3 and 4. (Drawing not to scale)

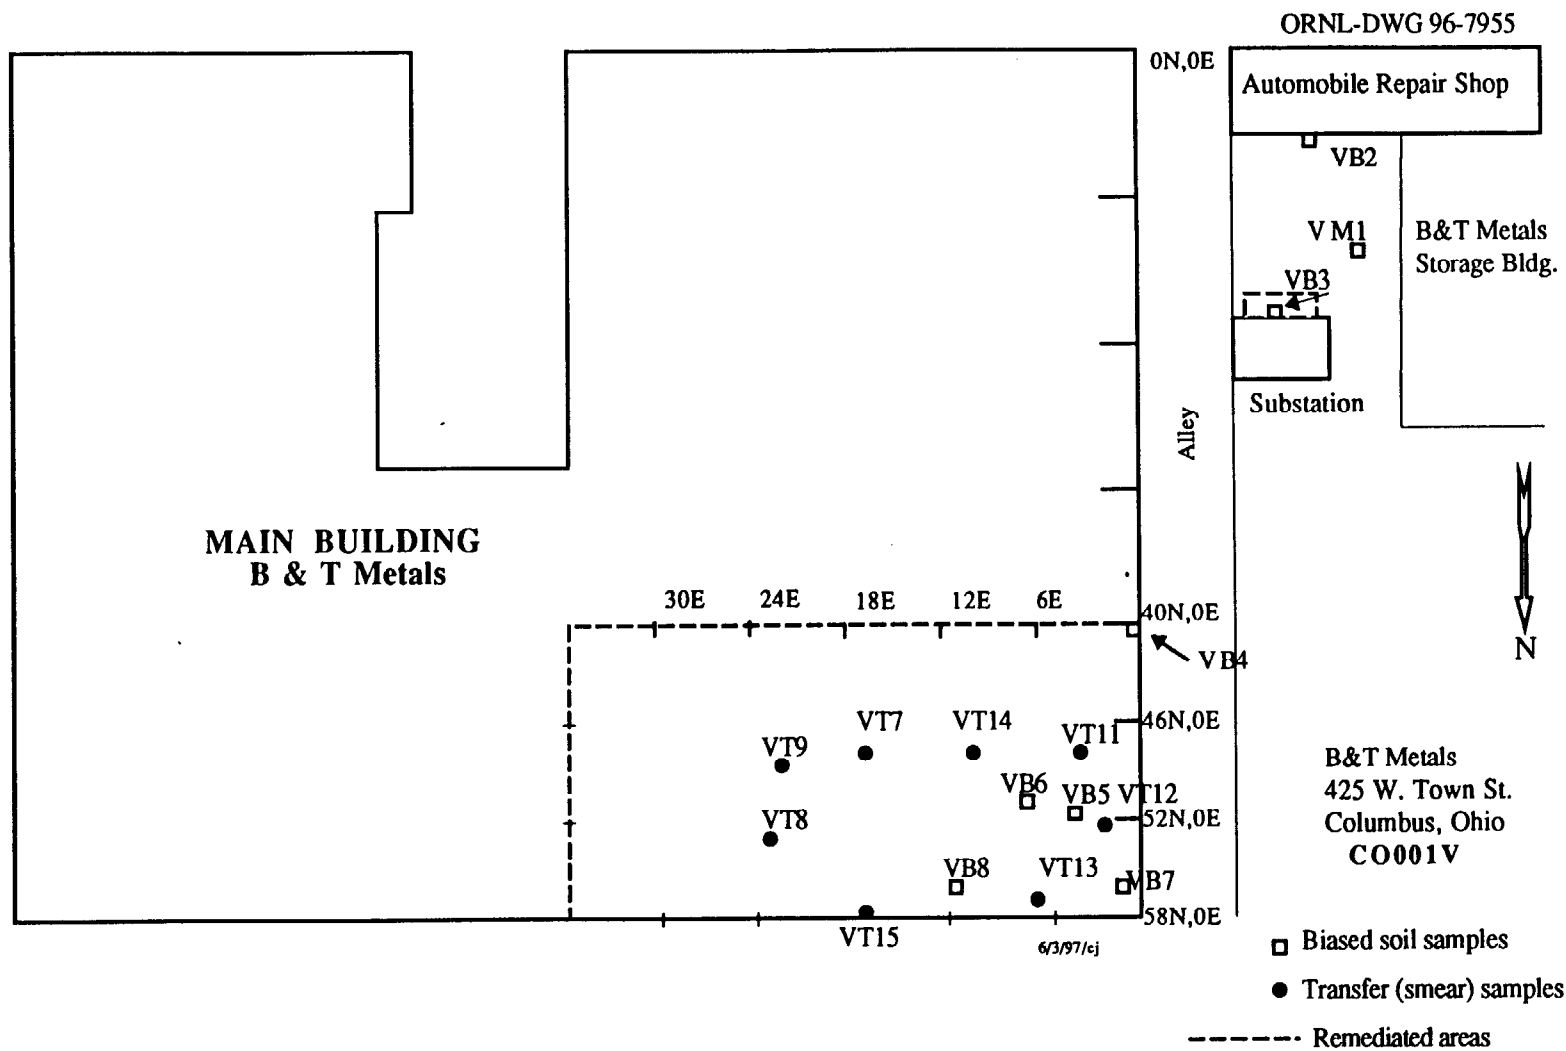
Systematic and biased samples of soil and other material were taken outdoors west of the main building between the substation and the storage building, and on the roof from the gutters. Samples were taken indoors under the concrete floor where trenches had formed in the crumbling concrete. Sample locations are shown on Figs. 4 and 5.

Fig. 5. Locations of smears taken inside on overhead structures, and soil samples taken both inside and outside the main building. Results of analyses are shown on Tables 3 and 4. (Drawing not to scale)
