*Certification Docket for the  
Remedial Action Performed  
at the Associate Aircraft Site,  
Fairfield, Ohio, 1994-1995*

*Department of Energy  
Former Sites Restoration Division  
Oak Ridge Operations Office*

*October 1996*

**Bechtel National, Inc.**

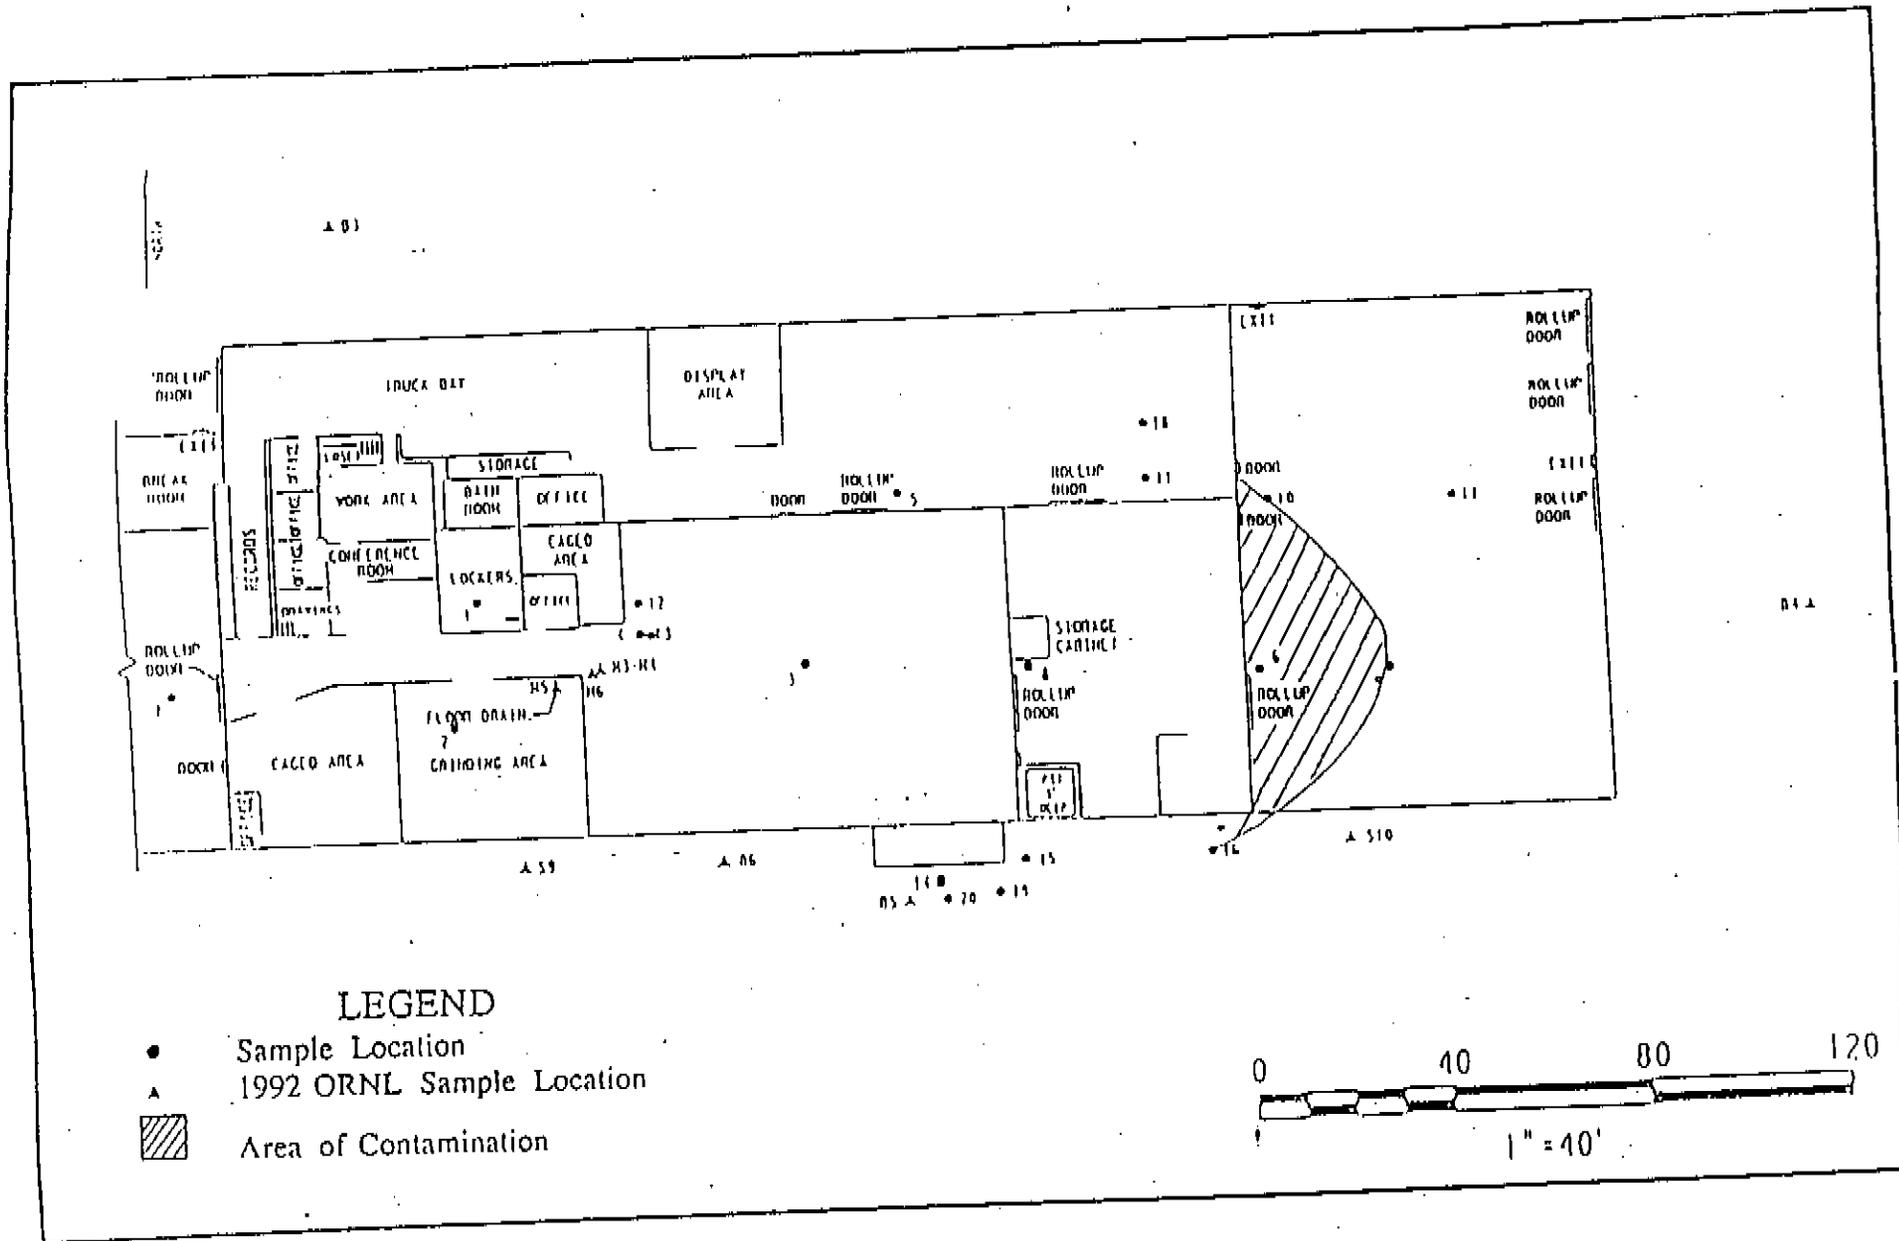
Figure 1  
Former Associate Aircraft Site

To determine the hazard associated with the localized sub-slab contamination found at the Associate Aircraft Site (AAS) in Fairfield, Ohio under a portion of the former AAS building (see figure 1). This assessment leads to the conclusion that the potential dose from the residual soil contamination is well below the current or likely use guideline, as proposed in 10 CFR 834.

Based on the results obtained, uranium-238 concentrations above the site specific criteria (35pCi/g) were found at locations 1, 4 and 6. Uranium-238 concentrations from the sampling locations in these areas are presented in Table 2. The radioactive contamination detected at locations 4 and 6 were delineated in a second phase of sampling by placement of sample locations 10, 9 and 16 for location 6, and additional sample locations 12 and 13 for location 4. Vertical and areal extent of contamination has thereby been established for these locations. The areas around location 1 and 4 were adjacent to a radioactively contaminated expansion joint and have since been remediated. Therefore this hazard assessment applies to the area in the proximity location 6.
