*Certification Docket for the Remedial
Action Performed at the
Former Herring-Hall-Marvin Safe
Company Site in Hamilton, Ohio*

*Department of Energy
Former Sites Restoration Division
Oak Ridge Operations Office*

December 1996

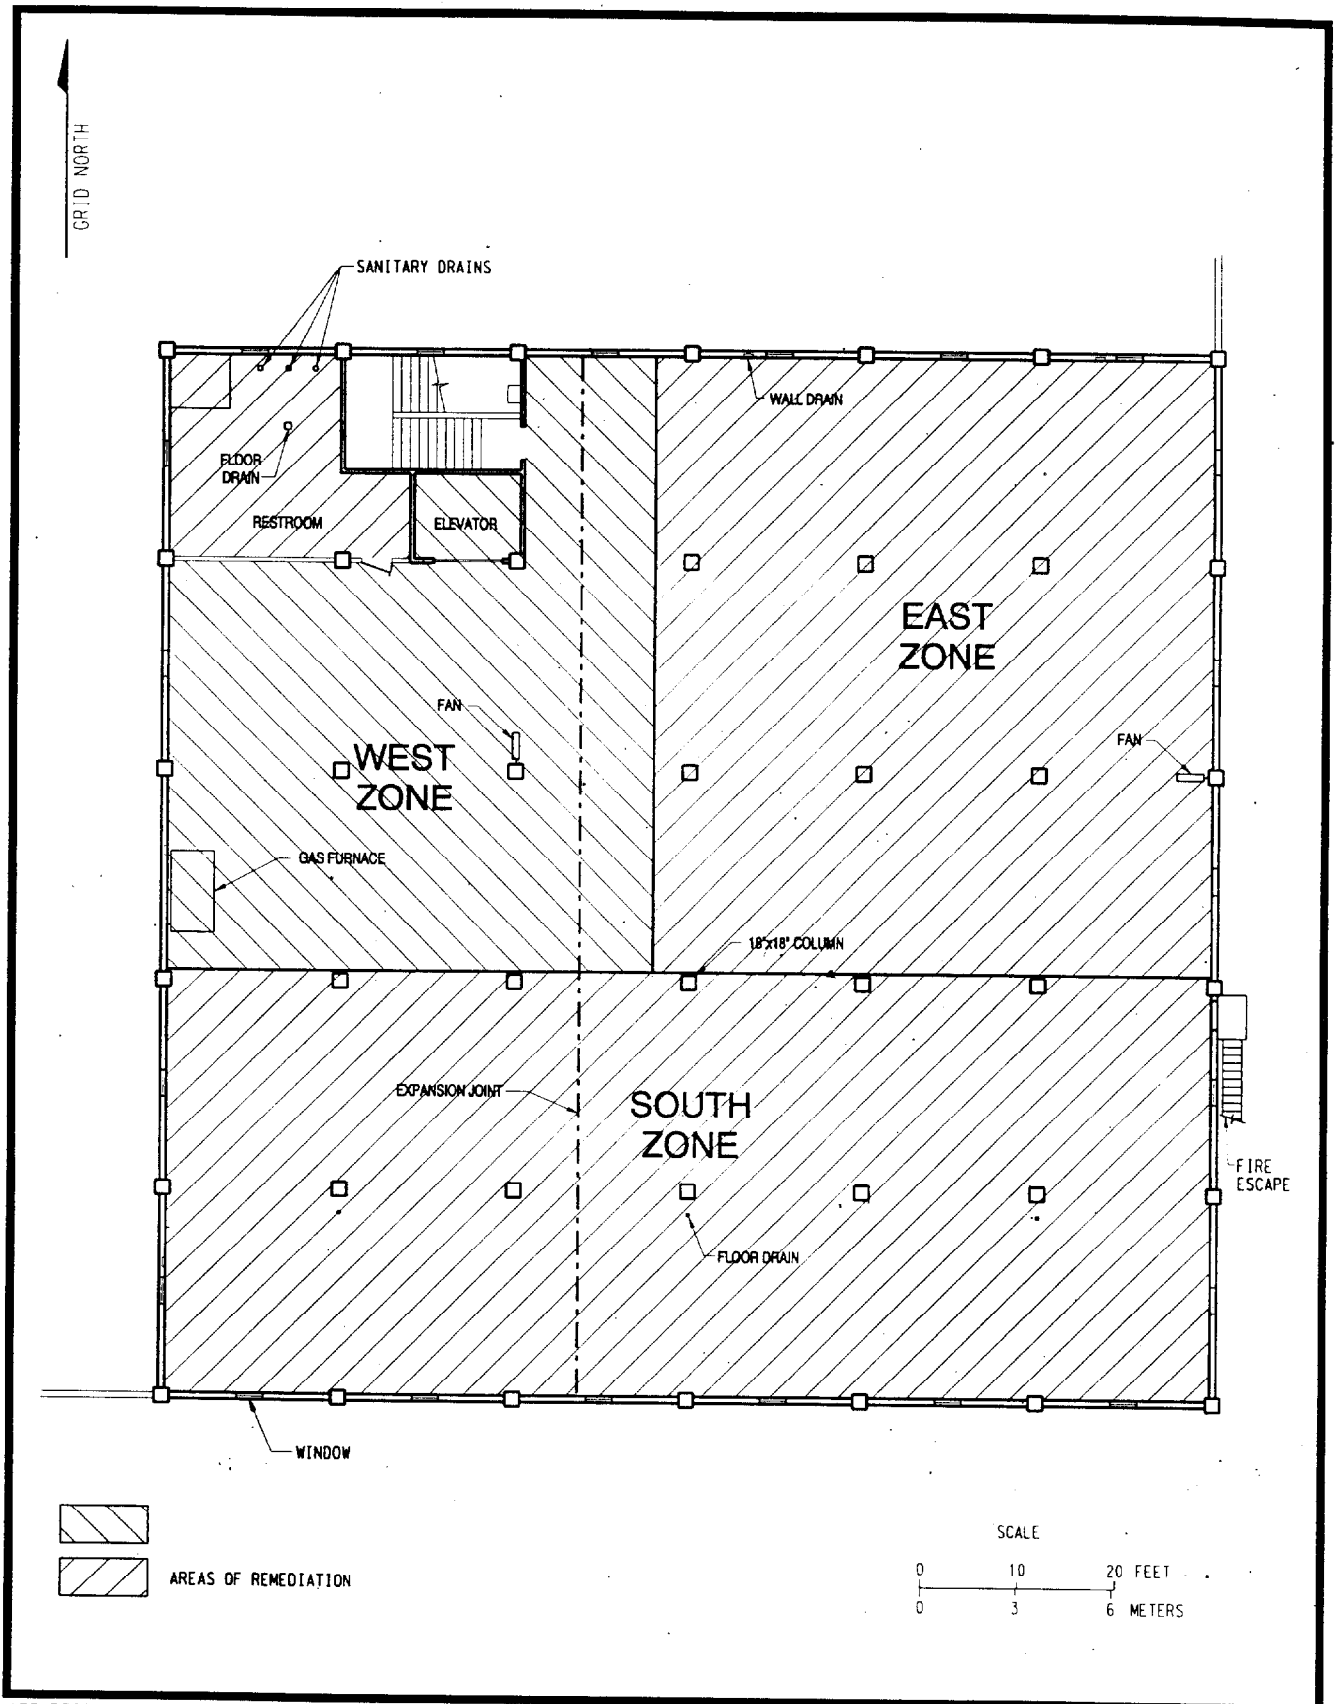
Figure I-5
 Herring-Hall-Marvin Safe Facility
 Areas of Remediation - Third Floor

The interior areas requiring remedial action were

- the entire floor surface [approximately 836 m² (9,000 ft²)], including approximately 1,150 lead anchor bolt sleeves;
- approximately 107 m² (1,150 ft²) of the northern wall and approximately 26 m² (275 ft²) of the eastern wall;
- two fans in the ceiling;
- portions of the elevator operations room above the elevator; and
- floor drains in the former production area and restroom.

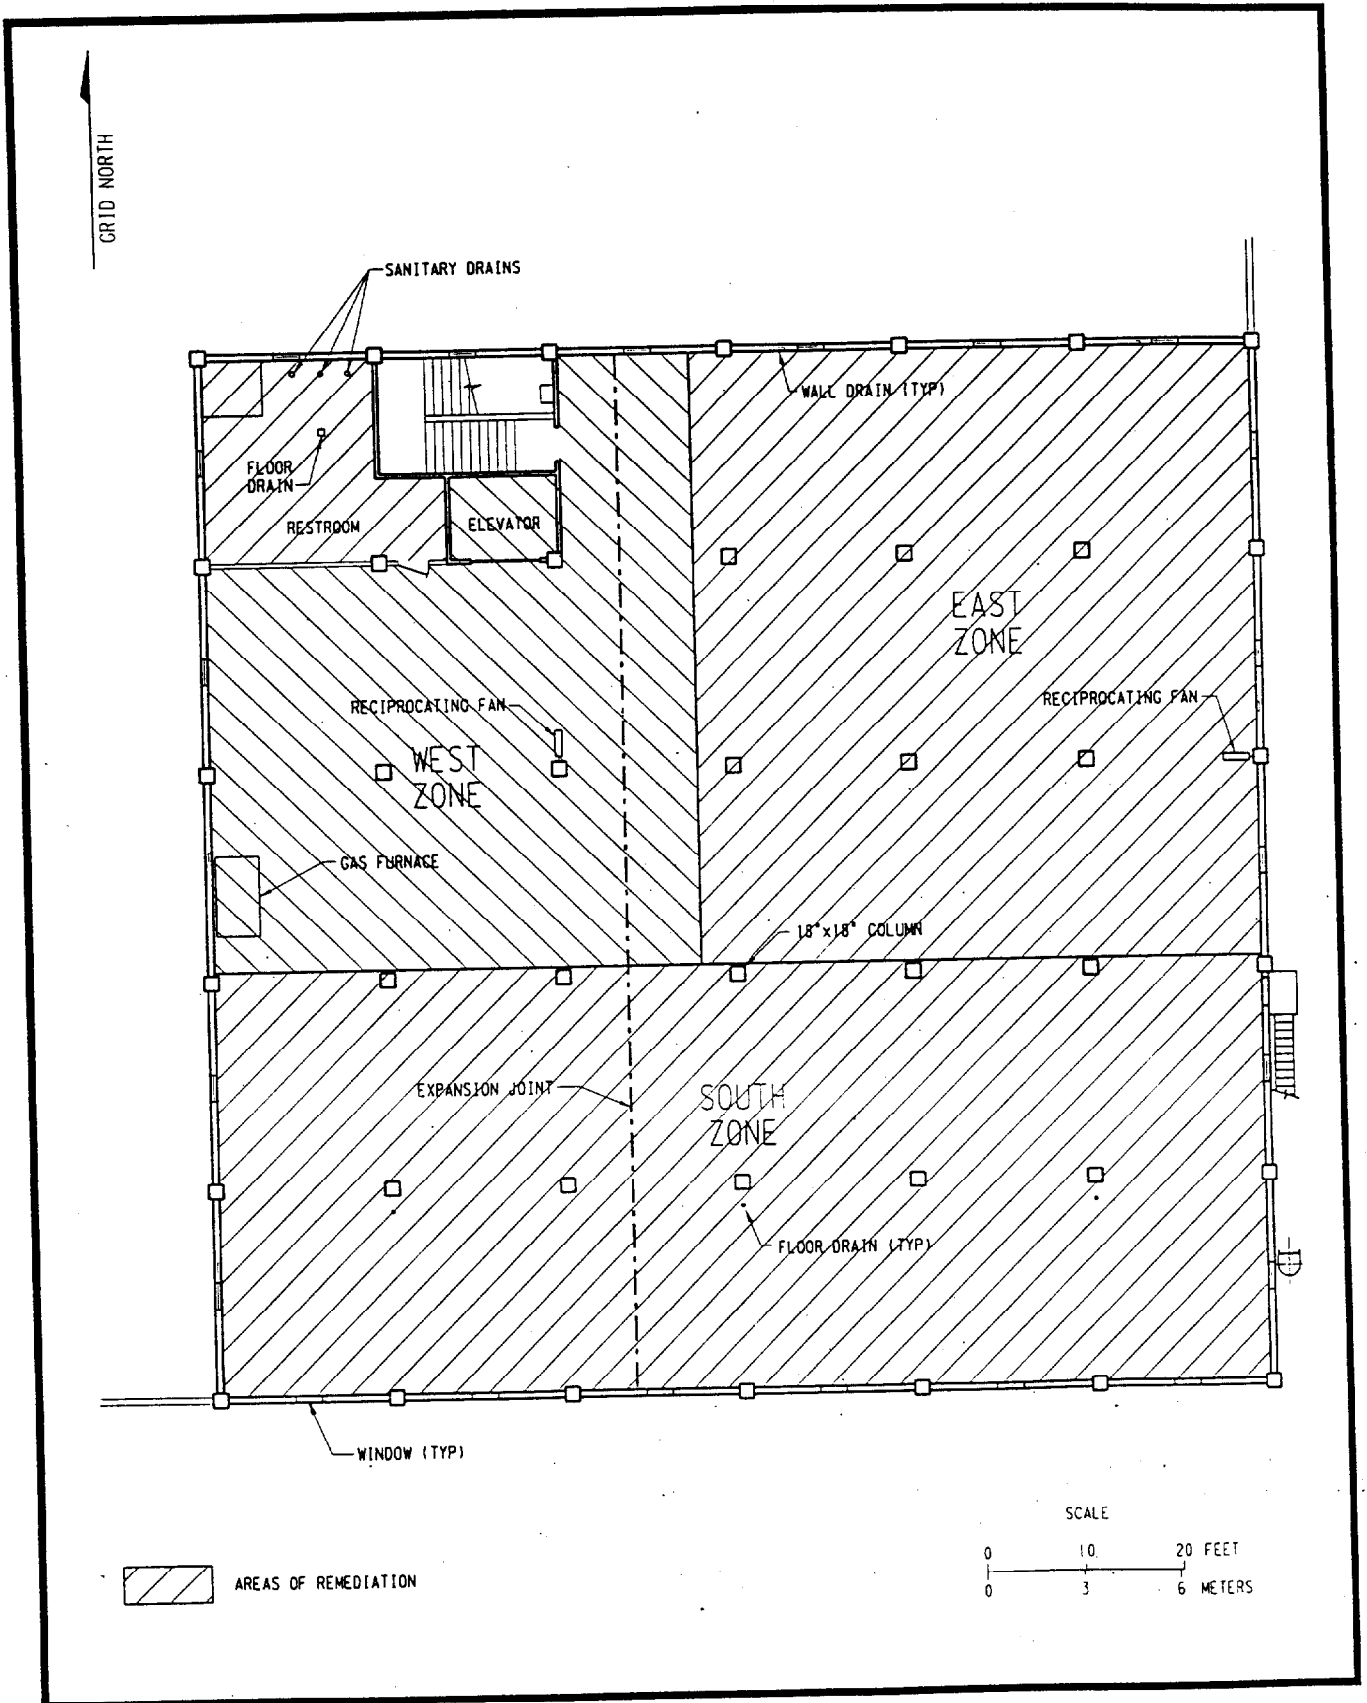
Figure III-1
 Herring-Hall-Marvin Safe Facility
 Areas of Remediation - 3rd Floor

The figures provided on the following pages are taken from the post-remedial action report; they illustrate the extent of remedial action performed at the HHMS site.
