9.0 Lakeview, Oregon, Disposal Site

The Lakeview, Oregon, Uranium Mill Tailings Radiation Control Act (UMTRCA) Title I Disposal Site was inspected June 30, 2021. No changes were observed on the disposal cell or in the associated drainage features. Inspectors identified minor maintenance needs but no cause for a follow-up or contingency inspection.

Figure 9-1. 2021 Annual Inspection Drawing for the Lakeview, Oregon, Disposal Site

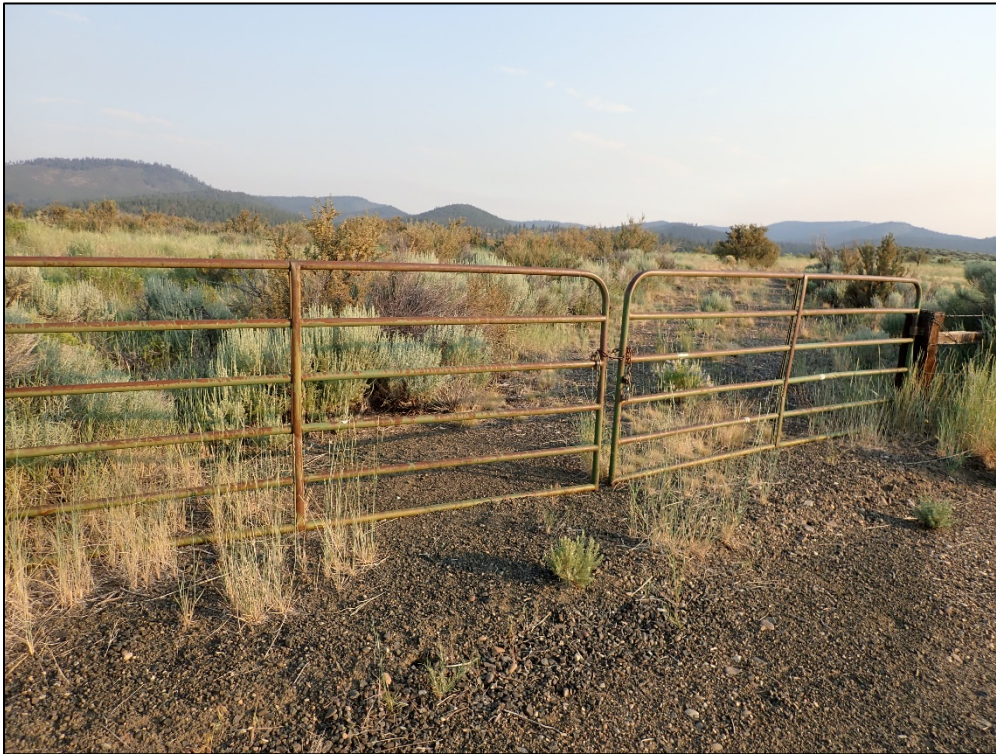
PL-1. Site Entrance Gate

Access to the site is from a gravel road that heads west from Lake County Road 2-16B. DOE was granted a perpetual easement on the approximately 1.2-mile access road between the county road and property boundary. A lockable gate across the access road on the adjacent privately owned land limits access to the site. The entrance gate to the site is in the southeast corner of the perimeter fence. The entrance gate was locked and undamaged (PL-1). The entrance sign is attached to a steel post set in concrete along the access road and was undamaged. A pedestrian gate in the northwest corner of the site was locked and undamaged. No maintenance needs were identified.

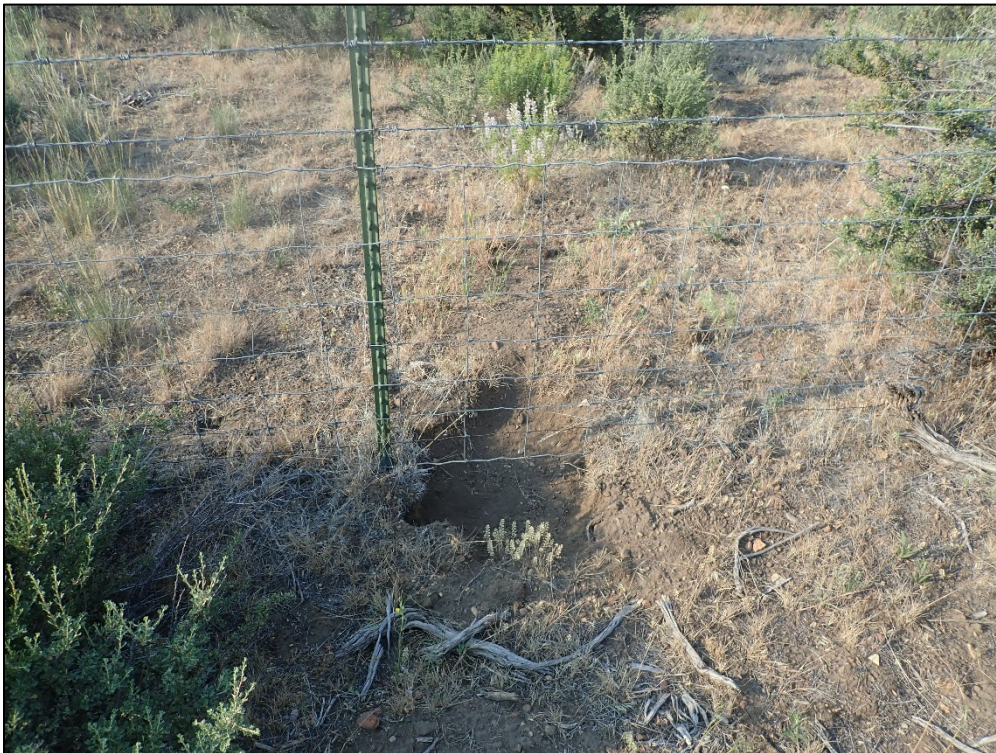
A four-strand barbed-wire perimeter fence (five-strand along much of the western boundary) encloses the site. Some vegetation is growing near, and entangled in, the perimeter fence line, but the fence appeared stable and remains functional. A bent fence post was observed near the southeast corner of the site and will be fixed during the next maintenance event. A small animal burrow (PL-2) was identified near the northeast corner of the fence line, but it is not a concern to the security or integrity of the fence.

PL-2. Animal Burrow near Northeast Corner of Site

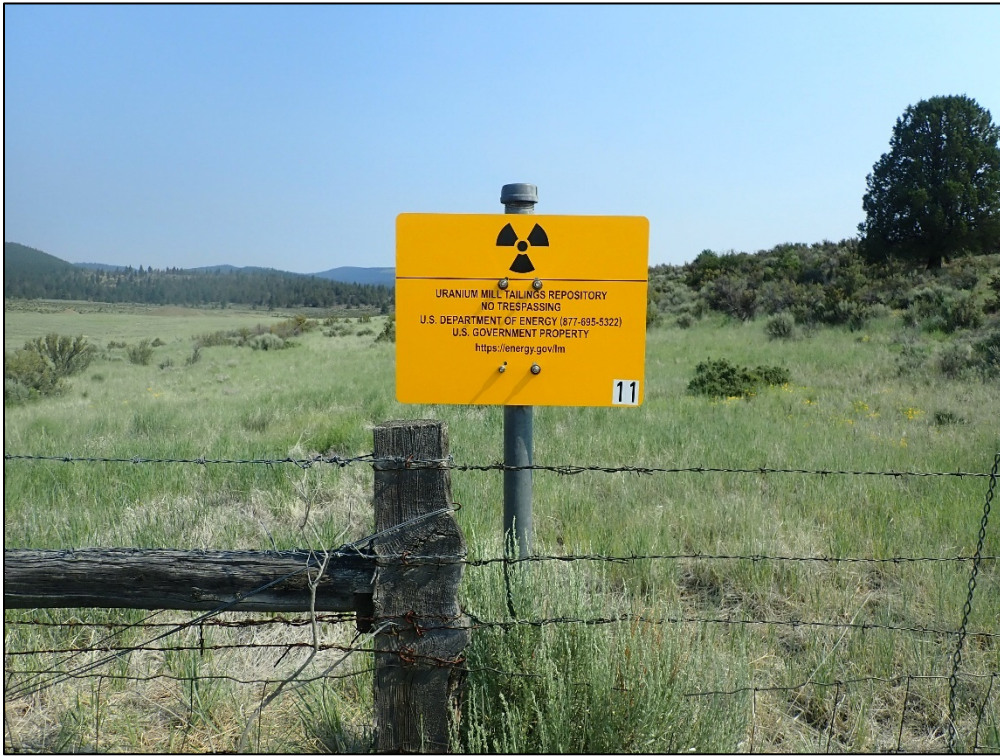
There are 12 perimeter signs, attached to steel posts set in concrete, positioned along the property boundary. Perimeter signs P10, P11, and P12, identified in the 2020 inspection as faded, were replaced with new signs (PL-3). No new maintenance needs were identified.

PL-3. New Perimeter Sign P11

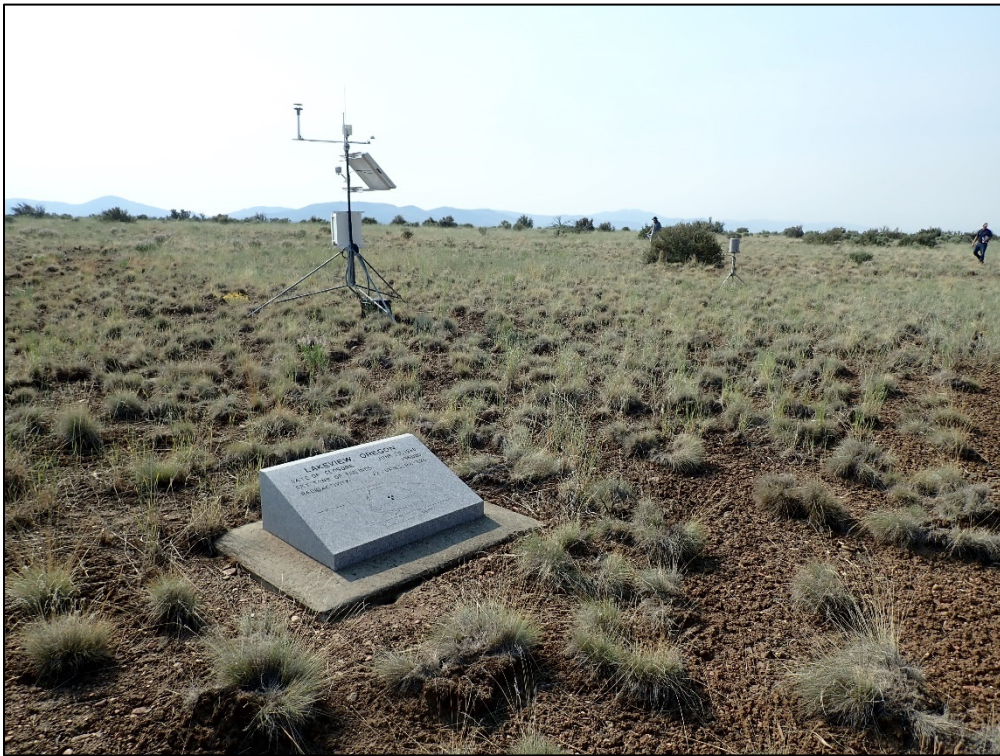
PL-4. Granite Site Marker 2

The site has two granite site markers. Site marker SMK-1 is just inside the entrance gate, and site marker SMK-2 (PL-4) is on the top slope of the disposal cell. No maintenance needs were identified.

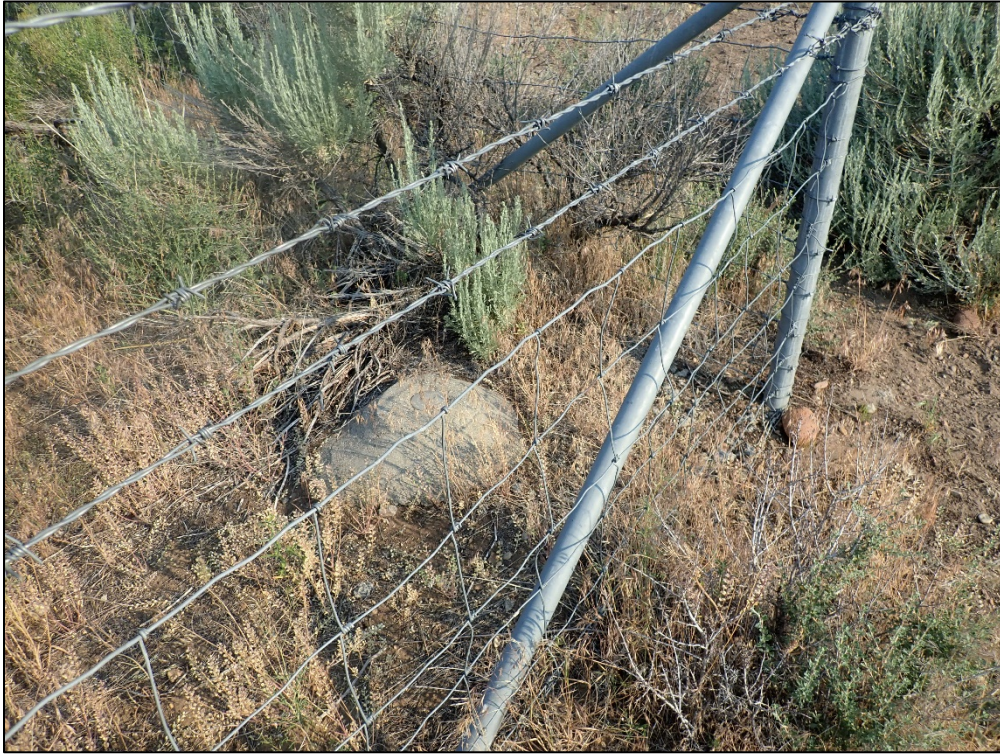
PL-5. Survey Monument 1

Three survey monuments (PL-5) and three boundary monuments delineate the property boundary. No maintenance needs were identified.

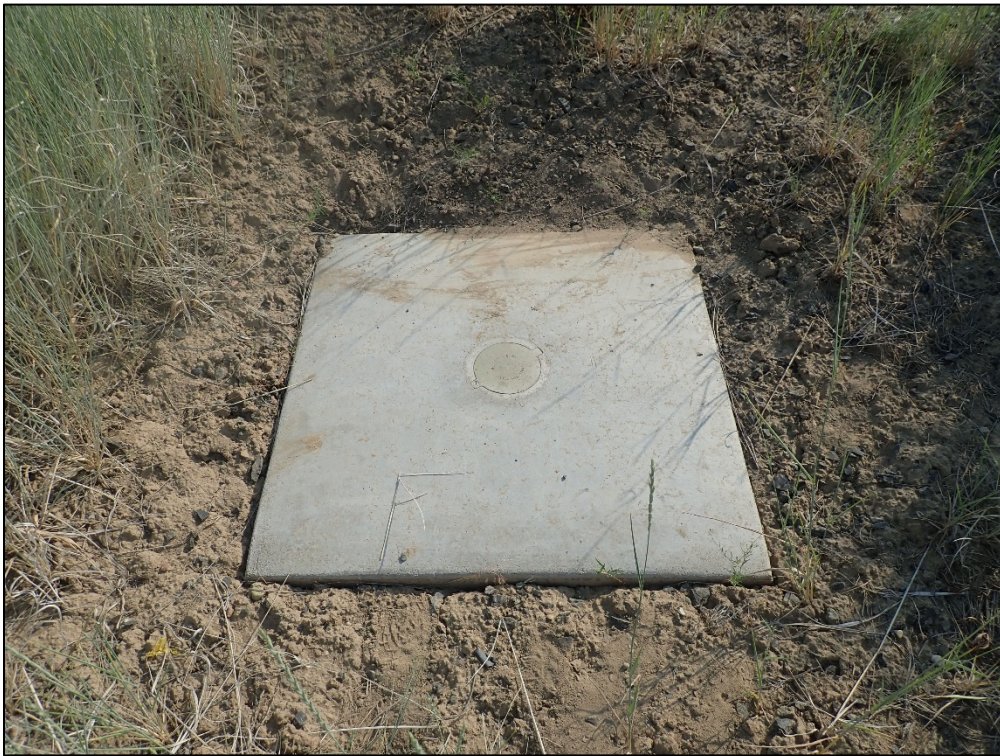
PL-6. Quality Control Monument QC5

In August 2019, five aerial survey quality control monuments (PL-6) were installed at the site in preparation for a baseline aerial survey of the disposal cell. These quality control monuments were inspected in 2021. No maintenance needs were identified.

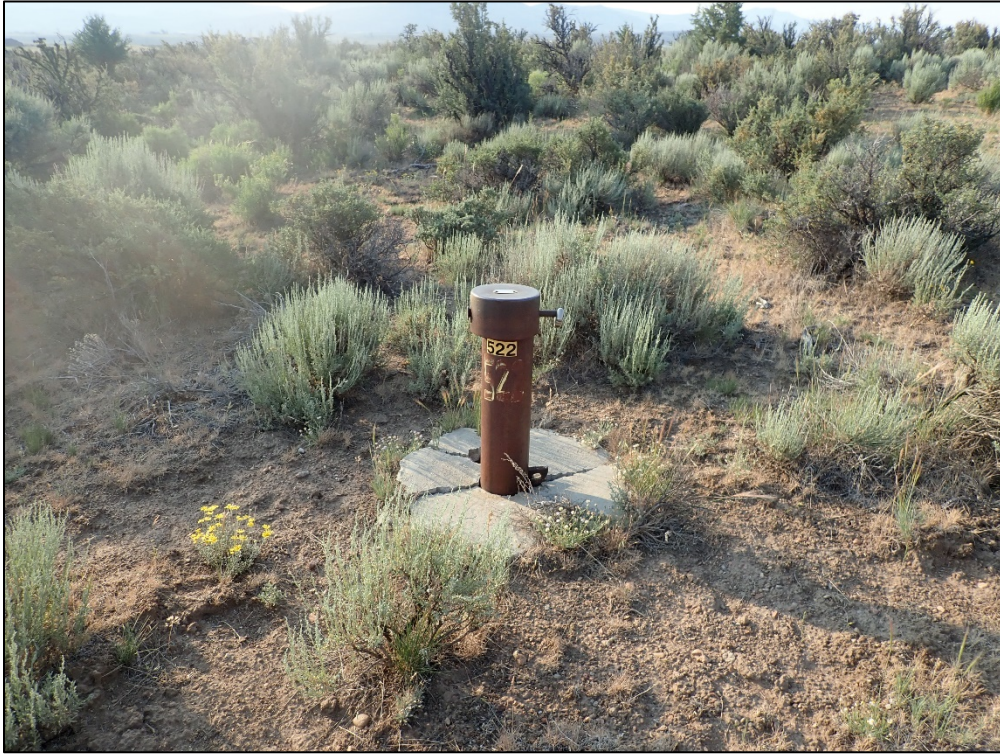
The site has 12 downgradient groundwater monitoring wells with four wells offsite to the east. Four upgradient wells are offsite to the west. A few of the concrete bases were cracked (PL-7), but the wellhead protectors remain stable. The wellhead protectors were locked and undamaged. The broken T-post adjacent to well 0516 observed during the 2020 inspection was removed during the 2021 inspection. No additional maintenance needs were identified.

PL-7. Monitoring Well 0522

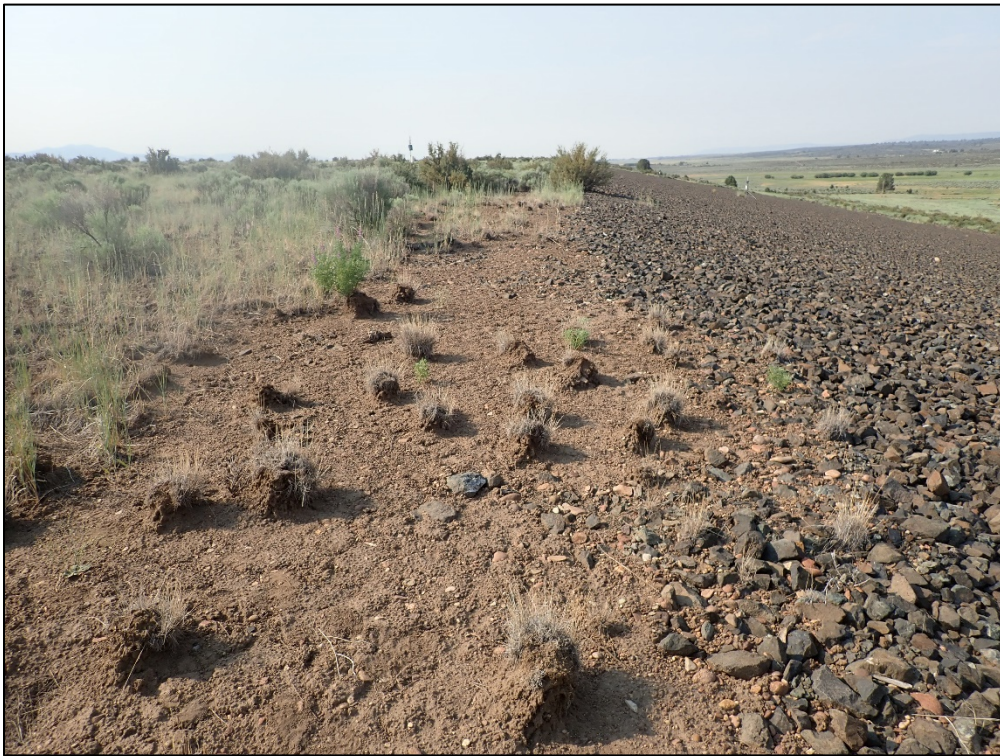
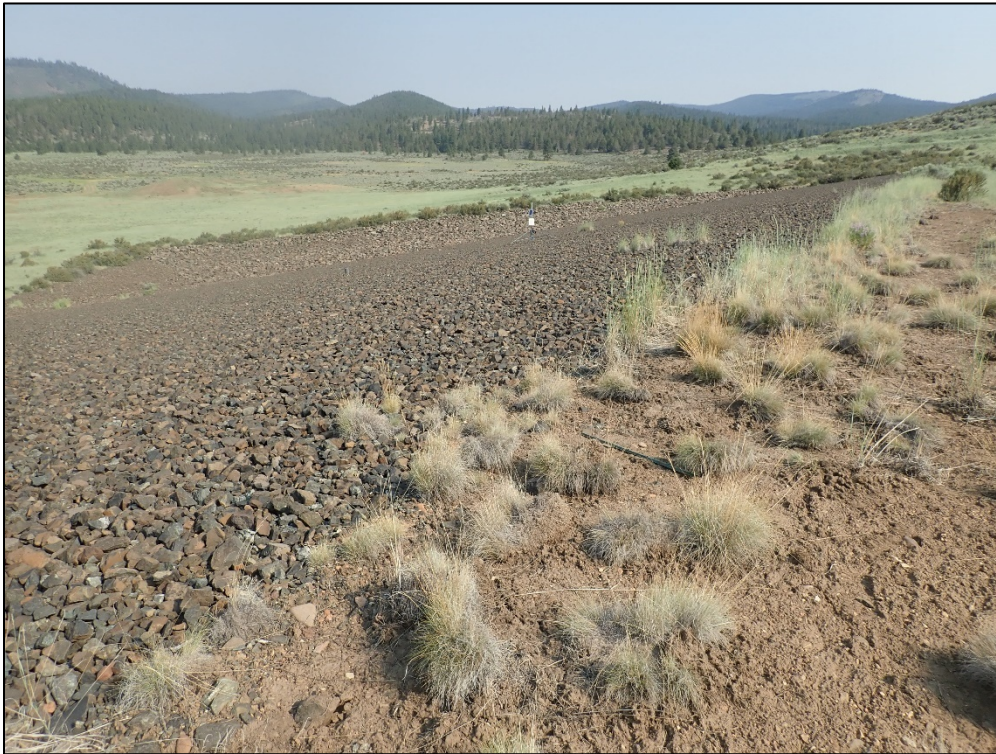
The contact boundary between the disposal cell top and side slopes was inspected and generally appears stable and uniform (PL-8 and PL-9). No erosion was observed during the inspection at the crest of the west side slope and the disposal cell top slope, which appears to be stable. Inspectors will continue to monitor the transition zone between the disposal cell top slope and the west side slope for erosion development. There was no evidence of settling, slumping, erosion, or any other modifying process on the top of the disposal cell that might affect the integrity of the disposal cell.

In 2015, LM proposed to replace annual gradation monitoring with inspection of rills that may form along the interface between the vegetated soil and rock top slope and the rock-covered west side slope (Dayvault 2015). Focusing on these areas allows LM to assess conditions that may indicate the development of potential failure points along the side slope. In 2019, NRC concurred with the discontinuation of rock gradation monitoring (Mandeville 2019); therefore, it was not performed in 2021. DOE is updating the LTSP to reflect this change. No rills or erosional features were observed along the interface between the vegetated soil and rock top slope during the inspection (PL-8 and PL-9).

PL-8. Top Edge of West Side Slope

PL-9. Top Edge of West Side Slope

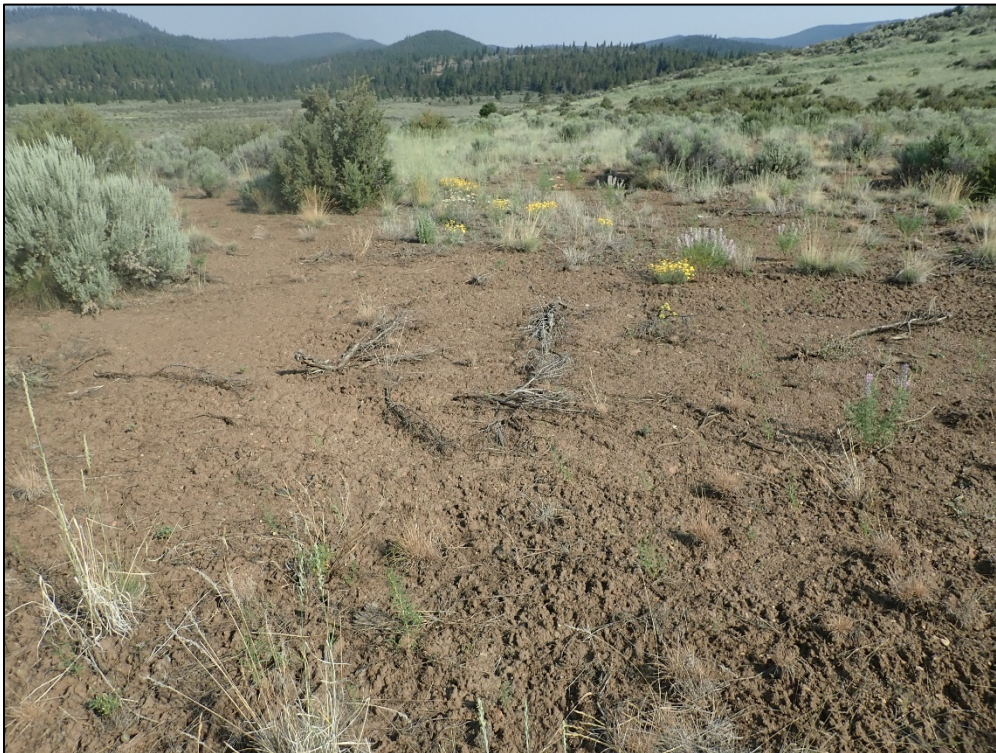
LM is participating in an NRC-sponsored project to investigate the effect of soil-forming processes on the performance of the radon barrier on UMRCA disposal cells. In October 2017, researchers excavated through the cover materials (soil, riprap, bedding material, and underlying radon barrier) at six locations on the disposal cell (five on the top slope and one on the west side slope) to support the study. Areas restored and reseeded in 2017 as part of the study were observed to have vegetation growth (PL-10). Inspectors will monitor the restored locations to confirm that no settlement is occurring, positive drainage is preserved, and vegetation reestablishes. No maintenance needs were identified.

PL-10. Reclamation of 2018 Soil Cover Study Test Area

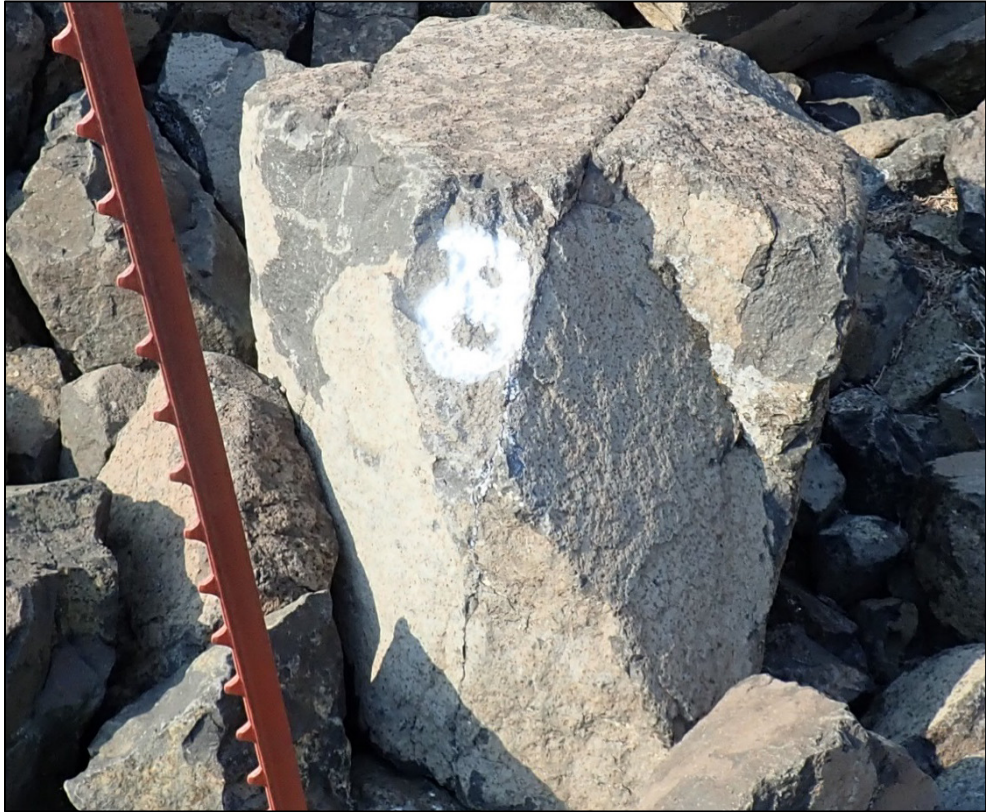
Minor rock degradation has been observed in the EDA since monitoring began at the original 10 photograph locations established in 1997 and at the 8 additional locations established in 2000. Annual photographic monitoring of the 18 locations for long-term rock monitoring was conducted during the 2021 inspection (PL-11). In 2018, it was observed that some of the numbered rocks had faded labels, and they were repainted in 2019. No significant degradation of the EDA rock has been observed since monitoring began.

PL-11. Riprap Monitoring Location No. 8 in the Energy Dissipation Area
