9.0 Lakeview, Oregon, Disposal Site

9.1 Compliance Summary

Figure 9-1. 2022 Annual Inspection Drawing for the Lakeview, Oregon, Disposal Site

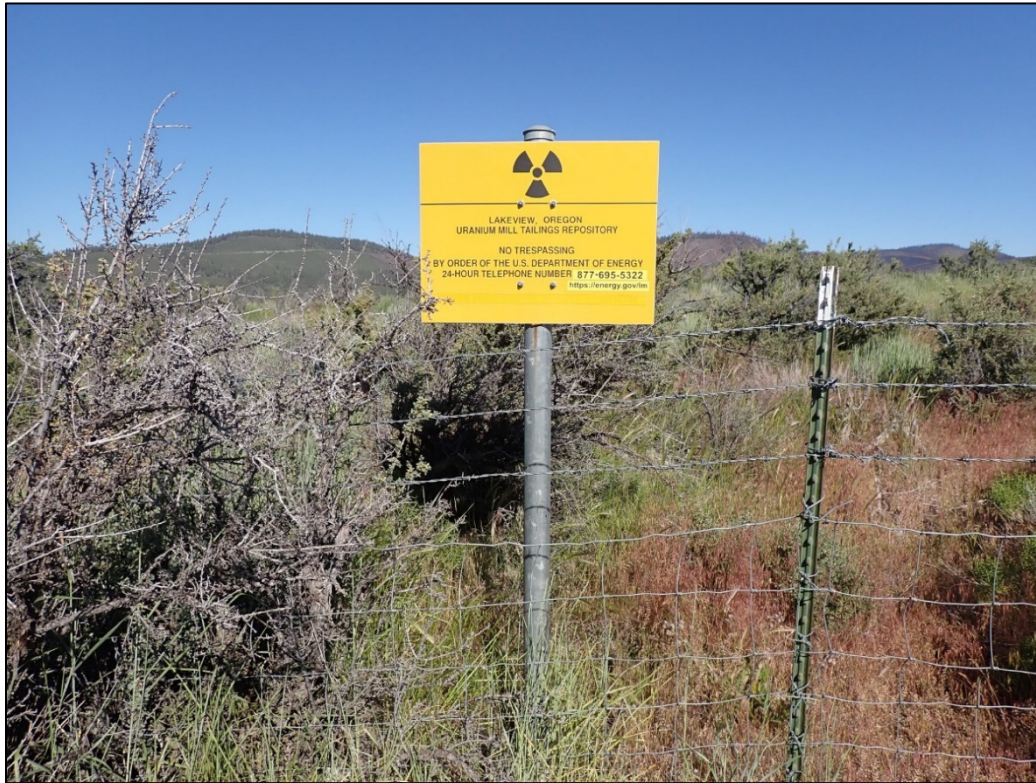
PL-1. Site Entrance Sign

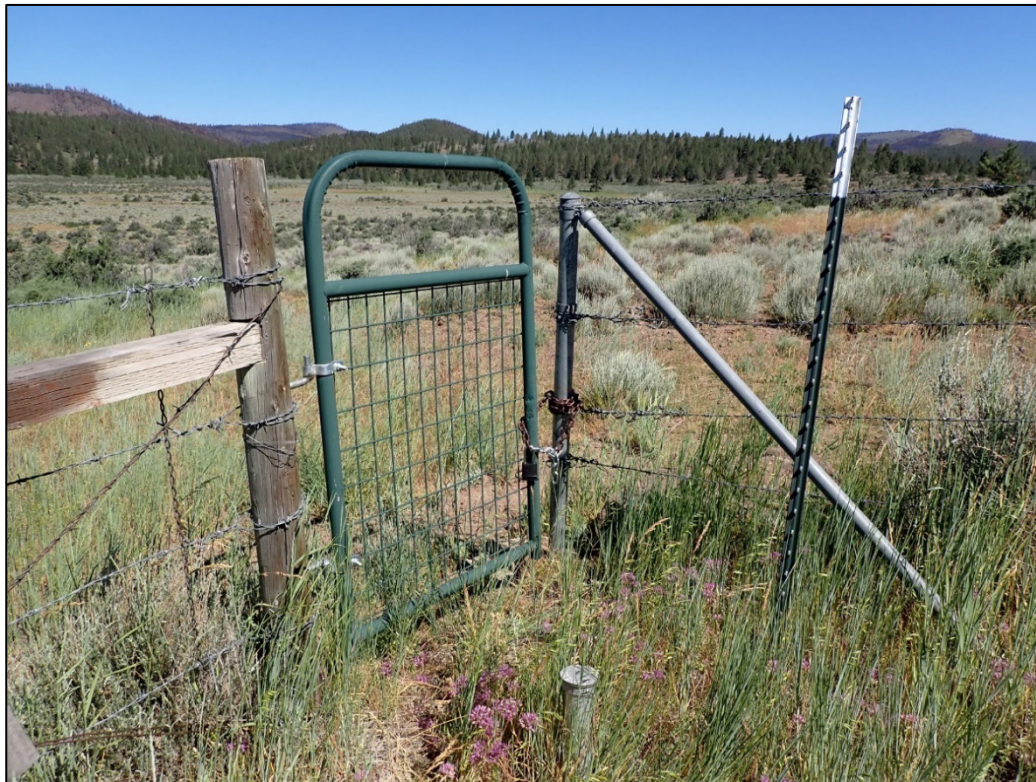
PL-2. Pedestrian Gate

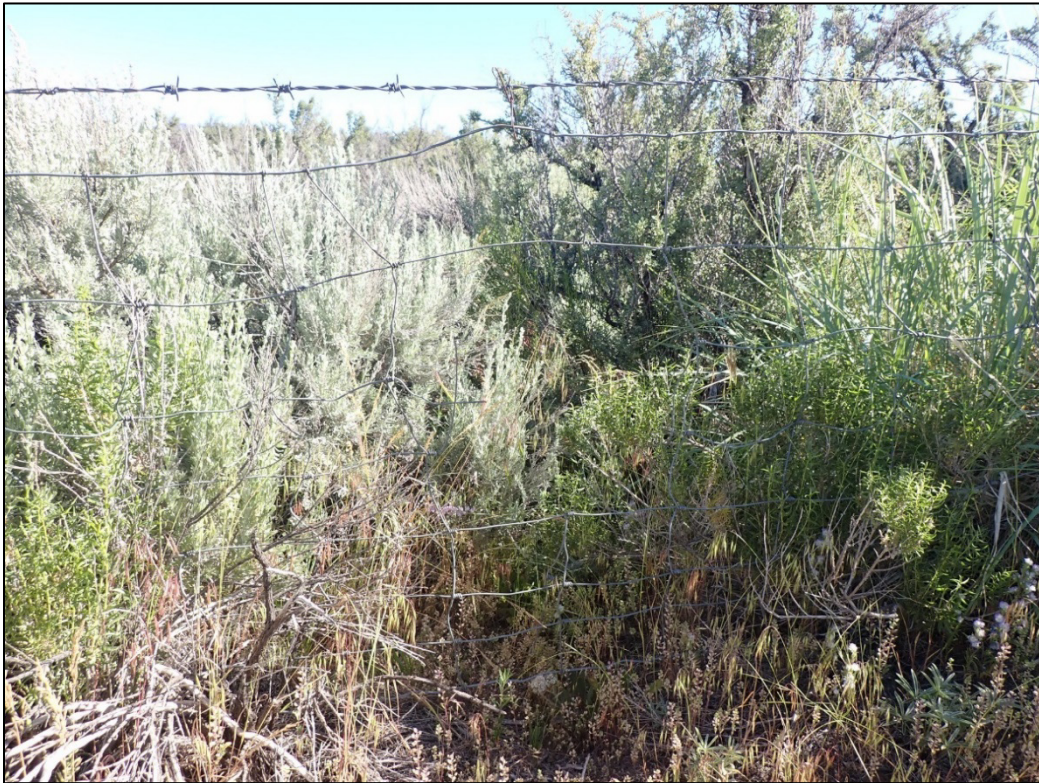
A four-strand barbed-wire perimeter fence (five-strand along much of the western boundary) encloses the site. There is also sheep fencing on the southeastern and southern boundaries of the site. Some vegetation is growing near, and entangled in, the perimeter fence line, but the fence appeared stable and remains functional. A bent fence post was observed during the 2021 inspection near the southeast corner of the site and will be repaired in the future. A small hole in the sheep fence was observed in the south fence line (PL-3). The hole appears to be man-made, possibly to help young animals escape through the fence. Evidence of minor erosion due to digging by animals under the fence was identified near the northeast and southeast corners of the fence line, but this is not a concern to the site security or the integrity of the fence.

PL-3. Hole in Sheep Fence

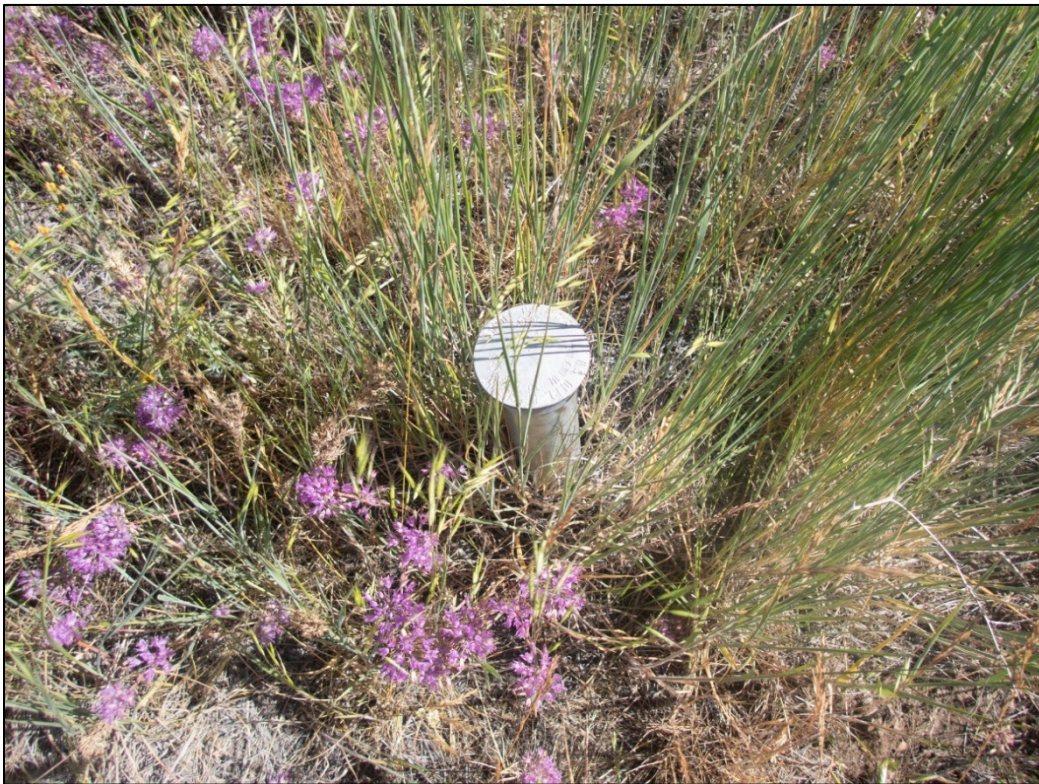
Three survey monuments and three boundary monuments (PL-4) delineate the property boundary. No maintenance needs were identified.

PL-4. Boundary Monument BM-1

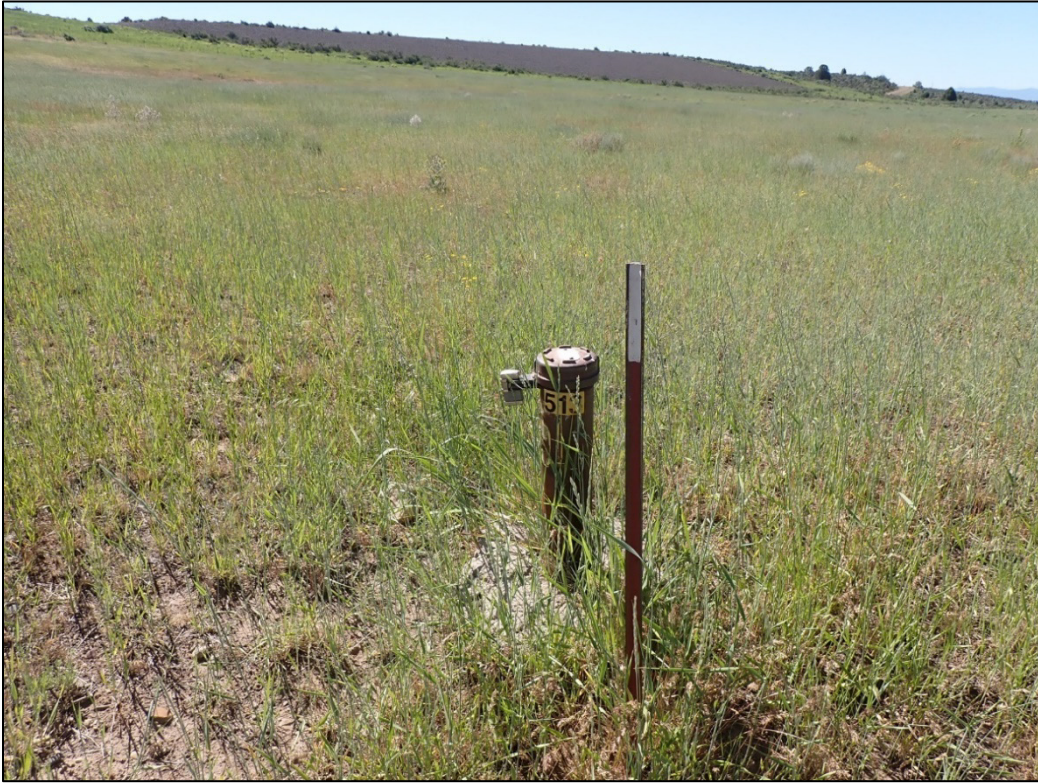
The site has 12 downgradient groundwater monitoring wells with four wells offsite to the east. Four upgradient wells are offsite to the west (PL-5). Wells 0522 and 0521 have concrete bases that are cracked, but the wellhead protectors remain stable. A dry, shallow depression remains near well 0602, as noted in previous inspections. The wellhead protectors were locked and undamaged. No maintenance needs were identified.

PL-5. Monitoring Well 0513

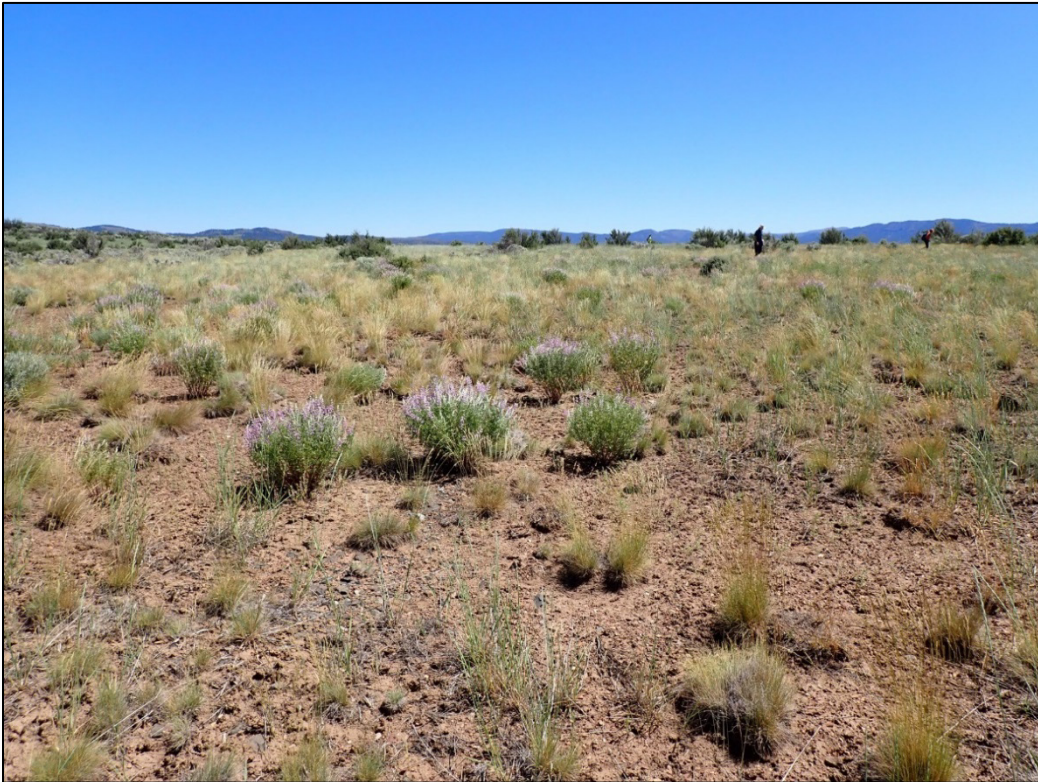
The incipient development of checkerboard soil erosion patterns was observed in some of the more sparsely vegetated areas on the top slope (consistent with similar areas offsite). A previously identified shallow rill on the top slope could not be found and was assumed to have stabilized from natural weathering processes. No additional changes were noted during the inspection. No structural or disposal cell performance concerns are associated with this condition because the riprap rock cover is continuous beneath the top slope soil cover, slope crests, and side slopes. Inspectors will continue to monitor this condition.

PL-6. Vegetation on Top Slope of Disposal Cell

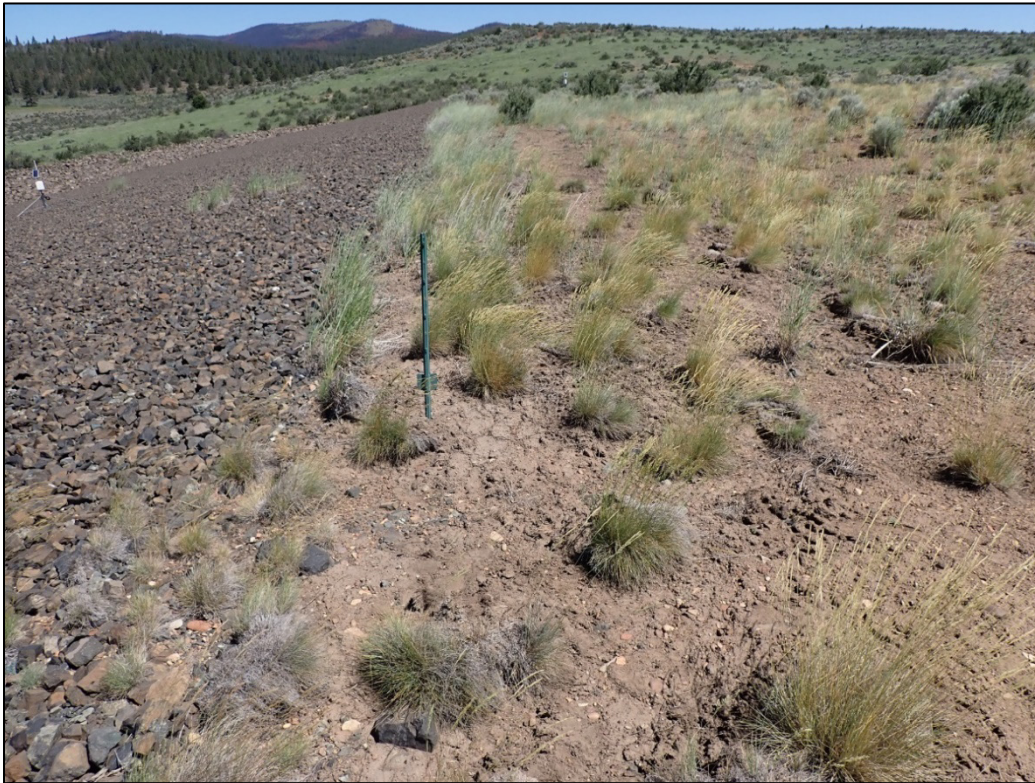
The contact boundary between the disposal cell top and side slopes was inspected and generally appears stable and uniform (PL-7). No erosion was observed during the inspection at the crest of the west side slope and the disposal cell top slope, and both appear to be stable. Inspectors will continue to monitor the transition zone between the disposal cell top slope and the west side slope for erosion development. There was no evidence of settling, slumping, erosion, or any other modifying process on the top of the disposal cell that might affect the integrity of the disposal cell.

PL-7. West Side of Disposal Cell

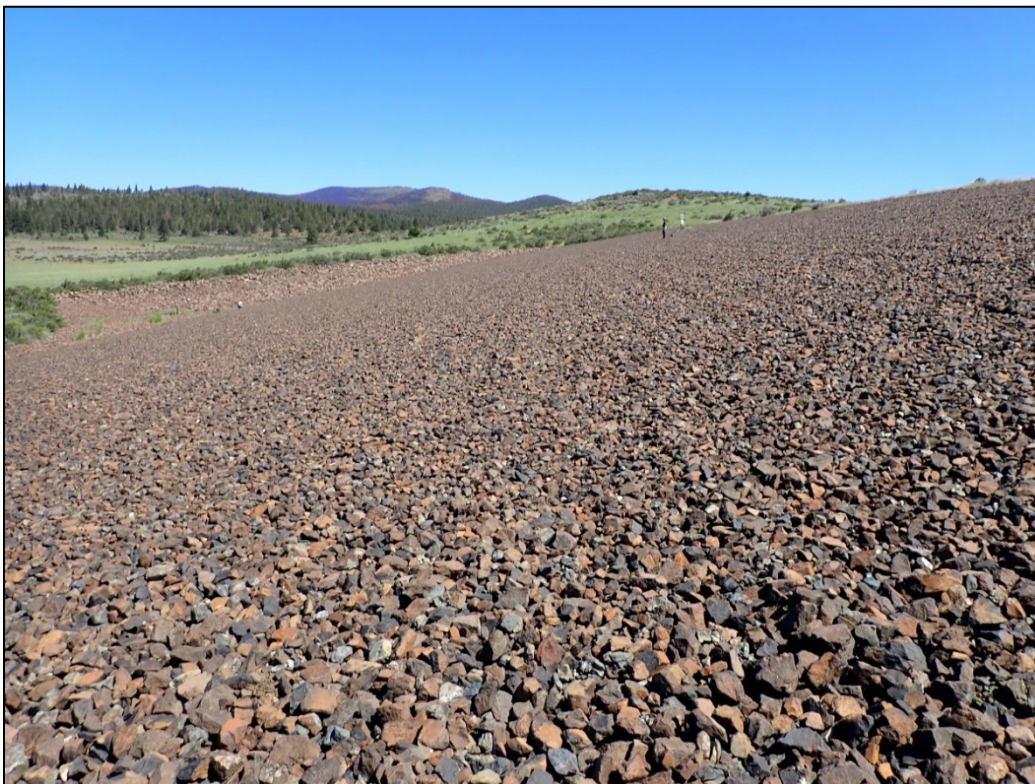
In 2015, LM proposed to replace annual gradation monitoring with rill inspections. The rills may form along the interface between the vegetated soil and rock top slope and the rock-covered west side slope (Dayvault 2015). Focusing on these areas allows LM to assess conditions that may indicate the development of potential failure points along the side slope. In 2019, NRC concurred with the discontinuation of rock gradation monitoring (Mandeville 2019); therefore, it was not performed in 2022. DOE is updating the LTSP to reflect this change. No rills or erosional features were observed along the side slope (PL-8) and the interface between the vegetated soil and rock top slope during the inspection.

PL-8. West Side Slope of Disposal Cell

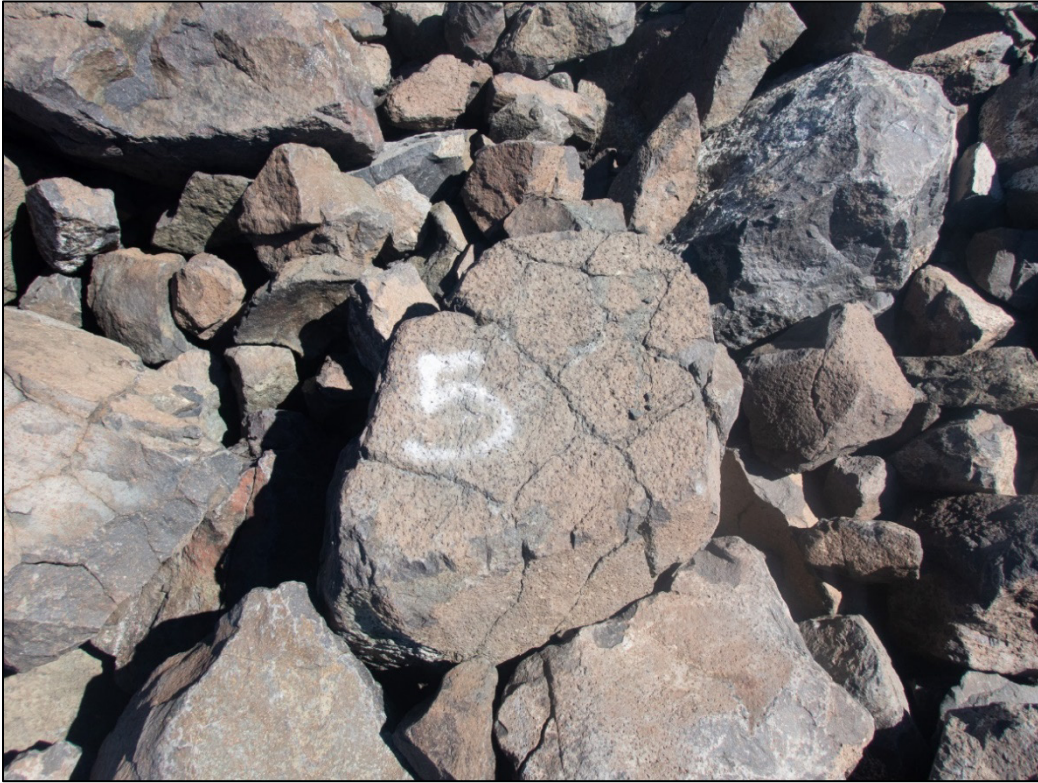
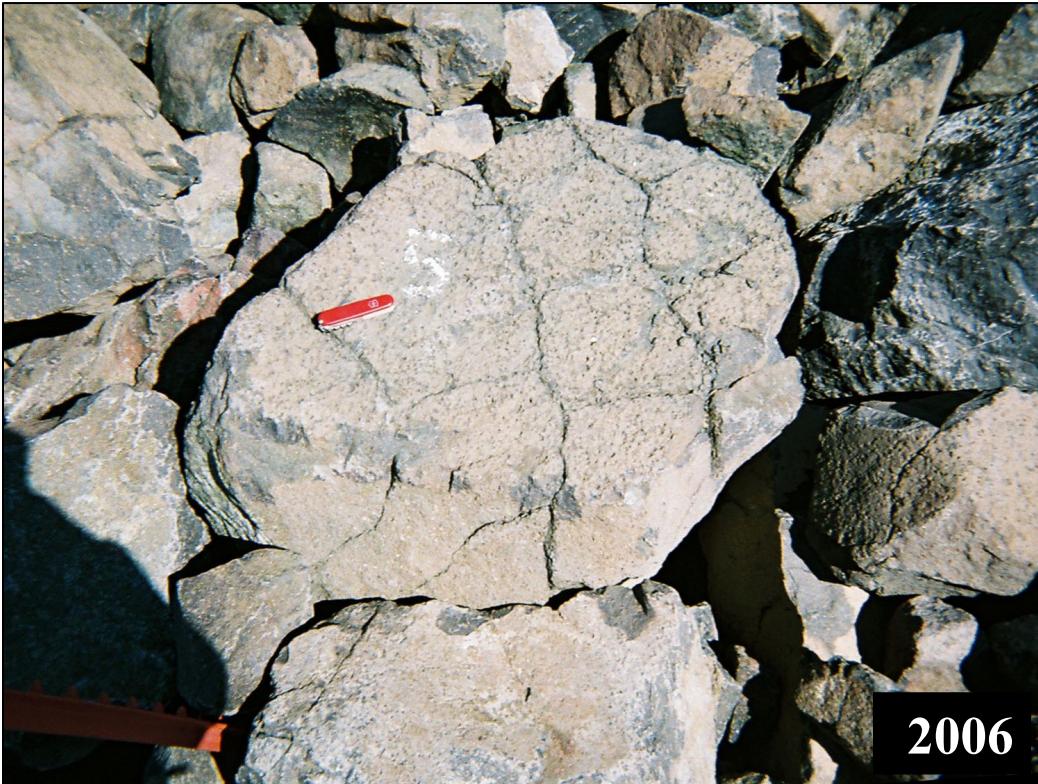
Annual photographic monitoring of the 18 locations for long-term rock monitoring was conducted during the 2022 inspection (PL-9a). Minor rock degradation has been observed in the EDA since monitoring began at the original 10 photograph locations established in 1997 and at the 8 additional locations established in 2000 (PL-9b). No significant degradation of the EDA rock has been observed since monitoring began.

PL-9a. Riprap Monitoring Location No.5 in EDA

PL-9b. Historical (2006) Photo of Riprap Monitoring Location No.5 in EDA

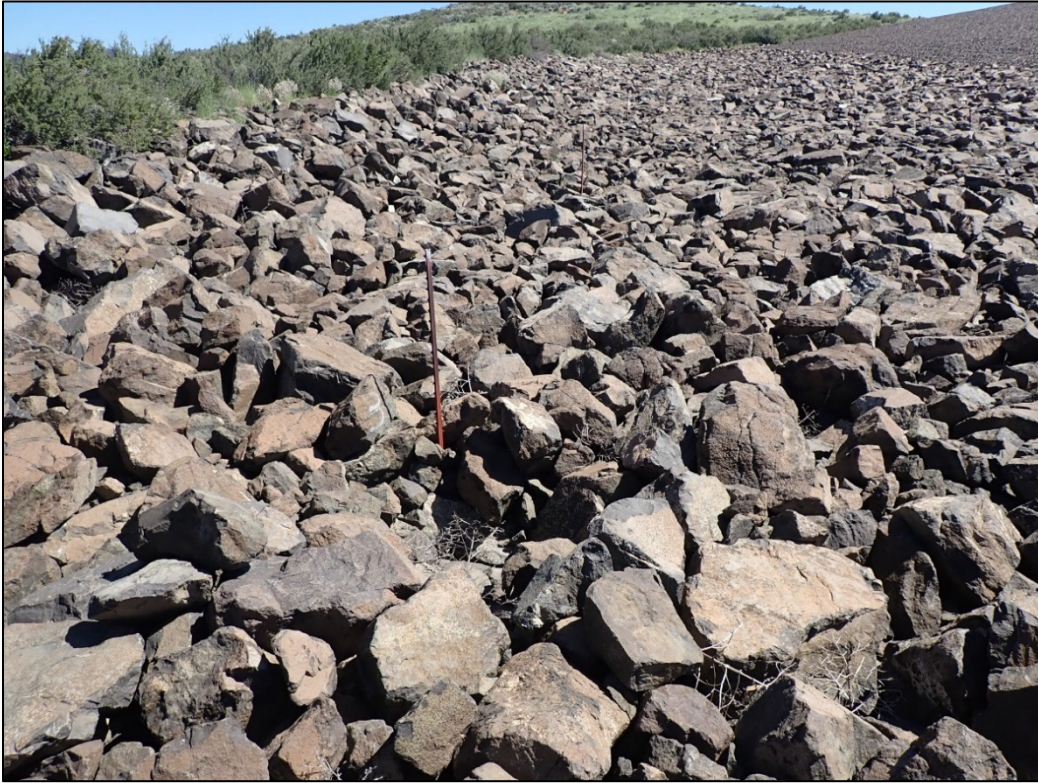
In the past, water has been observed in the large depression in the EDA at the lower end of the drainage channel. Water is a potential concern because inundation may accelerate deterioration of the large riprap by the freeze-thaw process. Dry conditions were again observed in the EDA depression during the 2022 inspection (PL-10).

PL-10. Dry Depression in EDA

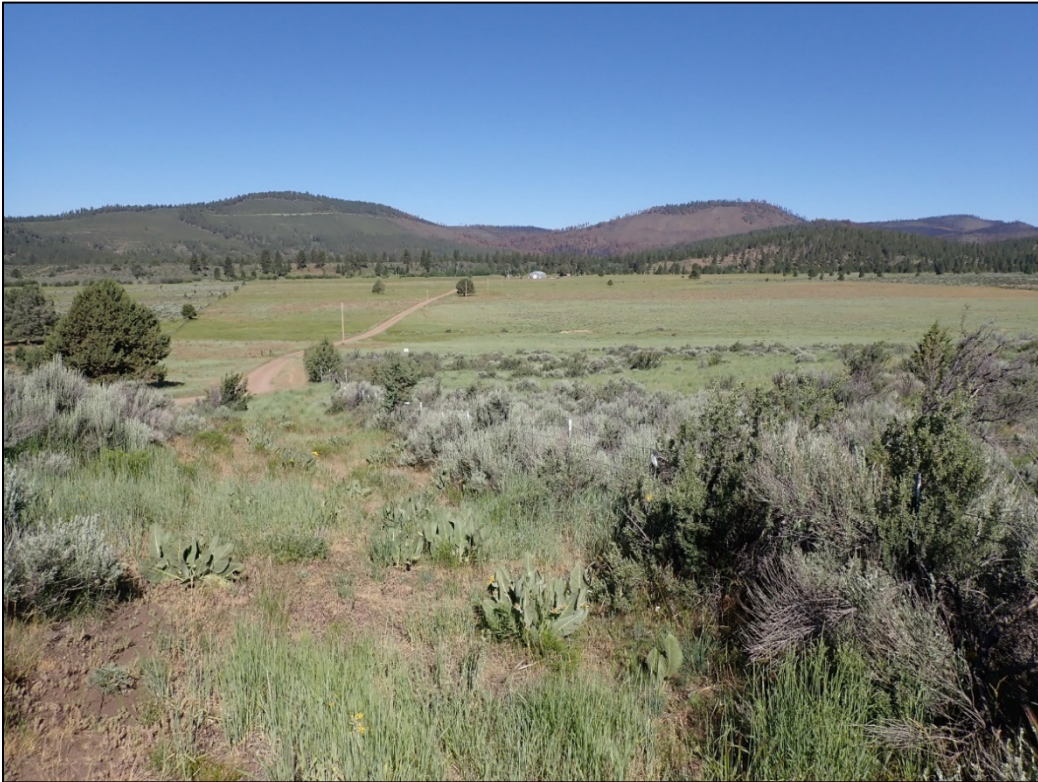
In September and October 2021, the Cougar Peak Wildfire burned approximately 91,000 acres to the west of the site mostly within the Fremont-Winema National Forest. The fire perimeter was within 2 miles of the site and the burn scar can be clearly seen from the site (PL-11).

PL-11. Southern Fence Line with Cougar Peak Fire Burn Scar in Distance

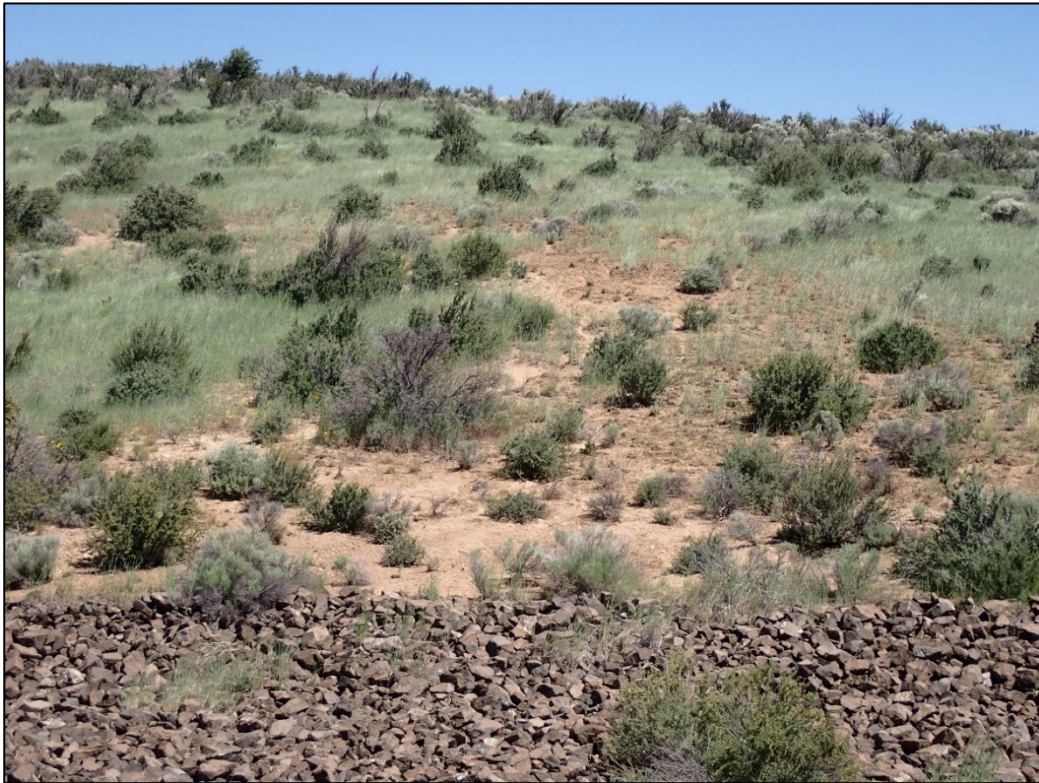
PL-12. Erosional Features on North Slope of Disposal Cell
