9.0 Lakeview, Oregon, Disposal Site

The Lakeview, Oregon, Uranium Mill Tailings Radiation Control Act (UMTRCA) Title I Disposal Site was inspected on July 10, 2024. No changes were observed on the disposal cell or in the drainage features. Inspectors identified minor maintenance needs but found no cause for a follow-up or contingency inspection.

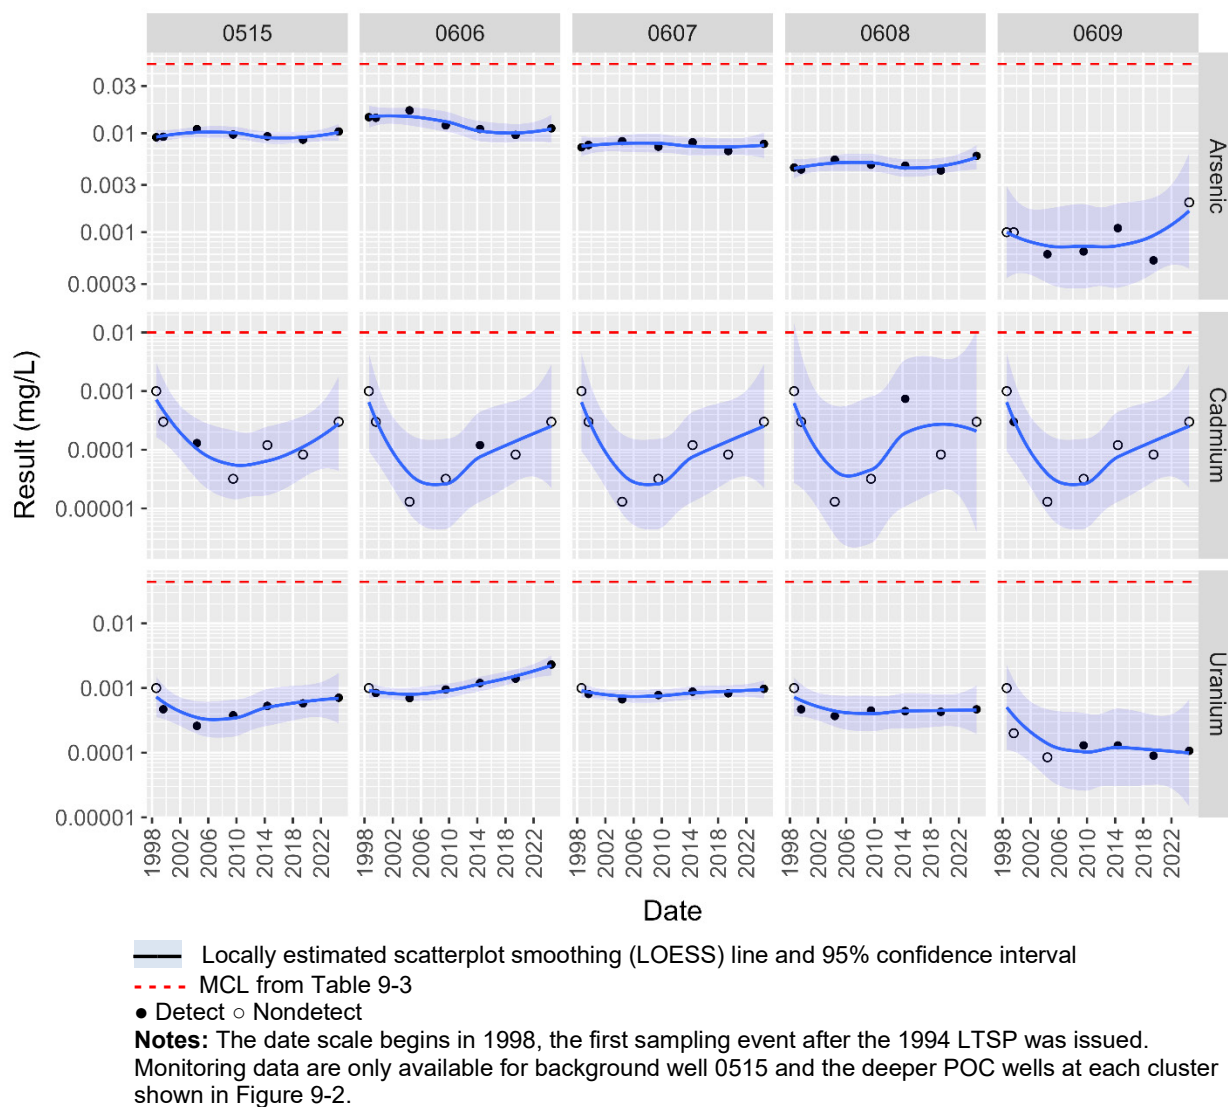
Figure 9-4. Time-Concentration Plots of Arsenic, Cadmium, and Uranium in Monitoring Wells at the Lakeview, Oregon, Disposal Site

Consistent with historical observations, concentrations of these constituents continue to remain below their respective MCLs in 2024 (Figure 9-4). Arsenic concentrations were ≤ 0.01 milligrams per liter (mg/L) and comparable to or less than the background (well 0515) measurement. As is true for most results since 1998, cadmium results for all wells were below the laboratory detection limit of 0.0003 mg/L. Uranium concentrations remained stable in most wells, with only results for wells 0606 and 0607 slightly exceeding background. The results of Mann-Kendall trend analysis indicate no significant concentration trend except for uranium in southernmost well 0606, with a significant increasing trend (p-value of 0.020).¹ The most recent uranium result for this well, 0.0023 mg/L, is still well below the corresponding 0.044 mg/L MCL.

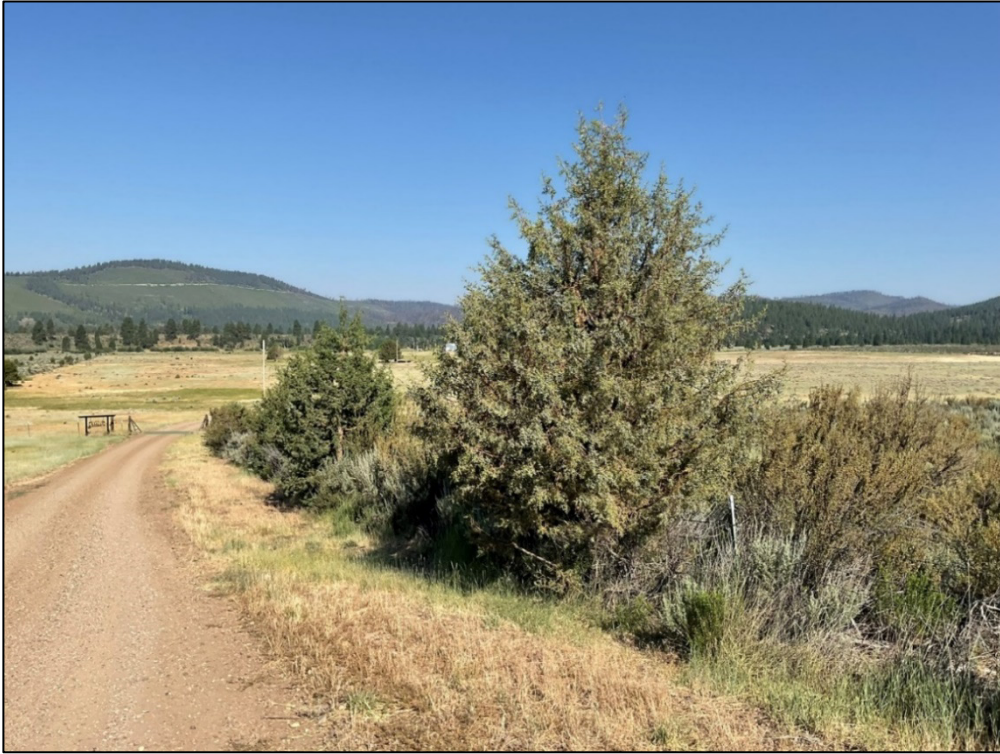
A sheep fence and four- or five-strand barbed wire enclose the site. Sheep fencing is on the southeastern and southern boundaries of the site. Some juniper trees and other vegetation are growing near, or entangled in, the perimeter fence line (PL-2), but the fence appears stable and remains functional. An empty post was found near the southern fence and will be removed in the future. A small hole in the sheep fence was observed in the southern fence line. The hole appears to be man-made, possibly to help small animals escape through the fence. Evidence of minor erosion from animals digging under the fence was identified near the southeast corner of the fence line and along the northern fence line during the 2022 and 2023 inspections, but these areas are not a concern to site security or the integrity of the fence. New evidence of animal digging was observed along the eastern fence line during the 2024 inspection (PL-3).

PL-2. Entangled Brush and Juniper Trees in Southern Fence Line

- Remove brush covering perimeter sign P1
- Trim back vegetation encroaching along the southern and southeastern fence lines

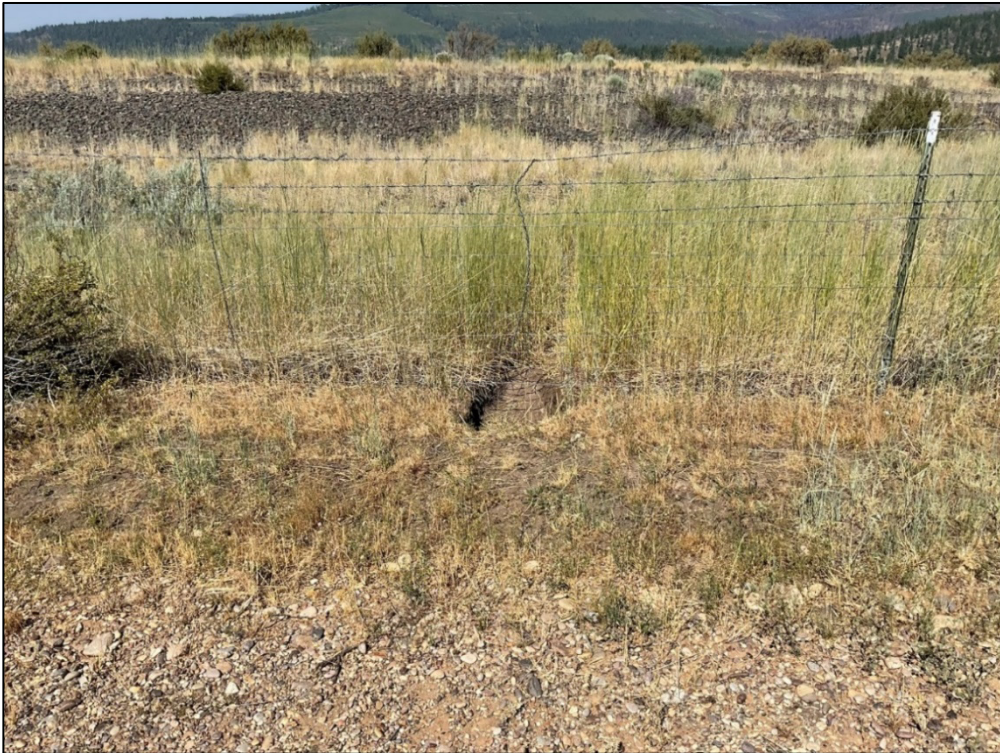
PL-3. Animal Digging Under Eastern Fence Line

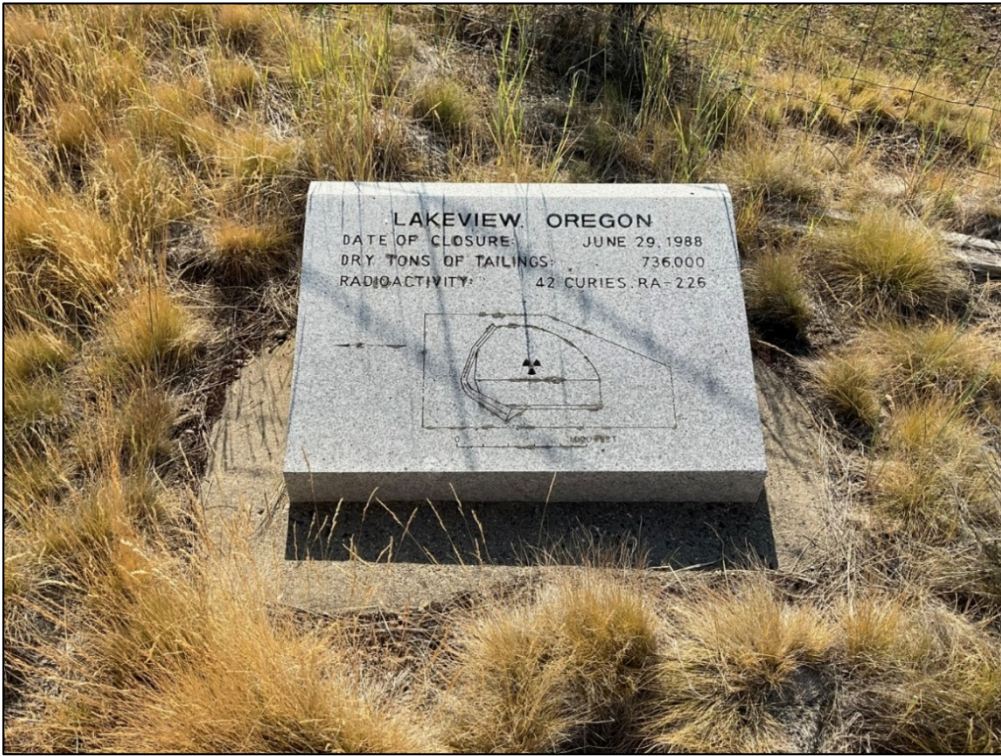
The site has two granite site markers. Site marker SMK-1 (PL-4) is just inside the entrance gate, and site marker SMK-2 is on the top slope of the disposal cell. No maintenance needs were identified.

PL-4. Site Marker SMK-1 near the Entrance Gate

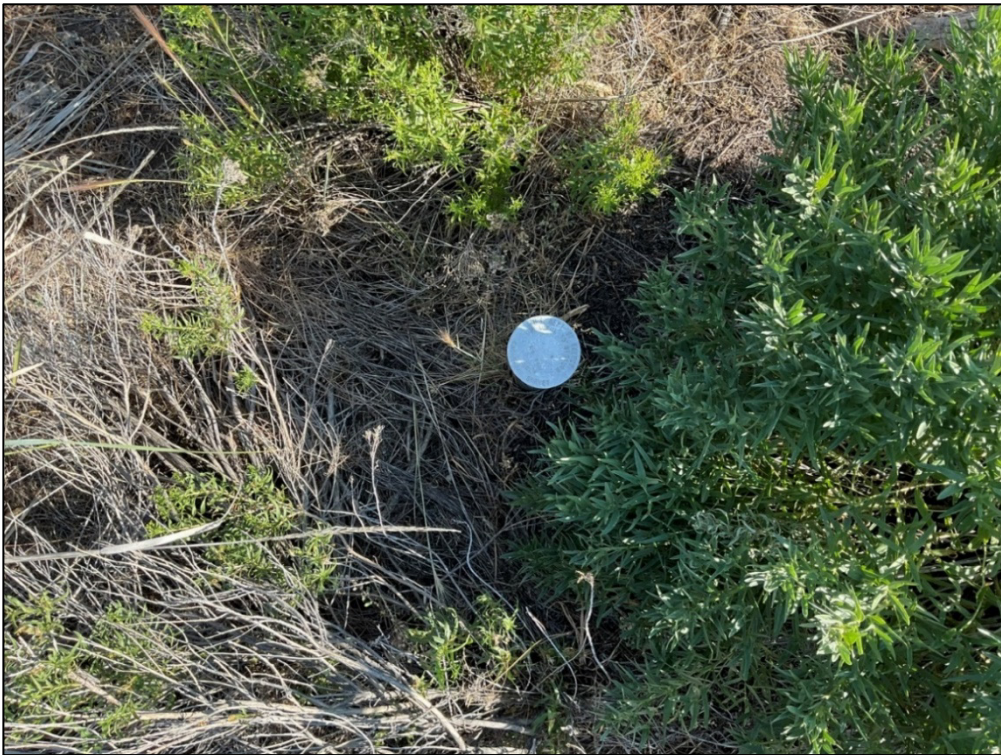
Three survey monuments and three boundary monuments (PL-5) delineate the property boundary. No maintenance needs were identified.

PL-5. Boundary Monument BM-3

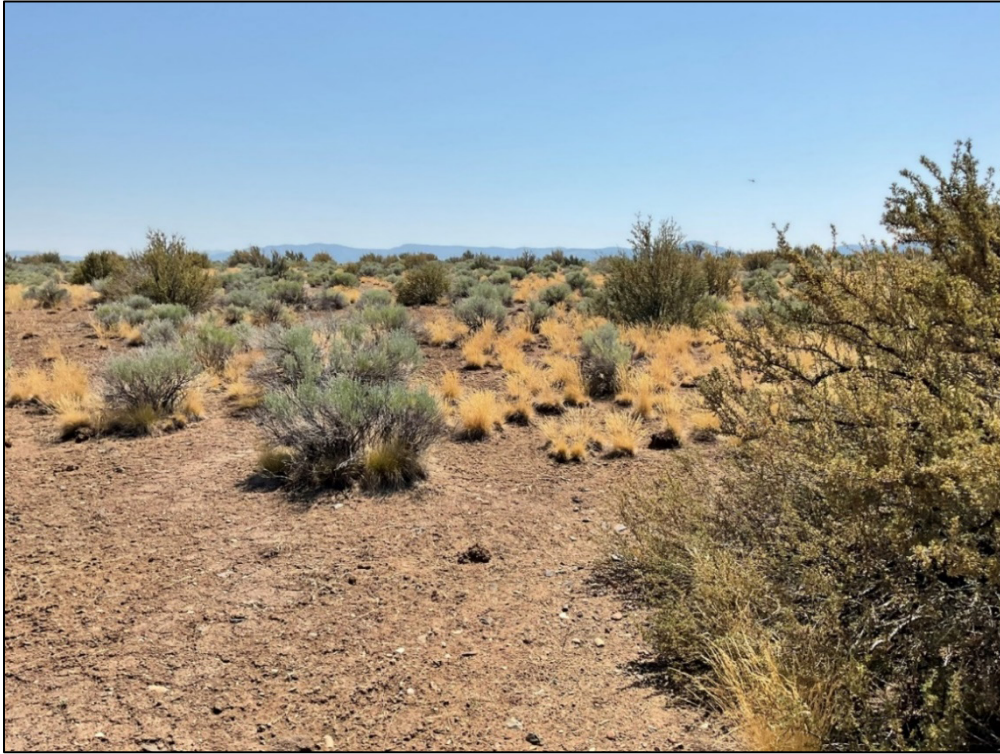
PL-6. Grasses and Forbs on Top of the Disposal Cell

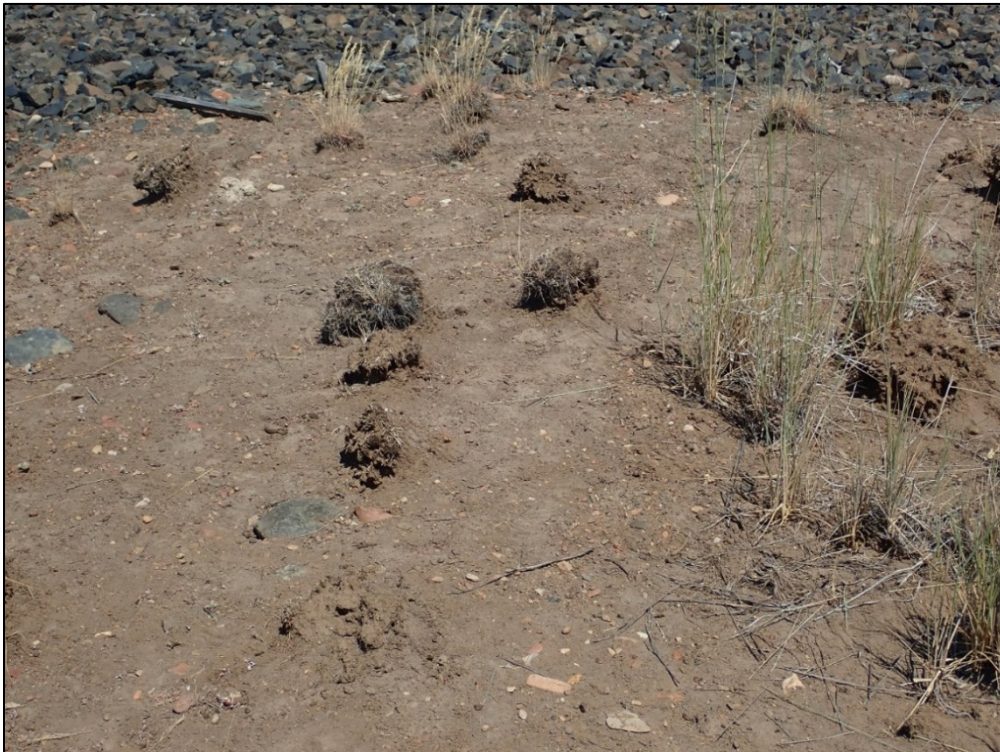
Wind erosion of the soil is evident in places on the disposal cell cover. In these areas, the roots of vegetation have been exposed as wind carries the soil away (PL-7). Previously identified erosional features such as small rills were not observed in 2024 and are assumed to have stabilized through natural processes. No structural or disposal cell performance concerns are associated with soil erosion because the riprap rock cover is continuous beneath the top slope soil cover, slope crests, and side slopes. Inspectors will continue to monitor this condition.

The contact boundary between the disposal cell top and side slopes was inspected and generally appears stable and uniform. Windblown erosion was observed during the 2024 inspection at the northwest corner of the crest on the west side slope and the disposal cell top slope; both appear to be stable. Inspectors will continue to monitor the transition zone between the disposal cell top slope and the west side slope for erosion development. There was no evidence of settling, slumping, erosion, or any other modifying process on the top of the disposal cell that might affect the integrity of the disposal cell.

PL-7. Windblown Erosion on Northwest Corner of the Disposal Cell

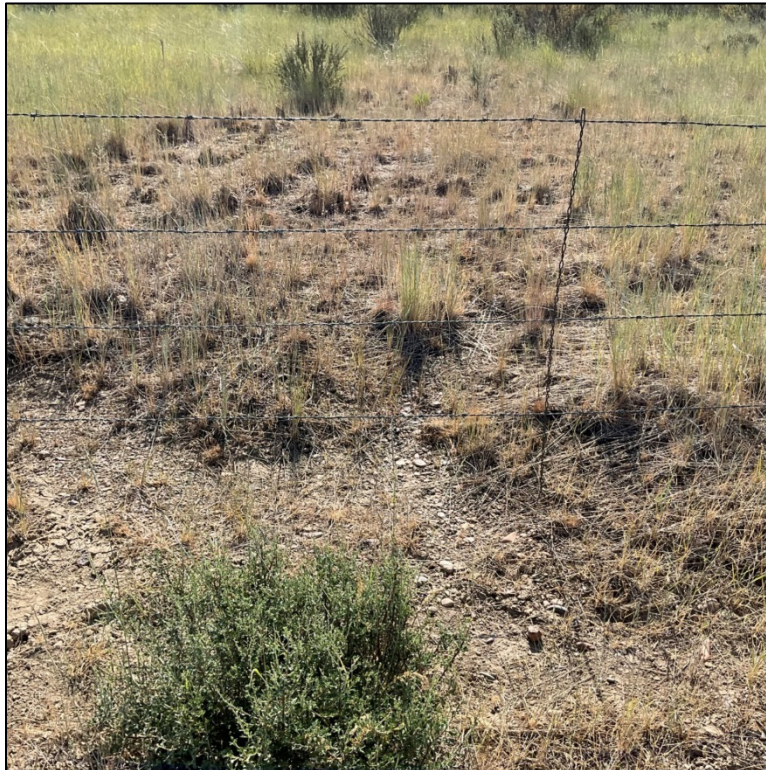
PL-8. Livestock Trail Outside Site Boundary

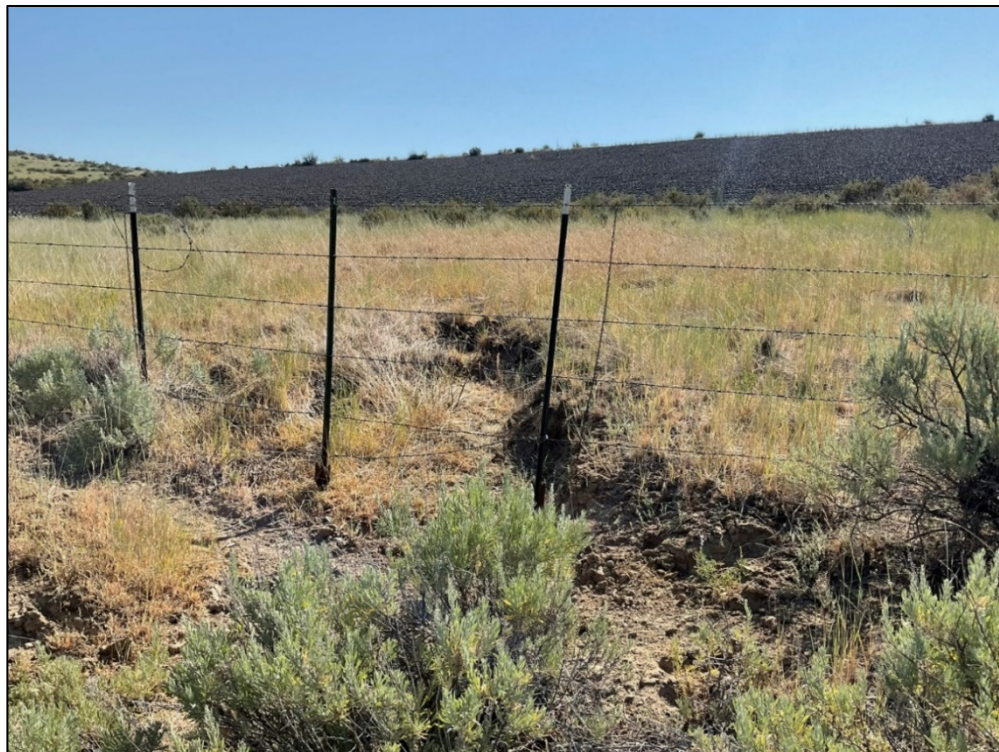
Gullies that formed in seeded areas extending west of Apron Toe Drains 1 through 5 were filled with rock in 2000. Although the rock has generally arrested the headcutting that was advancing eastward from the adjacent private property onto DOE property, some minor headcutting is still

evident (PL-9). Several small gullies have been observed on the private property directly west of the site in the heavily grazed areas downslope of the perimeter fence line near monitoring well 0515. Several rills and shallow gullies were also observed onsite on the slope north of the disposal cell where grass reestablishment has been limited, in a drainage area north of perimeter sign P7, north of perimeter sign P8, and in the southwest corner of the site. These rills and gullies were identified during previous annual inspections but appear to have stabilized, as no significant changes were observed in 2024. The gullies do not pose a threat to disposal cell integrity, and inspectors will continue to monitor these areas. In previous years, inspectors have observed a pile of galvanized posts with concrete bases in the southwest corner of the site. These galvanized posts and bases were removed by the adjacent landowner in July 2024. No other maintenance needs were identified.

PL-9. Headcutting at Apron Toe Drain 3
