Memorandum

Date: 21 September 2011

Subject: **2011 Annual Survey**

MMG conducted the comprehensive annual survey at the Dr. Modesto Iriarte Technological Museum (former BONUS Facility) during the dates of 4 – 5 August 2011 with support from PREPA personnel. This survey was conducted in accordance with the Sampling and Analysis Plan (SAP) for the BONUS Facility prepared by the U.S. Department of Energy (DOE) (or DOE contractor) as amended by a 16 January 2001 Memorandum from Webb to Alvarado. The survey was also altered, as presented below in this report, in consideration of the covering of contamination areas/surfaces by paint and/or concrete, the shielding (concrete floor) placed on the Basement Level, the verification survey performed in January 2005 (refer to 22 February 2005 Memorandum entitled: *2004 Annual Survey and Verification Survey for Basement Floor*), and subsequent annual surveys. This report is organized in accordance with Section 6.2 of the SAP. The sampling and inspection results are discussed below.

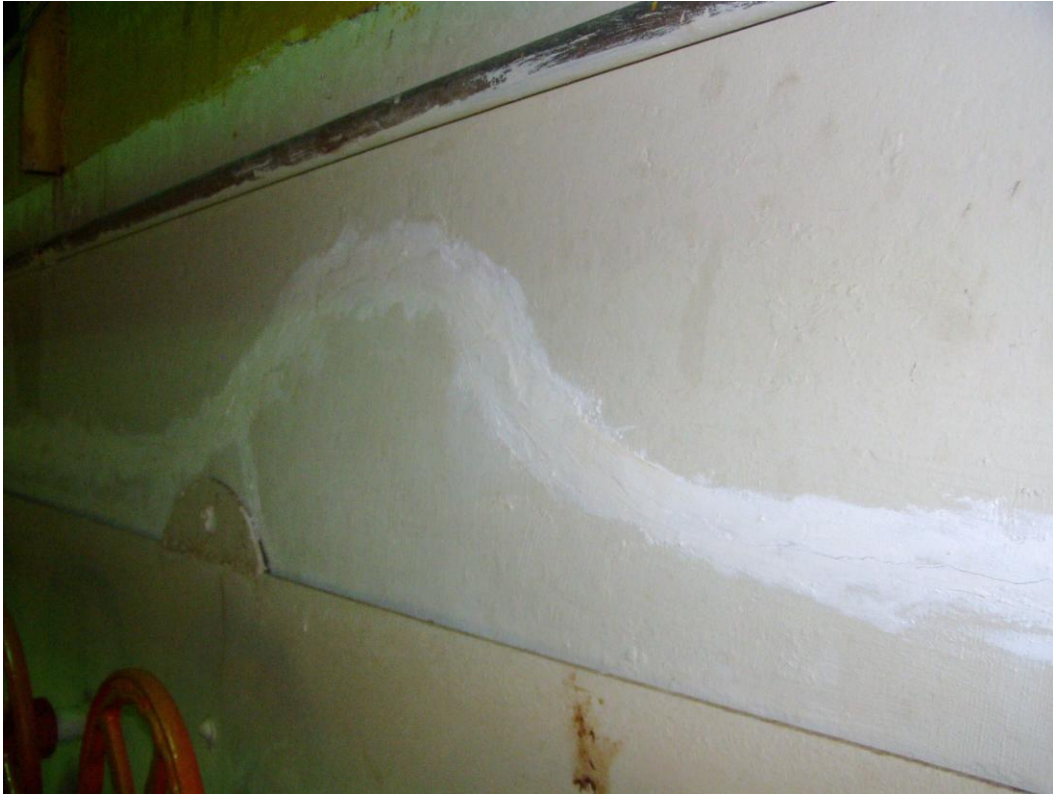
Dome-Entombed Concrete Monolith and Monolith Penetrations: Inspection of the Concrete Monolith area revealed superficial cracks throughout the surface of the structure (Attachment 1, Figure 1). Superficial cracks are also present along the base of the “top plug” of the concrete monolith top (Attachment 1, Figures 2 and 3). All dose rate measurements taken around the structure were not significantly different from background measurements taken. No immediate action is necessary.

Figure 1. Entombment Top (North Side) – Surface Cracks (Typical)

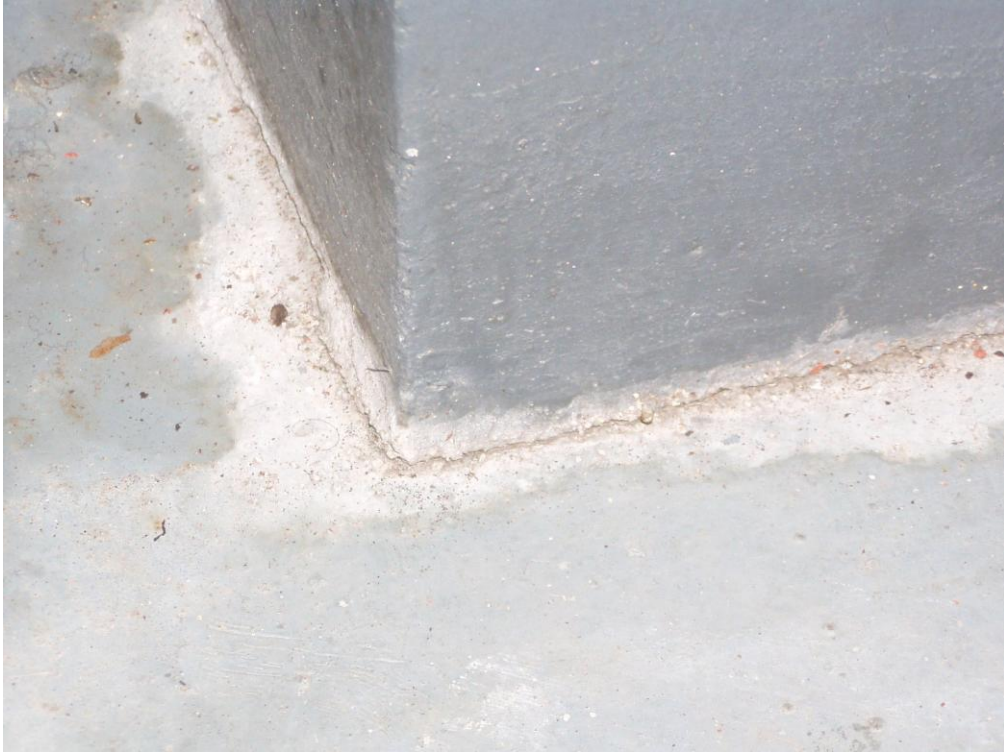
Figure 3. Entombment Top (Top Plug) – Surface Cracks (Typical)

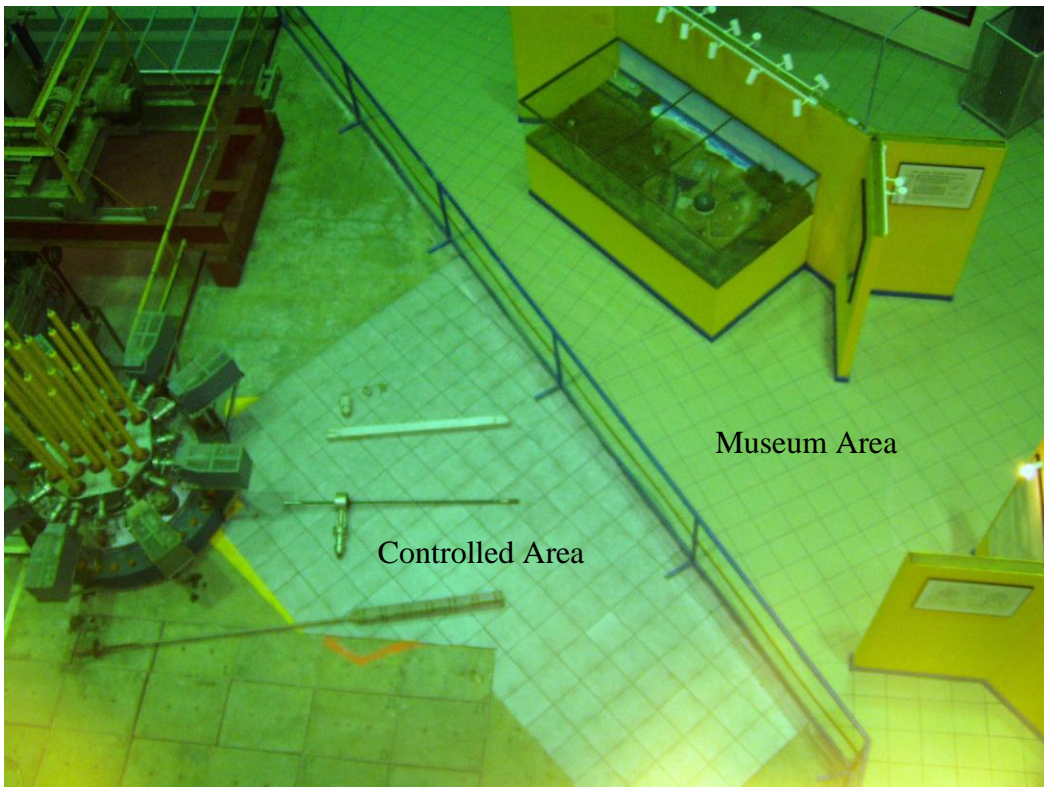
Dome-Main Level: The Main Level (Controlled Area) is that portion of the Main Level that is not accessible to the public (Attachment 1, Figure 4). The two historical contamination sites remain covered with floor tiles; the tile work is in good condition and is effective in reducing the dose levels. One area adjacent to the north side of the Monolith is also covered with lead bricks (Attachment 1, Figure 18), which is effective in reducing elevated dose rate levels in this area. Ongoing and routine assessment of the floor tile and lead bricks in this area is recommended. There is also no discernable evidence of work and/or damage affecting the control measures (floor tiles) on the Main Level, Museum Area (Attachment 1, Figures 4, 12, and 14 through 17). No immediate action is necessary on the Main Level.

Figure 4. Main Level View from Entombment Top

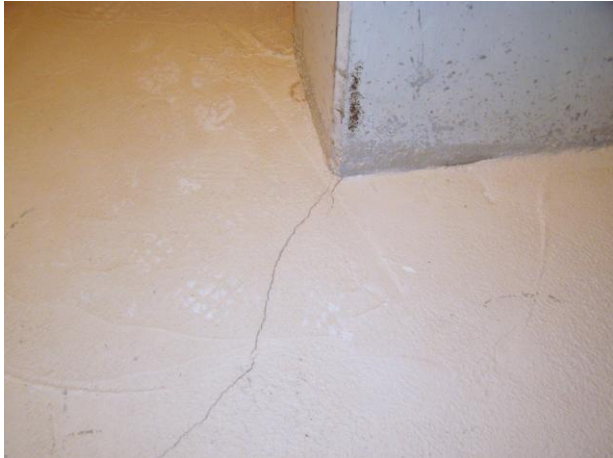
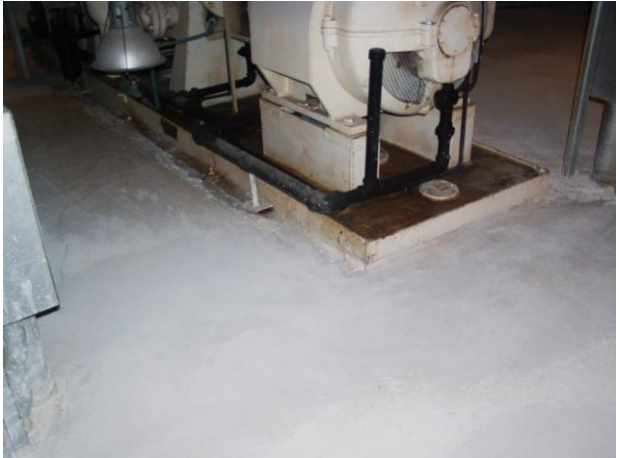
Figure 8a and 8b. Basement Level – Surface Cracks in Concrete Cover (Typical)

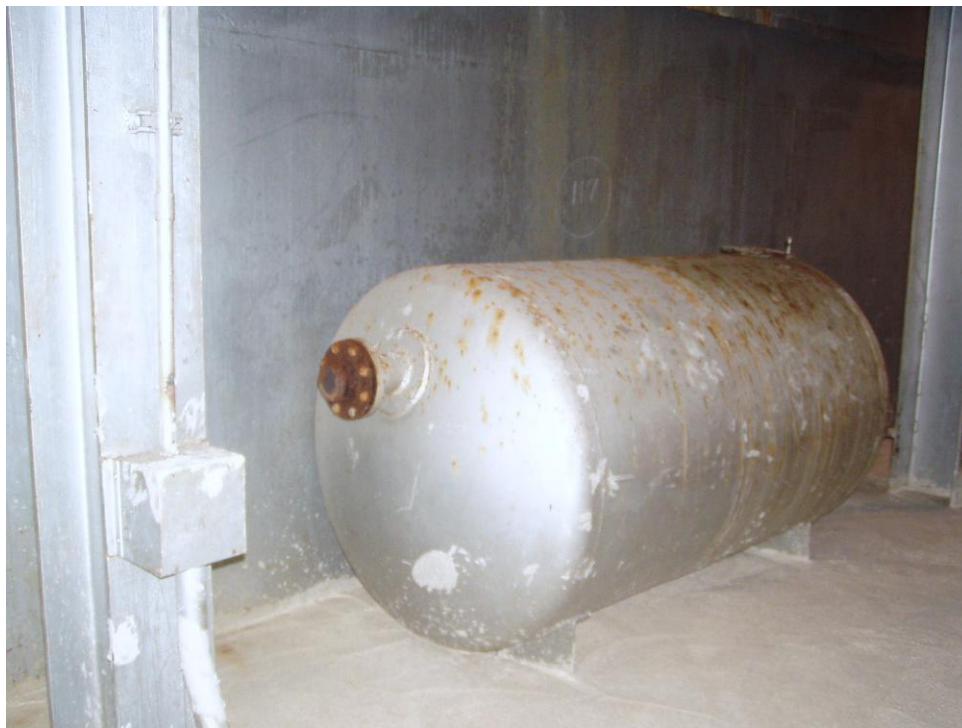
Two additional survey locations (42 and 43) were evaluated in the Vapor Sphere Room where a tank (Attachment 1, Figure 10) was historically used for radioactive waste/material storage (a sign indicating radioactive material storage was also present on the door). These survey locations were taken from on top of the newer concrete floor. Both removable and total surface readings at these two locations were below MDA.

Figure 10. Basement Level – Tank Formerly Labeled as Radioactive Material/Waste Storage Tank

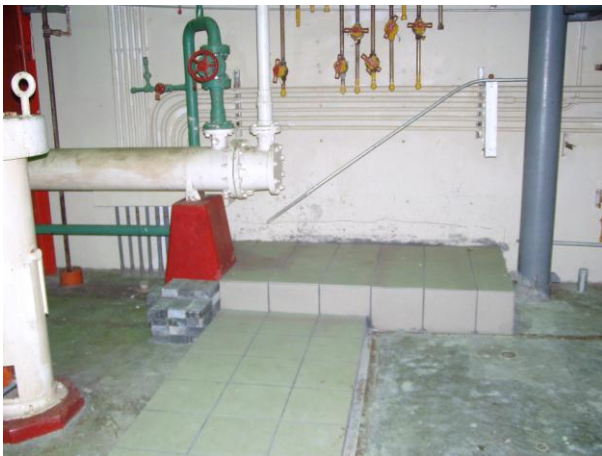
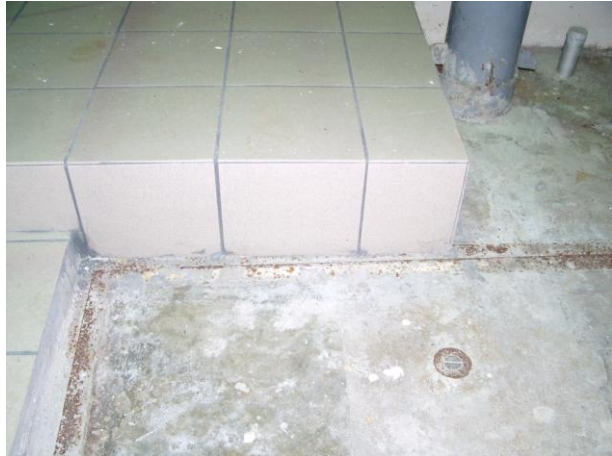
Figures 18a and 18b. Main Level – Tile, Concrete, and Lead Bricks Covering “Hot Spot” on North Side (Adjacent to Sample Locations 27 and 28)

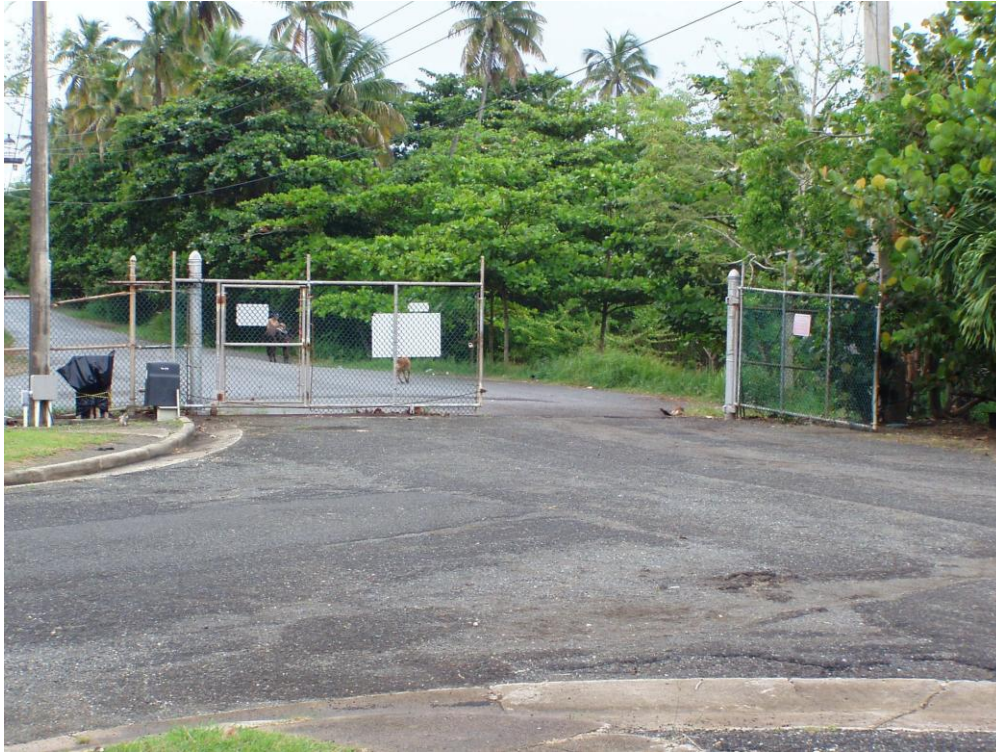
Site Surveillance Features: Asphalt of the access road and parking area is in fair and usable condition (Attachment 1, Figures 19 through 22). The motor of the entrance gate was not operational at the time of the survey, but was manually operated by the attending guard (Attachment 1, Figures 19 and 20). The security guard controlled access into the gated facility and kept log of visitors. The Dome monolith plaques were in fair condition. At one location on the beach-side of the property, the fence needs to be prepared to control access. Repair or replacement of the gate motor is recommended, but not critical in maintaining site security (repeat from 2010).

Figure 19. Site Security – Main Gate (Motor is Not Operational)

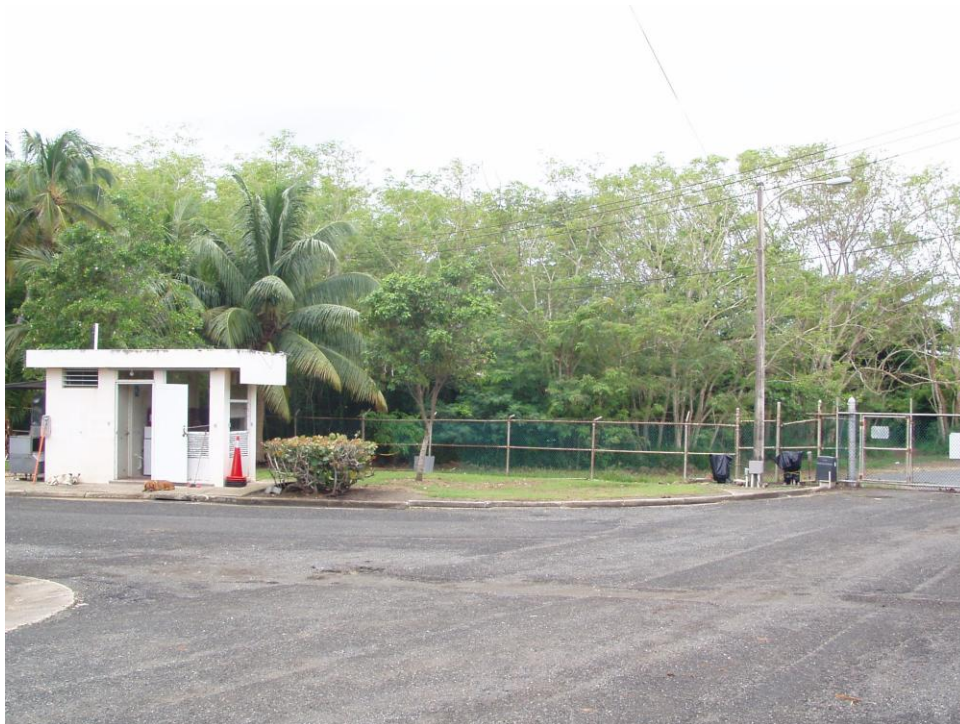
Figure 20. Site Security – Gate Security Building and Main Gate (Motor is Not Operational)

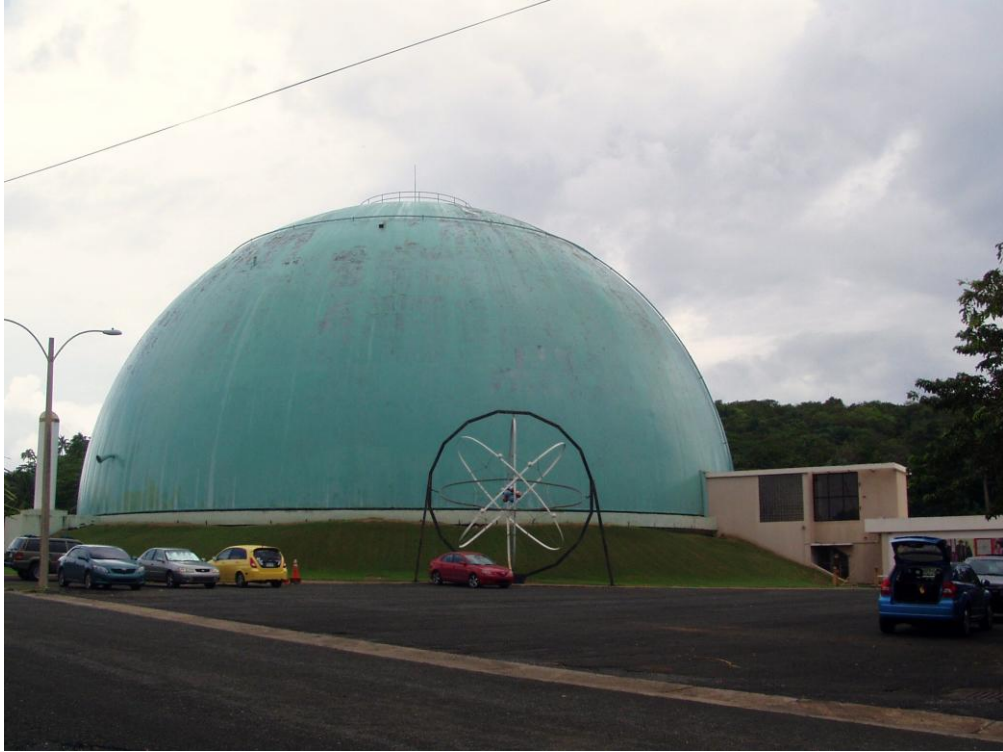
Dome-Exterior: Inspection of the Dome structure (Attachment 1, Figure 21) did not reveal any significant structural discrepancies, although the paint on the Dome shell has faded and is flaking in spots. Also, refer to the Basement Level flooding issues mentioned above. The metallic pass-through portal at the northern entrance also shows signs of significant corrosion (Attachment 1, Figure 29) and flaking paint. It is recommended that corrosion control coating and new paint be applied to the north entrance pass-through portal to prevent any structural or mechanical damage to the entrance door mechanism (repeat from 2010).

Figure 21. Dome Exterior

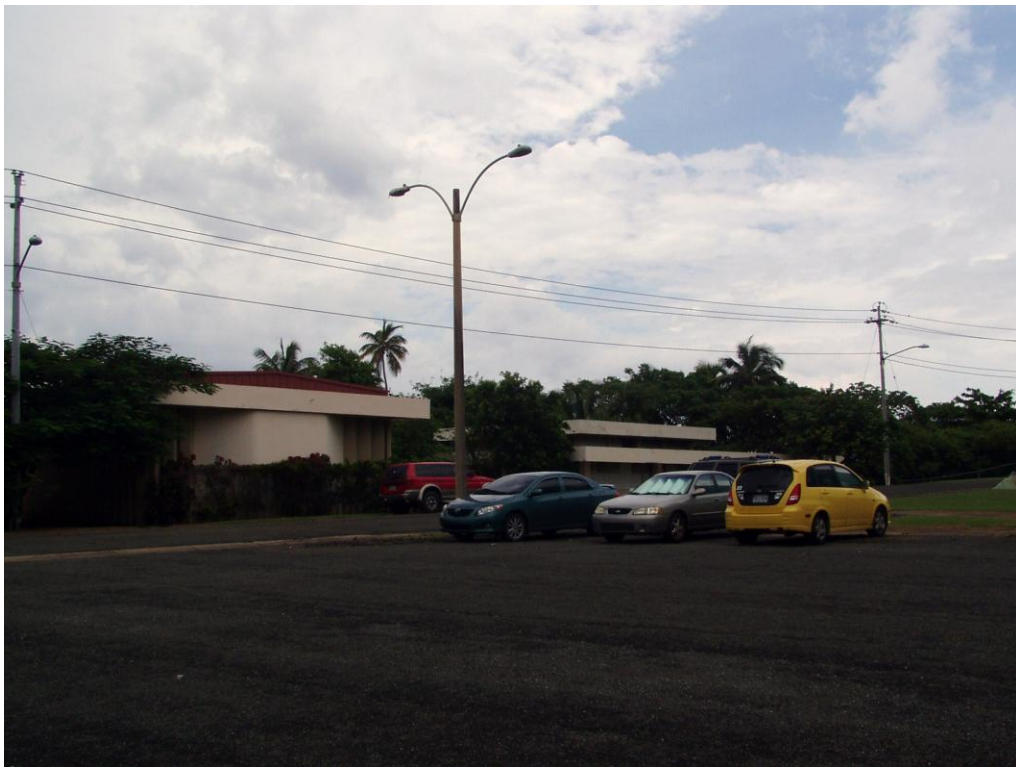
General Site Upkeep: The buildings and grounds appear well maintained (Attachment 1, Figure 22). However, it appears that the grass is not being routinely mowed. No immediate action is necessary.

Figure 22. Support Facilities (Theatre Building on Left)

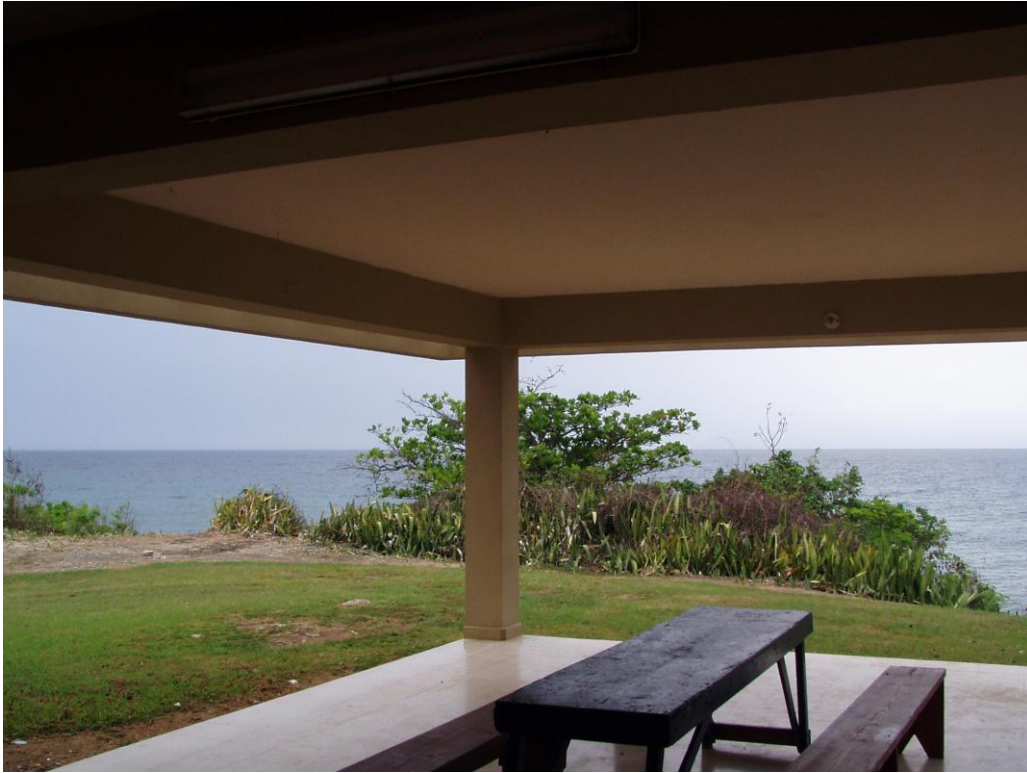
facility to the beach appears to be effectively controlling erosion (Attachment 1, Figure 23). No immediate action is necessary.

Figure 23. General Site – View from Back Deck of Theatre Building (Vegetation on Slope)

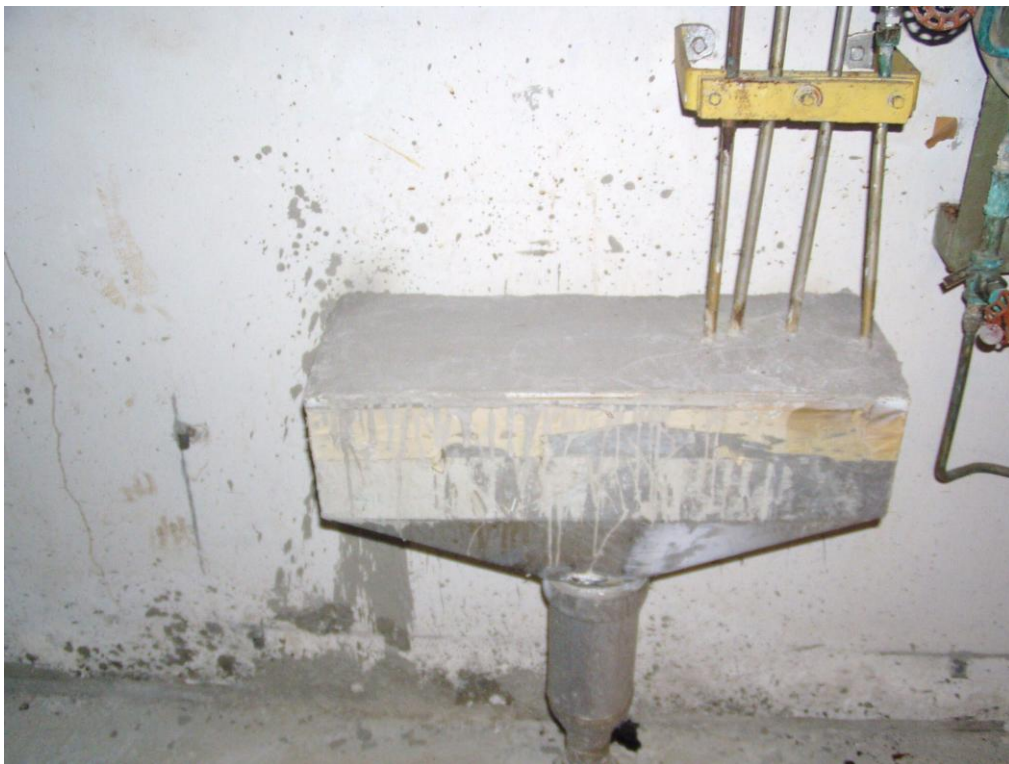
Figure 24. Basement Level – Concrete Filled Sink to Fix Removable Contamination (Good Condition)

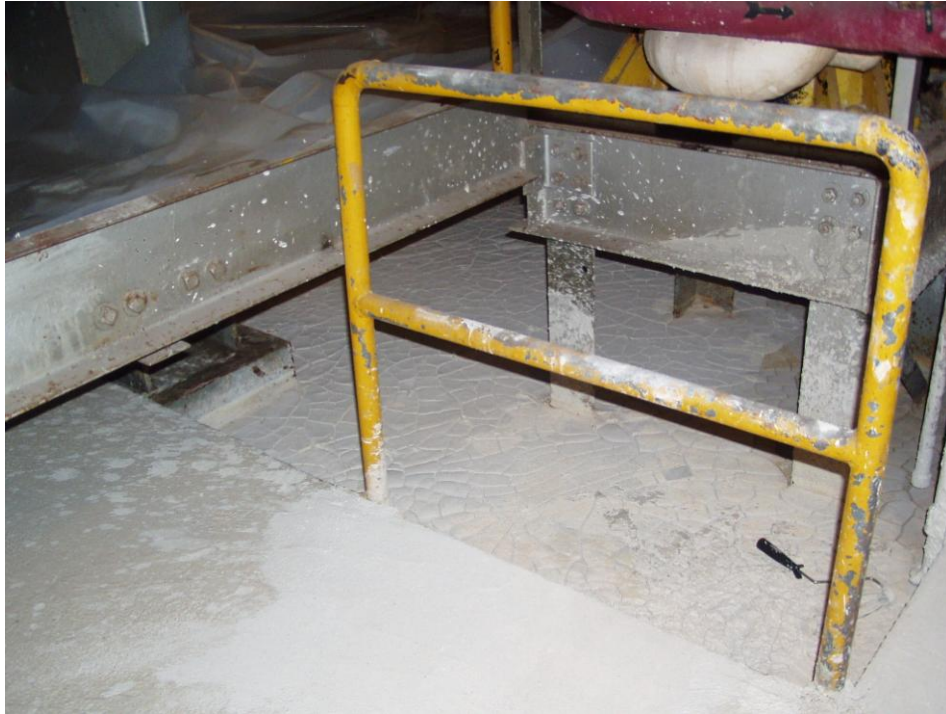
Figure 25. Basement Level – Lowest Point in Basement Shows No Recent Signs of Flooding (Dry, Cracked Silt/Mud is Visible)

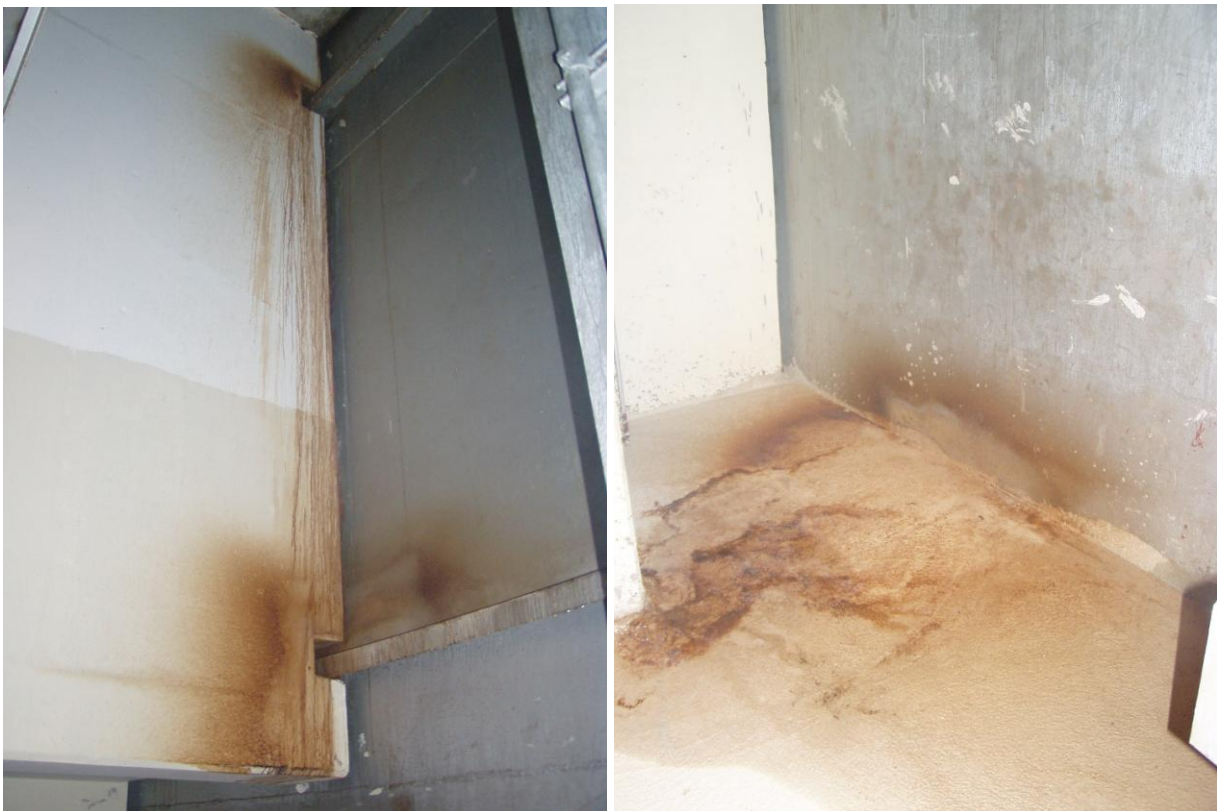
Figure 26a and 26b. Basement Level – Staining Due to Water Infiltration beneath Northern Entrance

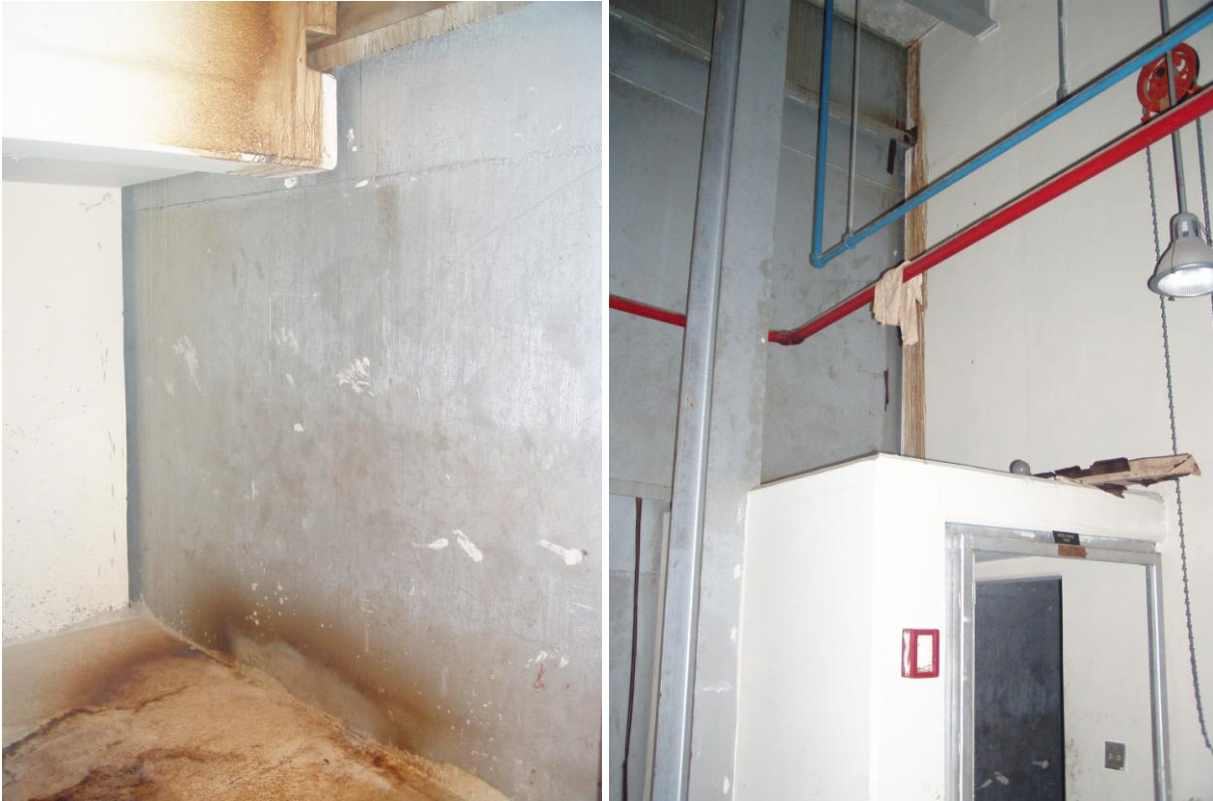
Figure 27. Basement Level – Additional View of Staining Due to Water Infiltration beneath the Northern Entrance

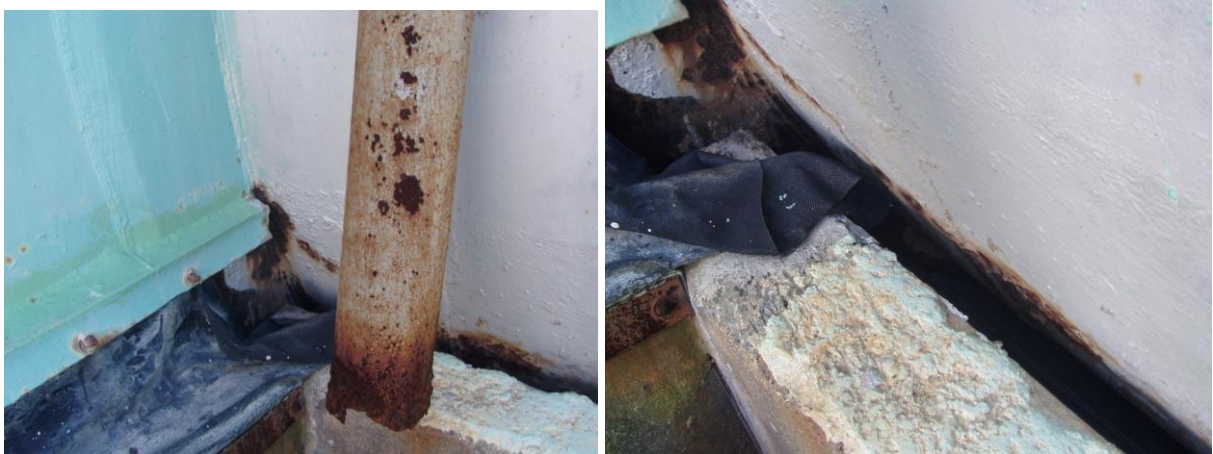
- The rubber gasket around the exterior base of the Dome is deteriorated (Attachment 1, Figures 28 and 30). The infiltration into the Basement Level due to the deteriorated gasket is most evident by staining on the interior Basement Level walls (Attachment 1, Figures 26 and 27) near and within the Vapor Sphere Room, which is beneath the northern entrance.
- The metal frame of the Basement Level loading door is corroded and allowing rainfall to infiltrate. The paved and concrete entrance pathway outside the loading

Figure 28. Gasket Seal at Northern Entrance Exterior Deteriorated

It is recommended that the exterior rubber gasket surrounding the Dome structure be replaced or repaired (repeat from 2010). Also, it is recommended that the concrete berm be expanded into a concrete ramp covering the corroded frame at the Basement Level loading entrance door after a civil survey has determined that the height of the ramp will effectively divert rainfall away from the door (repeat from 2010).

- The rubber gasket around exterior base of the Dome is deteriorated (Attachment 1, Figures 28 and 30). It is recommended that the exterior rubber gasket surrounding the Dome structure be replaced or repaired (repeat from 2010).

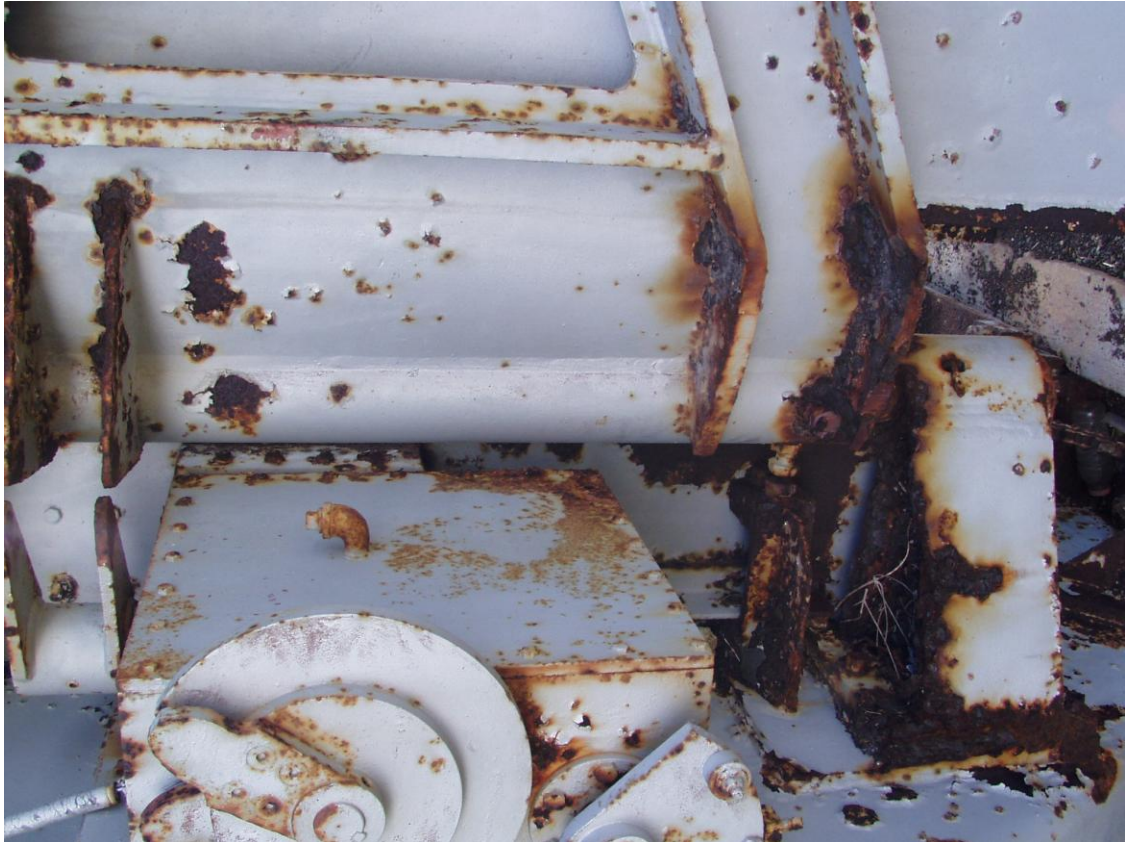
Figure 29. North Entrance – Pass-Through Chamber (Significant Corrosion)

- The metallic pass-through portal at the northern entrance shows signs of significant corrosion (Attachment 1, Figure 29) and flaking paint. It is recommended that corrosion control coating and new paint be applied to the north entrance pass-through portal to prevent any structural or mechanical damage to the entrance door mechanism (repeat from 2010).

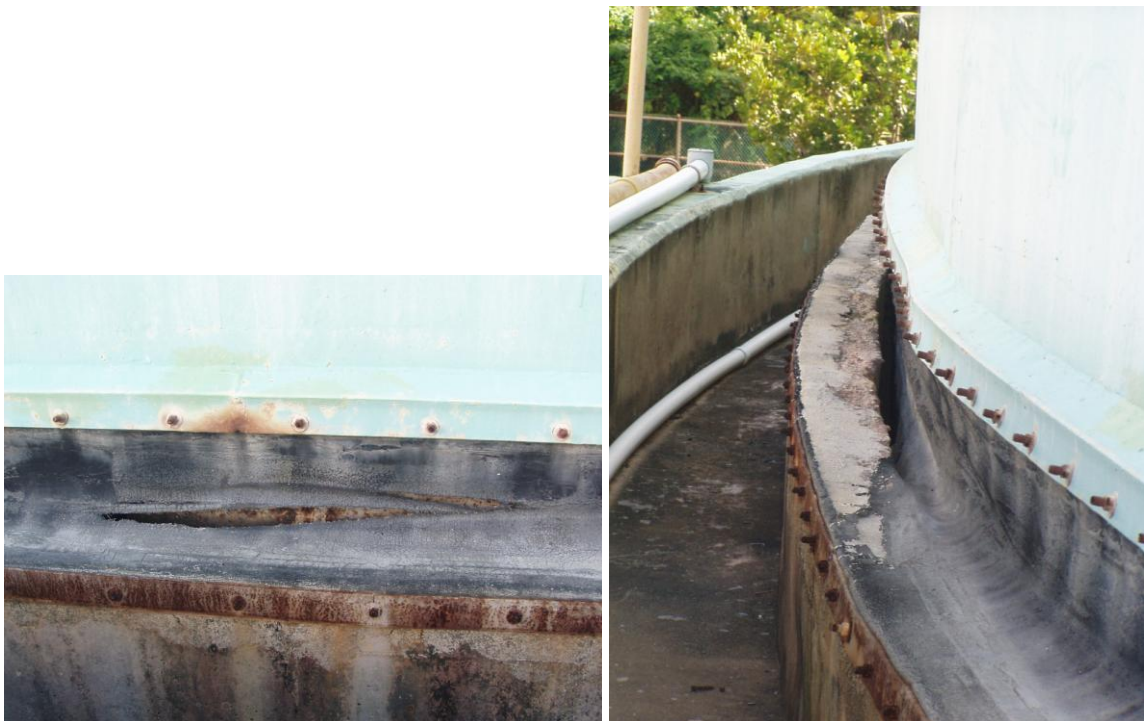
Figure 30a and 30b. Gasket Seal around Domed Metal Structure and Dome Base is Damaged and Diverts Rainwater into the Basement Level

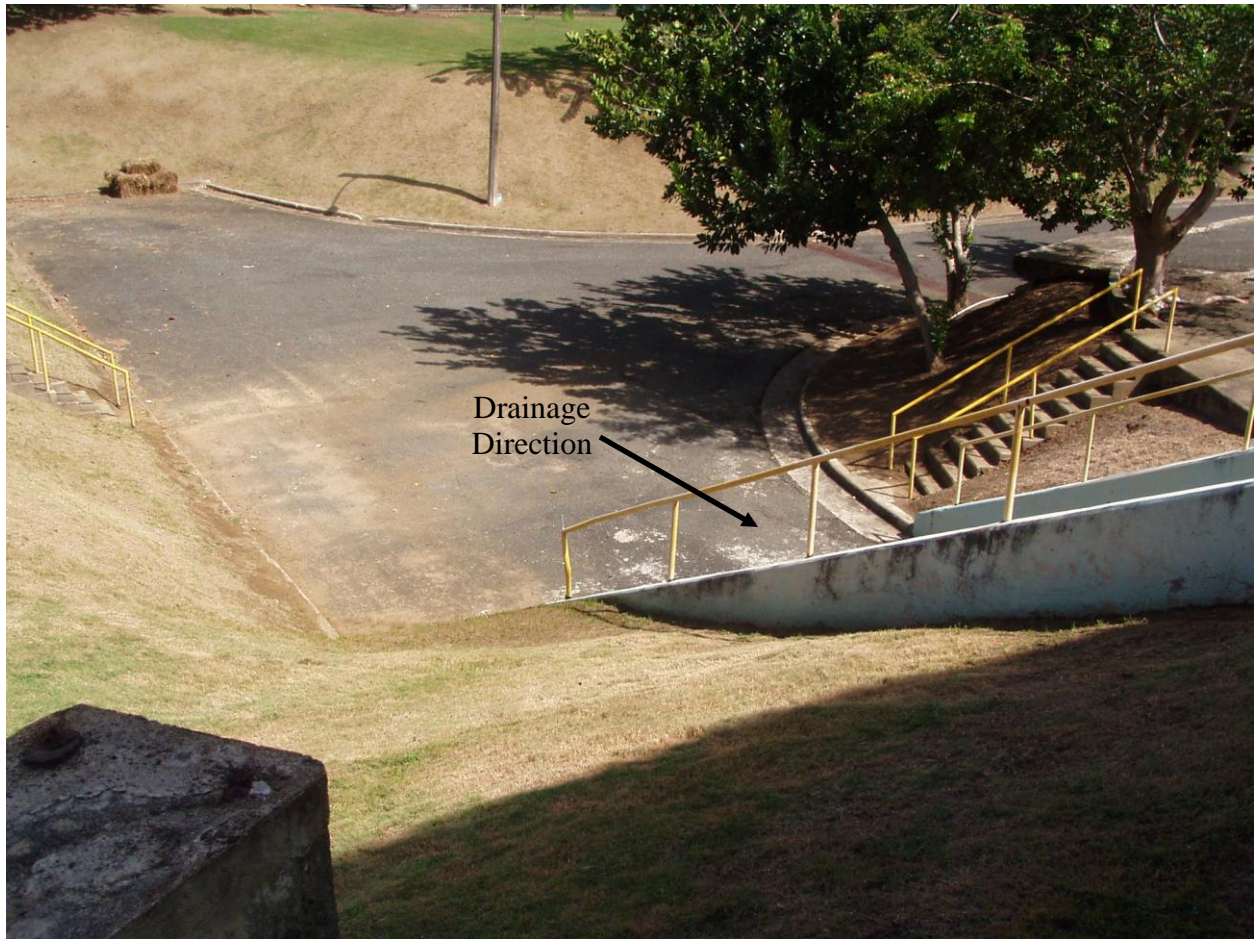
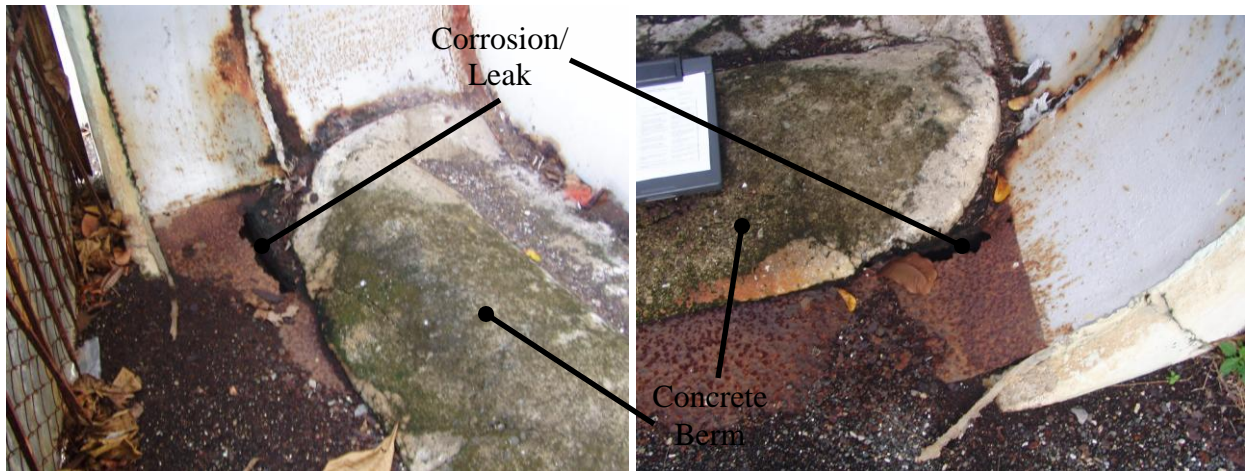
door diverts rainwater toward the door, which infiltrates the basement through the deteriorated metal frame under the door (Attachment 1, Figures 31 and 32).

Figure 31a, 31b, and 31c. Basement Level – East Side Basement Loading Access. 31a (Top) Shows the Pave Access Pad Drains Rainwater Toward the Loading Door. 31b and 31c (Left and Right) Show a Concrete Berm Across the Loading Door to Prevent Rainwater from being Diverted into the Basement Level. However, Corrosion of the Metal Frame in Front of the Berm Allows Rainwater to Leak into the Basement.

- The metal frame of the Basement Level loading door is corroded and allowing rainfall, which is diverted toward a concrete berm at the door entrance, to infiltrate (Attachment 1, Figure 31). It is recommended that the concrete berm be expanded into a concrete ramp covering the corroded frame at the Basement Level loading entrance door after a civil survey has determined that the height of the ramp will effectively divert rainfall away from the door (repeat from 2010).

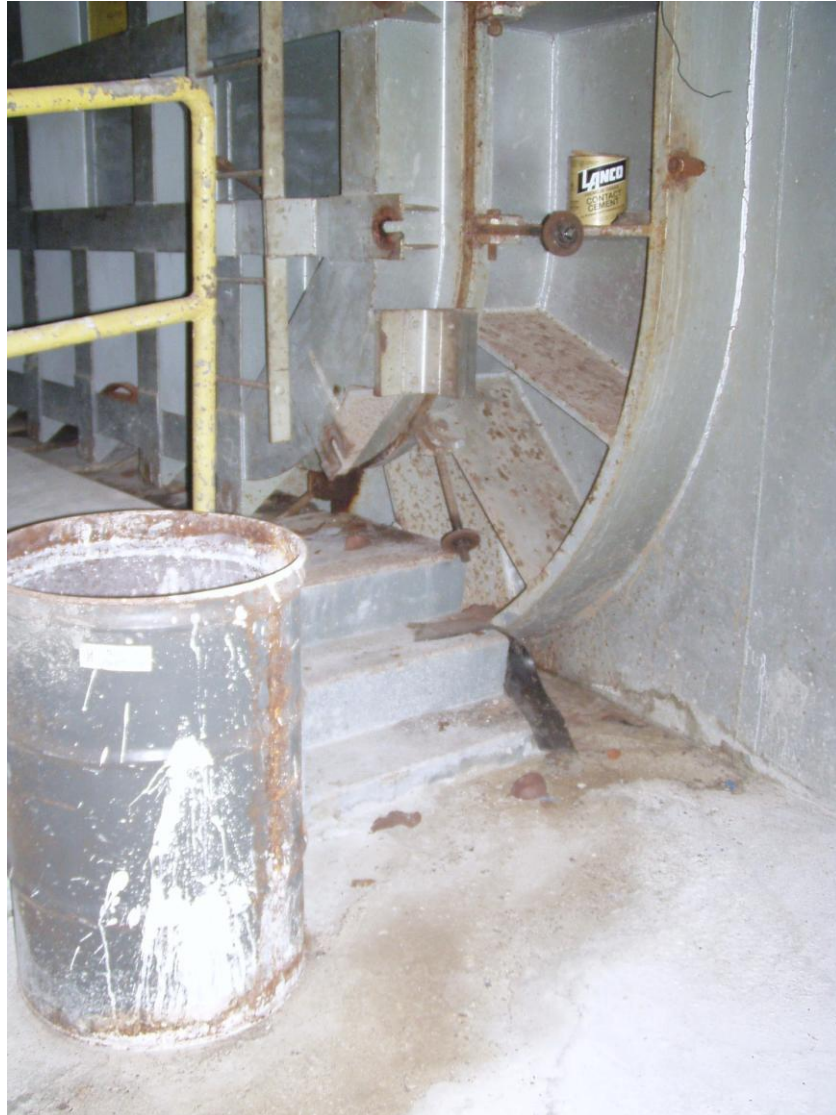
Figure 32. Basement Level – East Side Loading Access (Interior) with Water Stain Visible on Floor (Inflow through Corrosion of Metal Frame – Figure 31).

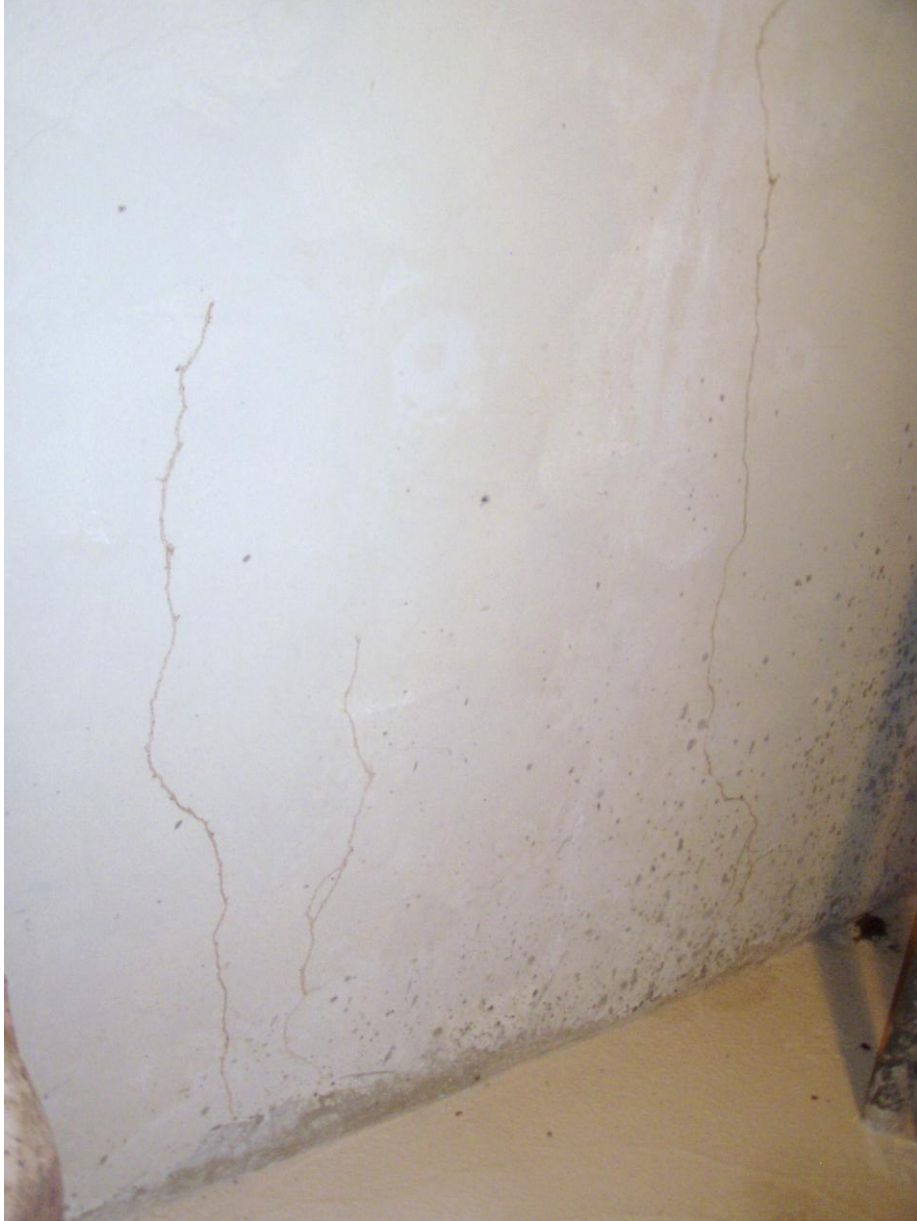
Minimal evidence of termites (vertical “tracks” on interior wall) was also noted in the Basement Level (Attachment 1, Figure 33). Since there are little to no wood building materials associated with the facility, no action is required at this time.

Figure 33. Basement Level – East Side Near Loading Access (Interior) with “Termite Tracks” Visible on Wall.
