**DR. MODESTO IRIARTE TECHNOLOGICAL  
MUSEUM (FORMER BONUS FACILITY)**

**2014 ANNUAL RADIOLOGICAL SURVEY REPORT**

**RINCON  
PUERTO RICO**

**FINAL  
November 2014**

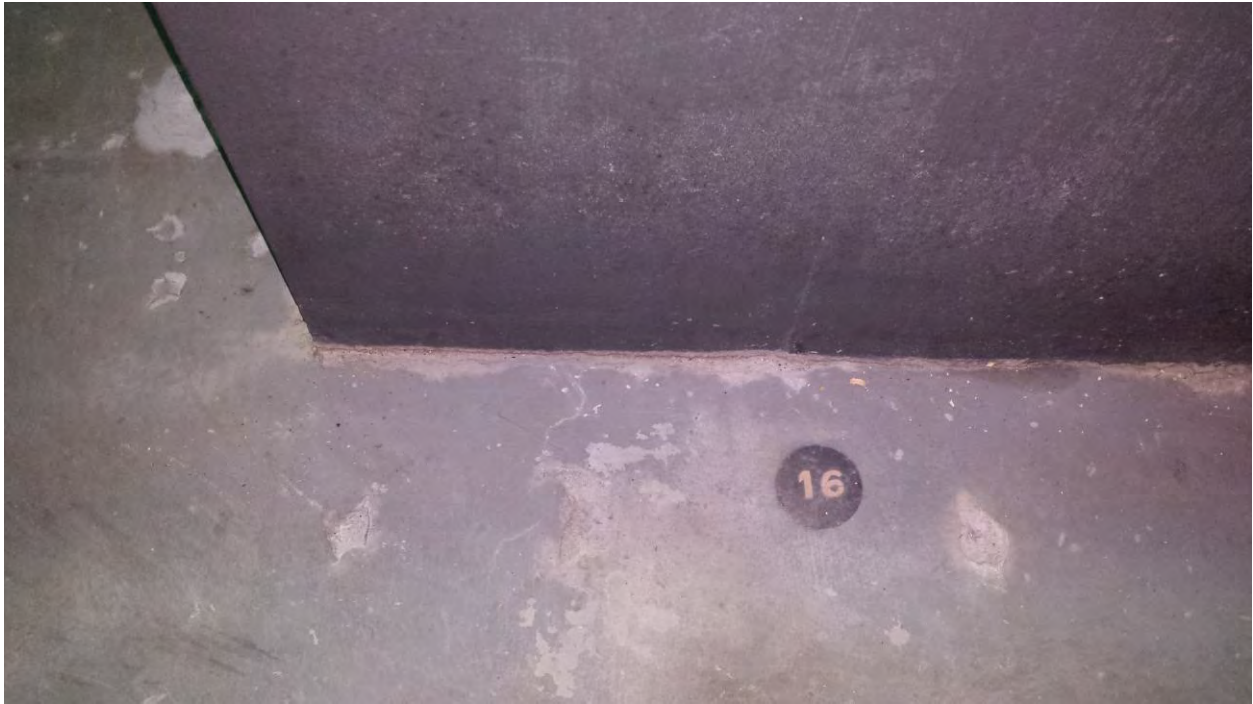
**Figure 1. Entombment Top (Top Plug, South Side) – Sampling Point 16 and Surface Cracks (Typical)**

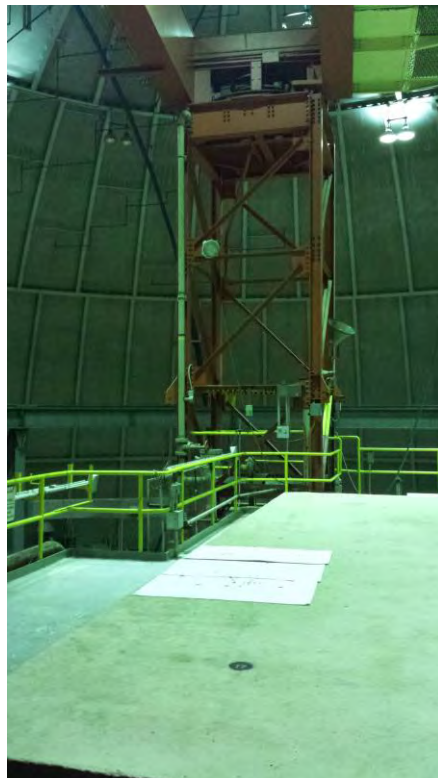
**Figure 2. Entombment Top (Crane) – Absorbent Pads Placed to Contain Oil/Lubricant Drips from Overhead Crane Equipment**

- Physical Condition:
  - Oil/grease continues to drip from the crane system onto the Concrete Monolith top at new locations (Appendix A, Figures 2 and 3). It is recommended that drip pans/pads continue to be placed at those locations where oil/grease is accumulating on the Concrete Monolith.

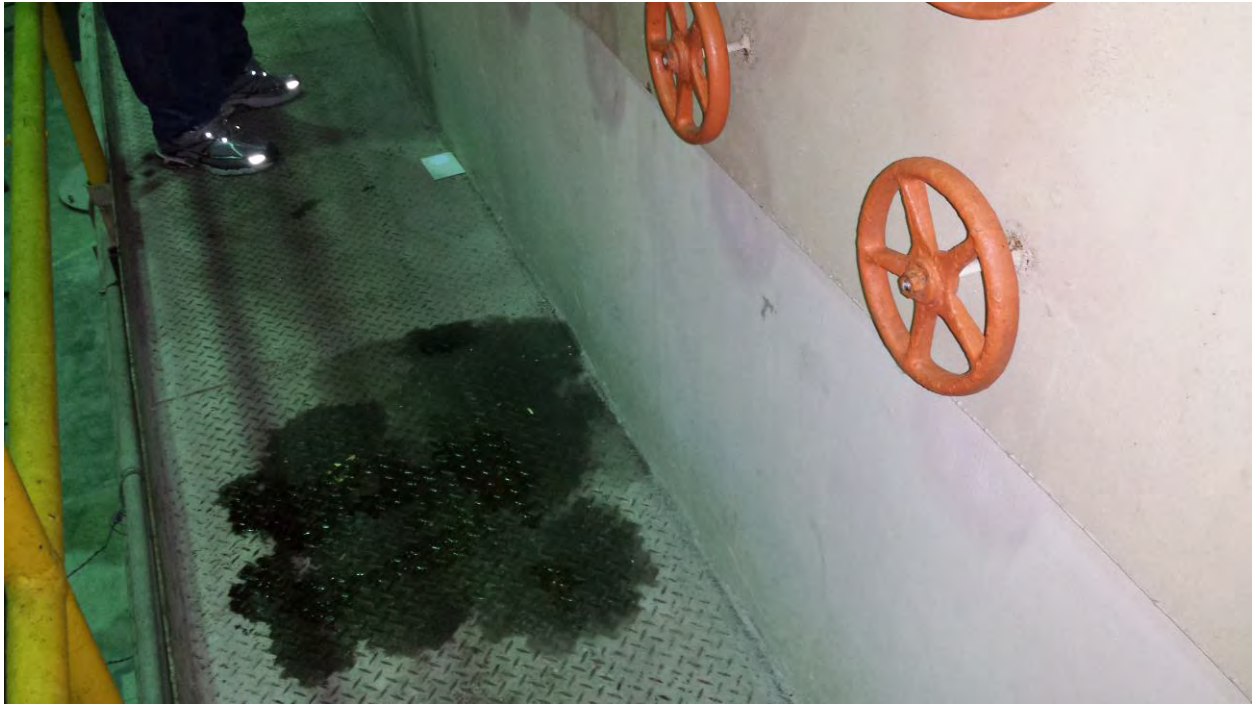
**Figure 3. Entombment Top – Oil Leaking from Overhead Crane (Near Sampling Points 1, 2, 3, and 4)**

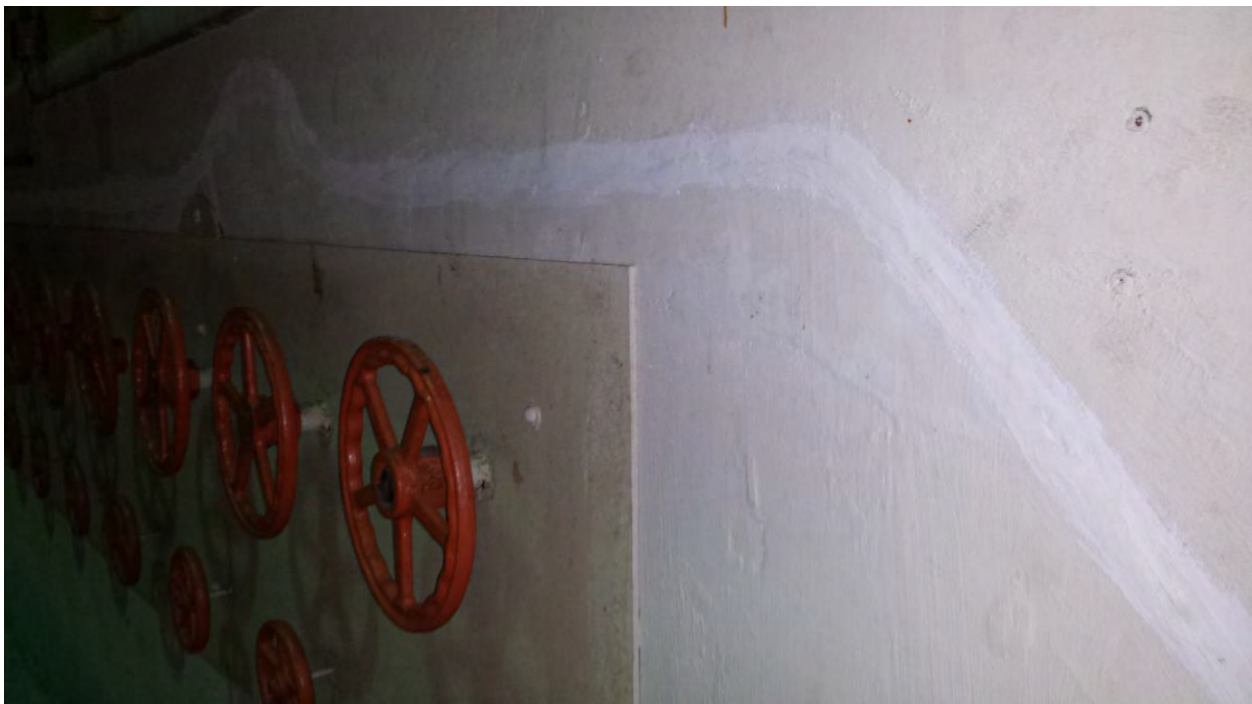
- **Dome-Entombed Concrete Monolith and Monolith Penetrations:** Inspection of the Concrete Monolith area revealed superficial cracks throughout the surface of the structure (Appendix A, Figure 4). Superficial cracks are also present along the base of the “top plug” of the concrete monolith top (Appendix A, Figure 1). All dose rate measurements taken around the structure were not significantly different from background measurements taken. No immediate action is necessary. Absorbent clothe has been placed to collect oil/grease dripping from the crane system above, however, a new leak was noted this year (Appendix A, Figures 2 and 3). Flaked paint (from the overhead crane and catwalk), which was noted in the 2013 Report, has been removed. It is recommended that absorbent clothes continue to be placed at those locations where oil/grease is accumulating on the Concrete Monolith.

**Figure 4. Entombment Top – Surficial Cracks (Typical)**

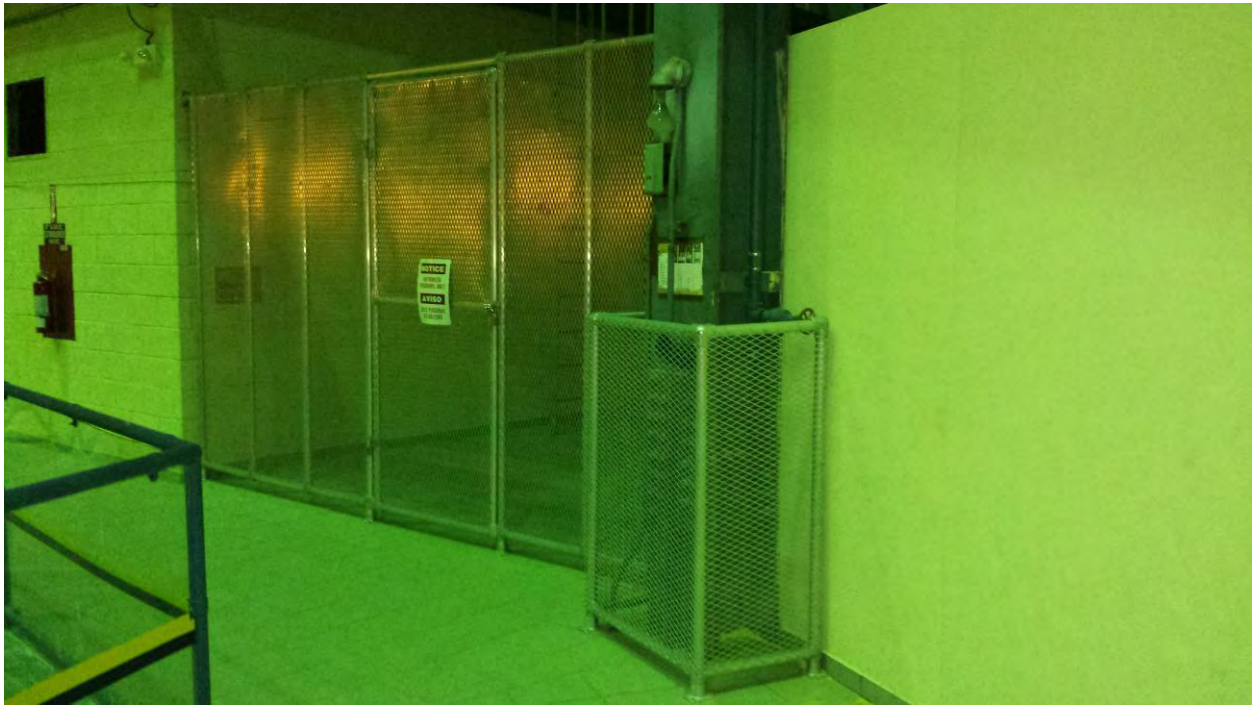
- **Dome-Mezzanine Level:** Access to ladders and stairways leading to the mezzanine level are being effectively maintained and controlled (Appendix A, Figures 11, 12, and 13). The structure appears sound and in good condition (Appendix A, Figure 24). No immediate action is necessary.

**Figure 11. Main Level – Locked and Controlled Access to East Mezzanine and Electrical Panels**

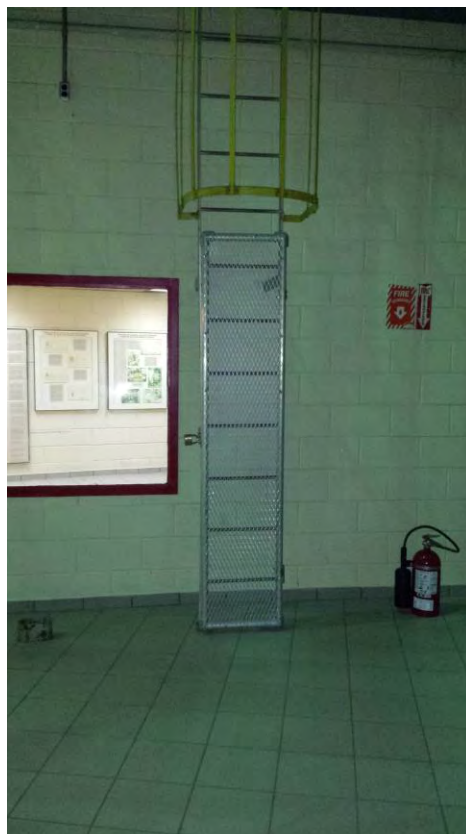
**Figure 12. Main Level – Locked and Controlled Access to South Mezzanine**

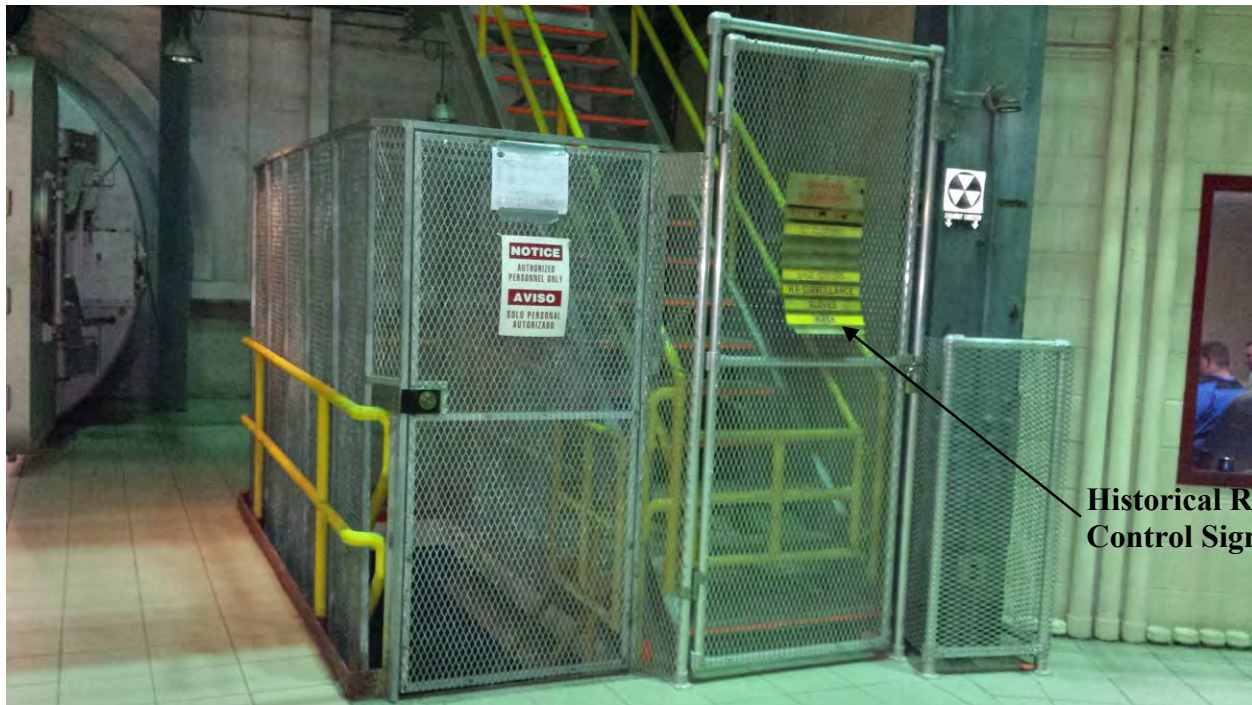
**Figure 13. Main Level (Museum Area) – Locked and Controlled Access to Basement Level (Left) and Mezzanine (Right)**

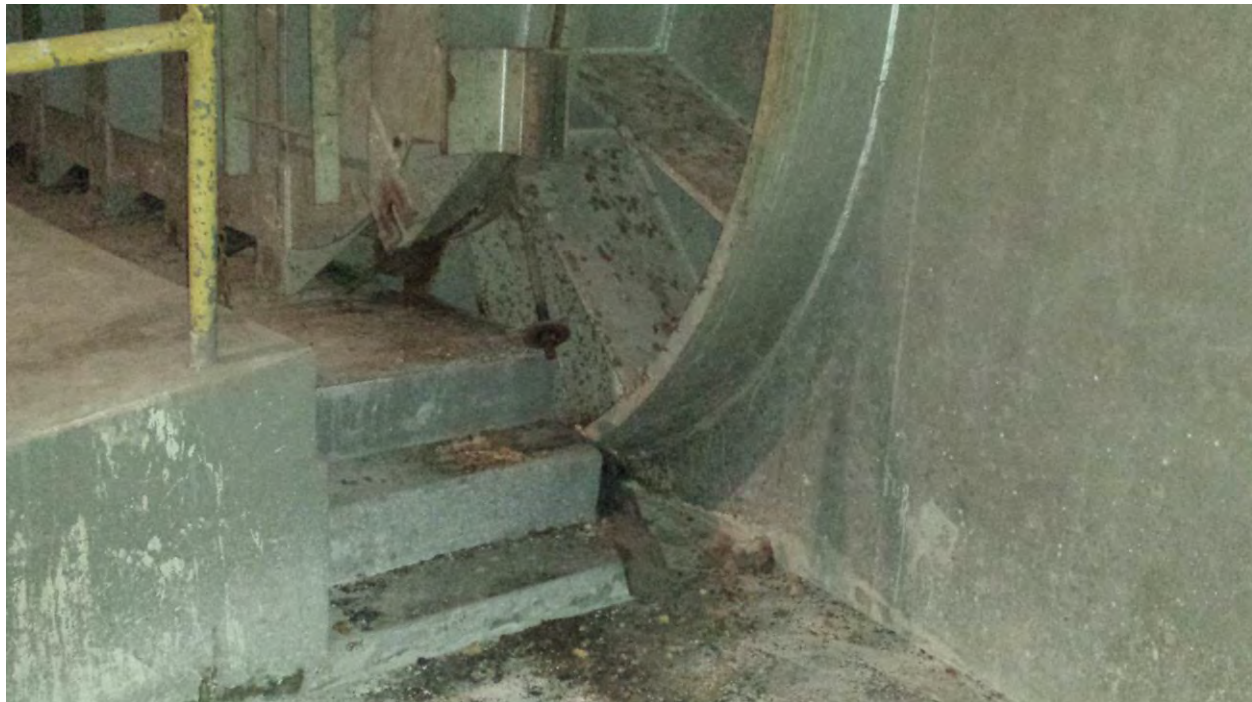
The gasket around the exterior base of the Dome, which is at ceiling level of the basement, has been replaced and some subsequent “patches” have been placed at the north entrance (Appendix A, Figure 27). The large bay door at the Basement Level remains sealed with expanding foam to prevent rainwater infiltration into the Basement Level (Appendix A, Figures 14 and 15).

**Figure 14. Basement Level – Bay Door (No Signs of Rain Water Infiltration)**

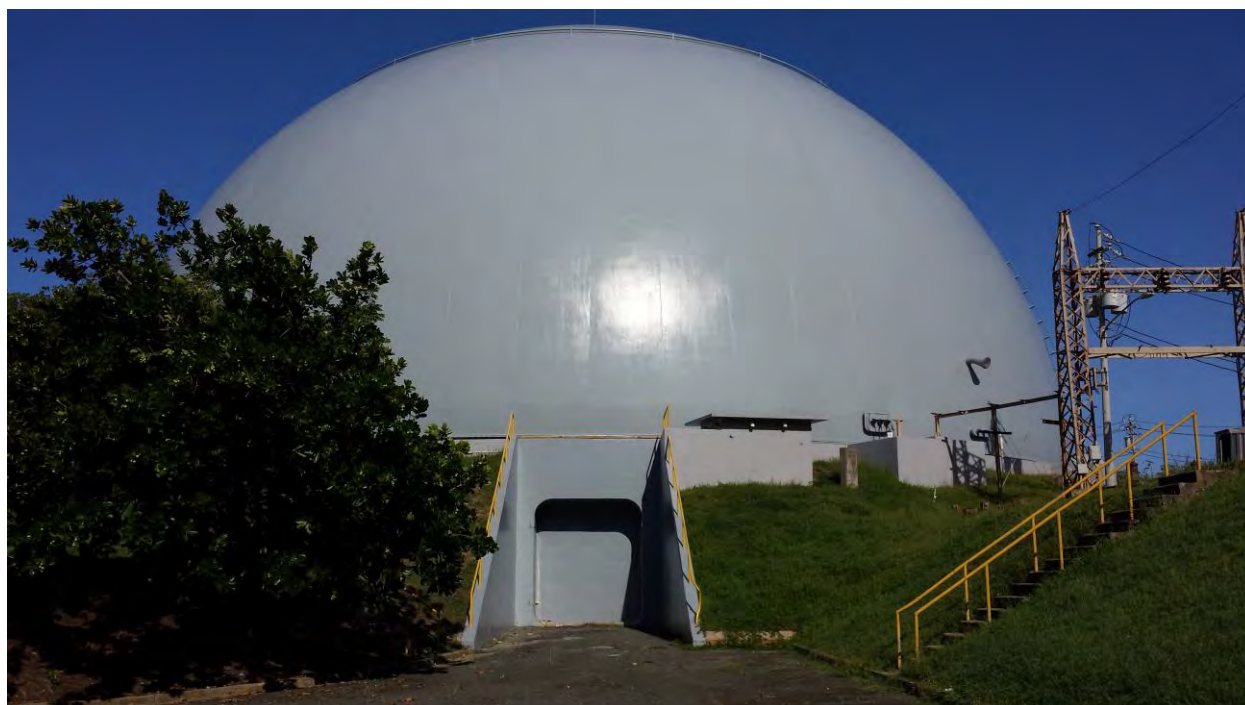
**Figure 15. Basement Level (Exterior) – Bay Door Sealed with Expanding Foam to Prevent Rain Water Infiltration**

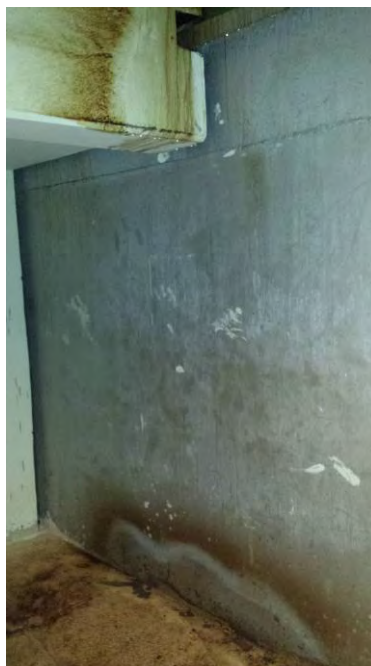
**Figure 16. Basement Level – Beneath North Entrance Air Lock (No Signs of Recent Water Infiltration – Older Stains Persist)**

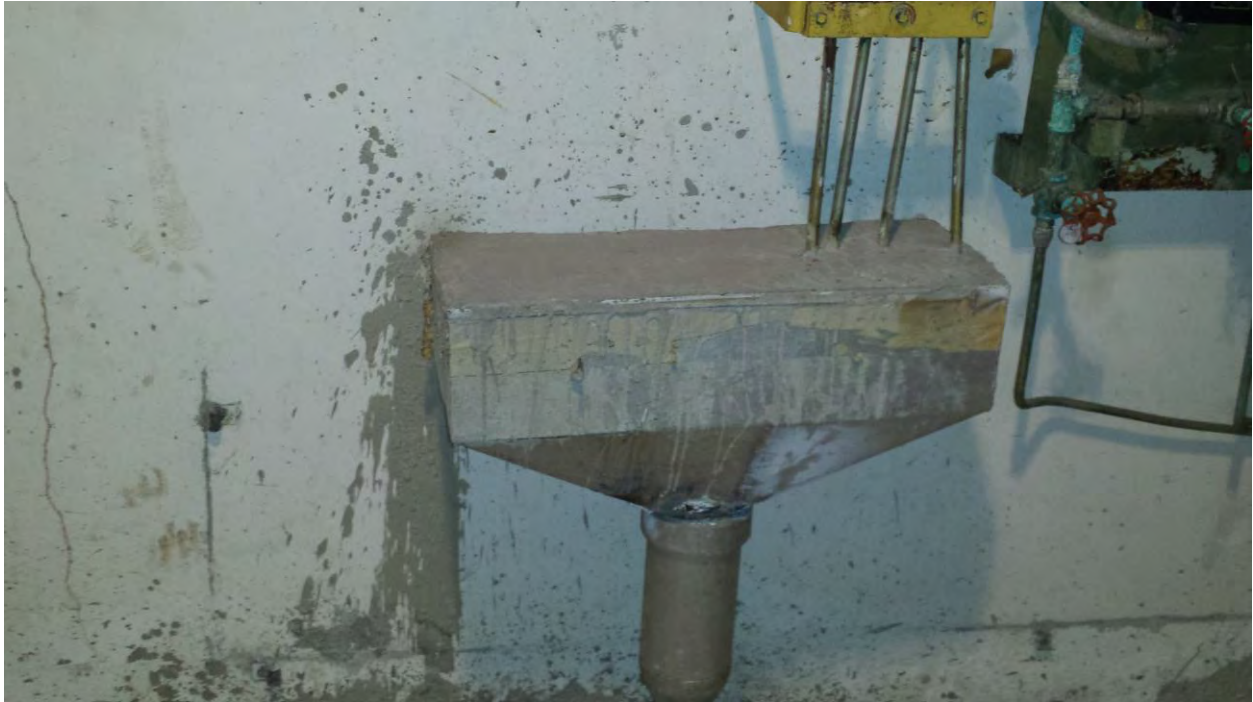
Control measures (fixed with paint and concrete layer in some places), which were previously implemented, were inspected (Appendix A, Figures 17 and 21). The yellow paint on the Liquid Water Retention Tanks is starting to show signs of thinning, but smears indicated no removable contamination at this time. Ongoing and routine assessment of accessible surfaces in the basement is recommended to evaluate the continued effectiveness of the concrete cover flooring and control measures (e.g., paint) emplaced on previous contamination areas. Although immediate action is not critical, it is recommended that yellow paint be re-applied to the three liquid water retention tanks

**Figure 17. Basement Level – Concrete Filled Sink**

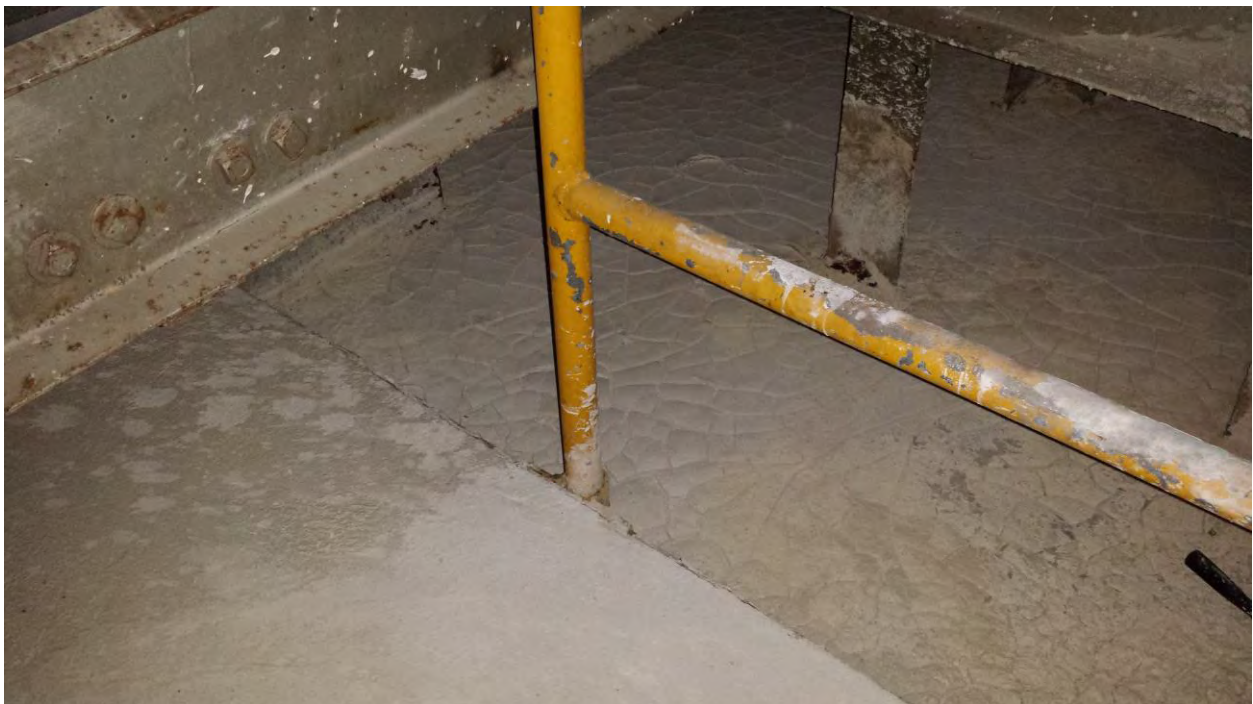
**Figure 18. Basement Level – Lowest Point in Basement with No Standing Water**

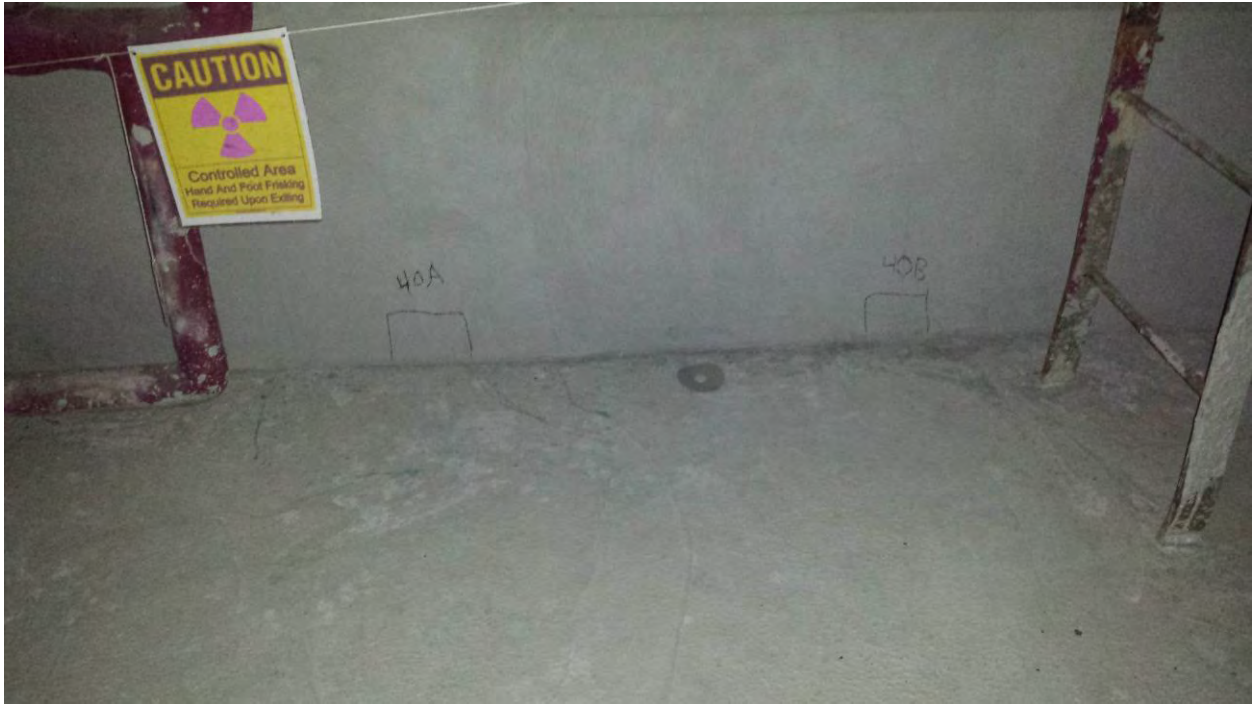
**Figure 19. Basement Level – Sample Locations 40A and 40B Covered by Engineering Control (~1/2 Inch Concrete) with Caution Sign Reading “Controlled Area – Hand and Foot Frisking Required Upon Exit”**

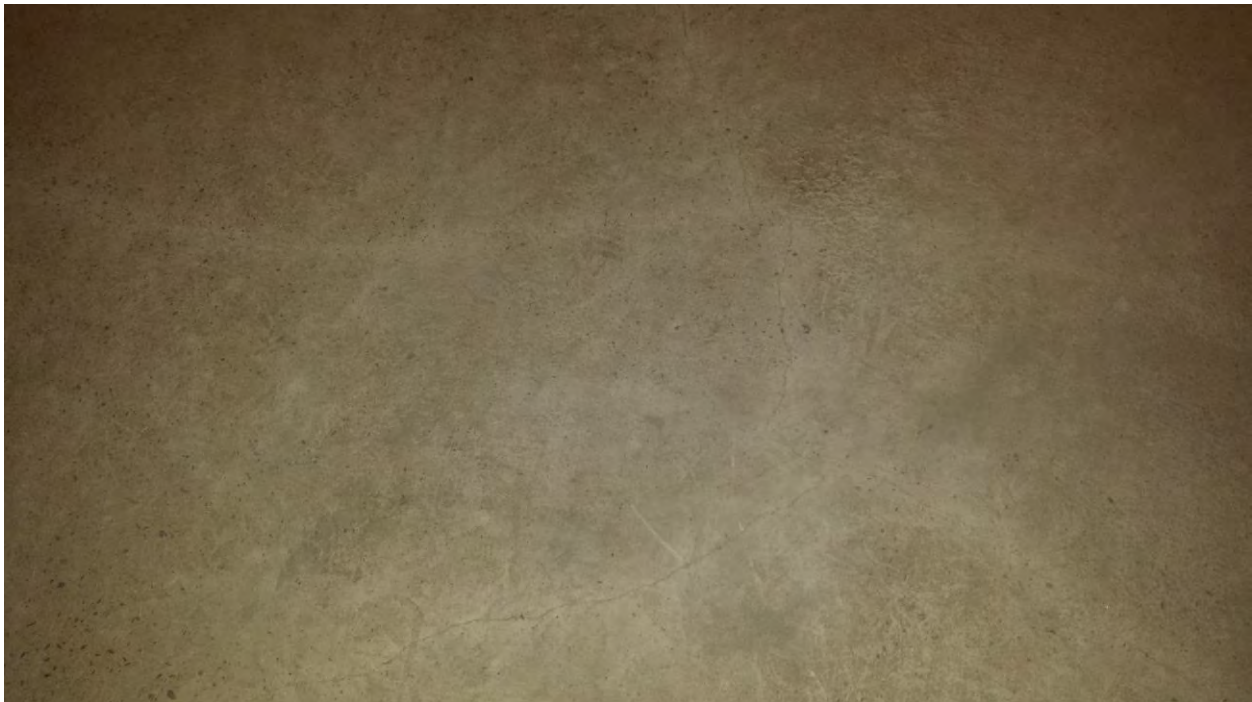
- **Dome-Basement Level:** Historically, corrosion was evident on all metal surfaces within approximately 6 in. of the floor, including contaminated surfaces. However, the concrete floor cover (installed in late 2004) covers all floor areas and bases of metallic structures/equipment where surface contamination was present, which is preventing contact with previously accessible contaminated and corroding surfaces. Surface fissures/cracks were noted in the concrete floor covering (Appendix A, Figure 20), but are not of concern.

**Figure 20. Basement Level – Engineering Control (~6 Inch Concrete Floor Covering) with Surficial Cracks (Typical)**

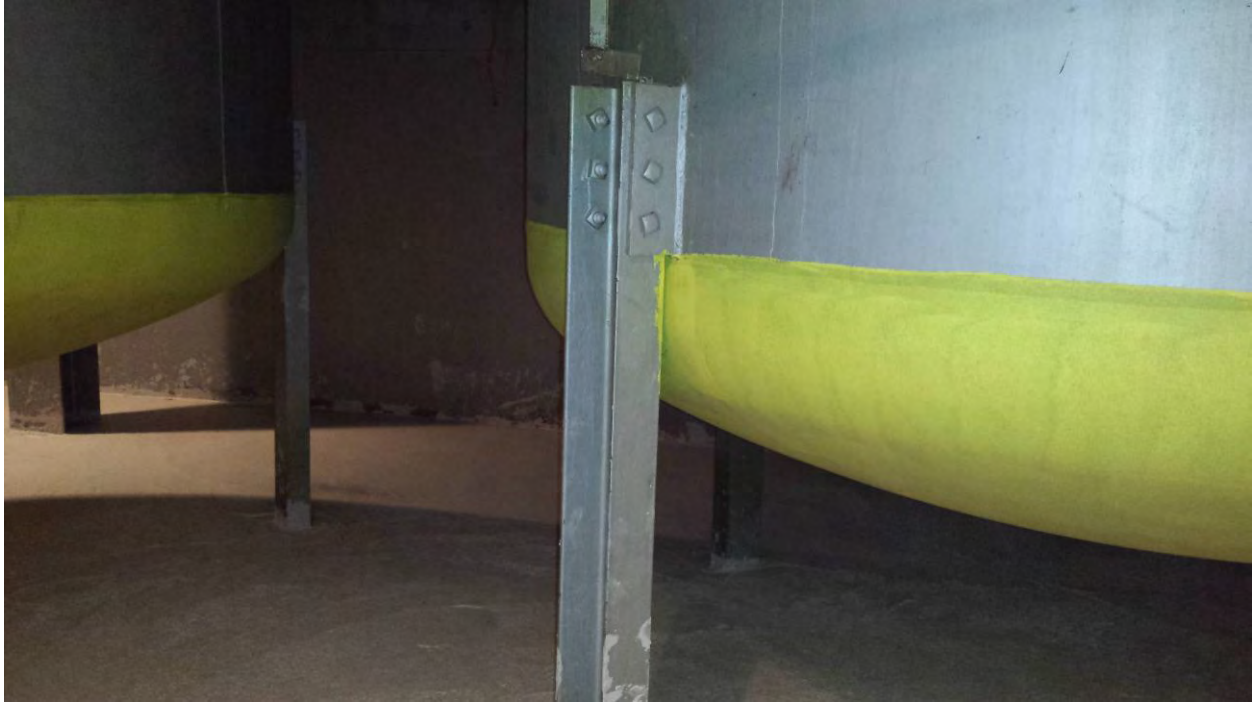
**Figure 21. Basement Level – Liquid Water Retention Tanks #1, #2, and #3 with Engineering Control (Yellow Paint) Starting to Show Signs of Thinning**

within the next two years (Appendix A, Figure 21). Access to areas with historical removable contamination is being effectively controlled.

- Control measures (fixed with paint and concrete layer in some places), which were previously implemented, were inspected and do not require maintenance at this time (Appendix A, Figures 17 and 21). Although no immediate action is necessary, it is recommended that yellow paint be re-applied to the three liquid water retention tanks within the next two years (Appendix A, Figure 21).

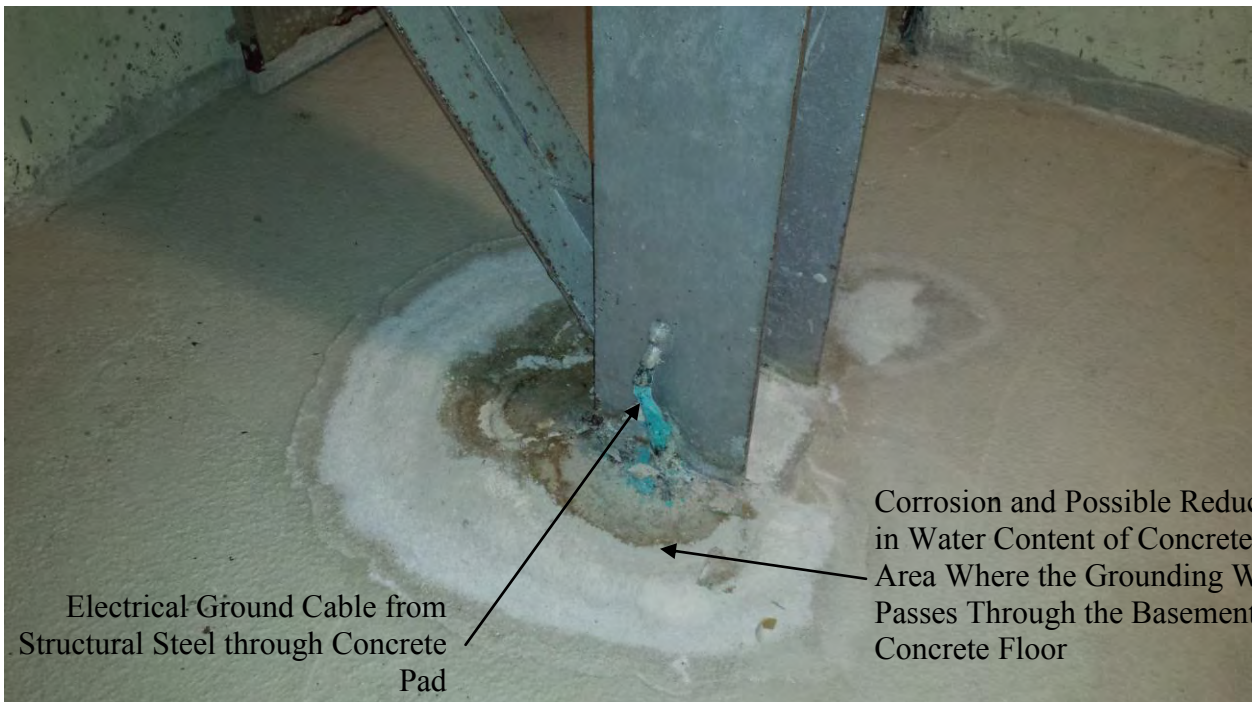
**Figure 22. Basement Level – Corrosion Issues on Concrete Floor near Sample Locations 50A and 50B**

On the concrete flooring and structural steel near Sample Locations 50A and 50B, significant corrosion and concrete spalling is occurring (this is a repeat observation from 2013). This appears to be centered around the grounding wire in this location which is attached to a structural steel column and passes through the concrete flooring (Appendix A, Figure 22). It is recommended that an electrician be contacted to inspect the grounding of structural steel in the basement.

Electrical Ground Cable from  
Structural Steel through Concrete  
Pad

Corrosion and Possible Reduction  
in Water Content of Concrete In the  
Area Where the Grounding Wire  
Passes Through the Basement  
Concrete Floor

- On the concrete flooring and structural steel near Sample Locations 50A and 50B, significant corrosion and concrete spalling is occurring (repeat from 2013). This appears to be caused by the grounding wire in this location which is attached to a structural steel column and passes through the concrete flooring (Appendix A, Figure 22). It is recommended that an electrician be contacted to inspect the grounding of structural steel in the basement.

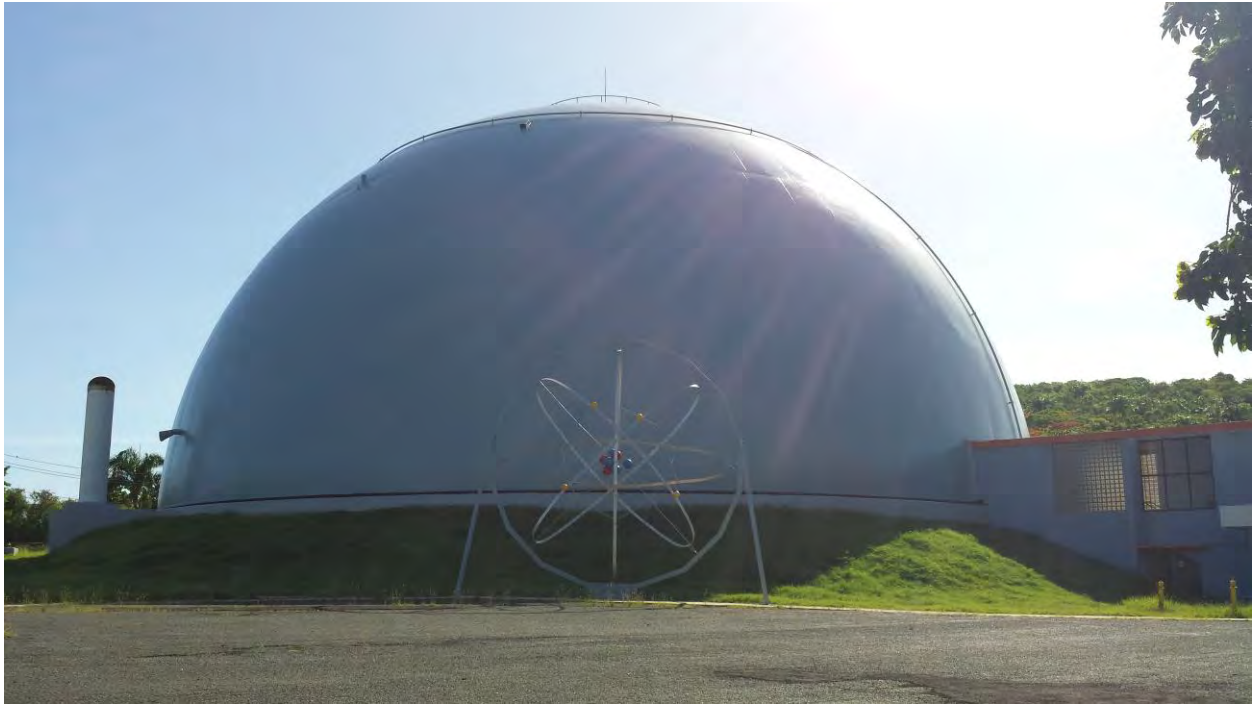
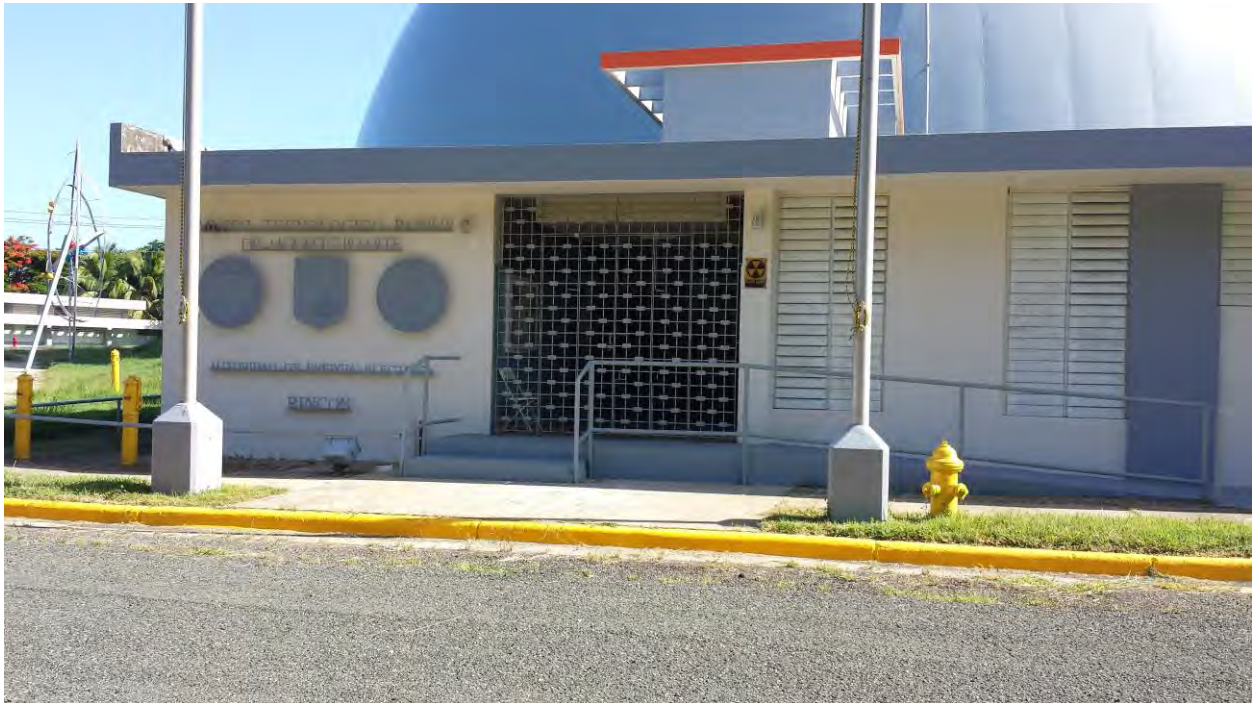
- **Dome-Exterior:** Inspection of the Dome structure did not reveal any significant structural discrepancies. The Dome structure exterior was re-sealed and painted since the last annual survey (Appendix A, Figure 23). Both entrance portals are in good condition.

**Figure 23. Dome Structure – Exterior With New Protective Coating and Paint**

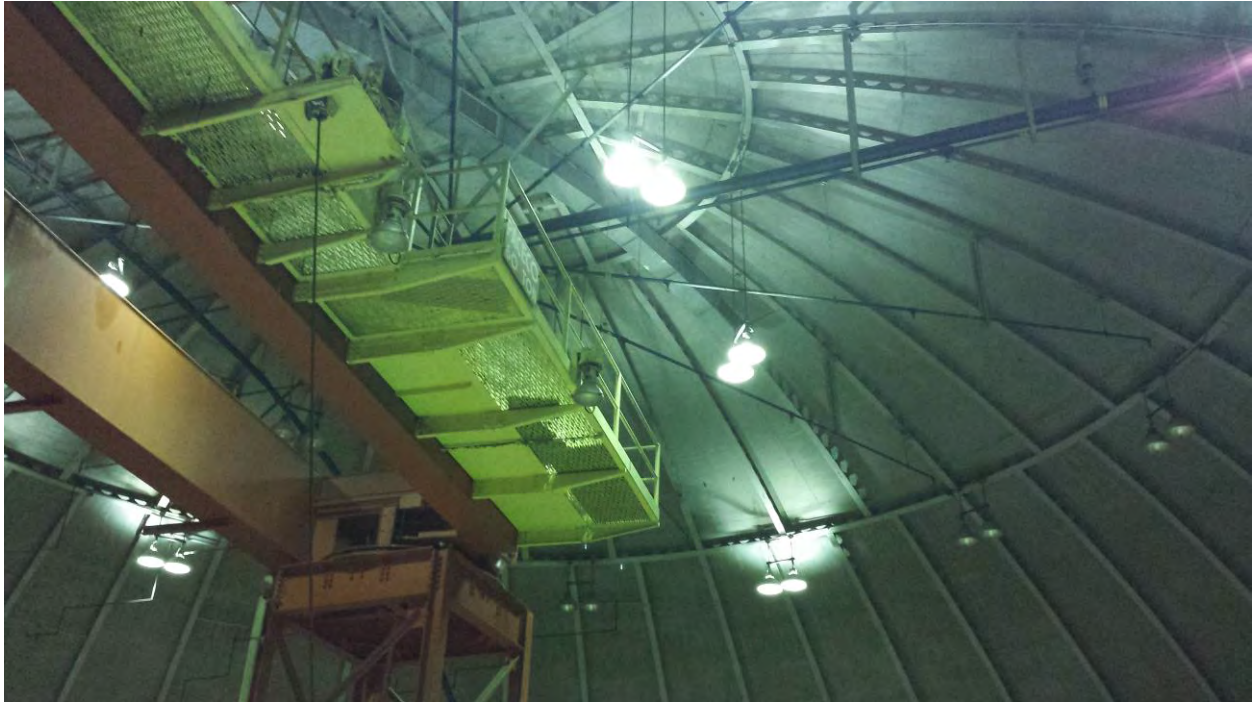
**Figure 24. Dome Structure – Interior with Fire Suppression Piping**

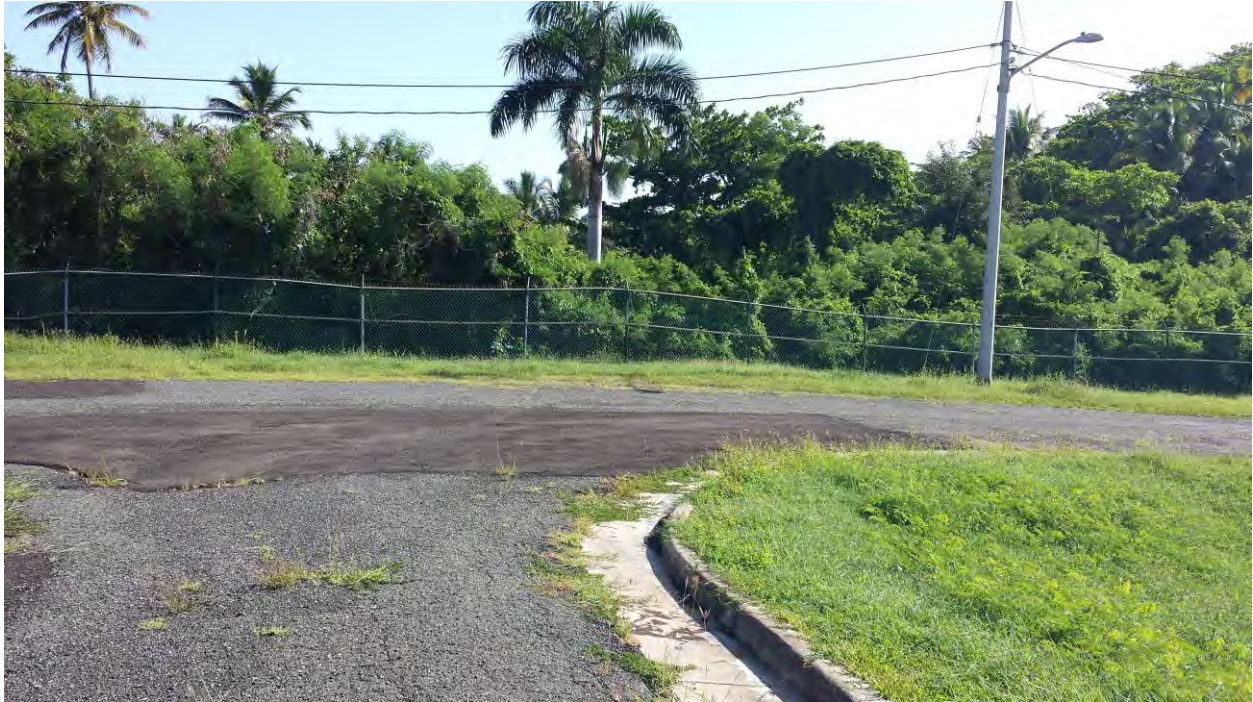
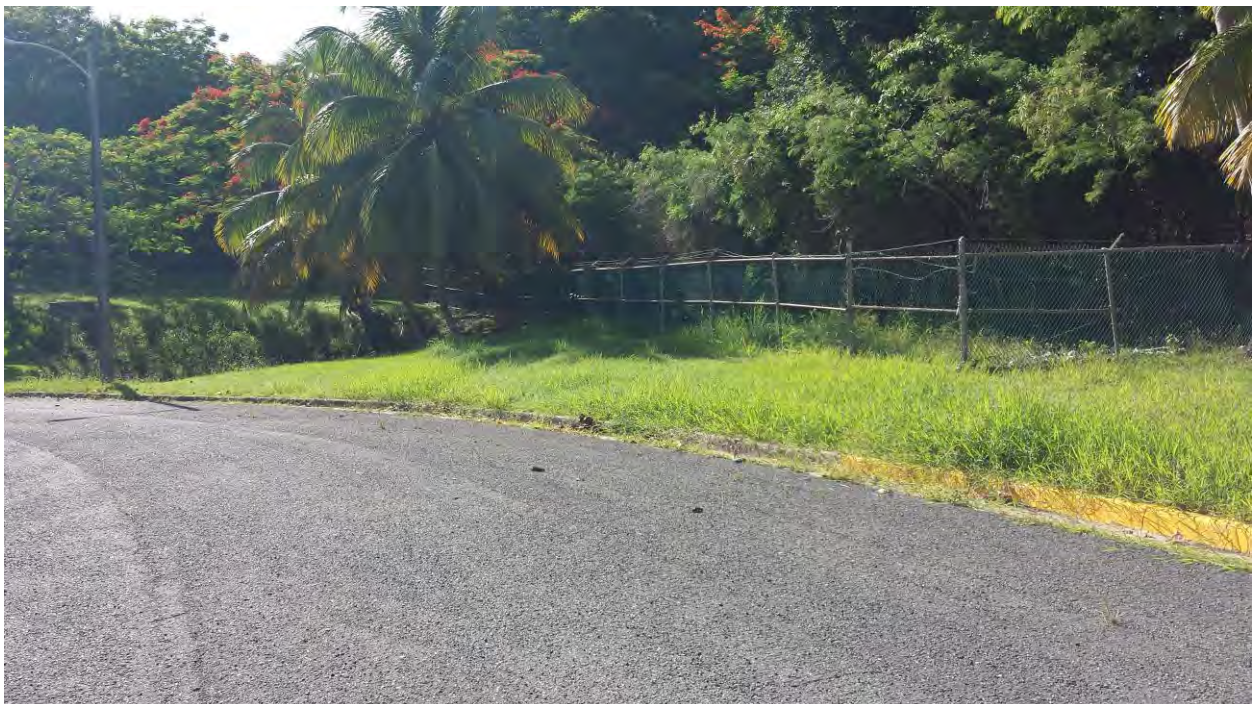
- **Site Surveillance Features:** Asphalt of the access road and parking area is in fair and usable condition. The entrance gate is manually operated by the attending guard (Appendix A, Figure 31). The security guard controlled access into the gated facility and kept log of visitors. The Dome monolith plaques were in fair condition. The fence surrounding the property is functional at controlling access and vegetation has been prevented from climbing the fence (Appendix A, Figure 26). No immediate action is necessary.

**Figure 26. Fence –Fencing and Perimeter has been Maintained**

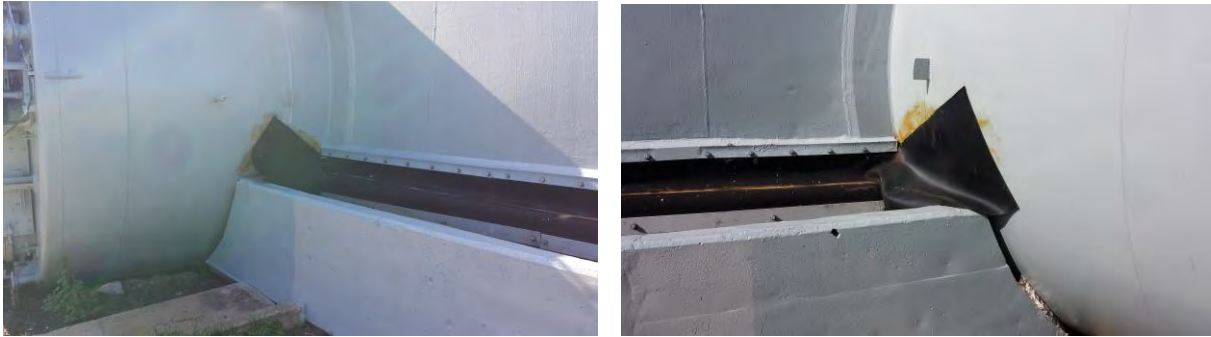
**Figure 27. Dome Structure – Flexible Gasket/Seal – North Entrance Air Lock (Several Repairs have been Made)**

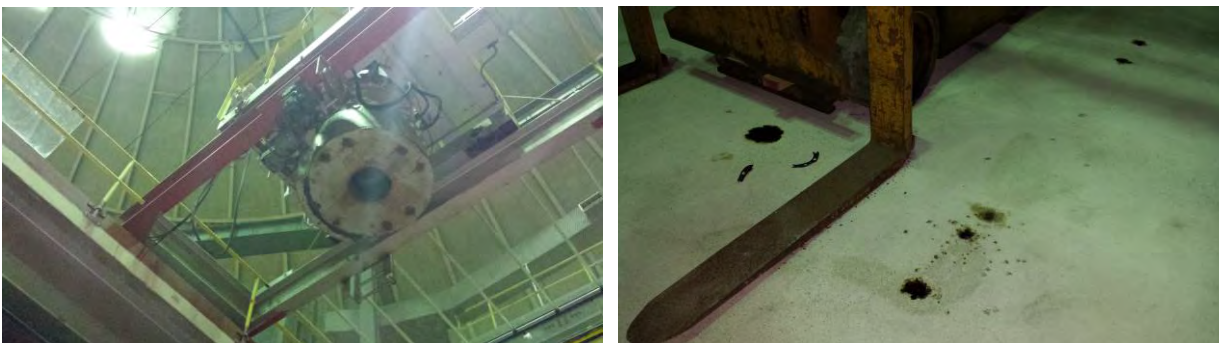
**Figure 29. Basement Level – Oil Leaking on Basement Floor from Overhead Machinery**

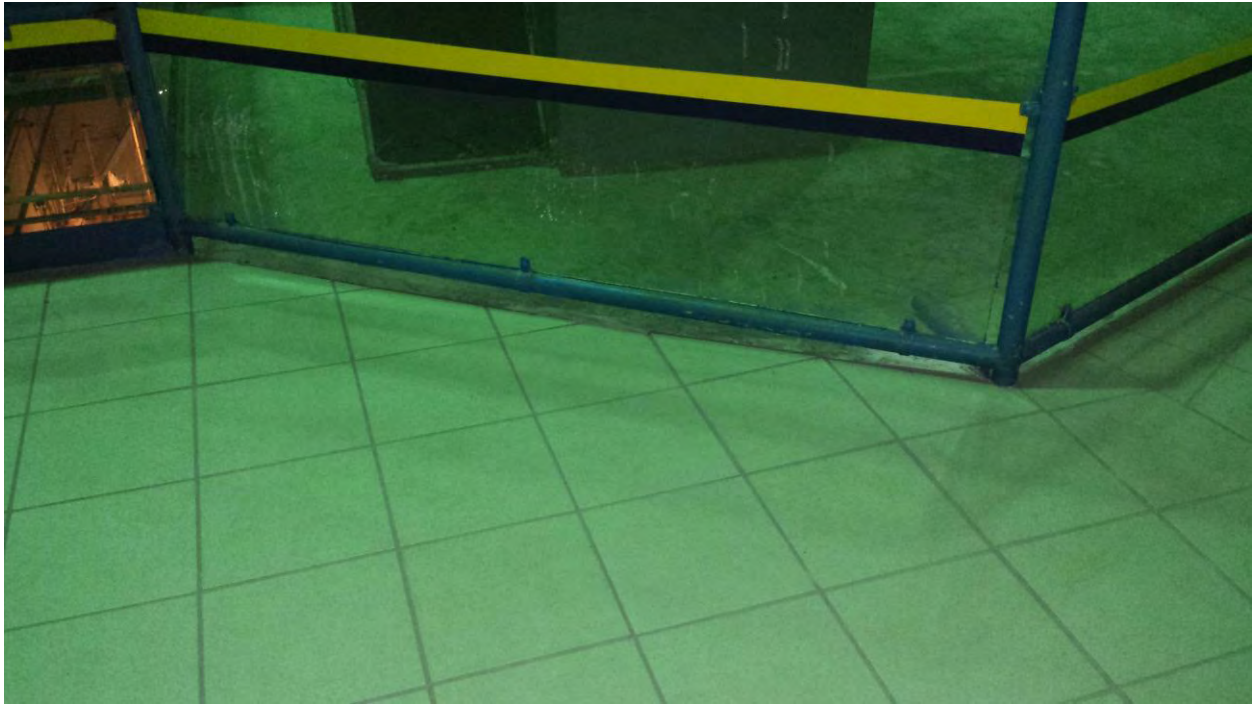
**Figure 30. Main Level (Museum Area) – Some Tiles Starting to Loosen**

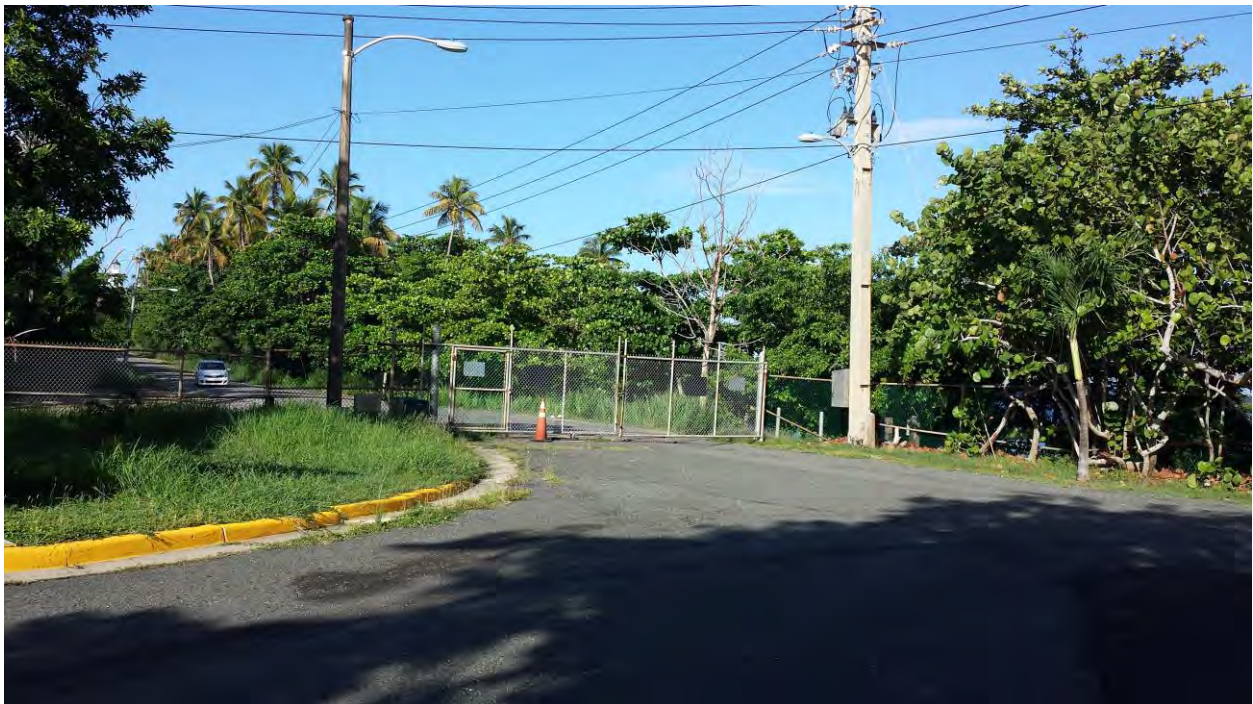
**Figure 31. Security – Main Gate in Good Working Condition (Manual Open/Close)**
