**DR. MODESTO IRIARTE TECHNOLOGICAL
MUSEUM (FORMER BONUS FACILITY)**

**2018 ANNUAL RADIOLOGICAL SURVEY REPORT -
DRAFT**

**RINCON
PUERTO RICO**

December 2018

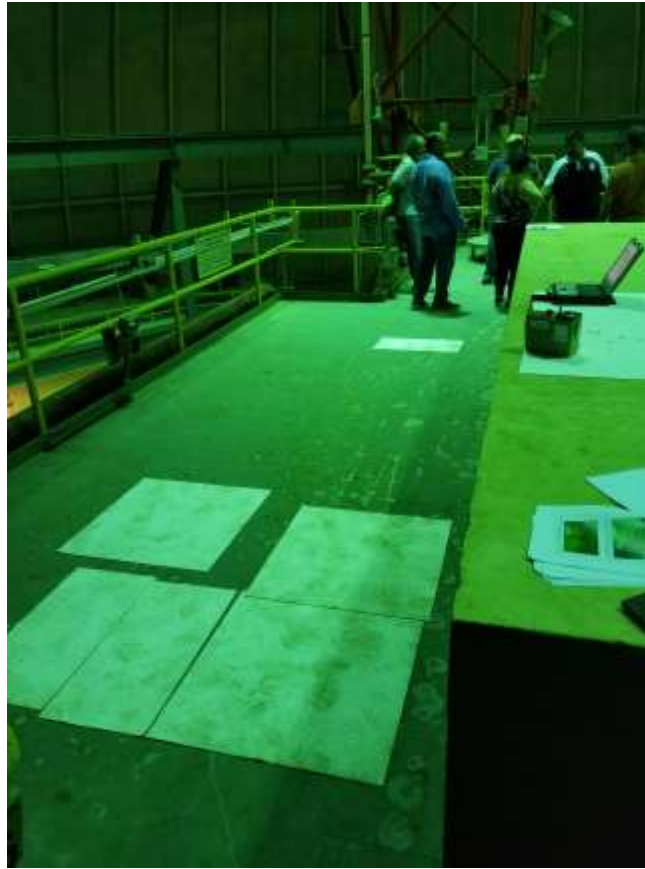
Figure 1. Entombment Top (Top Plug, Northwest Side) – Oil Pads Due to Overhead Crane

- It is recommended that absorbent clothes continue to be placed at those locations where oil/grease is accumulating on the Concrete Monolith and, especially, if/after the crane is moved.

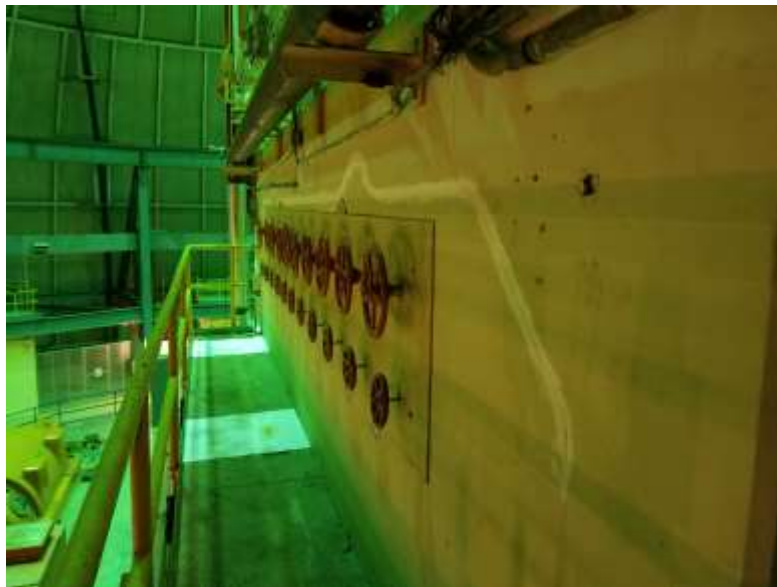
Figure 2. Entombment Top – Pad has been Placed to Address Oil Leaking from Overhead Crane (Near Sampling Points 1, 2, 3, and 4)

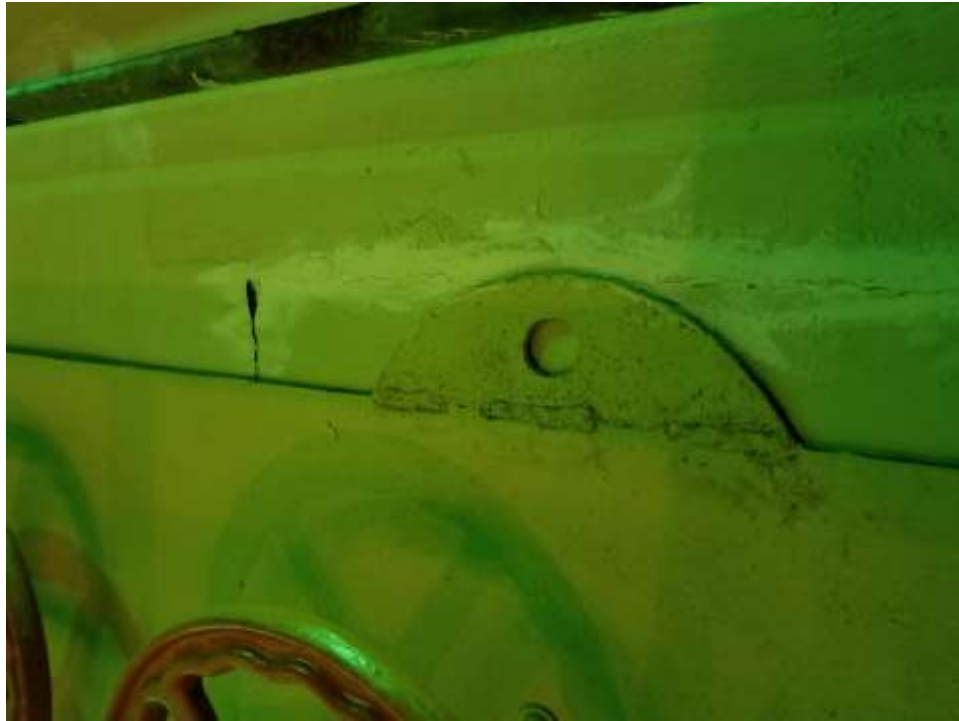
- **Dome-Entombed Concrete Monolith and Monolith Penetrations:** Inspection of the Concrete Monolith area revealed superficial cracks throughout the surface of the structure (Appendix A, Figure 3) – no change from past inspections. Superficial cracks are also present along the base of the “top plug” of the concrete monolith top, but with no change from past inspections. All dose rate measurements taken around the structure were not significantly different from background measurements taken. No immediate action is necessary. Additional absorbent clothes have been placed to collect oil/grease dripping from the crane system above (Appendix A, Figures 1 and 2). It is recommended that absorbent clothes continue to be placed at those locations where oil/grease is accumulating on the Concrete Monolith and, especially, if/after the crane is moved.

Figure 3. Entombment Top – Surficial Cracks (Typical)

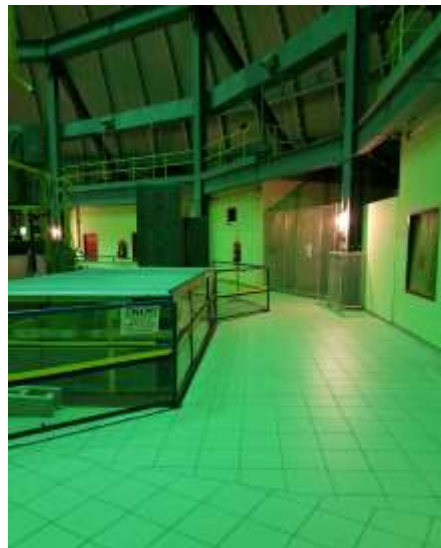
- **Dome-Mezzanine Level:** Access to ladders and stairways leading to the mezzanine level are being effectively maintained and controlled (Appendix A, Figures 11, 12, and 13). The structure appears sound and in good condition. No immediate action is necessary.

Figure 11. Main Level – Locked and Controlled Access to East Mezzanine and Electrical Panels

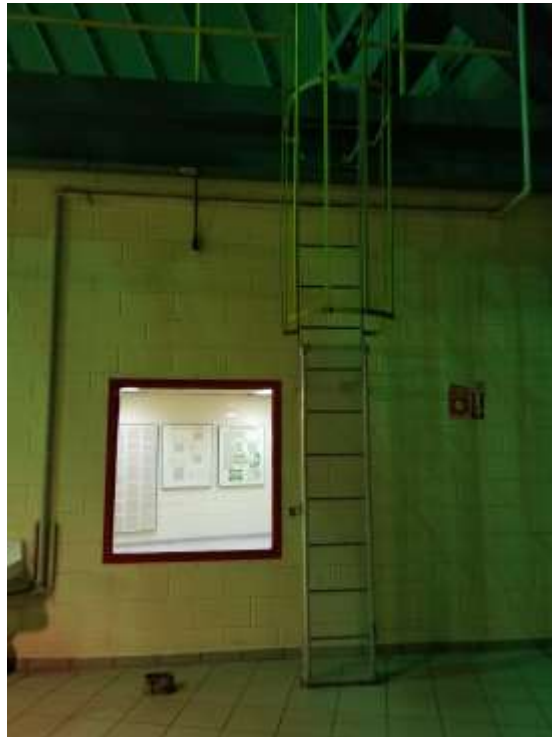
Figure 12. Main Level – Locked and Controlled Access to South Mezzanine

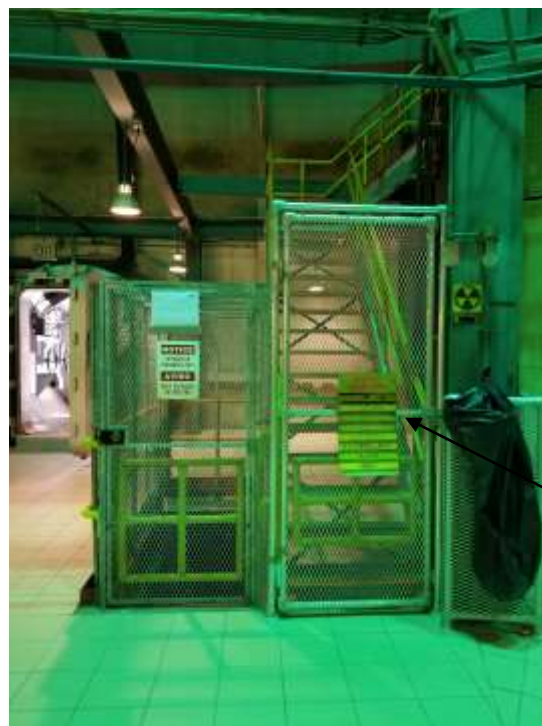
**Figure 13. Main Level (Museum Area) – Locked and Controlled Access to South Side of
Basement Level (Left) and Mezzanine (Right)**

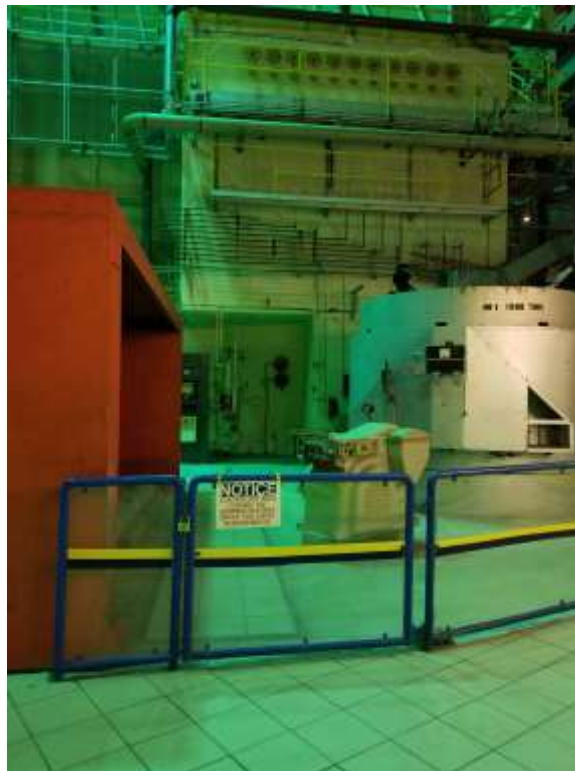
Museum Area to the Controlled Area, was in place and locked (Appendix A, Figure 15). The PREPA team will continue to monitor the tiles within the Museum Area for signs of cracks/failures.

Figure 15. Main Level (Controlled Area) – Locked Access from Museum Area to Controlled Area

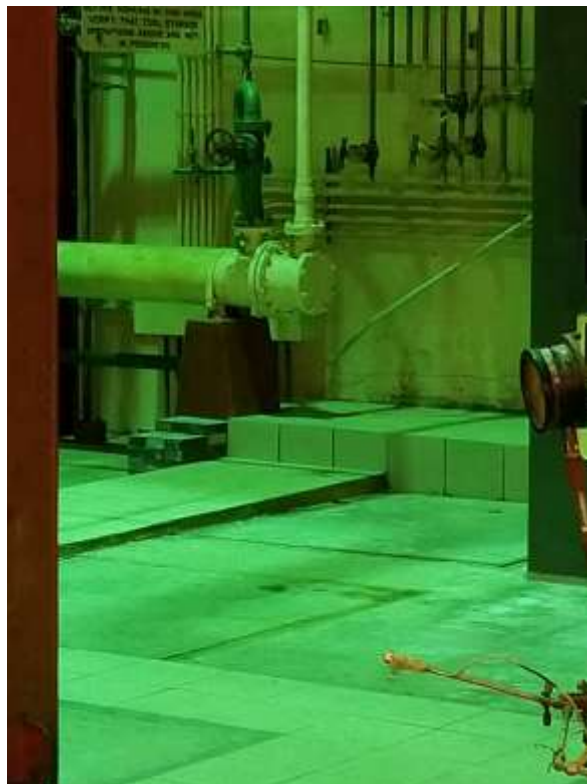
Figure 21. Main Level (Controlled Area) – Engineering Controls (Concrete, Tiles, and Lead Bricks) in Good Condition

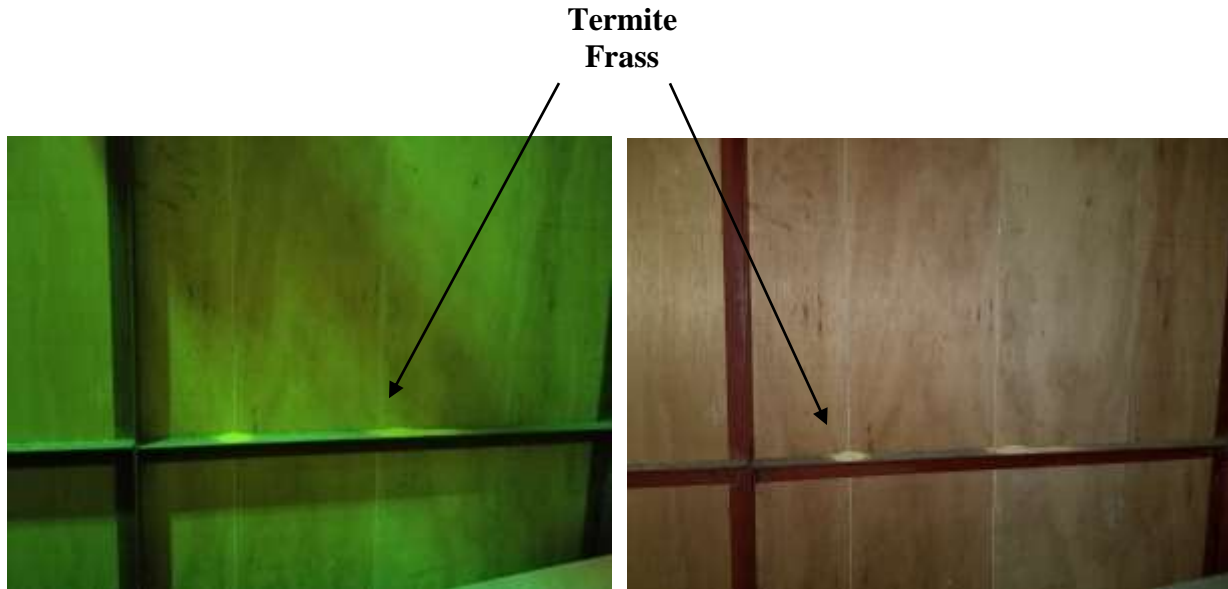
Evidence of termites (termite frass) was observed (repeat from 2015 and 2016) on the east side of Main Level (Museum Area) where plywood walls were constructed in recent years (Appendix A, Figure 22). No new/additional termite frass was observed during the 2018 survey/inspection – no action necessary.

Figure 22. Main Level (Museum Area) – Wood Paneling with Past Evidence of Termites (East Side)

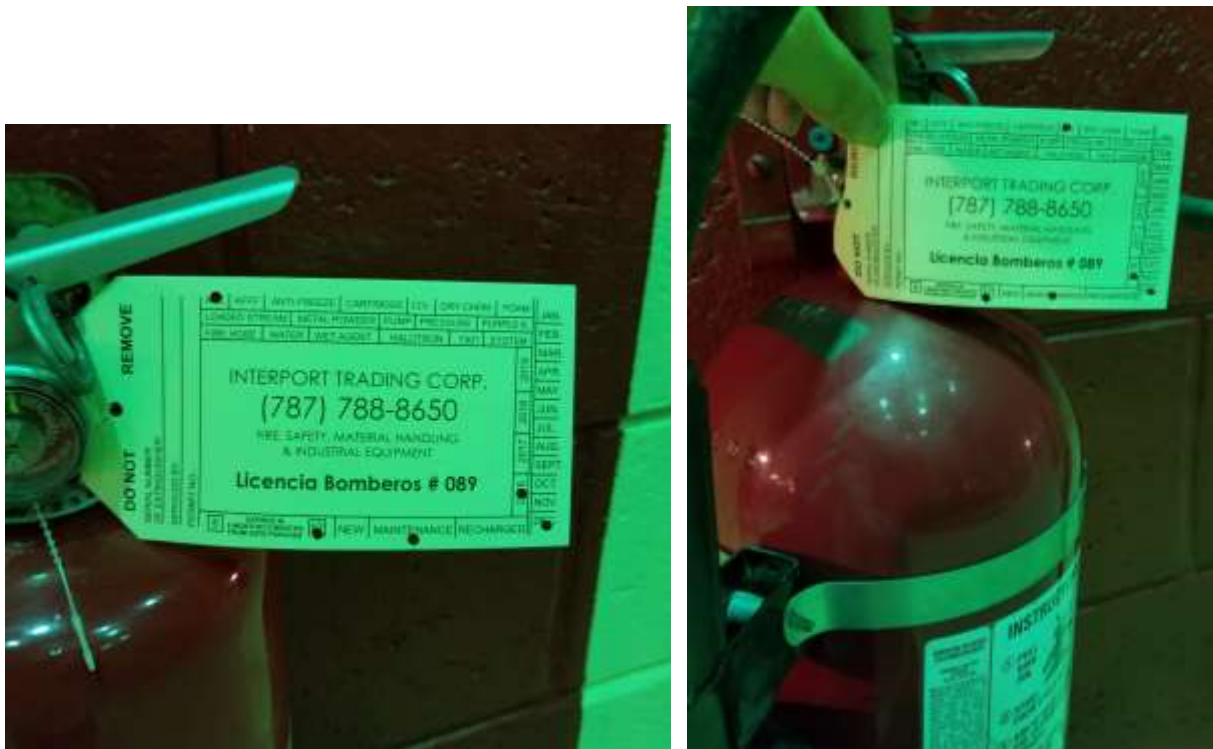
Fire extinguishers throughout the Main Level were inspected and appear to have out-of-date inspections and/or need to be replaced (Appendix A, Figure 23). It is recommended that all fire extinguishers throughout the facility be inspected and corrective actions taken, as necessary.

Figure 23. Main Level (Museum and Controlled Areas) – Fire Extinguisher Inspections Out of Date

- **Fire extinguishers throughout the Main Level were inspected and appear to have out-of-date inspections and/or need to be replaced (Appendix A, Figure 23). It is recommended that all fire extinguishers throughout the facility be inspected and corrective actions taken, as necessary.**

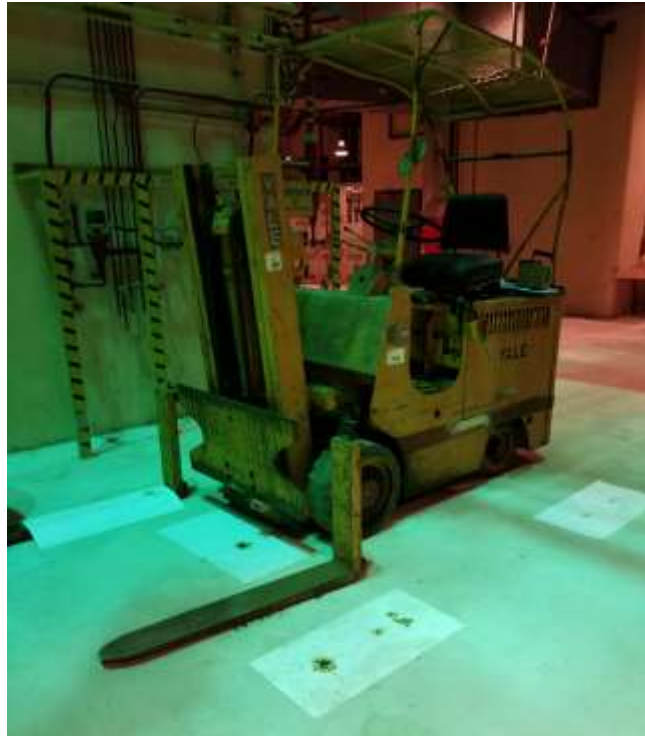
Figure 24. Basement Level – Oil/Lubricant Spots on Basement Floor from Overhead Equipment

- Near Sample Locations 50A and 50B, it was noted that absorbent clothes continue to be used to capture oil/lubricant dripping from area/overhead equipment (Appendix A, Figure 24). It is recommended that absorbent clothes continue to be placed at these locations during quarterly surveys, as needed.

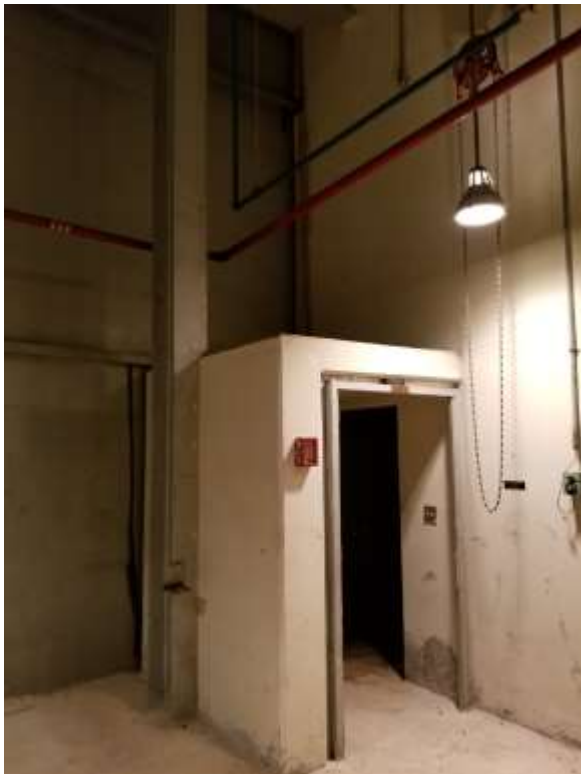
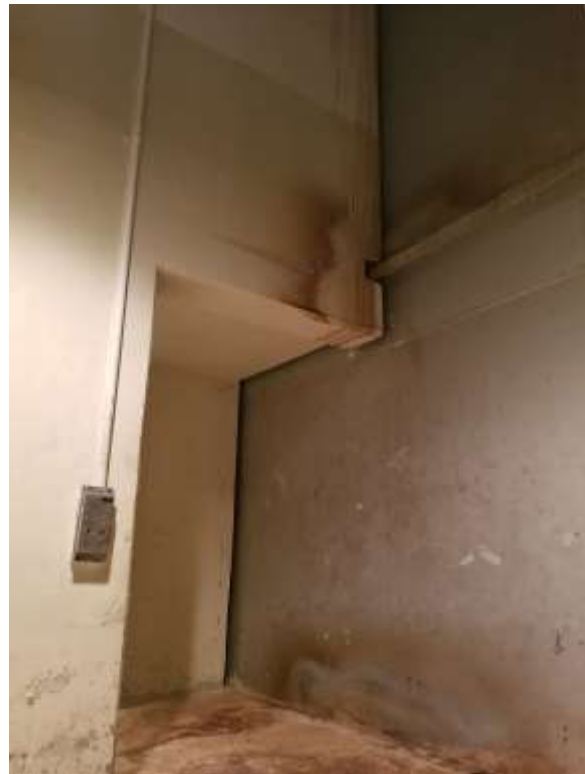
The gasket around the exterior base of the Dome, which is at ceiling level of the basement, remains intact and effective (Appendix A, Figure 25). The gasket is showing signs of weathering and surficial cracks (repeat from 2016) in the low areas of the gasket where it holds rain water and dries in the sun (Appendix A, Figure 37). The drains in the trough below the gasket are clear and draining rain water properly (Appendix A, Figure 38). The large bay door at the Basement Level remains sealed with expanding foam to prevent rainwater infiltration into the Basement Level. It is recommended that, when the gasket around the base of the Dome is replaced, the gasket is installed in a manner that does not retain rain water.

Figure 25. Basement Level – Beneath North Entrance Air Lock (No Signs of Recent Water Infiltration – Older Stains Persist)

- It is recommended that, when the gasket around the base of the Dome is replaced, the gasket be installed in a manner that does not retain rainwater.

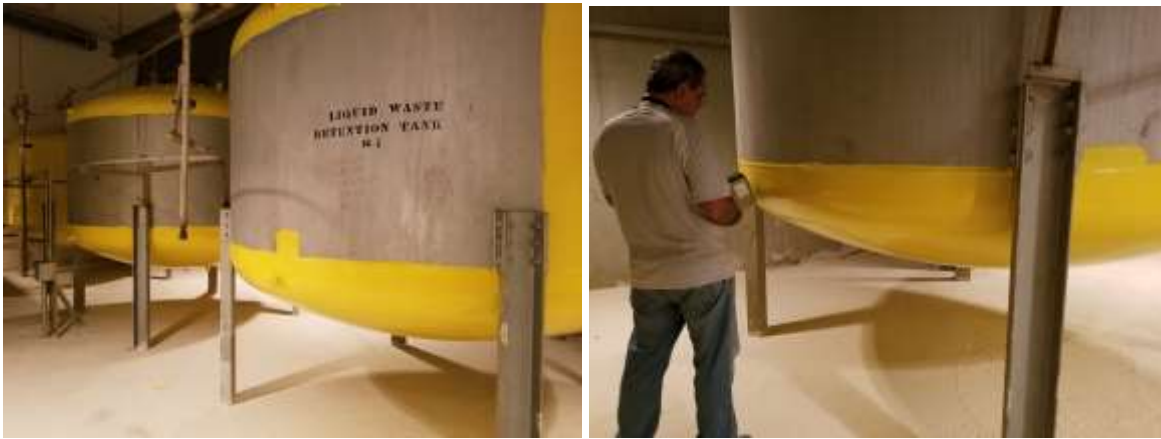
Control measures (fixed with paint and concrete layer in some places), which were previously implemented, were inspected (Appendix A, Figures 26, 28, 29, and 30). PREPA personnel applied a fresh coat of yellow paint since the 2016 survey on the Liquid Water Retention Tanks per previous recommendations. The concrete wall coating at Sample Locations 40A and 40B is showing signs of cracking and deterioration, but remains effective. Ongoing and routine assessment of accessible surfaces in the basement is recommended to evaluate the continued effectiveness of the concrete cover flooring and control measures (e.g., paint) emplaced on previous contamination areas. Although immediate action is not critical, it is recommended that an additional layer of concrete be placed over Sample Locations 40A and 40B within the next two years (Appendix A, Figure 30). Access to areas with historical removable contamination is being effectively controlled.

Figure 30. Basement Level – Sample Locations #30 and #31 on Liquid Waste Retention Tanks with Engineering Control (Yellow Paint) – Showing Signs of Wear

- Although immediate action is not critical, it is recommended that an additional layer of concrete be placed over Sample Locations 40A and 40B within the next two years (Appendix A, Figure 30).

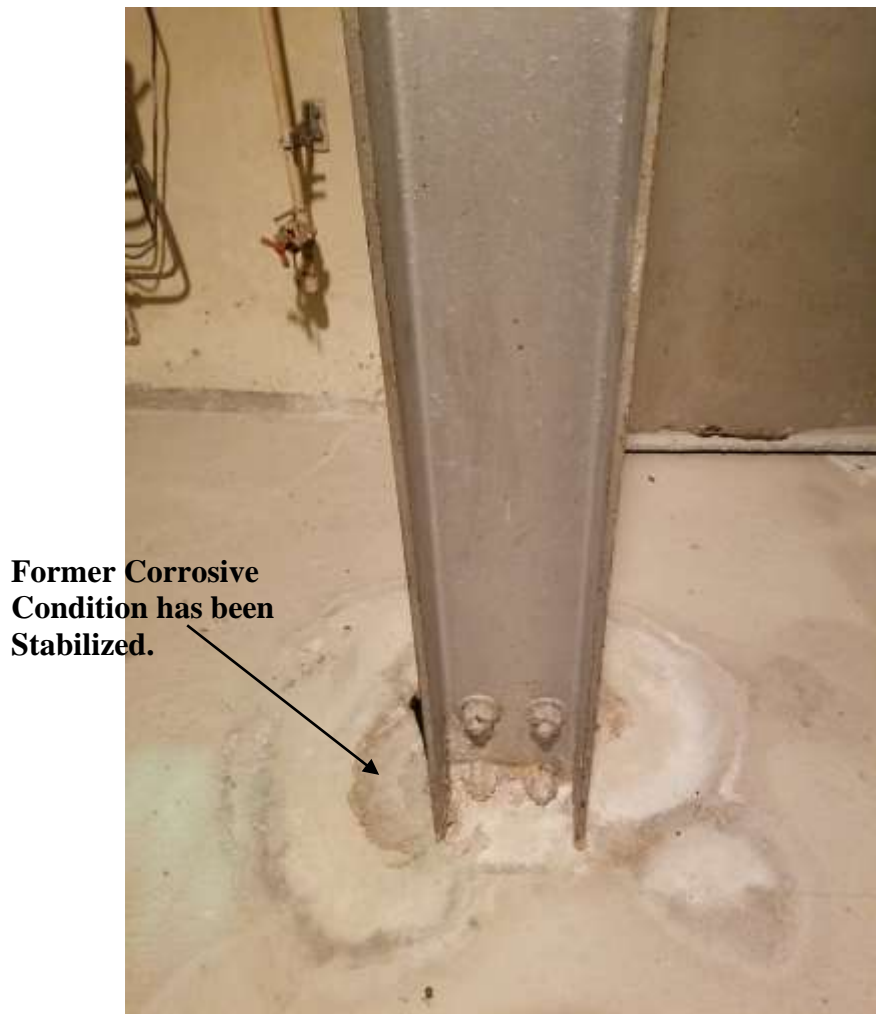
On the concrete flooring and structural steel near Sample Locations 50A and 50B, significant corrosion and concrete spalling was noted in previous surveys. PREPA personnel applied some anti-corrosive coating in 2017, which appears to have stabilized the area (Appendix A, Figure 31). It is recommended that the anti-corrosive compound continue to be applied during quarterly surveys, as needed. Also near Sample Locations 50A and 50B, it was noted that absorbent clothes continue to be used to capture oil/lubricant dripping from area/overhead equipment (Appendix A, Figure 24). It is recommended that absorbent clothes continue to be placed at these locations during quarterly surveys, as needed.

Figure 31. Basement Level – Corrosion Issues on Concrete Floor near Sample Locations 50A and 50B – Was Treated and Has Stabilized

- On the concrete flooring and structural steel near Sample Locations 50A and 50B, significant corrosion and concrete spalling was noted in previous surveys. PREPA personnel applied some anti-corrosive coating in 2017, which appears to have stabilized the area (Appendix A, Figure 31). It is recommended that the anti-corrosive compound continue to be applied during quarterly surveys, as needed.

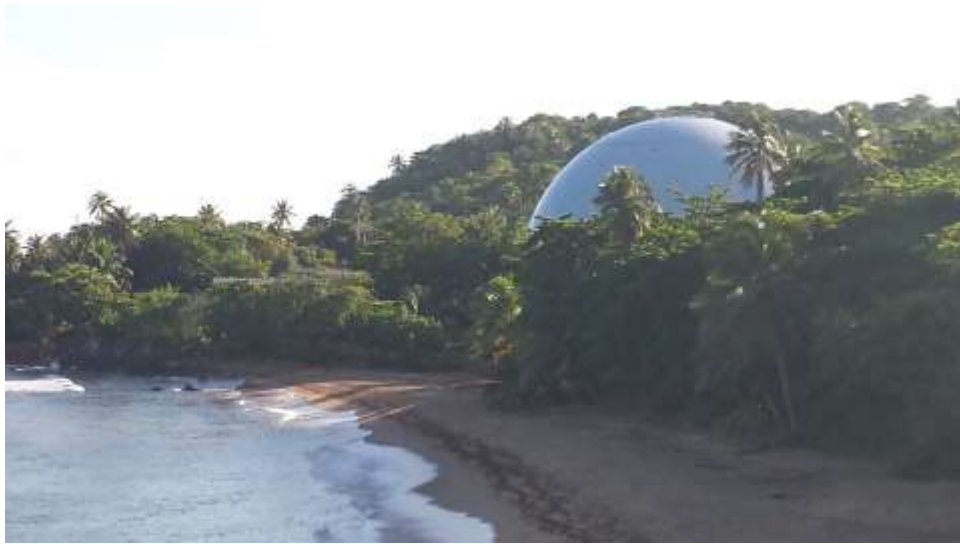
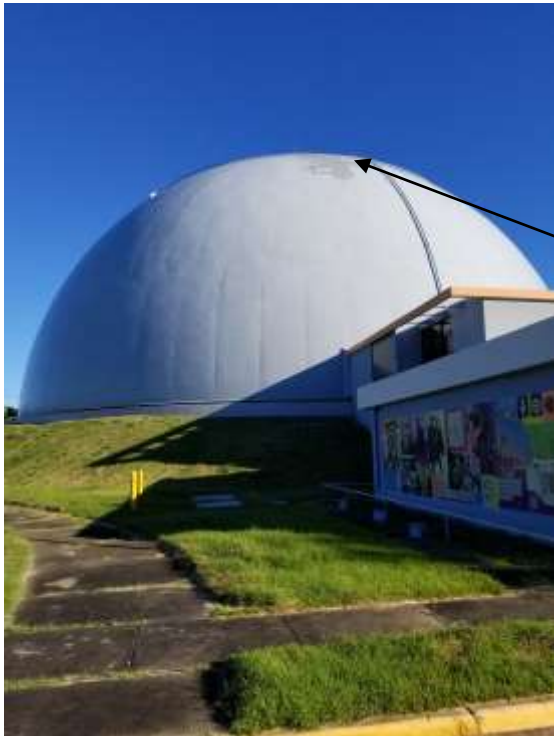
**Damage
from 2017
Hurricane
Season**

Figure 32. Dome Structure – Exterior with Protective Coating and Paint

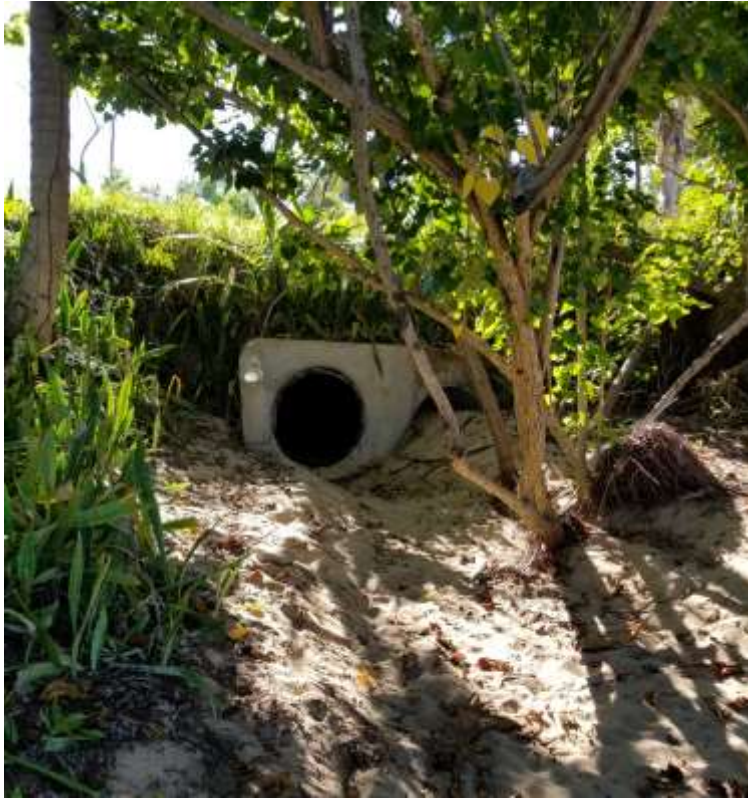
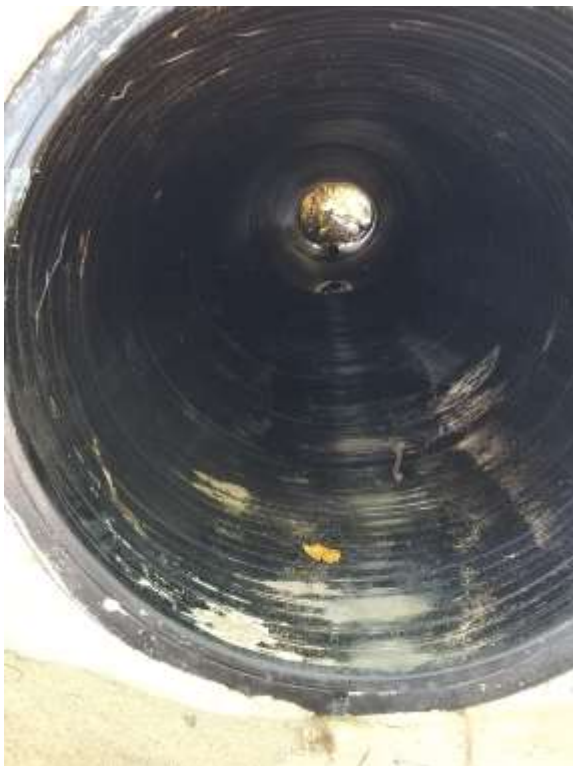
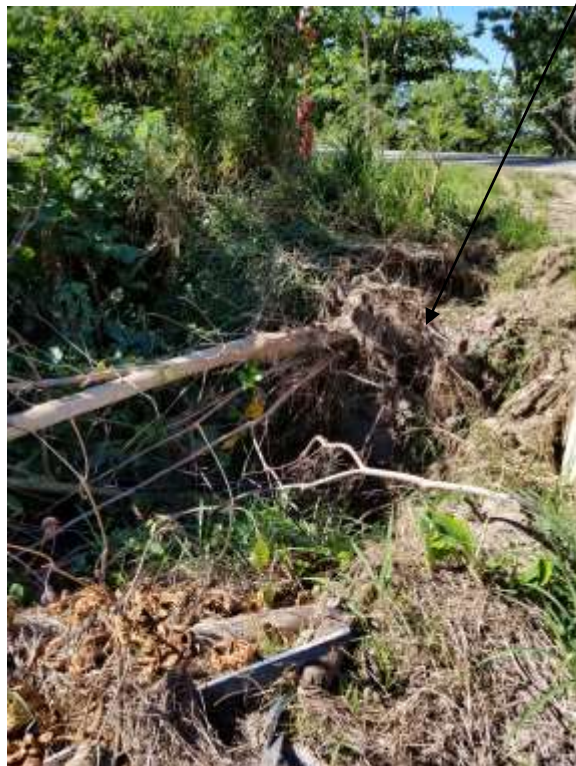
- One of the drainage pipes on the west side, where it passes under the main access road, is significantly obstructed with silt and debris – likely due to the 2017 hurricane season (Appendix A, Figure 35). It is recommended that the accumulated silt and debris be removed.

**Debris Blocking Pipes
on East Side of Road**

Figure 35. Dome Structure – Drainage Outfall Points and Ditches (Under Main Access Road –East side of road – right pipe filled with sand and debris)

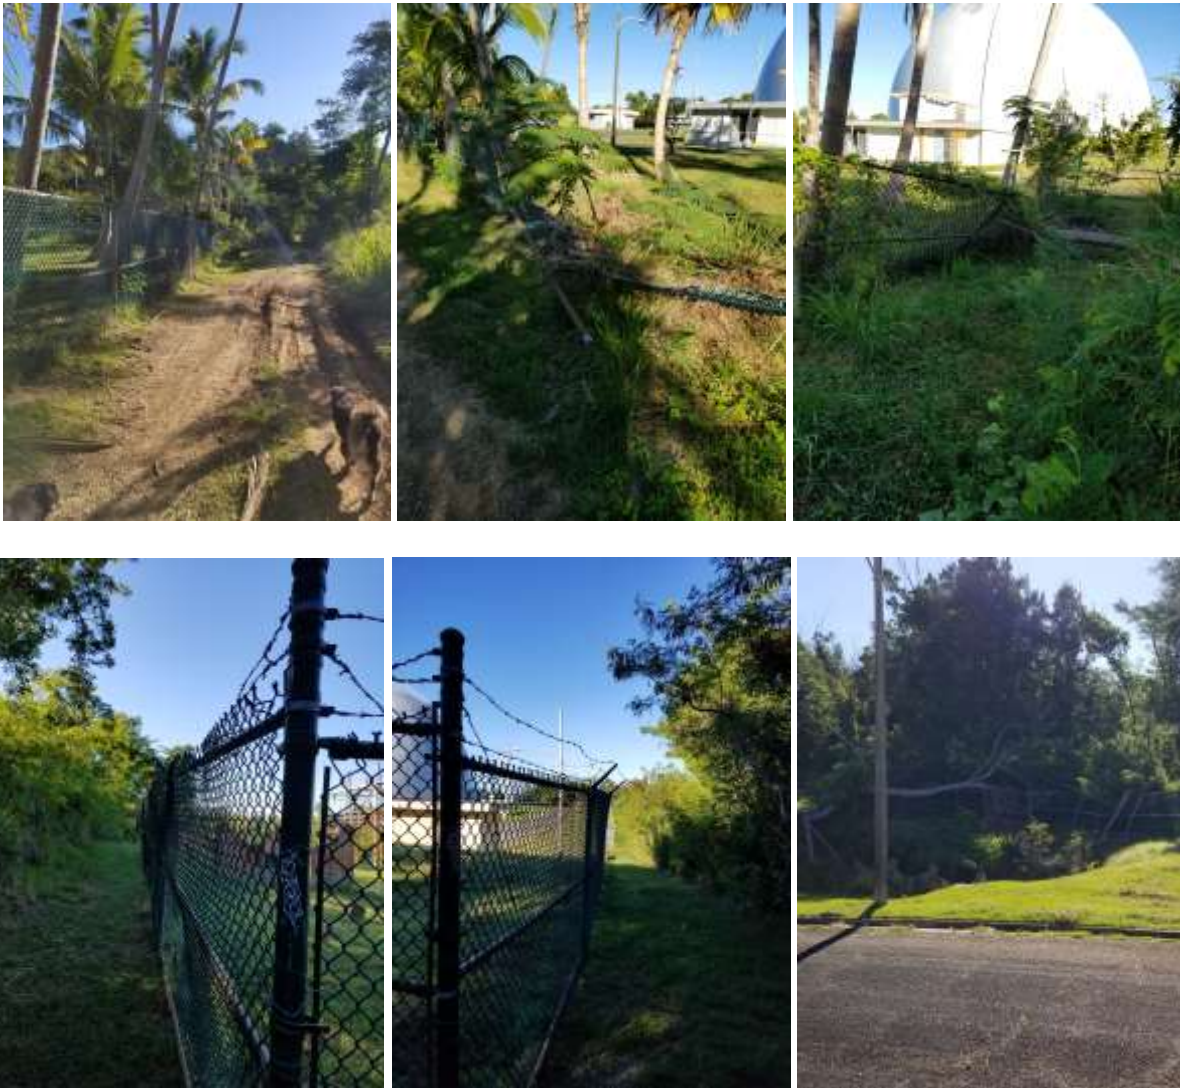
- Physical Condition:
 - Falling trees damaged the fence surrounding the property during the 2017 hurricane season at approximately six locations totaling approximately 100-ft in length (Appendix A, Figure 36). Recommend removing fallen trees and engaging a fencing contractor to repair the sections of damaged fence.

Figure 36. Fence –Fencing and Perimeter – 2017 Hurricane Season Damaged Several Sections of Fencing (Approximately 100-ft Total Length)

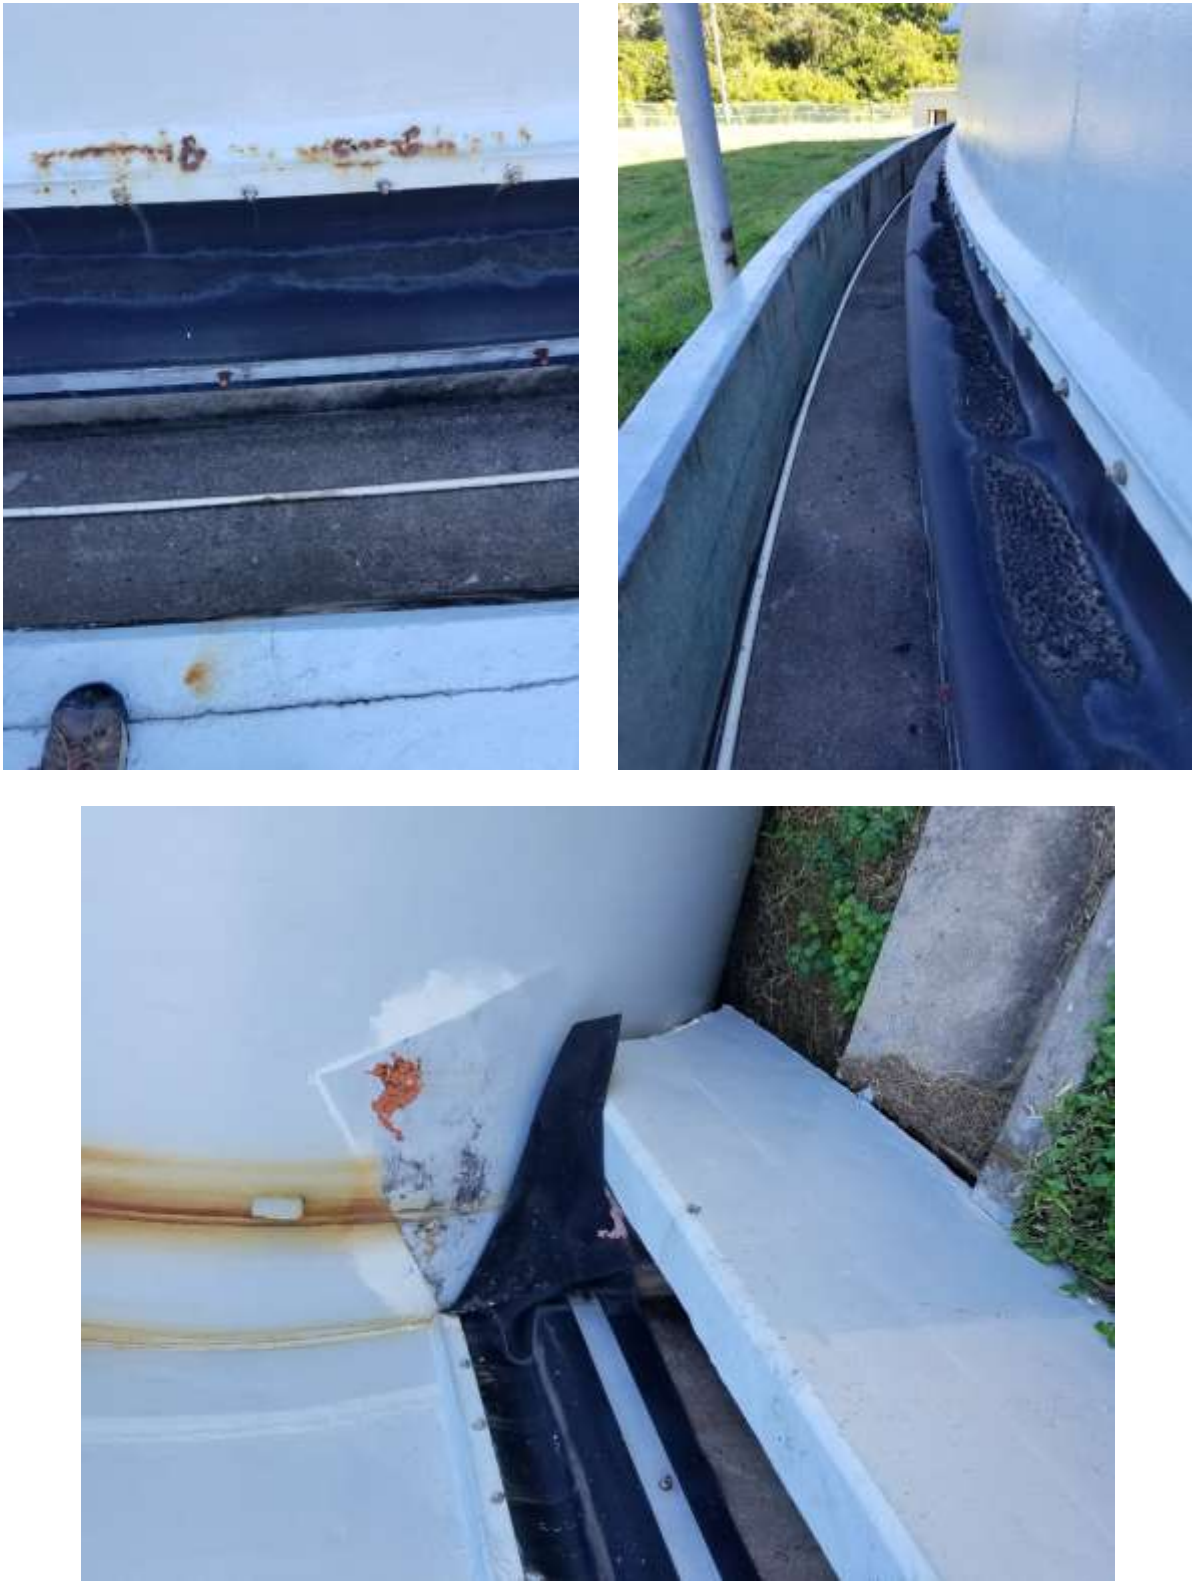
Figure 37. Dome Structure – Flexible Gasket/Seal – Dome Perimeter

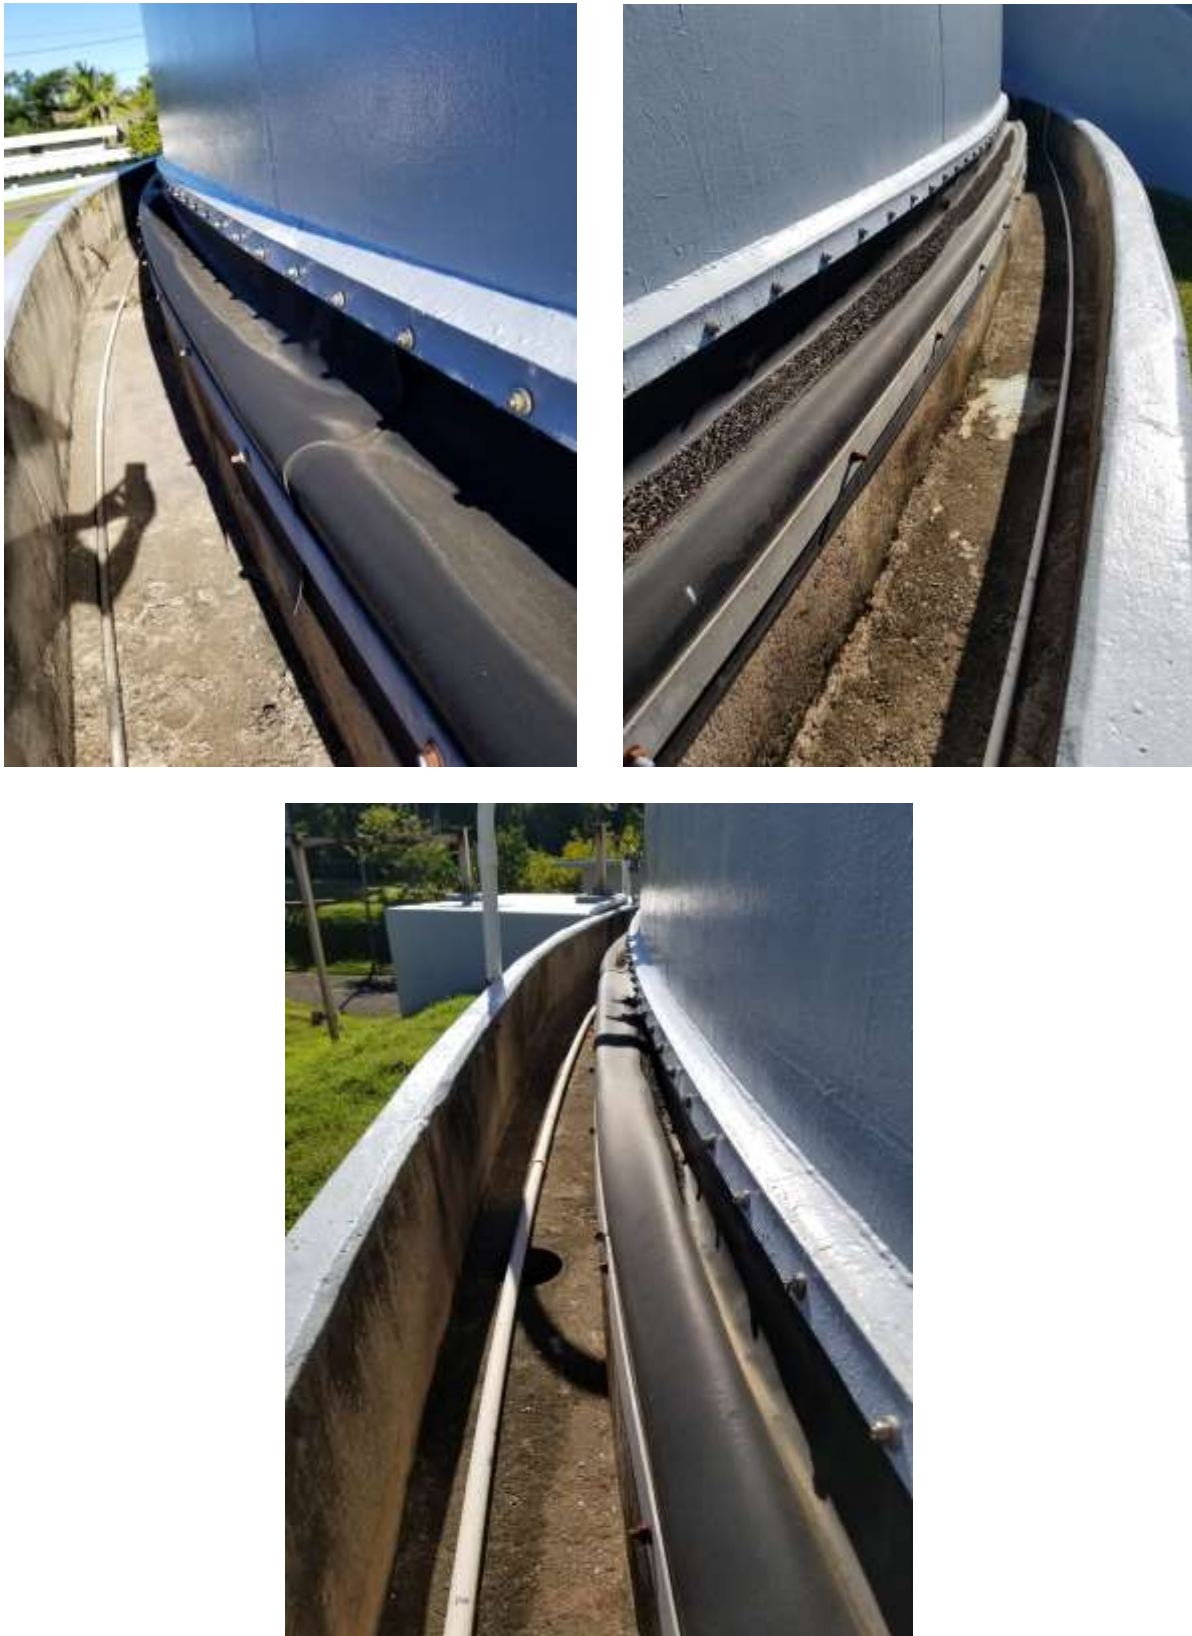
Figure 38. Dome Structure – Rain Trough Below Flexible Gasket/Seal (Drain is Free of Debris)

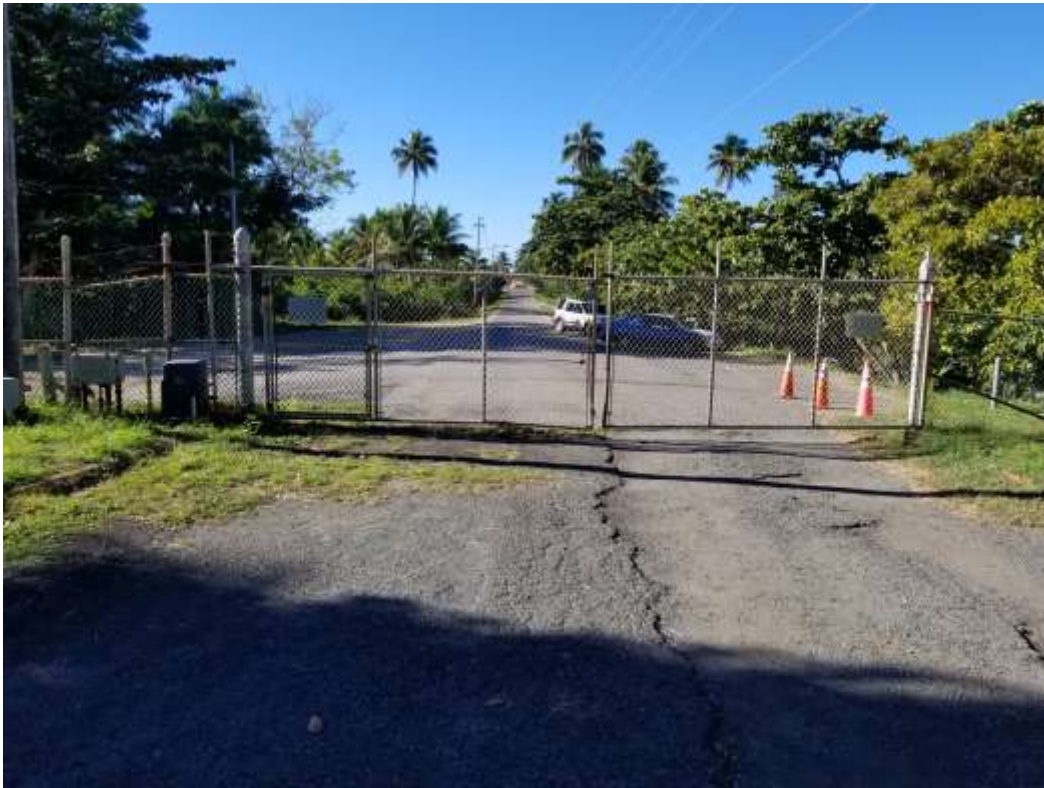
Figure 39. Security – Main Gate in Good Working Condition (Manual Open/Close)

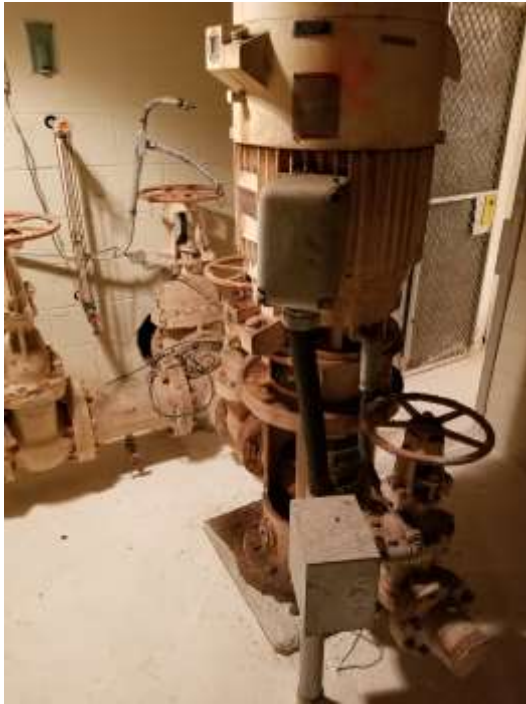
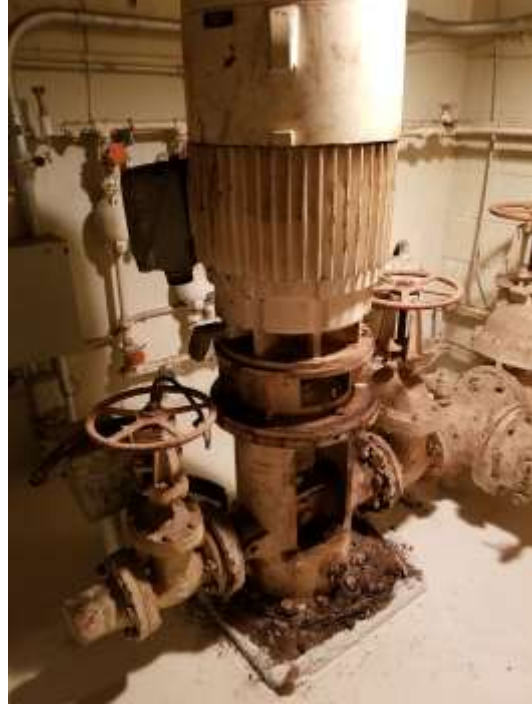
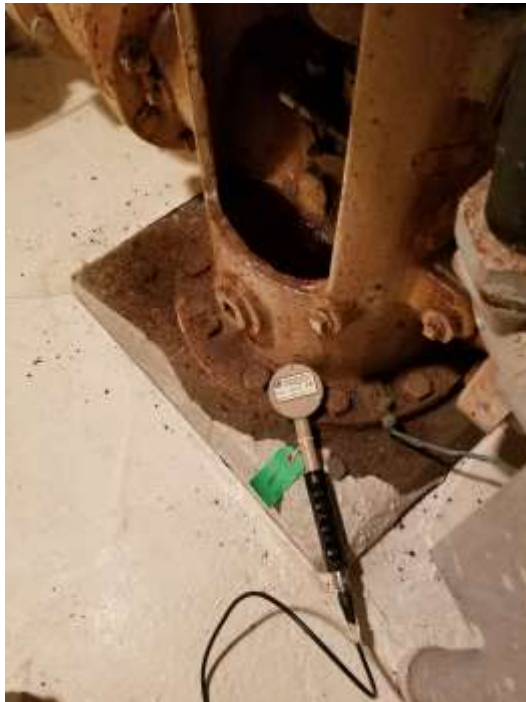
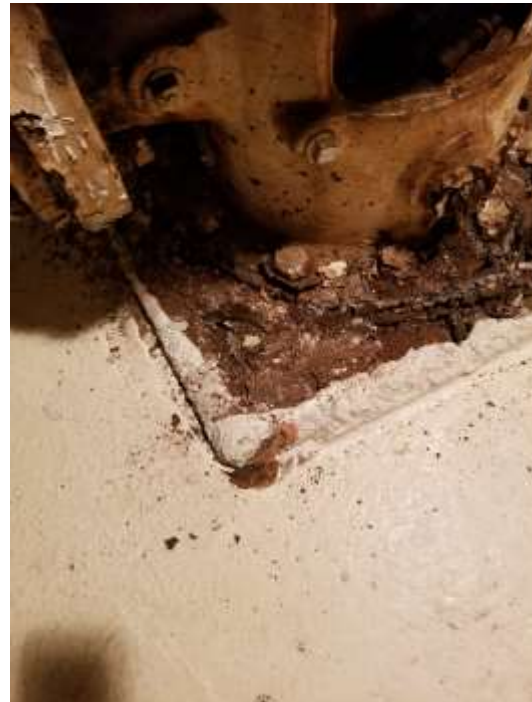
During a visual survey of the Basement Level, accumulation of oil-like substance and corrosive debris where observed at Condensate Pump #1 and #2 on the east side of the basement (Appendix A, Figure 41). Total surface beta/gamma readings and smear samples were performed at 2018-1 (base of Condensate Pump #1) and 2018-2 (base of Condensate Pump #2). Total surface beta/gamma contamination levels were 1,519 and 3,446 dpm/100 cm² for Condensate Pumps #1 and #2, respectively. Although the transferable/removable surface contamination results at these

two locations resulted in no removable contamination above MDA, loose/removable material was observed to be present on the surface of the base of each pump. Some loose debris from Condensate Pump #2 (from an approximate 100 cm² area) was placed on a sheet of paper (sample location identifier 2018-3) and counted in a background area, with a result of 1,779 dpm/100 cm² removable beta/gamma contamination). A direct surface reading was re-performed at the base of Condensate Pump #2, where the debris was removed, with a result of 2,631 dpm/100 cm² total surface beta/gamma contamination.

Figure 41. Basement Level – Changed Conditions at Condensate Pumps #1 and #2

- Additional non-public access area in the Basement Level – Conditions at Condensate Pumps #1 and #2 warrant posting as a Contamination Area (temporary posting was accomplished via rope and signage during the 2018 Annual Survey [Appendix A, Figure 42]). It is recommended that a RWP be prepared for general entry/exit of the area for visual inspection and performing annual/quarterly survey measurements. Administrative procedures should be in place to ensure that no other work (beyond the activities covered under the general access RWP) is performed on this level without review and approval by the RCM. Job-specific RWPs will be required for any future intrusive work in this area. It is further recommended that U.S. Department of Energy responsible persons be engaged to address the condition associated with Condensate Pumps #1 and #2 (e.g., removal/disposal of loose debris and entombment of the pumps).

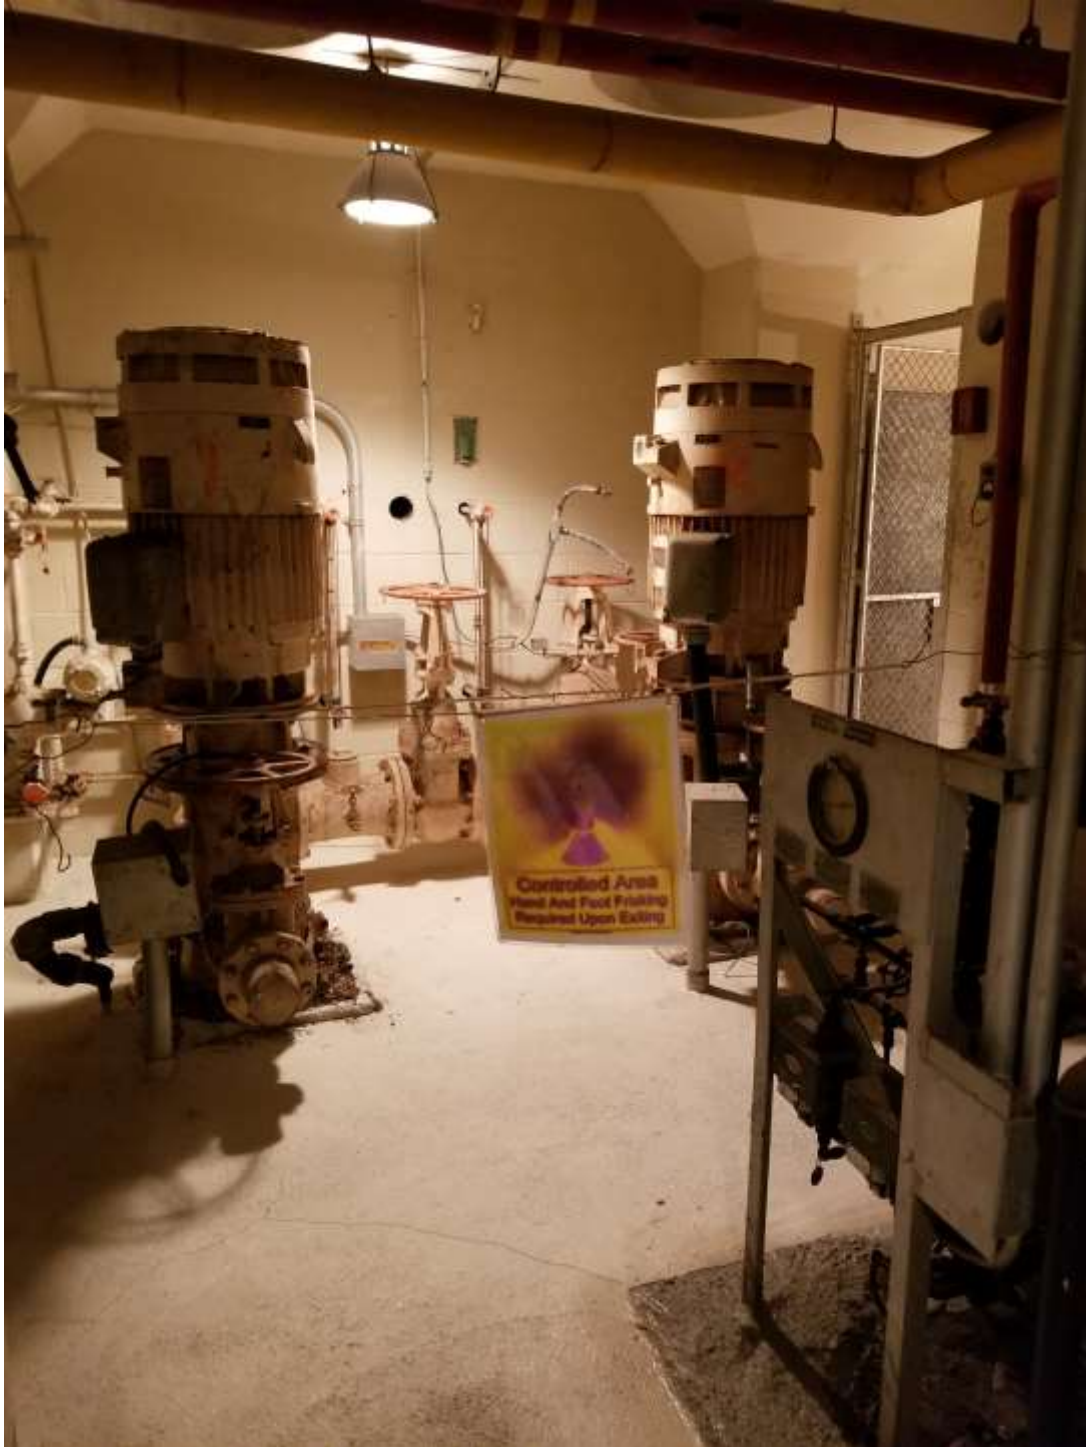
Figure 42. Basement Level – Temporary Posting

- It is recommended that the immediate area surrounding Condensate Pumps #1 and #2 be posted as a Contamination Area within the controlled area of the Basement Level (temporary posting was accomplished via rope and signage during the 2018 Annual Survey [Appendix A, Figure 42]). It is recommended that a RWP be

prepared for general entry/exit of the area for visual inspection and performing annual/quarterly survey measurements. Administrative procedures should be in place to ensure that no other work (beyond the activities covered under the general access RWP) is performed on this level without review and approval by the RCM. Job-specific RWPs will be required for any future intrusive work in this area. It is further recommended that U.S. Department of Energy responsible persons be engaged to address the condition associated with Condensate Pumps #1 and #2 (e.g., removal/disposal of loose debris and entombment of the pumps).
