**DR. MODESTO IRIARTE TECHNOLOGICAL  
MUSEUM (FORMER BONUS FACILITY)**

**2019 ANNUAL RADIOLOGICAL SURVEY REPORT –  
REVISION 0**

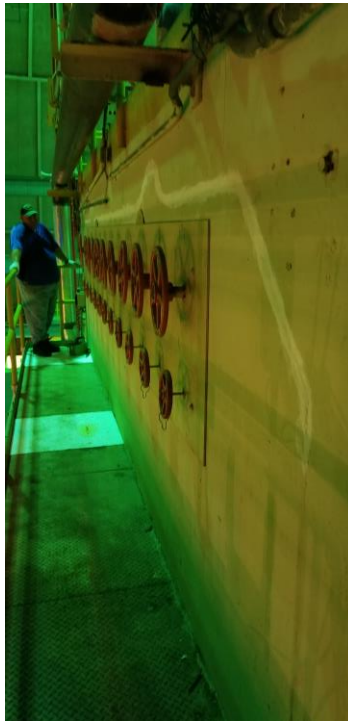
**Figure 2. Entombment Top – Pad has been Placed to Address Oil Leaking from Overhead Crane (Near Sampling Points 1, 2, 3, and 4)**

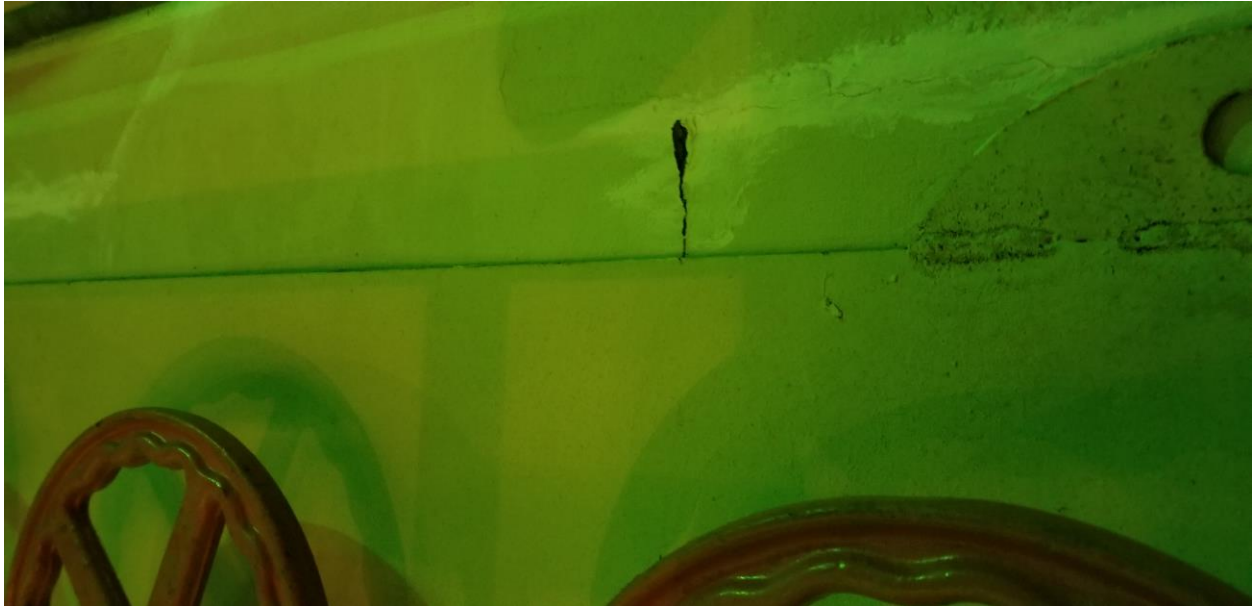
**Figure 3. Entombment Top – Surficial Cracks (Typical)**

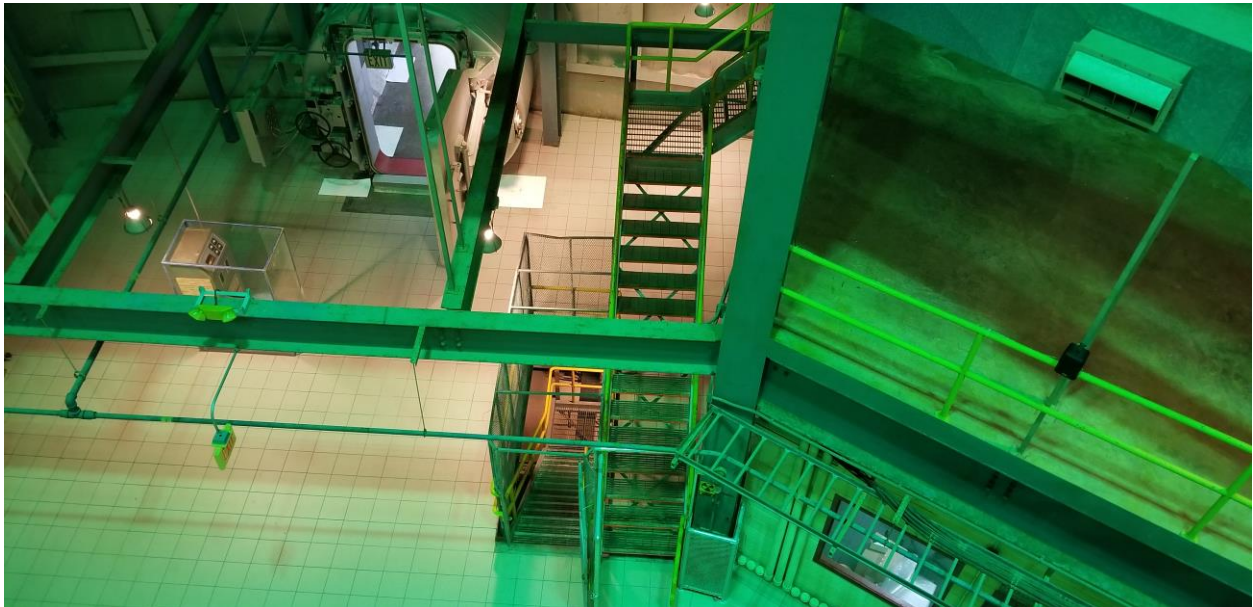
**Figure 4. Main Level (Southwest Side) – Overhead View**

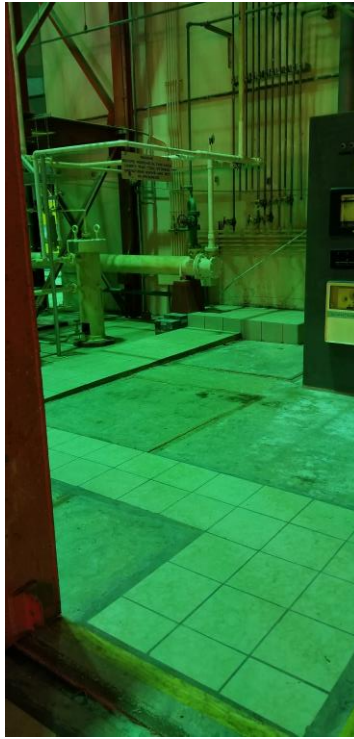
**Figure 21. Main Level (Controlled Area) – Engineering Controls (Concrete, Tiles, and Lead Bricks) in Good Condition**

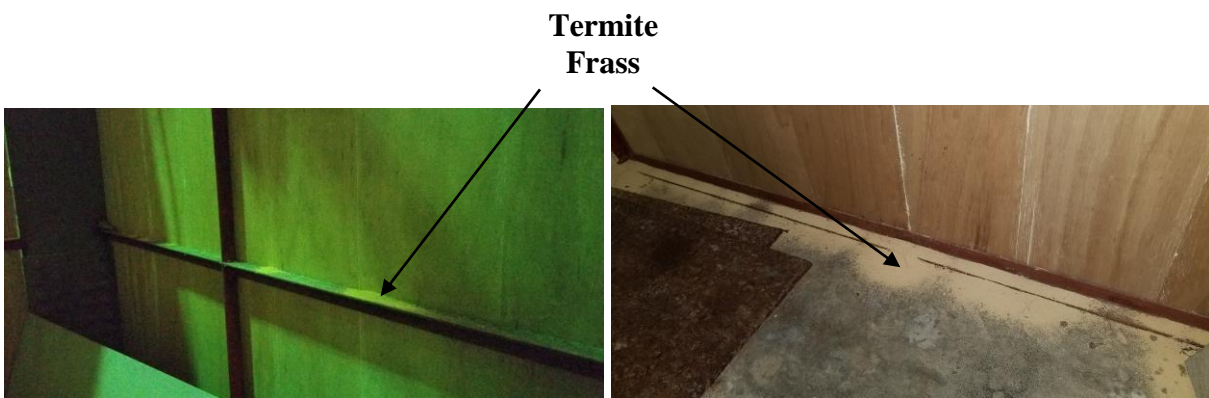
**Figure 22. Main Level (Museum Area) – Wood Paneling with Past Evidence of Termites (East Side)**

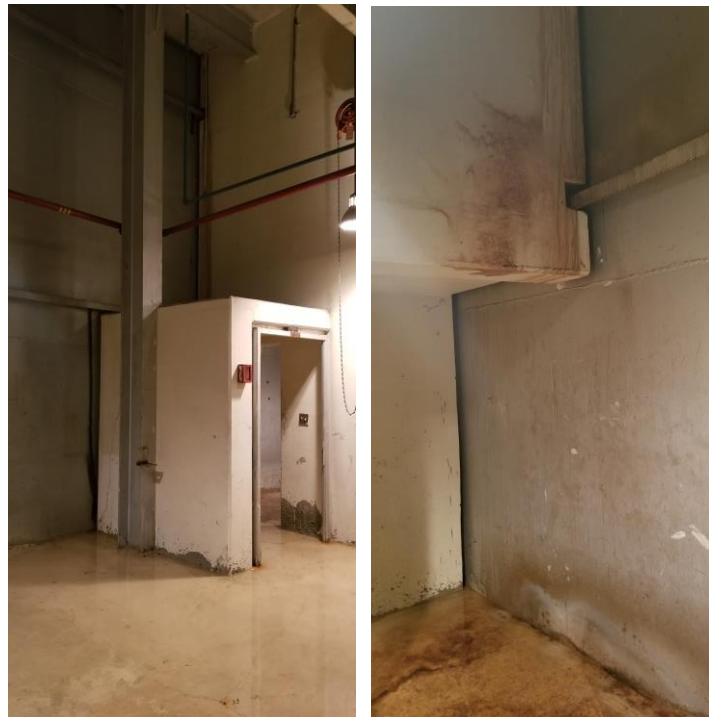
**Figure 25. Basement Level – Beneath North Entrance Air Lock (No Signs of Recent Water Infiltration – Older Stains Persist) – 1- to 2-Inches of Water on Floor Due to Accidental Flooding**

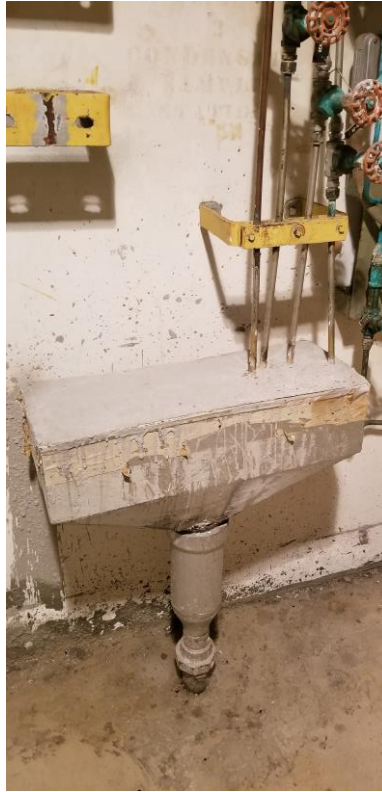
**Figure 26. Basement Level – Concrete Filled Sink**

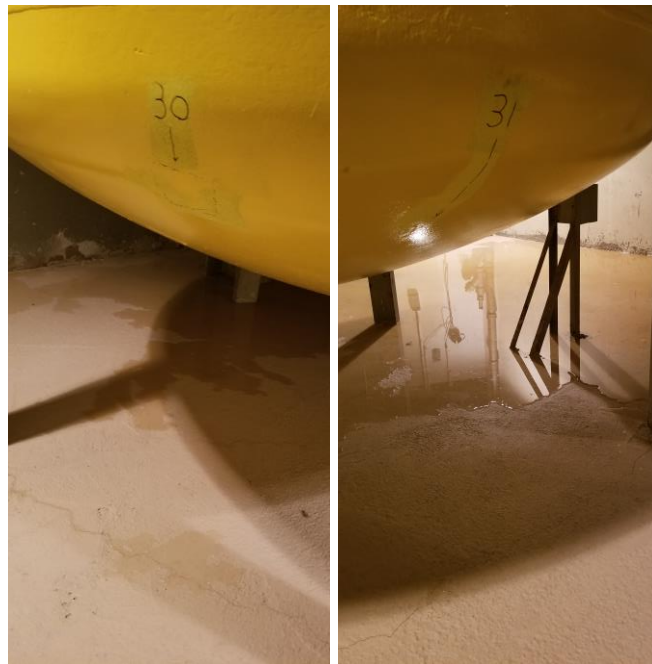
**Figure 30. Basement Level – Sample Locations #30 and #31 on Liquid Water Retention Tanks with Engineering Control (Yellow Paint) – Showing Signs of Wear**

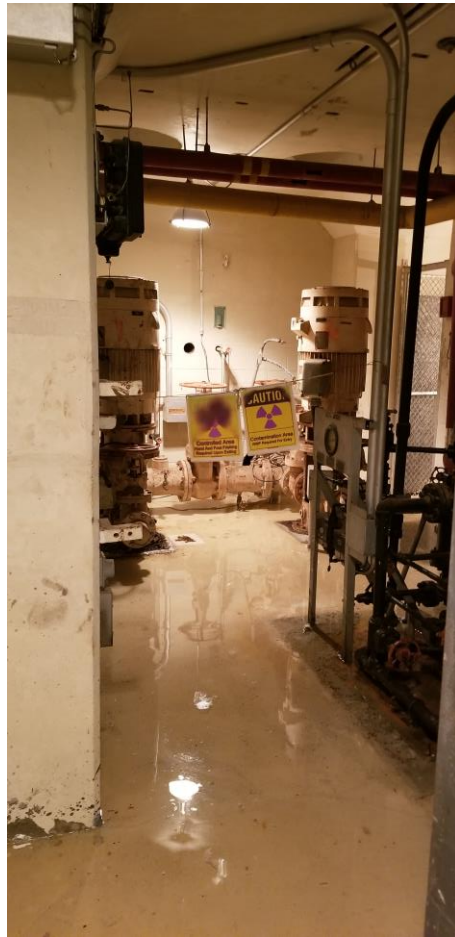
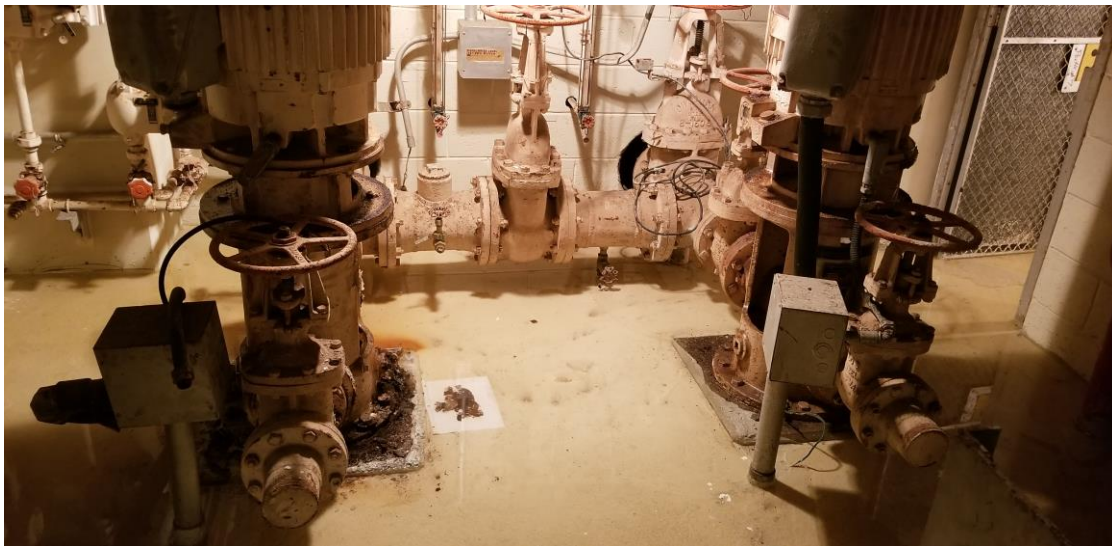
**Figure 31. Basement Level – Condensate Pumps #1 and #2 with Loose/Removable Contaminated debris (1- to 2-Inches of Water on Floor)**

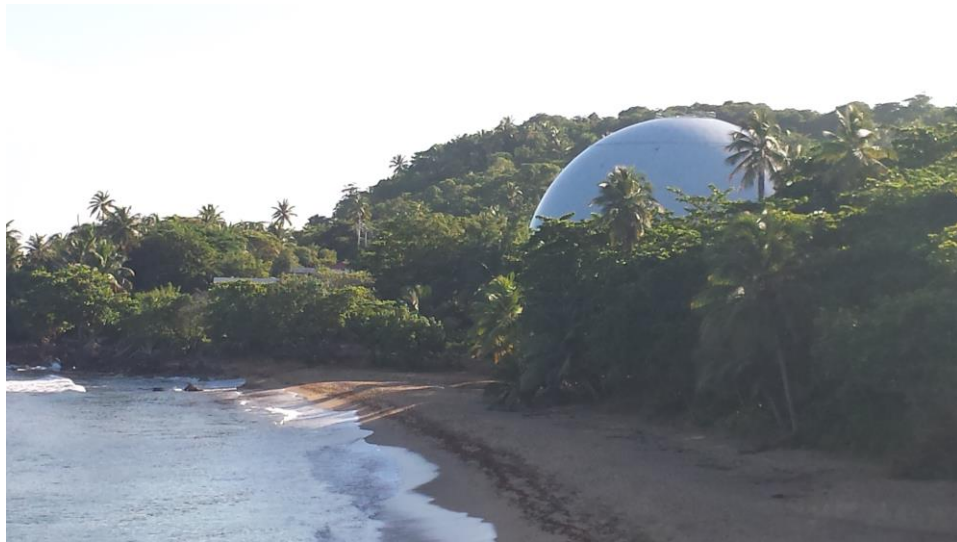
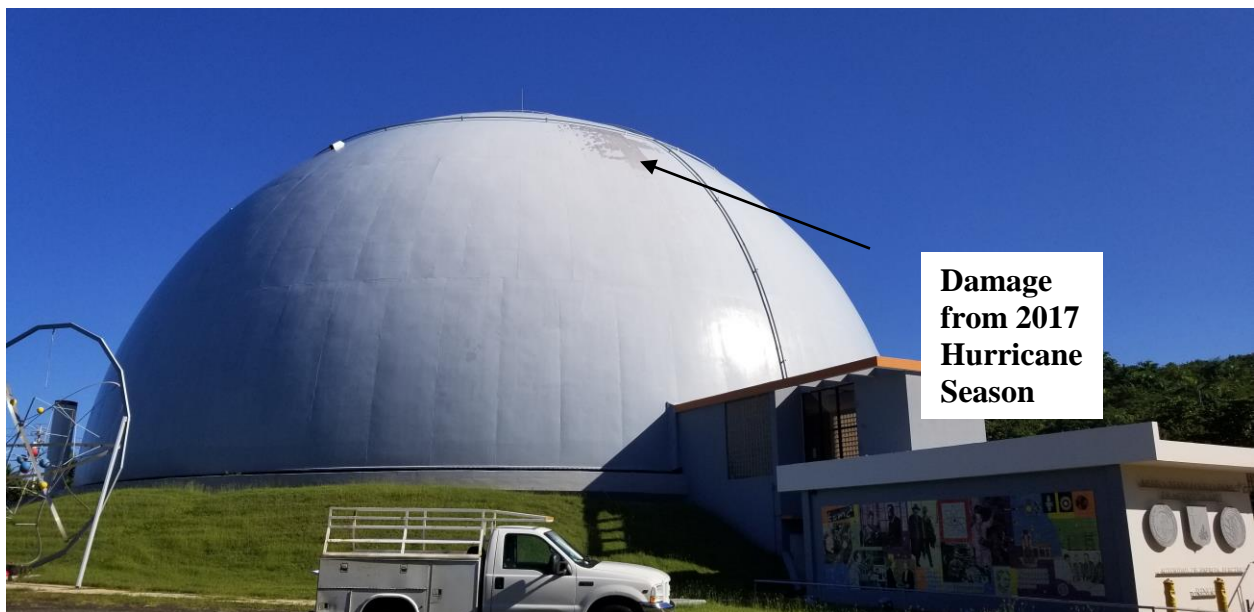
**Figure 32. Dome Structure – Exterior with Protective Coating and Paint**

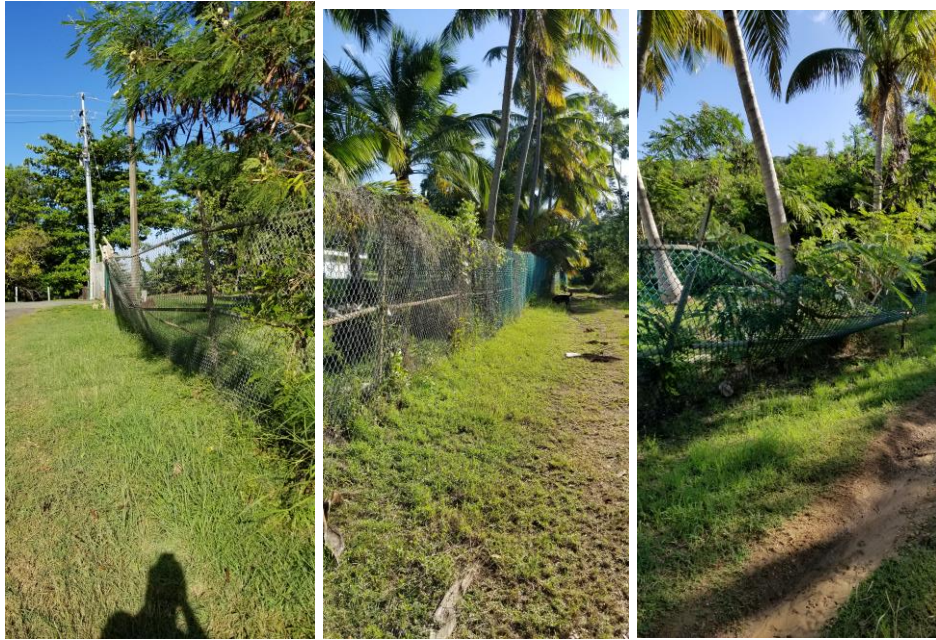
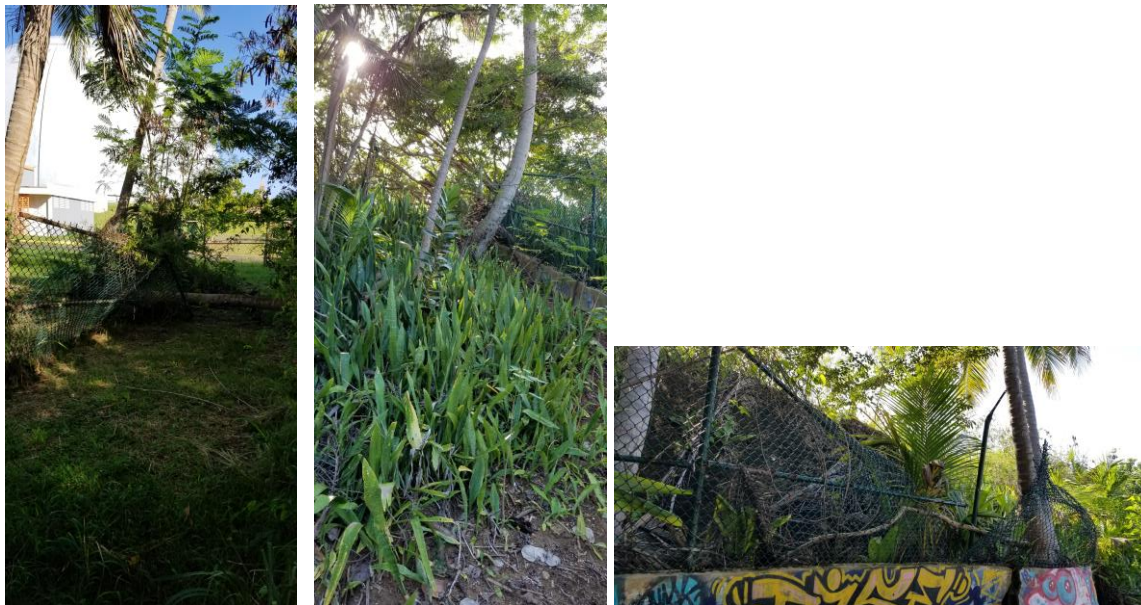
**Figure 36. Fence –Fencing and Perimeter – 2017 Hurricane Season Damaged Several Sections of Fencing (Approximately 100-ft Total Length)**

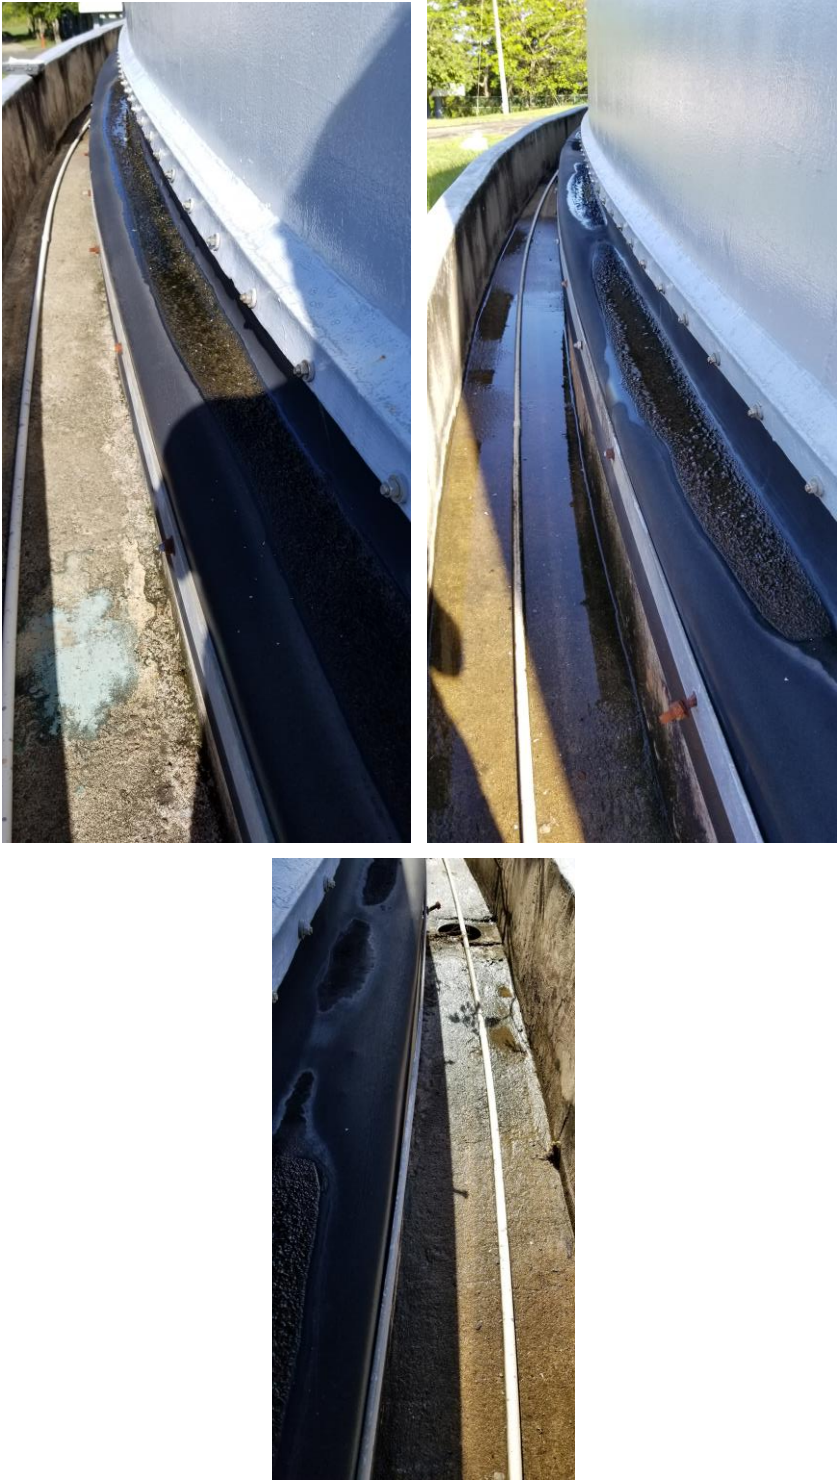
**Figure 37. Dome Structure – Flexible Gasket/Seal – Dome Perimeter**

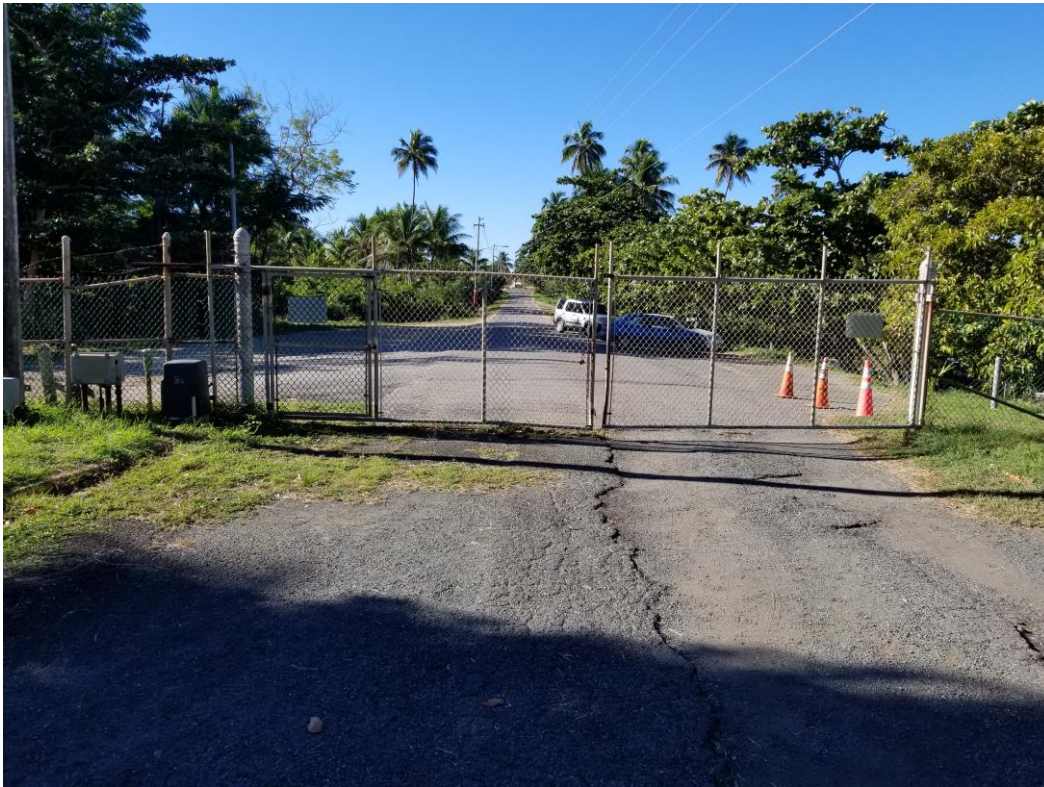
**Figure 39. Security – Main Gate in Good Working Condition (Manual Open/Close)**

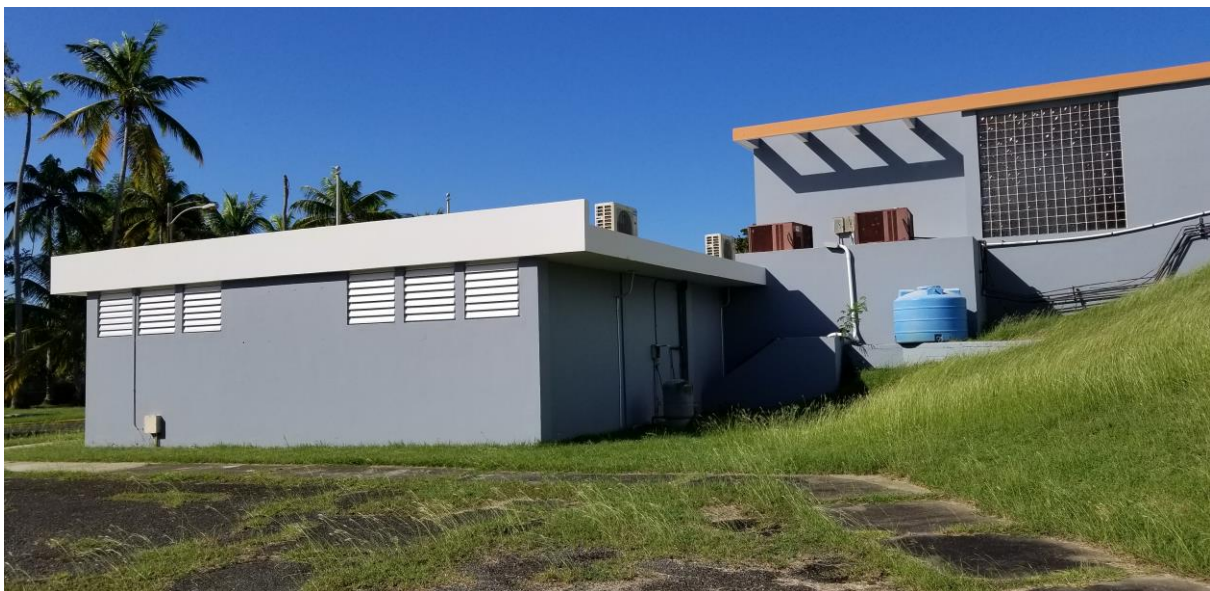
**Figure 40. Ancillary Buildings and Structures – Bathroom and Museum Area at South Entrance**
