Quarterly Site Inspection Report for the Fernald Preserve, Ohio, Site, June 2020

June 2020

**U.S. DEPARTMENT OF
ENERGY**

Legacy
Management

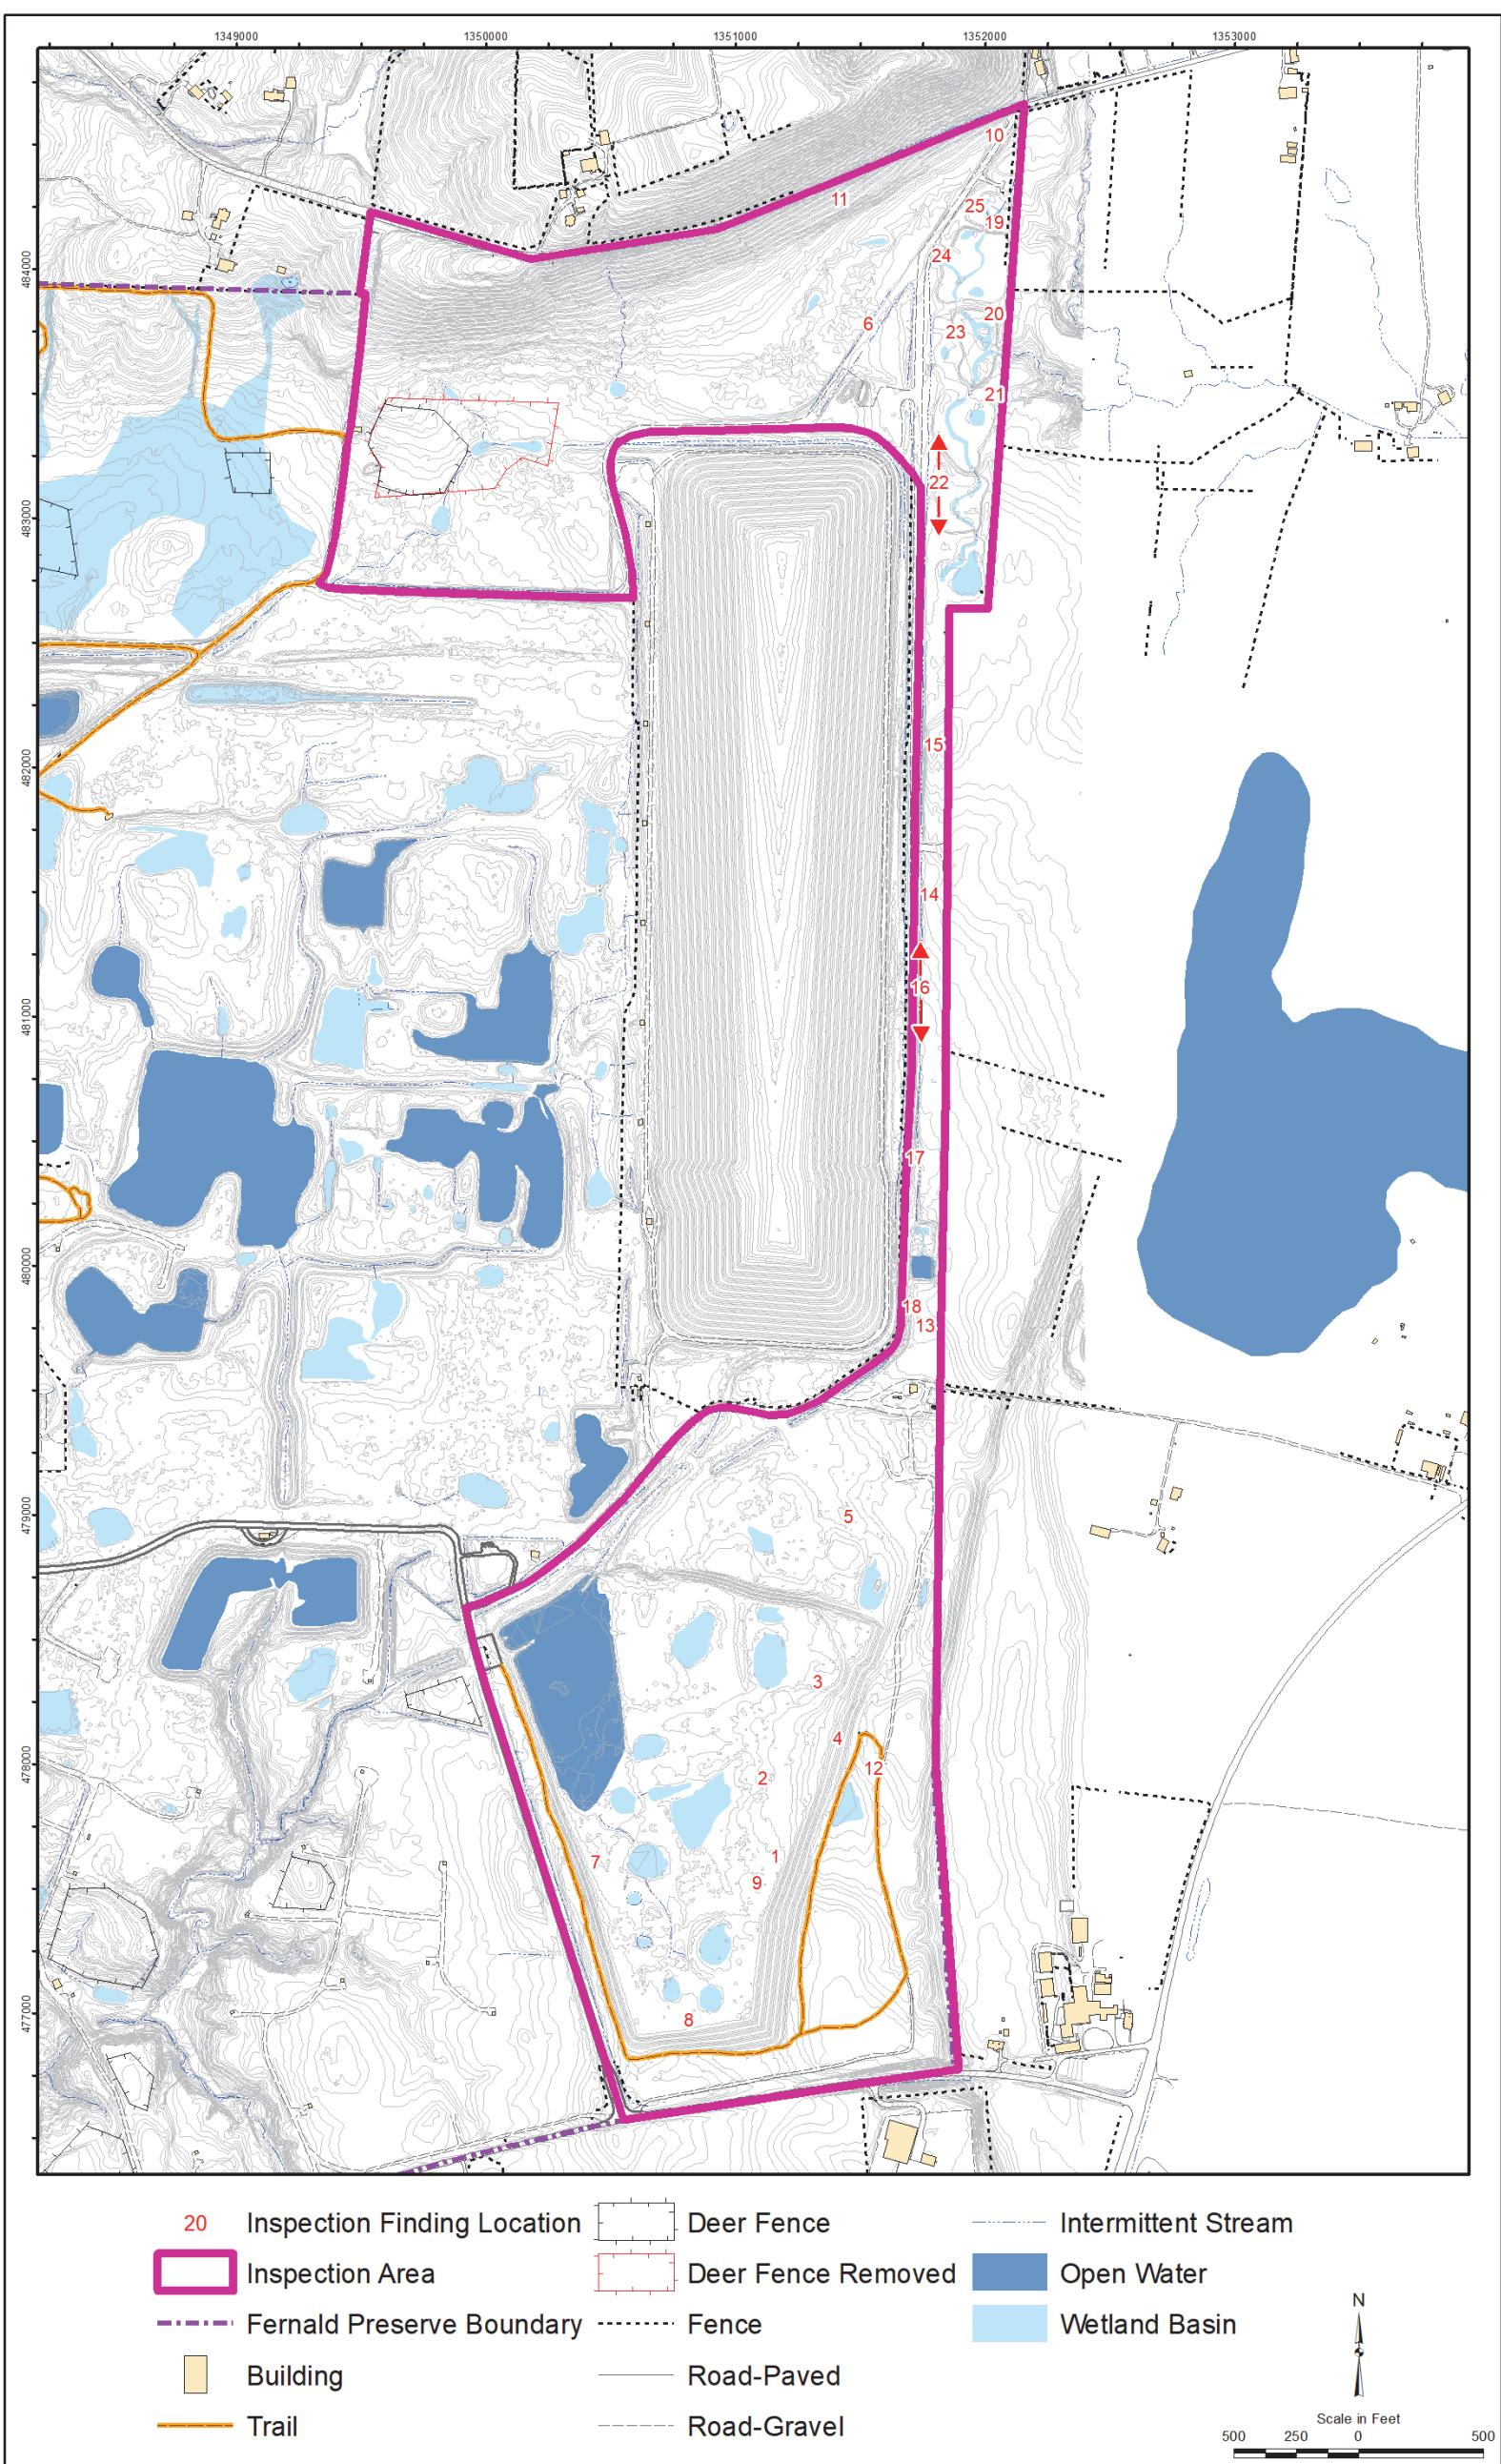
East Quadrant Inspection Findings, June 3, 2020

Map No.	Location	GPS?	Type of Finding	Description	Photo
1	West of slope bottom	No	Vegetation	Teasel monoculture	
2	East of W5	No	Vegetation	Pear trees	
3	East and southeast of W4	No	Vegetation	Pear trees	
4	West of slope bottom	No	Vegetation	Teasel	
5	East side of area, between wet areas	No	Vegetation	Teasel (patchy in low spots)	
6	East edge of pines	No	Vegetation	Multiflora rose	
7	South of Lodge Pond, bottom of west slope, west of W2	No	Vegetation	Multiflora rose (possibly)	
8	Bottom of south slope, south of W9	No	Vegetation	Pear trees and thistle	
9	West of slope bottom	No	Vegetation	Pear trees and thistle	
10	West of north entrance gate, north of pines	No	Vegetation	Canada thistle	
11	North of north pines, along St. rt. 126	No	Vegetation	Area becoming inundated with honeysuckle	
12	North end inside trail loop	No	Vegetation	Canada thistle	
13	North of DO Building, south of pond	No	Vegetation	Honeysuckle and pear trees

Map No.	Location	GPS?	Type of Finding	Description	Photo
14	East perimeter, south of well access road entrance	No	Bird Box	Bird box sild down post	
15	South of WM1, east of road	No	Vegetation	Honeysuckle and pear trees	
16	East edge of road	No	Vegetation	Teasel, honeysuckle, pear tree, autumn olive	
17	East edge of road	No	Vegetation	Honeysuckle and pear trees	
18	East of road in drainage	No	Vegetation	Teasel	
19	W7	No	Vegetation	Phragmites	
20	Berm of W1 and W6	No	Vegetation	Honeysuckle	
21	East edge of W1	No	Vegetation	Honeysuckle, pear trees, autumn olive shrubs and teasel	
22	West side of basins and berms between W2 and W3, and W3 and W4	No	Vegetation	Honeysuckle, pear trees, autumn olive shrubs and teasel	
23	West side of W1	No	Vegetation	Phragmites	
24	West side of W6	No	Vegetation	Phragmites, teasel, canada thistle	
25	Northwest corner of W7	No	Vegetation	Pear trees and honeysuckle

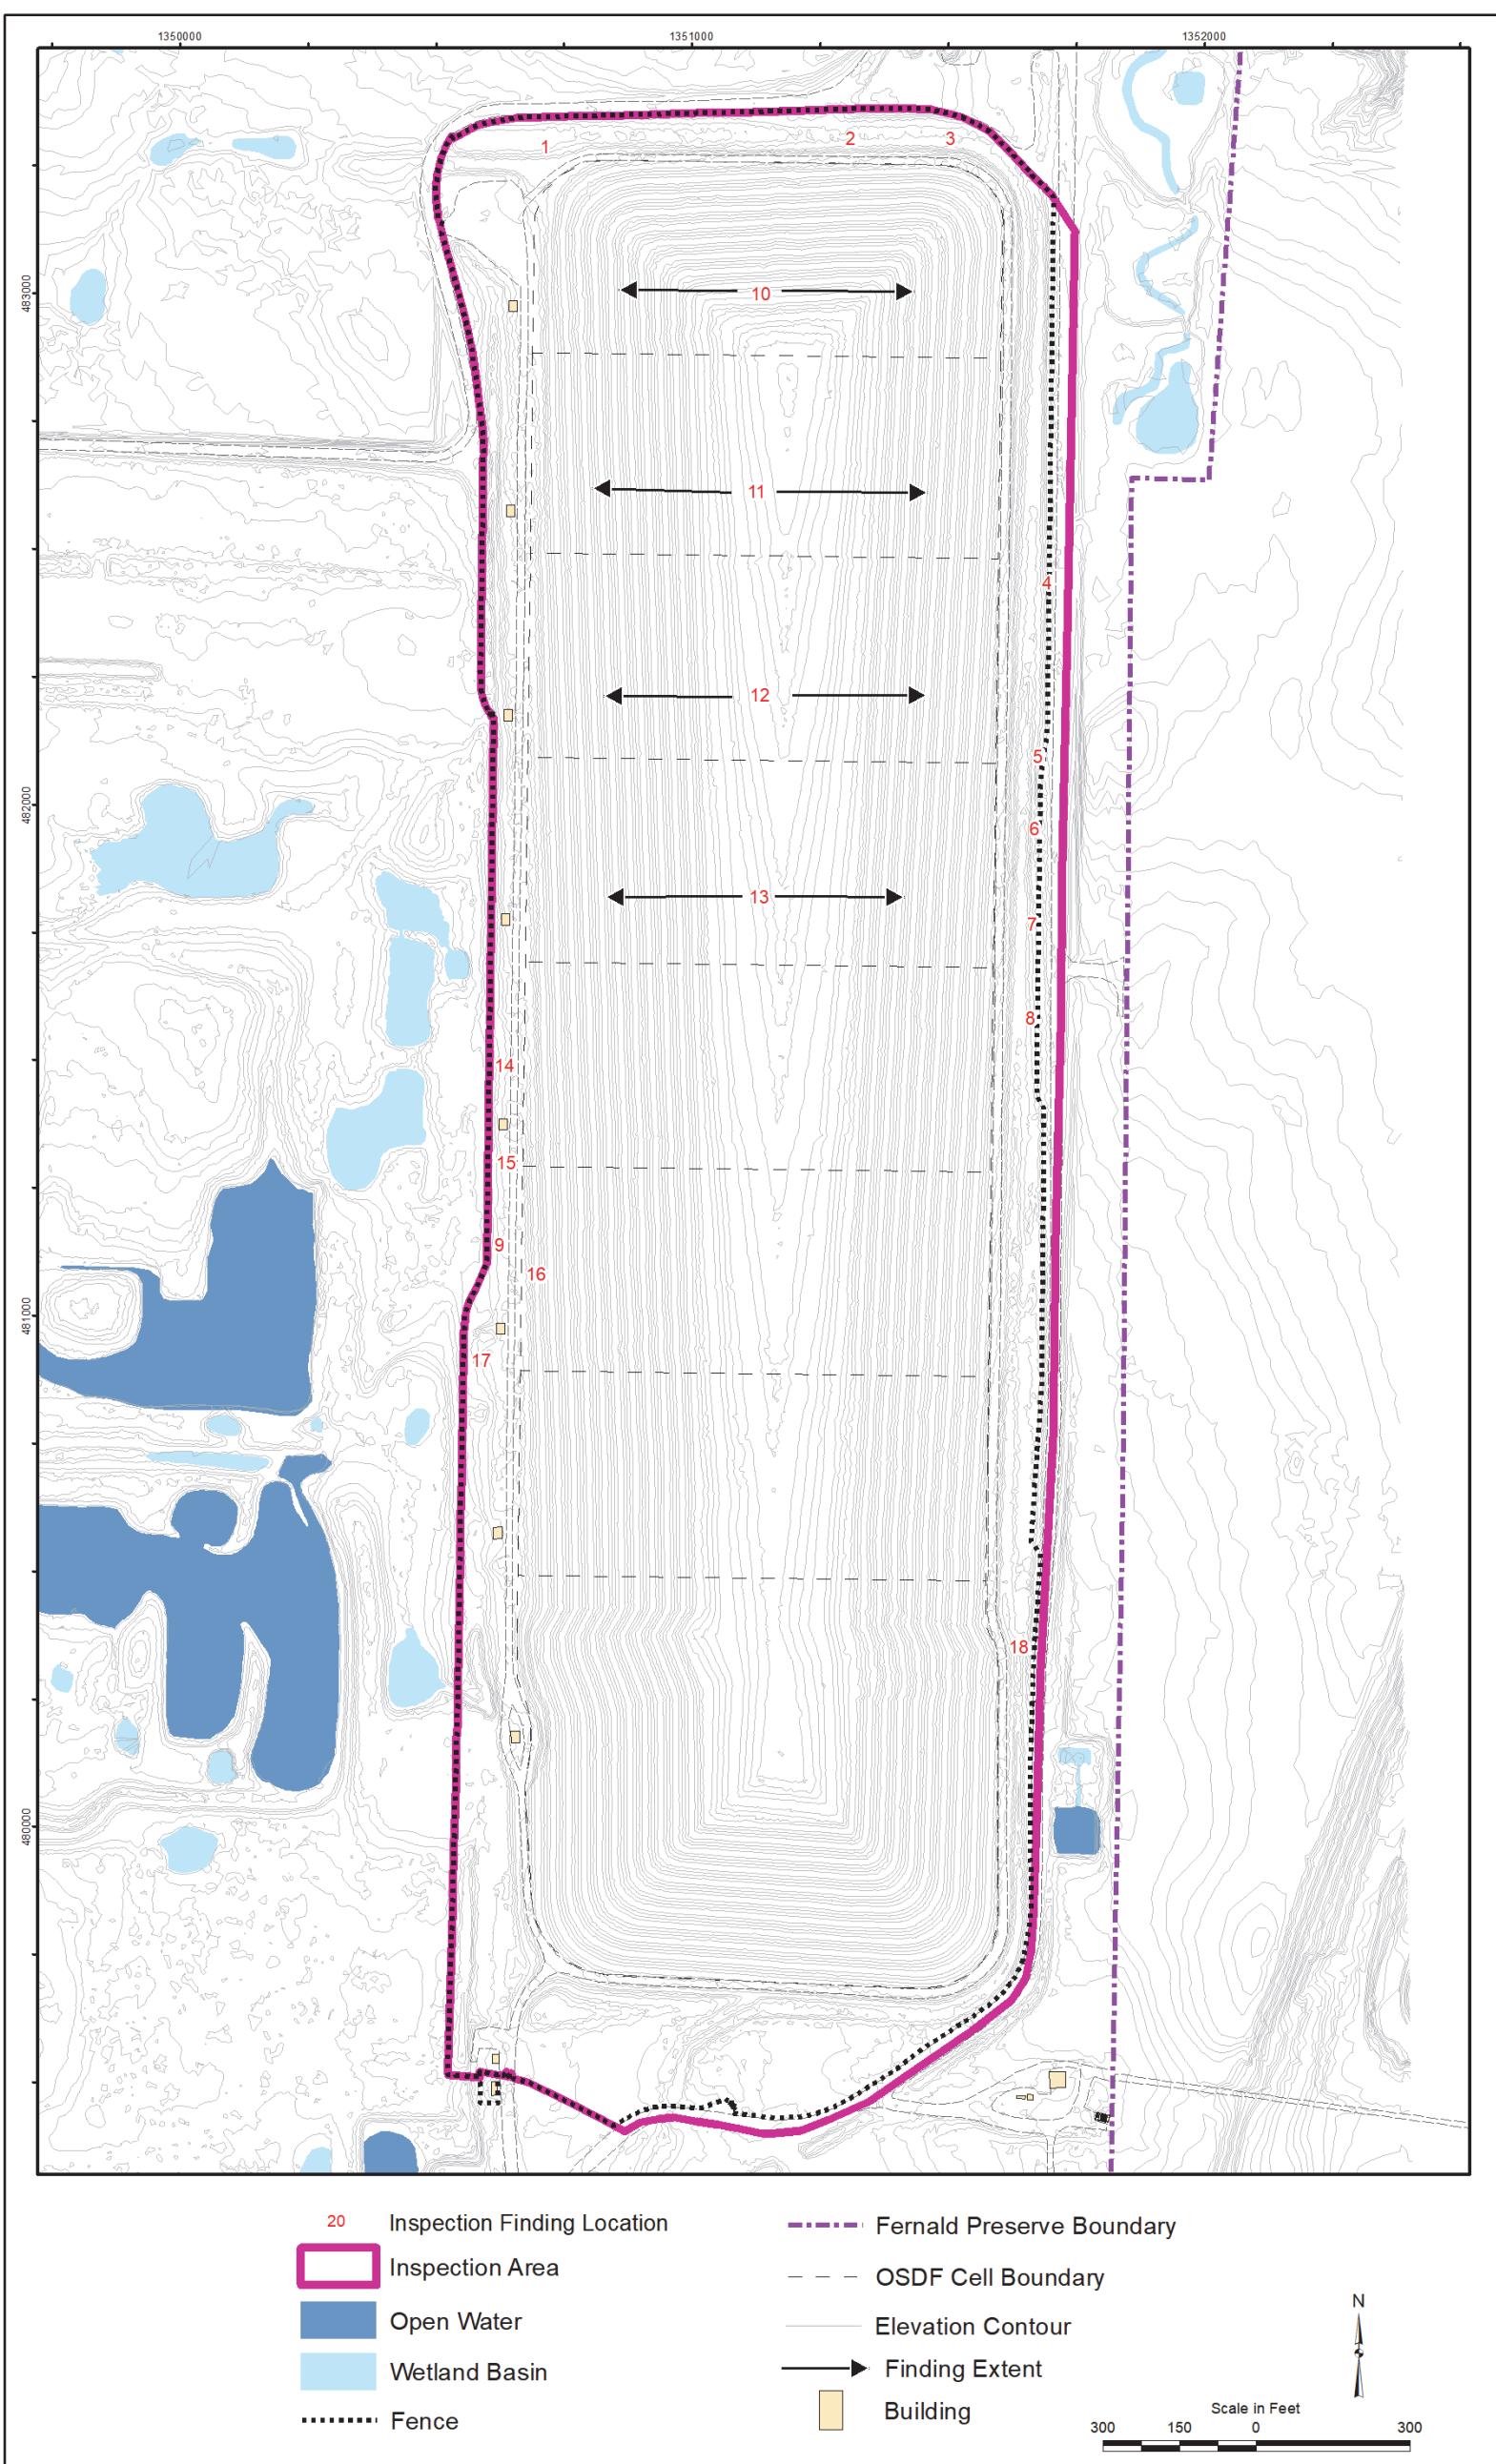
OSDF Inspection Findings, June 3, 2020

Map No.	Location	GPS?	Type of Finding	Description	Photo
1	Cell 1, north drainage, northwest corner	No	Vegetation	Teasel, pear tree, honeysuckle, cedar tree	
2	Cell 1, north drainage bottom at former gate location	No	Vegetation	Honeysuckle	
3	Cell 1, northeast corner drainage	No	Vegetation	Cedar, honeysuckle, pear	
4	Cell 3, east drainage at fence	No	Vegetation	Honeysuckle	
5	Cell 3/4 boundary, east drainage at fence	No	Vegetation	Pear tree	
6	Cell 4, east drainage at fence	No	Vegetation	Thistle and woody vegetation	
7	Cell 4, east drainage at fence	No	Vegetation	Canada thistle	
8	Cell 5, east drainage at fence	No	Vegetation	Pear trees	
9	Cell 6, west edge of road	No	Vegetation	Pear trees and honeysuckle	
10	Cell 1, east and west slopes	No	Vegetation	Scattered woody vegetation	
11	Cell 2, east and west slopes	No	Vegetation	Scattered woody vegetation	
12	Cell 3, east and west slopes	No	Vegetation	Scattered woody vegetation

13	Cell 4, east and west slopes	No	Vegetation	Scattered woody vegetation

Map No.	Location	GPS?	Type of Finding	Description	Photo
14	Cell 5, west side of road	No	Vegetation	Woody vegetation	
15	Cell 5, west side of road	No	Vegetation	Woody vegetation	
16	Cell 6, toe of slope	No	Vegetation	Woody vegetation	
17	Cell 6, west drainage	No	Vegetation	Woody vegetation, thistle, teasel	
18	Cell 8, east toe and drainage	No	Vegetation	Teasel
