1.0 Ambrosia Lake, New Mexico, Disposal Site

1.1 Compliance Summary

The Ambrosia Lake, New Mexico, Uranium Mill Tailings Radiation Control Act (UMTRCA) Title I Disposal Site (site) was inspected on September 11, 2020. No changes were observed on the disposal cell or in the associated drainage features. Inspectors identified several minor maintenance needs but found no cause for a follow-up or contingency inspection.

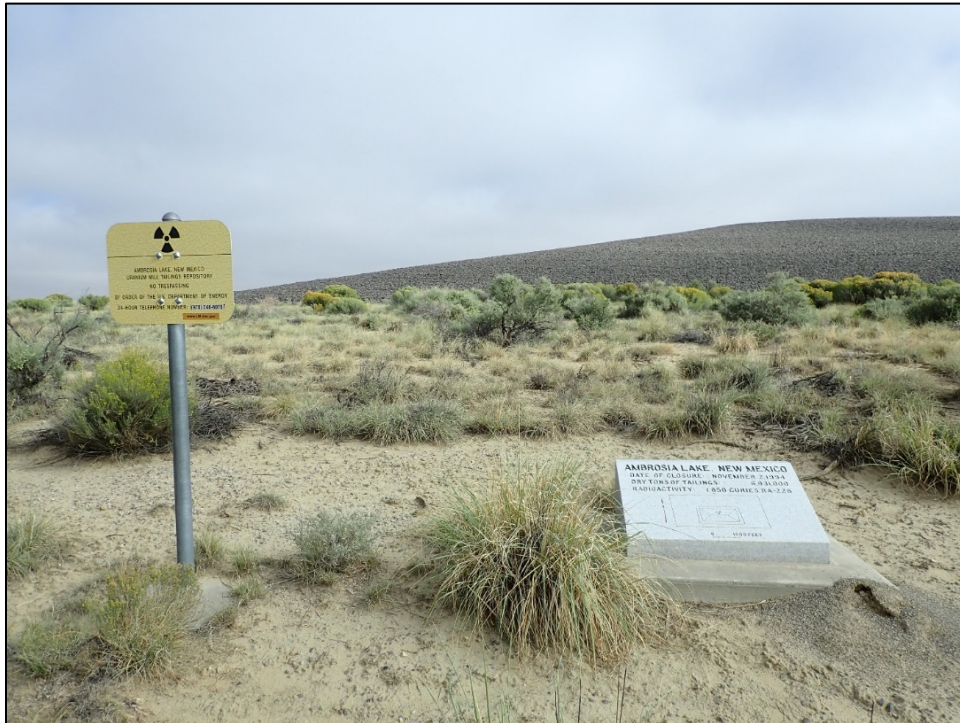
Access to the site is from a gravel road that crosses private property and leads to the site for approximately 1 mile from New Mexico Highway 509. Entrance to the site is through a locked steel gate at the intersection of the access road and Highway 509. The access road continues east past the site to private mining and grazing interests. The gate and access road are owned by Rio Algom Mining LLC. LM has been granted permanent access to the site but does not maintain the gate or the access road. The entrance sign is near the access road next to site marker SMK-1 (PL-1). The phone number on the entrance sign was updated during a subsequent site visit. No other maintenance needs were identified.

PL-1. Entrance Sign and Site Marker SMK-1

Inspectors noted the phone number on the entrance sign was outdated. The number was updated following the inspection. No other maintenance needs were identified.

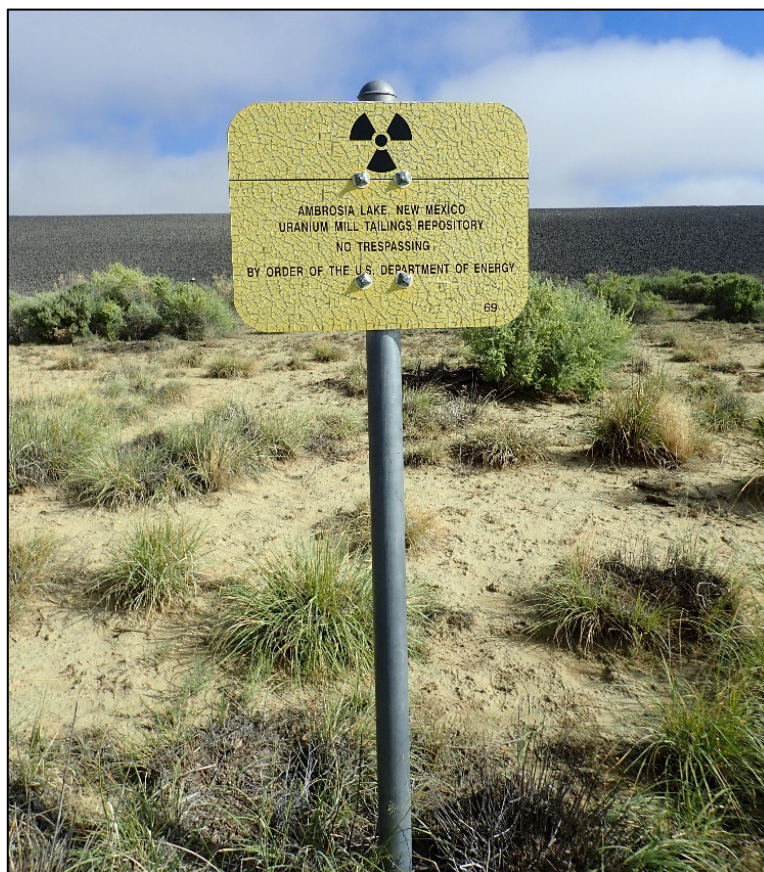
There are 70 perimeter signs, attached to steel posts set in concrete, positioned along the unfenced property boundary (PL-2). Posts for perimeter signs P1 through P15 include additional warning signs about mining restrictions. Many of the perimeter signs were cracked and weathered but remain legible. No maintenance needs were identified.

PL-2. Perimeter Sign P69

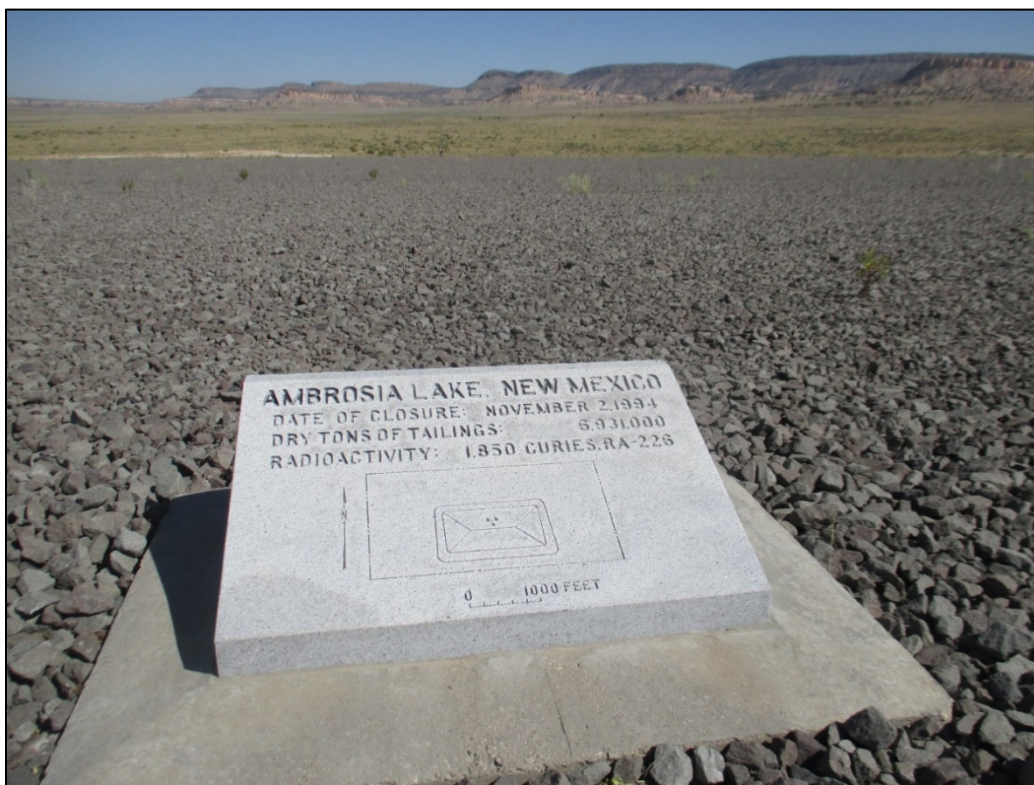
The site has two granite site markers. Site marker SMK-1 is just inside the site entrance, and site marker SMK-2 is on the top slope of the disposal cell (PL-3). No maintenance needs were identified.

PL-3. Site Marker SMK-2

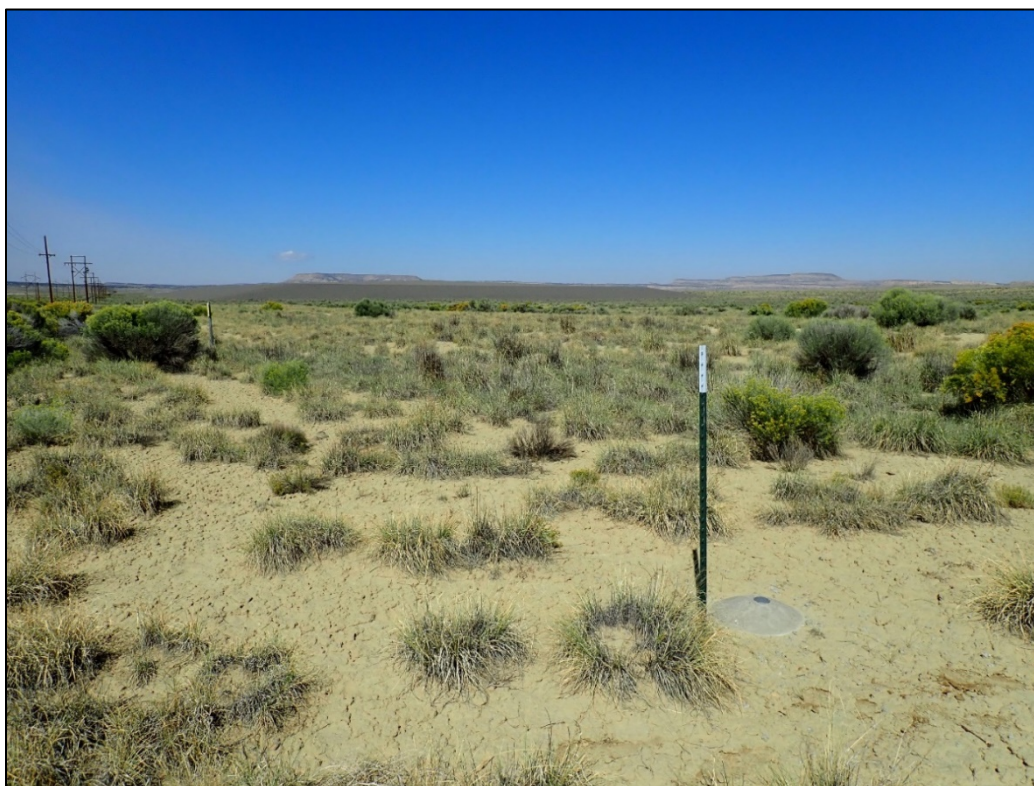
Three combined survey and boundary monuments and five additional boundary monuments delineate the property corners and boundary (PL-4). Steel T-posts were installed next to boundary monuments to help inspectors locate them. Erosion has occurred around the base of boundary monument BM-8, but the monument is stable. No maintenance needs were identified.

PL-4. Boundary Monument BM-1

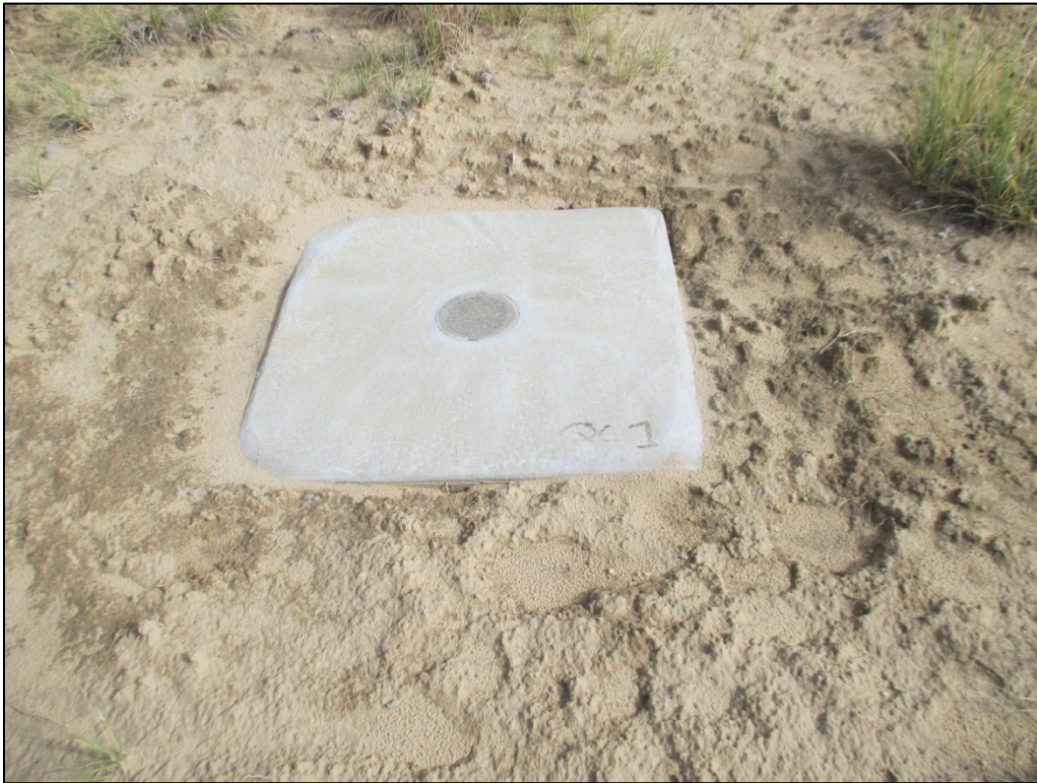
Six aerial survey quality control (QC) monuments, installed in 2019, were inspected during the 2020 annual inspection (PL-5). No maintenance needs were identified.

PL-5. Quality Control Monument QC1

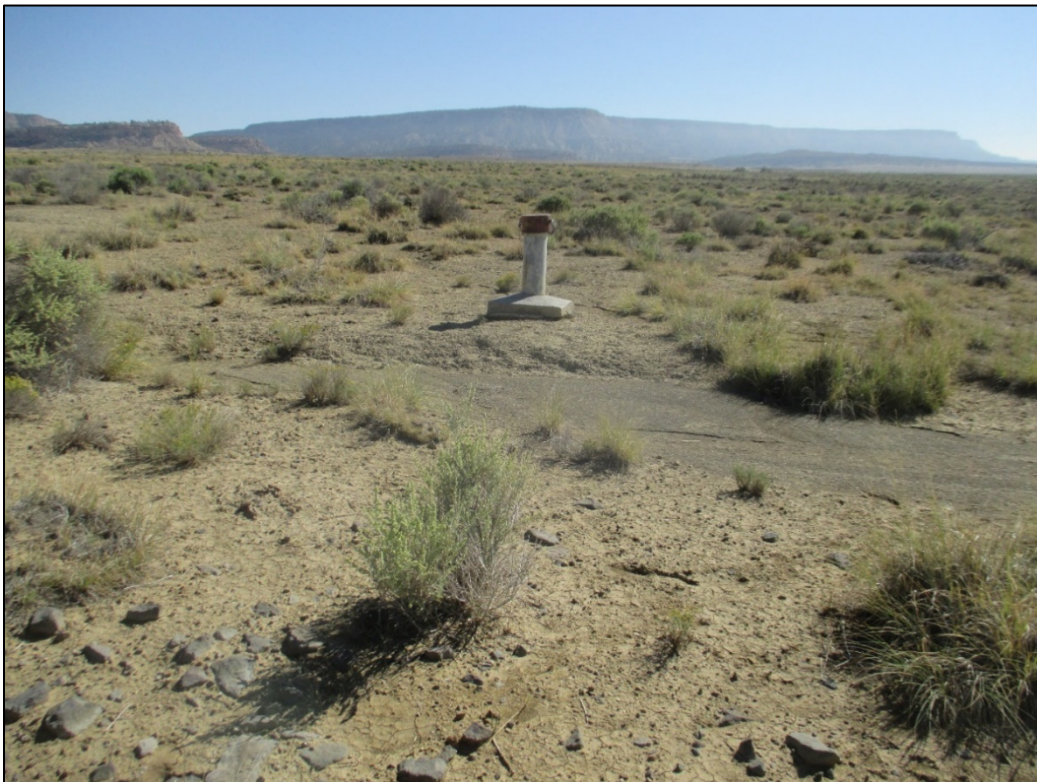
The site has three monitoring wells. A gully adjacent to well 0678 appears to be stable, and the well is not affected by the erosion (PL-6). All wellhead protectors observed during the inspection were undamaged, locked, and properly labeled. No maintenance needs were identified.

PL-6. Erosional Gully near Monitoring Well 0678

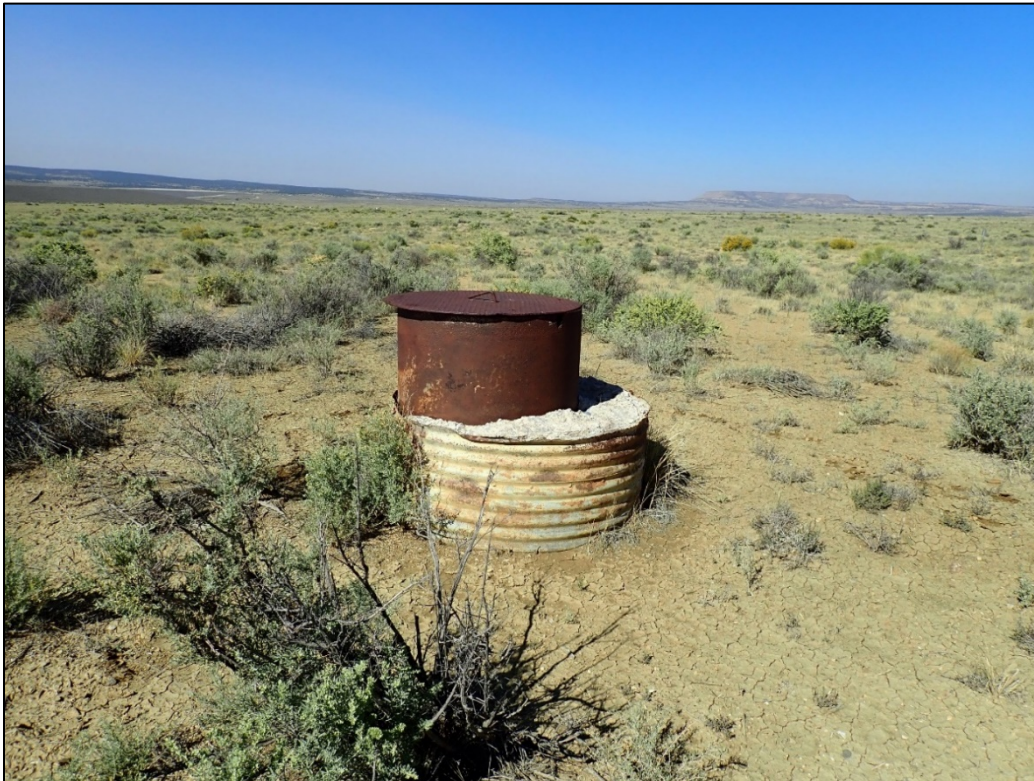
A mine vent shaft associated with an abandoned underground mine is within the site boundary in the northern portion of the site (PL-7). The vent has a spot-welded cover and a casing that rises approximately 3 feet above the ground. The vent was secure at the time of the inspection. Inspectors will continue to monitor the condition of the vent to ensure that the closure remains secure. No maintenance needs were identified.

PL-7. Mine Vent

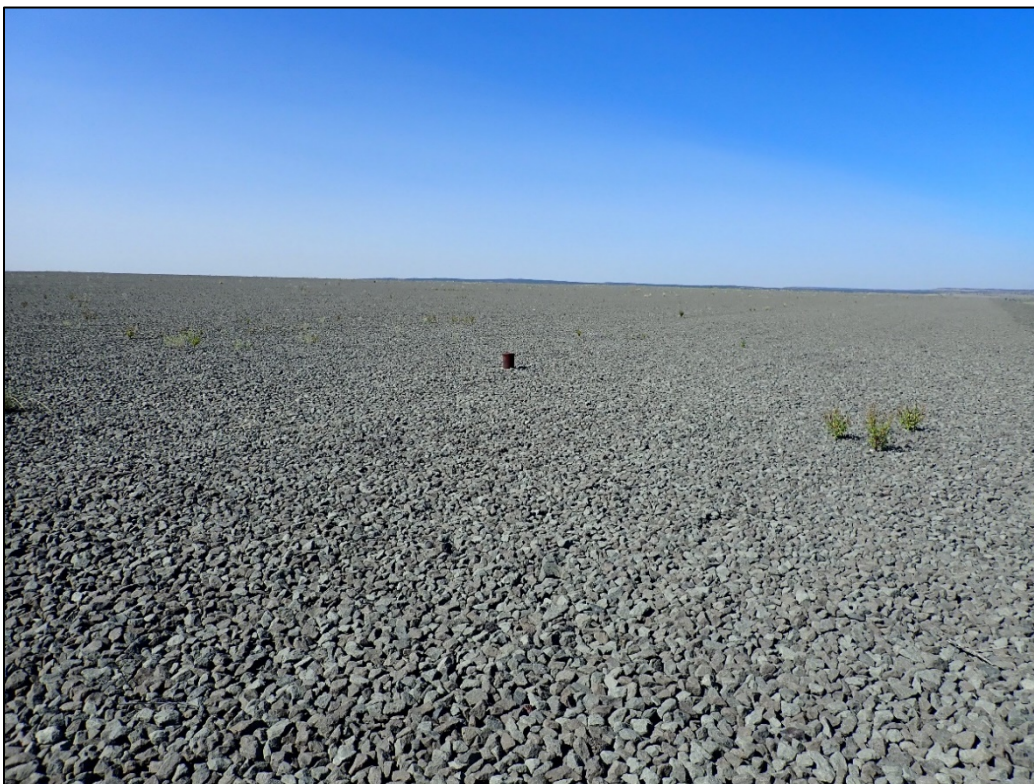
The disposal cell, completed in 1994, occupies 91 acres and is armored with basalt riprap to control erosion and deter animal and human intrusion. The top slope showed no evidence of cracking, slumping, or erosion, and there was no indication of riprap degradation. A shallow depression around settlement plate SP-4, near the northeast corner of the disposal cell cover, was first noted during the 1997 inspection and continued to grow in depth and area in subsequent years. The depression was repaired in August 2005. Visual observations during the 2017 annual inspection indicated that very minor settlement may have occurred since the depression was repaired. The area was inspected during the 2020 annual inspection, and although the area was observed to be slightly depressed, settlement was shallow enough that neither the depth nor the extent could be definitively assessed (PL-8). Inspectors will continue to monitor this area.

PL-8. Settlement Plate 4 and Top Slope of the Disposal Cell

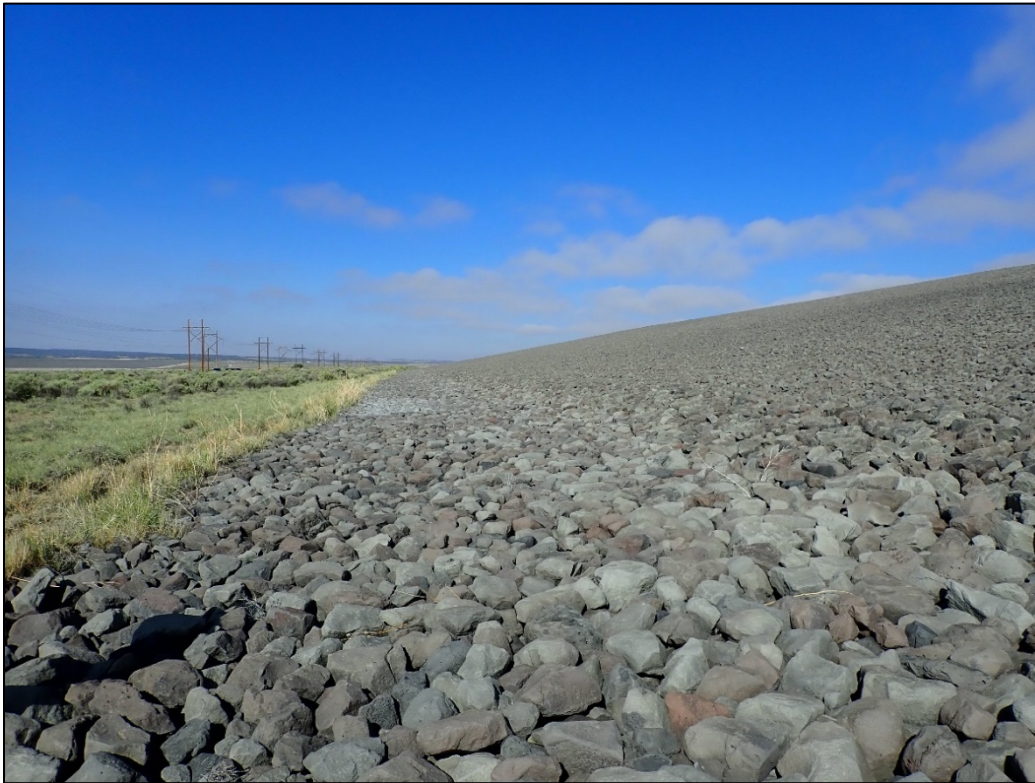
The basalt riprap-covered side slopes and apron showed no evidence of erosion, settling, slumping, or cracking. Standing water is occasionally observed in a portion of the south apron, but the area was dry during the inspection (PL-9). This location is the topographic low spot along the base of the disposal cell, and stormwater runoff collects in this area. No significant changes in the potential desiccation crack and small rills at the base of the disposal cell were observed. Inspectors will continue to monitor this area. No maintenance needs were identified.

PL-9. Base of South Side Slope of the Disposal Cell

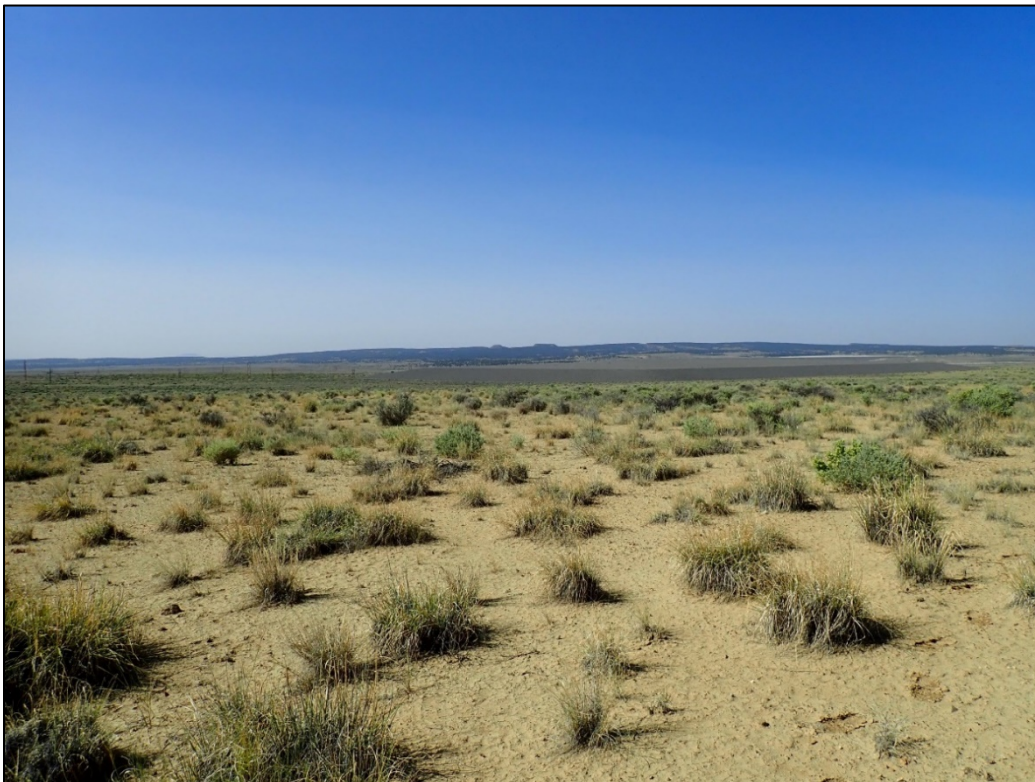
In general, site vegetation appeared to be healthy. However, some areas are windswept and have little growth, particularly in an area north of the disposal cell where mill tailings had formerly been stockpiled (PL-10). Because the site is not fenced, livestock occasionally enter it. Inspectors did not observe cattle near the disposal cell, but there was evidence of recent grazing on the site. Occasional grazing will not affect the disposal cell protectiveness or long-term performance, because livestock do not walk on riprap-armored surfaces.

PL-10. Disposal Cell and Northeast Portion of the Site
