2020 Annual Inspection and Radiological Survey Results for the Piqua, Ohio, Decommissioned Reactor Site

August 2020

U.S. DEPARTMENT OF
ENERGY

Legacy
Management

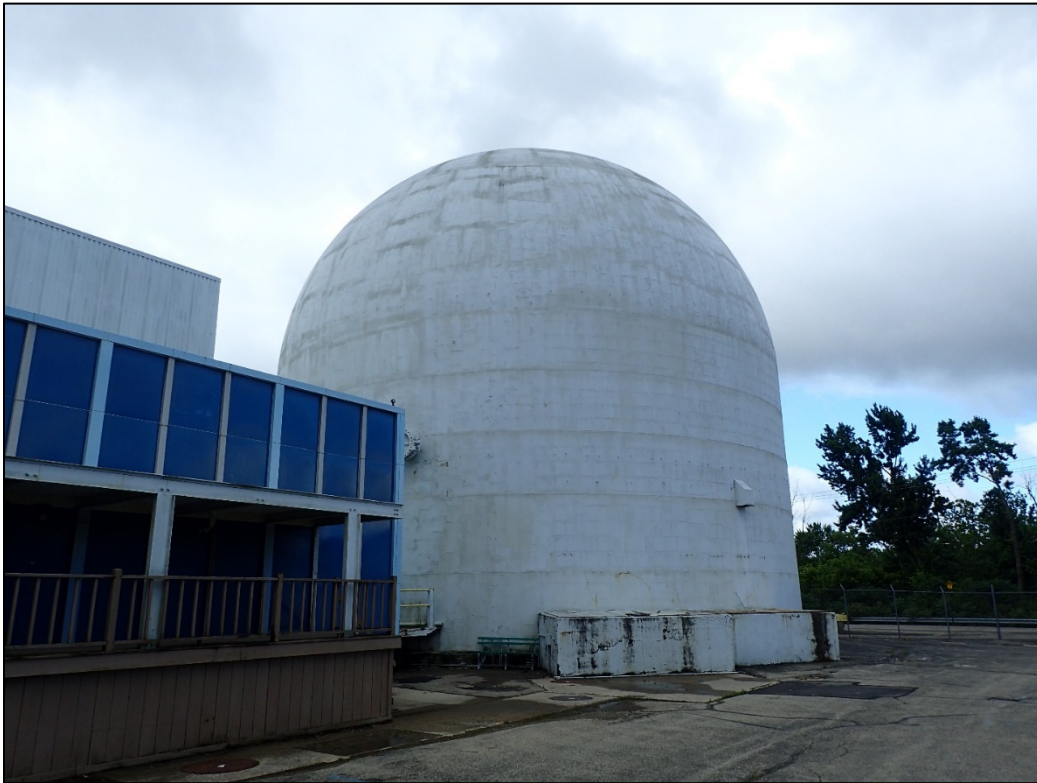
PL-1. Containment Building

The Containment Building exterior was refurbished circa 1995. The building's exterior surface is in overall good condition, but the paint is fading and beginning to peel in a few areas (PL-1). Some exterior electrical safety concerns identified in the 2015 site utility assessment (e.g., exposed exterior electrical wiring, broken conduits, and dismantled outlets) remain, electric power to the facility has been turned off. For instance, there is exposed conduit outside the Containment Building. The break in the fire suppression line was repaired by the city in 2018, but the fire suppression system itself (e.g., sprinkler heads) was not verified as operable. Since verification testing has not been completed, the fire suppression system is considered inoperable.

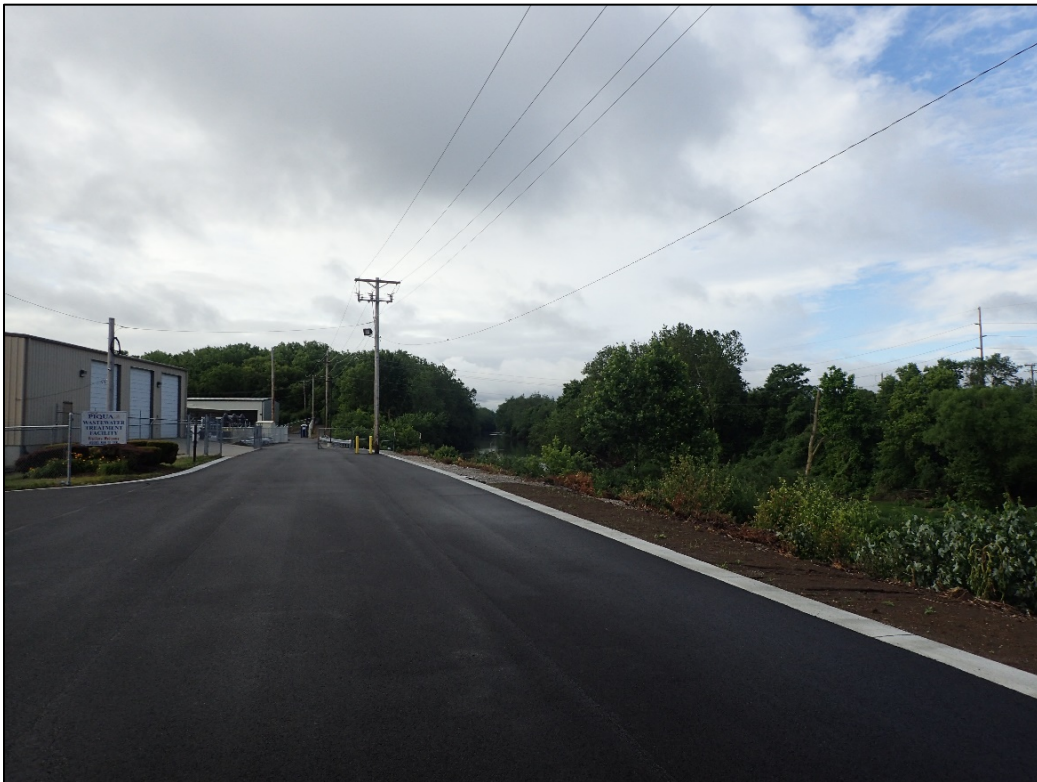
PL-2. New Paving to Water Treatment Plant

The area surrounding the site was visually observed. The city's wastewater expansion project (located southeast of the site) was mostly completed. The road leading to the wastewater plant facility was recently repaved (PL-2). A new retaining wall was constructed between the treatment plant expansion and the Auxiliary Building (PL-3). No changes that could impact the integrity of the site or the entombment were observed.

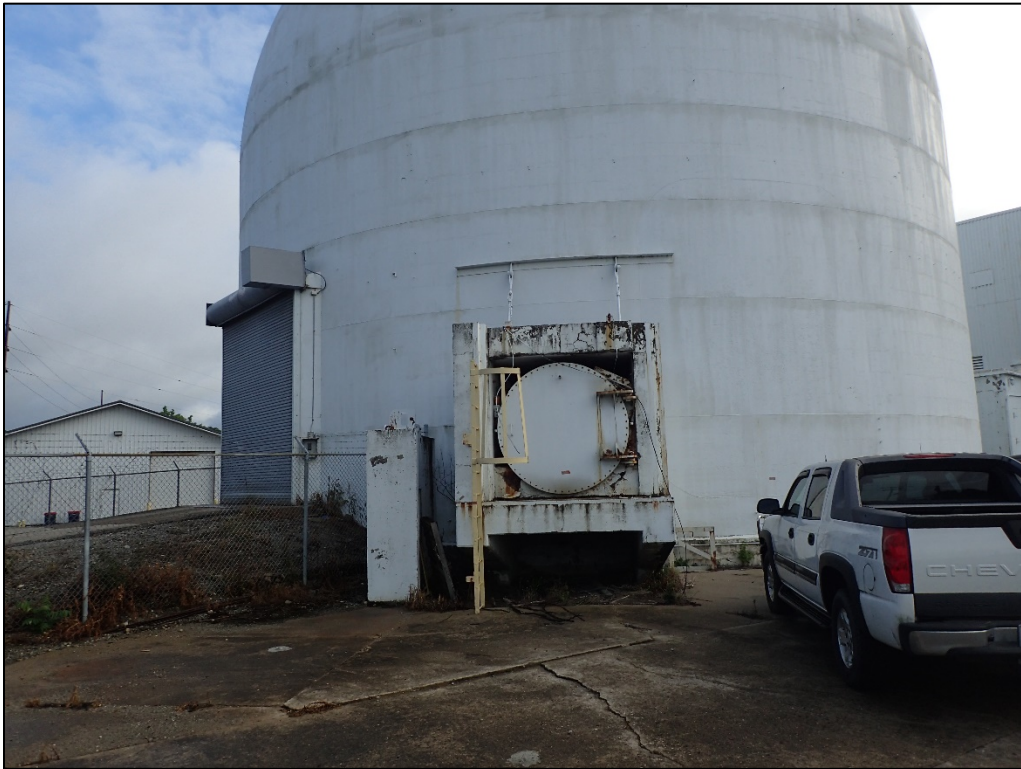
PL-4. Air Lock

100-foot level: The concrete around the southwest air lock of the Containment Building remains in need of repair. Numerous cracks are present, and some small pieces of concrete are falling off. LM is determining a path forward for the facility that will evaluate the repair of the concrete around the air lock (PL-4).

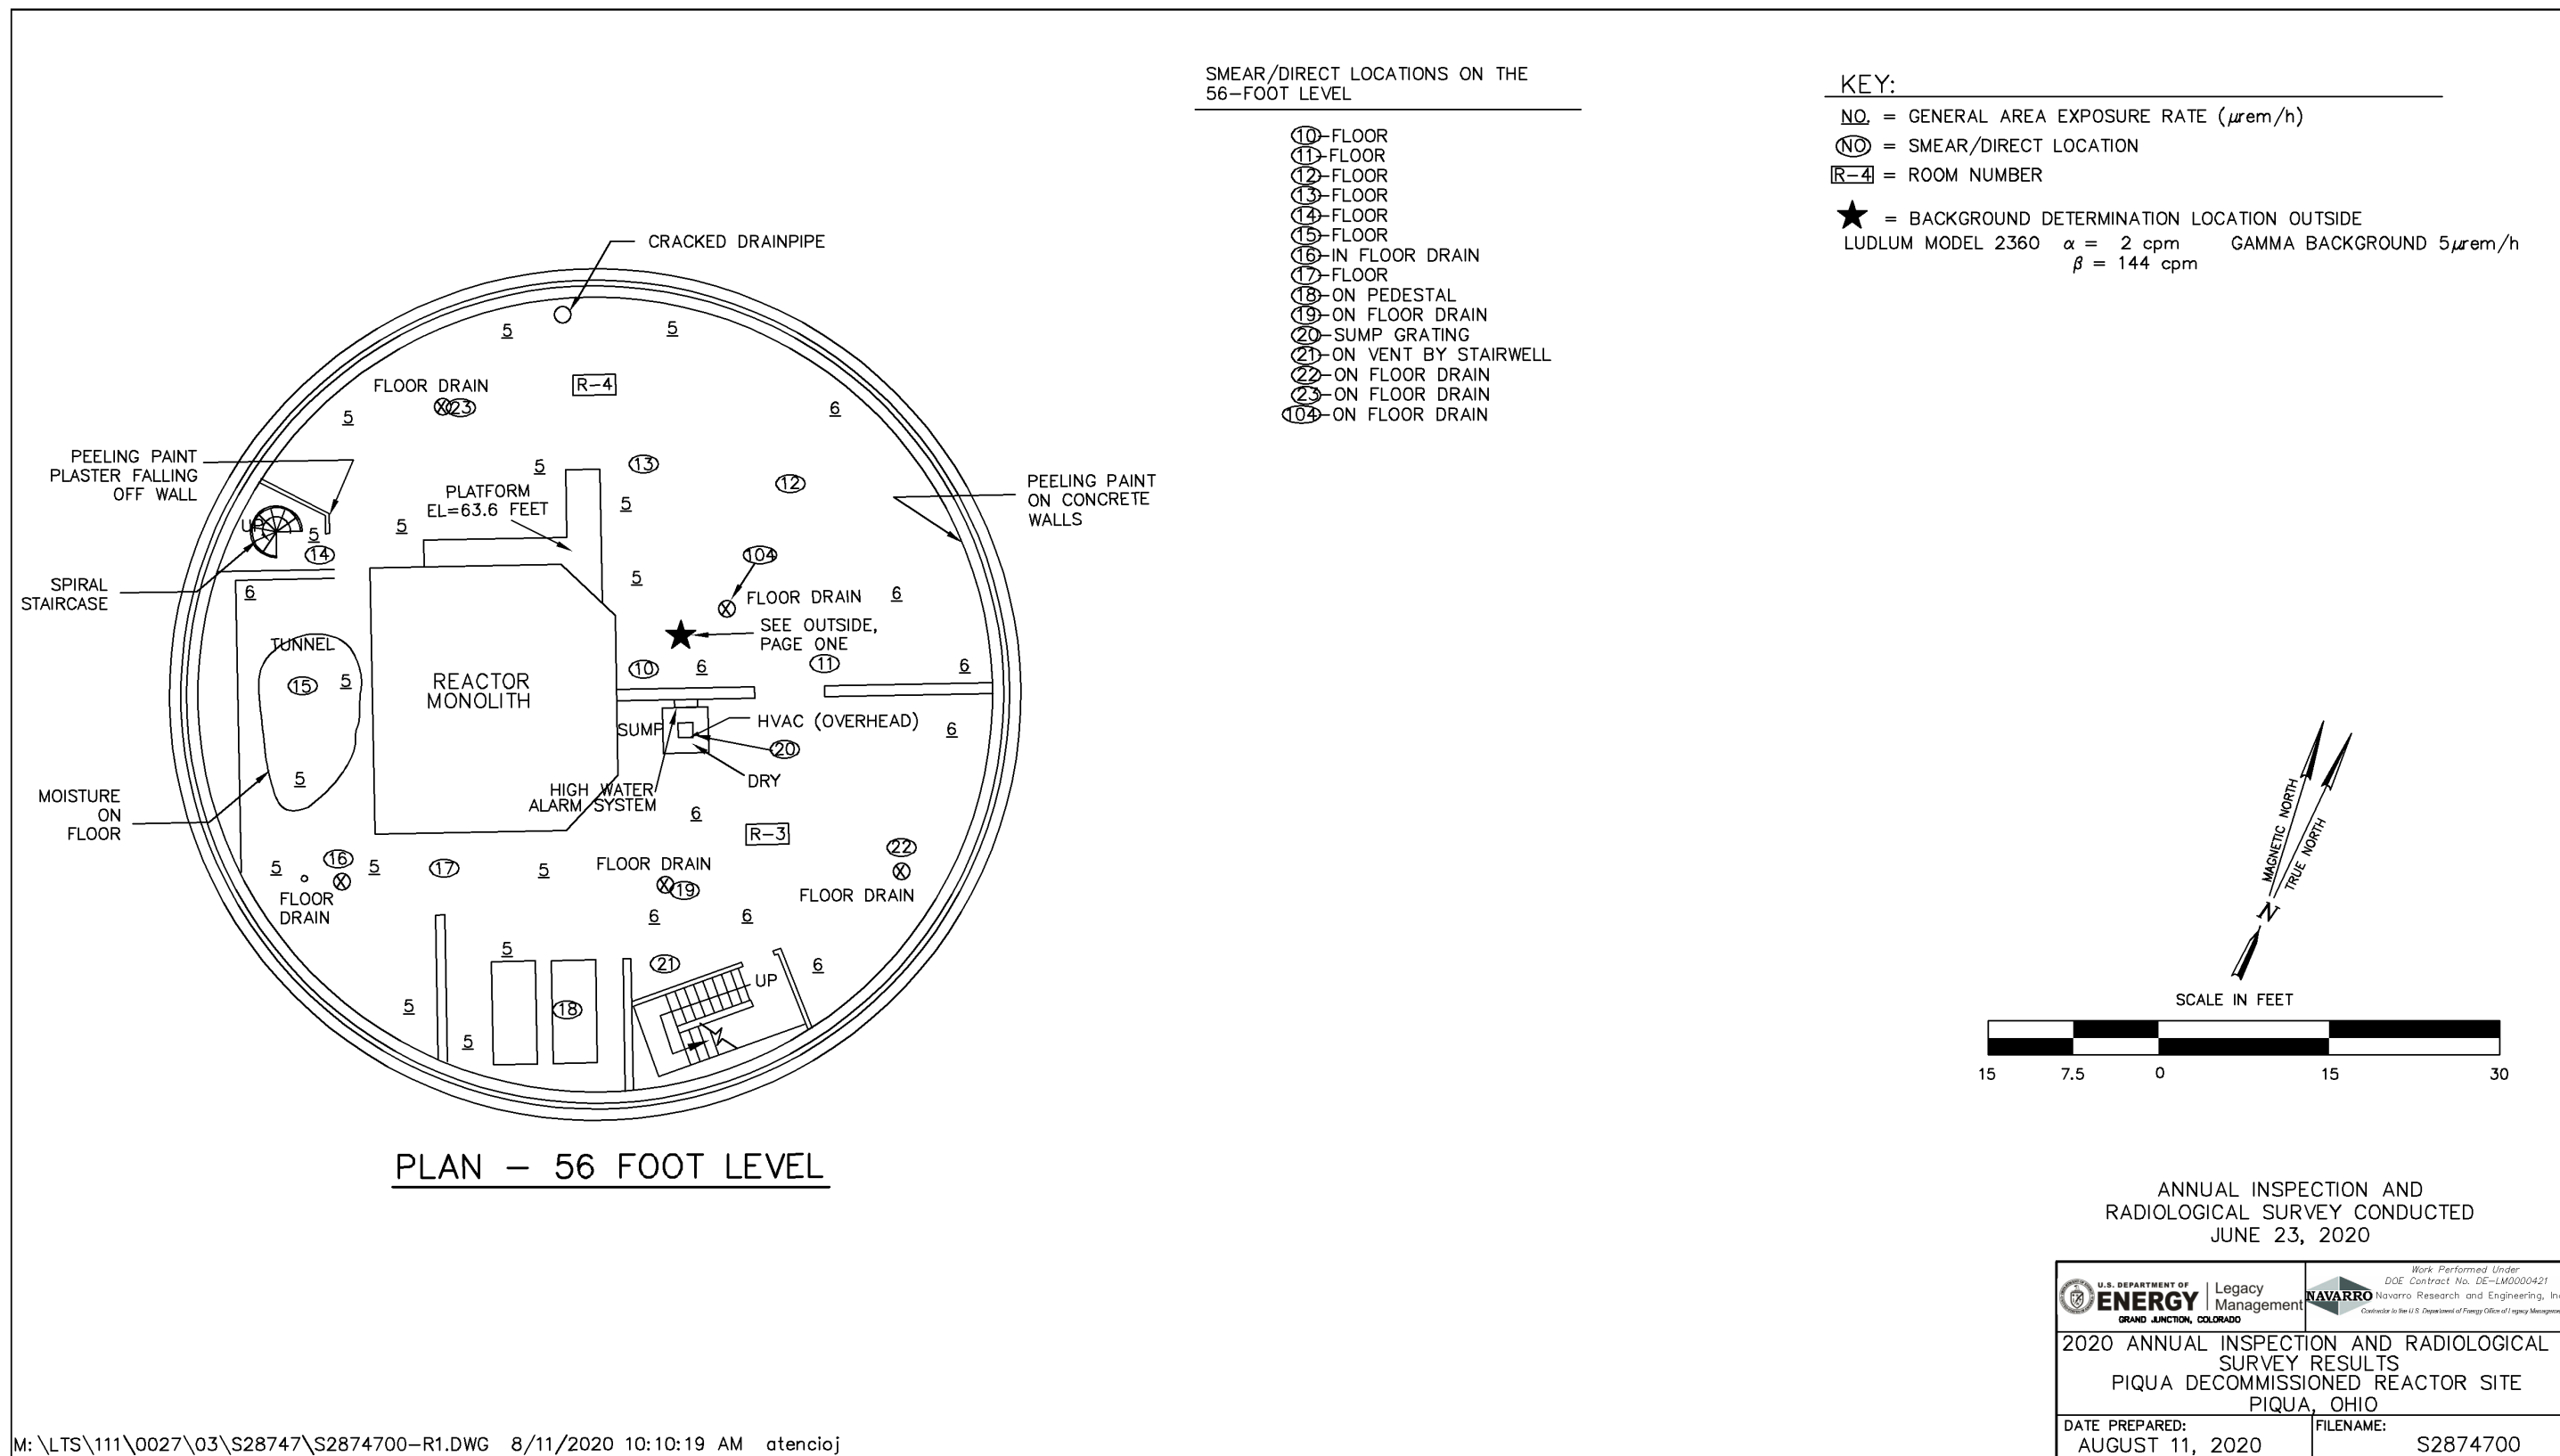
Figure A-2. Annual Radiological Survey Results Piqua, Ohio, Decommissioned Reactor Site Plan, 56-Foot Level

The results of both the direct and smear surveys were all lower than 10 CFR 835 limits for surface contamination. Only one location (floor drain location No. 16 on the 56 ft level) had a direct reading above the critical value of 73 dpm/100 cm² for beta. That direct reading was

688 dpm/100 cm² for beta, which is well below the 10 CFR 835 limit of 5000 dpm/100 cm² for beta. The smear from this location indicated that no removable activity was present. All direct readings for alpha were less than the critical value of 29 dpm/100 cm². The 10 CFR 835 limit for alpha is 500 dpm/100 cm².
