2020 Annual Inspection Report for the Parkersburg, West Virginia, Disposal Site

February 2021

U.S. DEPARTMENT OF
ENERGY

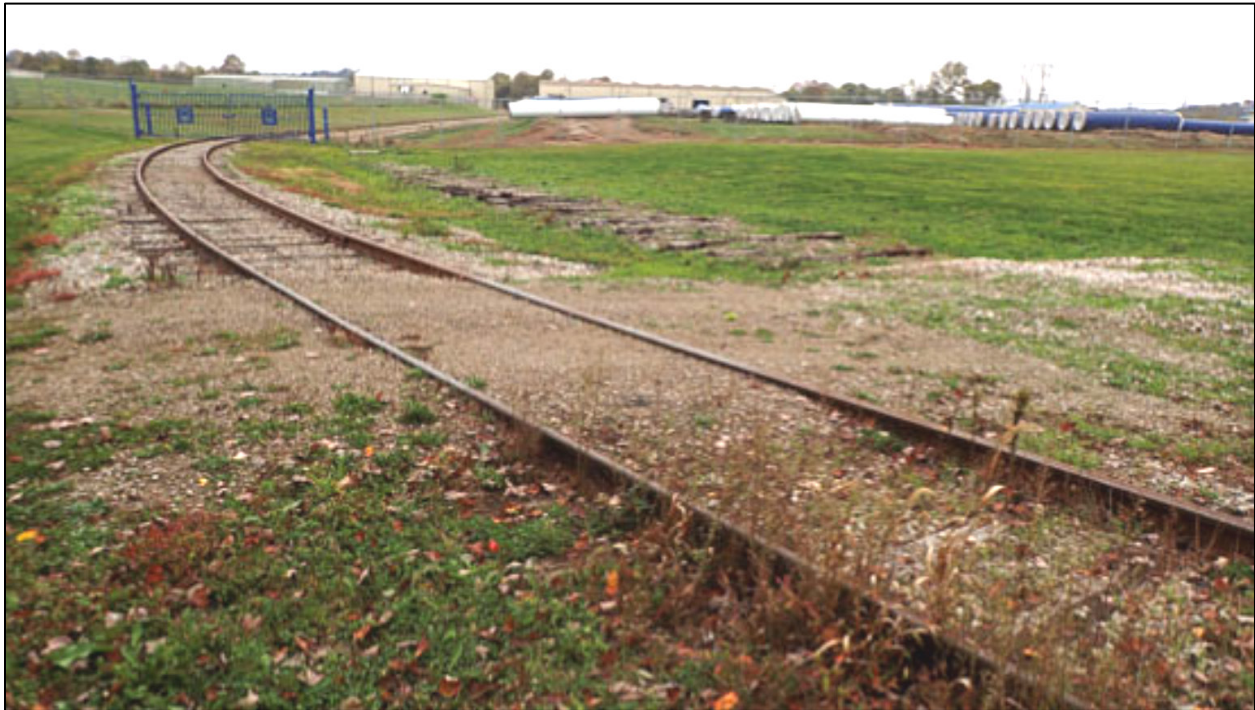
A rail spur belonging to Northwest Pipe Company that crosses the site right-of-way was replaced in 2016. Northwest Pipe Company maintains a gravel crossing where the rail spur crosses the site right-of-way to provide vehicle access to the site. The gravel crossing appeared to be well maintained (PL-1). Vehicle access across the new spur was good.

PL-1. Gravel Access Across Railroad Tracks

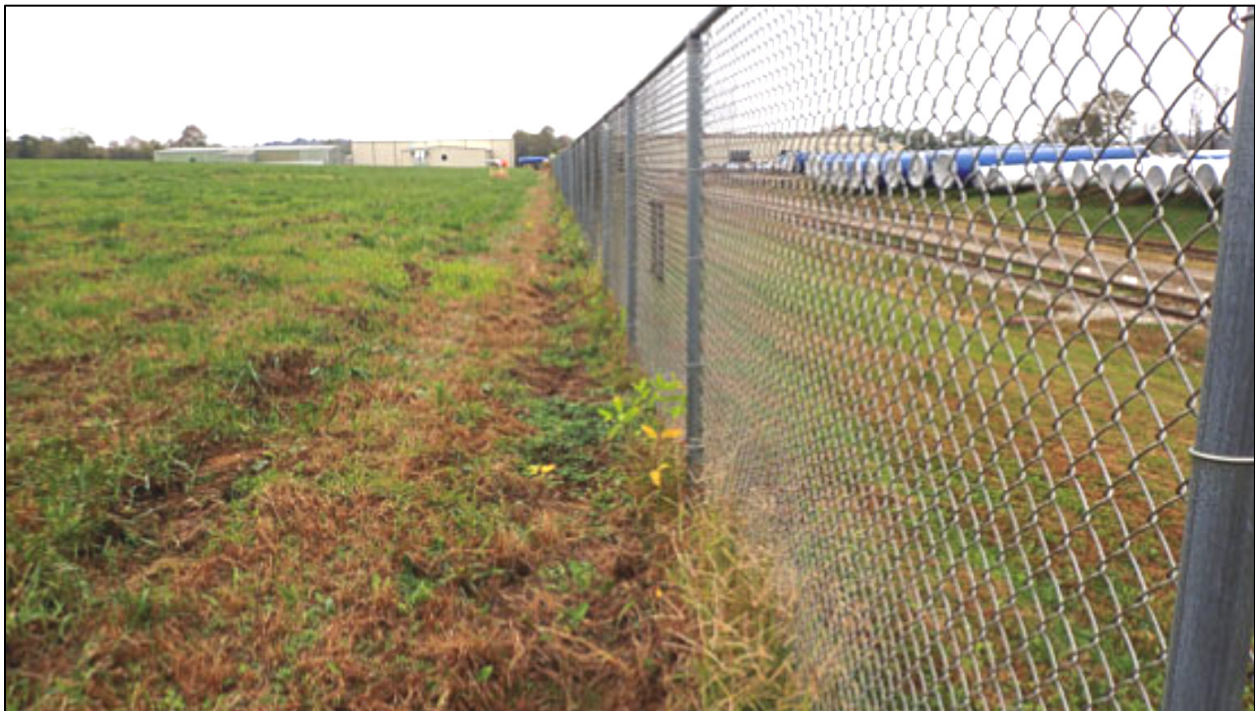
The perimeter fence was replaced in 2007. The site maintenance subcontractor is tasked with maintaining a vegetation-free zone along the base of the fence line and to keep vegetation from growing on the fence fabric. The vegetation-free zone along the fence line was not being maintained (PL-2), and the fence fabric was not free of vegetation (PL-3).

PL-2. North Fence Line

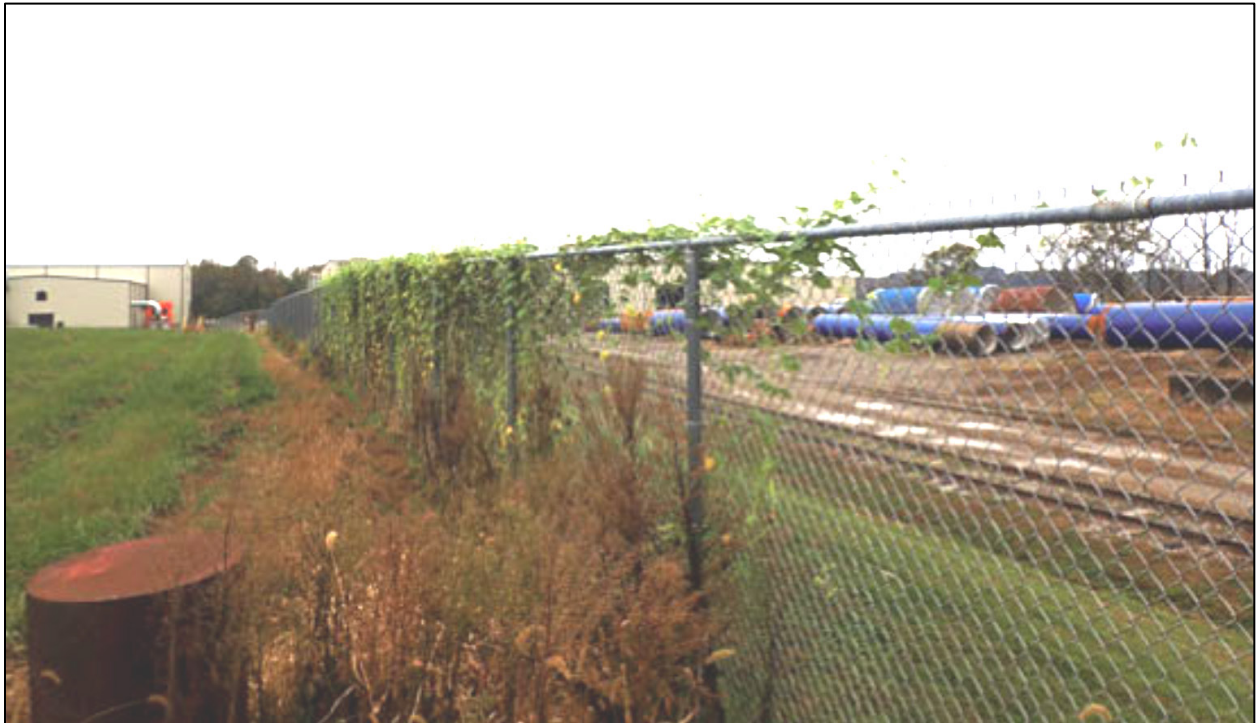
PL-3. Vegetation on Fence Fabric

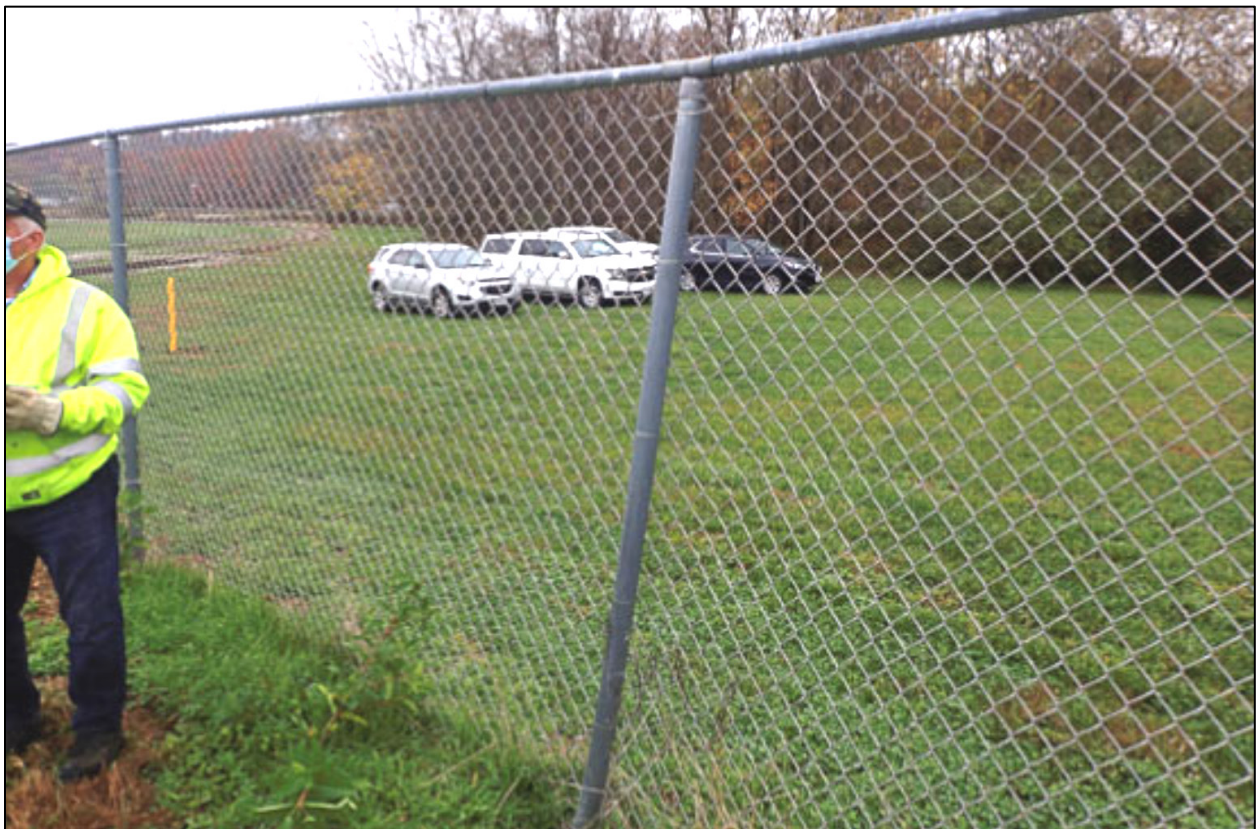
It appears that something ran into the fence in 2020, causing one of the vertical posts to lean slightly (PL-4). The fence remains serviceable; no action needs to be taken at this time to repair the damage.

PL-4. Leaning Fence Post

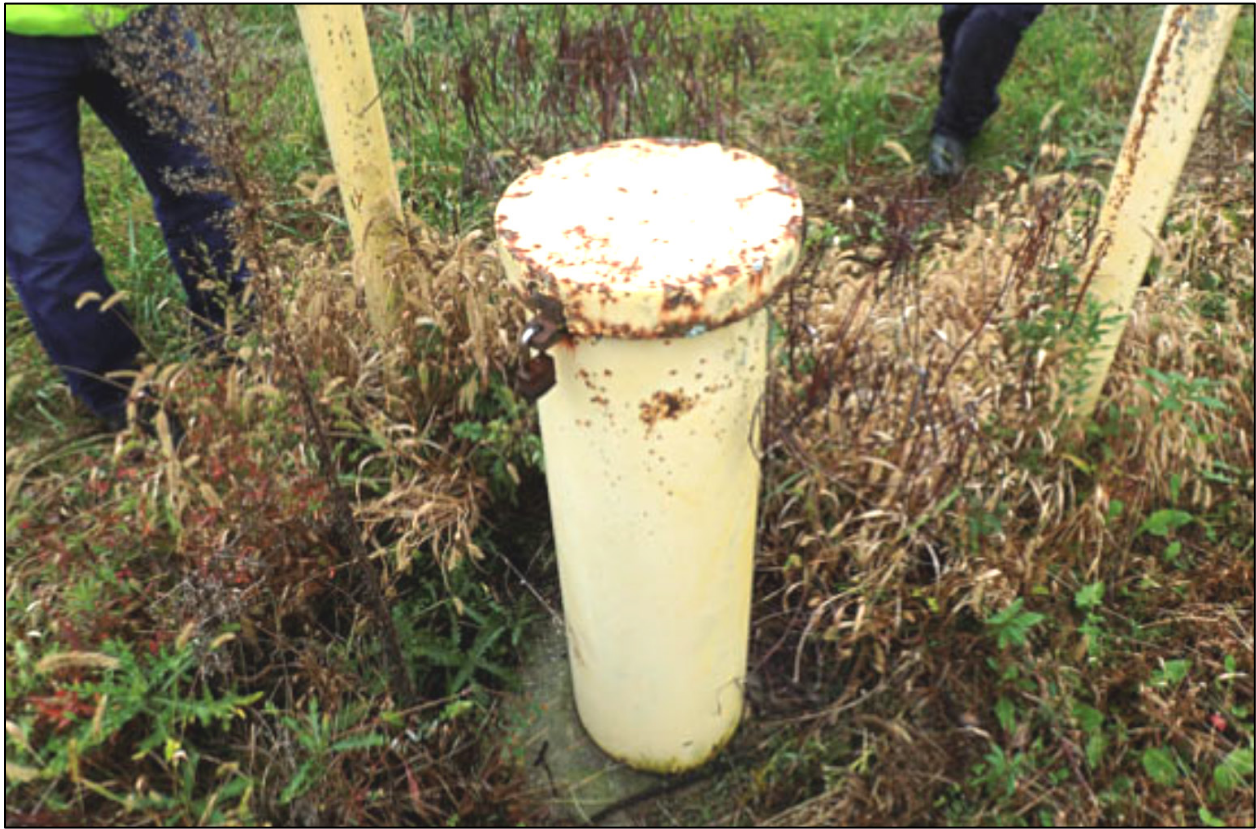
There are six groundwater monitoring wells at the Parkersburg site. All six wells are inside the security fence. The wells are numbered in the chronological order in which they were drilled and installed. All six wells were properly locked. The site maintenance subcontractor is tasked with keeping vegetation cleared from around the monitoring wells. Vegetation was not being properly controlled around the monitoring wells (PL-5).

PL-5. Monitoring Well MW-5

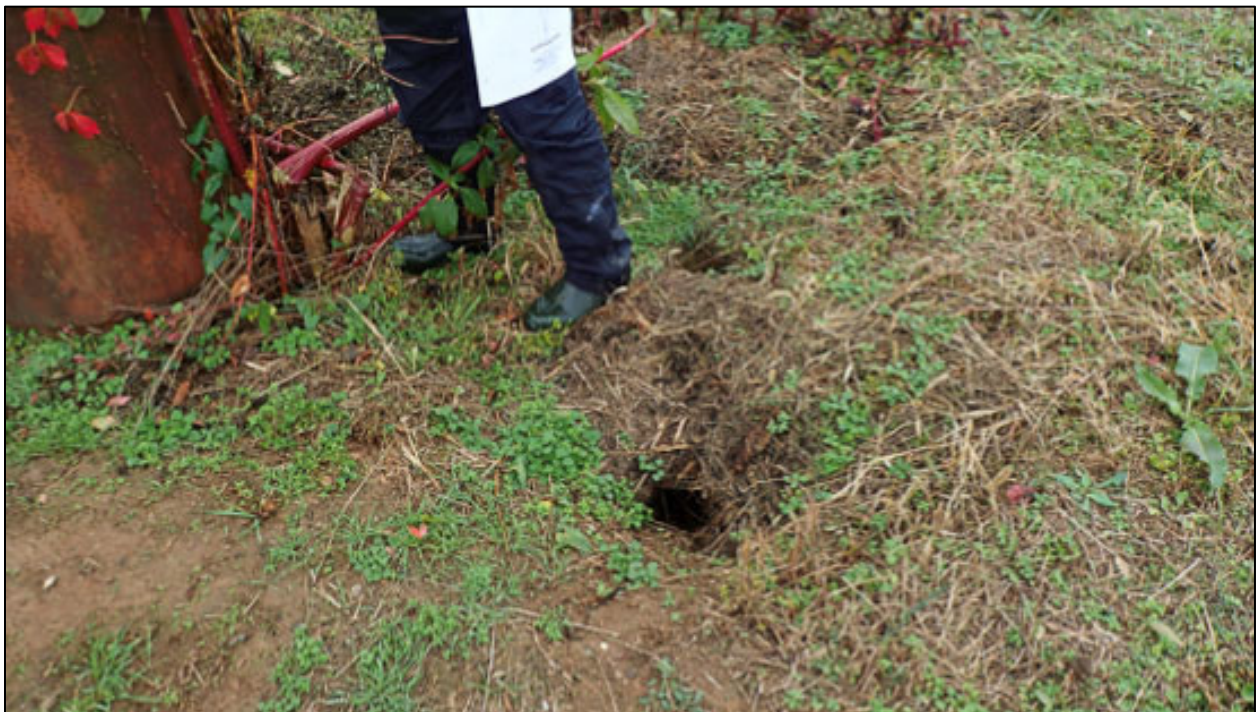
Animal burrows were observed near monitoring well MW-1. These animal burrows need to be addressed to eliminate tripping hazards (PL-6).

PL-6. Animal Burrows near Monitoring Well MW-1

Animal burrows along the west perimeter fence (between perimeter signs P9 and P10) and around monitoring well MW-1 need to be addressed to eliminate a potential safety hazard to the vegetation management crew.

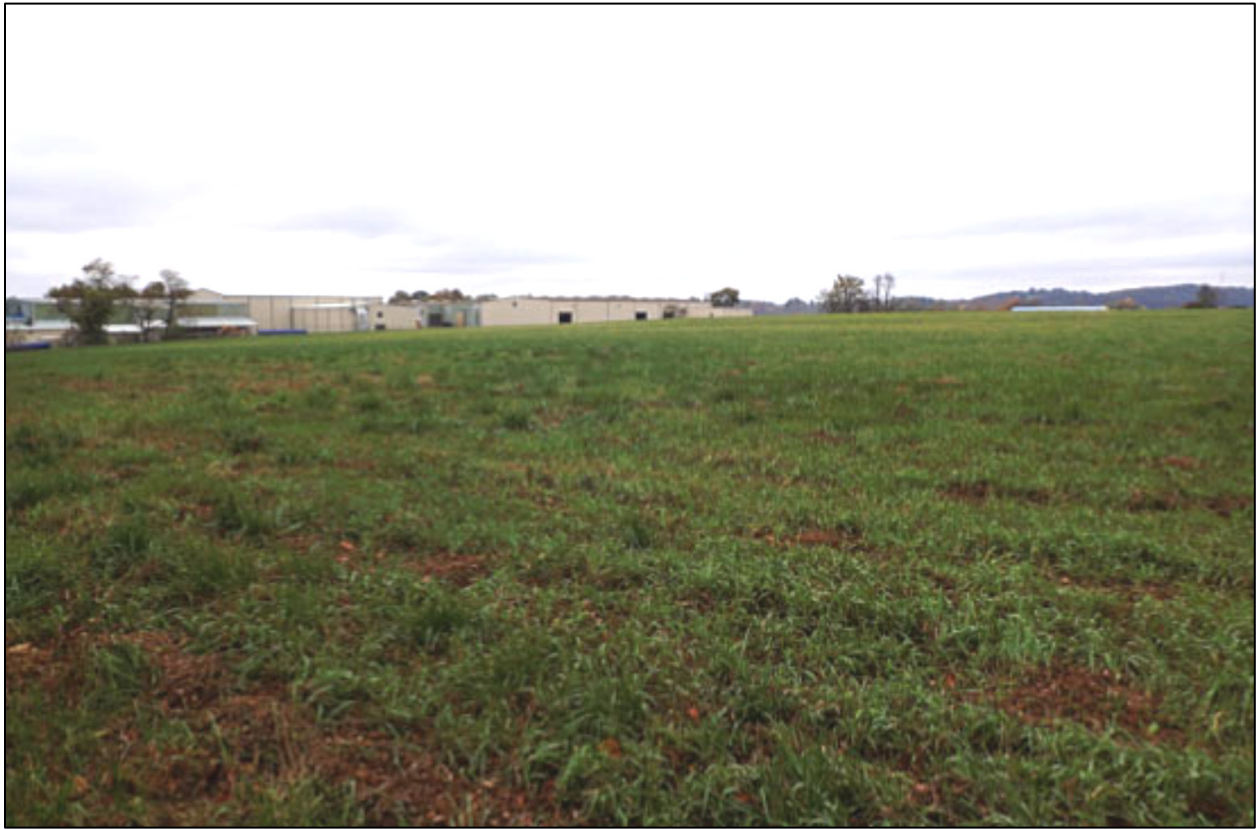
At the time of the inspection, vegetation on top of the disposal cell had been recently mowed. No evidence of erosion or slope instability on the disposal cell was noted during the inspection (PL-7).

PL-7. View Across Disposal Cell
