**Quarterly Site Inspection Report for
the Fernald Preserve, Ohio, Site,
December 2020**

January 2021

U.S. DEPARTMENT OF
ENERGY

Legacy
Management

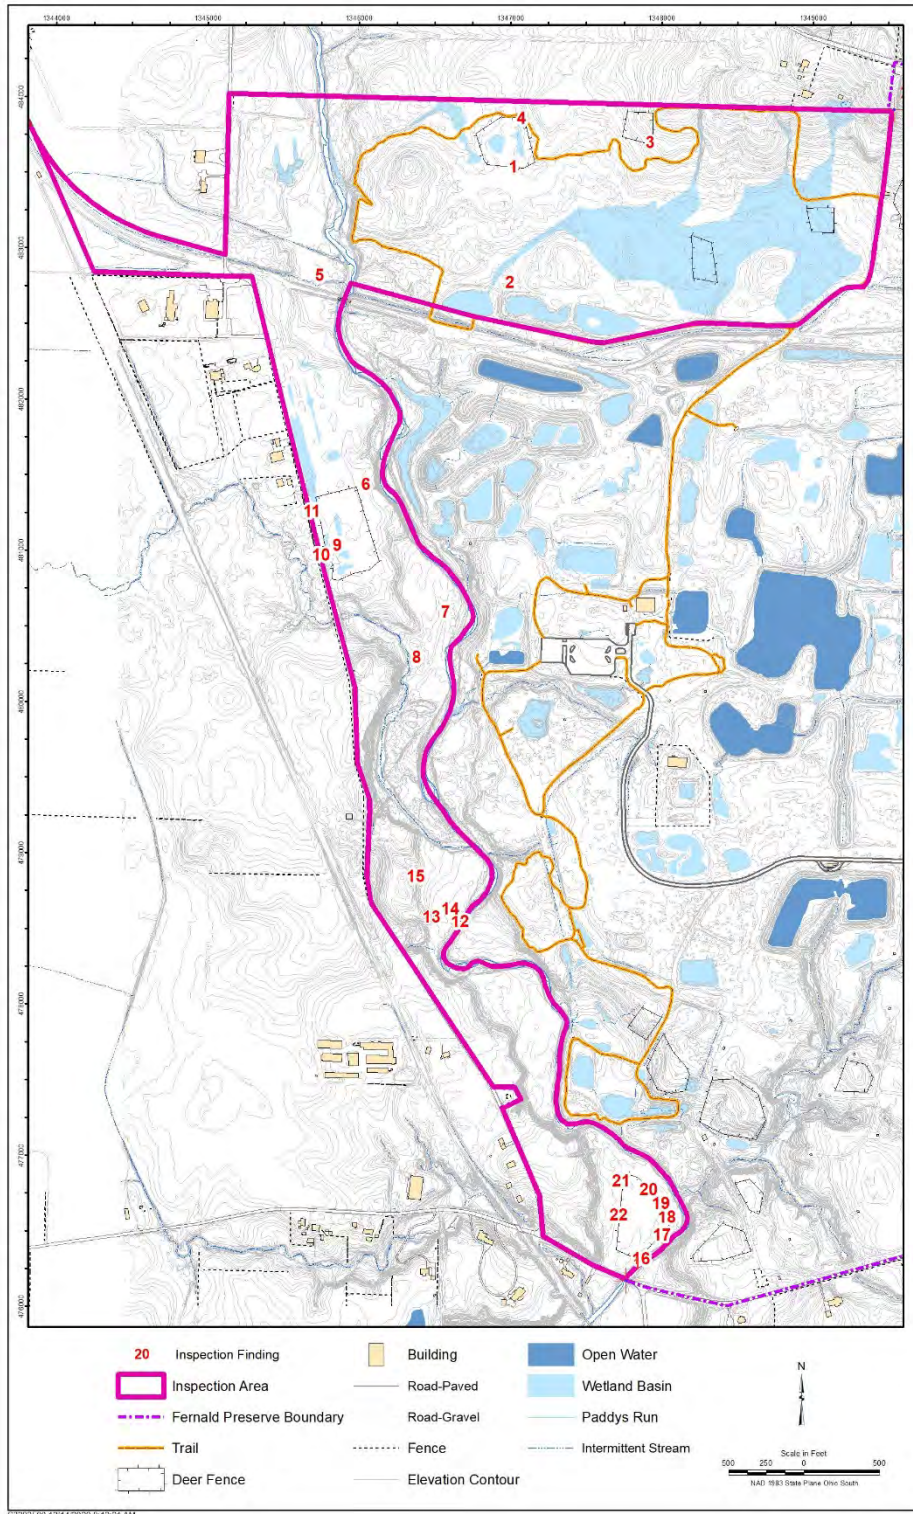
West Quadrant Inspection Findings December, 2020

Map No.	Location	GPS?	Type of Finding	Description	Photo
1	South side of deer fence	No	Fencing	Hole in deer fence	
2	Northwest corner of W2	No	Other	Barbed wire; tree cage	12082020_43_01
3	Southeast corner of deer fence	No	Vegetation	Japanese honeysuckle growing on fence	
4	Northeast corner of deer fence	No	Vegetation	Japanese honeysuckle growing on fence	
6	Inside east woodline at north end of deer fence	No	Fencing	Deer fence pole, metal post, cages	
7	Lower field along Paddys Run	No	Unauthorized Use	Appears to be 4-wheeler tracks	
8	Lower wooded area	Yes	Fencing	Mesh deer fencing	12082020_43_02
9	Inside deer fence	Yes	Vegetation	Pear tree	12082020_42_01
10	West side of deer fence	Yes	Fencing	Hole in deer fence	12082020_42_02
11	West side of deer fence	Yes	Fencing	Branch stuck on fence	12082020_42_03
12	East of former Ecological Restoration Park	Yes	Fencing	Pile of fencing and posts	12082020_41_03
13	East of former Ecological Restoration Park	Yes	Unauthorized Use	Hunting tree stand	12082020_41_05

Map No.	Location	GPS?	Type of Finding	Description	Photo
14	East of former Ecological Restoration Park	Yes	Fencing	Pile of fencing	12082020_41_06
15	North of former Ecological Restoration Park	Yes	Unauthorized Use	Hunting stand	12082020_41_07
16	East side of deer fence	No	Fencing	Tree fell on fence	
17	East side of deer fence	No	Fencing	Tree fell on fence	
18	East side of deer fence	No	Fencing	Hole in fence	
19	Northeast side of deer fence	No	Fencing	Top cable of fence broke	
20	North side of fence	No	Fencing	Hole in fence	
21	Northwest corner of deer fence	No	Fencing	Hole in deer fence; tree cages need removed	
22	West side of deer fence	No	Fencing	Top cable of fence broke; hole in fence

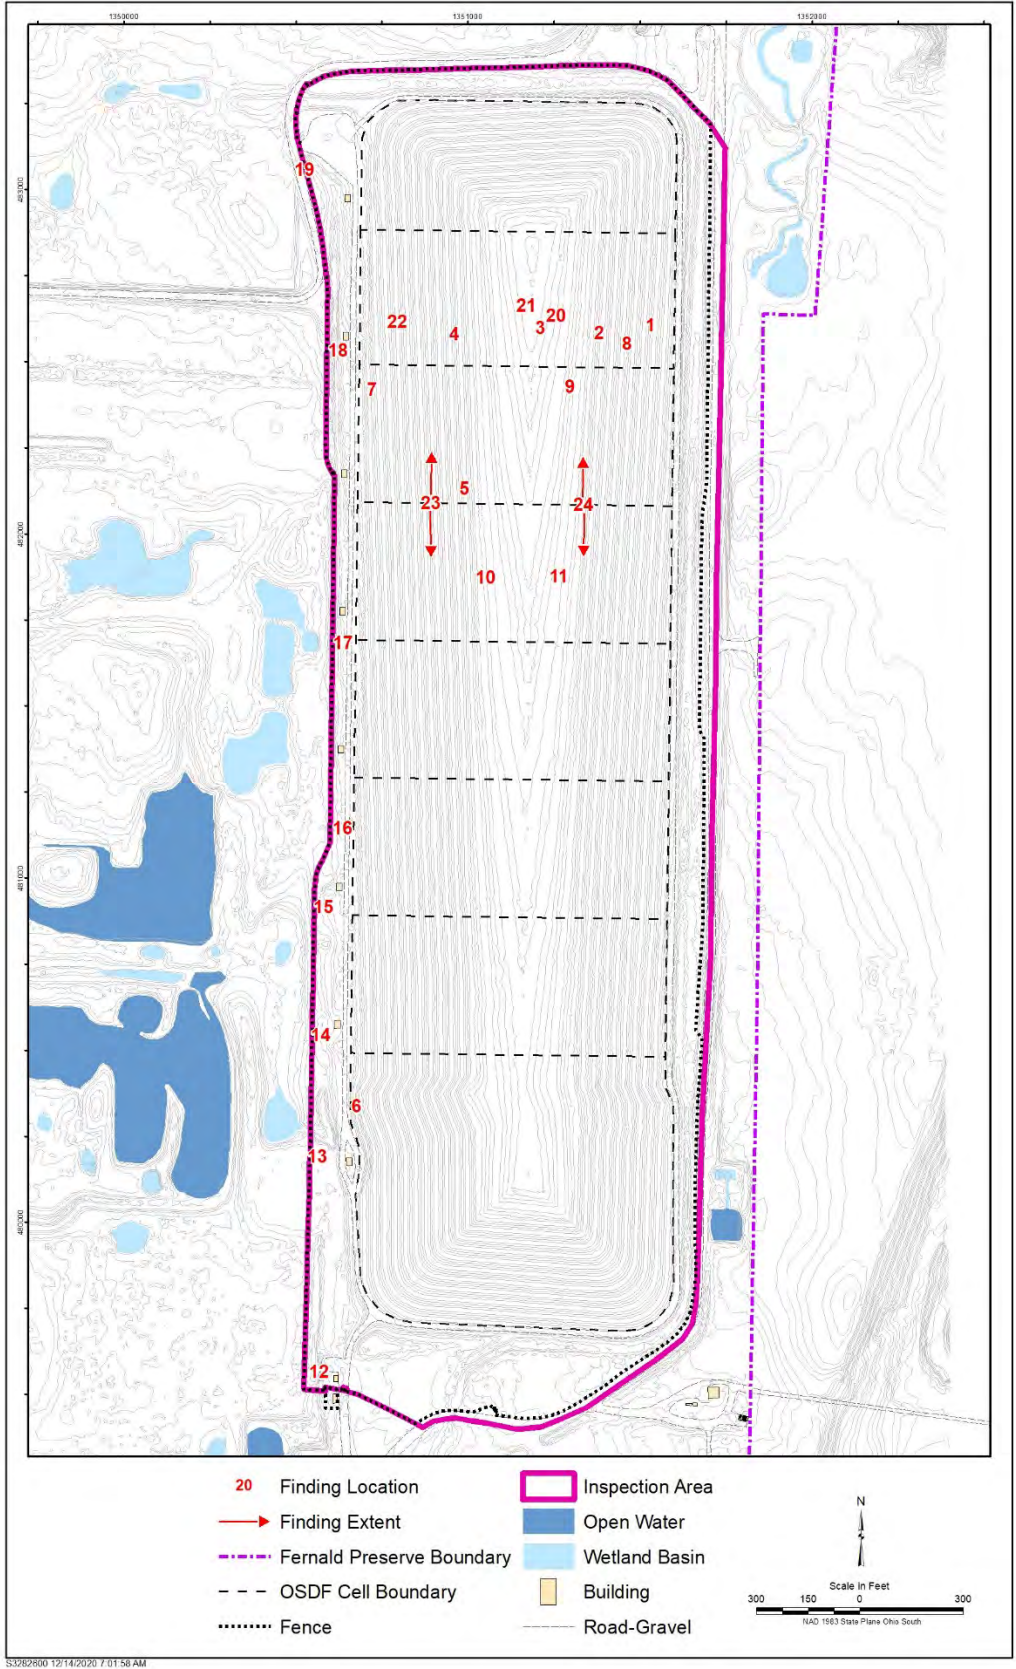
OSDF Inspection Findings, December 2020

Map No.	Location	GPS?	Type of Finding	Description	Photo
1	Cell 2, east 6:1 slope	Yes	Vegetation	Pear tree	12092020_41_01
2	Cell 2, east 6:1 slope	No	Vegetation	Pear tree	
3	Cell 2, top	Yes	Vegetation	Pear tree	12092020_41_02
4	Cell 2, west top	Yes	Vegetation	Pear tree (x2)	12092020_41_03
5	Cell 3/4 boundary, near top	Yes	Biointrusion	Animal burrow	12092020_41_04
6	Cell 8, west toe, north end	Yes	Biointrusion	Animal burrow	12092020_41_05
7	Cell 3, west toe	No	Biointrusion	Animal burrow	
8	Cell 2, east 6:1 slope, south half	Yes	Vegetation	Pear tree (previously identified) (x2)	12092020_44_01
9	Cell 3, east 6:1 slope (top)	No	Vegetation	Pear trees	
10	Cell 4, west 6:1 slope	No	Vegetation	Pear trees; honeysuckle	
11	Cell 4, east 20:1 slope	No	Vegetation	Pear trees	
12	Cell 8, southwest corner drainage	No	Vegetation	Grapevine	
13	Cell 8, west drainage, behind VH 8	No	Vegetation	Cedar tree; beaver activity in drainage

14	Cell 7, west drainage, behind VH 7	No	Vegetation	Cedars at the fence line

Map No.	Location	GPS?	Type of Finding	Description	Photo
15	Cell 6, west drainage, at fence behind VH 6	No	Vegetation	Cedars, multi-flora rose	
16	Cell 6, west drainage, at fence north of raptor perch	No	Vegetation	Dogwood	
17	Cell 5, west drainage, at concrete well pad south of VH 4	No	Debris	Concrete (x2)	
18	Cell 2, west drainage, behind VH 2 to south	No	Signage	Sign needs re-attached	
19	Cell 1, west perimeter, south of gate	No	Vegetation	Sapling, cedar	
20	Cell 2, east top	Yes	Vegetation	Pear tree	12092020_40_19
21	Cell 2, west top	Yes	Vegetation	Pear tree	12092020_40_20
22	Cell 2, west 6:1 slope	Yes	Vegetation	Pear trees (x2)	12092020_40_21
23	Cell 3/4 boundary, west 6:1	No	Vegetation	Pear trees scattered across slope	
24	Cell 3/4 boundary; east 10:1 and 6:1	No	Vegetation	Scattered woody vegetation across slope

Findings were primarily woody vegetation (Attachment 4). The scattered woody vegetation on the cell cap will be addressed in the spring. Plans are to conduct a prescribed burn on the entire OSDF cap; following the burn, woody vegetation will be identified and cut, and herbicide will be applied to the cut stumps. Three animal burrows were identified during the inspection. These burrows will be collapsed and filled in with soil. A map of the findings is presented in Attachment 5.
