Postclosure Inspection and Monitoring Report for Surface Corrective Action Unit 417 at the Central Nevada Test Area, Nevada, Site

February 2021

**U.S. DEPARTMENT OF
ENERGY**

**Legacy
Management**

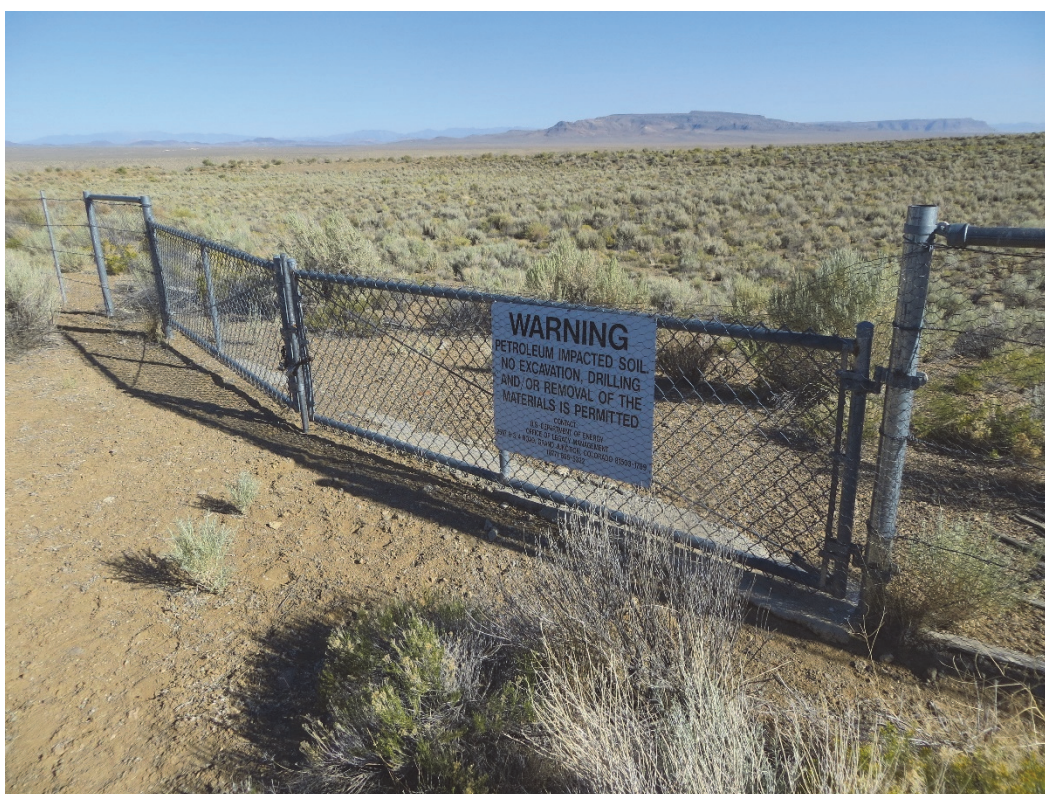
Photograph 1. UC-1 CMP (view from entrance gate on north fence line, looking southeast)

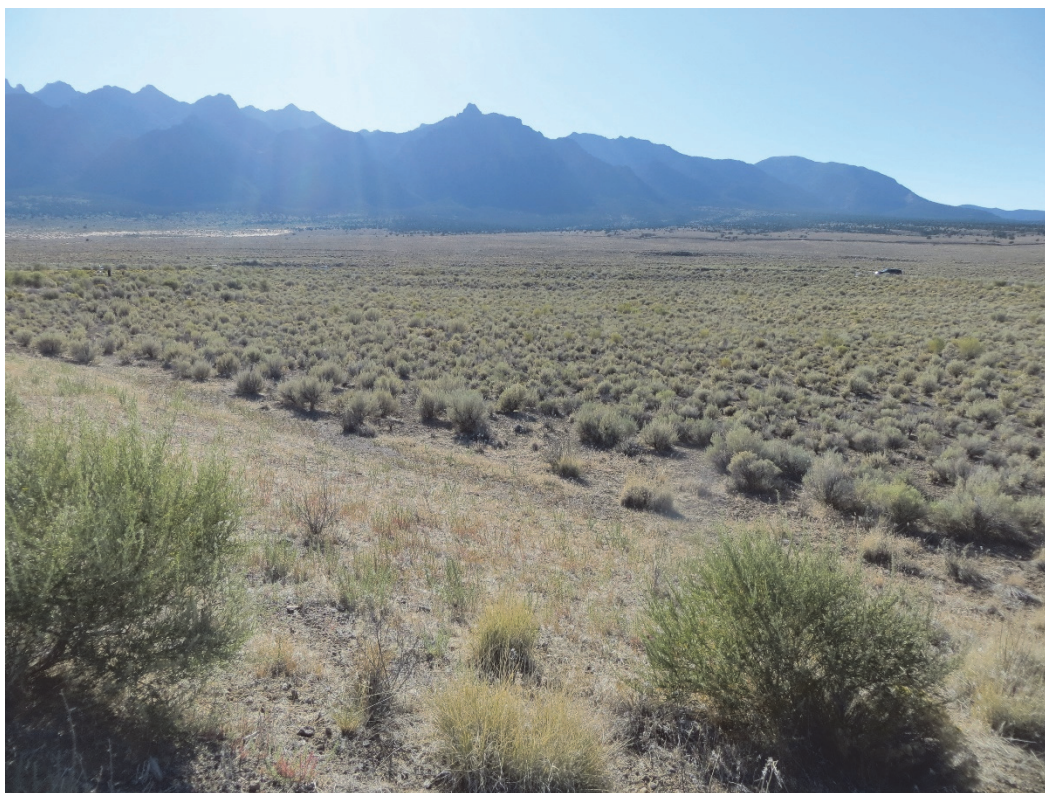
Photograph 2. UC-1 CMP (view from southeast end of CMP, looking west)

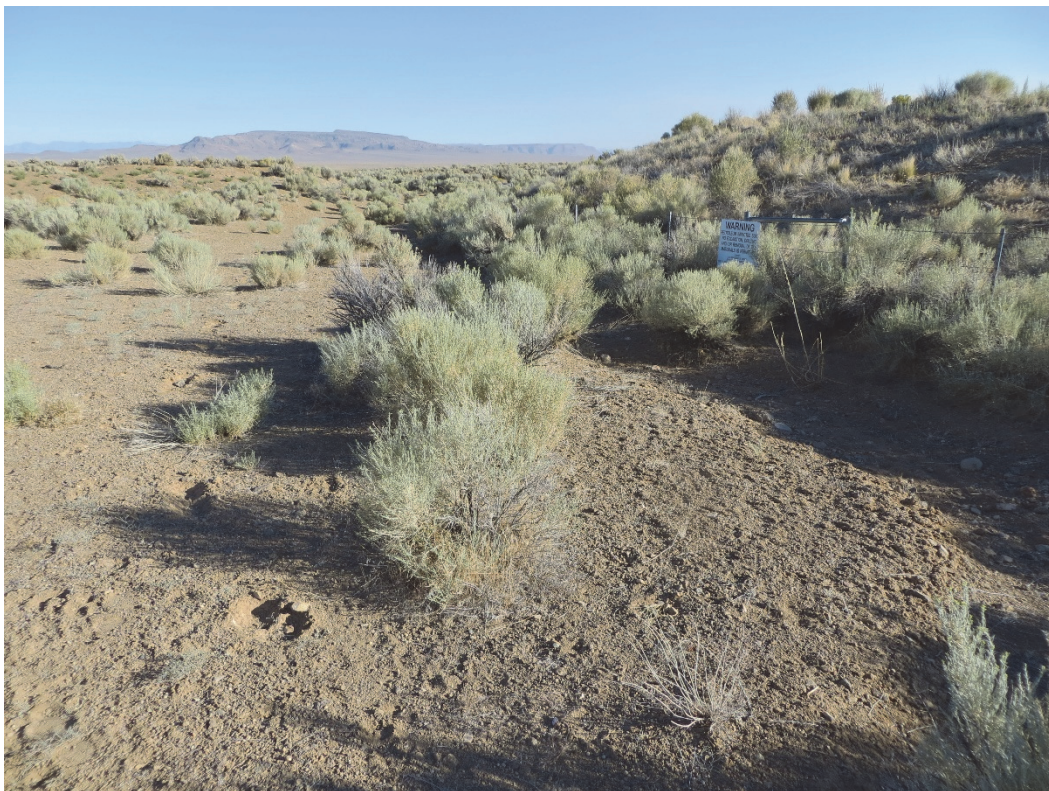
Photograph 4. UC-1 East Stormwater Diversion Channel (view from site access road, looking south)

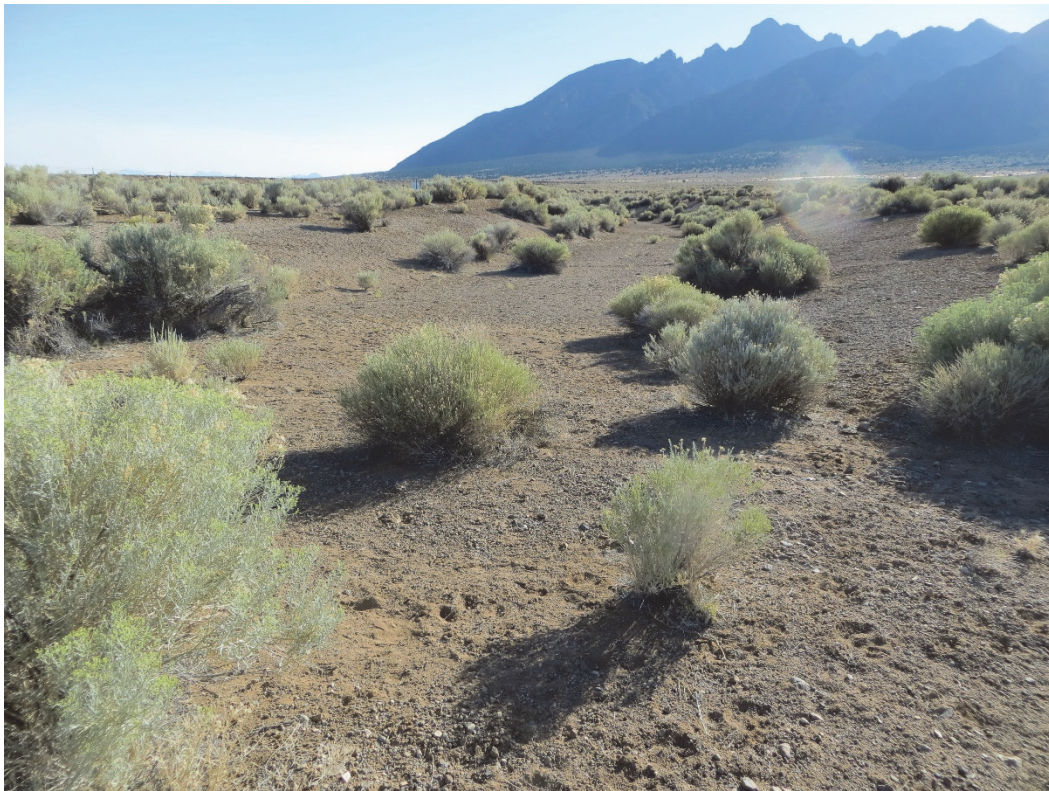
Photograph 5. UC-1 West Stormwater Diversion Channel (view from site access road, looking southwest)

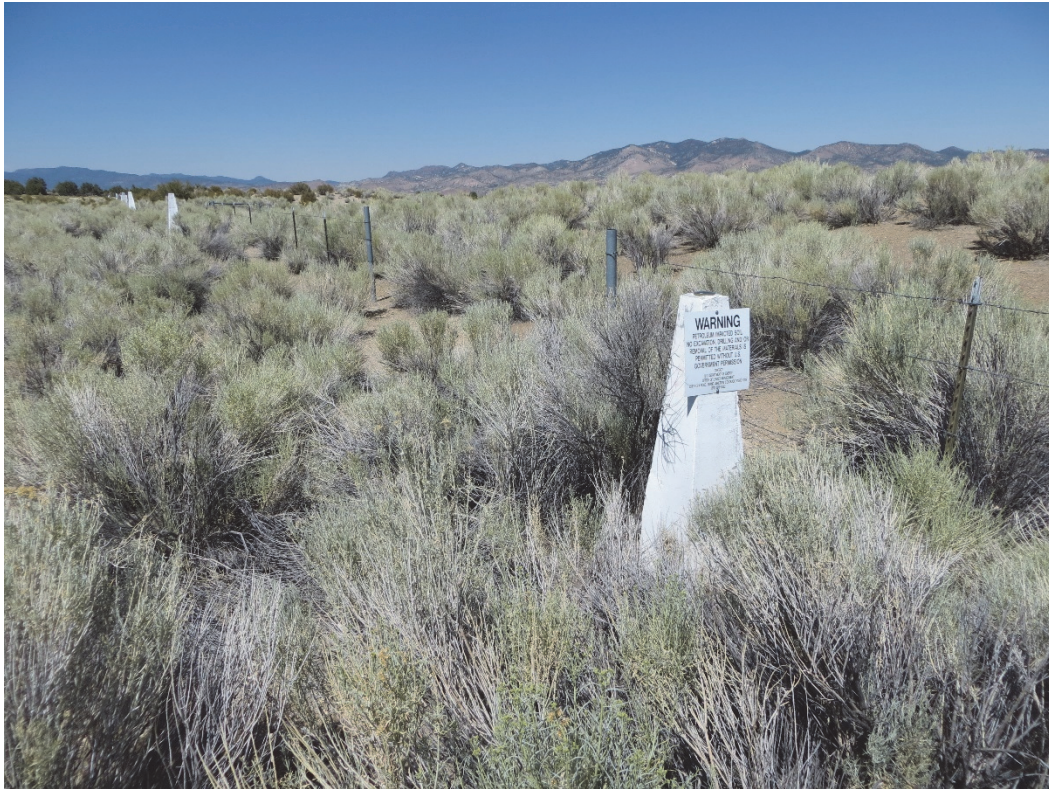
At the UC-4 site (Figure 6), a gate was missing from the Mud Pit C fenced area (Appendix B, photograph 11). A replacement gate was not available in Ely at the time of the inspection. The gate will be special ordered so it can be replaced during the next site visit planned for mid-2021. The remainder of the Mud Pit C fence, signs, and monuments were in good condition. No erosion rills were identified on Mud Pit C, and no issues that affected the integrity of the cover, including cracks or fractures, were observed. All signs and monuments at Mud Pits A, B, and D and Area X were in good condition (Figure 6). The gate to the Mud Pit C fenced area will be replaced during the next site visit, but no additional maintenance or repairs are recommended at this time. Photographs 9 through 14 in Appendix B show the condition of the UC-4 site at the time of the inspection.

The inspection of UC-4 revealed that the gate to the Mud Pit C fenced area was missing, though the remainder of the site was in good condition. No erosion rills, new fractures or extension of existing fractures were observed, and no issues with the fence, monuments, or signs were identified. Replacement of the gate to the Mud Pit C fenced area is planned for the next site visit in mid-2021. No other issues were identified, and no additional maintenance or repair activities are recommended at this time.

YES	NO	EXPLANATION
1. Adjacent off-site features within watershed areas.			
a. Have there been any changes in use of adjacent area?		X	
b. Are there any new roads or trails?		X	
c. Has there been a change in the position of nearby washes?		X	
d. Has there been lateral excursion or erosion/deposition of nearby washes?		X	
e. Are there new drainage channels?		X	
f. Change in surrounding vegetation?		X	
2. Security fence, signs.			
a. Displacement of fences, site markers, boundary markers, or monuments?		X	
b. Have any signs been damaged or removed? (Number of signs replaced: 0)		X	
c. Were gates locked?		X	The UC-4 Mud Pit C gate was missing at the time of the inspection.

5. Is current status/condition of vegetative cover satisfactory?	X		
6. Rationale for field conclusions: The gate to the UC-4 Mud Pit C was missing at the time of the inspection, but the remainder of the site was in good condition – no erosion rills were observed, the fence is in good condition, and no signs were down.

Photograph 11. UC-4 Mud Pit C (view of entrance to fenced area with missing gate, looking northeast)

- Replace the gate to the Mud Pit C fenced area during the next site visit planned for mid-2021
- Implement an inspection and reporting frequency of every 6 years, with the next inspection report in 2026 with submittal to NDEP in 2027
- Continue to respond within 90 days to any reports from the public about detrimental conditions at the site

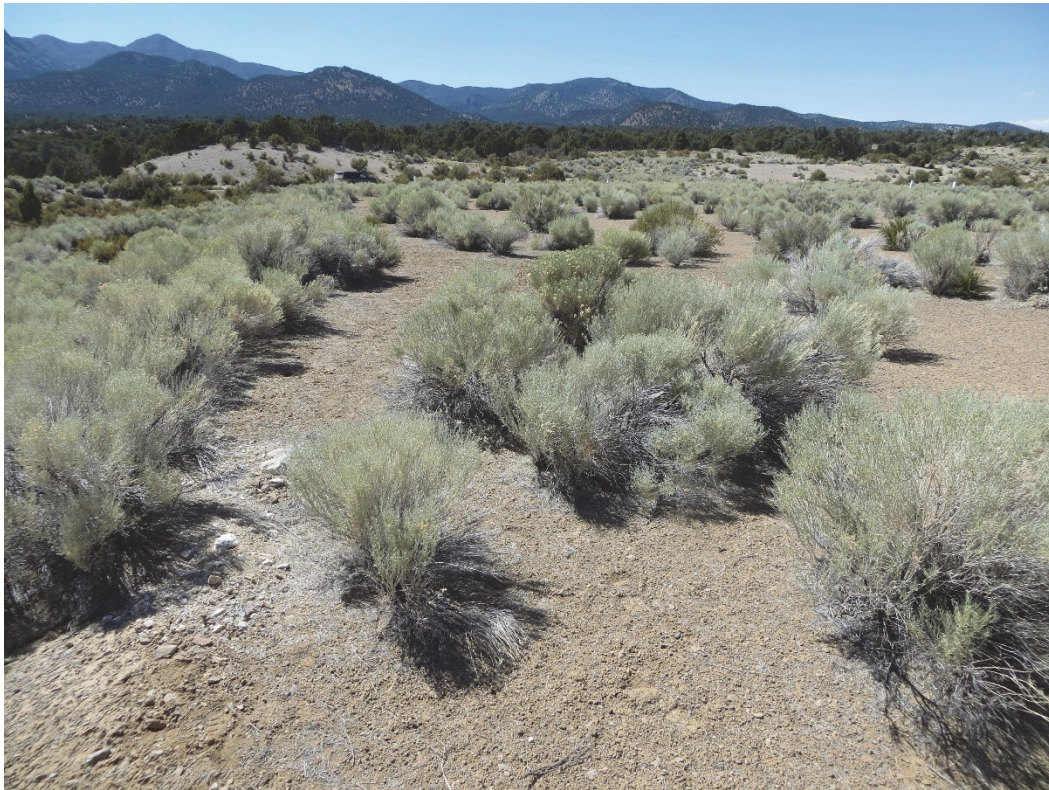
Photograph 12. UC-4 Mud Pit C (view from southeast corner of mud pit cover, looking west)
