**2021 Annual Land-Use Covenant
Inspection Report
for DOE Areas at the
Laboratory for Energy-Related
Health Research/Old Campus
Landfill Superfund Site
University of California–Davis**

January 2022

U.S. DEPARTMENT OF
ENERGY

Legacy
Management

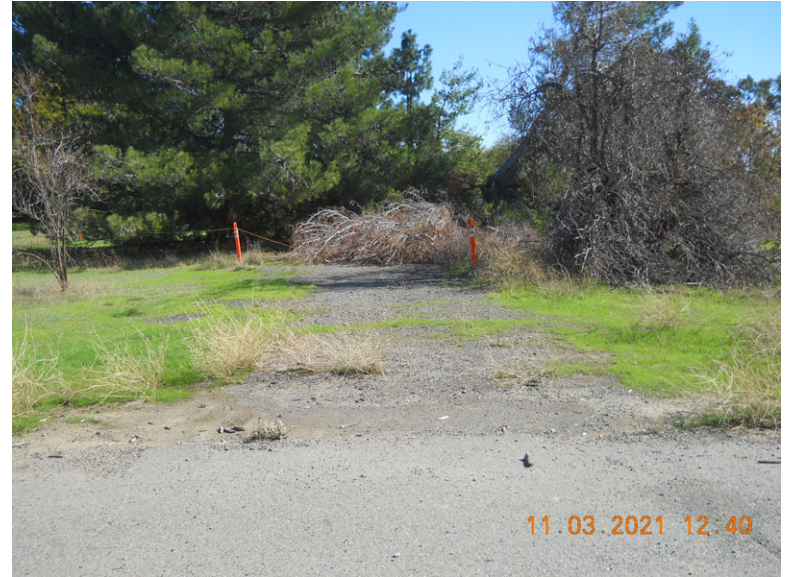
- One limb from tree 16219 had fallen to the ground.
- Two limbs from tree 16220 had fallen to the ground.
- Two limbs from shrub 16233 had fallen to the ground.
- Two large limbs from tree 16236 had fallen to the ground.
- The tag previously attached to tree 16210 was missing.
- A pine tree at the northeast boundary of the SWT Area was identified as not included in the catalog of trees in or near DOE Areas.

Ms. Lauesen noted the observation of the downed tree limbs described in Section 2.0 following a wind event on January 26 and 27, 2021, which was reported to DOE on February 9, 2021 (UC Davis 2021a).

View East of Eastern Dog Pens Area; Tree 16236 Fallen Limb in Center, Behind Stanchions and Rope (Photo No. 4491)

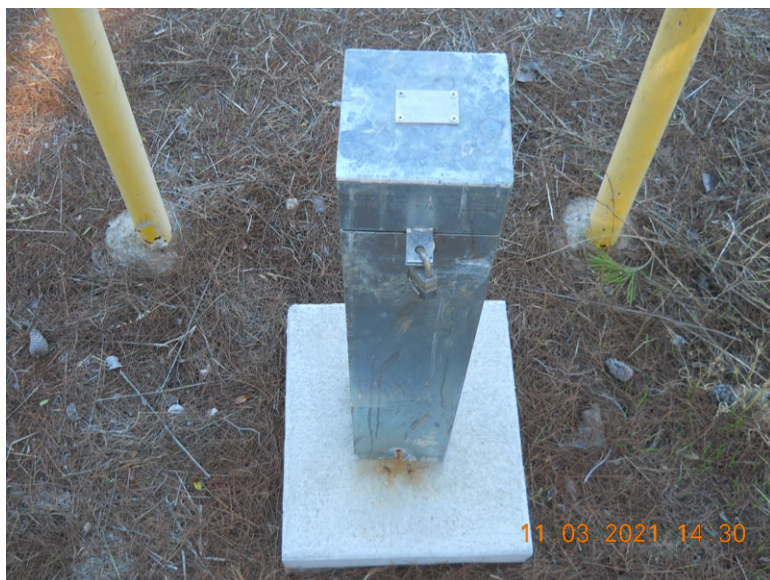
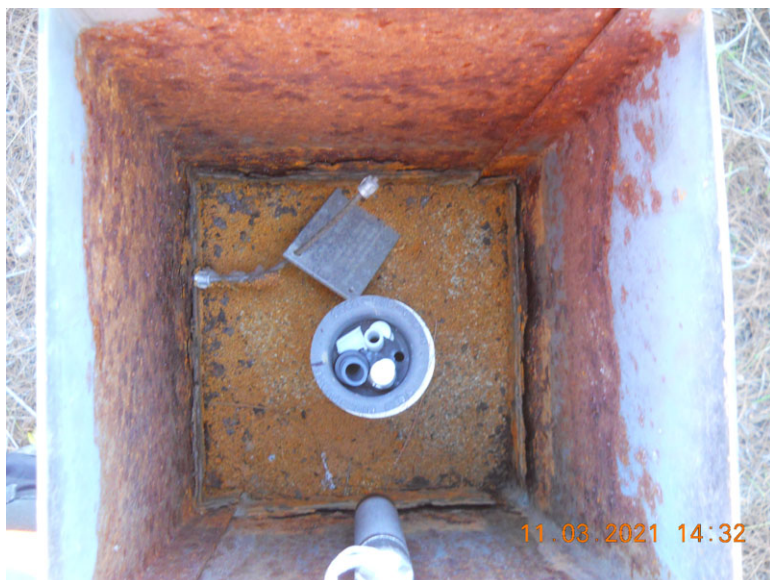
Well UCD1-070 – Water level and pump port plugs missing	11/3/2021	Repair Planned – Install new plugs	TBD	NA
Well UCD1-072 – Water level and pump port plugs missing	11/3/2021	Repair Planned – Install new plugs	TBD	NA

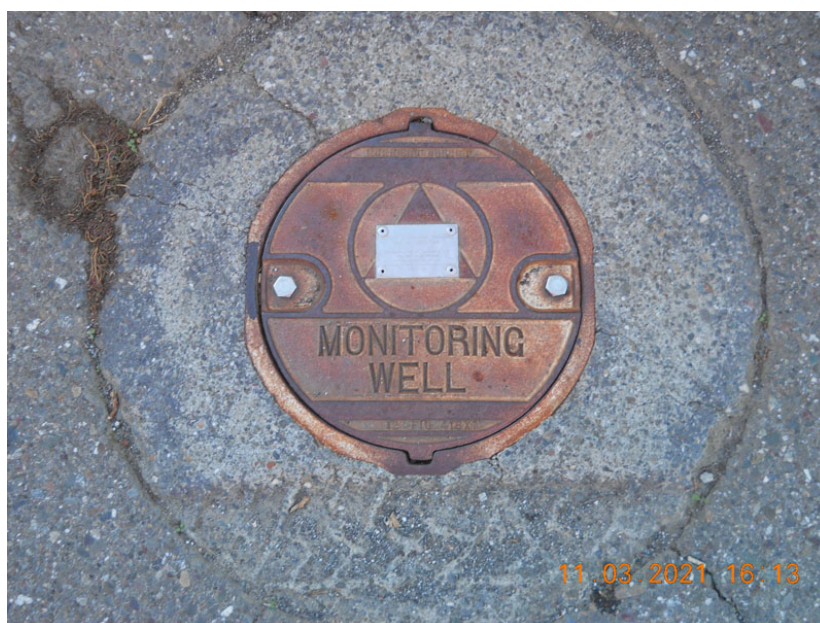
Well UCD1-054 – New bolts Installed in Vault Lid (Photo No. 4539)

Maintenance Item	Date Identified	Description of Completed or Planned Repair	Date Completed	Completion Photo No.
Well UCD1-054 – Vault lid bolt threads worn off (stripped)	11/5/2020	Repair Completed - Installed new bolts	12/17/2020	4539
Sapling in Southwest Trenches Area – No tag	11/4/2021	New tag will be prepared and installed	TBD	NA
Tree 16210 – Missing tag	11/4/2021	Repair Planned – Install new tag	TBD	NA
Well UCD1-072 – Vault lid bolt hole threads worn off	11/3/2021	Repair Planned – Re-tap threads; install new bolt if necessary	TBD	NA
Well UCD1-013 – Water level port plug missing	11/3/2021	Repair Planned – Install new plug	TBD	NA
Well UCD1-018 – Water level and pump port plugs missing	11/4/2021	Repair Planned – Install new plugs	TBD	NA
Well UCD1-023 – Pump port plugs missing	11/3/2021	Repair Planned – Install new plugs	TBD	NA
Well UCD1-063 – Water level and pump port plugs missing	11/4/2021	Repair Planned – Install new plugs	TBD	NA
