## 2.0 Burrell, Pennsylvania, Disposal Site

### 2.1 Compliance Summary

Figure 2-1. 2020 Annual Inspection Drawing for the Burrell, Pennsylvania, Disposal Site

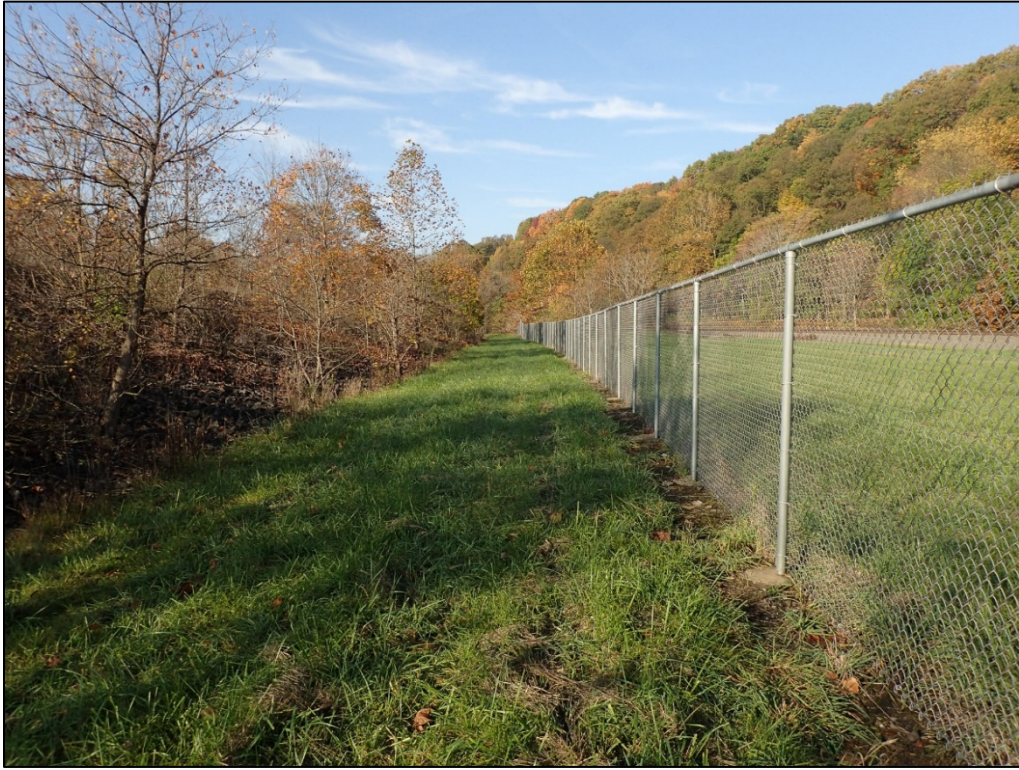
A chainlink security fence encloses the disposal cell and drainage features (PL-1). The site herbicide subcontractor keeps the fence line clear of vegetation, which should prolong the life of the security fence. Trees felled by strong storms in 2020 damaged the fence in two places. Fence repairs were made before the 2020 site inspection.

*PL-1. Fence Line along Northwest Side of Disposal Cell*

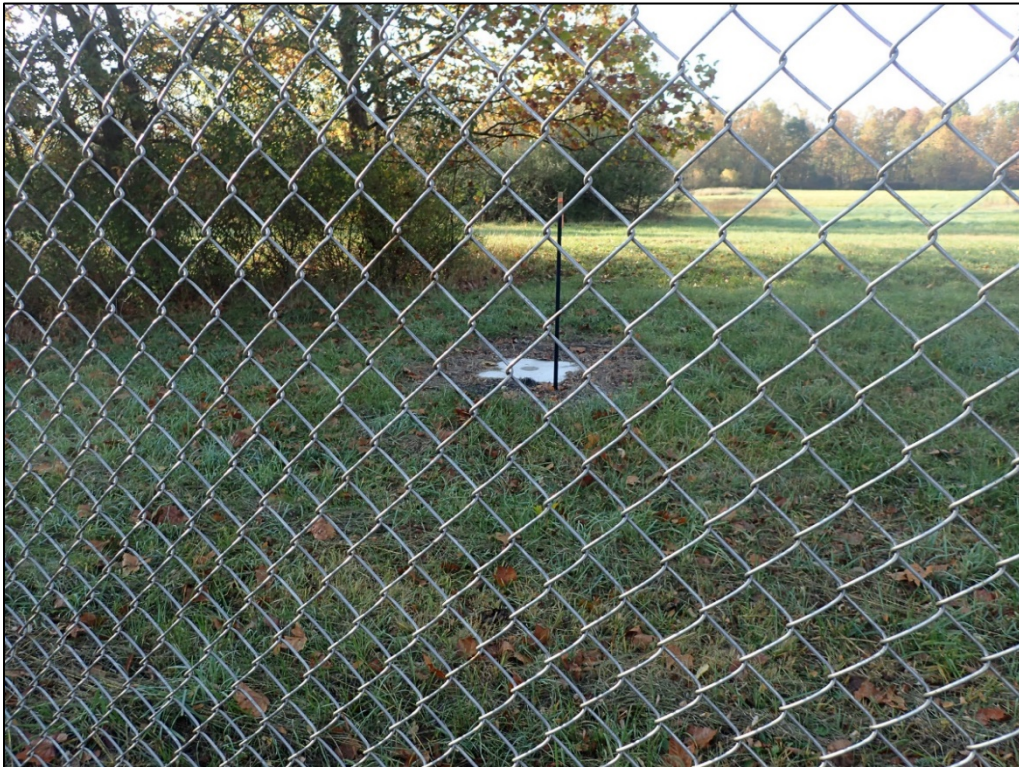
The site has three survey monuments and seven boundary monuments. Survey monument SM-102 was noted as missing in the 2017 and 2018 inspections. Quality control monument QC4 was installed in 2019 as a replacement for survey monument SM-102 (PL-2).

*PL-2. Aerial Survey Quality Control Monument QC4 and Survey Monument SM-102*

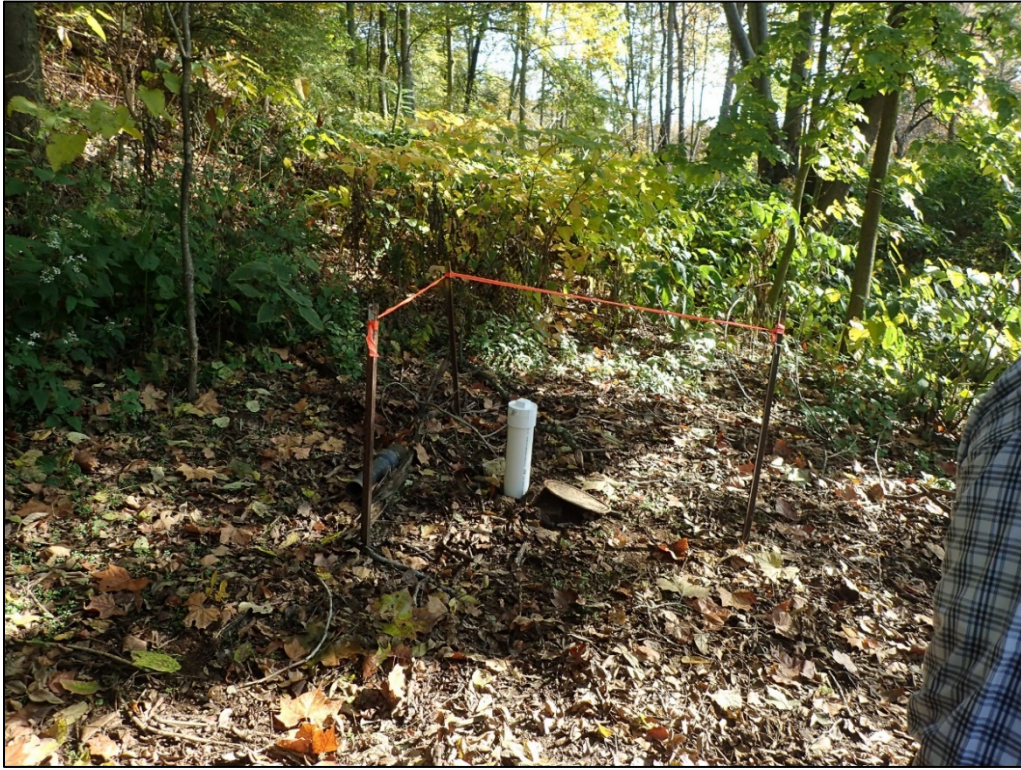
In past inspections, boundary monument BM-1 was difficult to locate because it was buried by dirt. LM installed a 4-foot-tall, 4-inch-diameter PVC pipe around and over boundary monument BM-1 in 2020 to aid in locating the monument (PL-3). LM also cut through a downed tree to provide access across the footpath leading back to boundary monument BM-1 (PL-4). Boundary monument BM-2 was not located during this year's inspection. A metal detector will be used during the 2021 inspection to locate it. No new maintenance needs were identified.

*PL-3. New Pipe Installed at Boundary Monument BM1*

- Installing 4-inch PVC pipe over boundary monument BM-1 for easier identification
- Removing a downed tree across the path leading to boundary monument BM-1

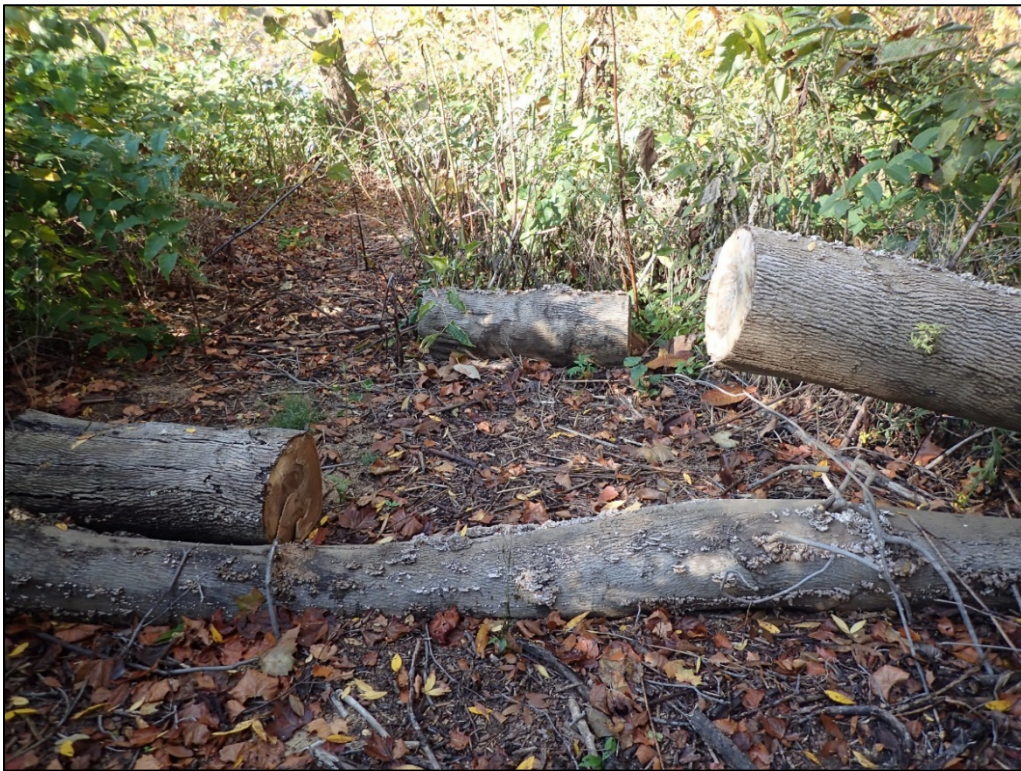
*PL-4. Cleared Tree on Path to Boundary Monument BM1*

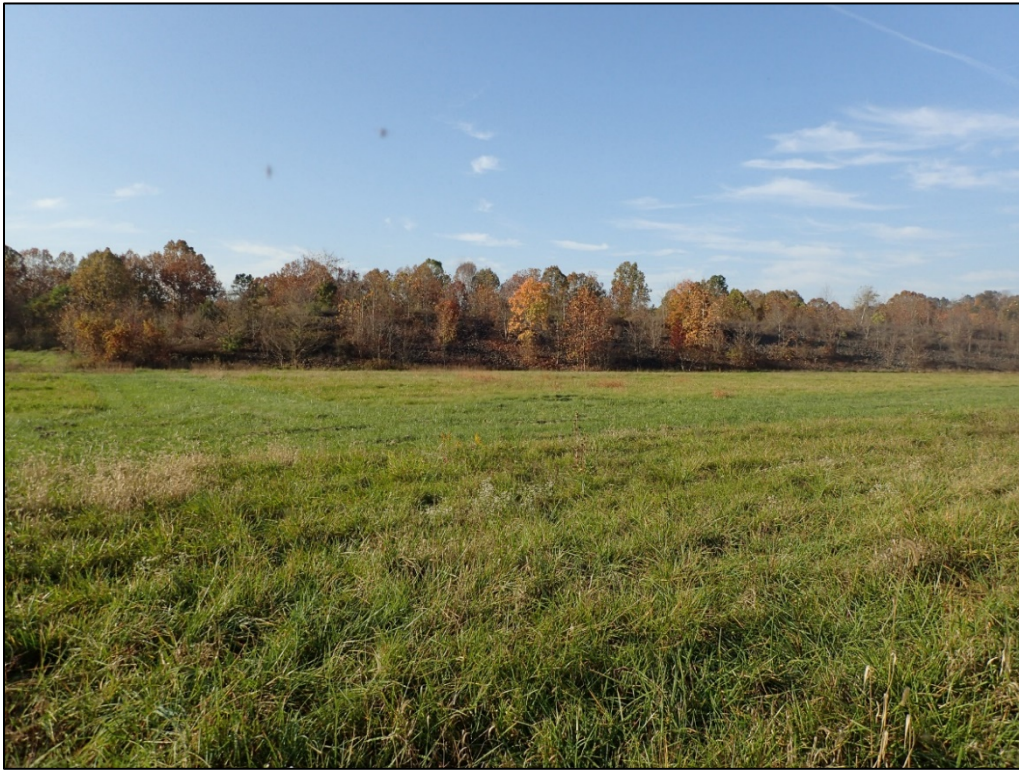
The disposal cell, completed in 1987, occupies 5 acres and is armored with riprap to control erosion and deter animal intrusion (PL-5). There was no evidence of erosion, settling, slumping, or any other modifying process that might affect the integrity of the disposal cell.

*PL-5. Northeast Side of Disposal Cell*

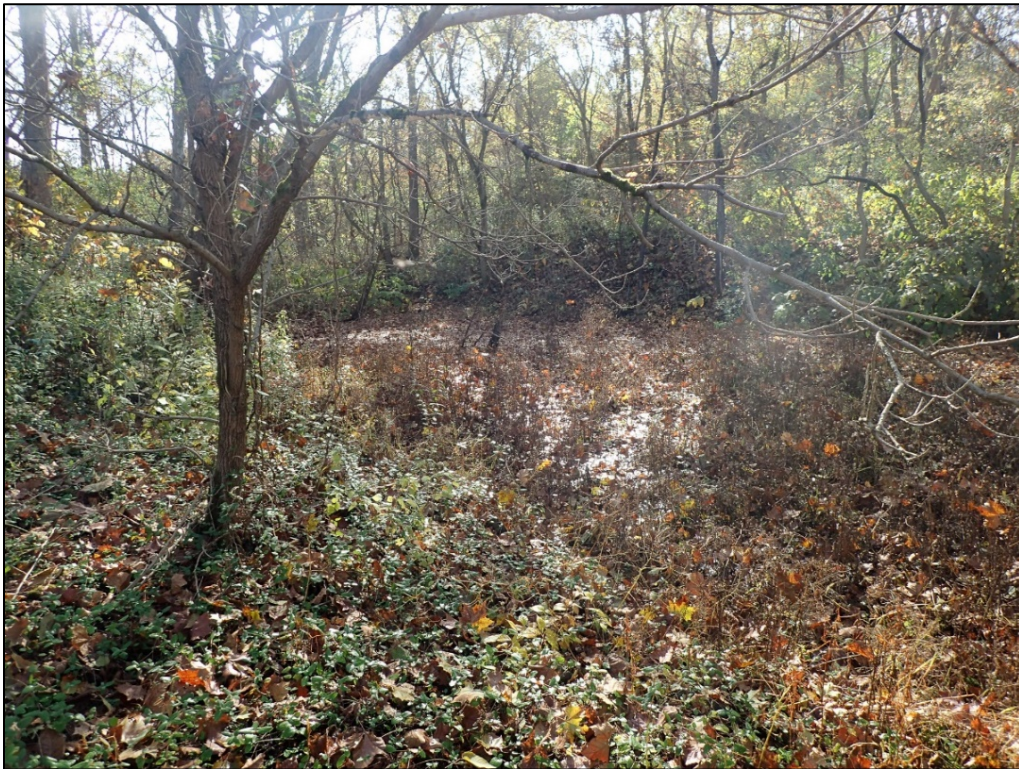
A small, inactive beaver dam remains in the slough south of the disposal cell. The site herbicide contractor indicated that the dam was inactive in 2020, as no evidence of recent activity was observed around the dam (e.g., animal tracks, new cuts). In its current state, it does not interfere with the flow of water enough to warrant action (PL-6). No maintenance needs were identified.

*PL-6. Upper Reach of Slough*

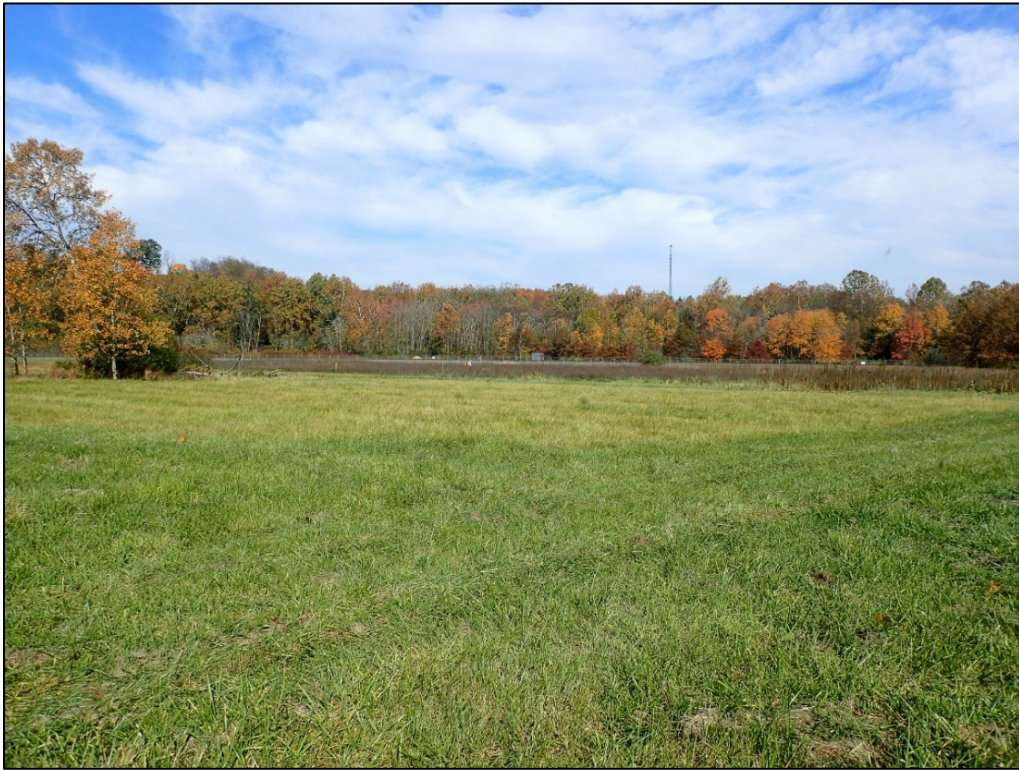
Several seeded wildflowers were observed during the 2020 inspection, and the prairie plot appears to be progressing as planned (PL-7). Prairie grasses and wildflowers are long-lived perennials that take their first couple of growing seasons to establish roots. A diverse flowering community is not expected for several years.

*PL-7. South View of Conservation Reuse Tallgrass Prairie Test Plot*

In 2021, the cool-season grasses and clovers in the prairie will need to be controlled to aid in the establishment of the native grasses and forbs. It is recommended that the prairie be mowed while flowers are on the cool-season grasses and clovers and before they set seed. Mowing the last 2 weeks of May or the first week of June should prevent the cool-season grasses from seeding out and will open the canopy for the native species when they are beginning to leaf out.

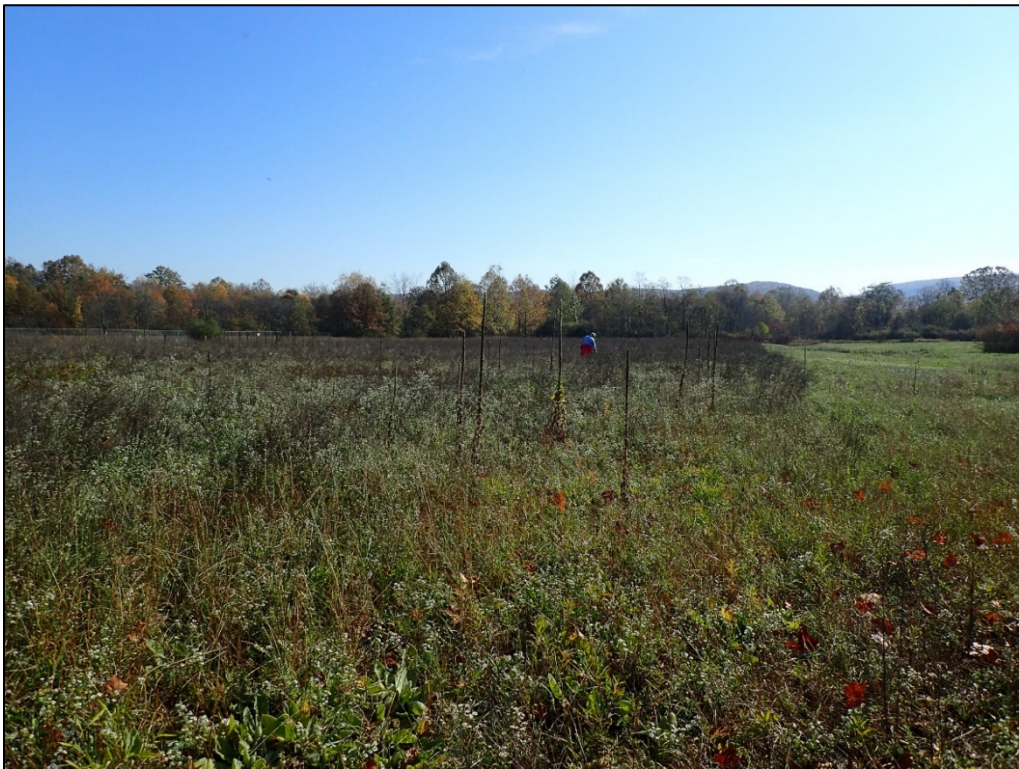
The prairie was surveyed during the 2020 inspection, and all but two plots had native grasses or forbs present from the seed mix (PL-8). Grasses found in the area included switchgrass and little bluestem. A wide variety of forbs were found: wild bergamot, gray-headed coneflower, purple coneflower, sawtooth sunflower, prairie dock, goldenrod species, and asters. Though the forbs were well mixed across the area, some clumps of single species are already forming. The forbs in some areas filled as much as 50% of a meter-square area, while the average 1-meter plot had about 15% coverage. Many of the late-flowering aster, sunflower, and goldenrod species still had flowers. The coneflowers and bergamot heads were dispersing seed. The native species are doing well in their second year.

*PL-8. Conservation Reuse Tallgrass Prairie Test Plot*
