3.0 Canonsburg, Pennsylvania, Disposal Site

3.1 Compliance Summary

The Canonsburg, Pennsylvania, Uranium Mill Tailings Radiation Control Act (UMTRCA) Title I Disposal Site (site) was inspected on October 20, 2020. No changes were observed on the disposal cell or in the associated drainage features. Inspectors identified a few minor maintenance needs.

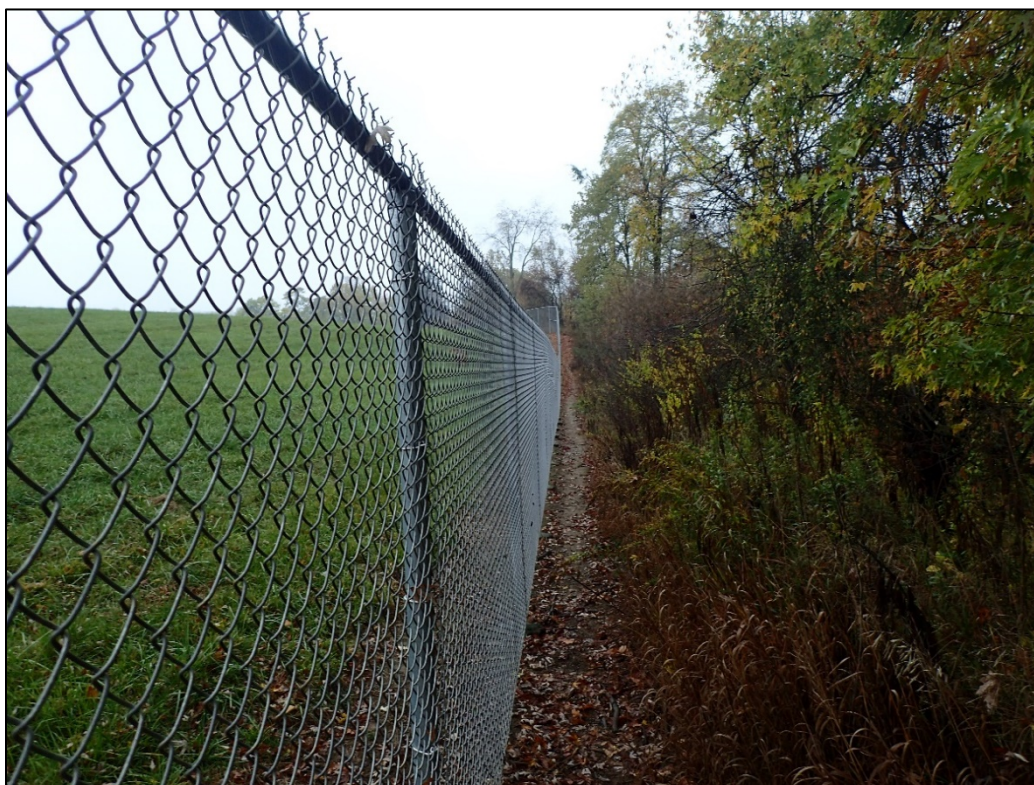
PL-1. West Fence Line

A chainlink security fence encloses most of the site. A vegetation-free buffer zone is maintained around the entire security fence (PL-1). An area of erosion under the west security fence remains. The area appears to be stable and has not grown in several years. For added security, slats were installed in 2016 across the area beneath the fence to help fill in the gap.

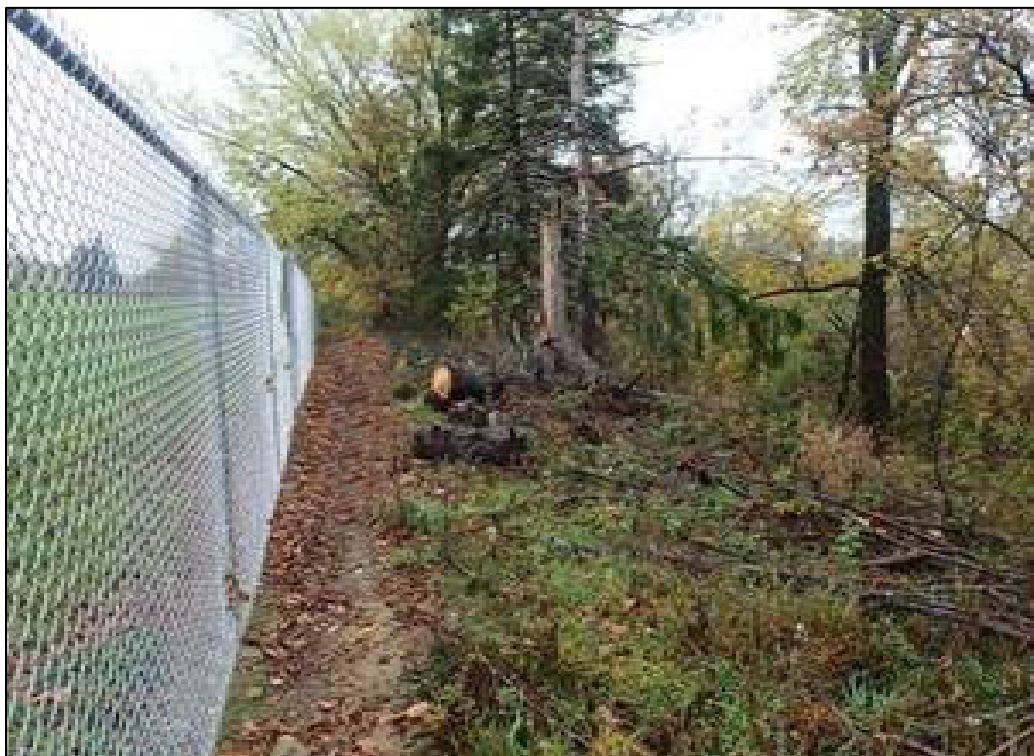
PL-2. Repaired Fence Line

The security fence was damaged in late 2019. A large tree fell on the fence and damaged both the fence and the northwest personnel gate. Repairs were made before the 2020 inspection (PL-2).

- Repairing the security fence and damaged personnel gate.

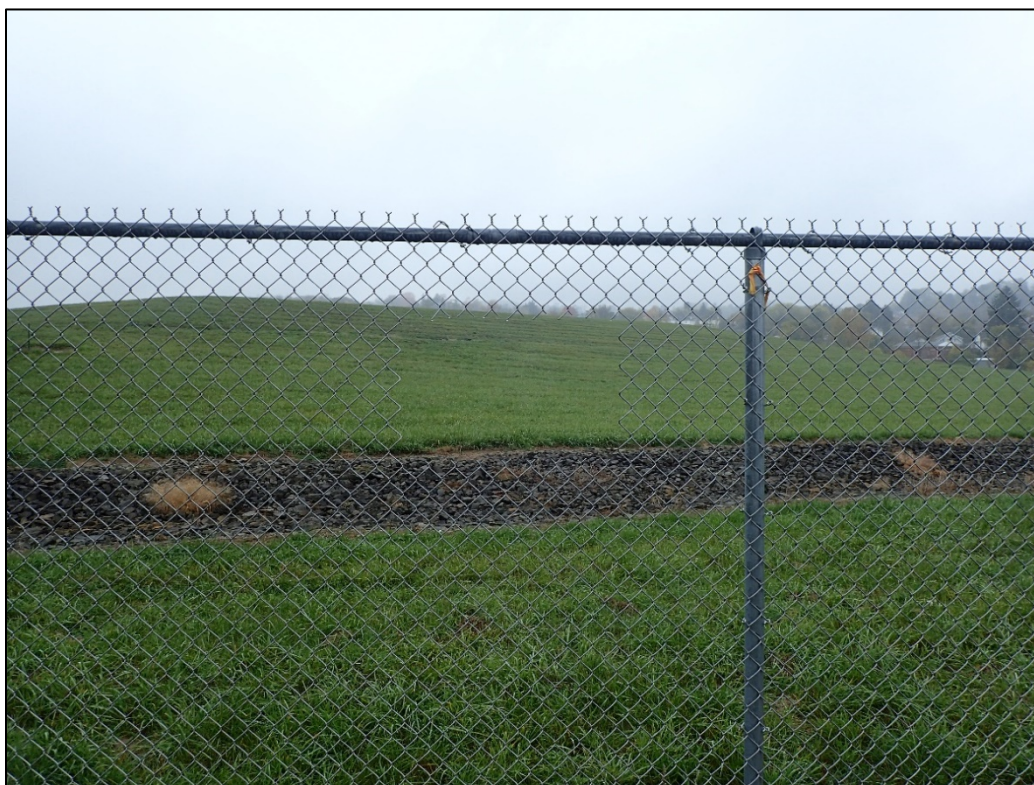
PL-3. Disposal Cell with Missing Perimeter Sign P1

There are 11 perimeter signs attached to the security fence. All but one of the perimeter signs were accounted for and legible in 2020. The fence fabric around perimeter sign P1 was cut, and the sign was removed (PL-3). The sign will be replaced. No other maintenance needs were identified.

- Locating and replacing (if necessary) boundary monuments BM-1, BM-2, and BM-3.
- Replacing perimeter sign P1.

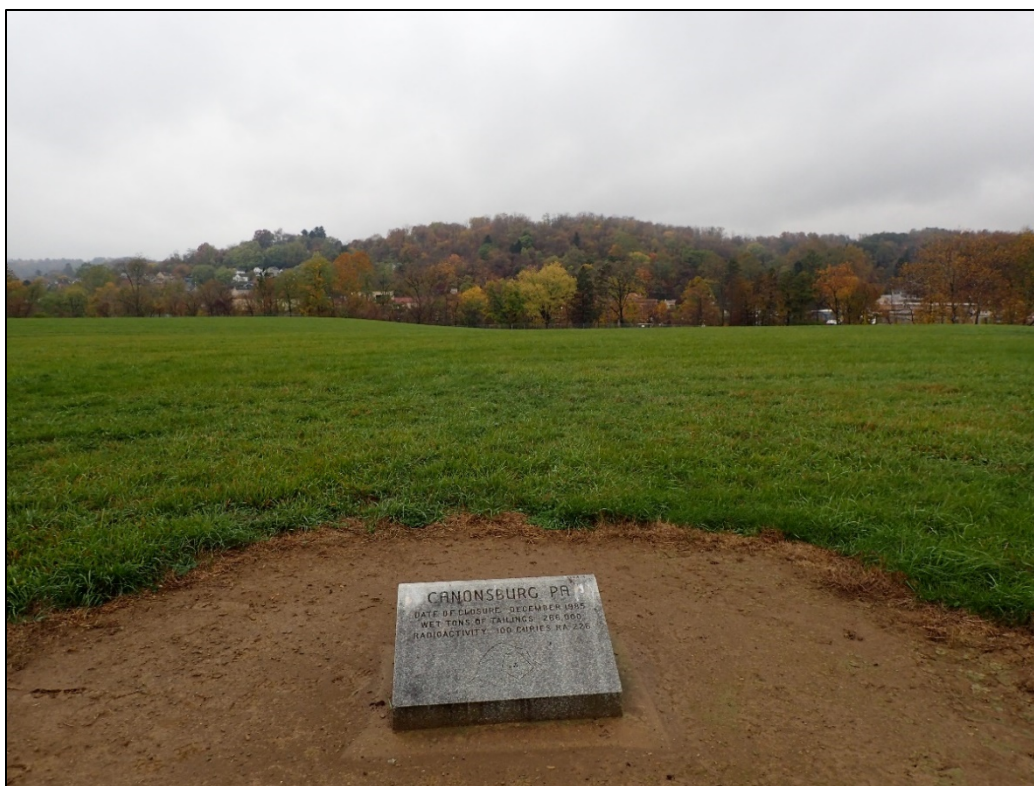
PL-4. Site Marker SMK-2

The site has two granite site markers. Site marker SMK-1 is just inside the main entrance gate, and site marker SMK-2 is on the top slope of the disposal cell (PL-4). No maintenance needs were identified.

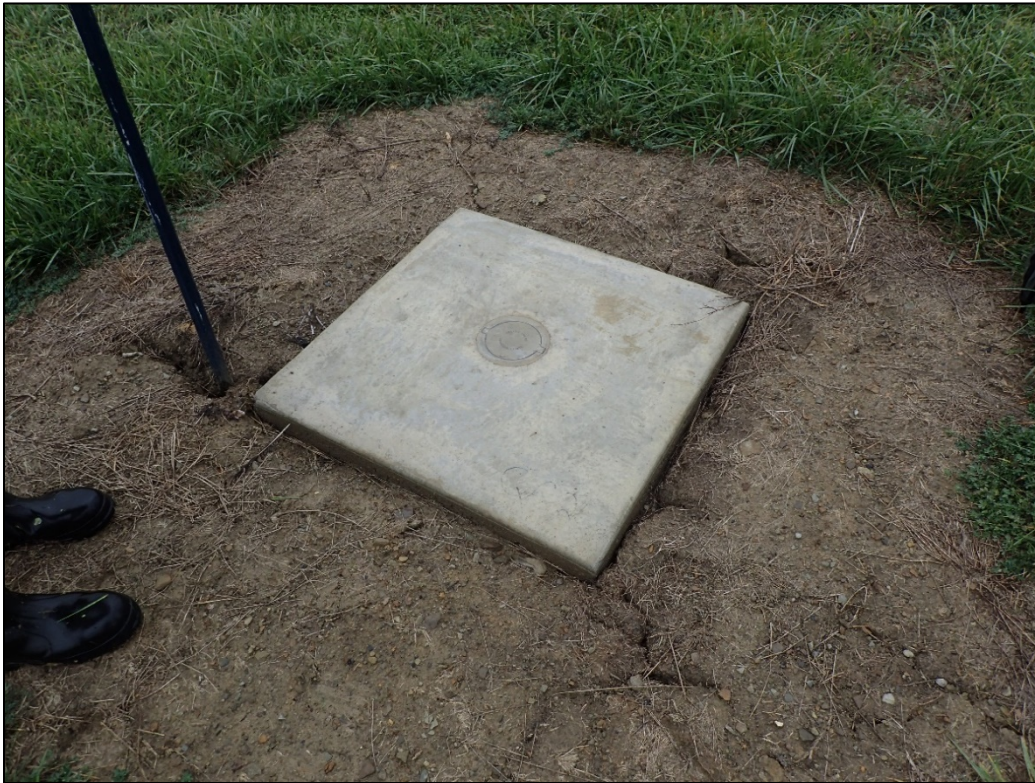
PL-5. Quality Control Monument QC2

Four aerial survey quality control monuments, installed in 2019, were inspected during the 2020 annual inspection (PL-5). No maintenance needs were identified.

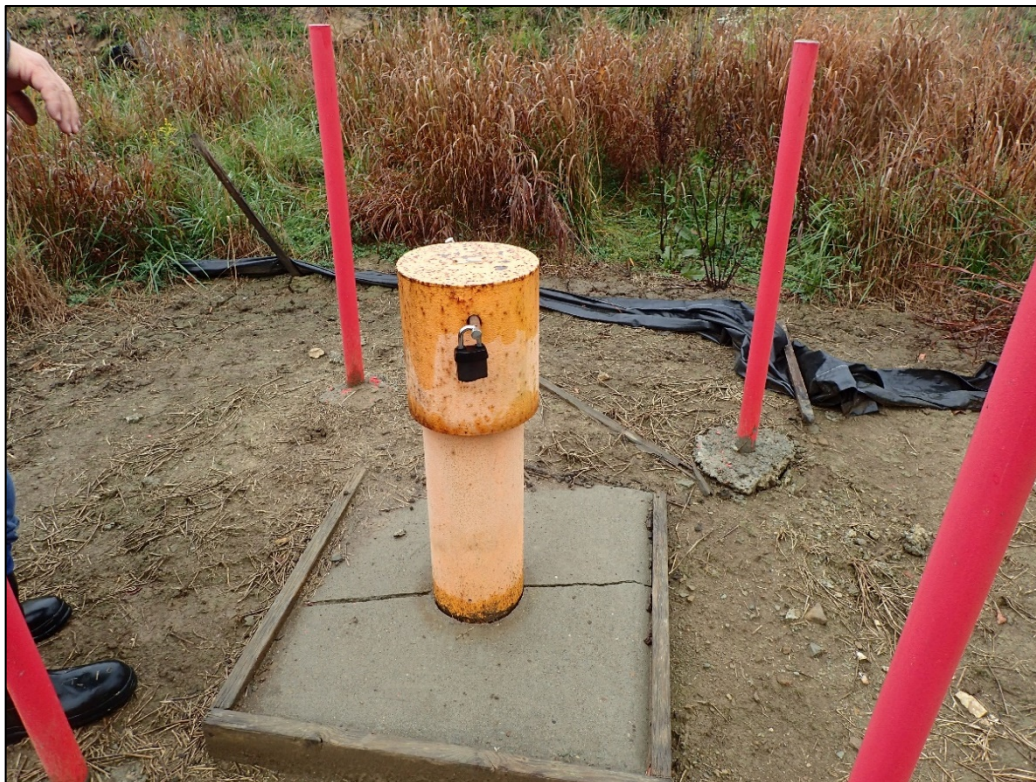
PL-6. Monitoring Well 0424

The site has five groundwater monitoring wells that are inspected on the inside when they are sampled. Monitoring wells were last sampled and inspected in October 2018. During the 2020 inspection, the outside of the wells were inspected, and the wellhead protectors were undamaged and locked. There is a crack in the well pad of monitoring well 0424 (PL-6). The pad remains serviceable. It will be evaluated for replacement or repair during the next regularly scheduled sampling event. No other maintenance needs were identified.

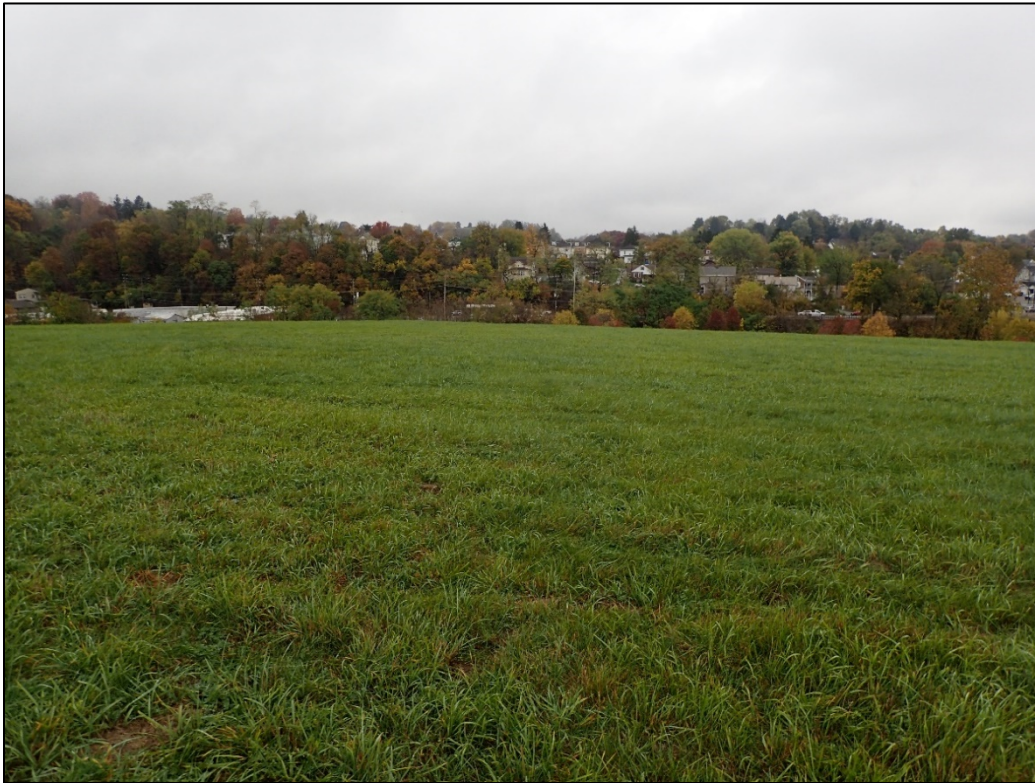
PL-7. Disposal Cell Top Slope

The disposal cell, completed in 1985, occupies 6.8 acres and is covered in grass (PL-7). There was no evidence of erosion, settling, slumping, or other modifying processes that might affect the integrity of the disposal cell. Animals burrow on the disposal cell cover, but such burrows should not pose a risk to disposal cell integrity or public health because the buried tailings are overlain by a 36-inch-thick clay layer (radon barrier), an 18-inch-thick biointrusion rock layer, and a 12-inch-thick topsoil layer. Biointrusion down to or through the radon barrier is unlikely. Inspectors will continue to monitor the location and significance of burrows. No new significant burrows were noted on the disposal cell during the inspection. No maintenance needs were identified.

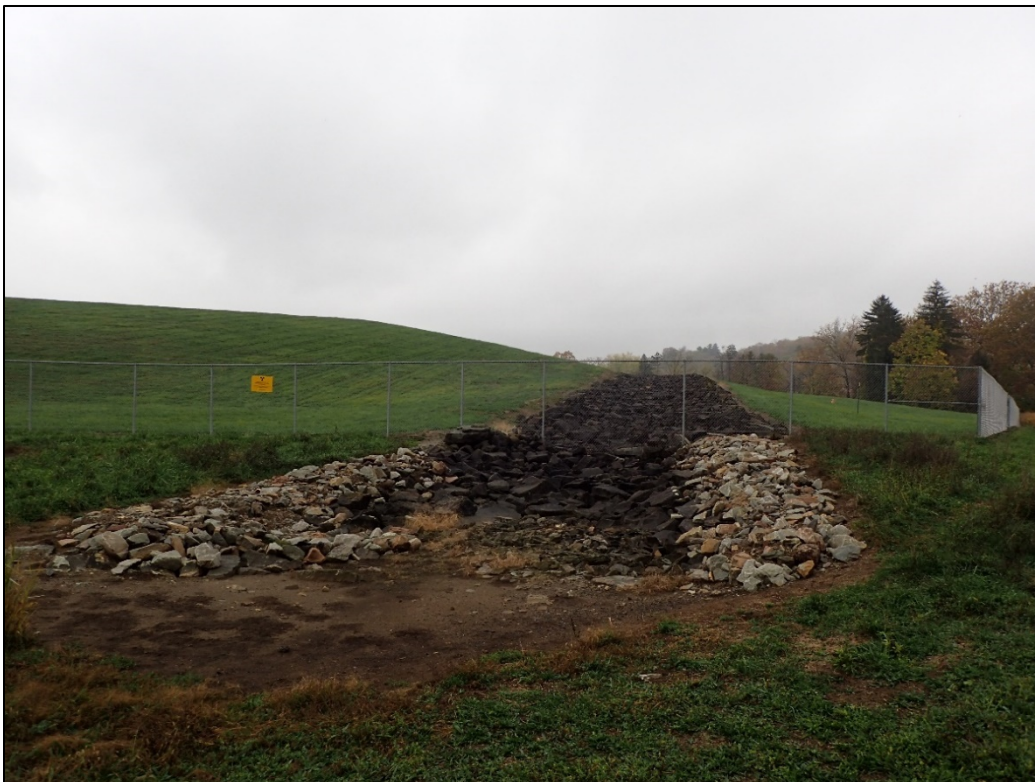
PL-8. Riprap Diversion Ditch Outlet

There was no evidence of rock deterioration or woody vegetation in the diversion channels and perimeter ditches (PL-8). Periodic physical removal and spot herbicide applications have been effective at reducing woody vegetation and will continue to be conducted as needed.

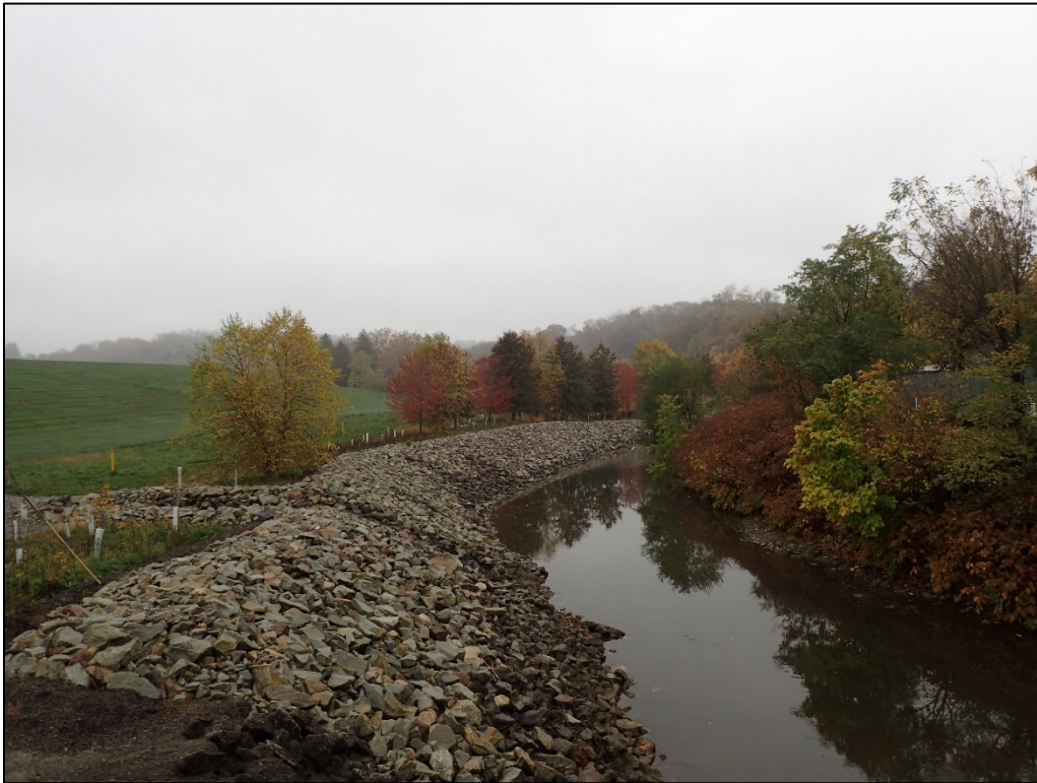
PL-9. Riprap Embankment

Between 2001 and 2008, several streambank-stabilization projects were conducted north and east of the site. The projects consisted of installing riprap armoring along the streambanks. Years of flow and heavy flow events in Chartiers Creek in late 2017 and early 2018 damaged those riprap installations. In late summer 2019, the entire length of the riprap embankment along Chartiers Creek north of the disposal cell (approximately 1200 linear feet) was repaired during low streamflow conditions. The work consisted of minor grading, replacing geotextile filter fabric, and importing and placing 2-feet-thick R6 riprap slopes (PL-9).

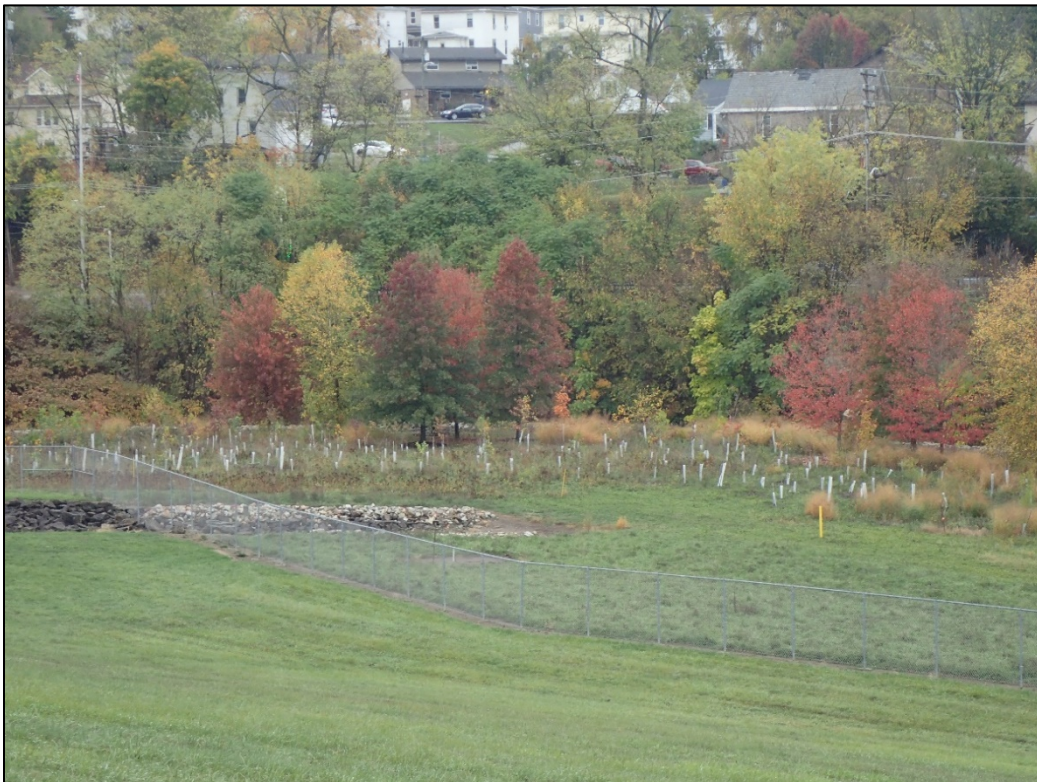
PL-10. Deer Tubes in the Riparian Forest Buffer Area

A conservation reuse initiative was included as part of the streambank stabilization repair project. A riparian forest buffer was planted following the riprap slope repair; it consisted of 525 new native trees and shrubs within a 1.7-acre corridor adjacent to Chartiers Creek. Disturbed areas were then seeded with a pollinator-friendly native grass and wildflower mix. This corridor will further protect the Chartiers Creek streambank and help prevent erosion above the riprap embankment. The riparian forest buffer is also recognized as a means to improve stream quality. This effort is part of the Commonwealth of Pennsylvania's goal to establish 95,000 acres of riparian forest buffer by 2025. The Pennsylvania Department of Conservation and Natural Resources was notified of the project. No concerns with the riprap embankment were noted during the inspection. Plantings in the riparian forest buffer experienced a 1-year survival rate of 97%. The general long-term health of the young plants in the riparian buffer area is tenuous due to browsing deer. A plan to better protect the plantings from deer needs to be developed. The

current use of deer tubes held up by wooden stakes is not adequate to protect the trees from browse or rub (PL-10).

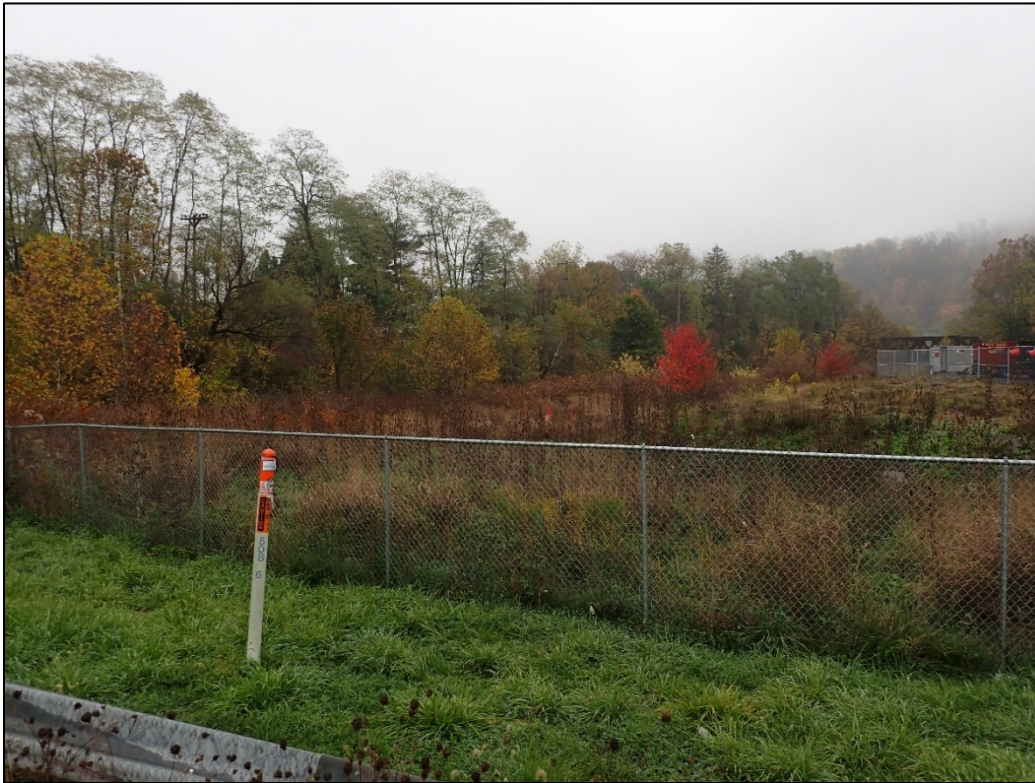
PL-11. Effective Invasive Weed Treatment Near Monitoring Well 0424 (not pictured)

Additional control of invasive vegetation on Area C between Strabane Avenue and monitoring well 0424A is recommended to enhance the health of the riparian corridor being established along Chartiers Creek north of the disposal cell. The current vegetation management approach does not address the spread of invasive vegetation from Area C to the recently planted riparian buffer area. The site vegetation management plan includes herbicide application to control invasive weeds around monitoring well 0424 (PL-11). Additional management, to include spraying and mowing in the area between the 0424 wellhead and Strabane Avenue, will be implemented to further address this invasive vegetation development.
