2.0 Edgemont, South Dakota, Disposal Site

2.1 Compliance Summary

Figure 2-1. 2020 Annual Inspection Drawing for the Edgemont, South Dakota, Disposal Site

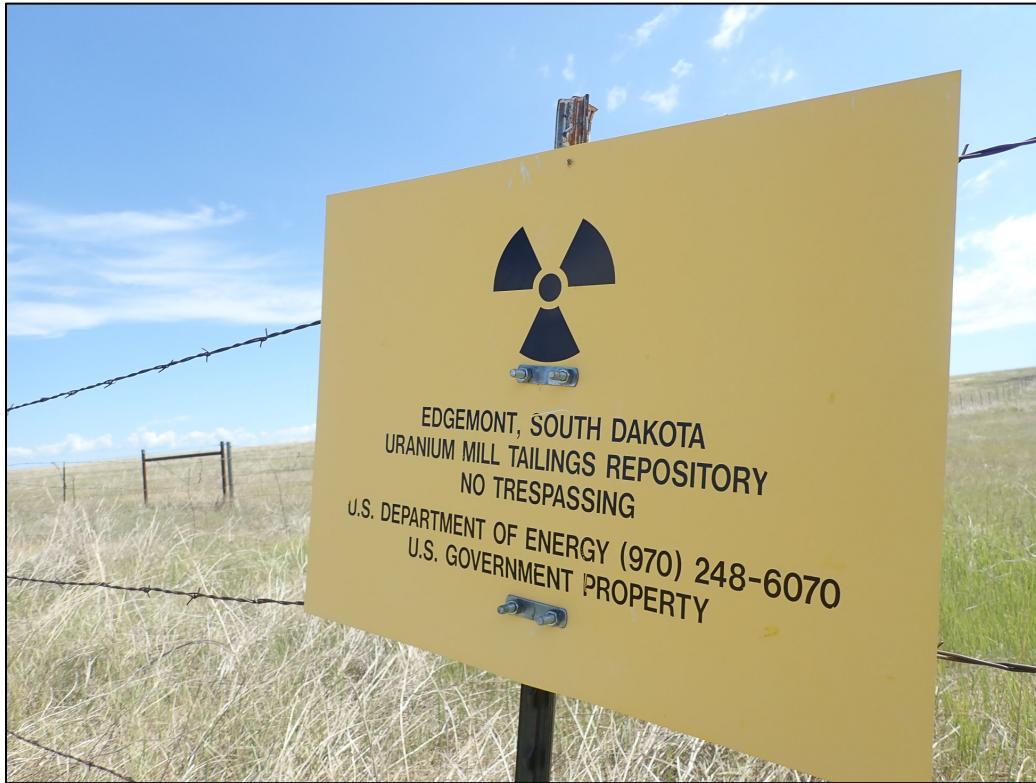
PL-1. Perimeter Sign P1

A four-strand barbed-wire fence encloses the site, truncating at the southeast corner to allow livestock access to a preexisting stock pond. Two perimeter signs are attached to the perimeter fence (PL-1). No maintenance needs were identified.

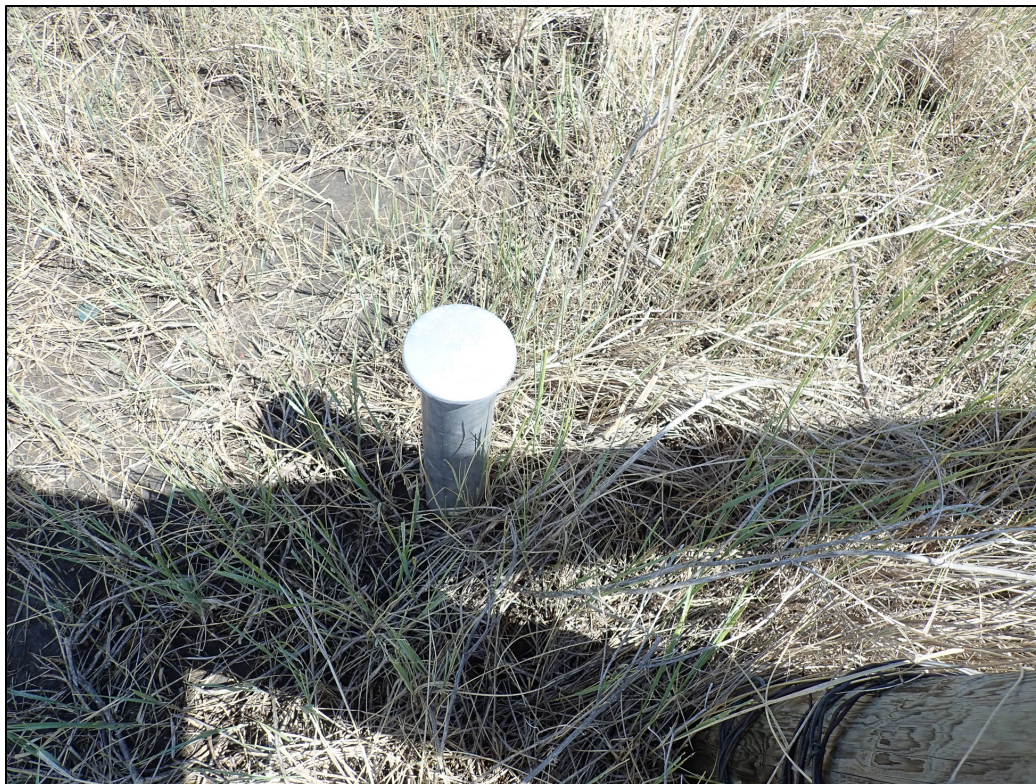
PL-2. Boundary Monument BM-1

Boundary monuments are present at each of the property's four corners (PL-2). All boundary monuments were inspected, and no maintenance needs were identified.

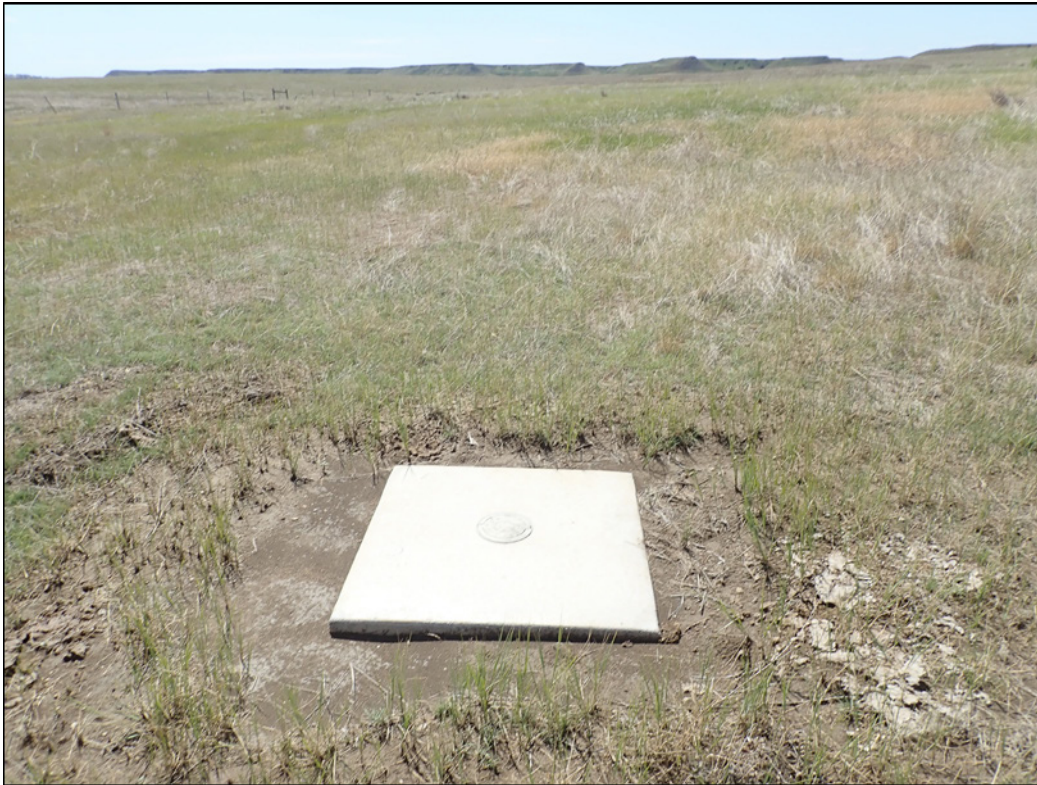
PL-3. Quality Control Monument QC4

Seven aerial survey quality control monuments, installed in 2019, were inspected during the 2020 annual inspection (Figure 2-1, PL-3). No maintenance needs were identified.

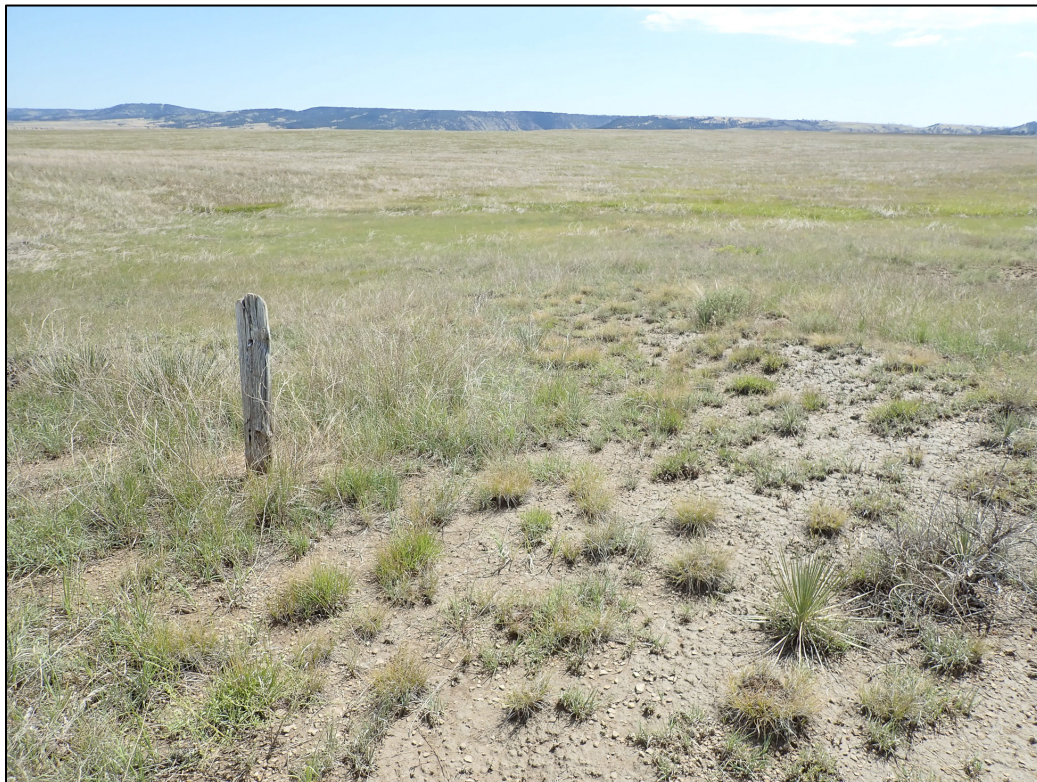
PL-4. Northeast View of Disposal Cell

The grass-covered disposal cell, completed in 1989, occupies 100 acres (PL-4). No signs of erosion, settling, or other modifying processes were found that could affect its integrity. No maintenance needs were identified.

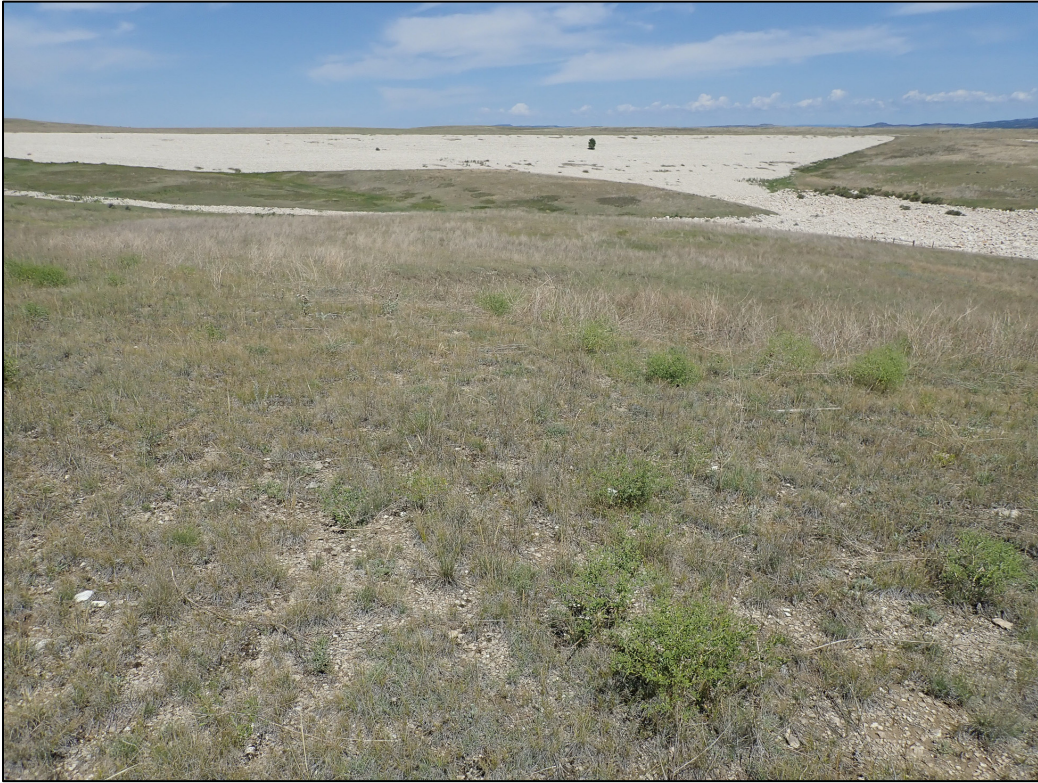
PL-5. Riprap-Armored Containment Dam and Outflow

The face of the containment dam, the steepest man-made slope onsite, is covered with riprap and showed no evidence of erosion, settling, slumping, or other modifying processes (PL-5). Grasses and annual weeds were growing in the riprap. These plants do not threaten the stability or function of the containment dam.

The diversion and drainage channels are covered with grass on their upslope portions (gentle swales on each side of the disposal cell) and armored with riprap on their downslope portions and on steep slopes. Sparse vegetation is present in the riprap, which helps to stabilize these areas and does not impair the function of the channels. Wetland vegetation is present at the base of the drainage channel outflow. No maintenance needs were identified.
