5.0 Falls City, Texas, Disposal Site

5.1 Compliance Summary

Figure 5-1. 2020 Annual Inspection Drawing for the Falls City, Texas, Disposal Site

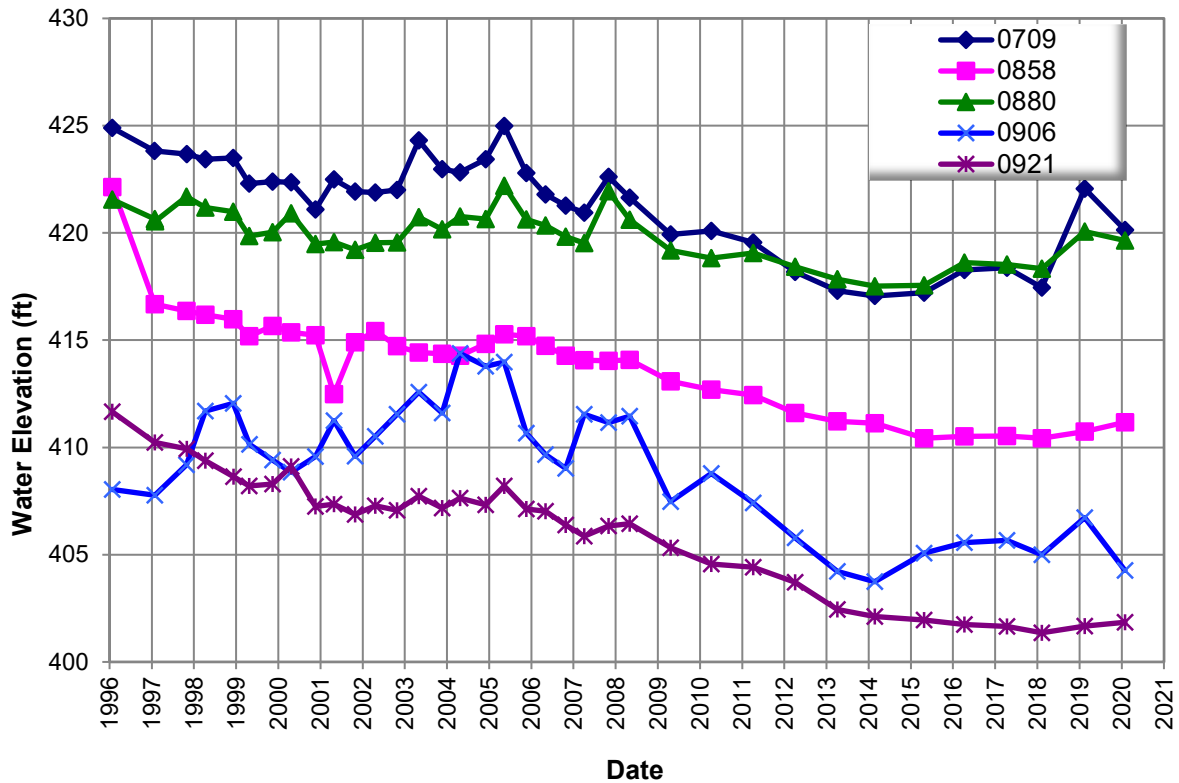
Figure 5-3. Water-Level Measurements at Disposal Cell Performance Monitoring Wells at the Falls City, Texas, Disposal Site

Water levels in all disposal cell performance wells had significant decreasing trends since 1996 based on Mann Kendall trend analyses (Figure 5-3). Water levels in these wells appear to have stabilized since 2014. Wells 0709, 0880, and 0906 have had apparent increase in water level since 2014. Groundwater compliance wells 0862, 0886, and 0963 had significant increasing water level trends since 1996, and wells 0891 and 0924 had no statistically significant trend (Figure 5-4). Wells with increasing water level trends each had a water elevation increase of about 5 ft since 1996.

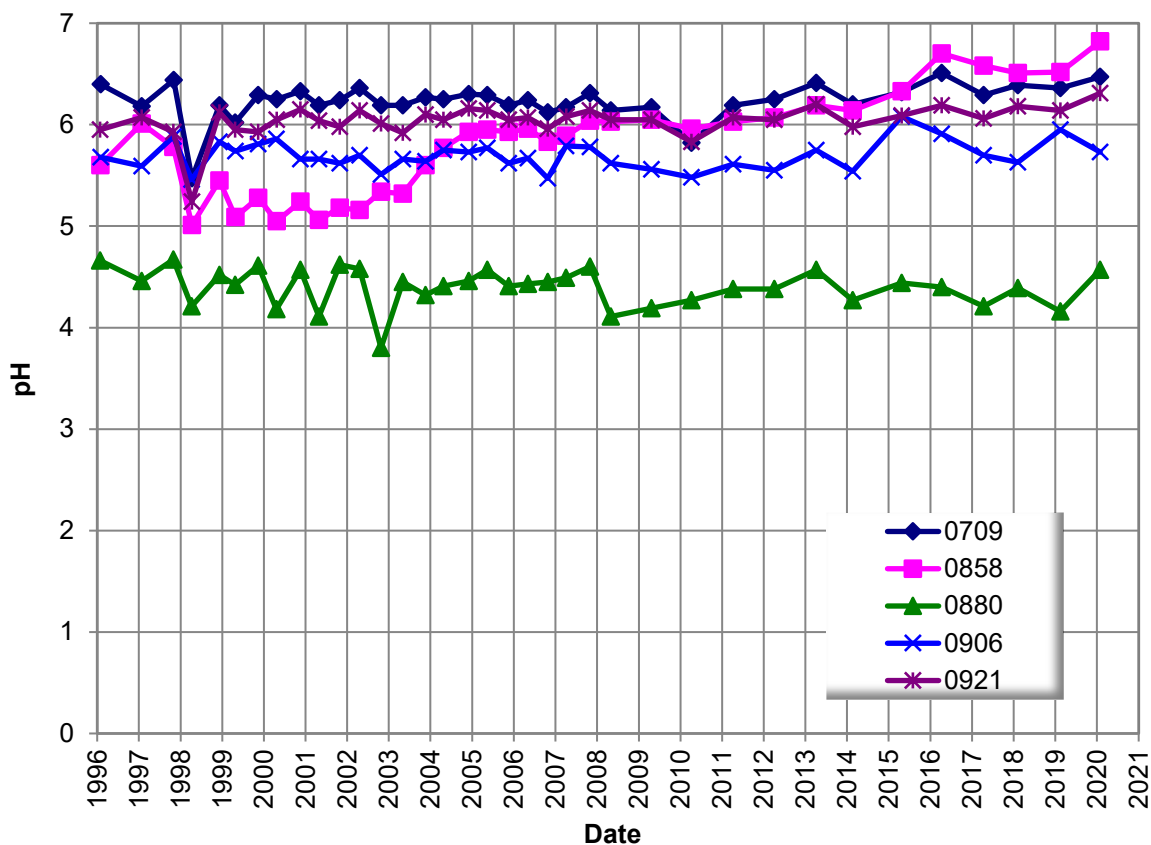
Figure 5-5. pH at Disposal Cell Performance Monitoring Wells at the Falls City, Texas, Disposal Site

pH: Wells 0858 and 0921 had significant increasing pH trends since 1996, based on Mann Kendall trend analyses, and all other disposal cell performance wells had no significant trend. At the disposal cell performance monitoring wells, pH levels have historically been greater than the pH in tailings pore fluids (pH level of 2.93). The 2020 pH levels were within the range of historical values for all disposal cell performance monitoring wells (Figure 5-5).

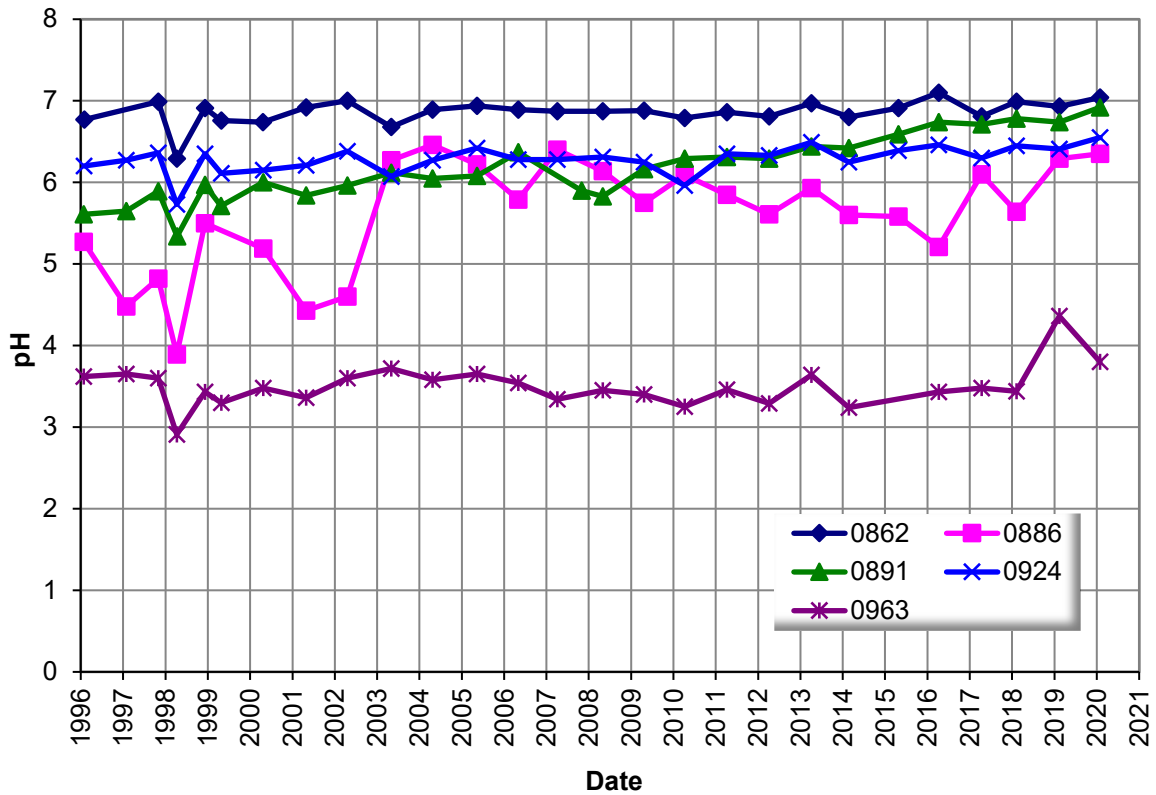
Figure 5-6. pH at Groundwater Compliance Monitoring Wells at the Falls City, Texas, Disposal Site

Statistically significant increasing trends in pH were in wells 0886, 0891 and 0924 since 1996, with no significant trends in wells 0862 and 0963 (Figure 5-6). The 2020 pH levels were within the range of historical values for all groundwater compliance monitoring wells. The pH in monitoring well 0963 historically has been lower than at the other groundwater compliance wells, with a pH of 3.8 in 2020 compared to between 6.0–7.0 in the other wells. Overall, groundwater in well 0963 had a similar pH to that of the tailings pore fluids, even compared to the wells adjacent to the disposal cell.

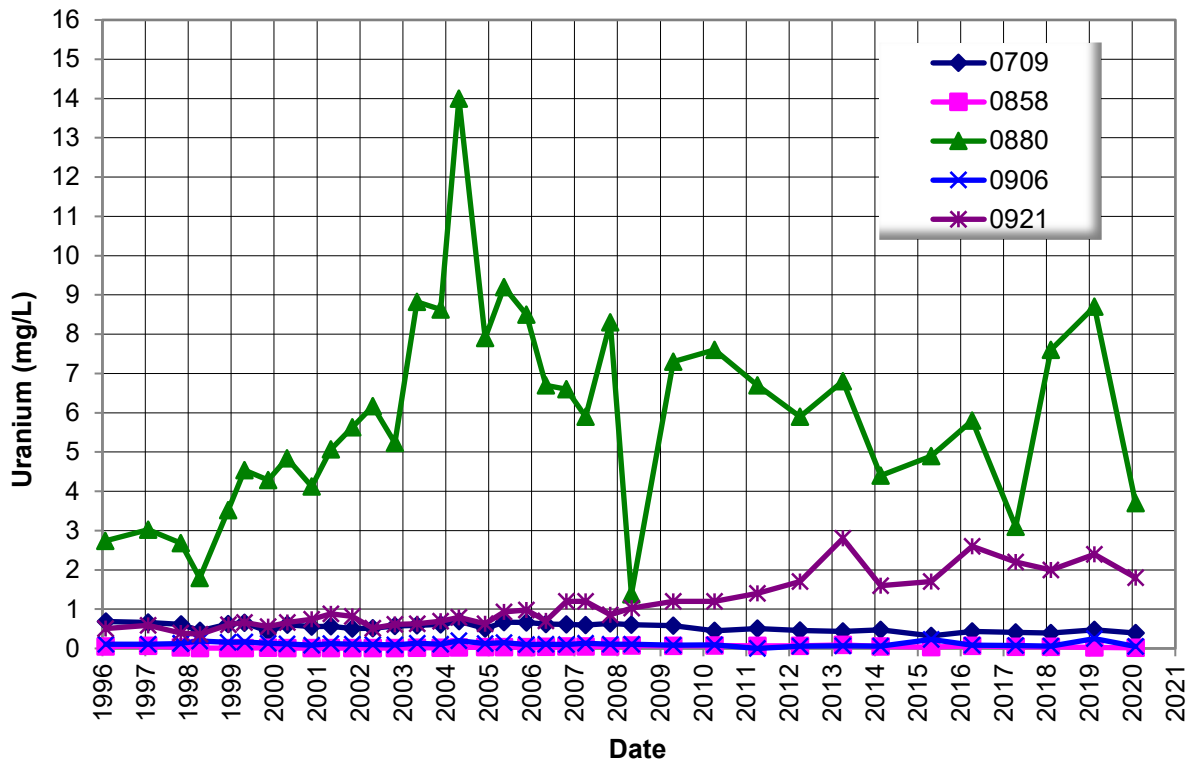
Figure 5-7. Uranium Concentrations at Disposal Cell Performance Monitoring Wells at the Falls City, Texas, Disposal Site

Uranium: The 2020 uranium concentrations for disposal cell performance monitoring wells were within the range of historical values for all groundwater compliance monitoring wells (Figure 5-7). In 2020, the uranium concentrations for monitoring wells 0709, 0906, and 0858 remained generally constant when compared with previous results. The uranium concentration in monitoring wells 0921 and 0880 decreased. Uranium concentrations in monitoring well 0880 show considerable variation, ranging from a low of 1.38 milligrams (mg/L) in 2008 to a high of 14 mg/L in 2004. The 2020 uranium concentrations for groundwater compliance monitoring wells were within the range of historical values for all groundwater compliance monitoring wells (Figure 5-8).

Uranium concentrations in disposal cell performance monitoring well 0880 have varied considerably since 1996, ranging from 1.38 mg/L in 2008 to 14 mg/L in 2004 (Figure 5-7). The uranium concentration was 3.7 mg/L in 2020. The pH at this location is less than at other disposal cell performance monitoring wells. Water levels at all the cell performance monitoring wells trended lower from 2007 until 2016, then increased in recent years (Figure 5-3). Because the uranium concentrations at some of the cell performance monitoring wells have been steady and concentrations vary at other locations, local conditions are likely influencing uranium concentrations. This is reasonable because (1) the disposal cell is located on tailings that were placed in existing open pit mines, (2) subeconomic ore remains in unmined areas, (3) the uppermost aquifer beneath the cell is oxidized and near the aquifer recharge area, and (4) uranium mineralization processes, which involve redistributing and concentrating uranium in the formation materials, are ongoing. Given the local conditions it is difficult to assess whether elevated uranium concentrations in the uppermost aquifer are a result of disposal cell performance or existing background conditions.

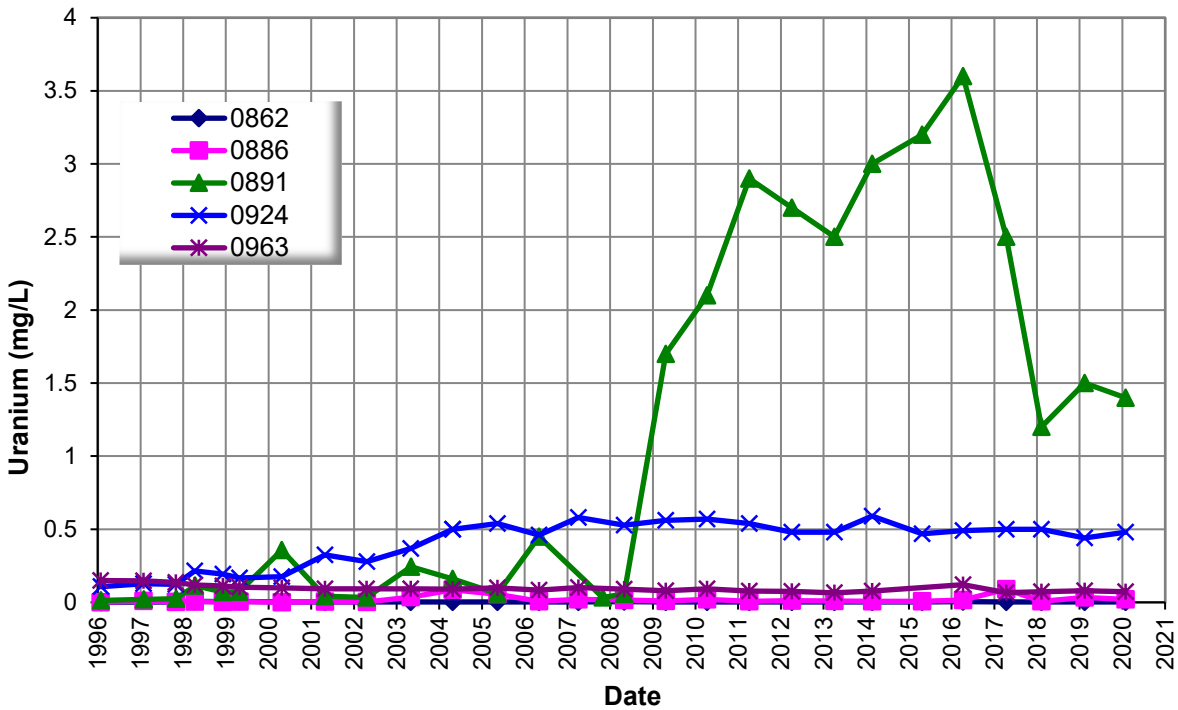
Figure 5-8. Uranium Concentrations in Groundwater Compliance Monitoring Wells at the Falls City, Texas, Disposal Site

The uranium concentration at monitoring wells 0862, 0886, and 0963 remains less than 0.2 mg/L. The uranium concentration at monitoring well 0924 has been relatively stable since 2004, fluctuating between 0.4 mg/L and 0.6 mg/L. Since 2008, the uranium concentrations measured at monitoring well 0891 have been greater than at other monitoring wells and are currently elevated when compared to the historical range for the well but not for the historical range of the aquifer (DOE 2010). The 2020 uranium result (1.4 mg/L) at monitoring well 0891 remains significantly less than the 2016 uranium result of 3.7 mg/L and less than the uranium concentration value used for groundwater in the Dilworth aquifer in the *Baseline Risk Assessment of Ground Water Contamination at the Uranium Mill Tailings Site Near Falls City, Texas* (3.04 mg/L) (DOE 1994). This suggests that a slug of groundwater with elevated uranium has flowed past this location.

The high uranium concentrations in groundwater compliance well 0891 since 2008, trending downward since 2016, likely reflects the passage of a slug of groundwater with elevated uranium flowing from the direction of the former processing site. Historical data from upgradient monitoring wells that were abandoned in 2001 show a uranium anomaly moved past them (Figure 5-9) (DOE forthcoming). LM defined the groundwater flow directions in the Deweesville and the Dilworth aquifers and identified areas of low pH where tailings-derived fluids have consumed all the natural buffering capacity (DOE 2008; Figure 2-7; Figure 2-8). Monitoring well 0891 is completed in the Dilworth aquifer. Monitoring well 0963 (completed in the Deweesville Sandstone) is in a zone of low pH where groundwater in the Deweesville aquifer flows into the underlying Dilworth aquifer. Monitoring well 0966 is the next downgradient Dilworth aquifer well.

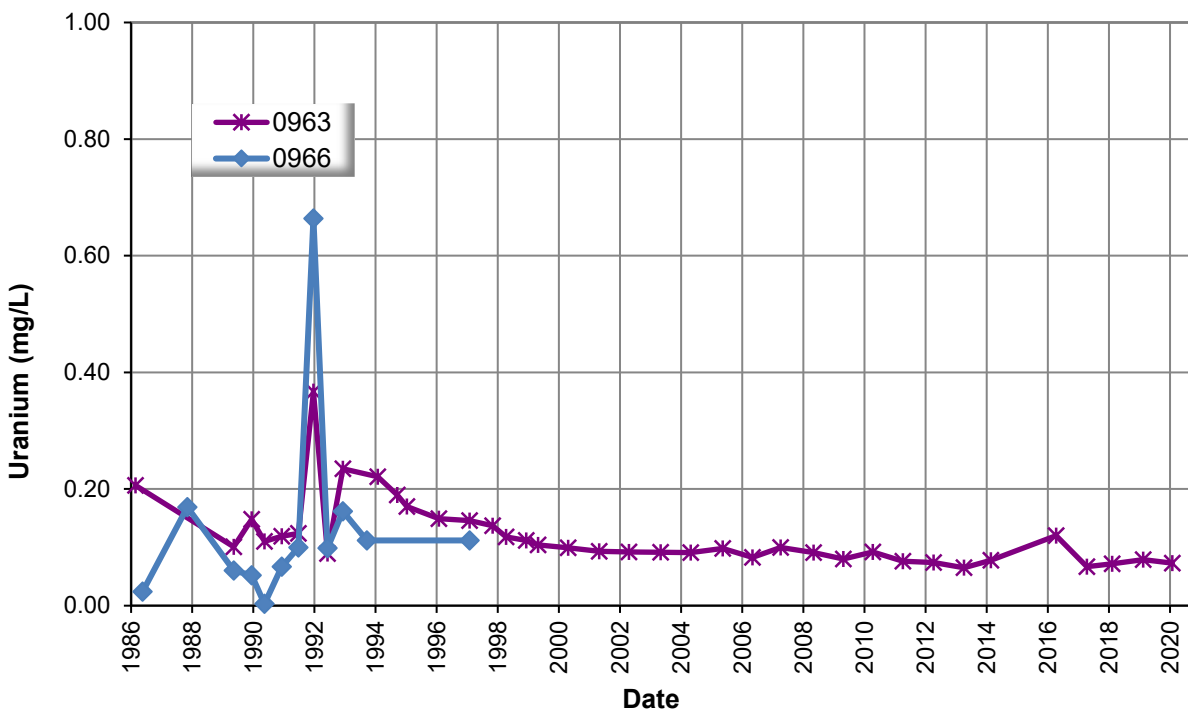
Figure 5-9. Uranium Concentrations in Monitoring Wells 0963 (in the Deweesville Aquifer) and 0966 (in the Dilworth Aquifer)

Figure 5-9 shows uranium concentration spikes in both wells (0963 and 0966) in 1992, with slowly declining uranium concentrations in 0963 over time (data for monitoring well 0966 are limited). This is likely due to an initial release of uranium and low pH tailings fluids during tailings deposition and subsequent acid leaching, with tailings removal by 1994 (DOE forthcoming). Monitoring well 0891 is the next Dilworth well directly downgradient of the low pH zone. Additionally, the elevated uranium at monitoring well 0891 is accompanied by

elevated alkalinity and chloride, which also supports the conclusion that the elevated uranium is the result of passage of a slug of groundwater containing processing-related constituents.

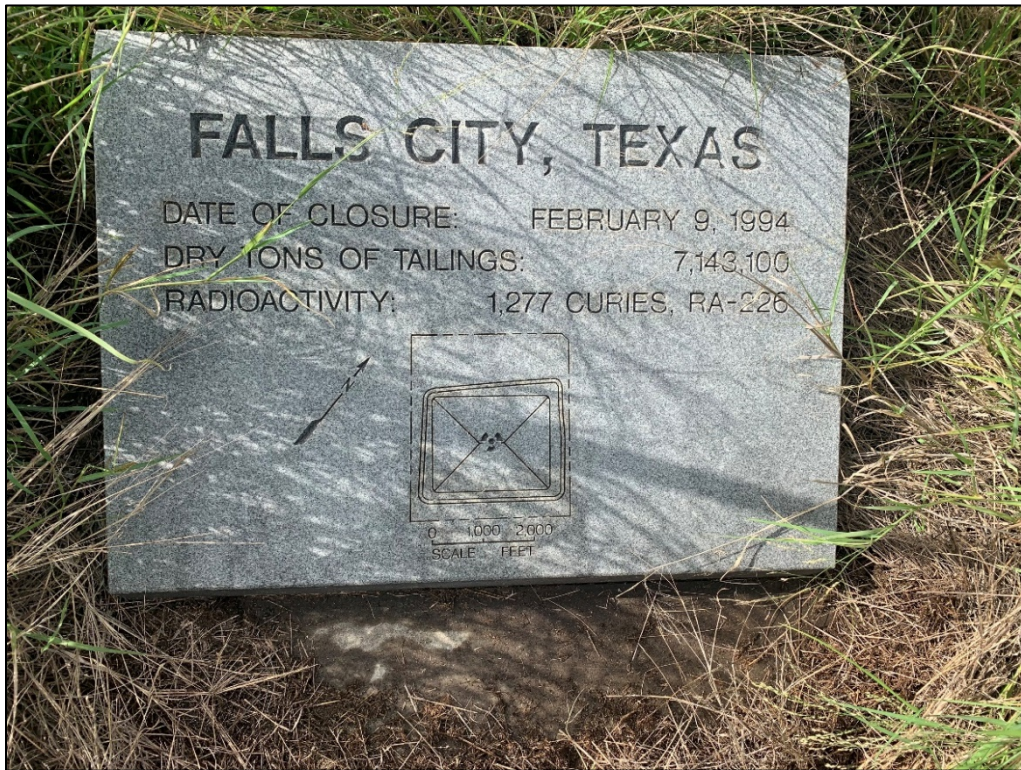
PL-1. Site Marker SMK-1

The site has two site markers. Site marker SMK-1 is just inside the entrance gate (PL-1). The corners of the concrete base around the marker are cracked. The cracks consistently are unchanged and repairs are not needed. Site marker SMK-2 is on the top slope of the disposal cell. No maintenance needs were identified.

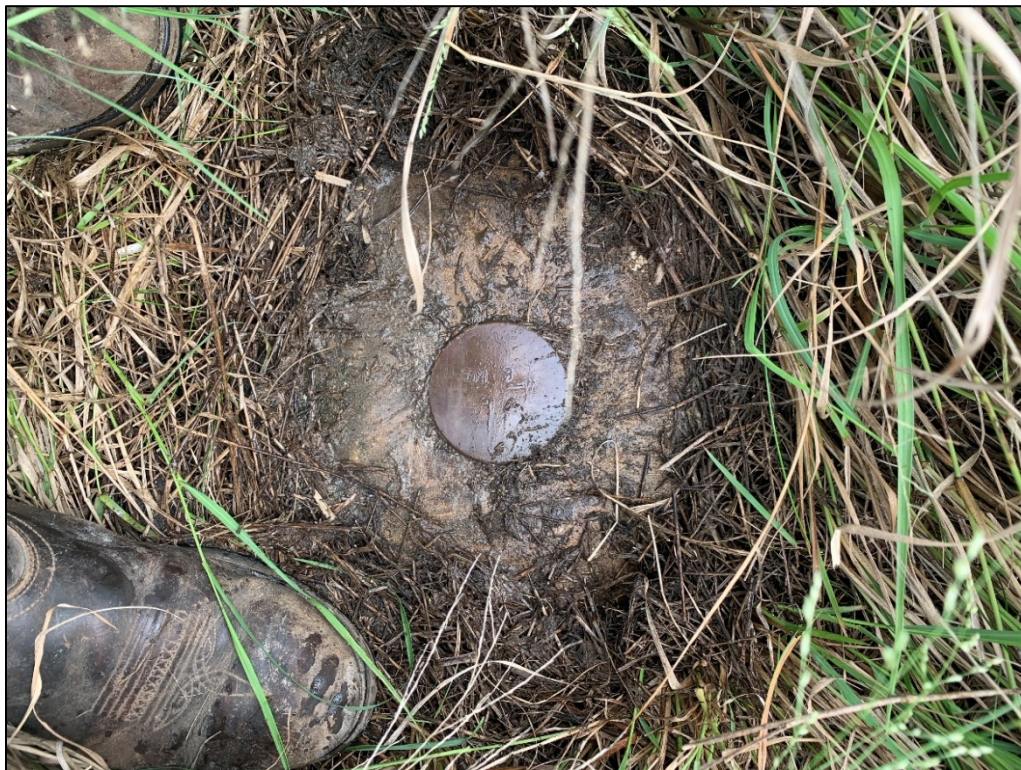
PL-2. Survey Monument SM-3

Three survey monuments and two boundary monuments delineate the corners of the property (PL-2). All monuments were located. No maintenance needs were identified.

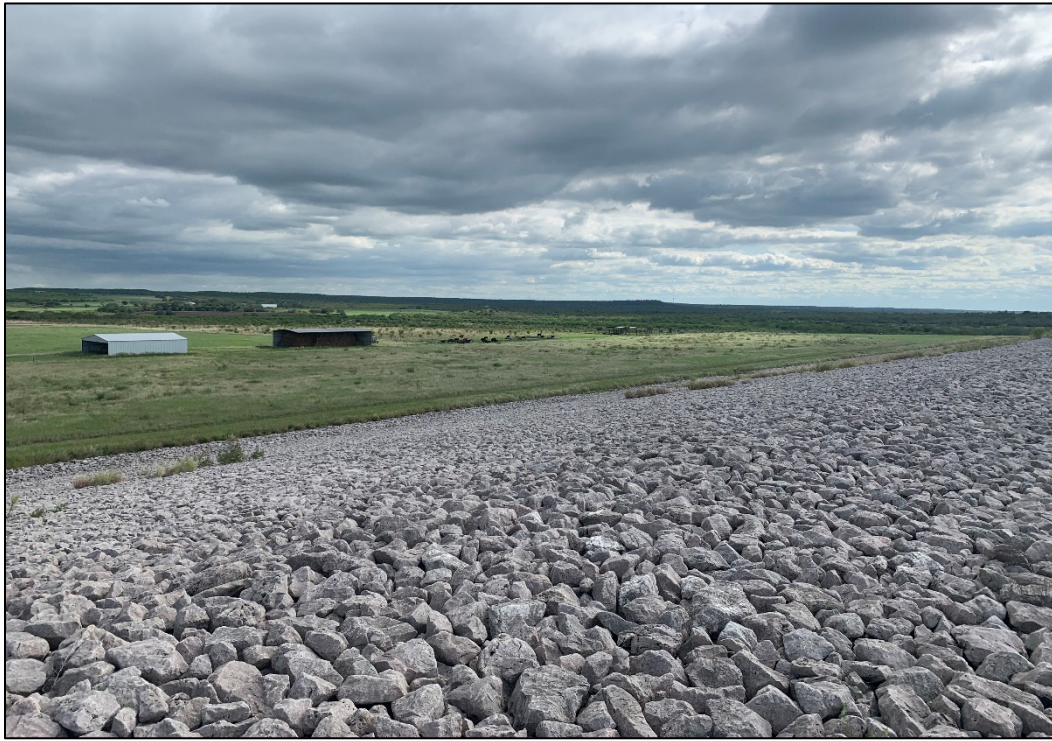
PL-3. South Side of Disposal Cell Side Slope

The disposal cell side slopes and a transition zone where the top slope meets the side slopes are armored with riprap (PL-3). LM has monitored several small depressions on the northwest side slope of the disposal cell since 2010. These depressions do not compromise the protectiveness of the riprap side slope, and no changes have been observed since 2010. Inspectors will continue to monitor these areas.

Fractured riprap has been observed on the disposal cell side slopes since it was completed. Pieces of riprap are fractured in place, indicating that the fracturing occurred after placement. Fracturing is likely a consequence of mechanical placement or thermal expansion and contraction; the riprap condition appears stable. LM periodically takes photos of riprap at the base of T-post 4 on the west corner of the disposal cell. On the basis of a qualitative evaluation of the photos in 2018, there is no indication that the riprap is degrading, but its durability will continue to be monitored. If the number of fractured rocks appears to be increasing, LM will establish a more quantitative monitoring program.

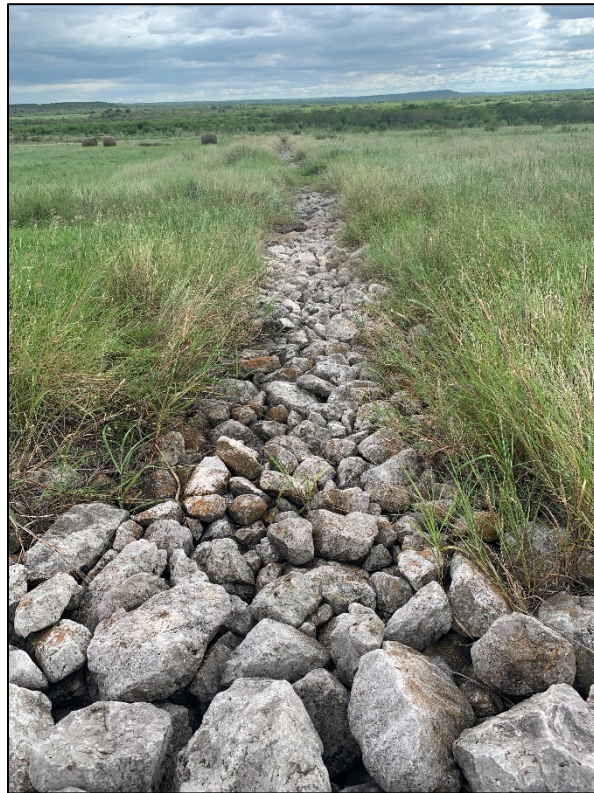
PL-4. Rock Drain on South Corner of Disposal Cell

No water was flowing in the south rock drain during the inspection (PL-4). Willows that grow along the south drain are periodically removed by the maintenance subcontractor. No water was observed in the north rock drain. Vegetation is left uncut at the outlets of the rock drains to help dissipate the energy of stormwater runoff and to reduce soil erosion. Vegetation in the apron outfall, midway along the northeast side slope, was cut back before the 2020 inspection. No maintenance needs were identified.
