6.0 Grand Junction, Colorado, Disposal Site

The Grand Junction, Colorado, Uranium Mill Tailings Radiation Control Act (UMTRCA) Title I Disposal Site (site) was inspected on December 9, 2020. No changes were observed on the disposal cell or in the associated drainage features. Inspectors identified minor maintenance needs that will be handled during the next routine maintenance event, but no cause for a follow-up inspection was identified.

Figure 6-1. 2020 Annual Inspection Drawing for the Grand Junction, Colorado, Disposal Site

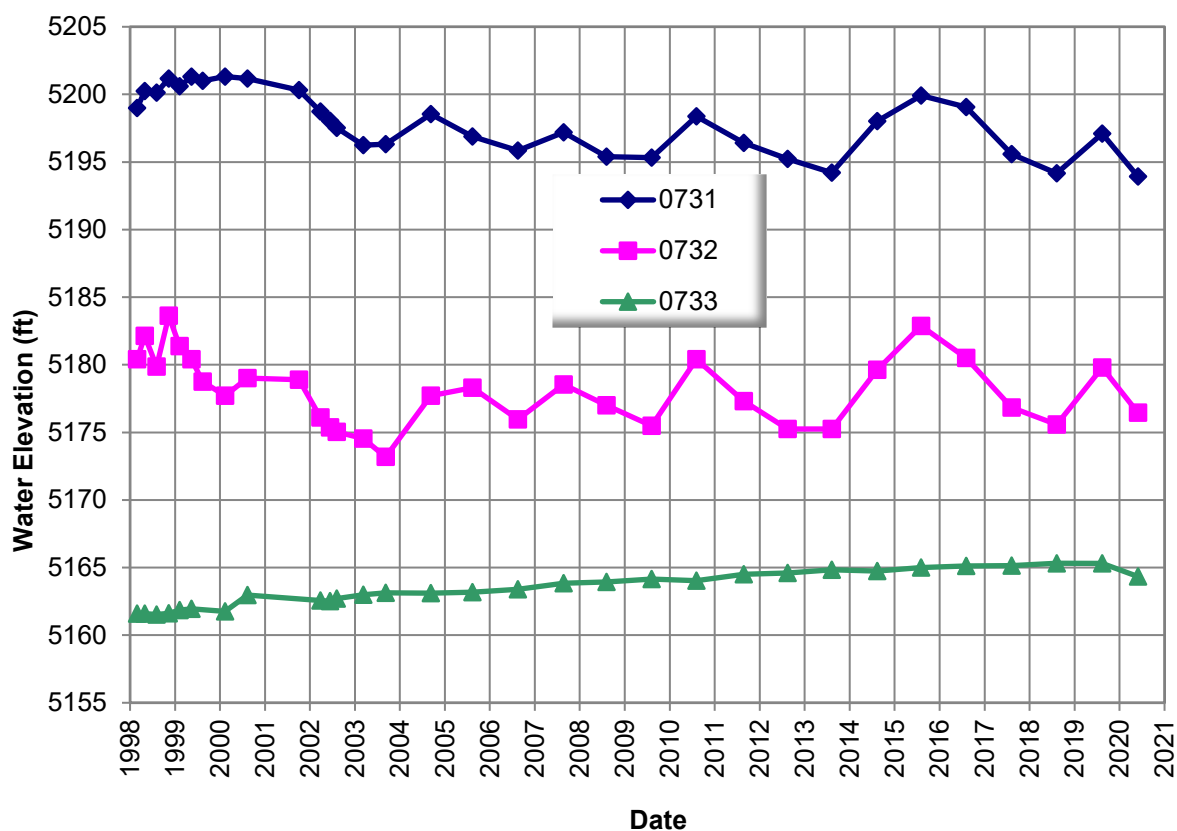
Figure 6-3. Water Level Measurements at the Grand Junction, Colorado, Disposal Site

Static water level measurements are obtained from each monitoring well before water quality samples are collected (Figure 6-3). Water levels in disposal cell monitoring well 0733 generally increased approximately 4 ft since 1998 and has remained lower than the adjacent water levels in the two paleochannel monitoring wells. Groundwater levels in wells 0731 and 0732 remained relatively constant with the same apparent trend in variability, suggesting the two paleochannel systems are influenced by the same upgradient recharge mechanisms. The 2020 sampling occurred in late May, whereas every previous sampling since 2003 occurred in August or early September. Consequently, water level measurements in 2020 may have a seasonal influence in relation to the historical data.

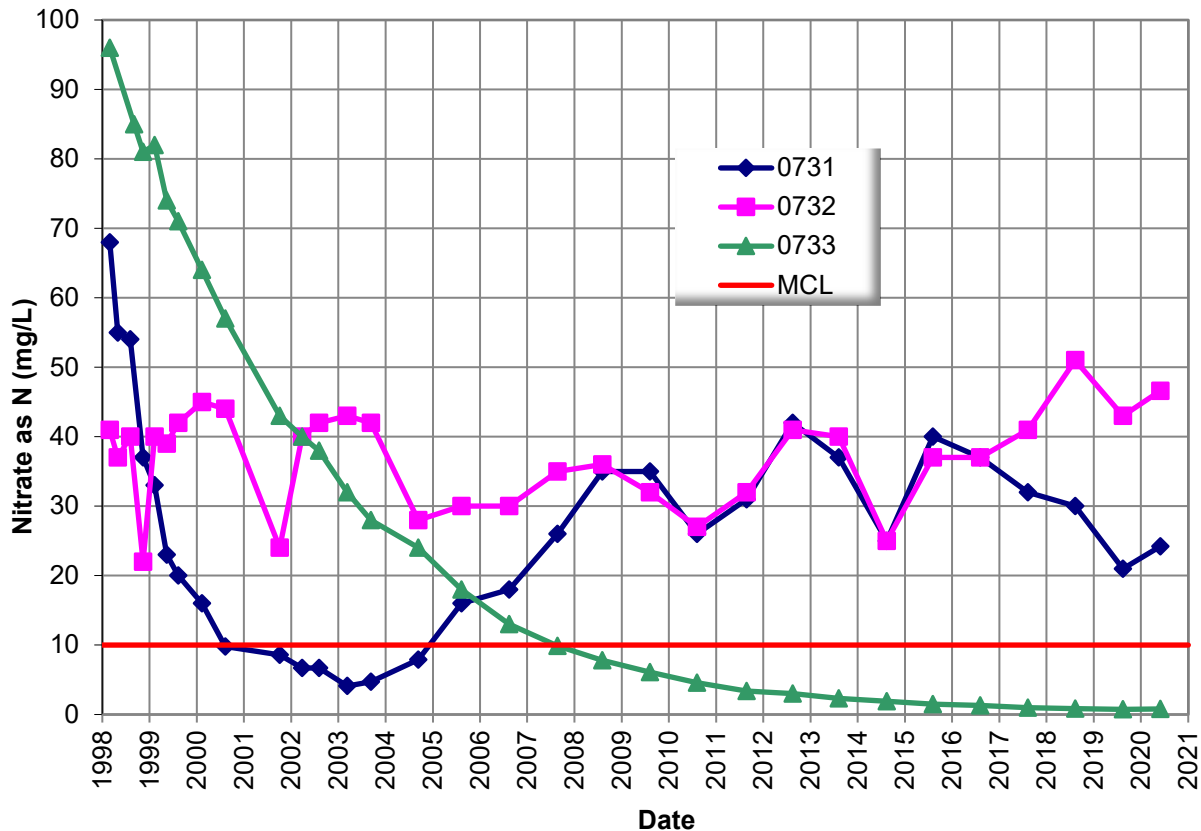
Figure 6-4. Nitrate (as Nitrogen) in Groundwater at the Grand Junction, Colorado, Disposal Site

Nitrate (as nitrogen) concentrations in disposal cell monitoring well 0733 continued to decline from 96 mg/L in 1998 to 0.8 mg/L in 2020, significantly below the MCL of 10 mg/L (Figure 6-4). Nitrate concentrations continued to exceed the MCL of 10 mg/L in the paleochannel monitoring wells 0731 and 0732. Concentrations in monitoring wells 0731 and 0732 increased slightly in 2020, with the concentration in monitoring well 0732 remaining near the historic high value, which is just above 50 mg/L.

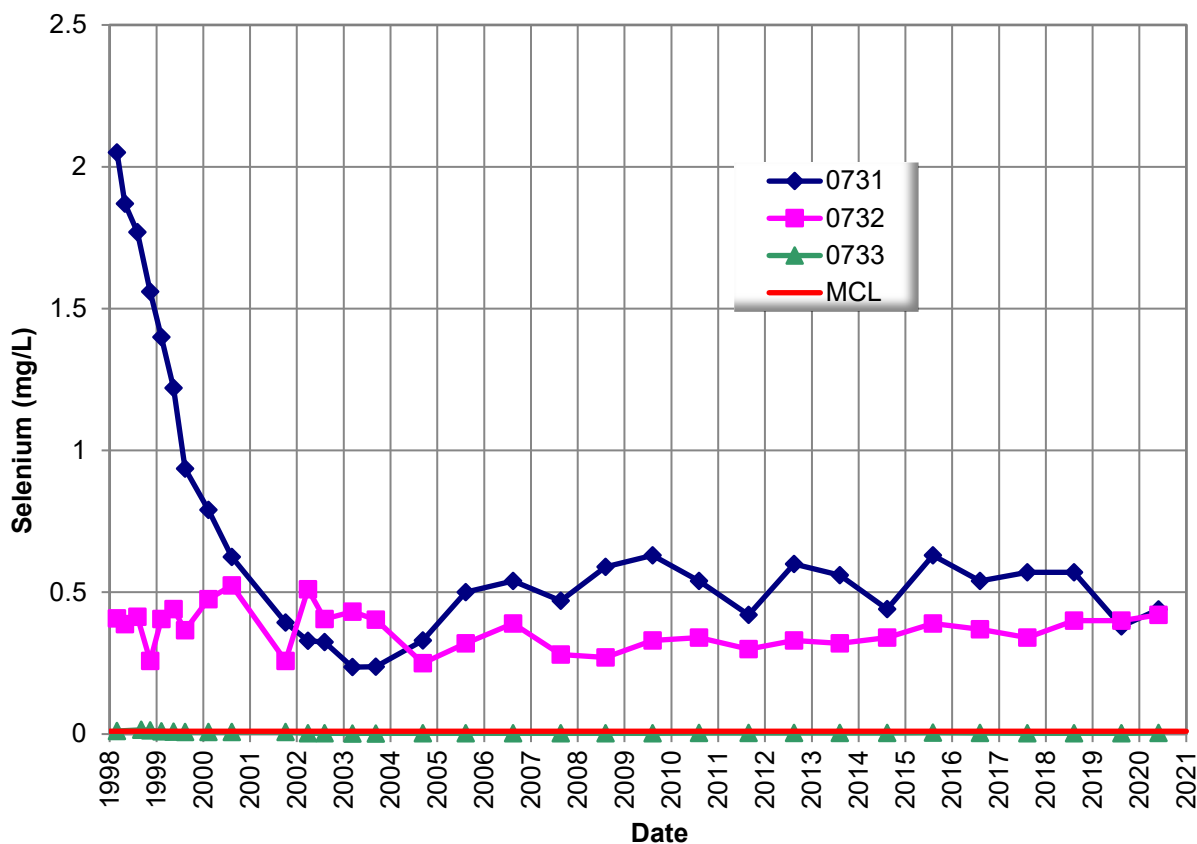
Figure 6-5. Selenium in Groundwater at the Grand Junction, Colorado, Disposal Site

Selenium concentrations continued to exceed the MCL of 0.01 mg/L in the paleochannel monitoring wells 0731 and 0732 (Figure 6-5). Selenium occurs naturally in the Mancos Shale deposits that underlie the disposal cell at concentrations slightly greater than the MCL of 0.01 mg/L. Paleochannel monitoring wells 0731 and 0732 are screened at the Mancos Shale unconsolidated soil contact with the alluvium. Background groundwater quality in these wells is brackish, with elevated TDS levels ranging from 870 to 7010 mg/L; this supports the theory that the shale is the source of the elevated selenium concentrations in both paleochannel monitoring wells. Disposal cell monitoring well 0733 is not screened in the weathered Mancos and selenium concentrations remain below the MCL.

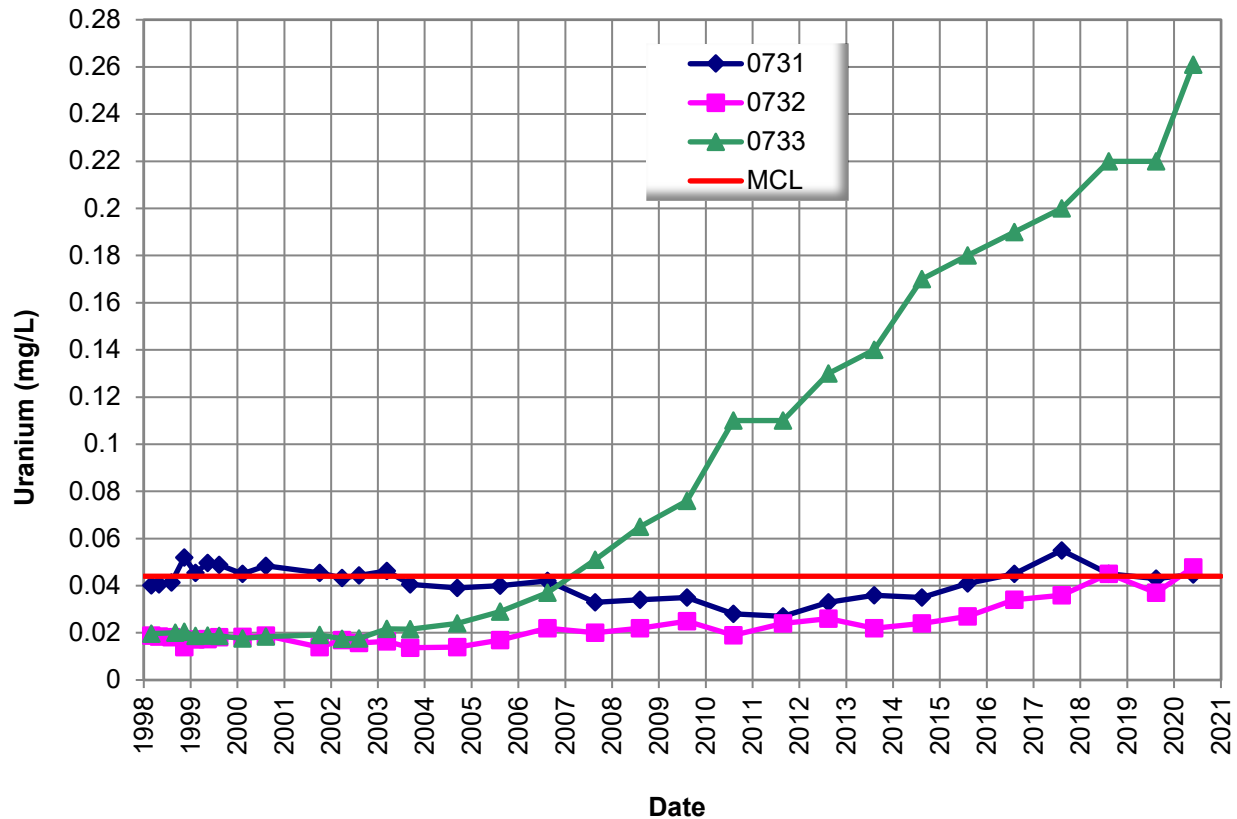
Figure 6-6. Uranium in Groundwater at the Grand Junction, Colorado, Disposal Site

Uranium concentrations in groundwater remained near the MCL of 0.044 mg/L in both paleochannel monitoring wells in 2020. Uranium concentrations in wells 0731 and 0732 have shown a gradual, apparent increasing trend since 2011 (Figure 6-6). Uranium concentrations in disposal cell monitoring well 0733 have increased from 0.02 mg/L in 2002 to 0.26 mg/L in 2020. Relatively high concentrations of uranium and other constituents are expected for a well screened in the disposal cell tailings. Constituents of concern and water levels in well 0733 are not subject to compliance goals and are monitored solely for information gathering purposes.

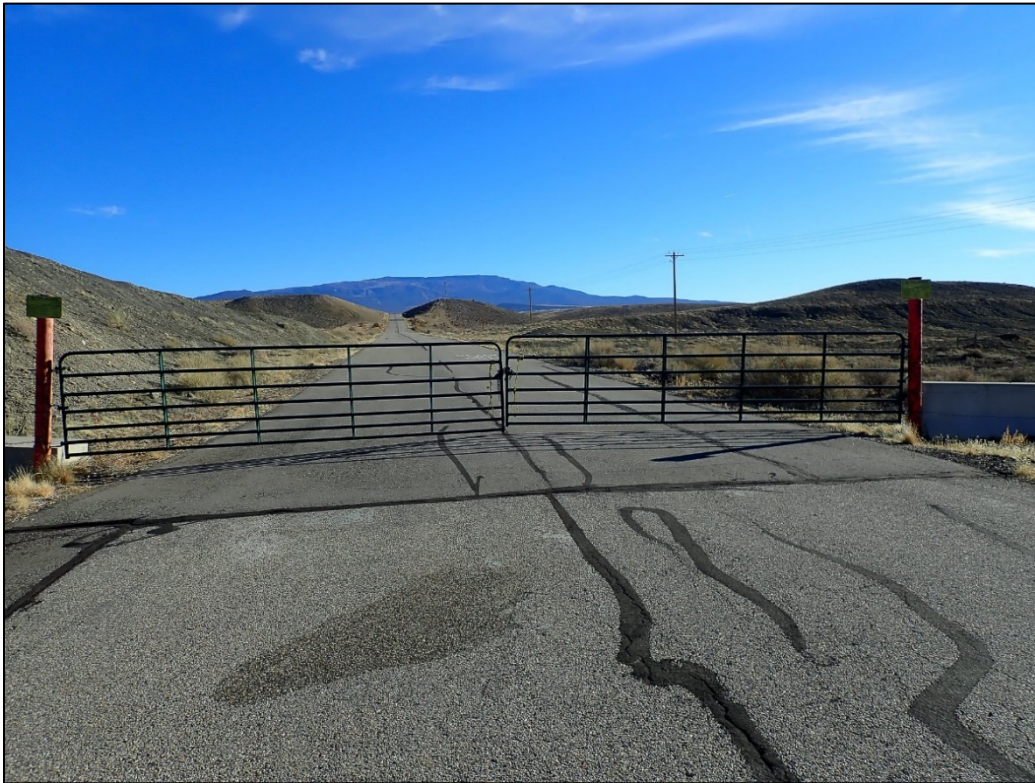
Access to the site is from U.S. Highway 50 by a right-of-way grant on federal land that is administered by the U.S. Bureau of Land Management (BLM). There is a steel double-swing access gate (PL-1) along the highway right-of-way fence providing access within the BLM-administered right-of-way. The access gate (PL-2) is secured by a locking device that was locked and functional at the time of the inspection. LM is one of several parties with access to the locking device.

PL-1. Site Access Gate

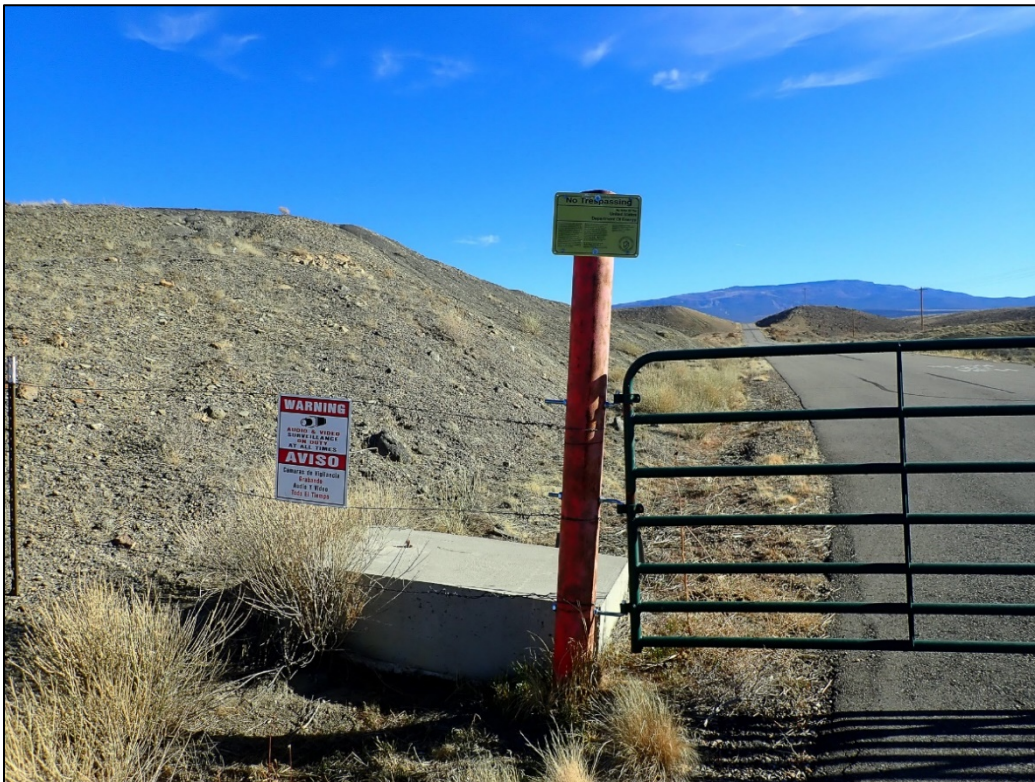
PL-2. Site Access Gate Signs

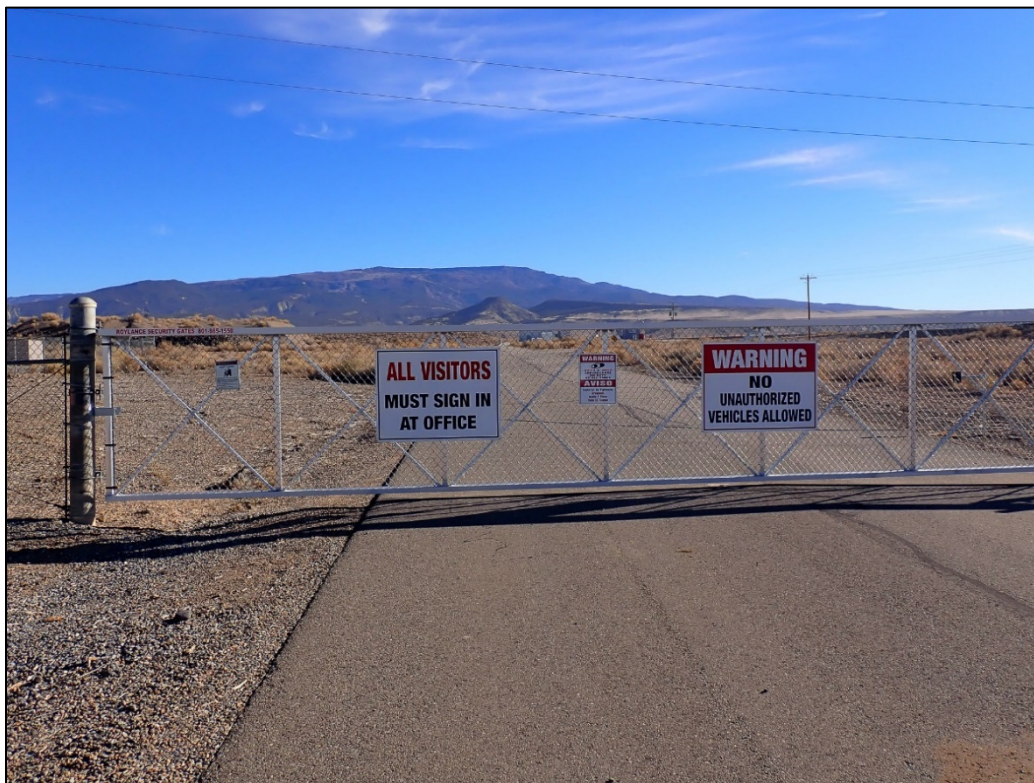
The site entrance gate was locked and functional, and site entrance signs on and next to the entrance gate were in good condition (PL-3). No immediate maintenance needs were identified.

PL-3. Solar-Powered Site Entrance Gate

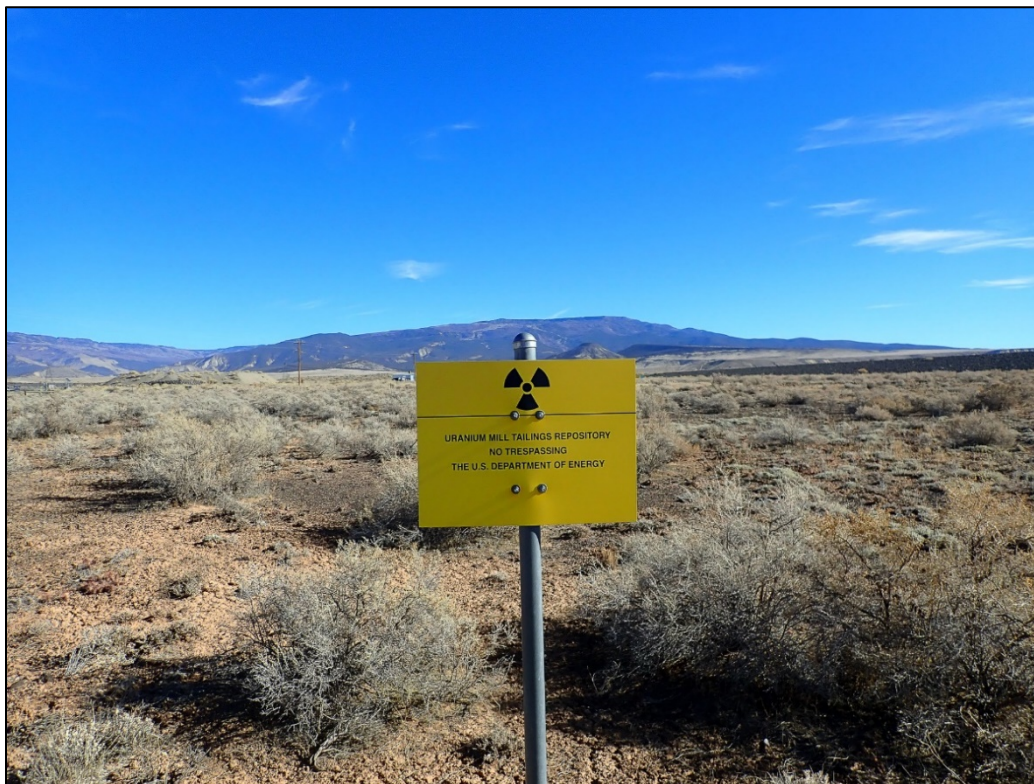
A perimeter fence encloses the disposal cell features and operations areas. It consists of a standard four-strand, barbed-wire fence in some areas and a woven wire fence topped with barbed wire in others. The perimeter fence does not match the property boundary in several areas. There are 29 perimeter signs attached to steel posts set in concrete positioned at regular intervals along the property boundary (PL-4). Perimeter sign P13, previously reported with bullet damage, was replaced. Perimeter signs P15, P16, and P20 have bullet damage but remain legible (PL-5). In addition to the perimeter signs, the perimeter fence also has warning signs (“No Trespassing” and “Controlled Area” signs). Several warning signs on the perimeter fence near the stile east of the south diversion channel are damaged and will be repaired during the next routine site maintenance event. No immediate maintenance needs were identified.

PL-4. Perimeter Sign P1

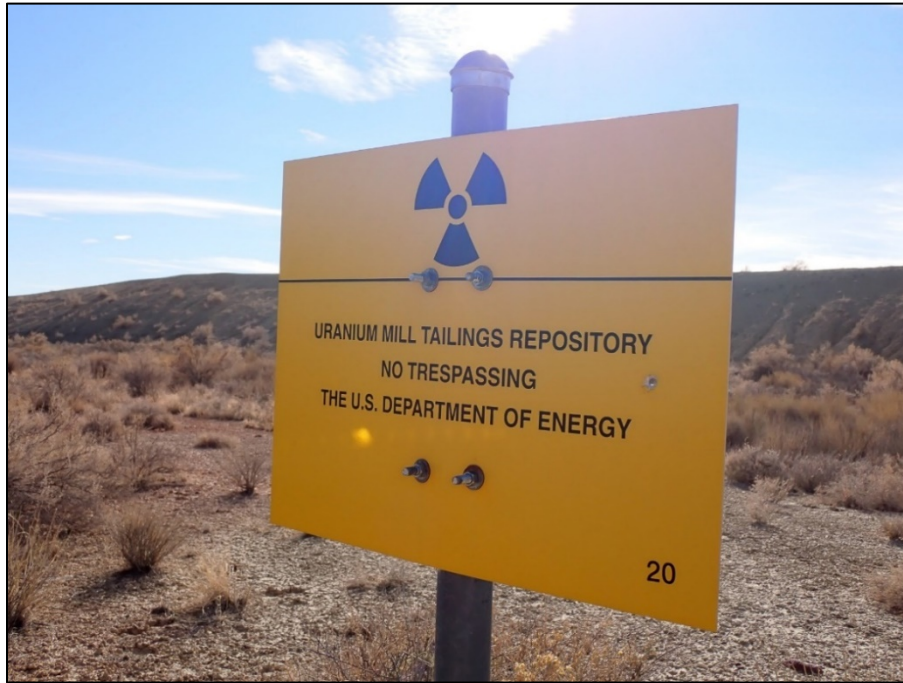
PL-5. Perimeter Sign P20 with Bullet Damage

Inspectors identified repairs needed to the southeast perimeter fence warning signs that will be addressed during the next routine site maintenance event. No other immediate maintenance needs were identified.

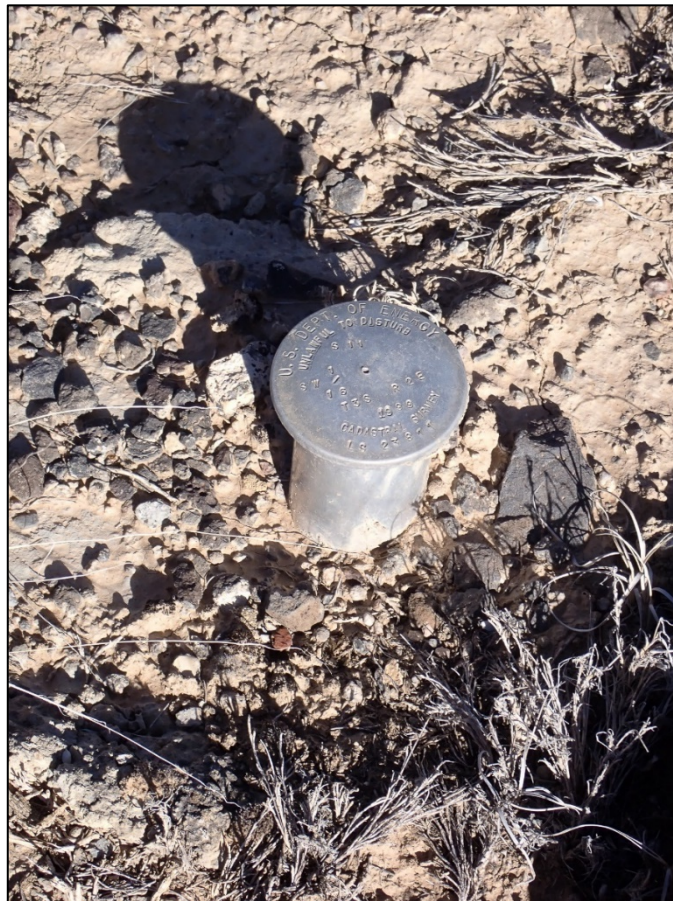
Four boundary monuments delineate the corners of the property boundary (PL-6). All were present and in good condition, and no immediate maintenance needs were identified.

PL-6. Boundary Monument BM-1

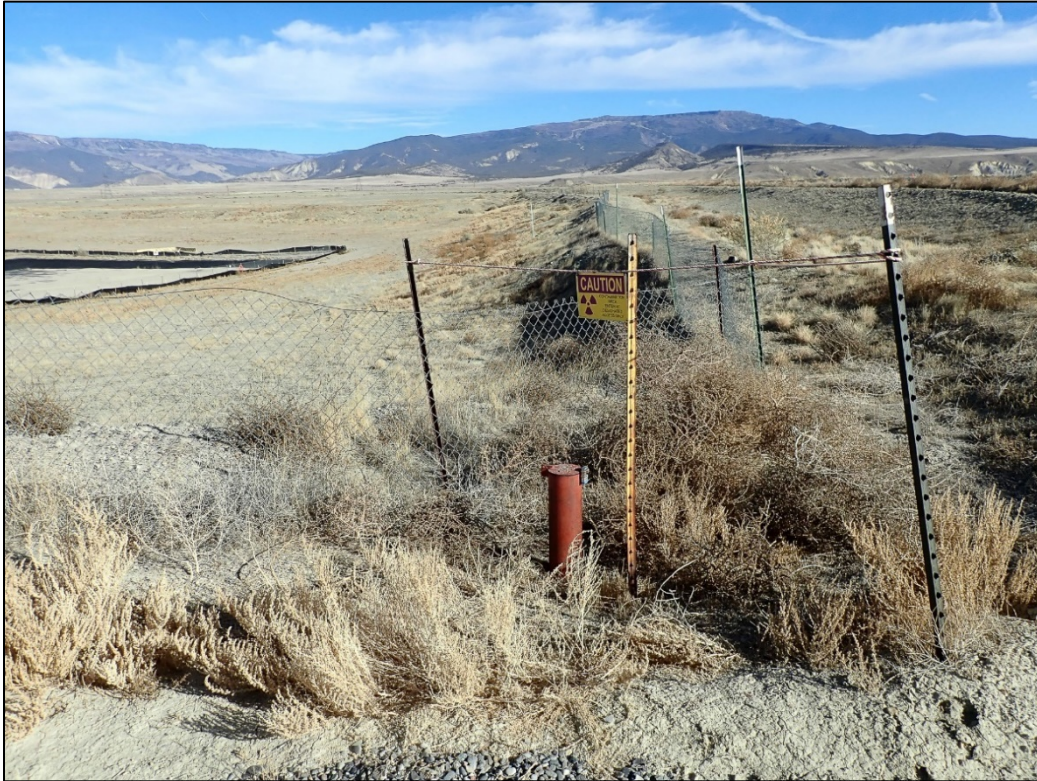
The groundwater monitoring network consists of three monitoring wells (0731, 0732, and 0733) (PL-7). All wellhead protectors were locked and undamaged, and no immediate maintenance needs were identified.

PL-7. Monitoring Well 0733

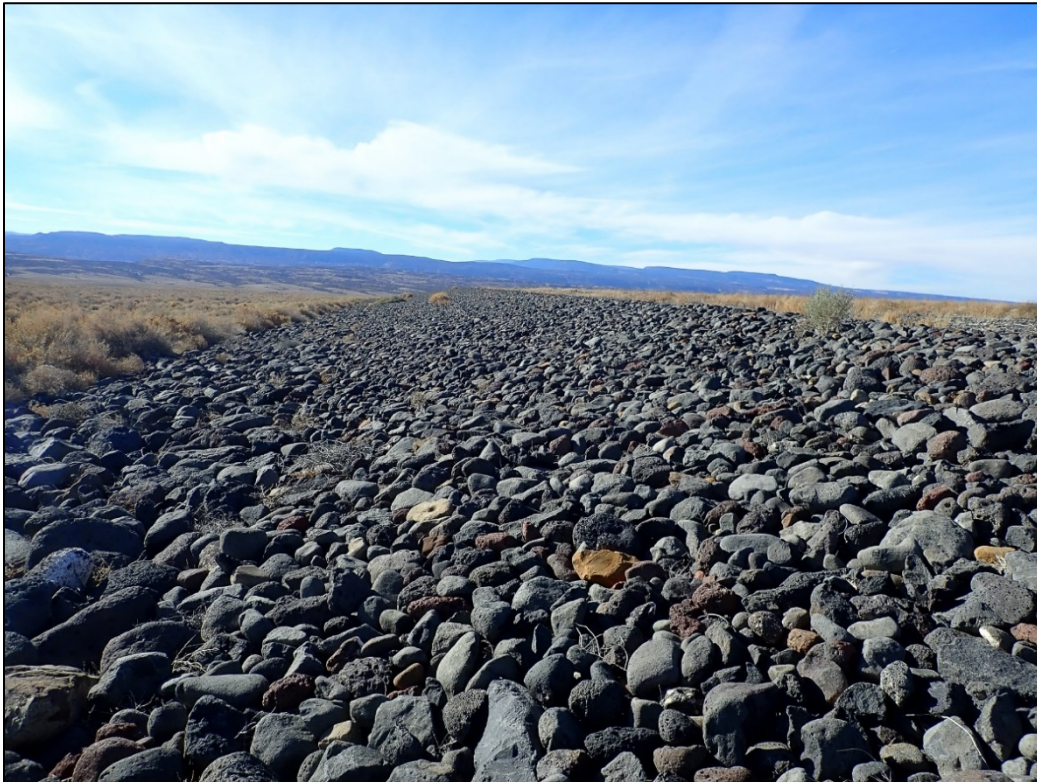
The closed portion of the disposal cell is armored with basalt riprap to control erosion (PL-8). The rock showed no significant weathering. There was no evidence of erosion, settling, slumping, rock degradation, or other modifying processes that might affect the integrity of the disposal cell.

PL-8. South Slope of Disposal Cell

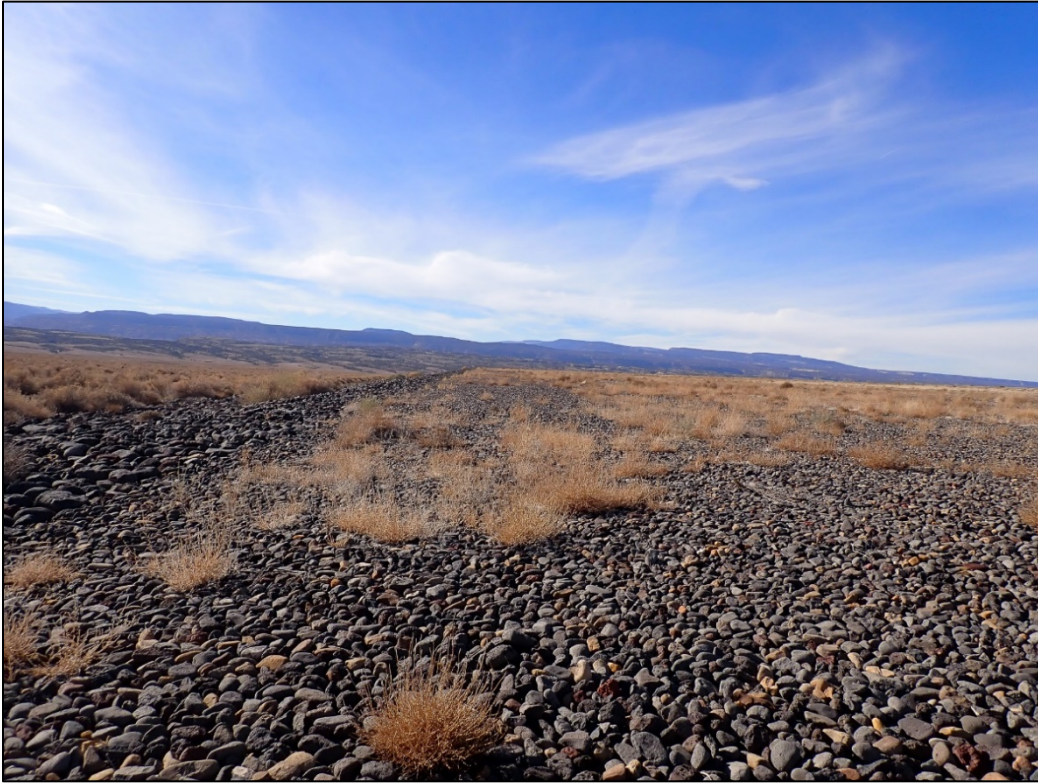
Grasses and weeds were growing on most of the disposal cell cover (PL-9). Historically, deep-rooted shrubs on top of the disposal cell have been treated with herbicide. Although treatment is not required by the Interim LTSP, LM plans to continue controlling the deep-rooted shrubs as needed.

PL-9. South Side of Disposal Cell

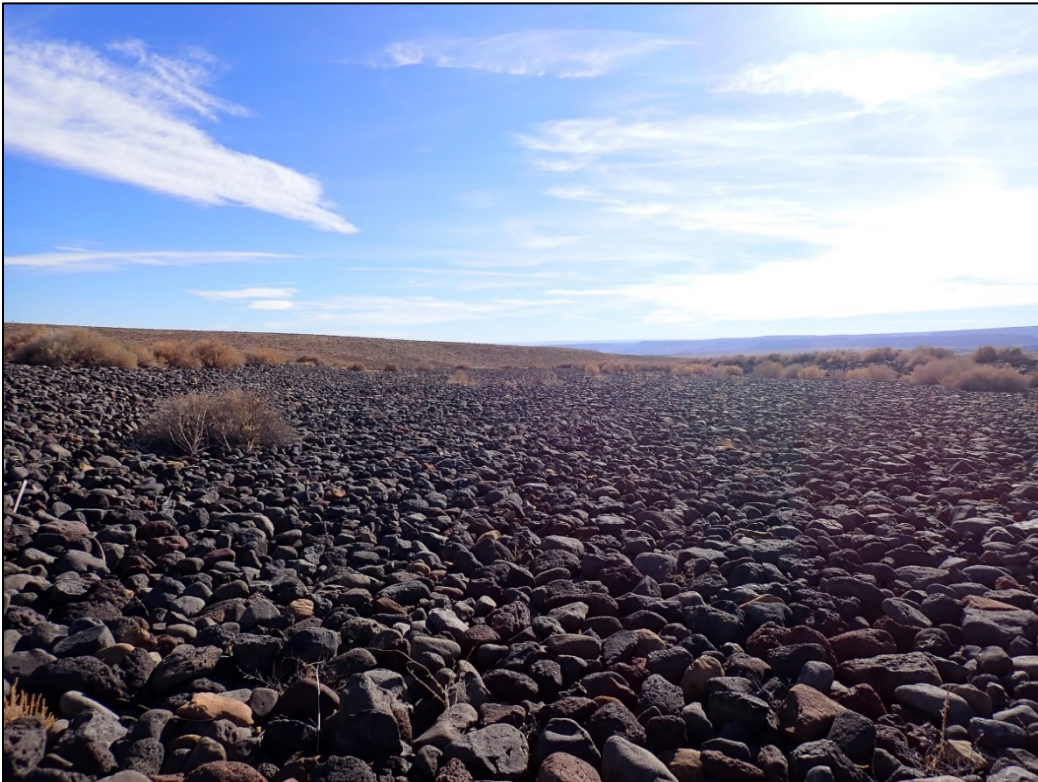
The south diversion channel is a large, riprap-armored structure that intercepts run-on water from offsite and onsite, as well as stormwater runoff from the disposal cell, and conveys the water into a natural drainage that flows away from the site to the southwest (PL-10). Grasses, weeds, and shrubs grow within the diversion channel, but this vegetation is not expected to degrade the channel's performance. The discharge area of the channel is armored with large-diameter basalt riprap.

PL-10. South Diversion Channel
