8.0 Gunnison, Colorado, Disposal Site

8.1 Compliance Summary

The U.S. Department of Energy (DOE) Office of Legacy Management (LM) conducted the Gunnison, Colorado, Uranium Mill Tailings Radiation Control Act (UMTRCA) Title I Disposal Site (site) inspection on September 15, 2020. No cause for a follow-up inspection was identified.

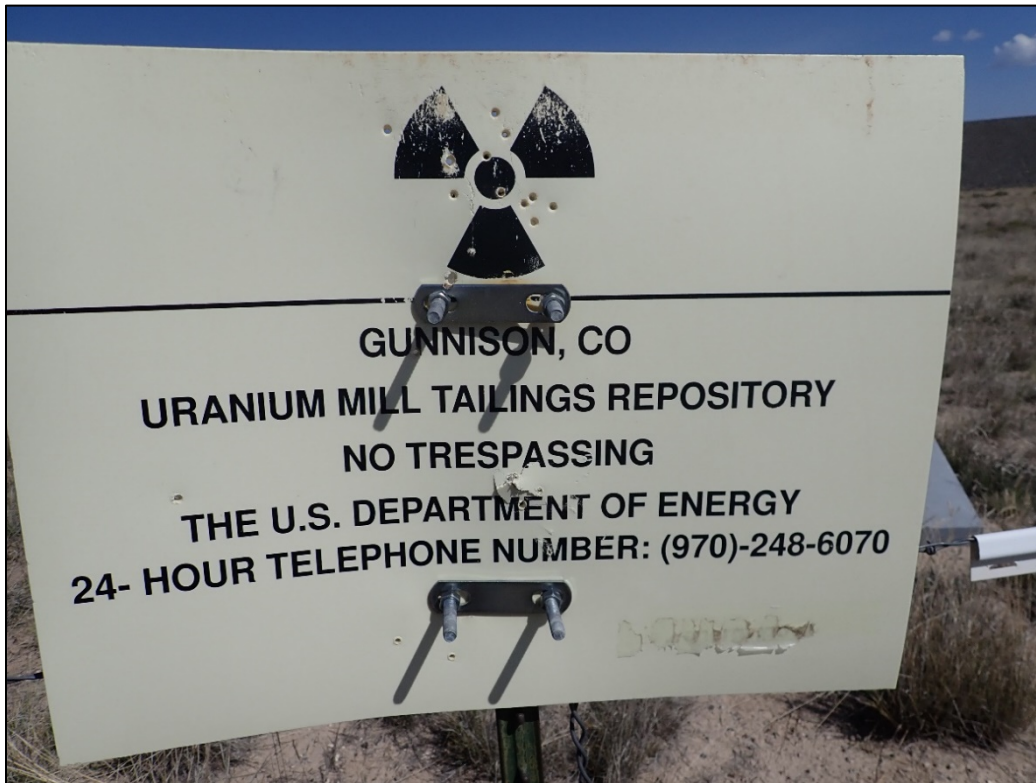
Access to the site is from Gunnison County Road 42 onto U.S. Bureau of Land Management (BLM) Route 3068, a gravel road maintained by BLM. Entrance to the site is through a locked gate that is part of the perimeter fence. The entrance gate was locked and functional. The entrance sign (PL-1) is bolted to a perimeter fence post next to the entrance gate. The entrance sign has bullet damage but remains legible. The front entrance sign will be replaced at the time of the next scheduled site maintenance activity. No other maintenance needs were identified.

PL-1. Entrance Sign

- Installation of new front entrance sign with current contact information
- Replacement of plastic perimeter signs P36, P37, P38, and P41
- Installation of new locks on wells 0630 and 0712
- Clearing of shrubs around boundary monuments BM-4 and BM-6

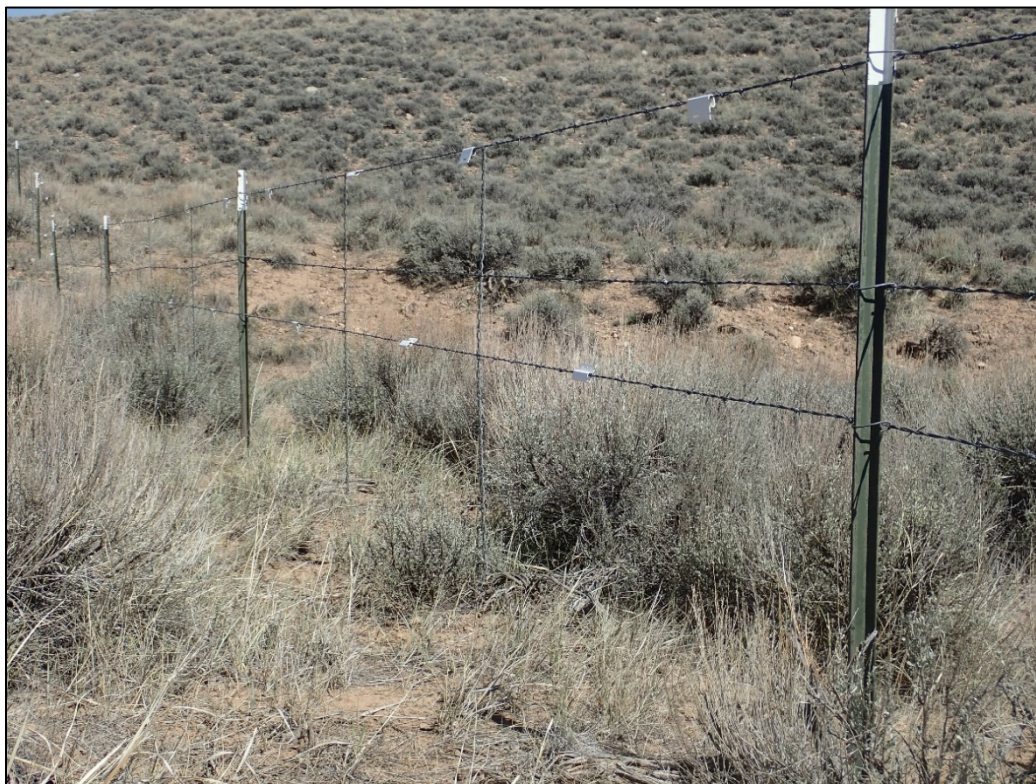
A three-strand barbed-wire perimeter fence encloses the site; most of it is set along the property boundary. In 2019, fence flagging (PL-2 and PL-3) was added as a mechanism for protecting sage grouse and antelope that occupy the area. The perimeter fence was intact. No other maintenance needs were identified.

PL-2. Fence Flagging on East Fence Line

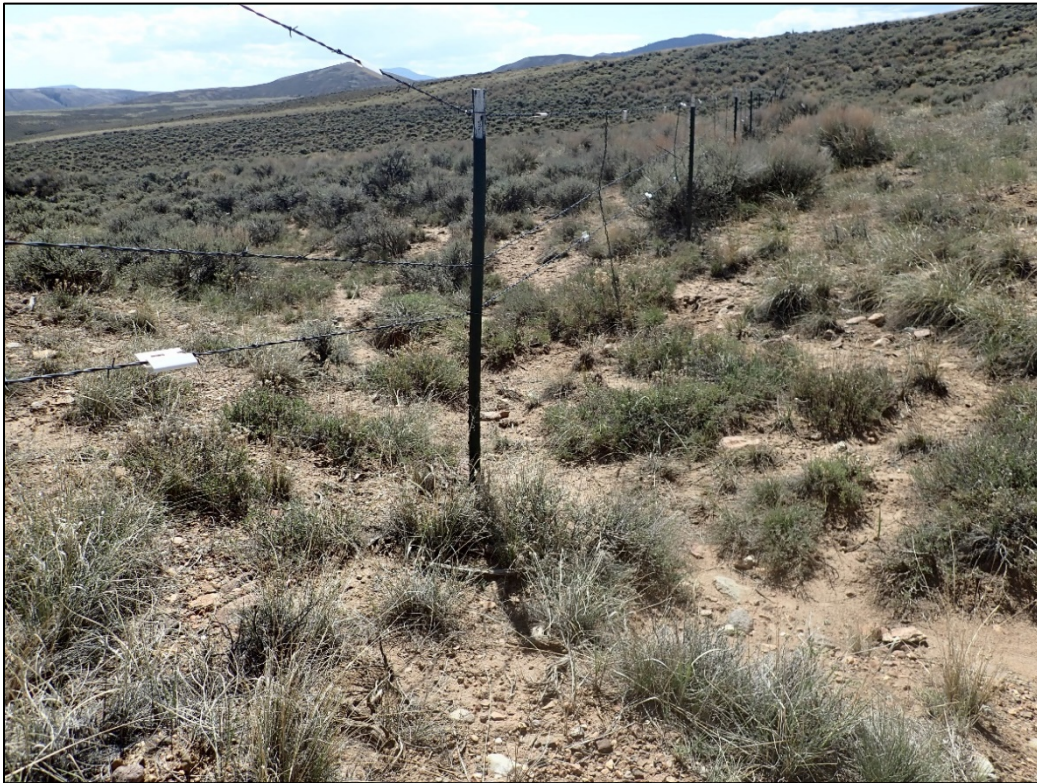
PL-3. Fence Flagging on East Fence Line

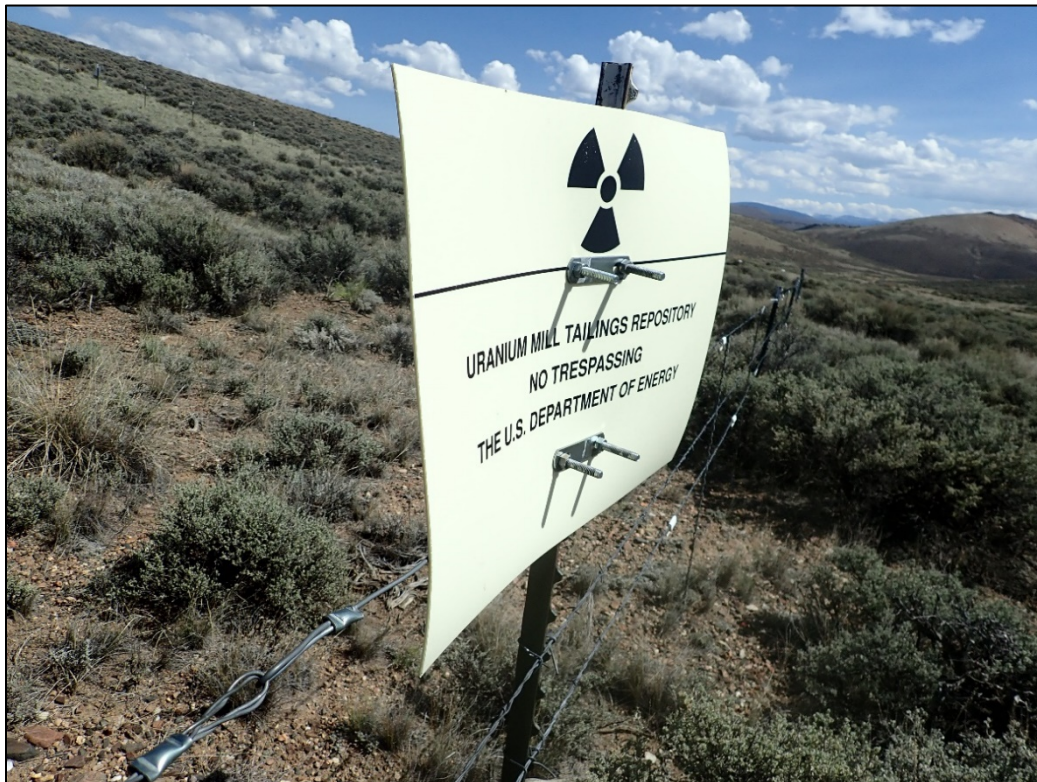
There are 45 perimeter signs bolted to the perimeter fence posts. Several perimeter signs have bullet damage but remain legible. In 2020, perimeter signs P4–P13 along the west perimeter fence were replaced. Perimeter signs P36, P37 (PL-4), P38, and P41 are constructed of plastic and are faded and curling. The plastic signs have been rescheduled for replacement with metal signs in 2021. All new signs will include the words “Gunnison Site.” Other perimeter signs that are damaged and showing wear will be replaced over the next 2 years. No other maintenance needs were identified.

PL-4. Perimeter Sign P37

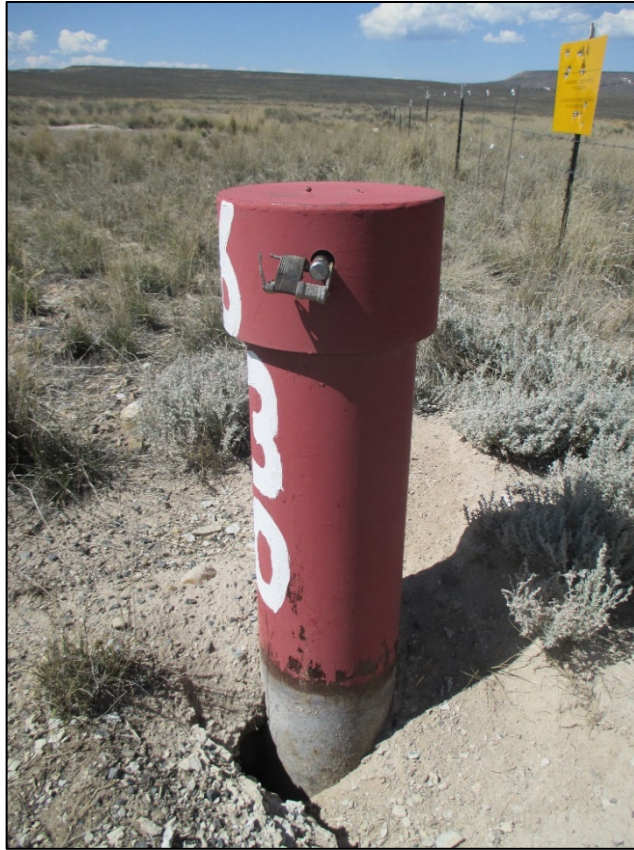
The site has 16 groundwater monitoring wells. The wellhead protectors were locked and properly labeled. Bullet damage is present on the locks of monitoring wells 0630 (PL-5) and 0712 and on the wellhead protector of monitoring well 0634. Both wells are secure, though new locks will be installed on both monitoring wells. Gunnison County landfill operators have placed concrete barriers to protect monitoring well 0716, which is on landfill property, from landfill activities. The edge of an adjacent spoil pile, although close to the concrete barriers, does not impair access to monitoring well 0716. The base of monitoring well 0709 is cracked but remains stable. Inspectors will continue to monitor these features. No maintenance needs were identified.

PL-5. Well 0630

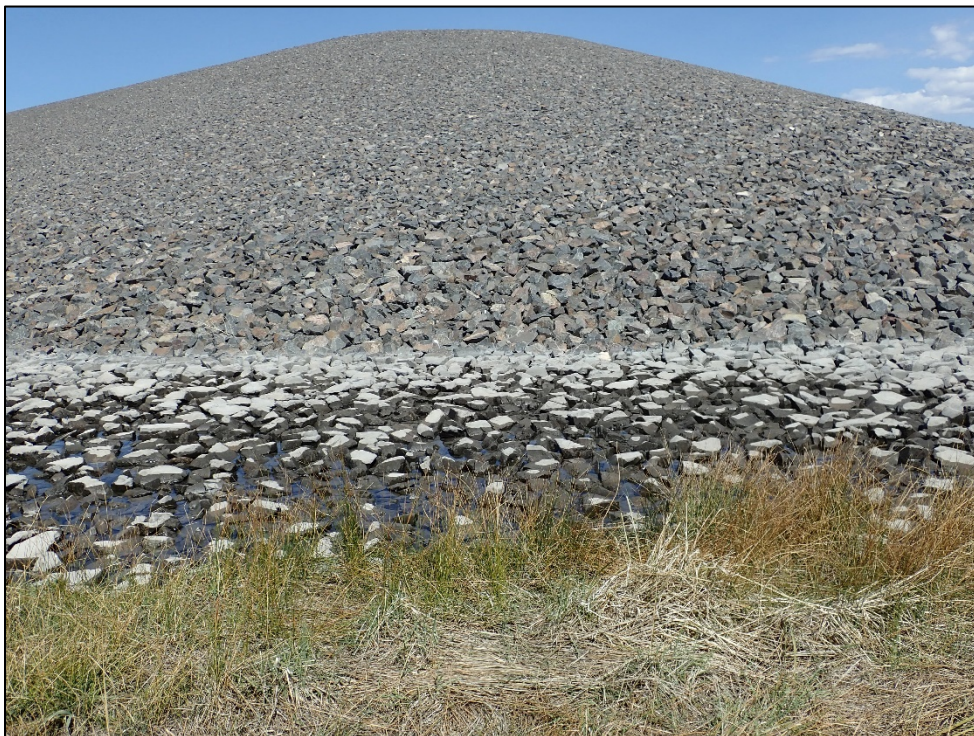
Stormwater runoff from the disposal cell occasionally ponds in a low-lying area at the southeast corner of the disposal cell; standing water was present at the time of the inspection (PL-6). The riparian-type vegetation that has become established there indicates that the area retains moisture. Water collection in this area does not pose a problem because the disposal cell surfaces are designed to drain to the southeast, and any water that ponds there is below the elevation of tailings placed under the engineered cover. No maintenance needs were identified.

PL-6. Water in Cell Apron, Southeast Corner

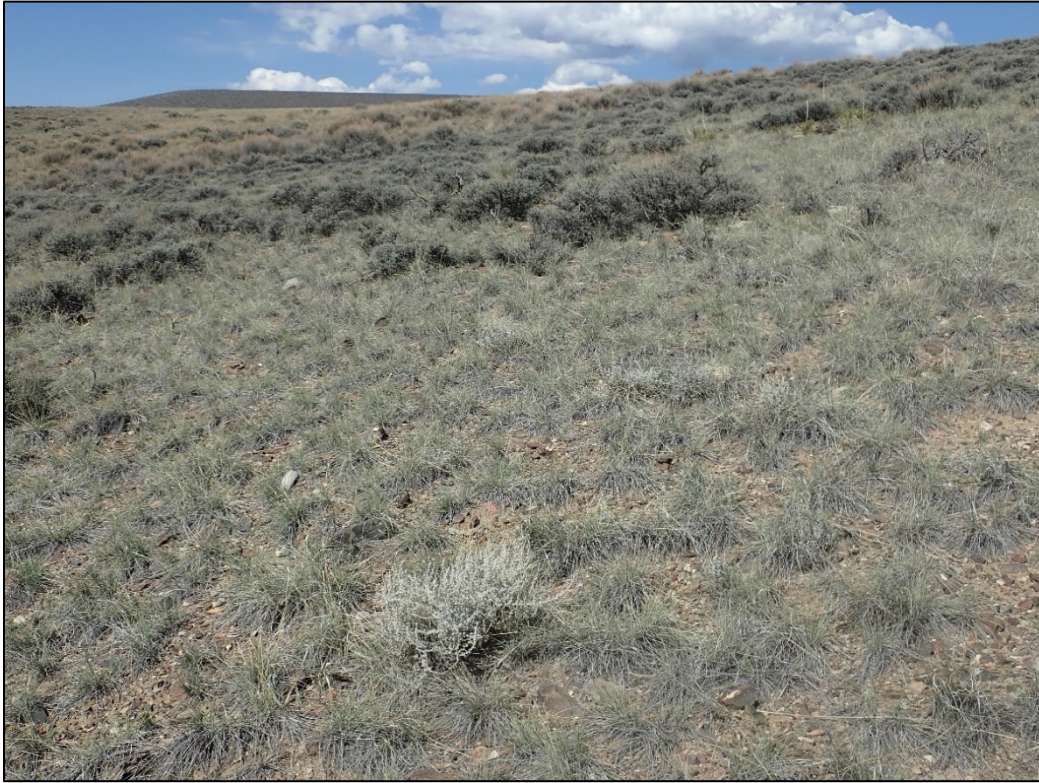
Reclaimed and undisturbed areas comprise the area between the disposal cell and the site boundary (PL-7). In general, the vegetation in the reseeded, reclaimed areas consists of well-established grass; native plants are much less abundant and less diverse in reclaimed areas than they are in undisturbed areas. Former erosion areas continue to be stable and are naturally revegetating with native plant species. No maintenance needs were identified.

PL-7. Reclaimed Area East of Cell

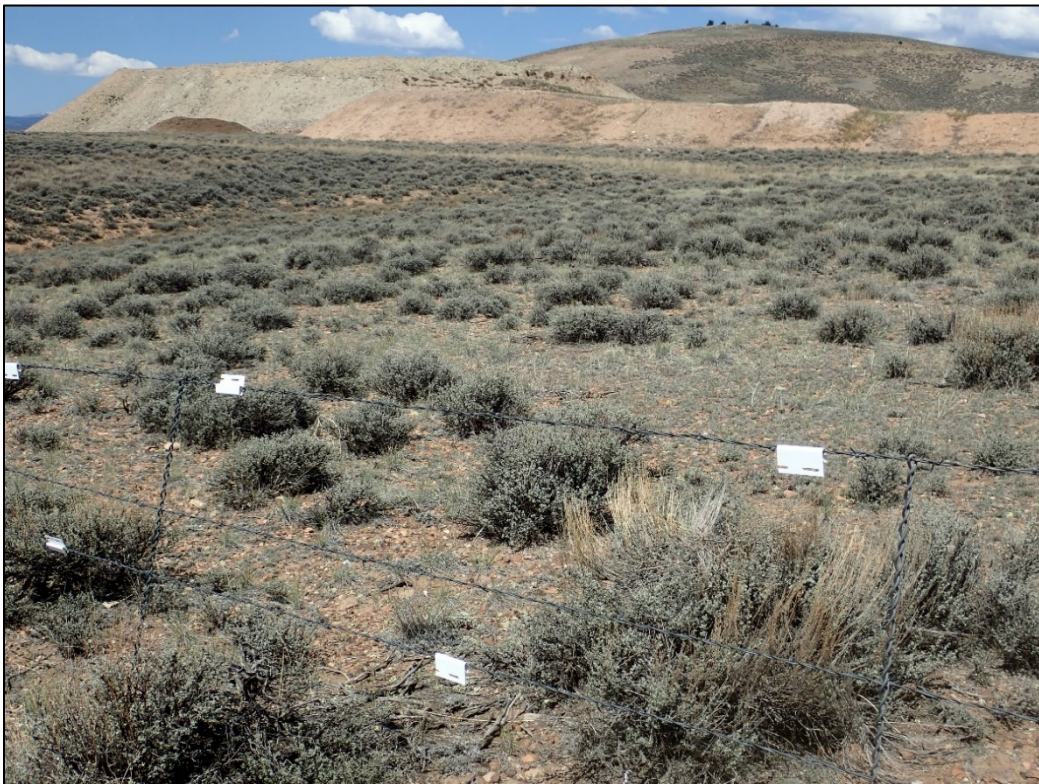
The area beyond the site boundary for a distance of 0.25 mile was visually observed for erosion, changes in land use, or other phenomena that might affect the long-term integrity of the site. Gunnison County owns the land that adjoins the site boundary to the north and east and uses the land for a municipal landfill. The nearest landfill operations continue to be approximately 400 feet north of the site (PL-8). Although landfill activities do not affect the site, inspectors will continue to monitor the level of activity occurring near the site boundary and surveillance features (e.g., fences and monitoring wells). With regard to groundwater flow, the landfill operations are upgradient from the disposal cell. The proximity of the spoil pile to monitoring well 0716 (see Figure 8-1) is the only current concern for activities that could affect a site asset. Inspectors will continue to monitor this area.

PL-8. Gunnison County Landfill Operations
